Building and Timber Pest Inspection Report

Inspection Date: Fri, 27 Mar 2026

Property Address: 131 Woodcourt Rd, Berowra Heights NSW
2082, Australia

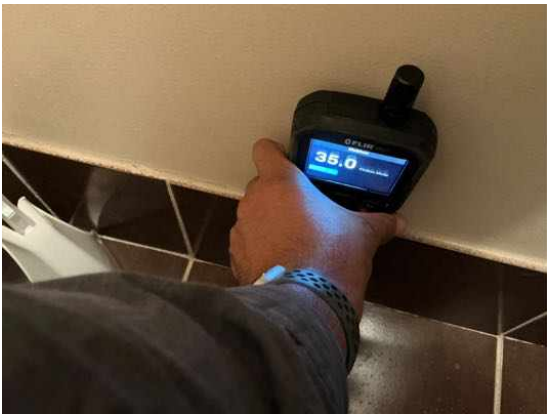
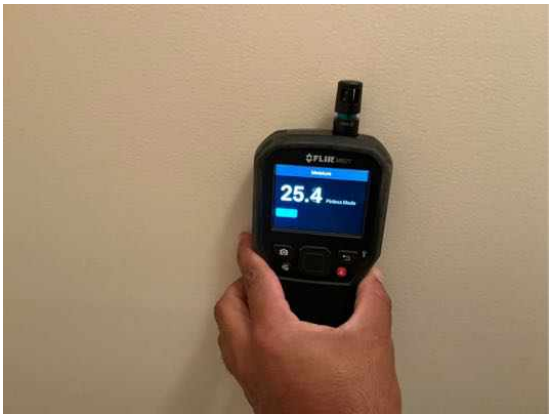
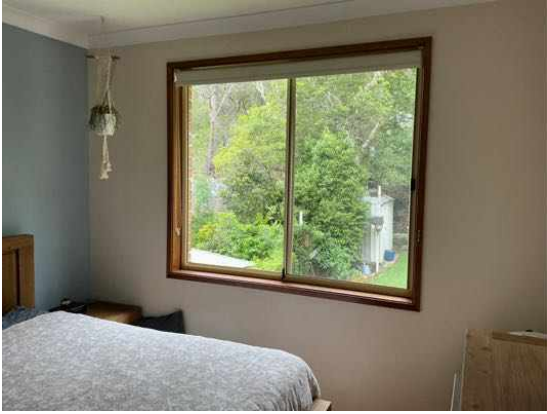
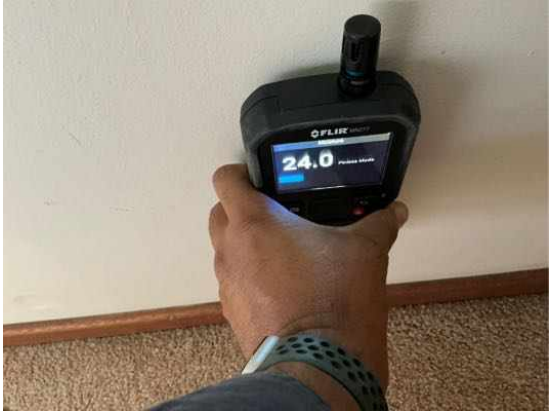
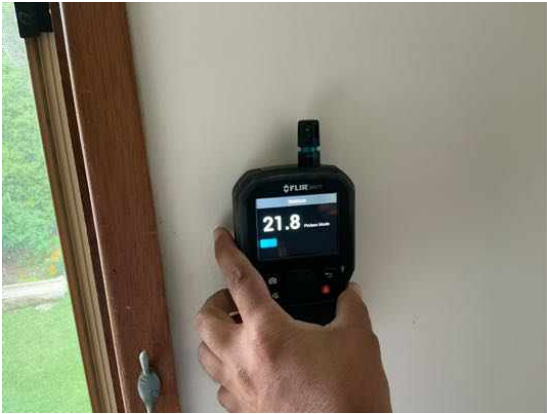
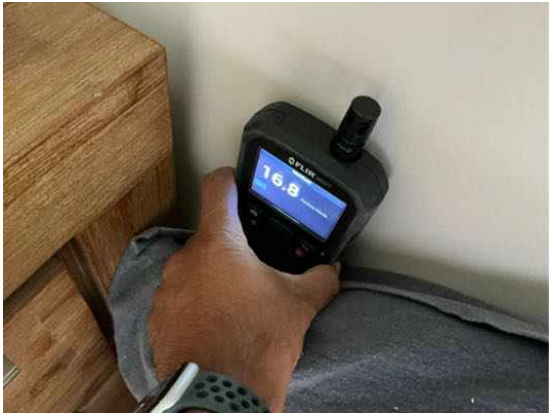
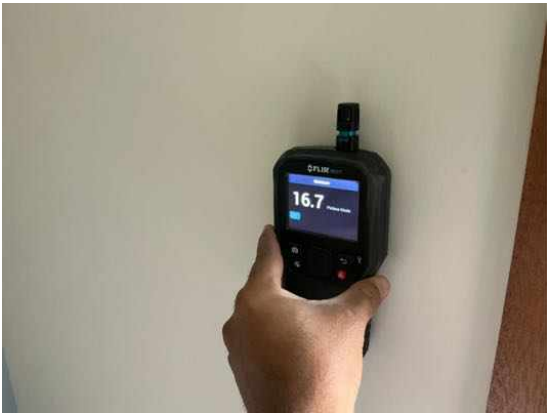
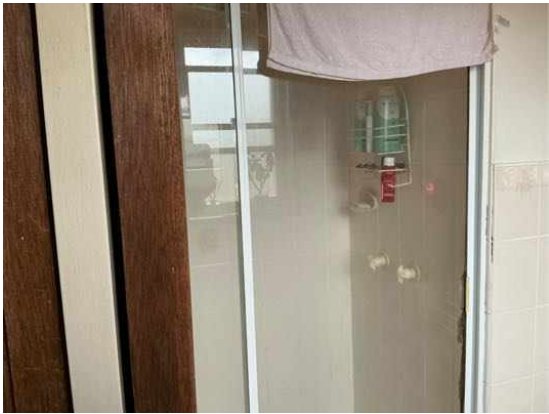
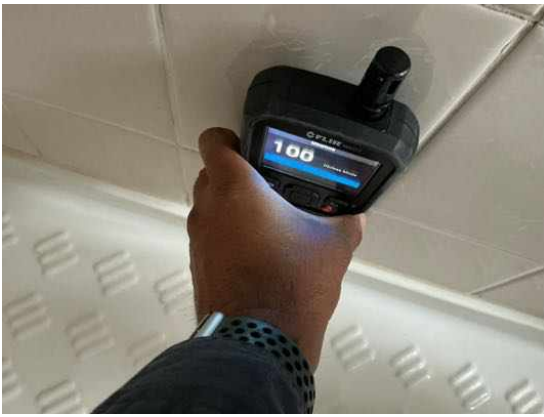
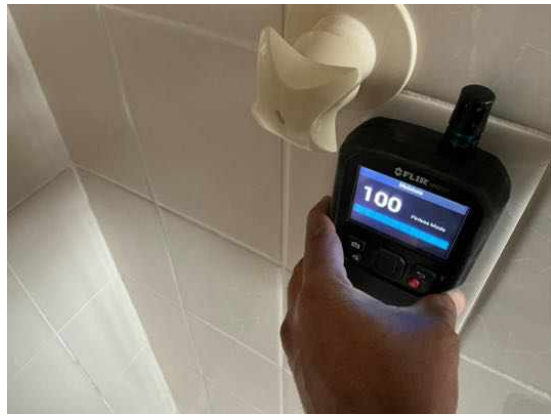
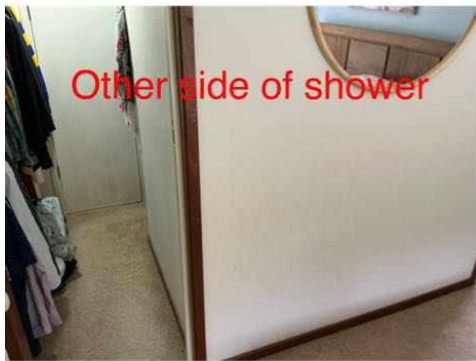
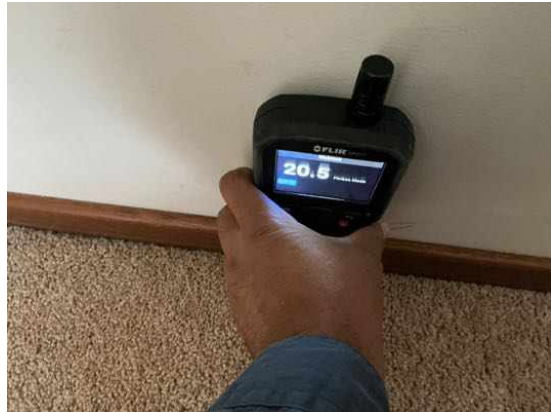
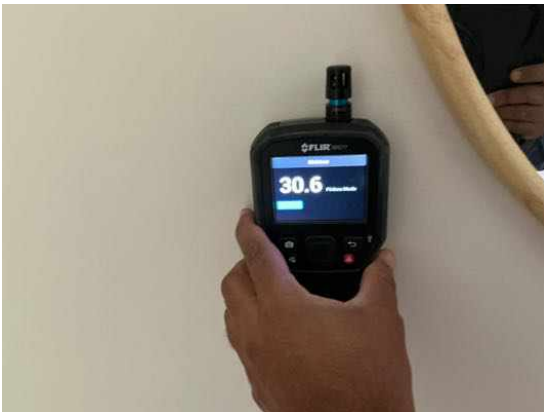
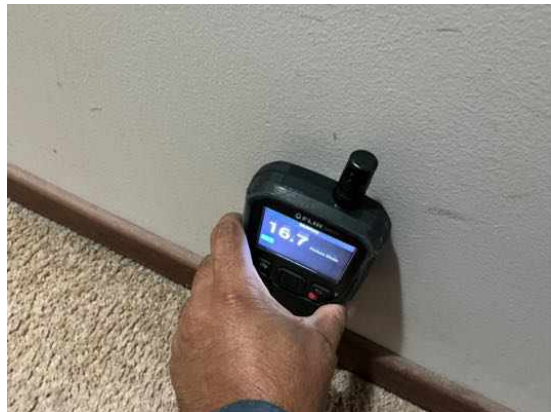
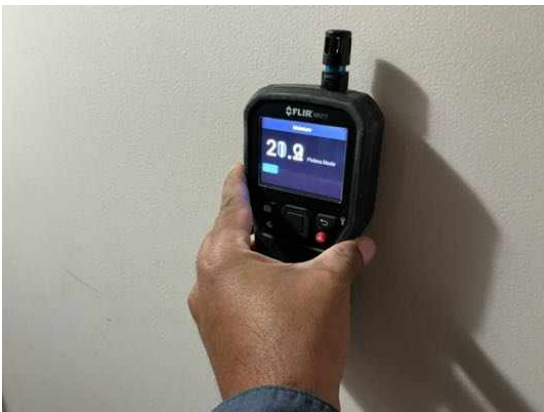
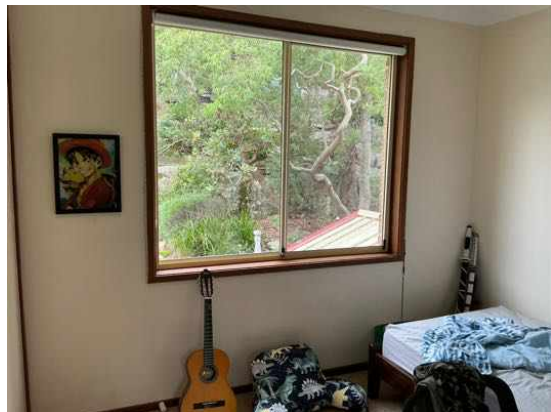
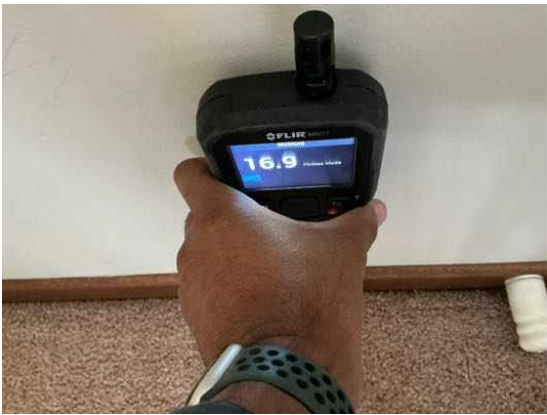
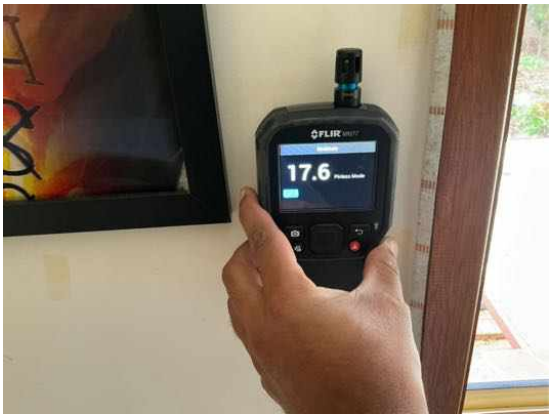
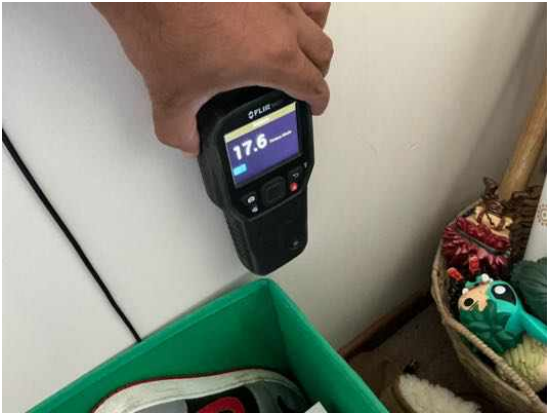
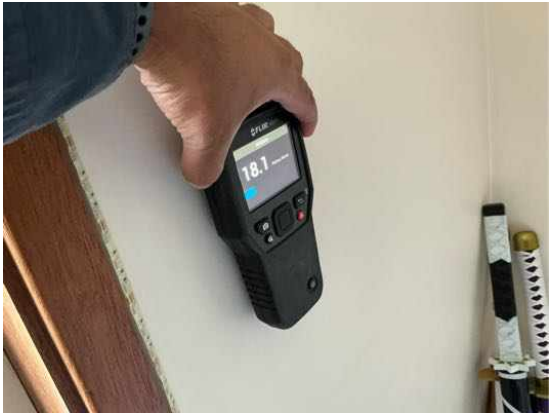
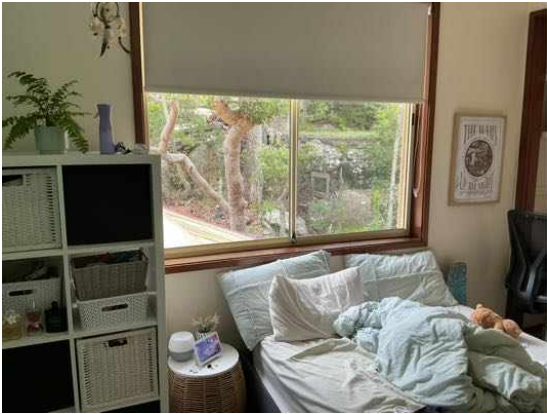
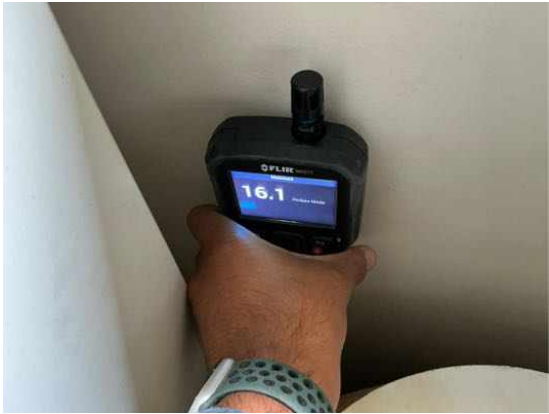
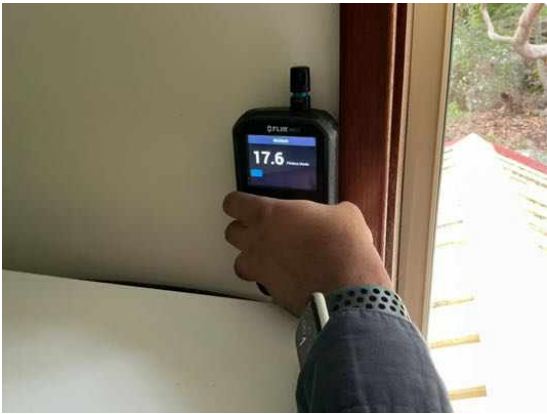
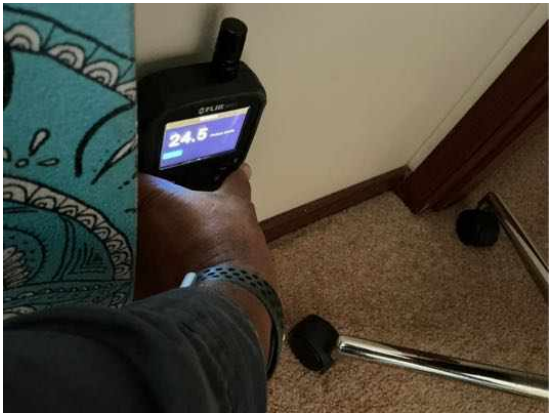
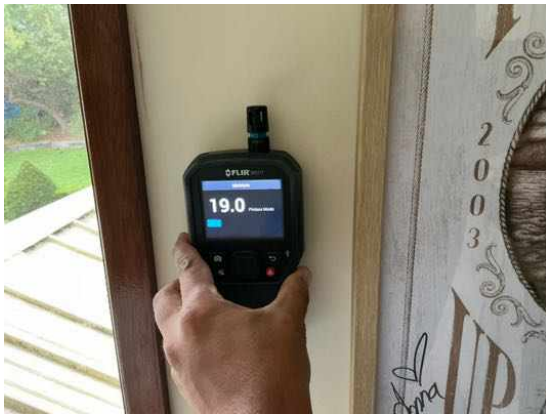
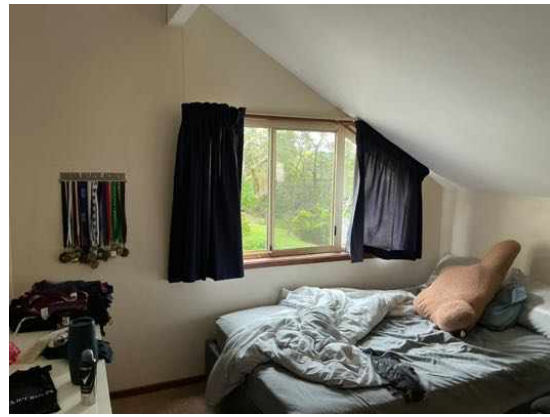
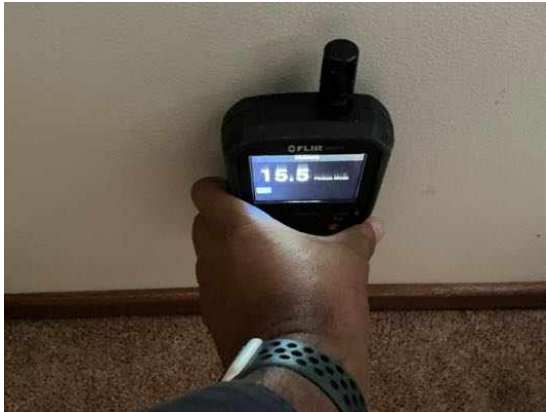
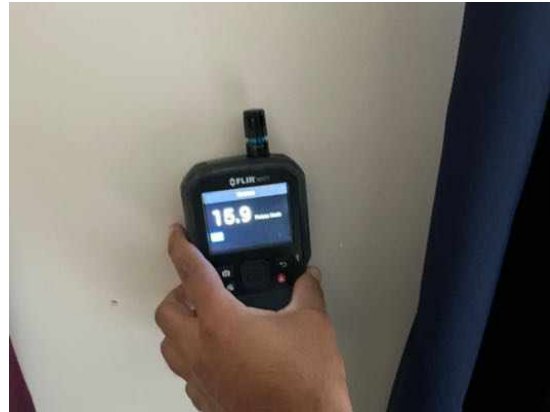
Building: Main Building
Location: All Areas
Finding: Additional Photos - Moisture Meter Readings
Information: Additional moisture meter reading photos have been provided for the property to offer further clarity on areas tested during the inspection. These photos are intended to give a visual reference for the specific locations where moisture levels were measured. These readings were taken at the time of the inspection to assess any potential moisture-related issues within the property. Any defects related to moisture that were identified during the inspection have been separately mentioned in the defect statements within the report.

It is important for the client to understand that moisture levels can fluctuate over time due to various factors, including changes in weather, humidity, and environmental conditions. While the readings reflect the property’s moisture levels during the inspection, they may not represent future conditions, and increased moisture could lead to issues such as dampness, mould growth, or deterioration of building materials if left unmonitored.

For further clarification or additional information regarding the moisture readings, the client is encouraged to contact the building inspector directly. Regular monitoring of moisture-prone areas is recommended to ensure any emerging concerns are addressed promptly, particularly during wetter seasons or in high-humidity conditions.

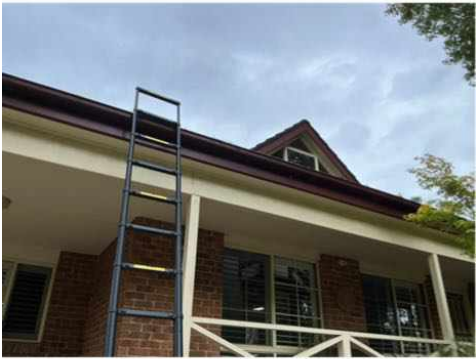
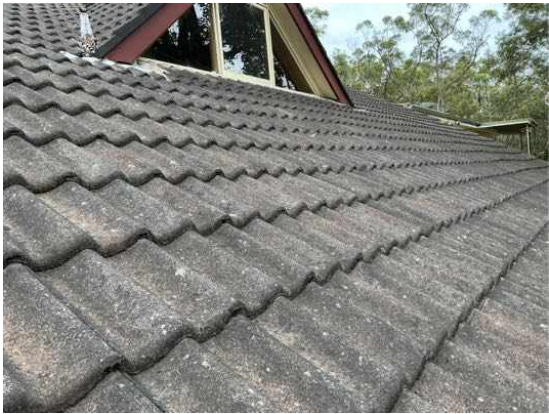
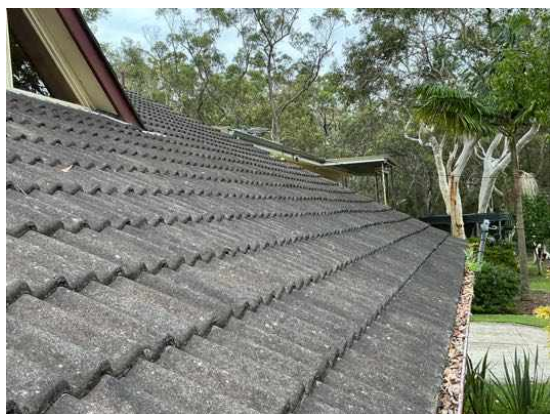
Information: As part of the information provided, please note that the attached roof photos represent the condition of the roof at the time of inspection. These photos are for visual reference only and do not constitute a detailed roofing assessment. Any defects or issues identified with the roof are mentioned separately in the defect statements. It is strongly recommended that the client engage a qualified roofer to conduct a thorough inspection of the roof, ensuring that any potential issues, such as leaks, structural integrity, or wear and tear, are properly identified and addressed.

Additionally, the condition of the roof may change over time due to weather, natural wear, or other unforeseen factors. Regular maintenance and inspections by a licensed professional are advised to ensure the roof remains in good condition and to avoid costly repairs in the future. The information provided in these photos should be considered a snapshot of the roof's condition during the time of inspection and not a guarantee of its future performance.

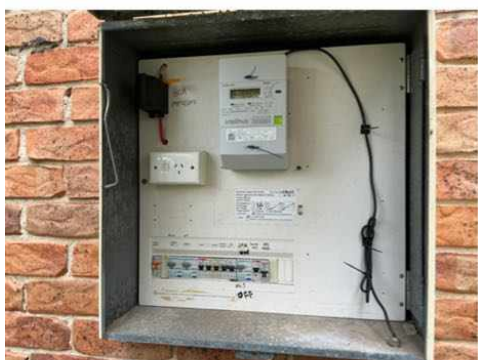
Building: Main Building
 Location: Meter Box
 Finding: Termite Management Recommendation – No Evidence of Chemical Installation
 Information: At the time of inspection, there was no visible evidence of a chemical termite management system installed around the property. Chemical barriers are a key component of termite protection and are particularly important in preventing concealed termite entry into timber elements of the structure.

In accordance with standard requirements, a durable notice should be located within the electrical switchboard to detail any termite protection systems applied, including chemical treatments. No such notice was observed during the inspection.

It is recommended that the client engage a licensed pest controller to assess the suitability of installing a chemical barrier, and to provide advice on associated costs and procedures. This should be considered a short-term priority, particularly if the property has any history of termite activity or is located in a high-risk area.
