Building and Timber Pest Inspection Report

Inspection Date: Thu, 19 Mar 2026

Property Address: 10A Stables Ln, South Yarra VIC 3141,
Australia

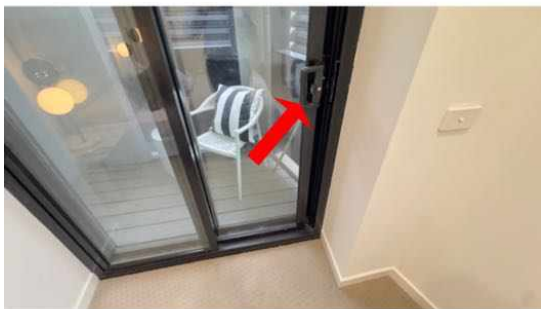
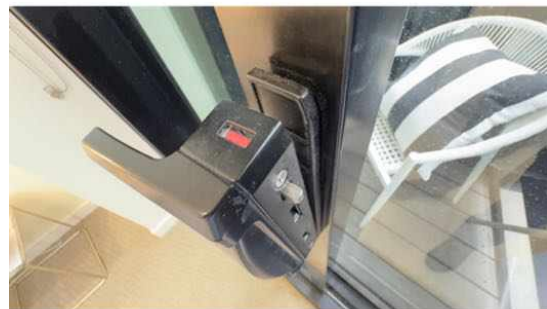
Building: Main Building
 Location: All Areas >
 Finding: Doors - Loose Door Handles
 Information: The inspection identified loose door handles in this area. Loose door hardware can affect door operation, making opening and closing difficult and reducing overall functionality.

The issue appears to be caused by wear and tear, corrosion, improper installation, or impact damage.

A qualified carpenter or door specialist should be engaged immediately to repair, replace, or adjust the loose handles. Prompt rectification will ensure doors operate smoothly and maintain functionality.

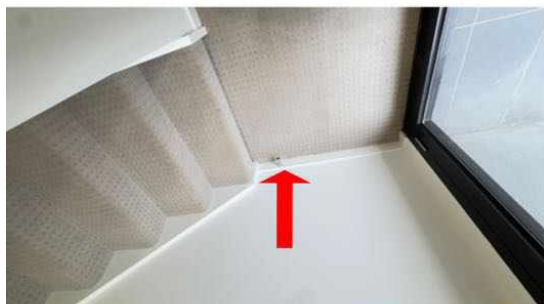
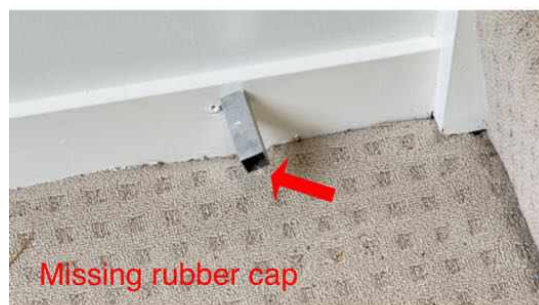
Finding 3.03

Building: Main Building
 Location: All Areas >
 Finding: Doors - Missing Door Stops
 Information: The inspection identified missing door stops in this area. Missing door stops can lead to damage to walls or doors and may impair the proper operation of the doors.

The absence of door stops may be due to them not being installed during construction or having been removed after installation.

It is recommended that a qualified carpenter or competent handyman be engaged promptly to install the missing door stops. Correct installation will protect doors and walls and ensure proper door functionality.

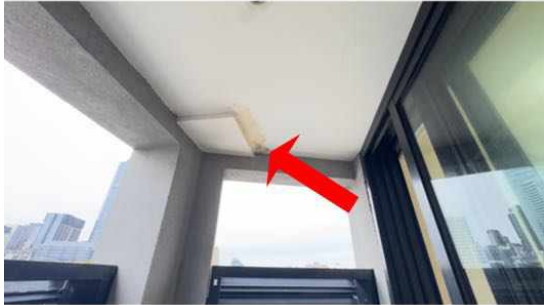
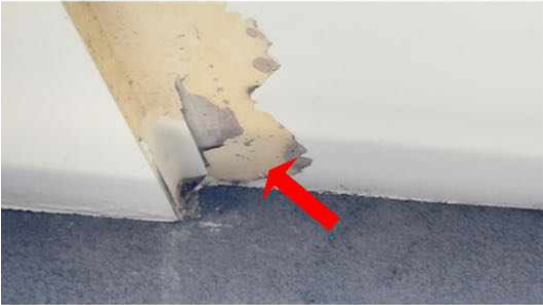
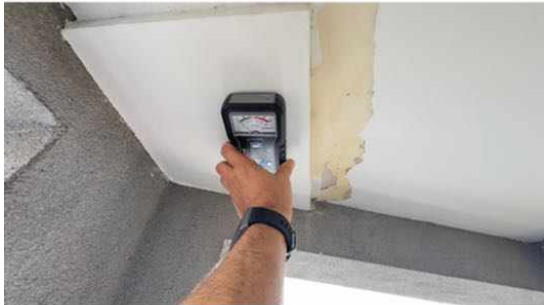
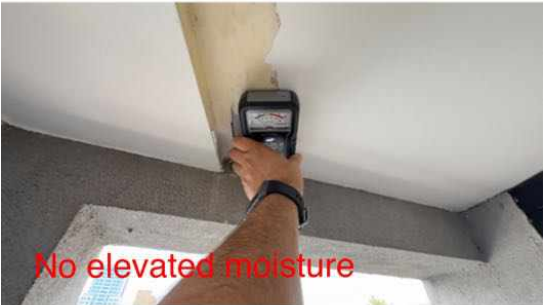
Finding 3.04

Building:	Main Building
Location:	Level 2 Balcony Area >
Finding:	Ceilings - Historic Damp Damage
Information:	The ceilings were inspected and dampness and moisture-related damage were observed in this area. Damp ceilings can weaken ceiling linings, cause mould growth, damage paint, and in severe cases may lead to partial collapse, creating a safety risk.

This may be due to roof leaks, defective roof coverings, plumbing leaks from above, condensation from poor ventilation, faulty flashings, or lack of timely maintenance and repair.

No elevated moisture levels were present at the time of inspection. The area should be monitored, and if any signs of moisture, deterioration, or related issues arise, a registered builder or licensed plumber should be engaged immediately to further investigate and rectify as required.

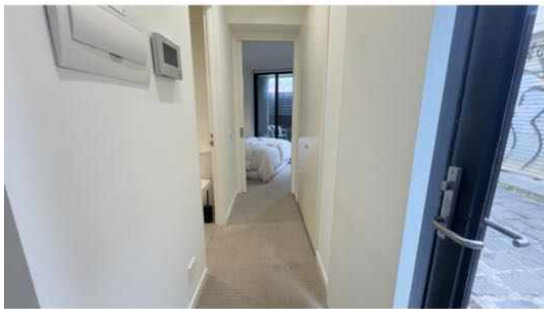
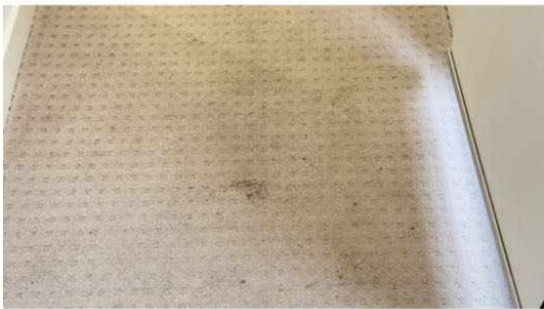
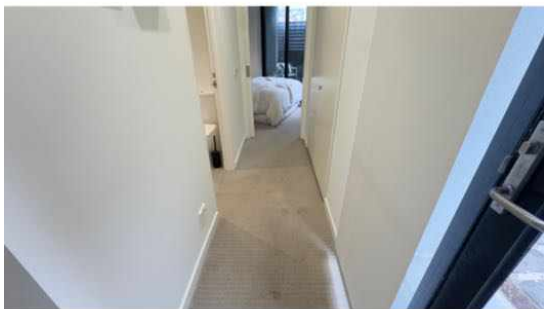
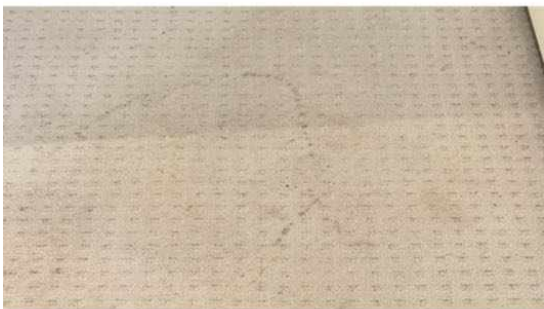
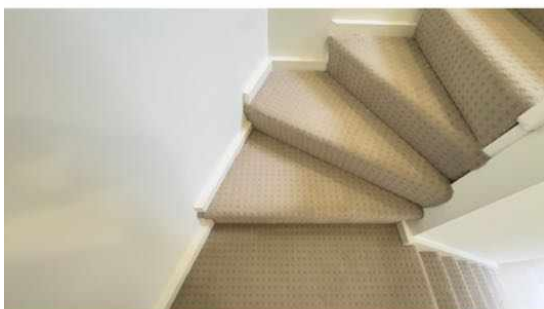
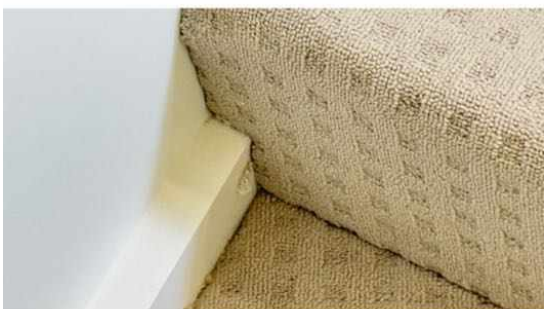
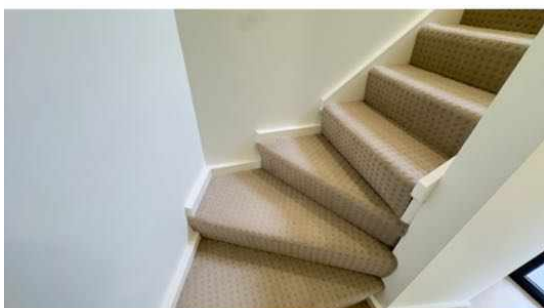
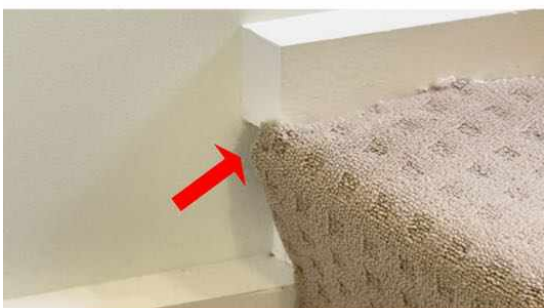
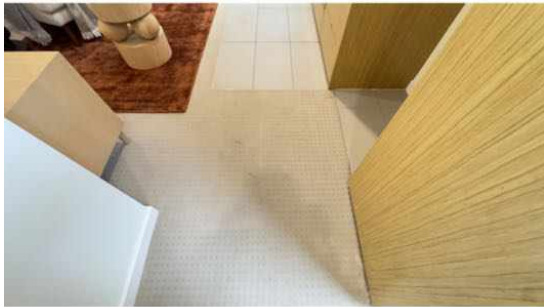
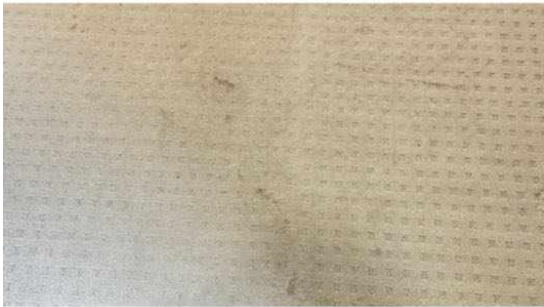
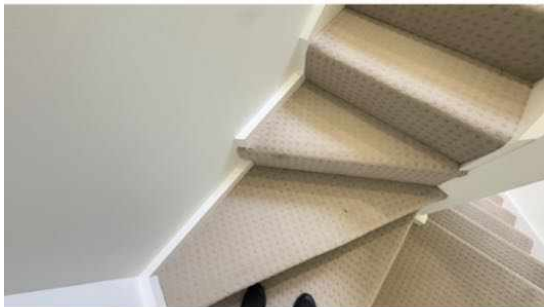
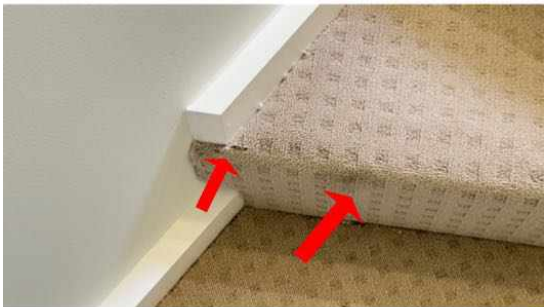
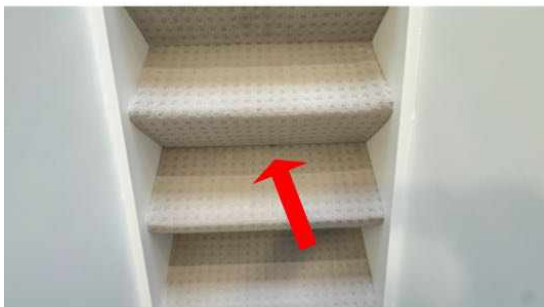
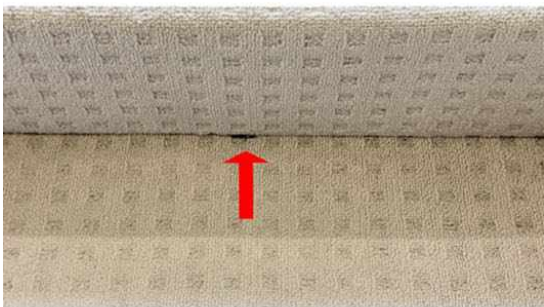
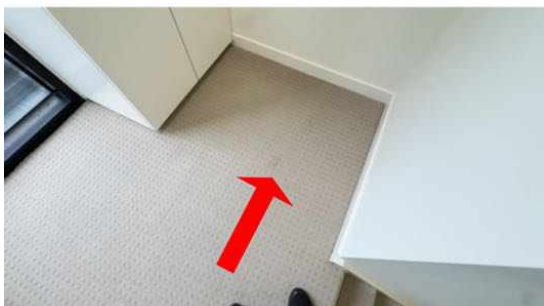
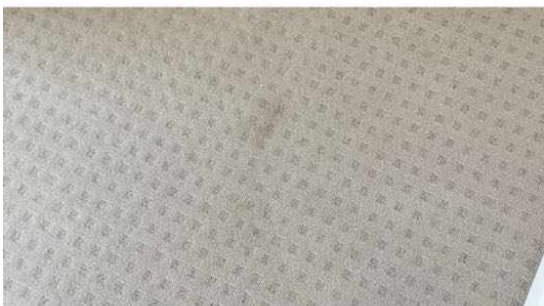
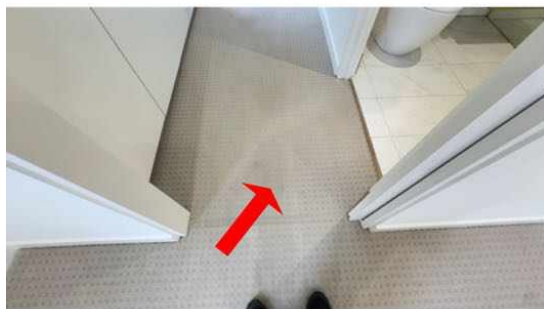
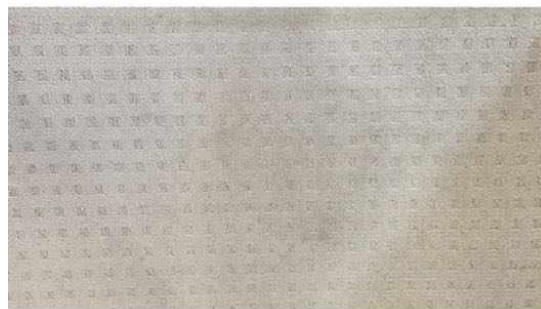
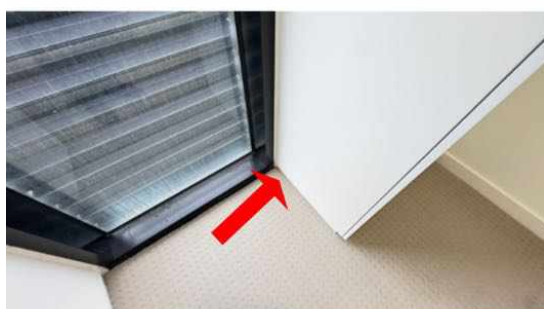
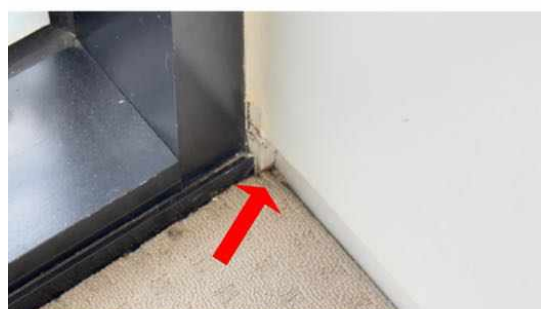
Finding 3.05

Building: Main Building
Location: All Areas >
Finding: Floors - Carpet Deteriated
Information: The carpet was inspected and found to be deteriated in this area, with signs of wear and staining. Damaged carpet can reduce comfort, detract from the appearance of the space, and, over time, expose the subfloor to additional wear or moisture.

This condition may result from everyday use, accidental impact, or age-related deterioration.

A qualified flooring installer should be engaged when practical to clean, repair and or replace the affected carpet. Timely attention will restore visual appeal, comfort, and the longevity of the flooring.

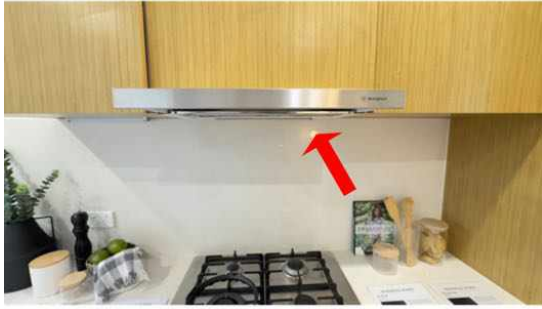
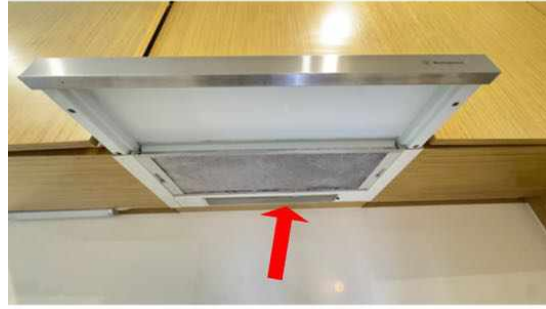
Finding 3.06

Building:	Main Building
Location:	Kitchen
Finding:	Kitchen Ventilation - Light Not Operational
Information:	During the inspection, the kitchen ventilation light was observed not to be operational. A non-functioning light may reduce visibility during food preparation and can indicate an electrical fault within the fitting, wiring, or switch.

The issue may be due to a failed globe, faulty light fitting, wiring defect, or switch malfunction.

It is recommended that a licensed electrician be engaged immediately to inspect the ventilation unit, identify the cause of the fault, and carry out necessary repairs to restore safe and proper operation.

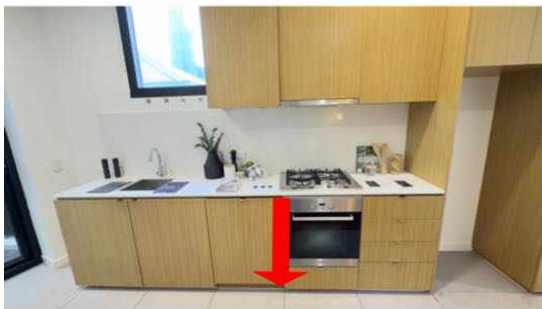
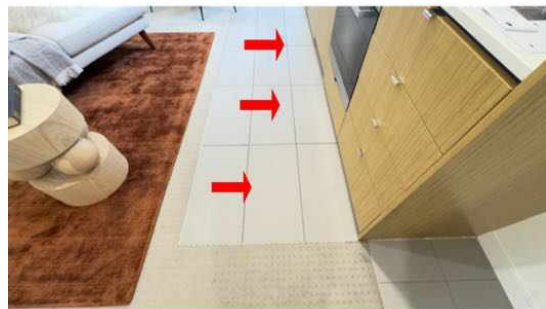
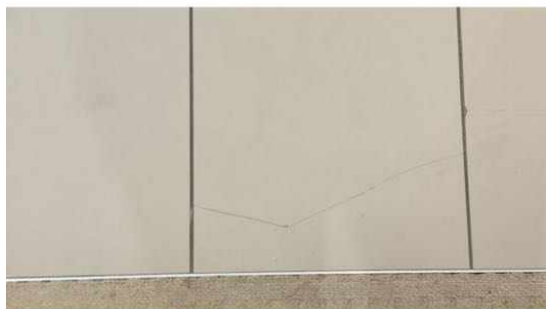
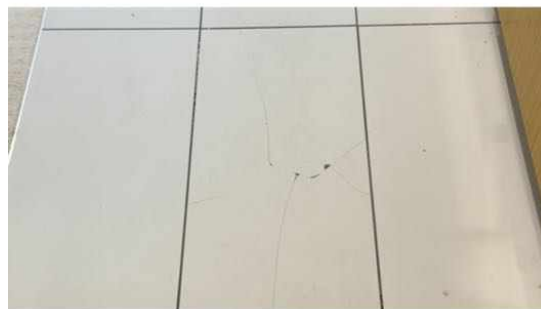
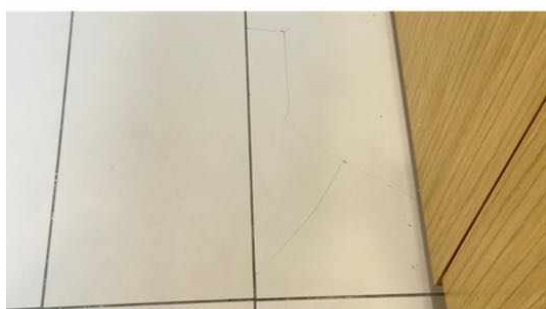
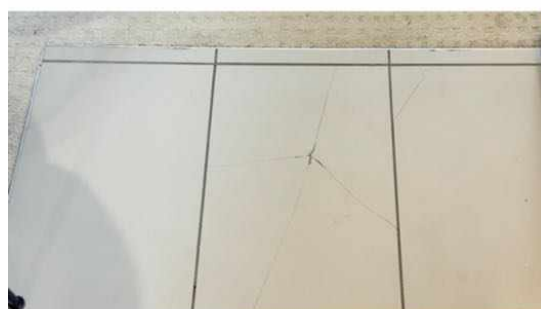
Finding 3.07

Finding: Tiles - Cracked

Information: Cracked tiles were observed in this area. Cracked tiles can reduce durability and appearance and, if left unaddressed, may result in further detachment or damage.

This condition may be due to inadequate adhesive during installation, movement of the substrate, age-related deterioration of the tile bonding, or impact from normal use.

A qualified tiler or competent handyman should be engaged immediately to secure or replace the affected tiles. Prompt attention will restore surface integrity, maintain hygiene, and protect the long-term appearance of the tiled area.

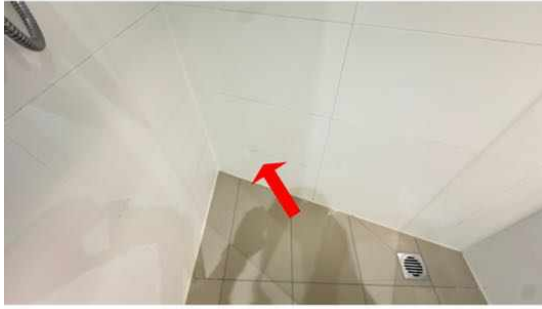
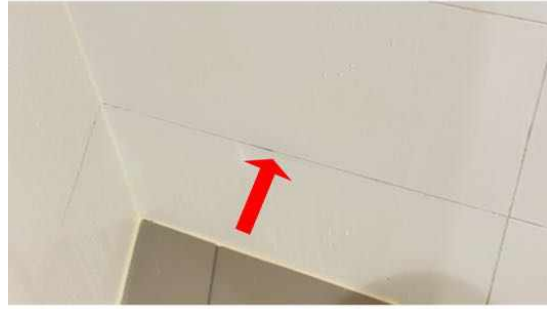
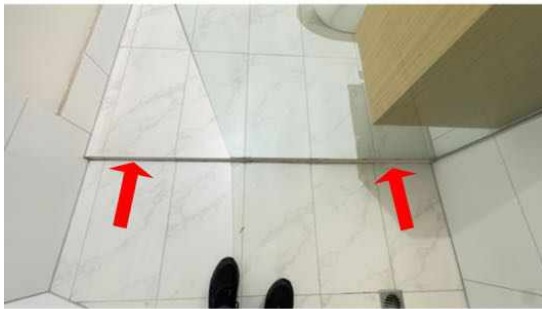
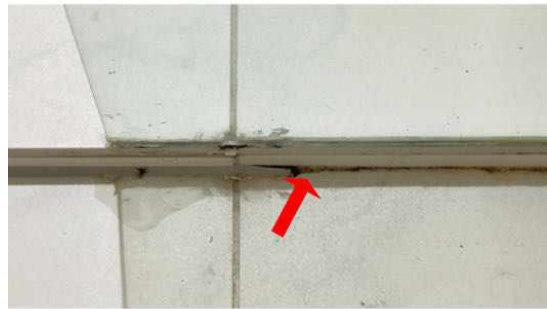
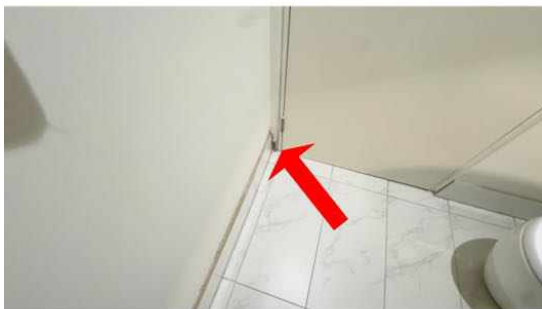
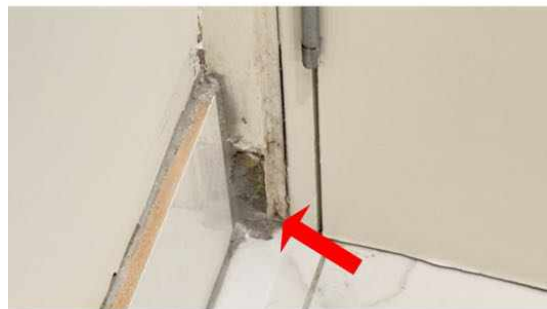
Building:	Main Building
Location:	All Bathroom Areas
Finding:	Tiles - Inadequate Grout
Information:	Tiles were observed to have inadequate and deteriorated grout between joints in this area. Insufficient grout can allow water penetration, lead to tile movement, and contribute to substrate deterioration or mould growth.

Possible causes include poor original installation, age-related wear, or moisture exposure.

A qualified tiler should be engaged immediately to re-grout the affected areas. Prompt remediation will restore water resistance, maintain tile stability, and prolong the life of the flooring.

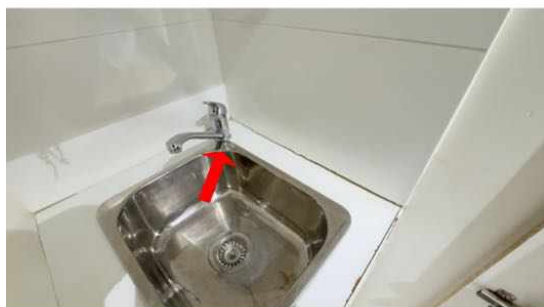
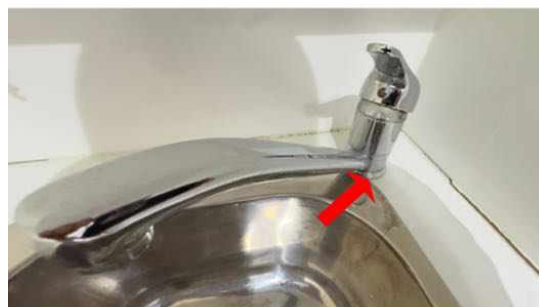
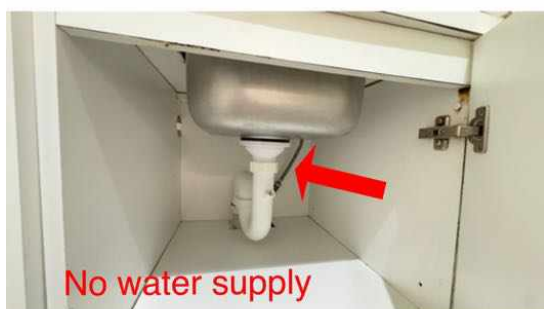
Finding 3.09

Building: Main Building
 Location: Laundry
 Finding: Laundry Tap Fitting - Loose
 Information: Fittings were observed to be loose and inadequately secured to walls in this area, moving when light pressure was applied. This reduces usability and may cause further damage if not addressed.

Common causes include incorrect or inadequate fixings, use of anchors unsuitable for the wall type, movement of the wall or timber substrate, wear from repeated use, or improper installation.

If left unresolved, loose fittings may detach, damage wall finishes, or cause progressive deterioration of both fittings and surrounding surfaces.

When practical, a qualified carpenter or experienced handyman should be engaged to securely refix or replace all loose fittings using appropriate fixings and methods for the wall type. The fittings should be monitored over time to ensure they remain secure.

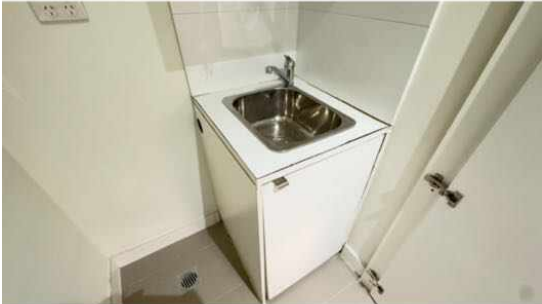
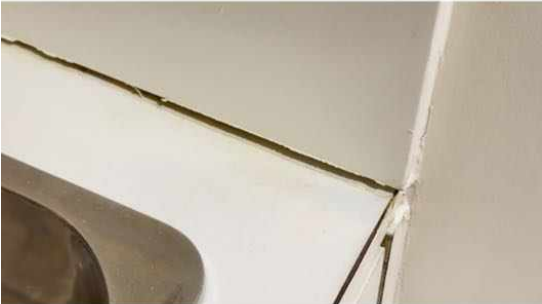
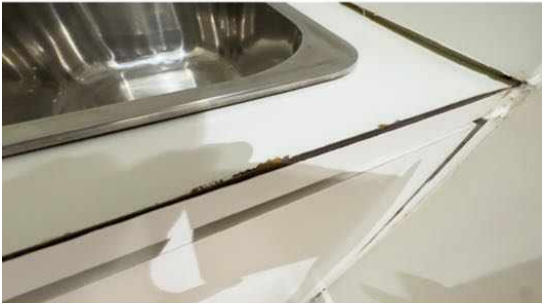
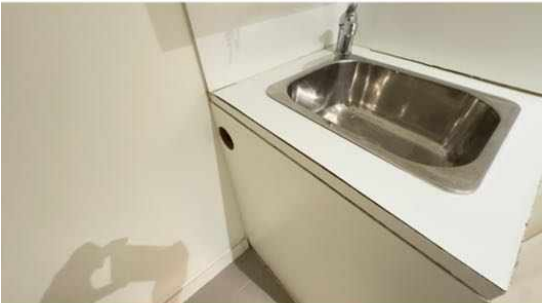
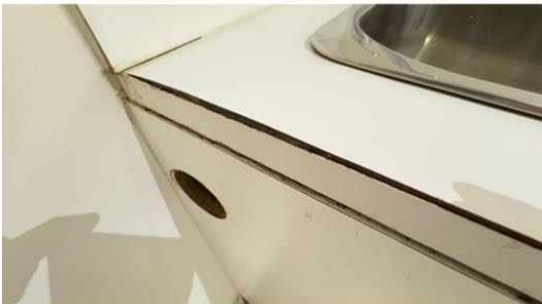
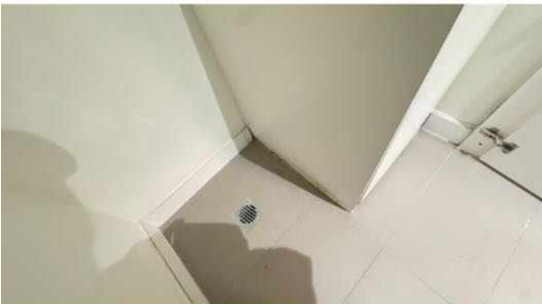
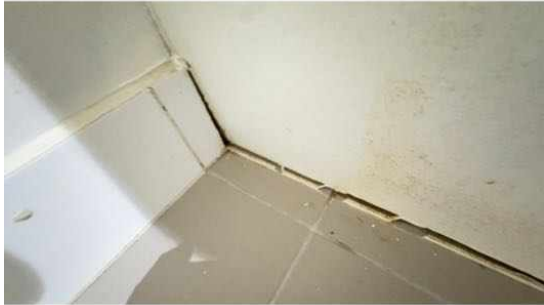
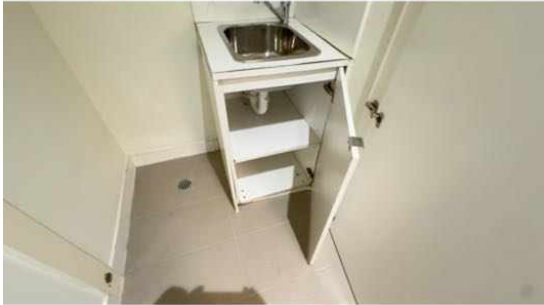
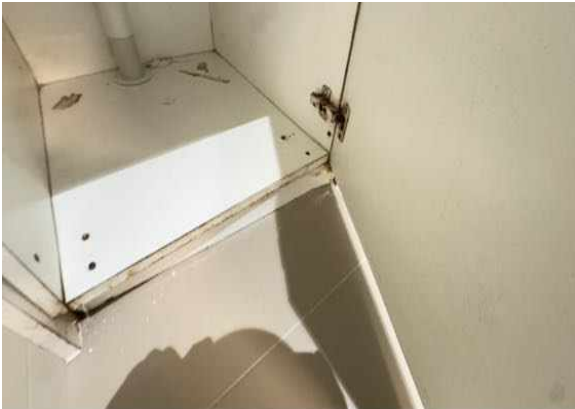
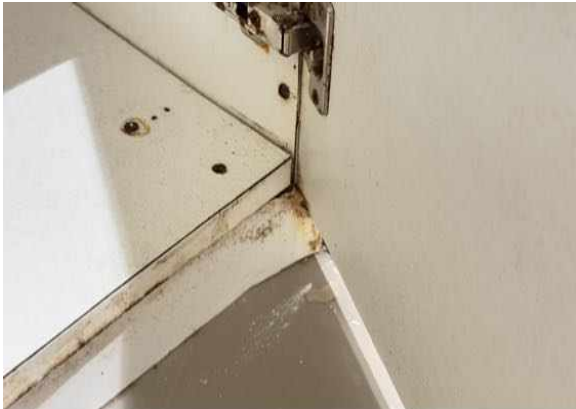
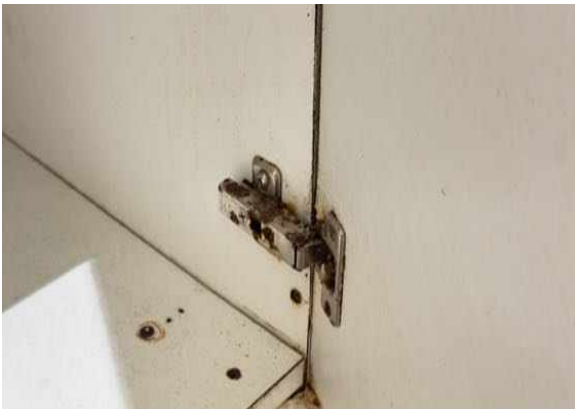
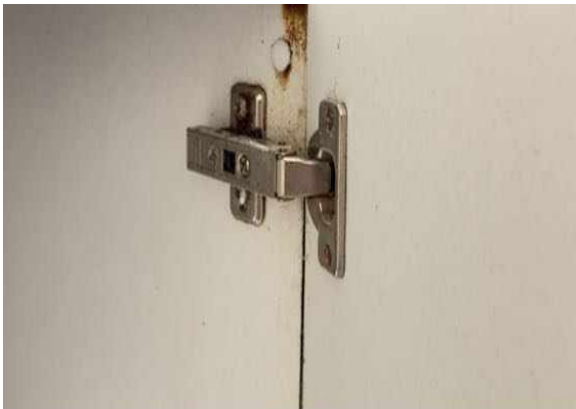
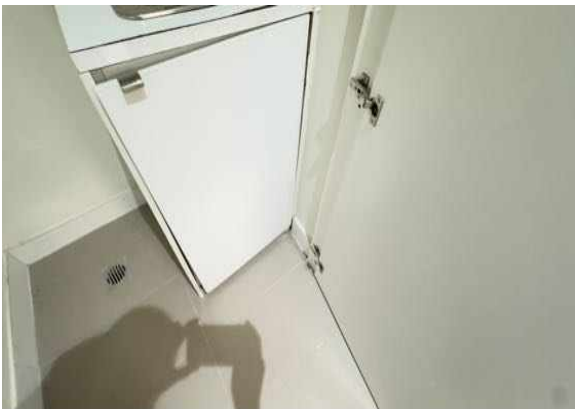
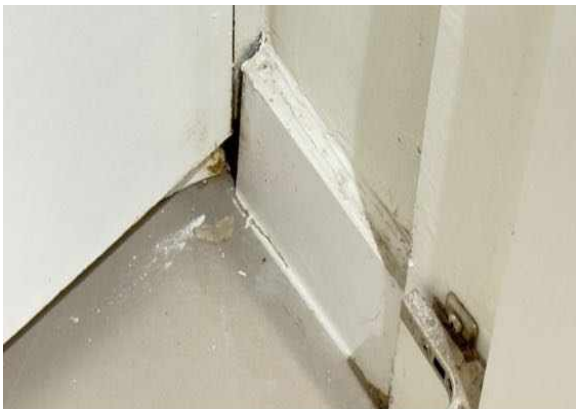
Finding 3.10

Building:	Main Building
Location:	Laundry
Finding:	Laundry Cabinets - Water Damage -
Information:	Swelling, distortion, and deterioration are present in the cabinets in this area, consistent with water exposure.

The damage may be caused by leaks from nearby plumbing fixtures, such as the sink or associated pipework, poor sealing around benchtops, splashbacks, or sink cut-outs allowing water ingress, or previous flooding, overflows, or prolonged exposure to high humidity.

It is recommended that a licensed plumber be engaged immediately to investigate for any active leaks from plumbing fixtures or connections. Defective sealants should be renewed, and any damaged cabinetry repaired or replaced as necessary. Preventative maintenance, including regular resealing around sinks and benches, is strongly

advised to prevent recurrence and prolong the service life of the cabinets.

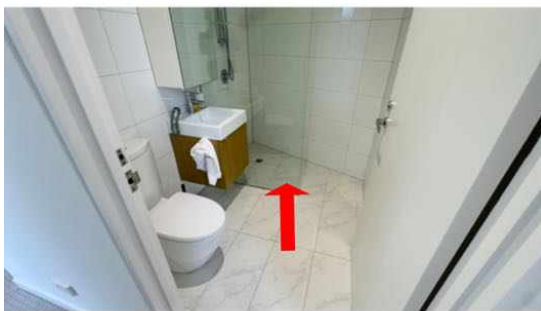
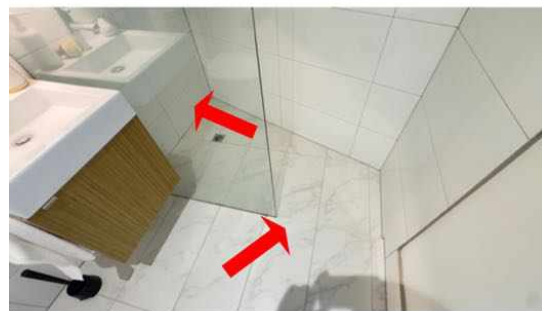
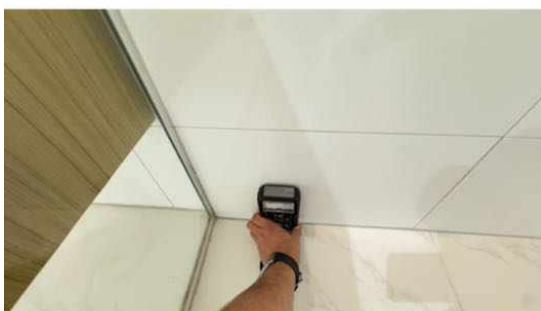
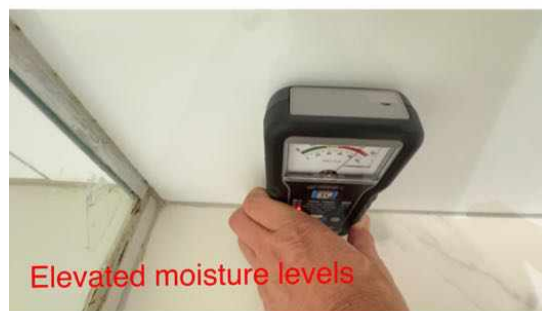
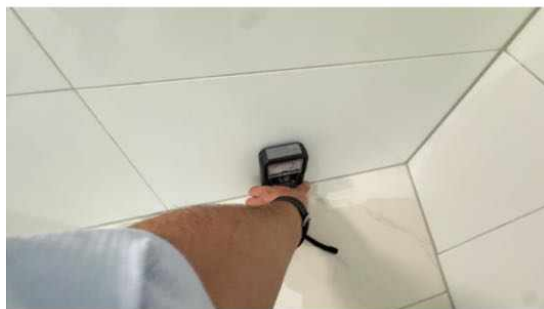
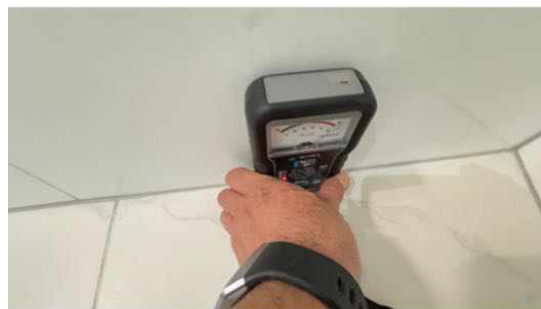
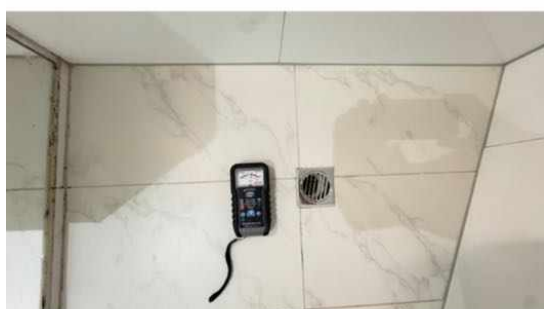
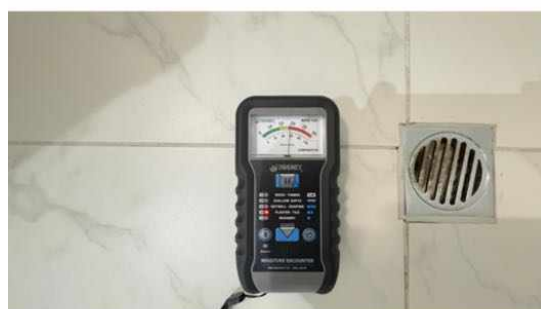
Finding 3.11

Building: Main Building
Location: Ensuite - Master Shower >
Finding: Shower Damp - To Be Monitored & Epoxy Grout
Information: Damp is evident to the lower wall to the shower alcove and acceptable level moisture reading were found to the reverse side of the shower. Moisture readings were not found to the wall adjacent to the shower.

Damp (or structural damp) refers to the presence of unwanted moisture in the structure of a building, either as the result of intrusion from outside, or condensation from within the structure. In the shower area, internal water leaks or other sources of excessive moisture are generally the cause of damp.

It is advised to engage an epoxy grout specialist to remove and replace the grout with epoxy grout and install epoxy to all floor wall corner joints.

Always ensure that sealant and grout is in good condition to prevent any moisture issues occurring in the future

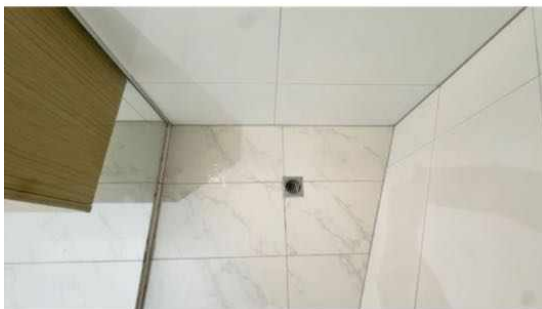
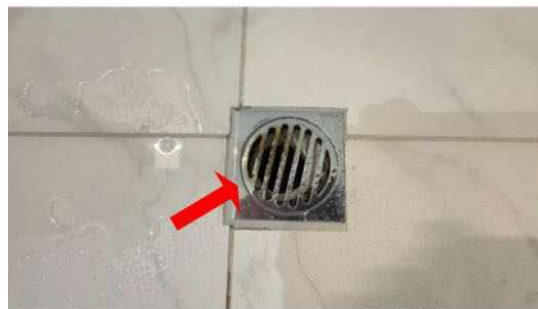
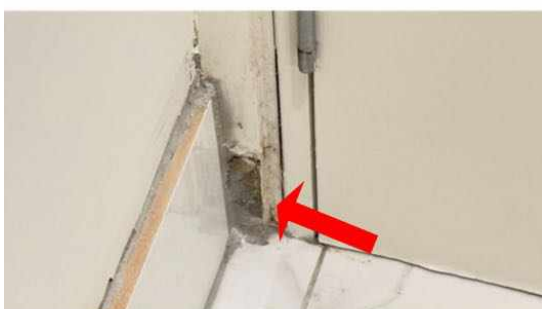
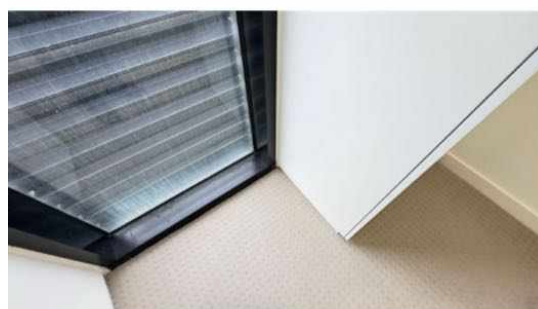
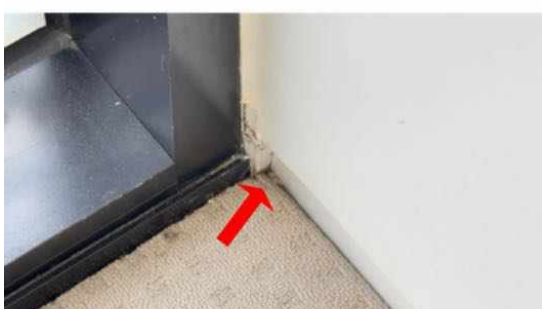
Finding 3.12

Building:	Main Building
Location:	All Areas
Finding:	Building element - Damaged
Information:	Breakage occurs generally when the building materials have either aged and decayed, or as a result of damage (accidental or deliberate).

Repair and/or replacement of broken elements is advised to ensure that additional secondary defects do not arise as a consequence. Such works are necessary, as all building elements play a key role in the operation and function of the overall structure and its performance.

A relevant tradesperson should be appointed to repair or replace the affected building element prior to any subsequent damage being caused.

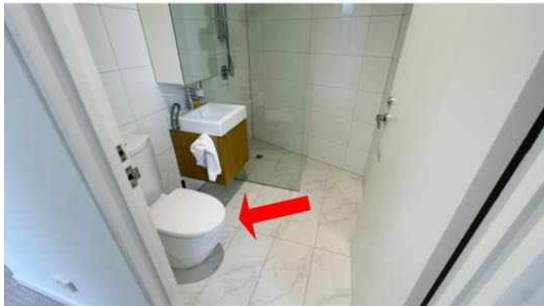
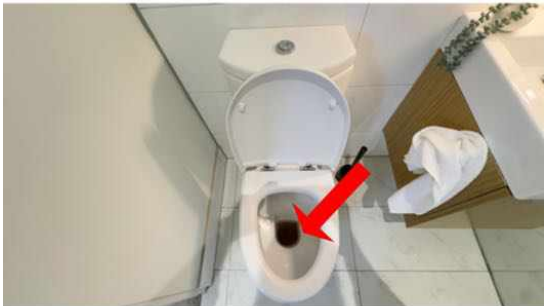
Finding 3.13

Building:	Main Building
Location:	Bathroom 1
Finding:	Toilet - Not flushing
Information:	The toilet did not flush at the time of inspection.

Non-operational building elements such as this are vital to the function of the household and must be fixed.

A qualified plumber should be appointed immediately to repair the toilet and return it to an operational state.

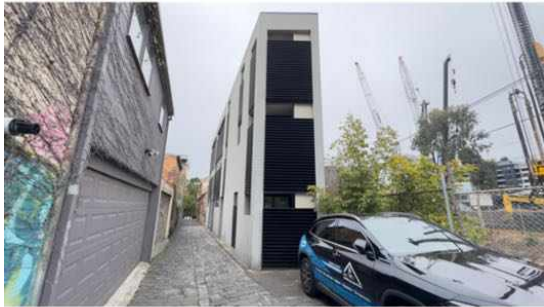
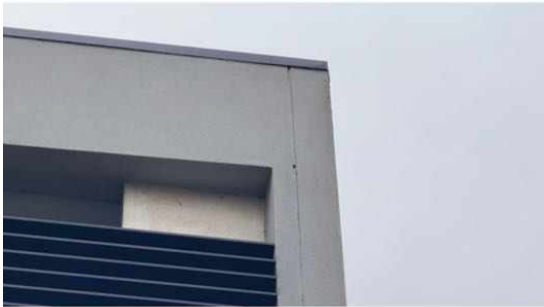
Finding 3.14

Building: Main Building
Location: All External Areas >
Finding: External Walls - Minor Cracking To Wall Claddings
Information: Minor cracking was observed to the external walls in this area. The cracking appeared superficial and did not indicate significant structural movement; however, such cracking can allow moisture ingress if left unaddressed.

The cracking is likely due to building movement or minor settlement.

When practical, a registered builder should assess and repair the cracking, which may include sealing and repainting. The area should be monitored, and any increase in cracking or signs of movement should be further investigated immediately by a Structural Engineer.

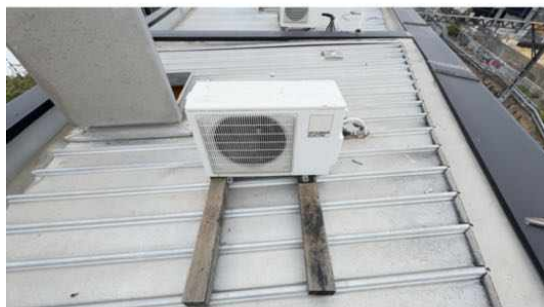
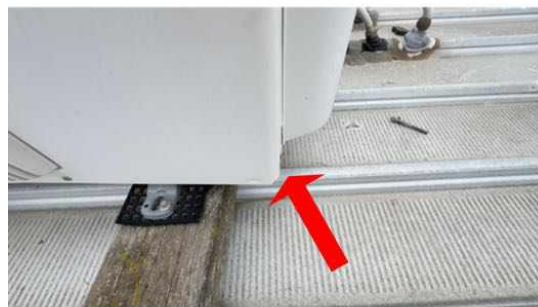
Finding 3.15

Building:	Main Building
Location:	All External Areas >
Finding:	AC Condensate Drain - Not Connected To Storm Water
Information:	The air conditioning condensate drain in this area was observed to be disconnected from stormwater drainage.

When condensate is not properly directed to a stormwater outlet, water can accumulate around the building or air conditioning unit, creating damp conditions that may lead to secondary defects such as timber rot, corrosion of nearby metal components, mould growth, or slippery surfaces. Prolonged pooling of water may also attract termites and contribute to long-term deterioration of surrounding building

elements.

A qualified HVAC technician or licensed plumber should be engaged immediately to connect the condensate drain to a suitable stormwater outlet. Prompt rectification will ensure proper drainage, protect the building fabric, and reduce potential health and safety risks.

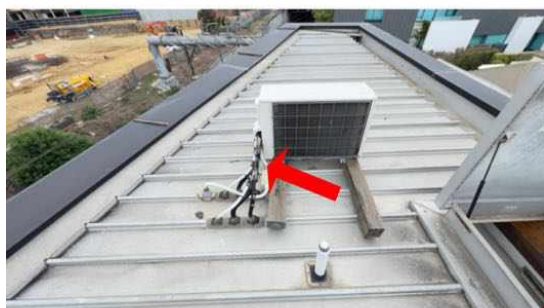
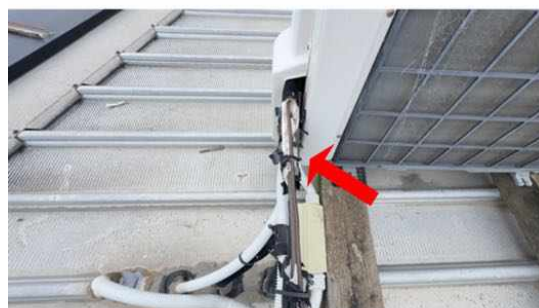
Building: Main Building
 Location: Roof
 Finding: Roof Exterior - HVAC Insulation Deteriated
 Information: Deterioration to the HVAC insulation was observed in this area.

Deteriorated may result in reduced system efficiency, air leakage, potential condensation issues, and compromised indoor air quality. Continued deterioration may also lead to system failure.

It is recommended that a suitably qualified HVAC technician inspect the pipe work immediately and carry out repairs or replacement as required to restore effective operation and prevent further degradation.

Rectification should be undertaken by a licensed and suitably qualified HVAC contractor.

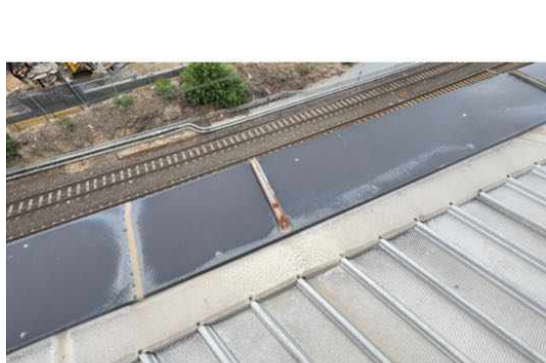
Finding 3.19

Building: Main Building
 Location: Roof Exterior
 Finding: Roof Plumbing - Rusted & Corroded
 Information: The roof plumbing has areas of rust and corrosion. It is suspected that this has been caused by blockages, resulting in pooling or standing water, that have prematurely rusted elements of the roof plumbing.

Rusted roof plumbing will generally develop holes and leaks that can affect other building elements with poor drainage of storm water. Poorly drained roof areas will

also lead to damp conditions surrounding the base perimeter of the building which, if left unmanaged, can lead to a range of secondary building defects.

Repair and/or replacement of rusted roof plumbing is highly required in order to reinstate the roof drainage system to a fully operational level. To further maintain these areas, gutters should be cleaned frequently, allowing the avoidance of any partial blockages.

A licensed plumber or specialist roof restoration company should be appointed to undertake these works. It is advised that such works be completed as soon as possible to prevent any further damage and deterioration.

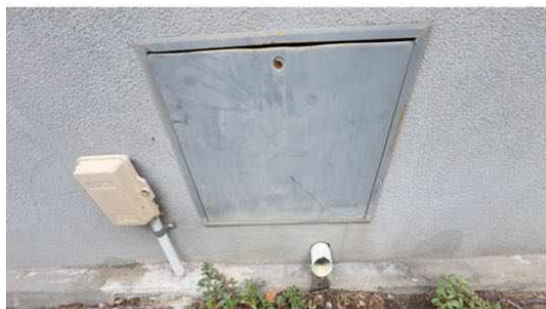
Finding 6.02

Building:	Main Building
Location:	All External Areas
Finding:	AC Condensate Drain - Not Connected To Storm Water
Information:	The air conditioning condensate drain in this area was observed to be disconnected from stormwater drainage.

When condensate is not properly directed to a stormwater outlet, water can accumulate around the building or air conditioning unit, creating damp conditions that may lead to secondary defects such as timber rot, corrosion of nearby metal components, mould growth, or slippery surfaces. Prolonged pooling of water may also attract termites and contribute to long-term deterioration of surrounding building elements.

A qualified HVAC technician or licensed plumber should be engaged immediately to connect the condensate drain to a suitable stormwater outlet. Prompt rectification will ensure proper drainage, protect the building fabric, and reduce potential health and safety risks.

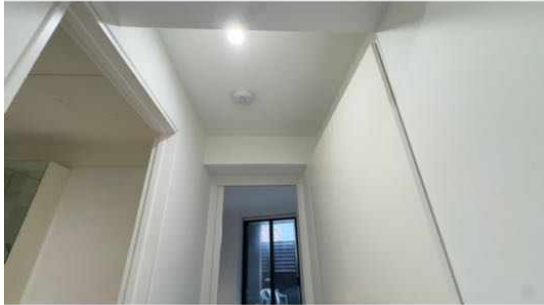
Smoke detectors are critical life-safety devices, and non-compliant, outdated, or non-operational units may not provide adequate warning in the event of a fire.

It is recommended that a licensed electrician be engaged immediately to test, service, and upgrade smoke detectors as required to ensure correct operation and compliance with current safety requirements.

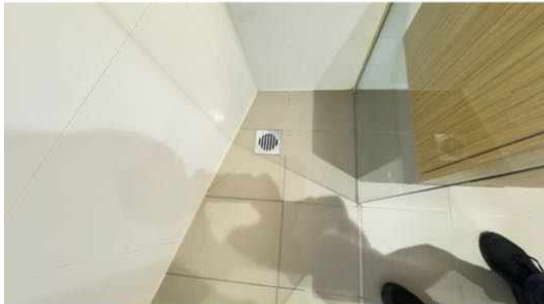
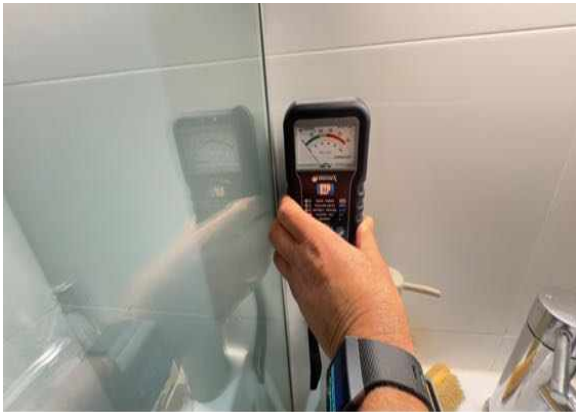
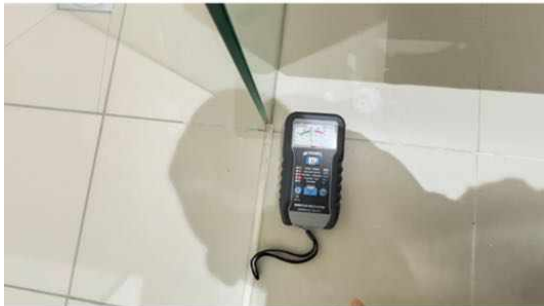
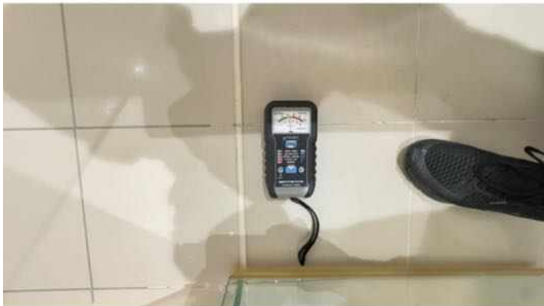
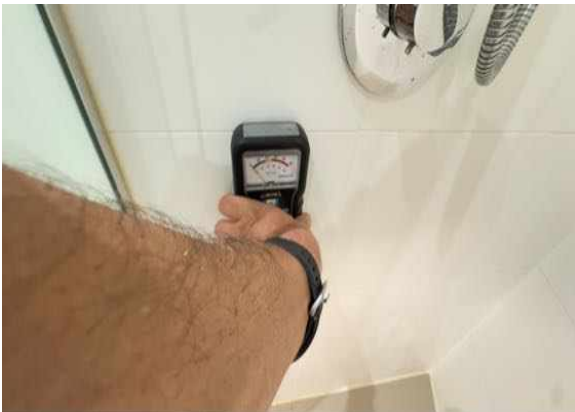
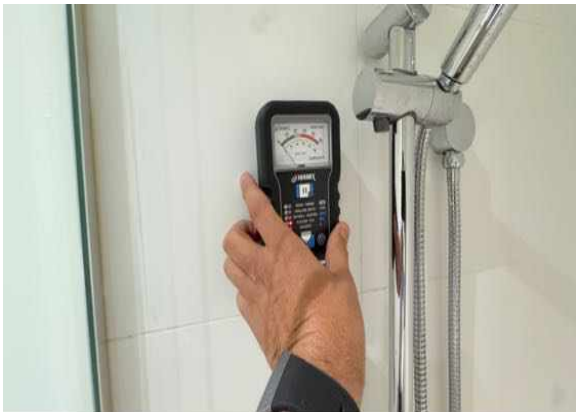
Building: Main Building
 Location: All Areas Interior & Exterior
 Finding: Moisture Levels - Advisory - No Elevated Moisture Levels Present
 Information: At the time of inspection, no elevated moisture levels were detected in these areas. Moisture readings were taken (using a Tramex Moisture Meter) and non-invasive testing methods and reflect conditions present at the time of inspection only. This item is noted for advisory purposes and should not be relied upon as a guarantee that moisture issues are not present elsewhere or may not occur in the future.

Ongoing monitoring of the property is recommended, and further investigation by a qualified tradesperson should be considered if signs of water ingress, dampness, staining, mould growth, or material deterioration become apparent.
