Building and Timber Pest Inspection Report

Inspection Date: Thu, 19 Mar 2026

Property Address: 10A Stables Ln, South Yarra VIC 3141,
Australia

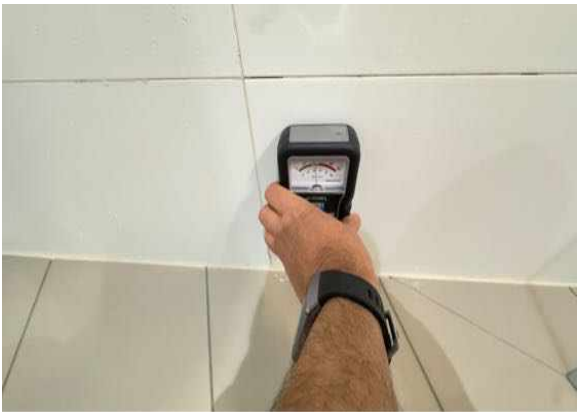
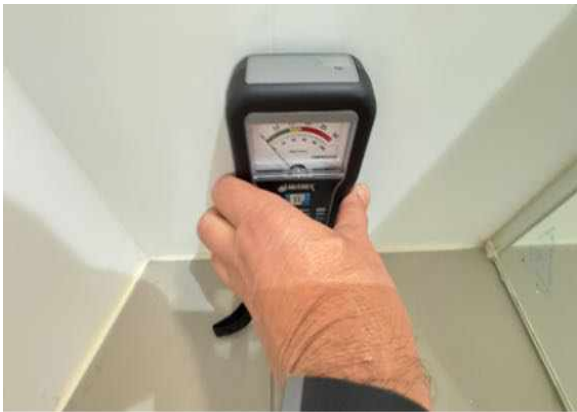
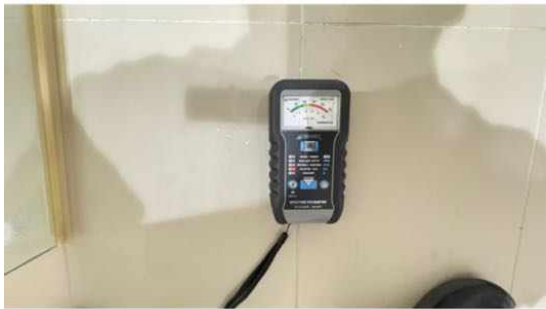
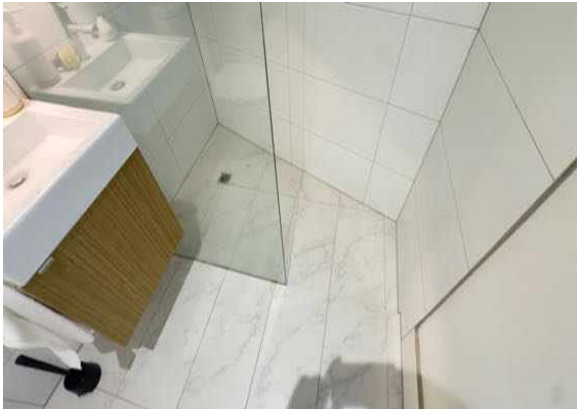
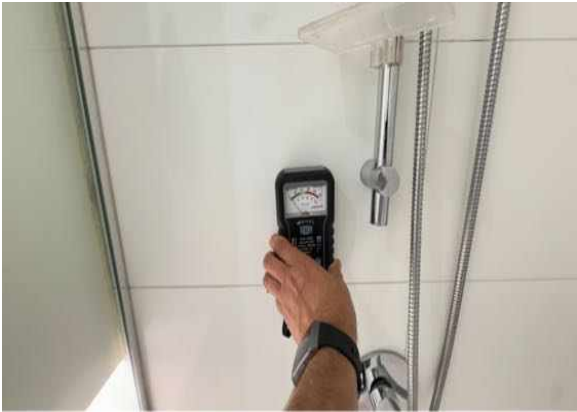
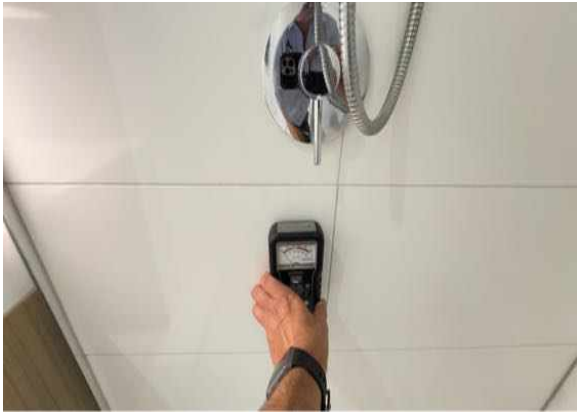
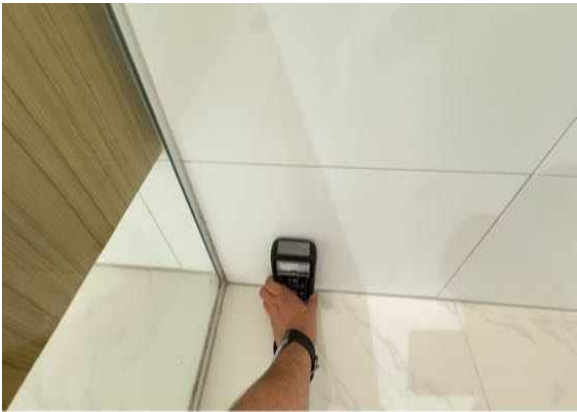
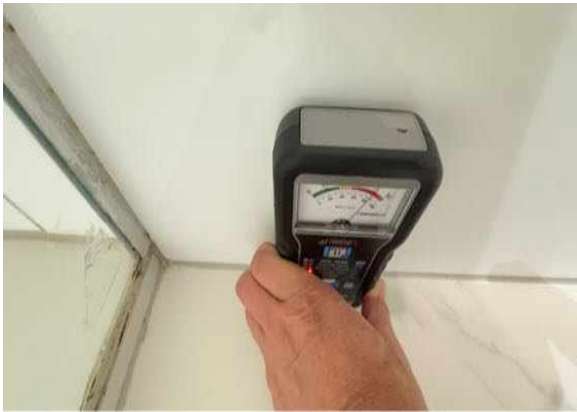
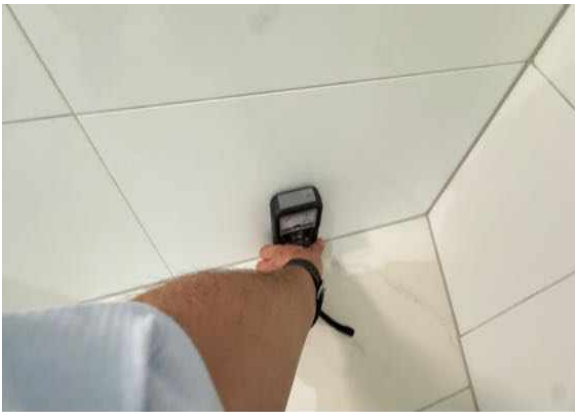
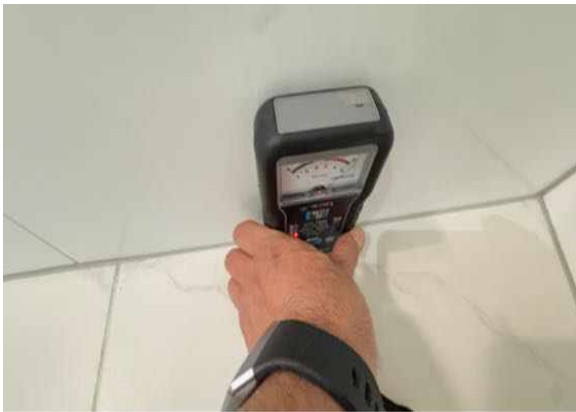
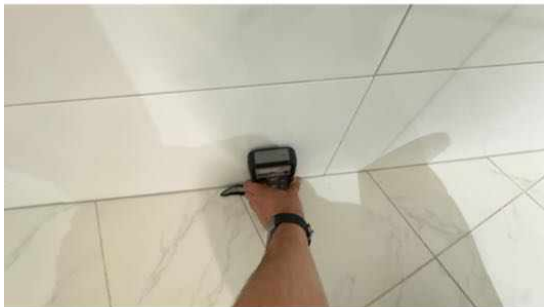
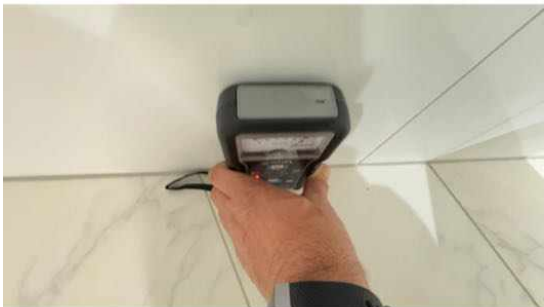
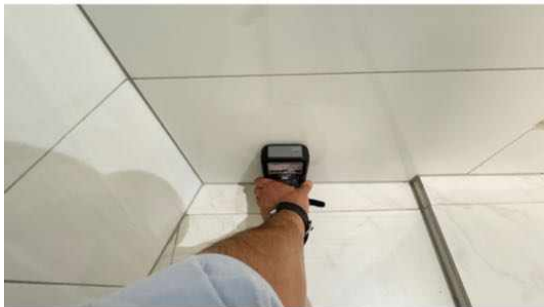
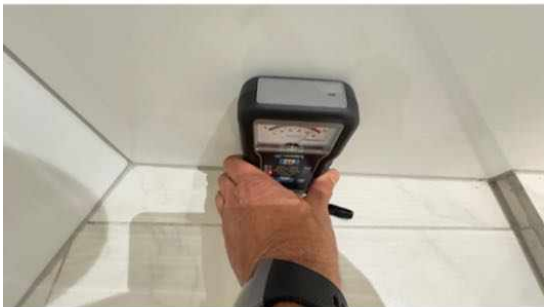
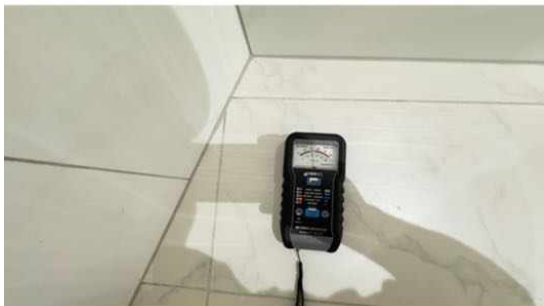
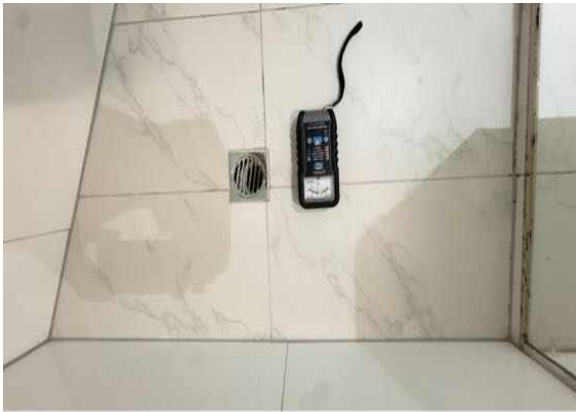
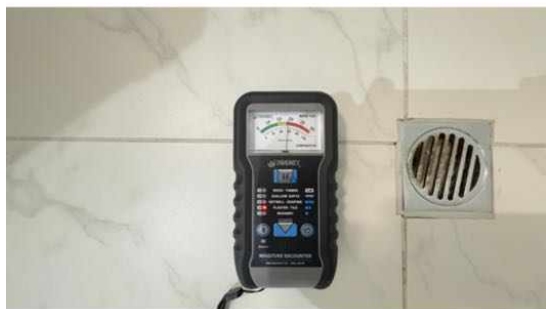
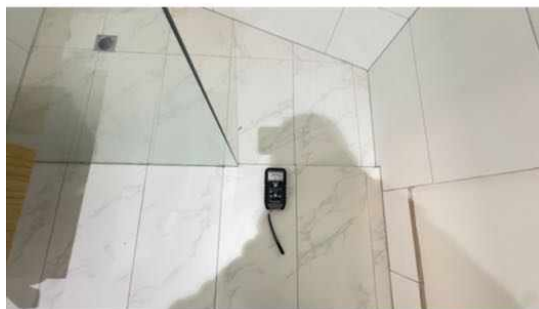
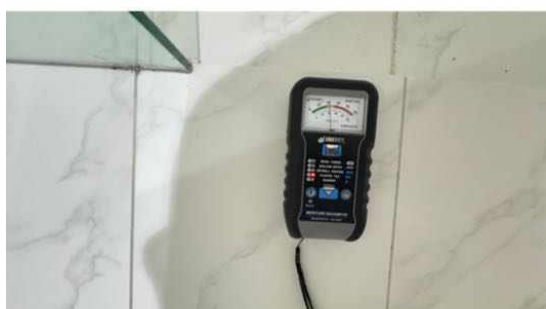
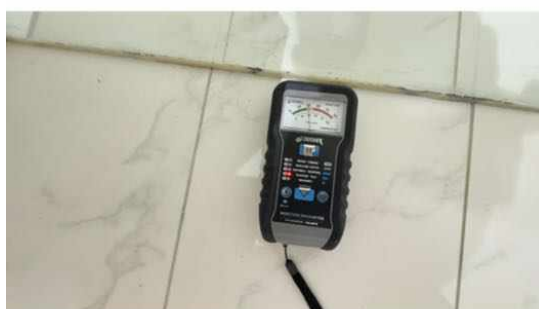
Building: Main Building
 Location: All Areas Interior & Exterior
 Finding: Thermal Scanning & Diagnostic - Advisory - No Elevated Moisture Levels Present
 Information: During the inspection, a thermal imaging camera was utilised as a non-invasive diagnostic tool to assist in identifying potential irregularities associated with moisture ingress, heat loss, insulation deficiencies, or concealed building defects. Thermal imaging detects surface temperature variations that may indicate abnormal conditions within building elements.

Any thermal anomalies identified during the inspection were further assessed where accessible using visual inspection methods and moisture testing. It is noted that thermal imaging is an indicative tool only and does not confirm the presence of defects or moisture without supporting evidence.

Due to the concealed nature of building construction and the limitations inherent in non-invasive inspection methods, the absence of significant thermal anomalies at the time of inspection does not guarantee that concealed defects or moisture issues are not present. Ongoing monitoring and further investigation are recommended should concerns arise.

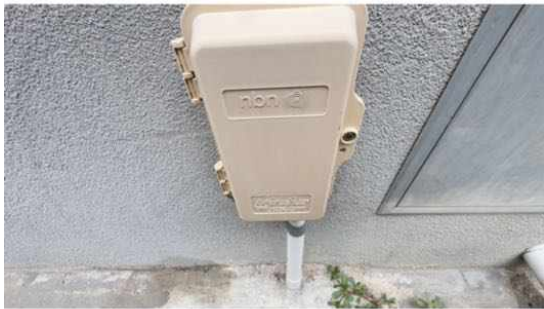
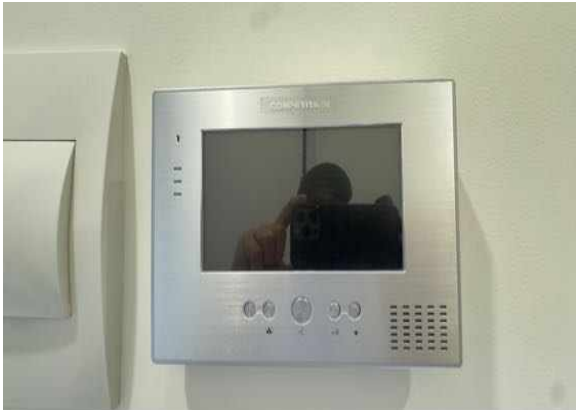
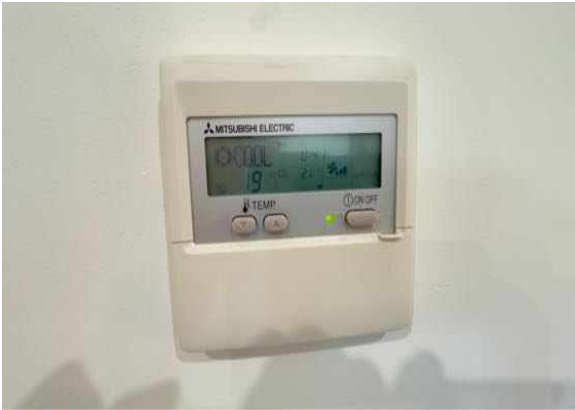
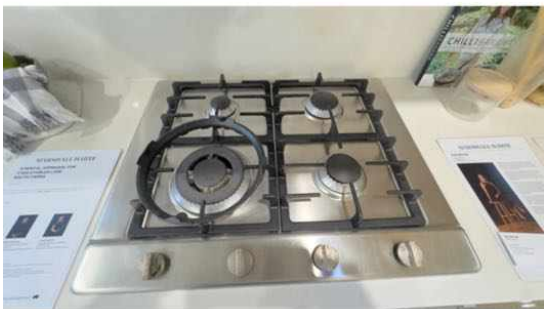
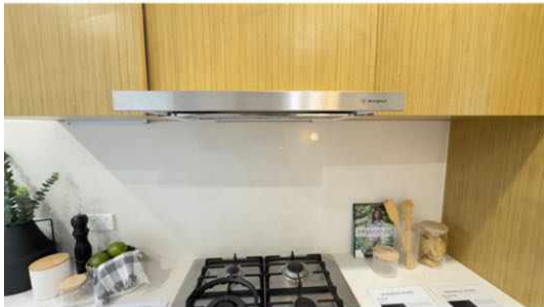
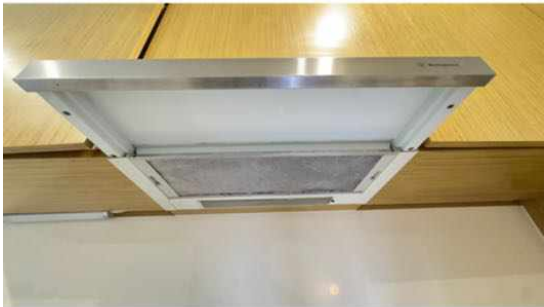
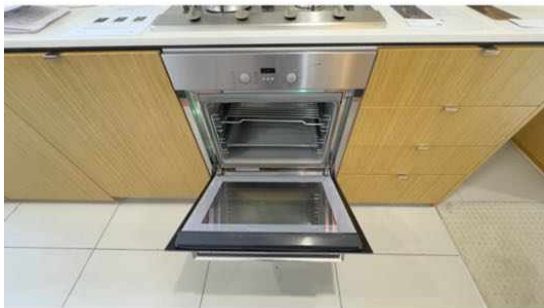
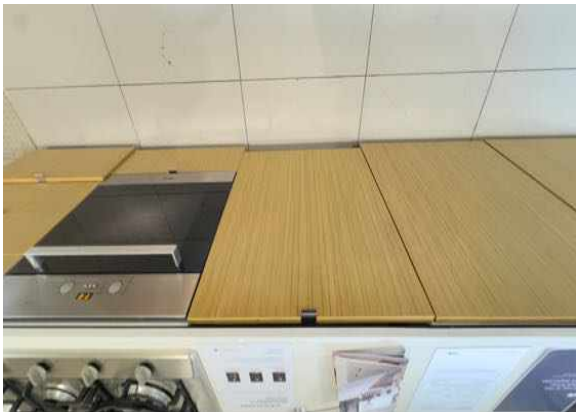
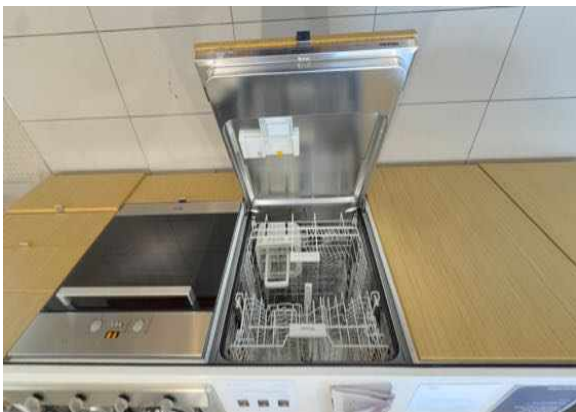
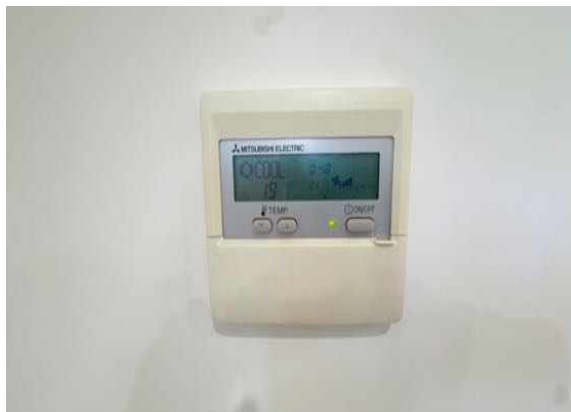
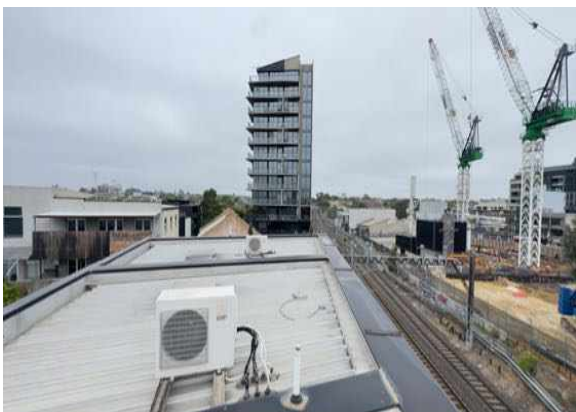
Building:	Main Building
Location:	All Areas, Interior & Exterior
Finding:	Appliances, Heating & Cooling Systems, Mechanical Systems, Plumbing, Electrical, Fireplaces - Advisory
Information:	The inspection did not include testing, operation, safety, or assessment of any installed or portable appliances or mechanical systems. This includes, but is not limited to, ovens, cooktops, microwaves, rangehoods, dishwashers, ducted vacuum systems, air-conditioning units, heating systems, hot water services, ceiling fans, exhaust fans, intercoms, security systems, fireplaces, and solid fuel heaters.

Appliances may be worn, damaged, or malfunctioning. Electrical or gas appliances can pose serious safety hazards if incorrectly installed or maintained.

Service, repair, or replace equipment as necessary, particularly where service history or warranty coverage is unknown.

Inspect any water, gas, or electrical connections associated with appliances to ensure safety and compliance.

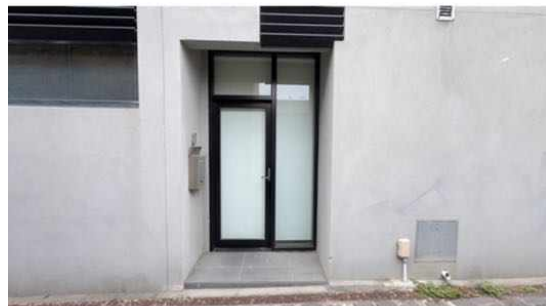
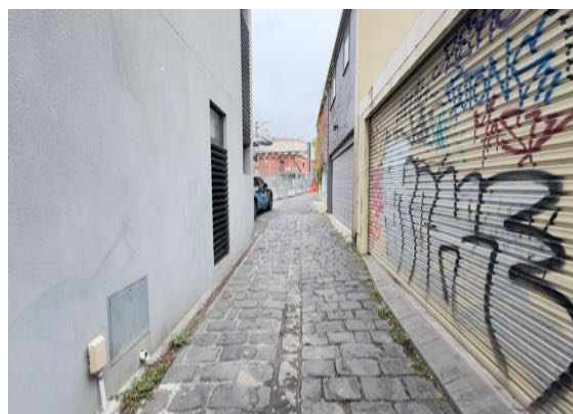
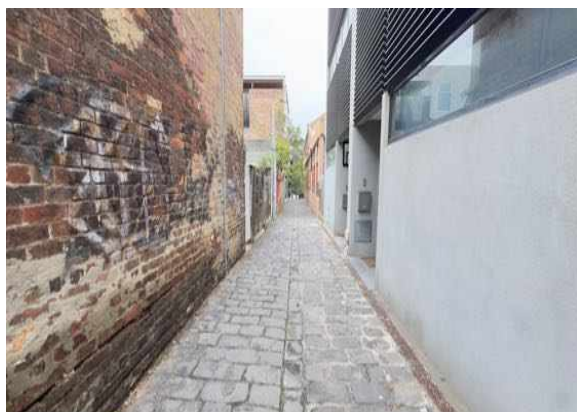
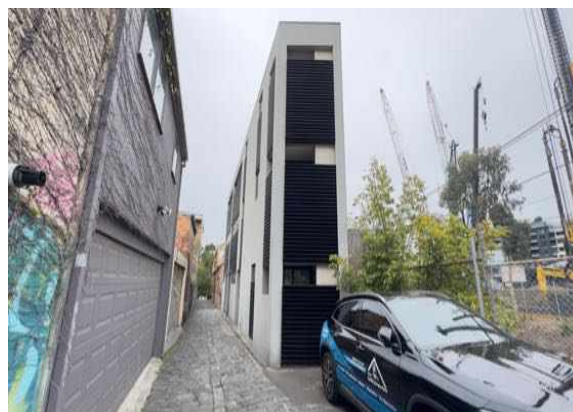
Building:	
Location:	Limited Areas
Finding:	Council Assets - Footpaths, Crossovers, & Adjacent Infrastructure
Information:	For your information, council-owned assets located on or adjacent to the property, including footpaths, vehicle crossovers, kerbs, drainage pits, street signage, and other infrastructure, were visually inspected where accessible.

During the inspection, minor cracking, surface wear, or uneven sections were observed on footpaths or crossovers. Some accessible metal components, such as street signage or grates, showed signs of rust or deterioration. Debris accumulation and vegetation encroachment were also noted around council infrastructure. Access or visibility was limited to certain council-owned assets.

These areas should be monitored, and for detailed assessment, maintenance, or compliance verification, the relevant local council authority should be contacted immediately. Regular monitoring of adjacent council assets is recommended to ensure ongoing safety and proper maintenance.

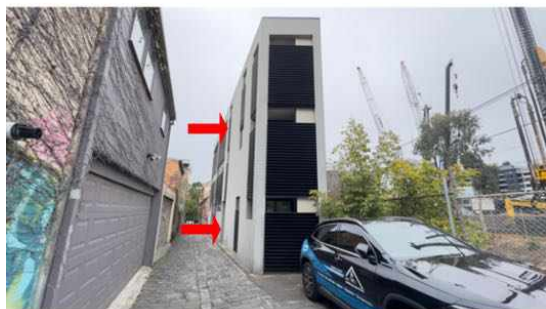
Building:	Main Building
Location:	All Internal Areas
Finding:	Timber Pests - Conducive Conditions - Potential Termite Infestation Risk via Shared Party Wall
Information:	The property shares a party wall with the neighbouring dwelling, potentially providing a concealed pathway for termite entry between the buildings. Visual inspection did not confirm the presence of a physical or chemical termite management system along the party wall. An effective termite management system must be continuous and cover all potential entry points, including junctions with adjoining structures.

Where properties are built against each other, as in this situation, the lack of suitable termite barriers or visual inspection zones at the party wall interface might allow termites to enter undetected from the neighbouring property. The risk is higher if the adjacent property does not have a termite management system in place.

It is advisable to engage a qualified timber pest technician to recommend necessary treatments for the building's protection. Additionally, if there is no existing management system, routine termite inspections are recommended at least twice a year to detect early signs of activity.

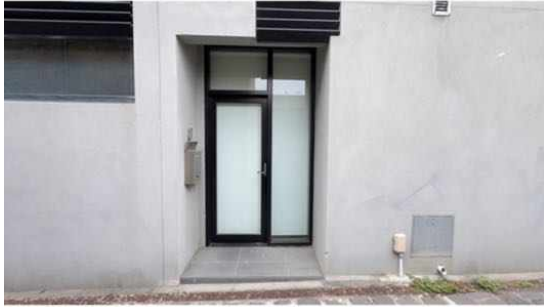
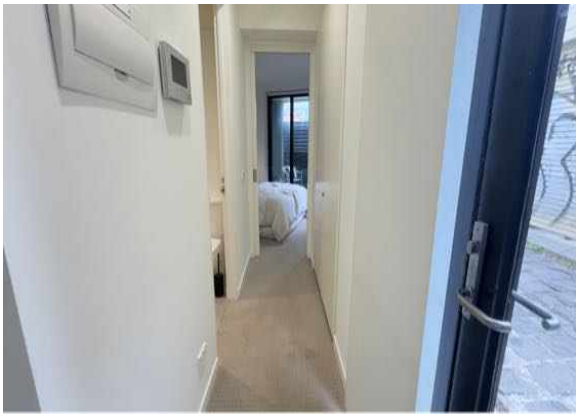
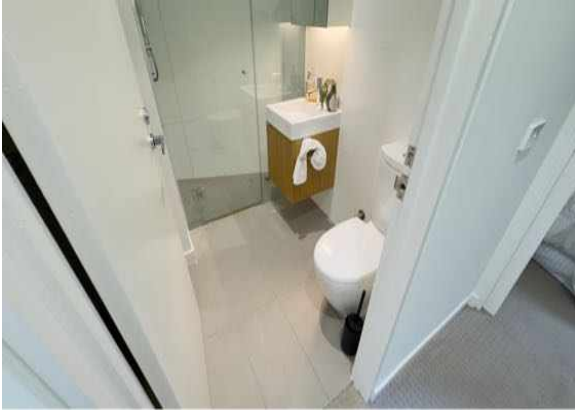
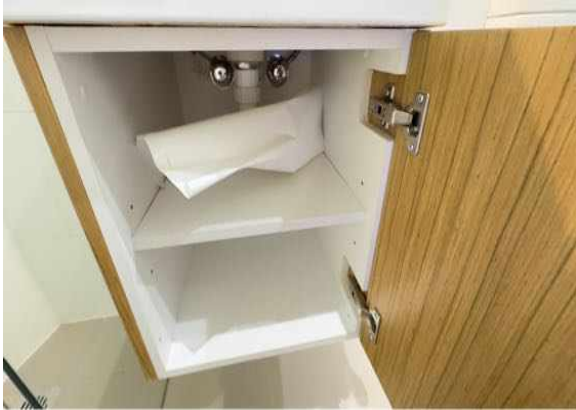
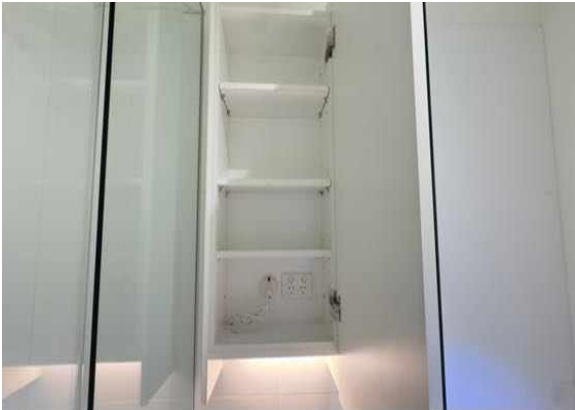
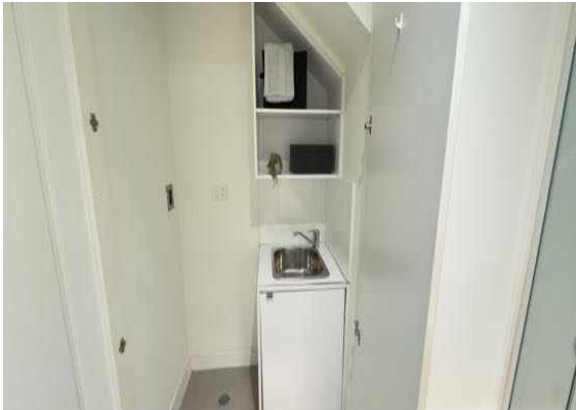
It is important to note that these restrictions can conceal a wide range of building defects, including but not limited to:

Structural damage such as cracking or movement in walls, floors, or ceilings.

Pest activity such as termites or timber decay.

Electrical, plumbing, or safety hazards.

Because these areas could not be visually assessed, no comment can be made on their condition within this report.

It is strongly recommended that obstructions be removed and concealed areas made fully accessible immediately. A re-inspection should then be carried out to allow a complete assessment of the property's condition. This is particularly important prior to purchase, as defects in concealed areas can carry significant rectification costs.
