Building and Timber Pest Inspection Report

Inspection Date: Thu, 19 Mar 2026

Property Address: 79 Greenwood Parkway, Jordan Springs
NSW 2747

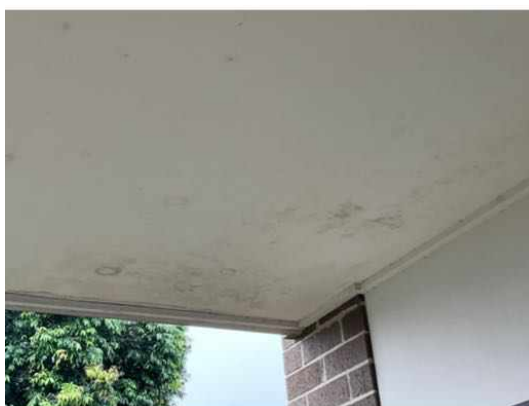
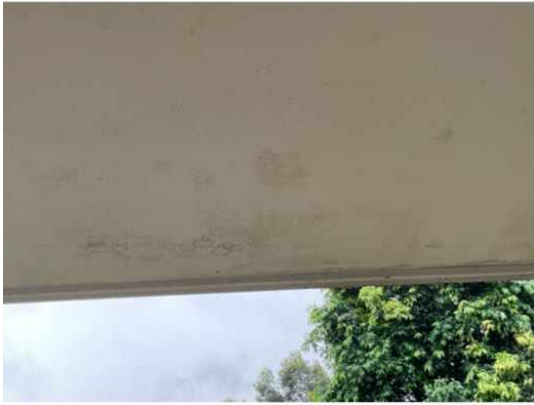
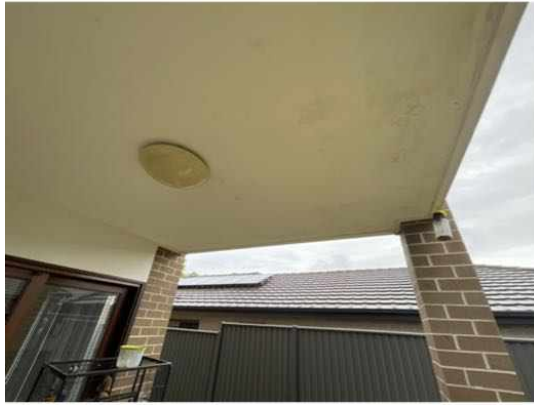
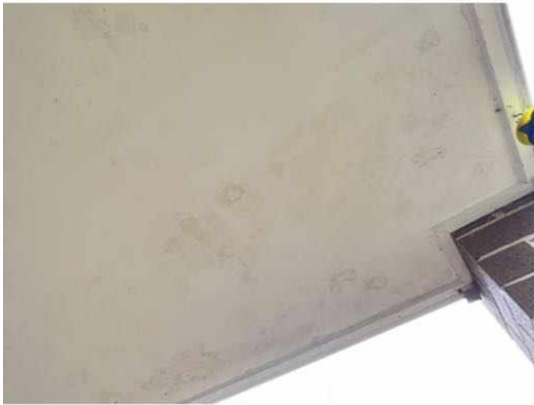
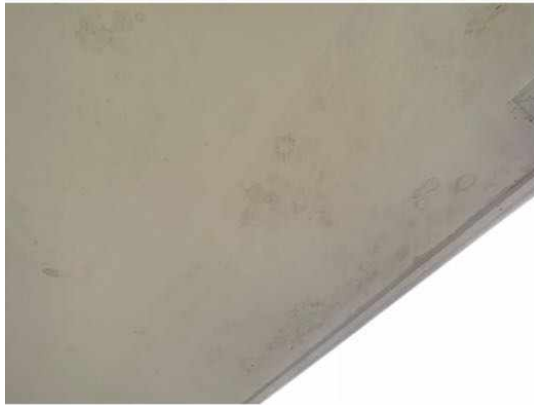
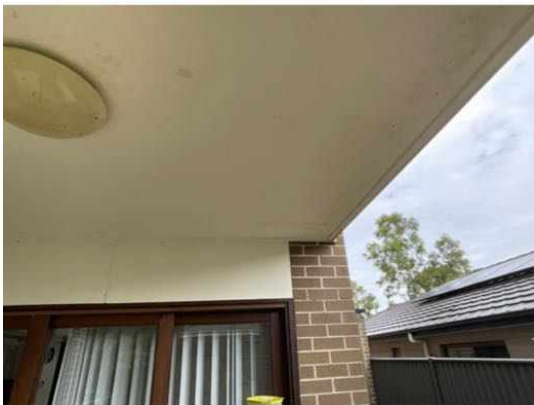
Finding 3.04

Building: Main Building

Further investigating Structural roofing elements

- Re-gluing or re-adhering the ceiling sheeting
- Re-securing sheets using appropriate modern fixings
- These works can be carried out by a qualified plasterer or painter,
- Ongoing monitoring is advised to detect any worsening of the condition or further movement over time.

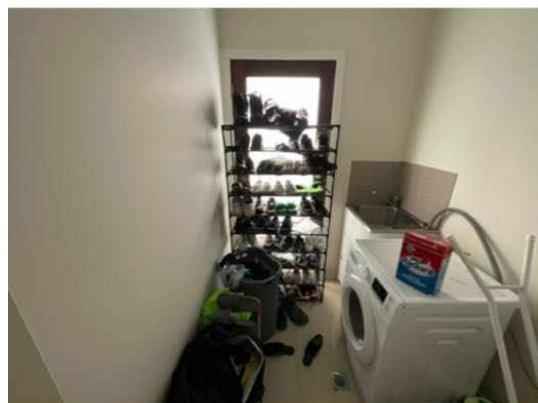
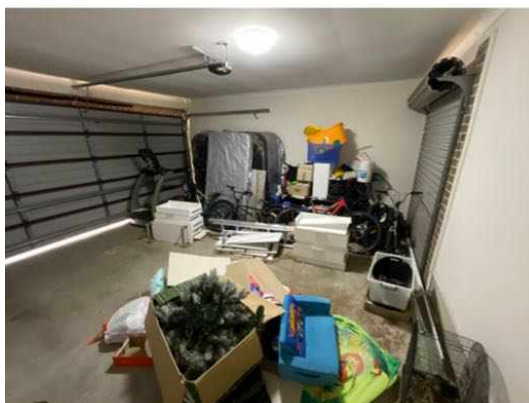
Noted Item

Building:	Main Building
Location:	All Areas
Finding:	Thermal Imaging – Termite Activity Assessment..
Information:	During the inspection, a Flir E6 Thermal Imaging Camera was used to detect irregularities in the internal walls and ceilings.

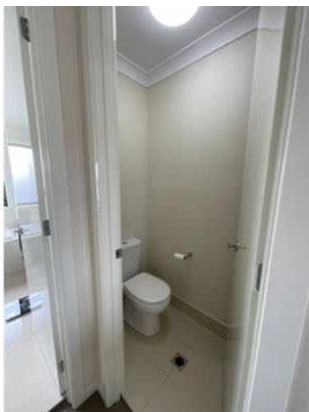
Building: Main Building
Location: Toilet (WC)
Finding: Overall Condition: Toilet.
Information: TOILET ASSESSMENT

Toilet:

- No leaks were observed during the flushing process.
- The toilet operated normally with no signs of malfunction or abnormal water flow.
- The toilet pan was securely fixed to the floor at the time of inspection.
- The exhaust fan appeared to be operational

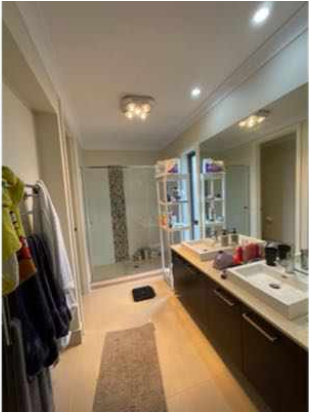
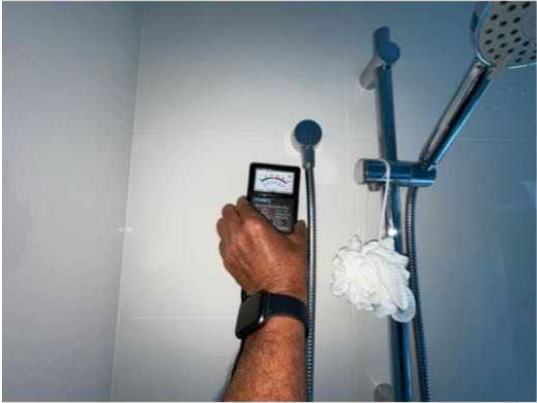
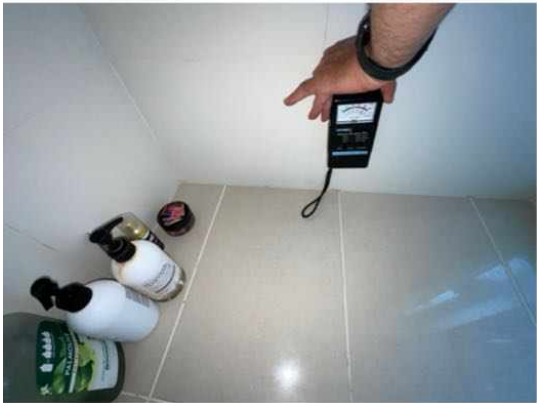
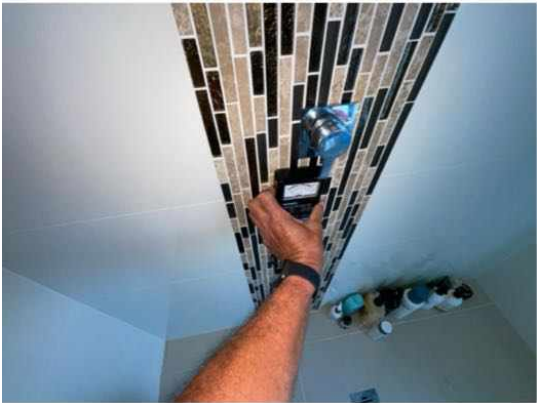
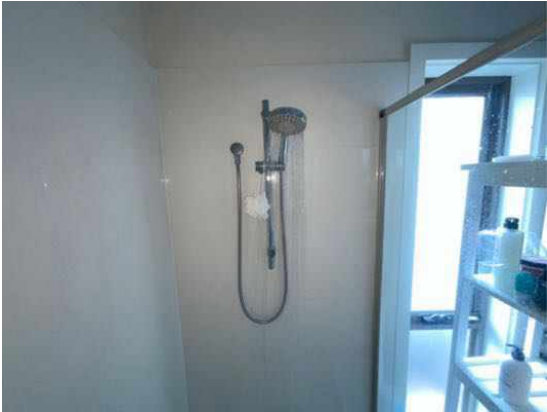
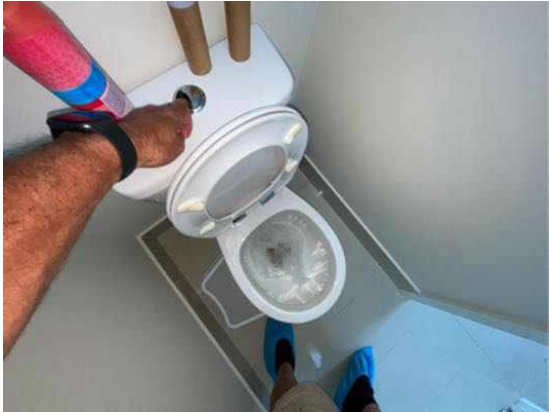
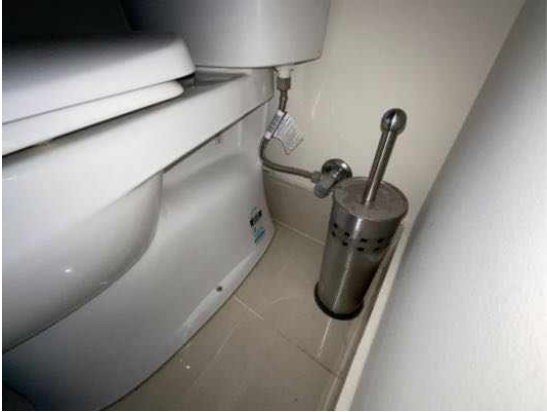
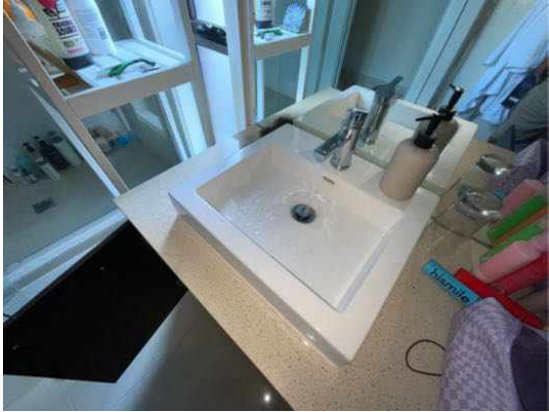
Building: Main Building
 Location: Ensuite
 Finding: Wet Areas - Bathroom(s) - Overall Condition & Recommendations.
 Information: Overall Condition & Recommendations

- Water appeared to drain slowly towards the shower floor waste at the time of inspection, indicating minimal fall. This may result in water pooling or ponding during regular use. Rectification is at the client's discretion.
- Flood testing of the shower recess is recommended. This may reveal inadequacies in the waterproofing or shower screens, which could lead to water damage in surrounding areas.
- Floor waste was found to be clear and free of blockages at the time of inspection. Further monitoring is advised after consistent use to identify any drainage issues or buildup requiring cleaning.
- No elevated moisture readings were detected around the tap fittings, suggesting no active plumbing leaks at the time of inspection.

- Elevated moisture readings were found in the lower shower walls, which is a common occurrence with certain tile types that naturally absorb more moisture. This should be monitored over time.
- Sealing of grout and tiles is recommended to prevent moisture buildup and mould growth in damp areas such as showers.
- The condition of grout and sealant appeared to be serviceable.
- The exhaust fan appeared to be operational, which supports moisture control in the bathroom.

- No leaks were observed during flushing. The toilet operated normally, and the toilet pan appeared to be securely fixed to the floor.

- Basin(s) were water tested and inspected, with no leaks or blockages identified in the plumbing or drainage system at the time of inspection.
- Further monitoring is recommended after the basin(s) are placed under regular use to confirm ongoing performance and cleanliness.
- No visible water damage was observed to the vanity cabinetry at the time of inspection.
- Stored items inside the vanity obstructed full visibility during the inspection. It is advised that the area be re-inspected once all obstructions are removed.

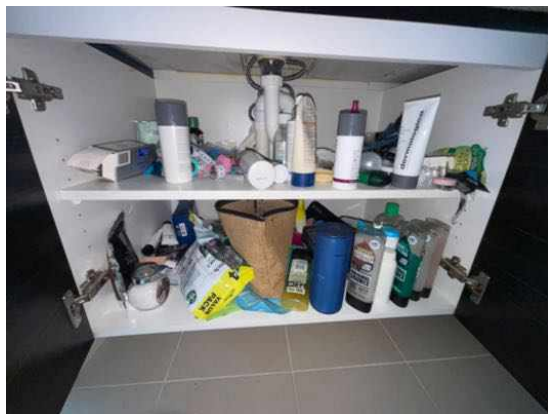
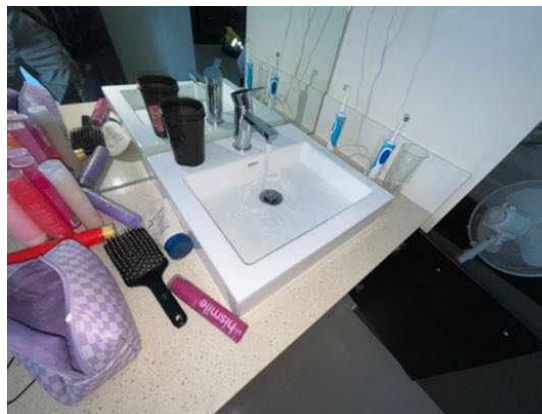
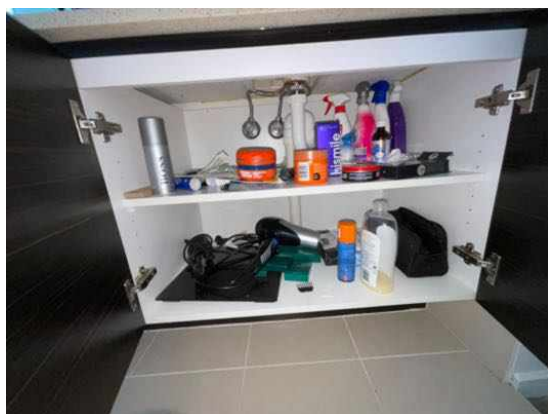
Building: Main Building
 Location: All Areas
 Finding: Water Pressure – Observation Only.
 Information: During the inspection, water pressure appeared to be within a normal operating range based on a basic functional check. However, this observation was made without the use of pressure testing equipment and does not constitute an assessment by a licensed plumber.

It is strongly recommended that a Licensed Plumber be engaged to conduct a comprehensive assessment of the plumbing system to verify its functionality, check for any underlying issues, and confirm compliance with current regulations and standards.

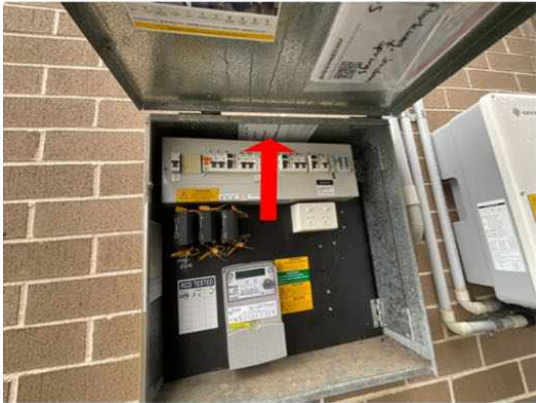
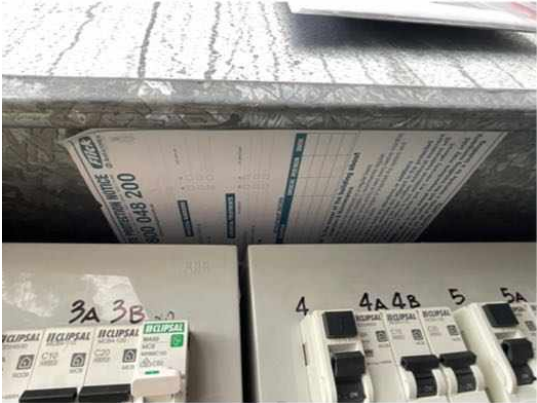
Building:	Main Building
Location:	All Areas
Finding:	Termite Management System – Previous Barrier Noted..
Information:	Observation:

At the time of inspection, evidence of a previous termite management system was noted, indicated by the presence of a durable notice affixed to the electrical switchboard.

- Chemical treatments
- Baiting systems
- Regular inspections and monitoring
