# Building and Timber Pest Inspection Report

Inspection Date: Wed, 25 Mar 2026

Property Address: 6 Evans St, Sans Souci NSW 2219, Australia

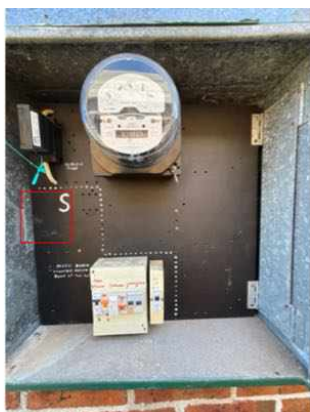
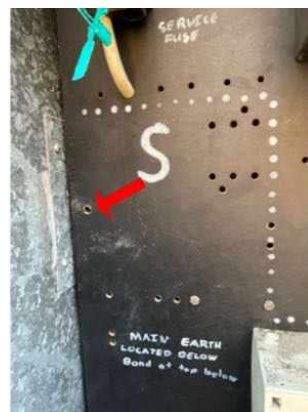
re-fix the board is missing.

The board needs to be secure to avoid un-authorized persons access the live wires in the meter box.

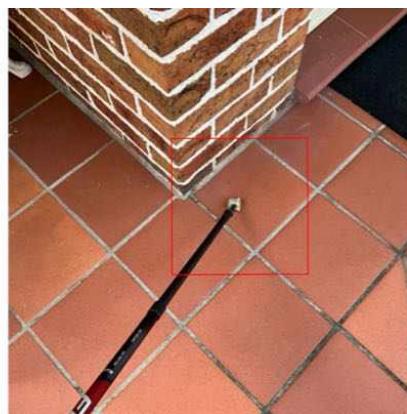
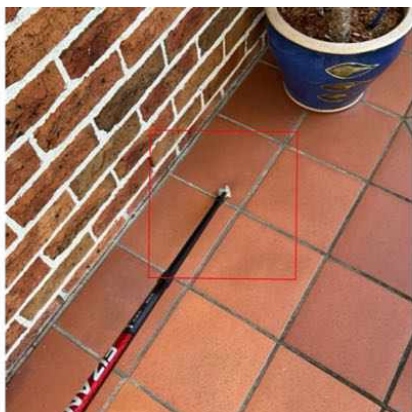
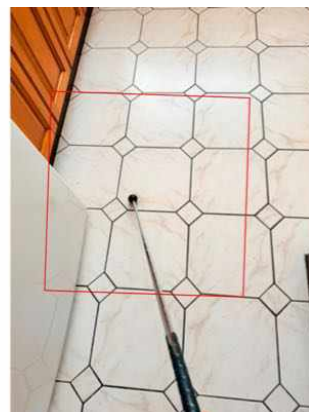
### Finding 3.02

Building:	Main Building
Location:	All Areas
Finding:	Tiles - Cracked, Damaged or Missing
Information:	At the time of inspection cracked, damage or missing tiles were evident to the tiling in several areas throughout the property. While this appears to be minor, there are some areas that are frequently exposed to water, allowing potential for water penetration into adjoining sections of walls or flooring. If left unmanaged, water penetration to these areas may lead to subsequent water damage, which is likely necessitate repair work to affected building elements. A tiling contractor should be appointed to replace cracked, damaged or missing tiles to ensure that no further water damage occurs. The re-application of silicone and grouting throughout remaining tile work is also advised, to further protect the area against water penetration.

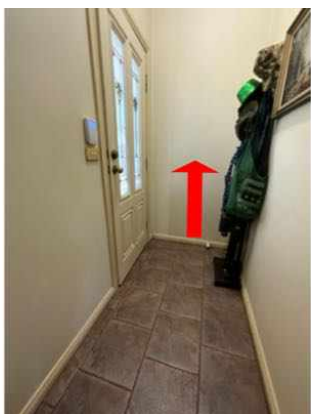
### Finding 3.08

Building:	Main Building
Location:	All Areas
Finding:	Ceiling - Sagging
Information:	Sections of the ceiling were found to be sagging at the time of inspection. Sagging to the fixed ceiling structure generally indicates that the building materials have swollen, due to contact with water, or that fixings (e.g. nails or glue) have become loose and require reattachment.

In some cases, sagging ceiling linings may also indicate that there are structural issues, causing surfaces to warp, twist or sag. Where sagging appears to be major, appointment of a structural engineer is advised to further inspect the property and identify the source and rectification works required.

The appropriate action should be taken by the client as soon as possible to ensure that any potential further damage is limited.

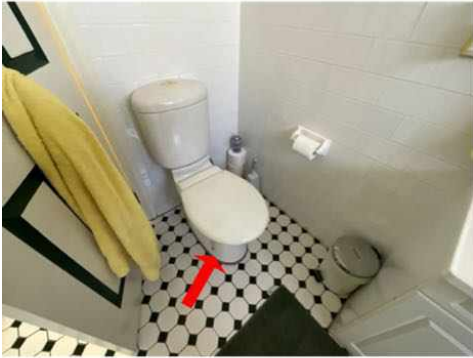
### Finding 3.16

Building:	Main Building
Location:	Hallway; Ensuite
Finding:	High Moisture Reading
Information:	At the time of inspection, it was noted that there was high moisture readings to several areas around the building.

High moisture readings can have several causes: from water migrating into the plasterboard, live termite activity or different types of building material eg ACM board or an electrical bracket interfering with the moisture readings.

Constant monitoring of the area or an invasive inspection is recommended to confirm these findings.

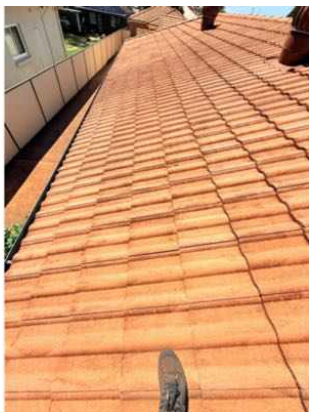
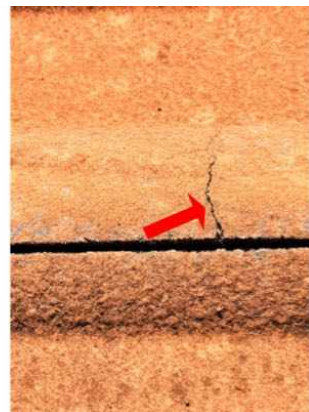
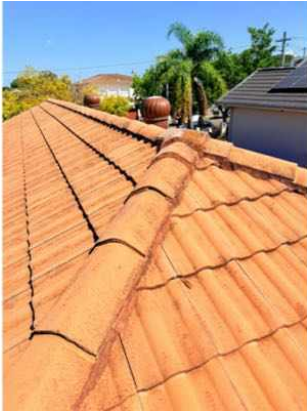
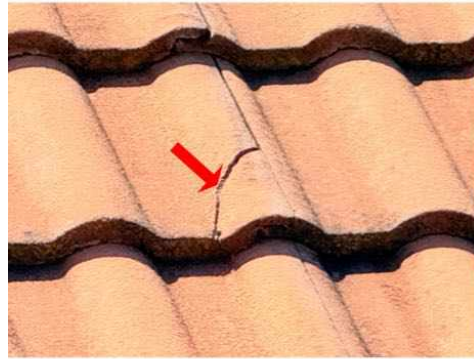
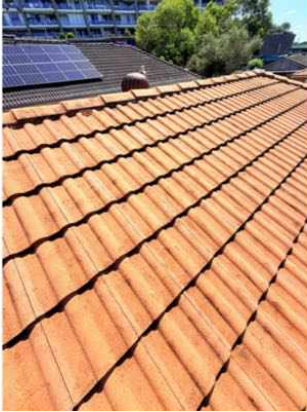
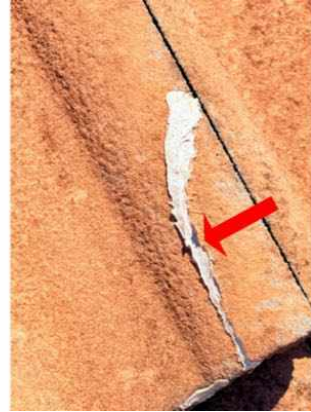
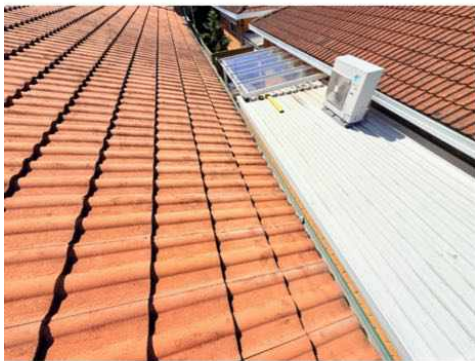
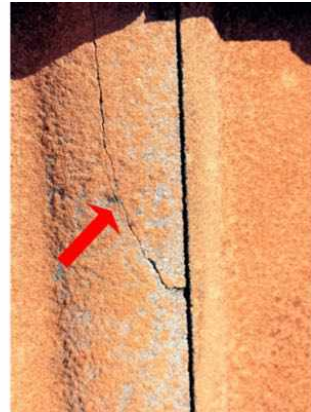
Building:	Main Building
Location:	Roof Exterior
Finding:	Roof tiles - Broken
Information:	Upon inspection of some areas of the exterior roof covering, broken roofing tiles were identified. Broken and friable roof tiles are generally the result of ageing and weathering of what is essentially a porous material.

If left to further deteriorate, broken and brittle roof tiles are likely to lead to water penetration via the roof into the ceiling space, causing secondary damage to ceiling linings, insulation and roof structures. Broken roof tiles are also likely to detract from the effectiveness of the roof drainage system, creating potential for secondary damage to the exterior roof covering and roof plumbing.

Replacement of broken tiles is required and should be performed by a roofing contractor as soon as possible.

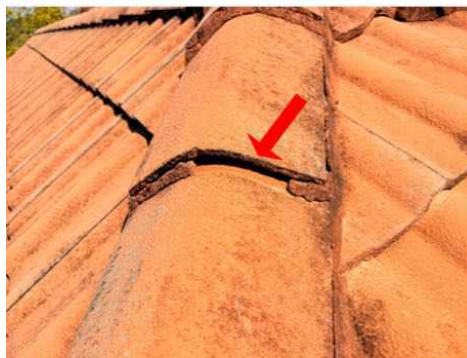
### Finding 3.19

Finding: Mortar - Deterioration

Information: Mortar, or 'bedding', is the material which fills joints and intersections between tiles and other building elements on the exterior roof covering, such as gable ends, hip capping and valleys. Upon inspection of the exterior roof, it was noted that sections of the mortar show varying levels of deterioration.

Mortar generally deteriorates as a result of frequent exposure to weather conditions over a prolonged period of time. Mortar that is deteriorating may allow water ingress into the roof void, putting associated building elements and roofing structures at risk of

water damage. Deteriorated mortar also detracts from the functionality of roof tiles and other roofing elements, potentially decreasing weather tightness and roof drainage.

Mortar deterioration can be attended by a roofing contractor.

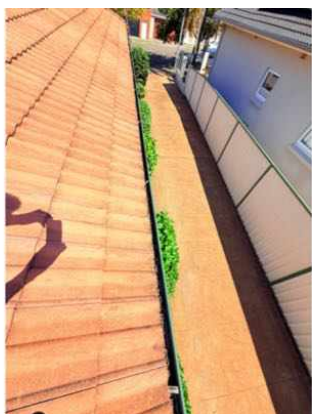
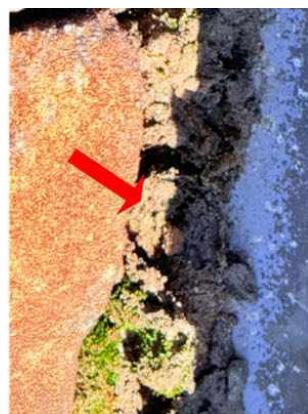
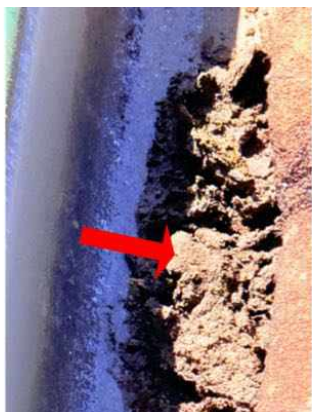
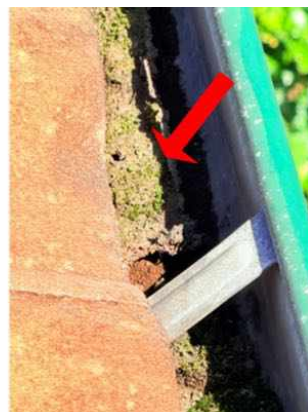
### Finding 3.20

Building:	Main Building
Location:	Roof Exterior
Finding:	Blocked gutters.
Information:	Roof plumbing structures, such as guttering, downpipes and valleys, should be free of all debris to prevent blockages.

Blocked gutters, downpipes and valleys are likely to lead to high levels of moisture to the affected area.

Such moisture will not only cause rust and decay of the associated building materials, but can also provide conditions that are conducive to termite and timber pest activity as well as mould growth.

Blockages should therefore be removed to ensure dry conditions are maintained.

It is highly advised that blocked gutters, downpipes and valleys be cleaned frequently.

Where areas have a high tree density, installing a gutter guard may be an option in preventing leaves accumulating in the gutters and associated roofing elements.

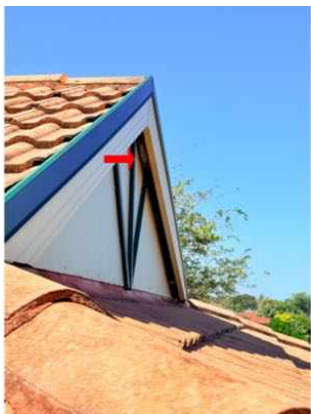
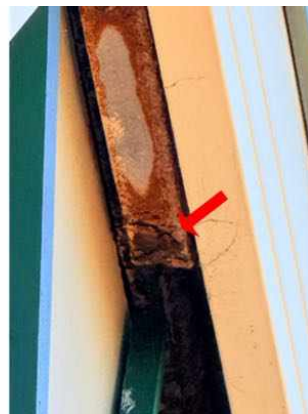
### Finding 3.21

Building:	Main Building
Location:	Roof Exterior
Finding:	Roof truss rust/corrosion
Information:	An exposed steel roof truss was observed to have visible signs of corrosion (rust).

This condition is typically associated with prolonged exposure to moisture and/or inadequate protective coating. While no immediate structural failure was evident at the time of inspection, continued corrosion may lead to deterioration of the steel section and reduced structural performance over time.

It is recommended that a remedial builder assess the extent of the corrosion and carry out remedial works as required. This may include cleaning, treatment with a rust inhibitor.

Further investigation may be required to determine the source of moisture contributing to the corrosion.

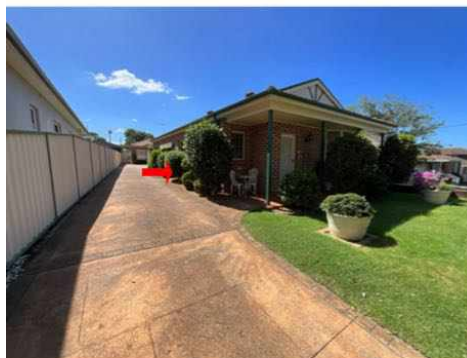
### Finding 6.03

Building:	Main Building
Location:	All Areas
Finding:	Garden bed- conducive to timber pest activity.
Information:	Garden beds were found to be evident in the garden area. These garden beds which lay against the building and allow easy undetected ingress for termites can include untreated timber, and with a combination of moisture from watering can make conditions conducive to termite activity.

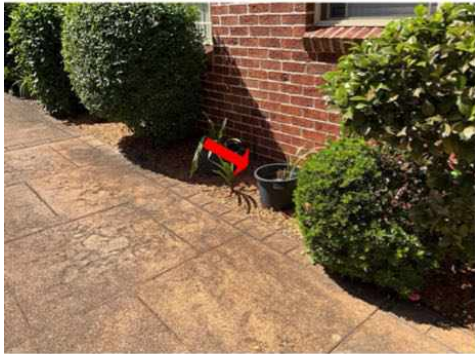
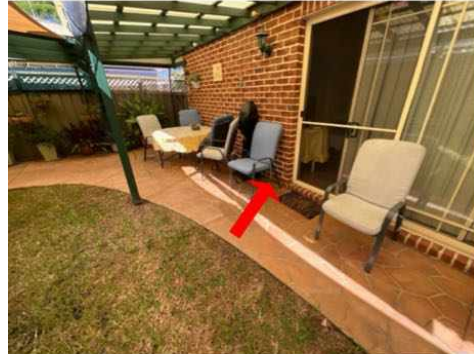
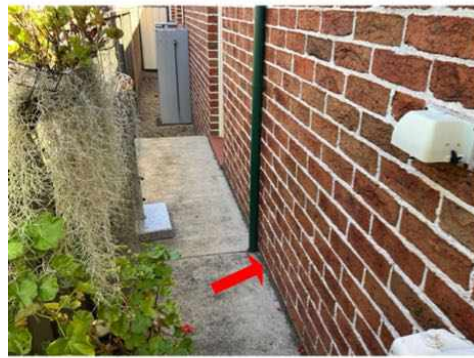
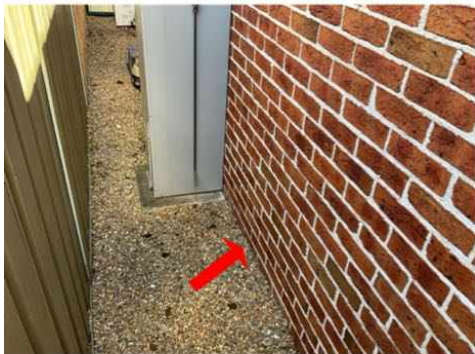
## Finding 6.04

Building:	Main Building
Location:	All Areas
Finding:	Slab Edge - Exposure
Information:	An inspection zone of at least 75mm in relation to the exposed slab edge, between the bottom brick and the perimeter pavement, is required. This inspection zone should be maintained in order to force termites into the open where they can be detected more readily during regular inspections. The slab edge should not be concealed by anything that may prevent inspection of the area, including render, landscaping, soil, turf, paving, concrete cladding or other structures.

If the slab edge is not properly exposed there is a high risk of termite attack. Sometimes, in order to determine the type of slab, a suitably qualified person such as an architect or builder may be required to consult the construction plans.

Where the slab edge cannot be properly inspected, it is highly recommended that termite or timber pest inspections be carried out every 6-12 months to aid protection of the property against infestation.

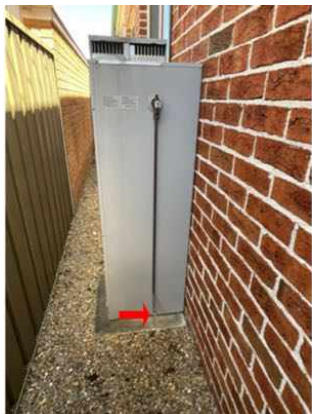
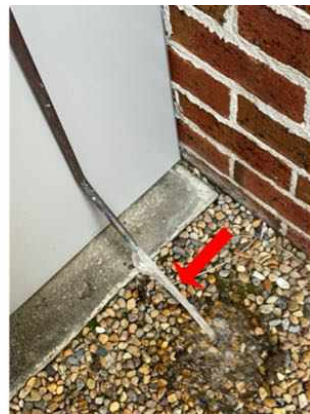
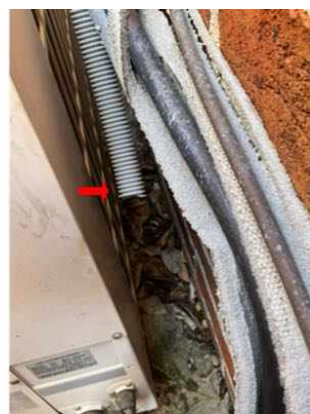
### Finding 6.05

Building:	Main Building
Location:	Exterior walls - right side
Finding:	HWS/AC overflow not connected
Information:	The Hot Water System (HWS) and A/C overflows were found to be disconnected from storm water drainage and is creating excessive moisture in the surrounding area. These damp conditions can lead to secondary defects such as rot, rust or corrosion

of associated building elements, the formation of fungal decay, or even the creation of potential slip hazards. When coupled with poor site drainage, pooling of water may also attract termite activity to this area. It is highly recommended that a licensed plumber be appointed to connect the HWS and A/C overflows in order to prevent such an environment from being created. These minor works should be carried out as soon as possible.

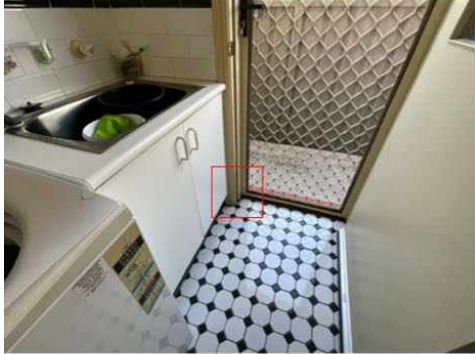
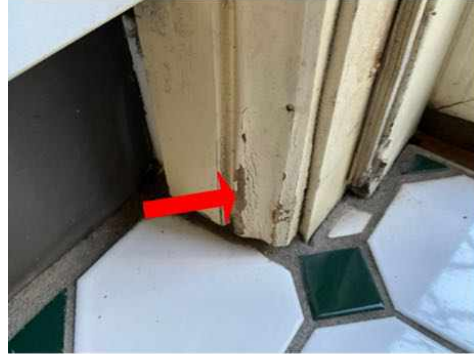
### Finding 7.01

Building: Main Building  
 Location: Laundry  
 Finding: Wood rot - internal door frame  
 Information: Wood rot was found to be affecting the door frame in this area .

Wood rot, also known as Fungal Decay, occurs when timbers and other cellulose building materials are exposed to damp conditions on an ongoing basis.

It appears that this wood rot has developed as a result of frequent exposure to water.

This has resulted in the door frame and flooring deteriorating at an accelerated rate,

increasing their susceptibility to the development of wood rot.

A remedial builder may be consulted in order to positively identify the exact reason for the leak, before commencing remedial works to rectify this issue.

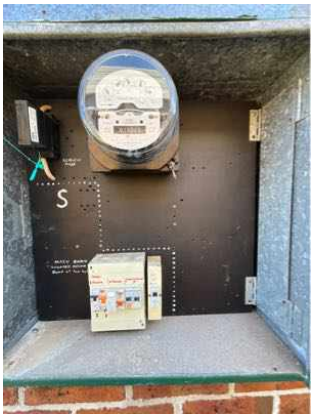
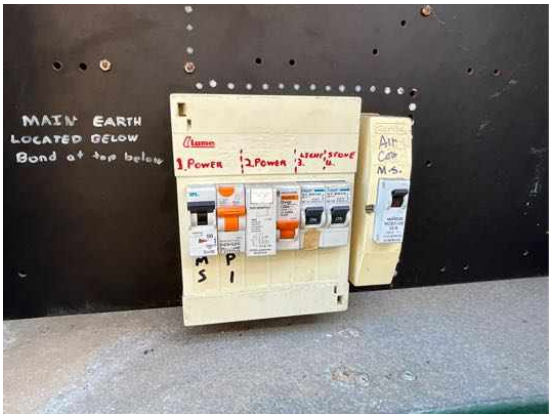
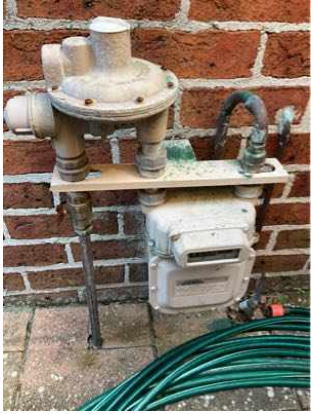
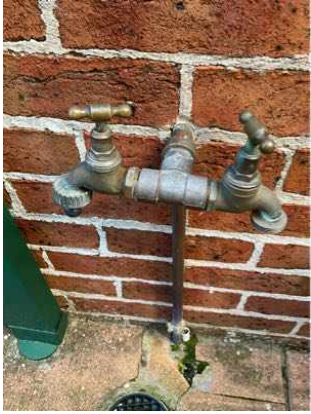
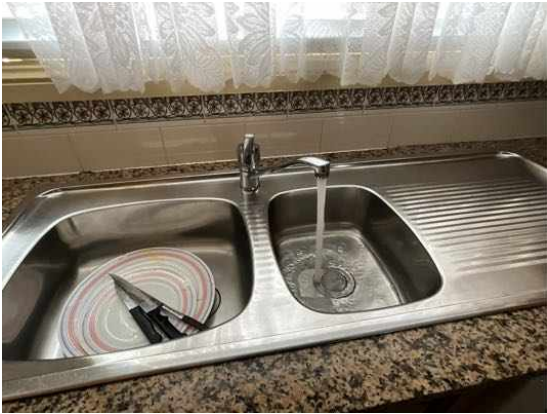
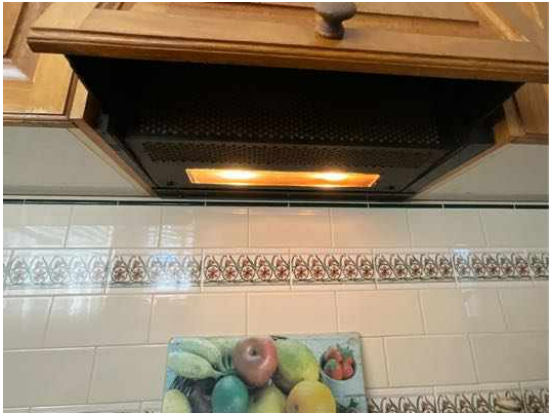
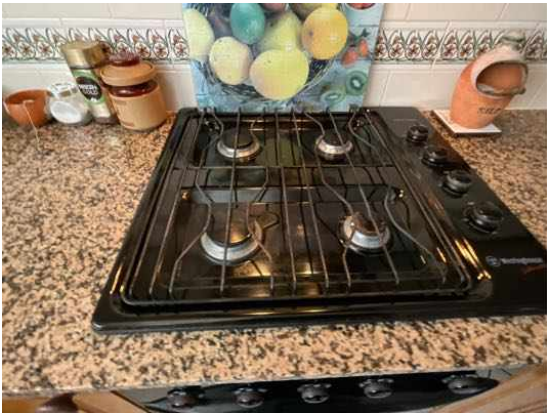
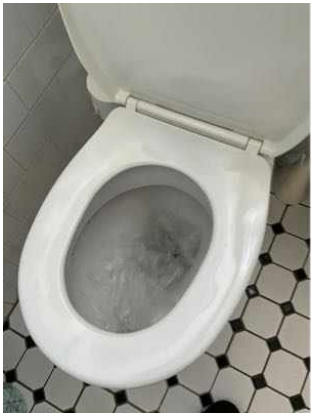
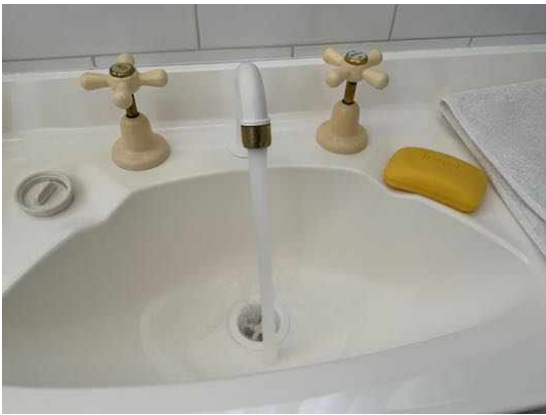
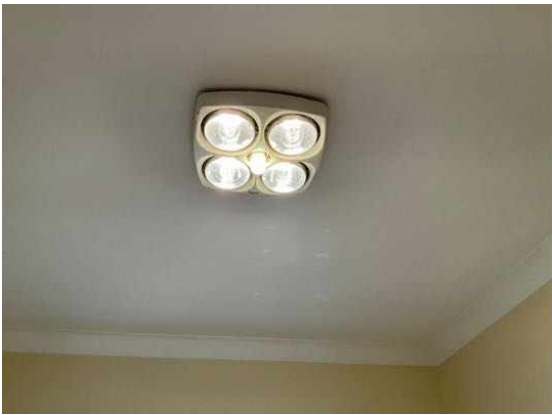
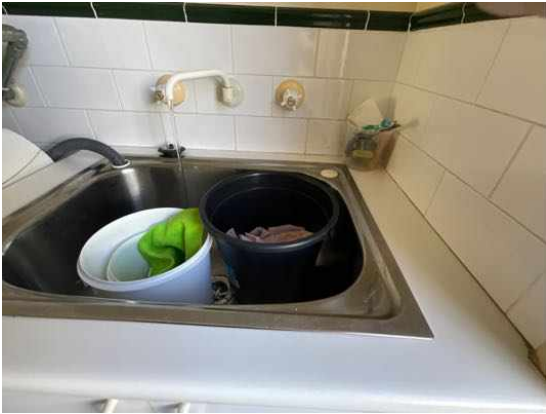
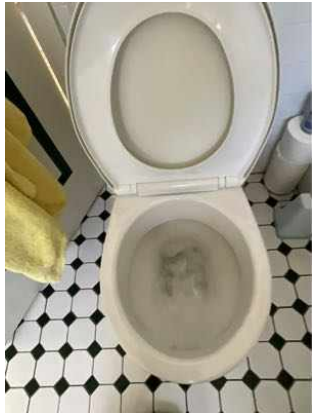
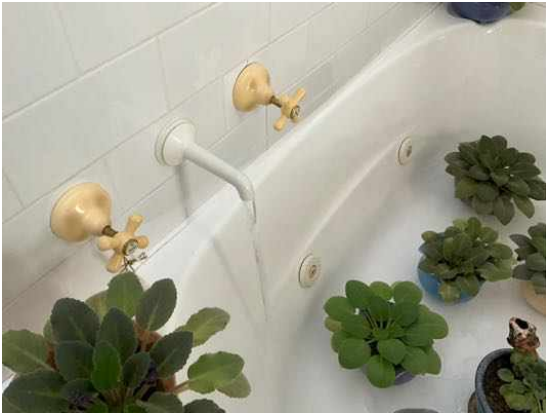
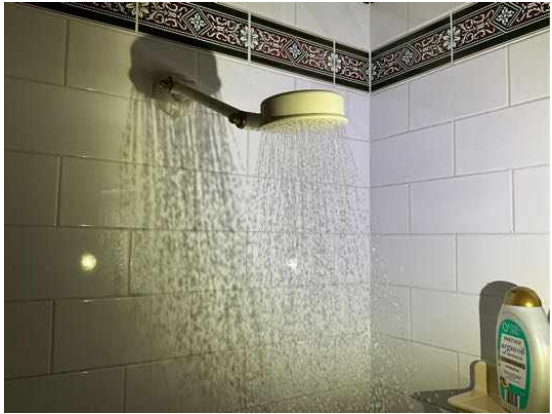
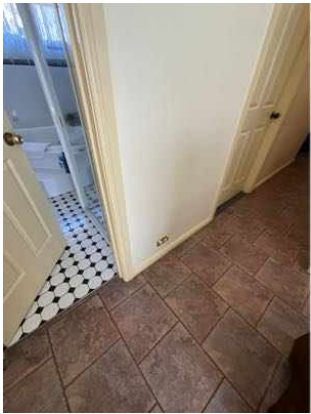
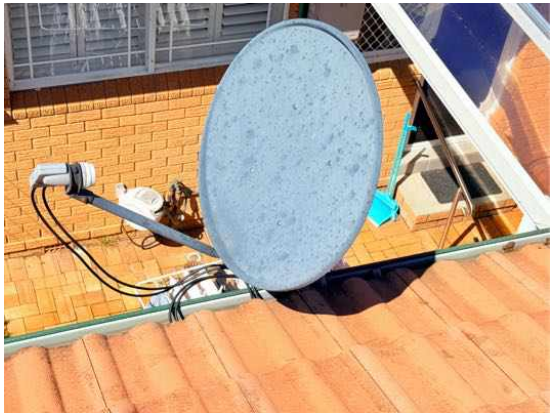
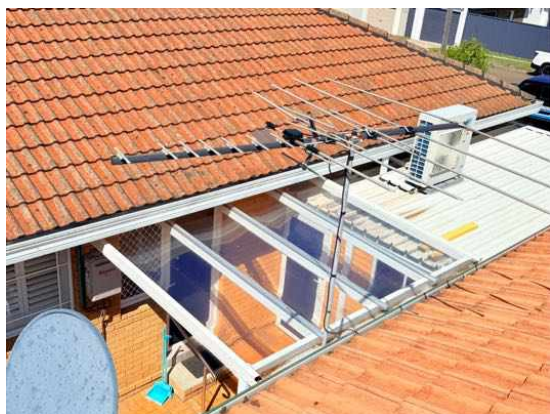
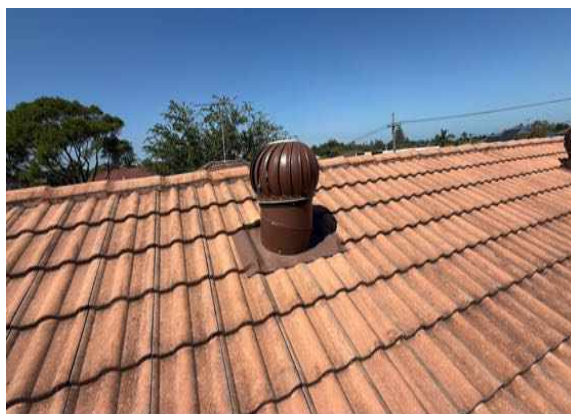
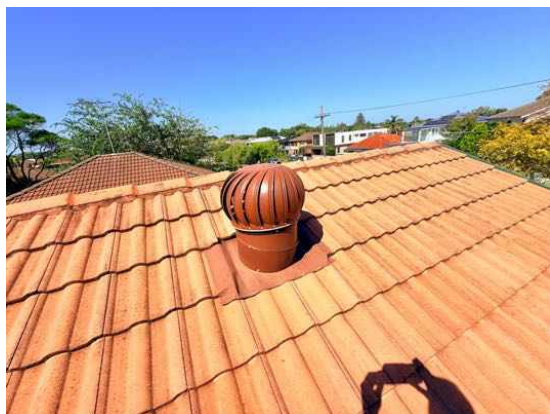
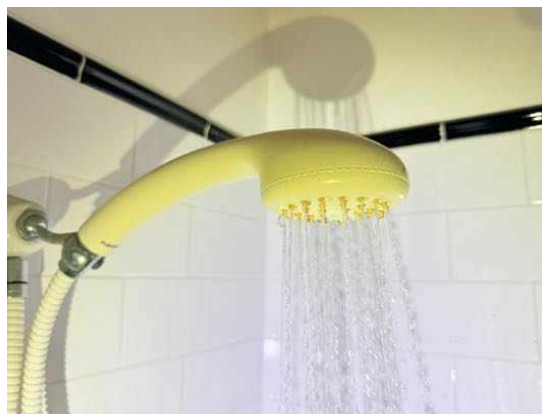
Building: Main Building  
Location: All Areas  
Finding: Additional Photos  
Information: Additional photos are provided for your general reference

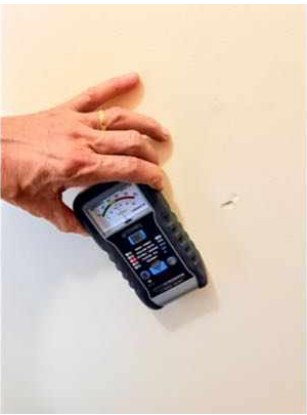
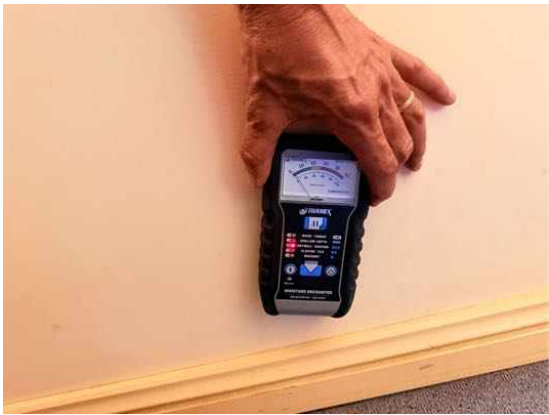
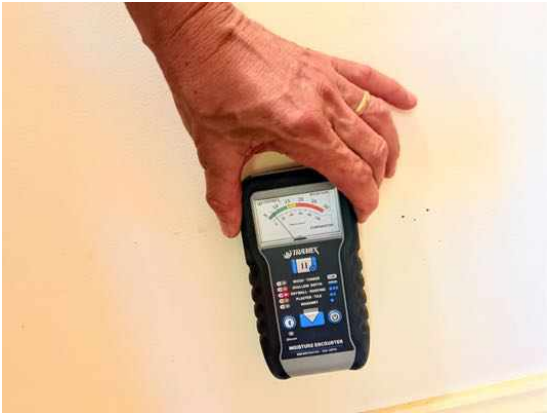
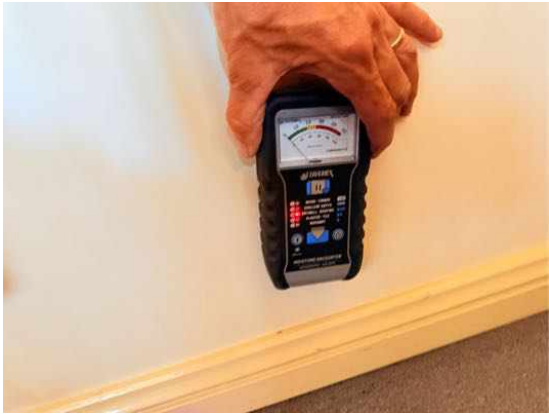
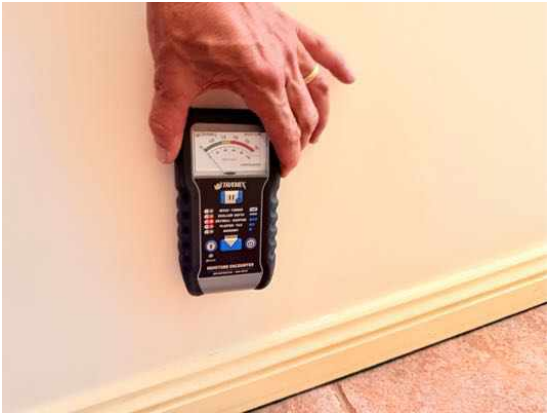
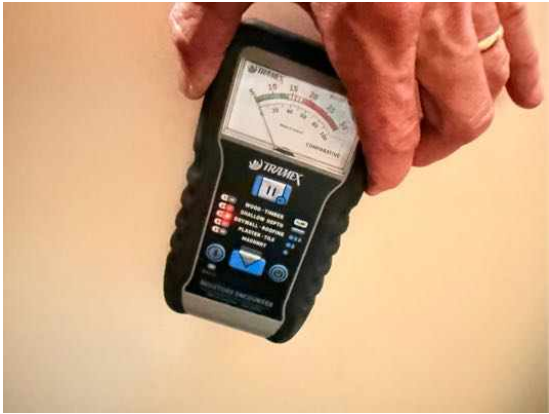
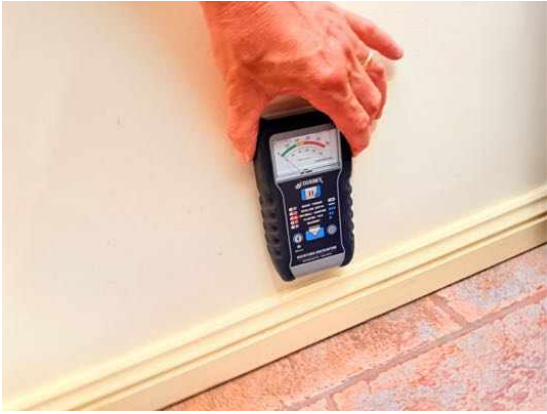
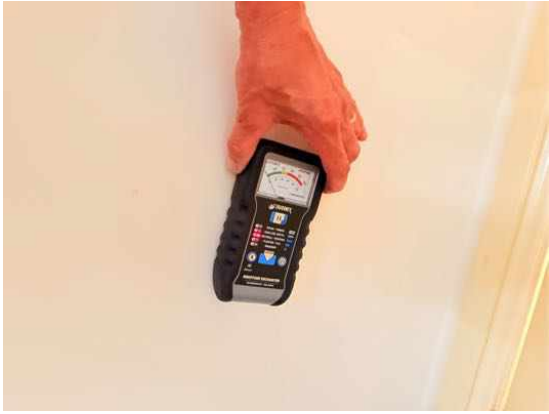
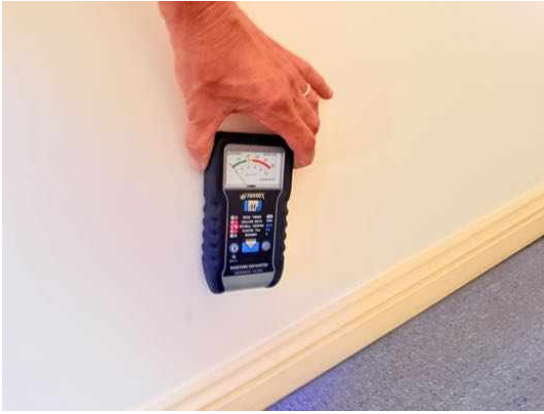
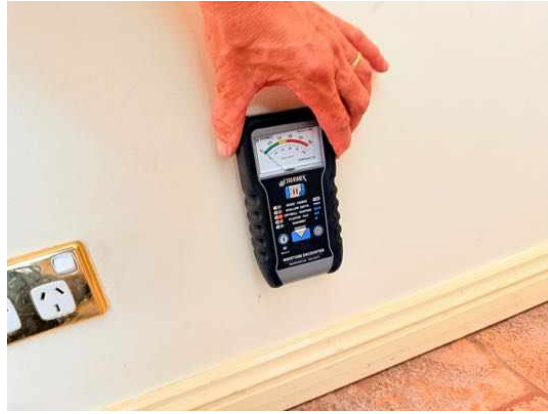
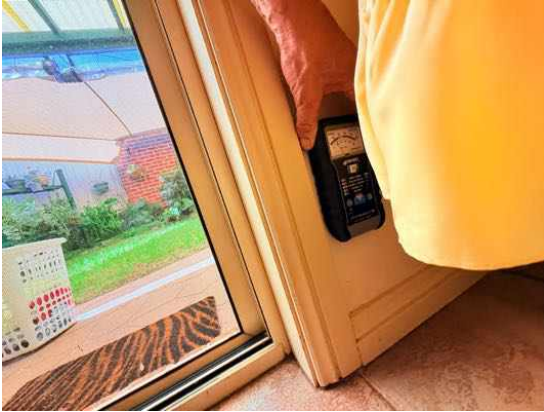
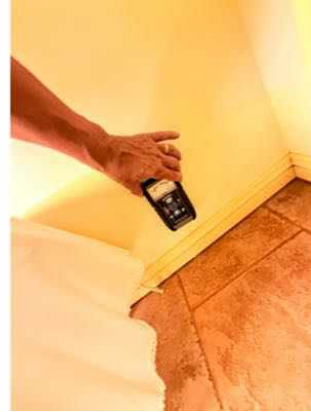
Building: Main Building  
 Location: All Areas  
 Finding: Moisture readings  
 Information: At the time of inspection, low moisture readings were noted in several accessible areas of the property, including, but not limited to, those shown in the accompanying photographs.

These areas were evaluated for elevated moisture levels and temperature irregularities, which can indicate potential issues such as hidden leaks, failing waterproofing, timber pest activity or poor ventilation.

Identifying such conditions is essential, as prolonged moisture can result in structural deterioration, mould growth, and an increased risk of timber pest activity.

Any anomalies detected during the inspection have been documented in this report and may warrant further invasive investigation to determine their source and extent.

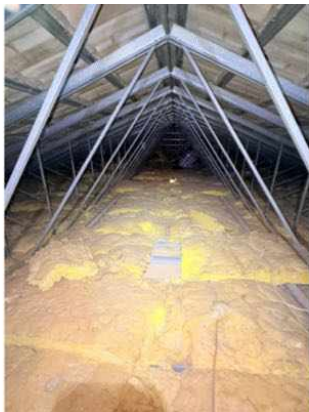
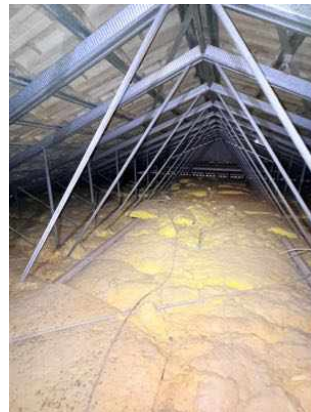
Building: Main Building  
 Location: All Areas  
 Finding: Obstructions and Limitations-additional photos  
 Information: The photographs represent only a small sample of the obstructions and limitations to areas (where applicable) of the roof void, subfloor, internal and external areas that restricted a full inspection of the property. Such obstructions may conceal a variety of defects and should be removed to allow a comprehensive inspection to be carried out.

A re-inspection is strongly recommended once these areas are made fully accessible.
