## Building and Timber Pest Inspection Report

Inspection Date: Tue, 3 Feb 2026

Property Address: 6 Lambert Rd, Bardwell Park NSW 2207,  
Australia

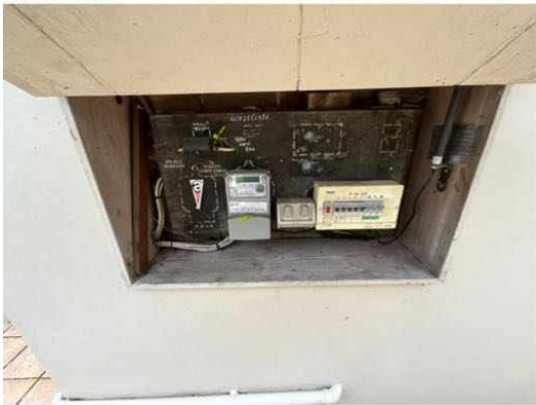
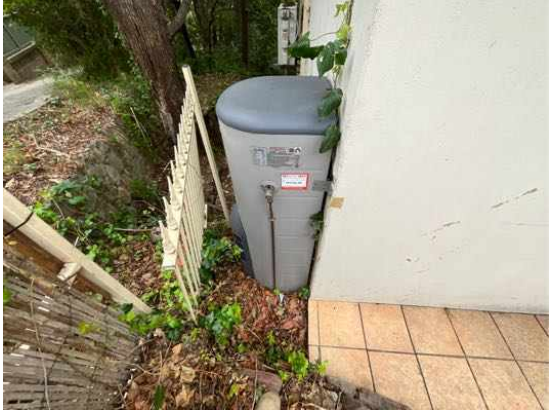
Building: Main Building  
Location: All Areas  
Finding: Photos Added  
Information: Additional photos are provided for your general reference.

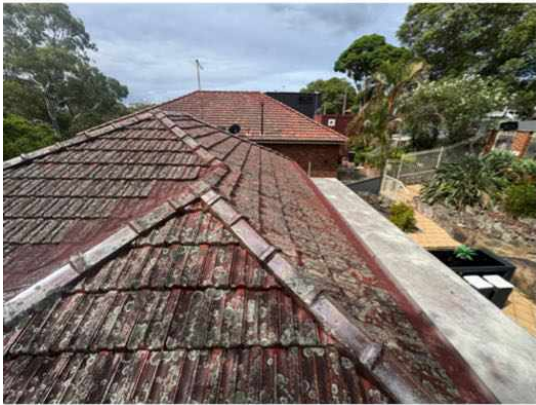
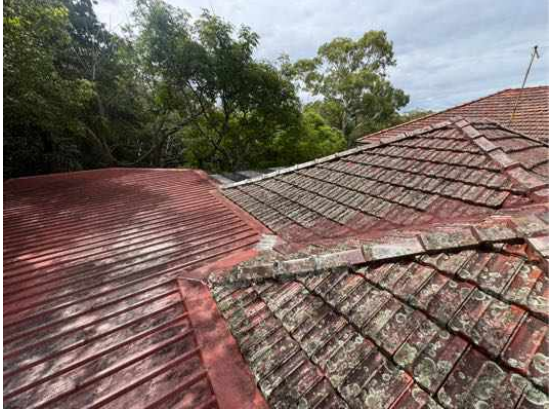
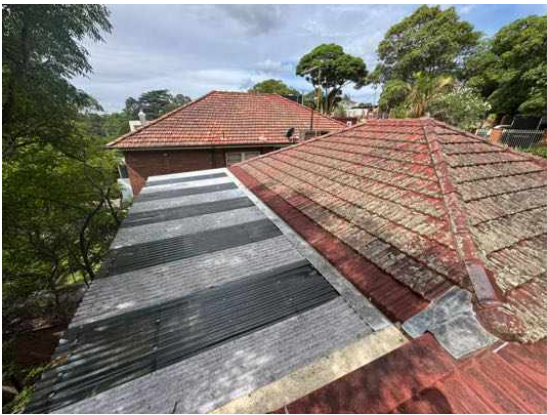
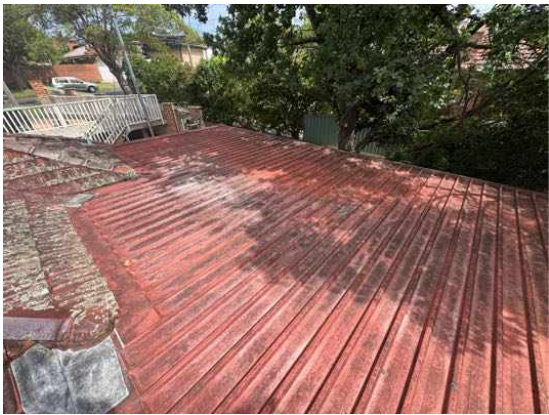
Building: Main Building  
Location: Roof Exterior  
Finding: Photos Added  
Information: Additional photos are provided for your general reference.

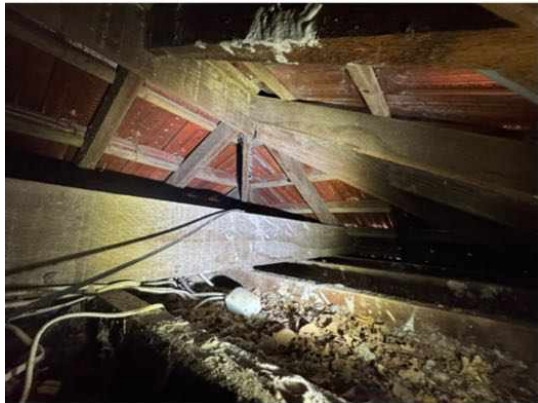
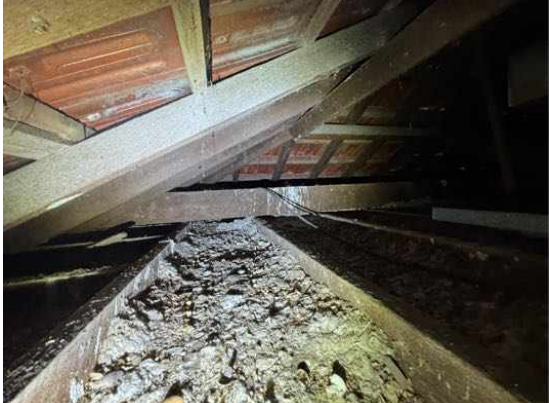
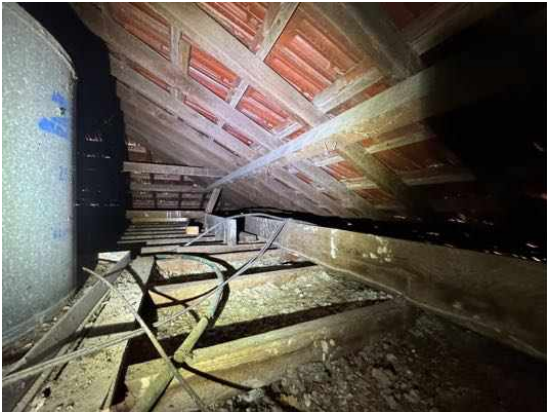
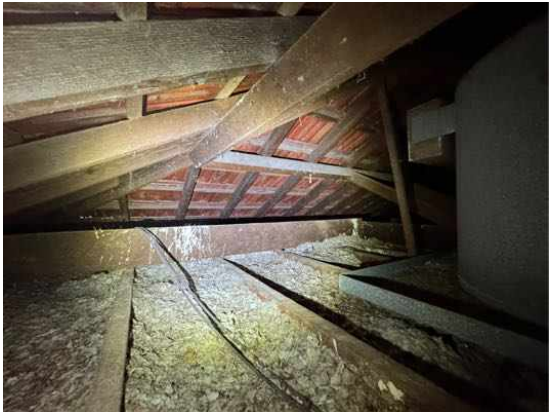
Building: Main Building  
 Location: Roof Void  
 Finding: Photos Added  
 Information: Additional photos are provided for your general reference.

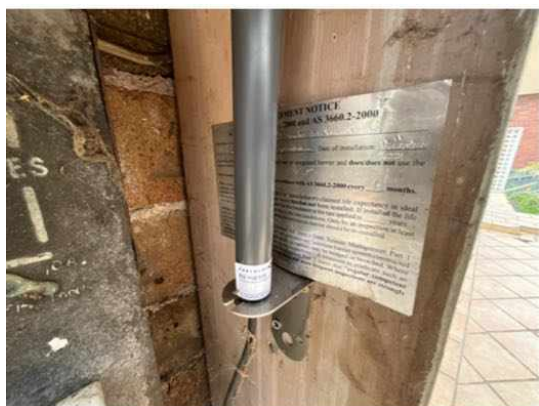
Where a Termite Management System has been identified you should refer to the type of barrier date of installation warranty conditions and any documentation provided by a builder or past owner. Consult the company who installed the barrier to confirm whether the system is still under warranty.

Most chemical termite management systems expire and require replenishment and all physical systems are primarily designed to prevent concealed entry.
