Building and Timber Pest Inspection Report

Inspection Date: Thu, 15 Jan 2026

Property Address: 16 Sophia St, Shellharbour NSW 2529,
Australia

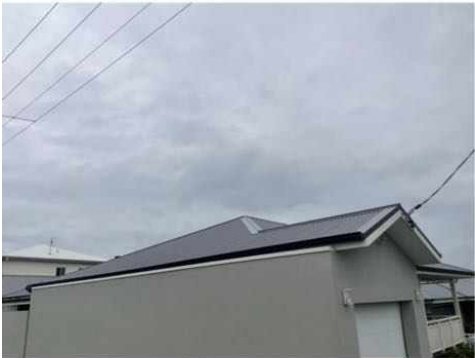
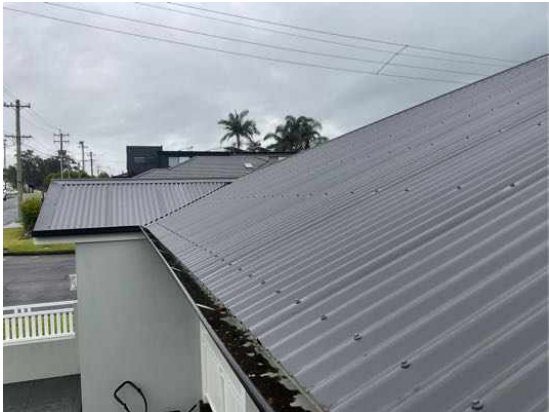
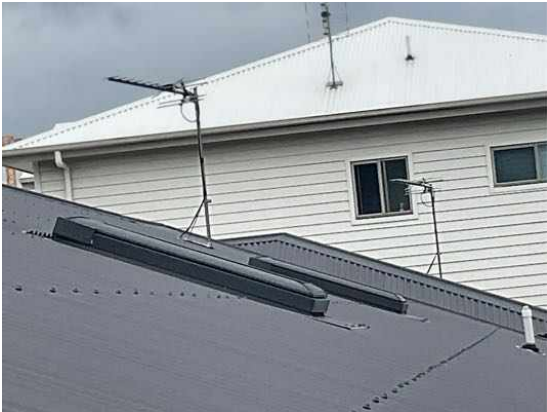
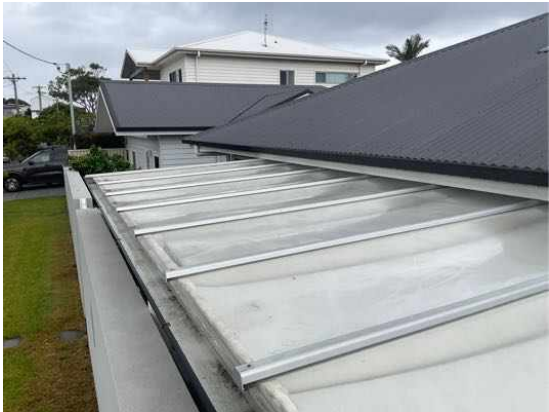
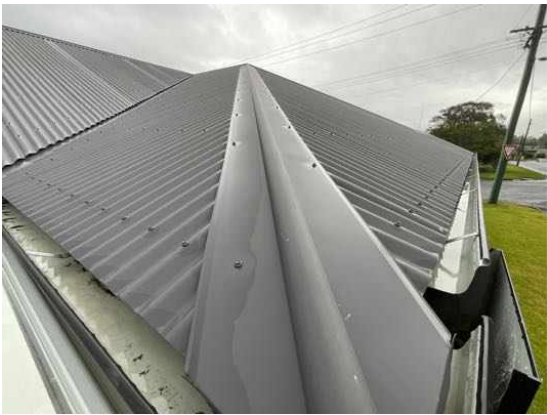
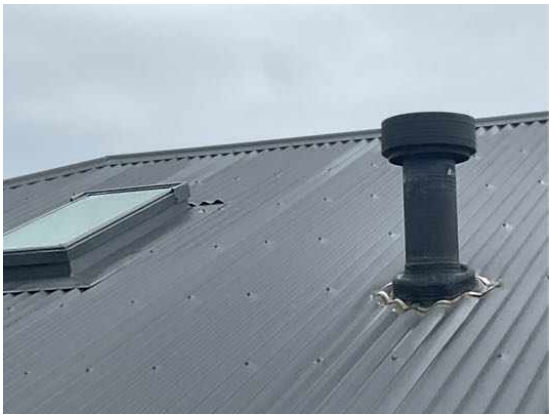
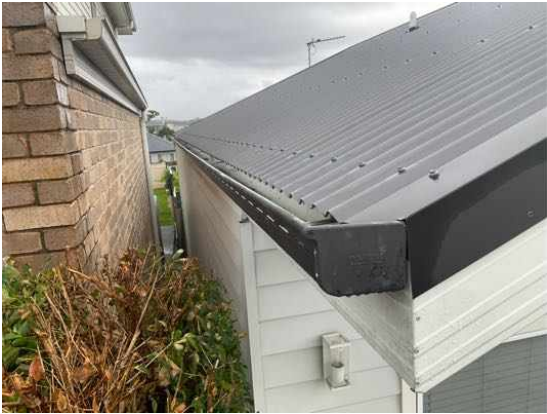
Building: Building 1
Location: Roof Exterior
Finding: Additional Photos
Information: Additional photos are provided for your general reference

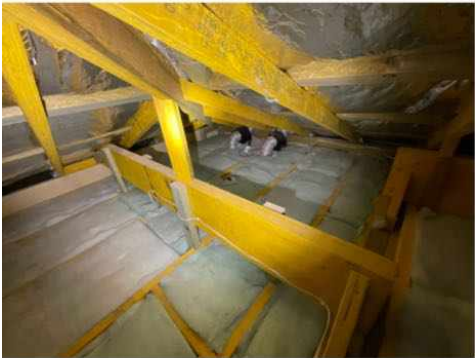
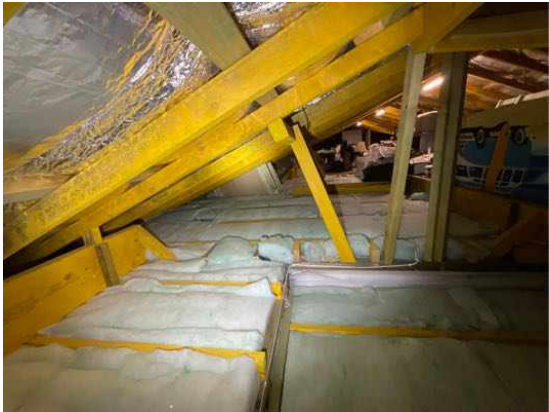
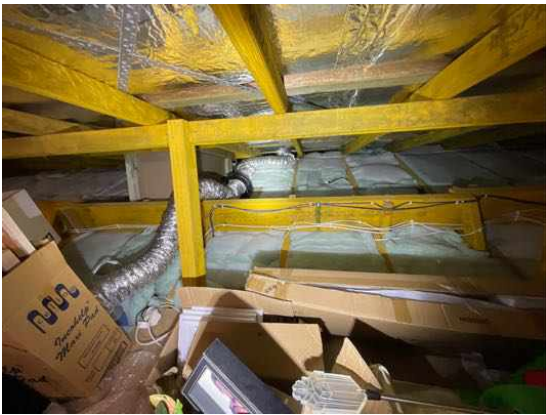
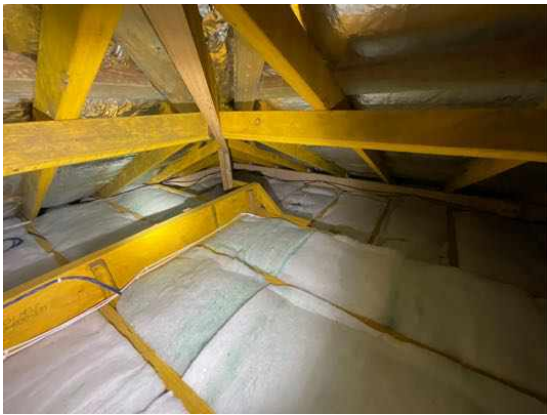
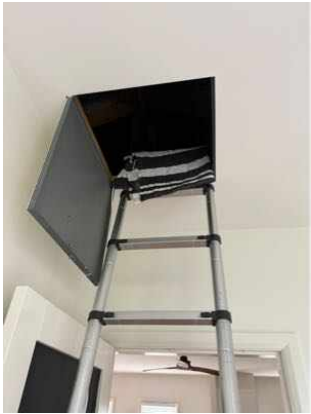
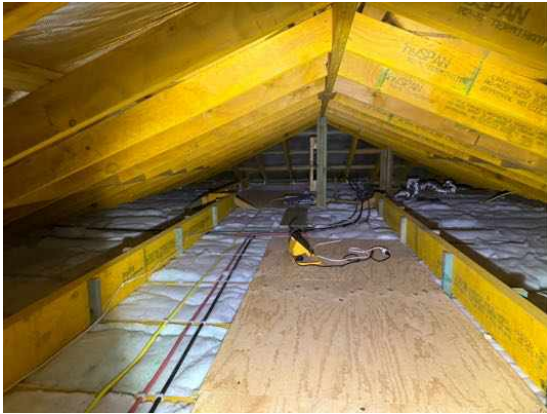
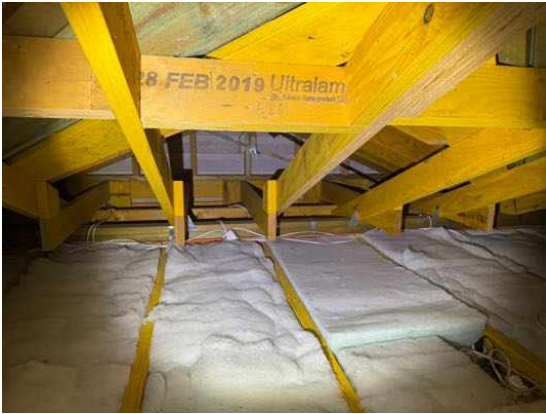
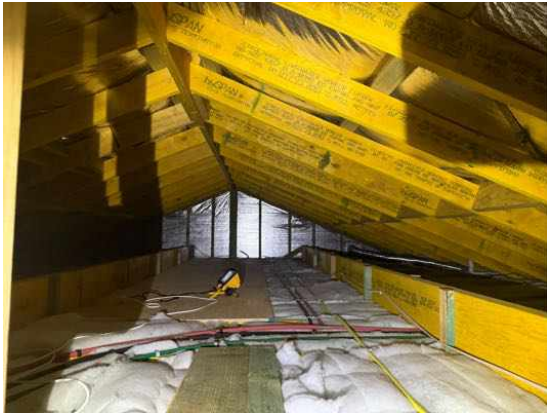
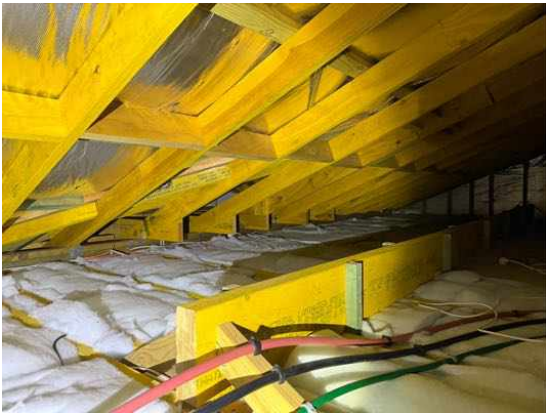
Building: Building 1
Location: Both Roof Voids
Finding: Additional Photos of both roof voids
Information: Additional photos are provided for your general reference

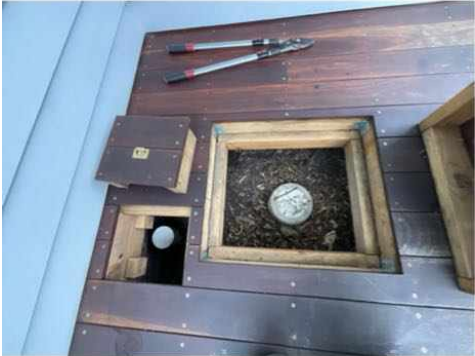
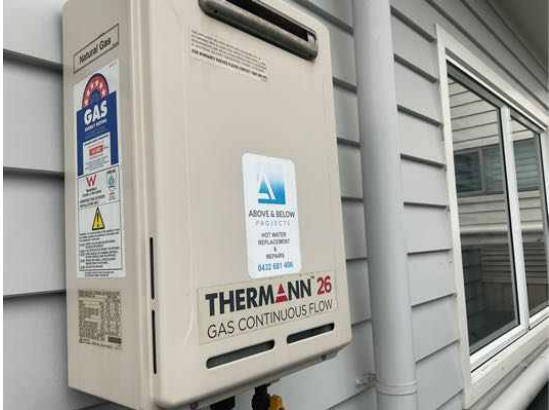
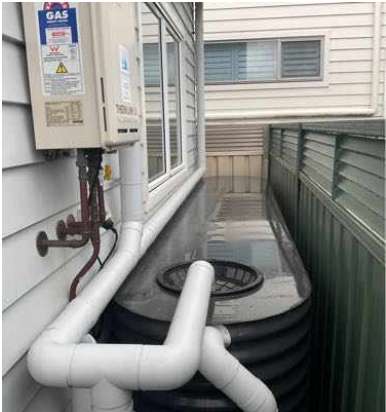
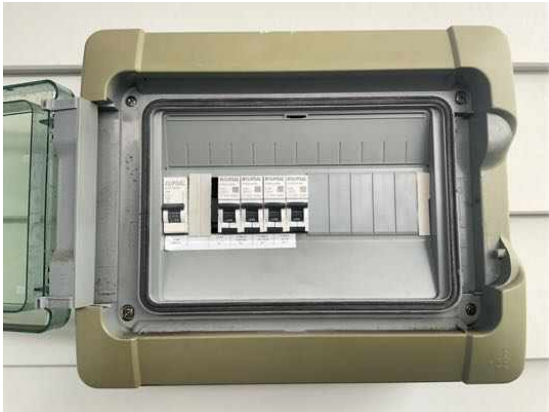
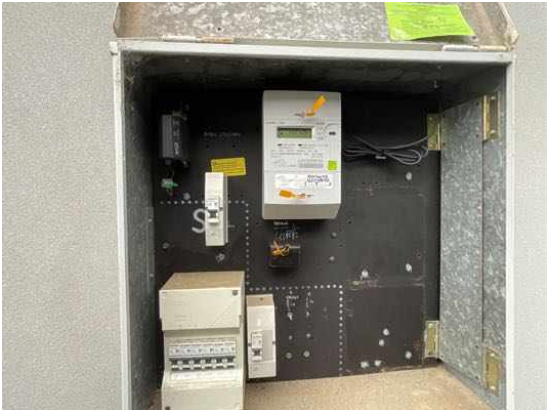
Building: Building 1
Location: All External Areas
Finding: Additional Photos
Information: Additional photos are provided for your general reference
