Building and Timber Pest Inspection Report

Inspection Date: Wed, 25 Mar 2026

Property Address: 1 Dickson St E, Woomargama NSW 2644,
Australia

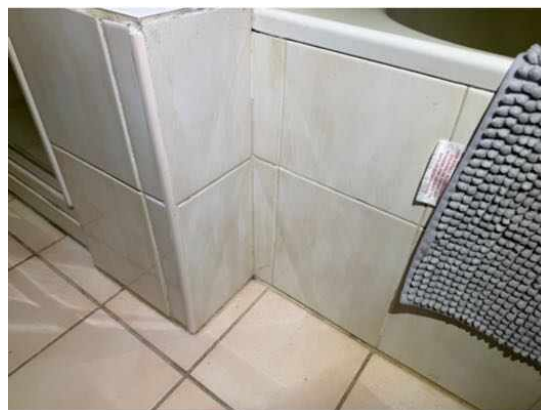
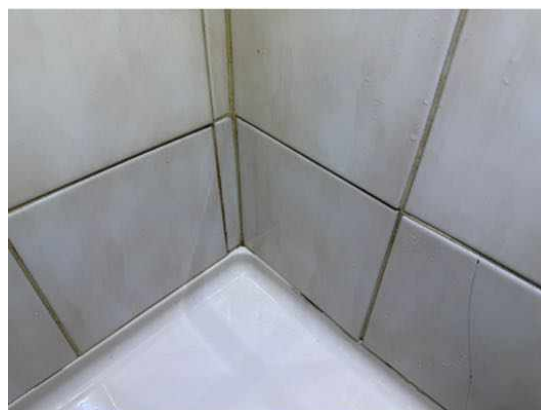
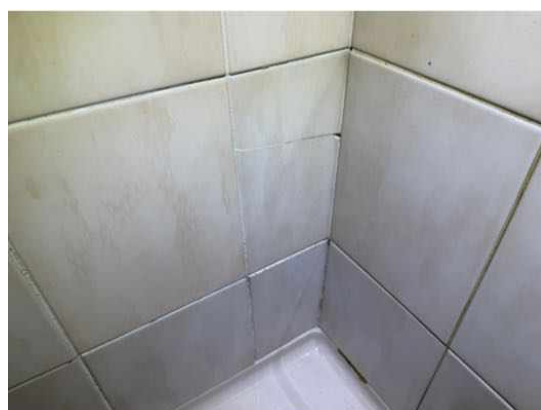
Building: Main Building
Location: Tiled Areas
Finding: Sealant / grouting - deteriorated or missing & Cracked/Drummy Tiles
Information: It appears that the sealant and grout has deteriorated or is missing throughout the tiled areas. Several cracked, drummy and loose tiles were also noted, which can allow for moisture ingress behind the tiles, if neglected.

Sealant and grouting in areas that come into regular contact with water should be maintained for the long term care of your property. Recommend engaging a licensed tiling contractor promptly, to provide remedial works, to ensure all tiled areas are sufficiently grouted sealed and waterproofed.

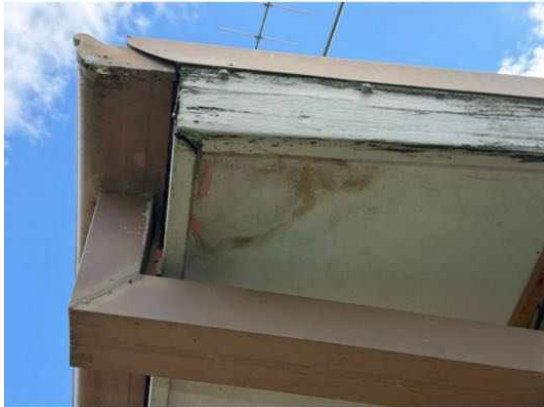
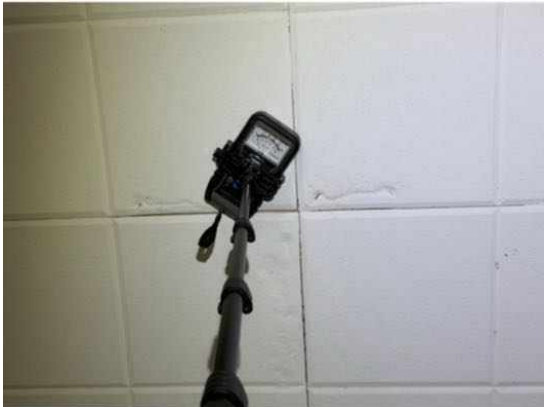
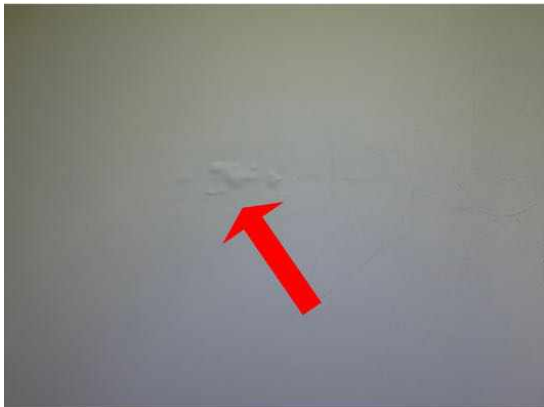
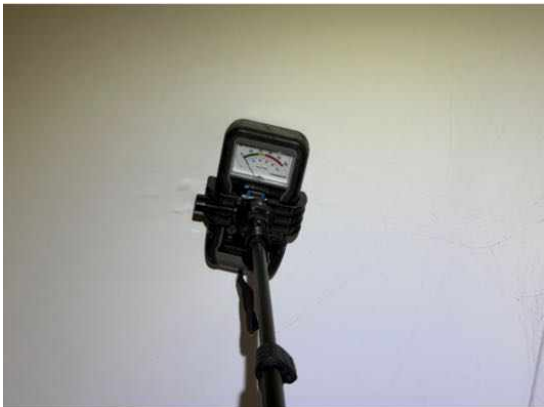
Finding 3.05

Building: Main Building
 Location: Lounge room & bedroom ceiling, eave
 Finding: Water Staining Present
 Information: It appears that water staining / bubbling was present at but not limited to, the lounge room & bedroom ceiling, as well as areas of the eave sheets. Potential causes of leaking include deteriorated roof cladding or damaged plumbing fittings and fixtures. No high moisture was evident in these areas at the time of inspection.

Recommend that the client closely monitor these areas and engage a licensed roof plumber promptly, should the leak persist or return.

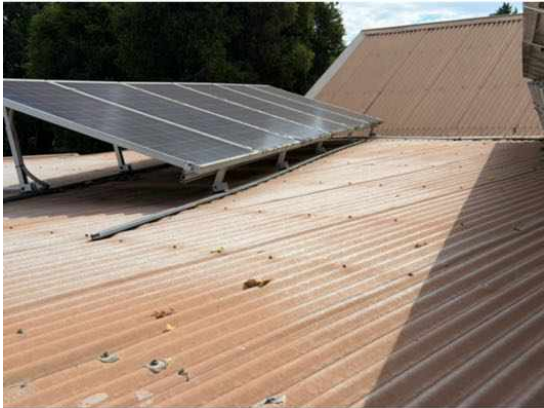
Finding 3.06

Building: Main Building
Location: Roof Exterior
Finding: Roof Exterior - Weathered & Faded
Information: The roof exterior was found to be in a weathered condition, evidenced by general fading of the coating. While weathering of the roof exterior is consistent with the age of the property, maintenance works are advised, to avoid further deterioration.

Recommend engaging a licensed roofing contractor in the short term, to provide remedial advice and maintenance works.

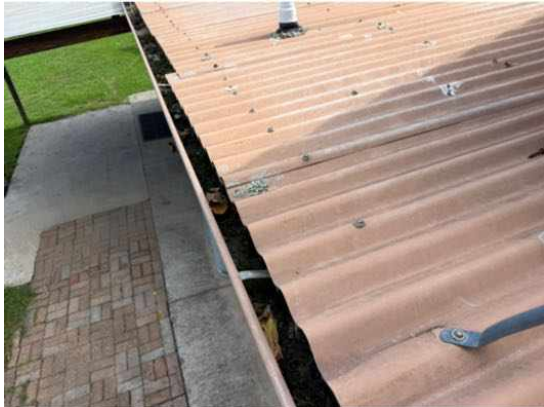
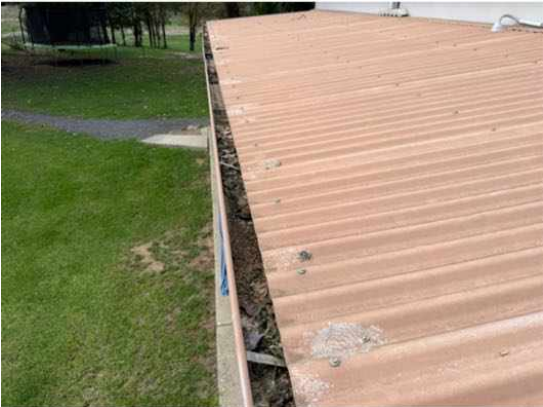
Finding 3.11

Building: Main Building
Location: Gutters
Finding: Debris in Gutters
Information: It appears that there is some debris in the gutters. Accumulation of debris can lead to blockages of the gutters & water overflows, if neglected.

Recommend engaging a general handyman to remove all debris from the gutters promptly to prevent overflows & blockages.

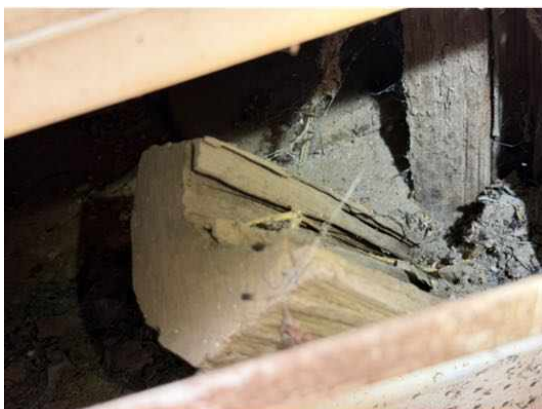
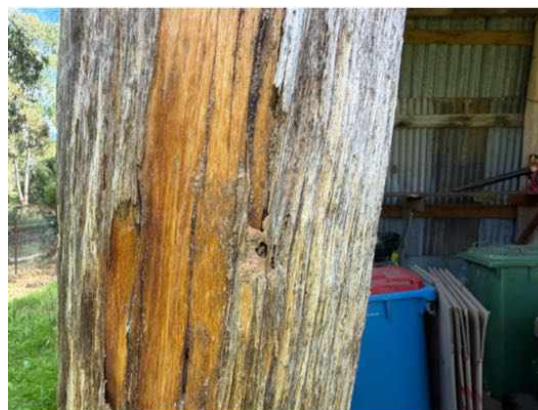
Building: Main Building
Location: Subfloor, Shed
Finding: Evidence of termite workings & damage
Information: Termite damage & workings were identified at, but not limited to, a timber stump to the edge of the subfloor and to the shed posts. The client should engage a licensed pest controller at their earliest convenience to provide further advice regarding installation of a termite treatment.

6 monthly ongoing termite inspections, conducted by a qualified termite inspector, are also recommended

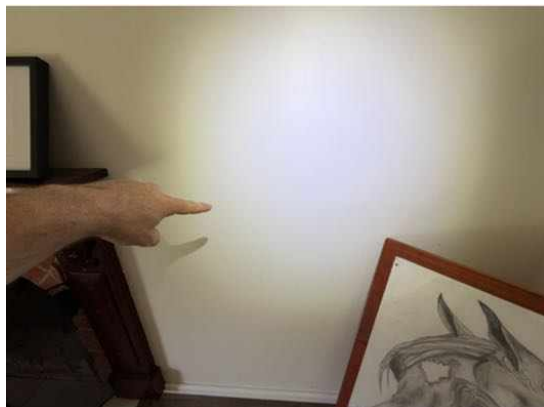
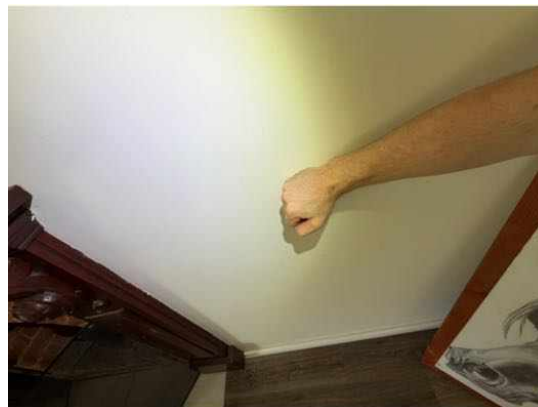
Information: It appears areas of audible droppings in the wall cavities were identified at, but not limited to the lounge room wall. This may be an indicator of potential termite damage in the wall cavity. A more invasive inspection conducted by a licensed tradesperson is recommended to confirm, and identify the extent of the damage.

Should termite damage be confirmed, a registered builder should then be engaged to replace any affected building materials.

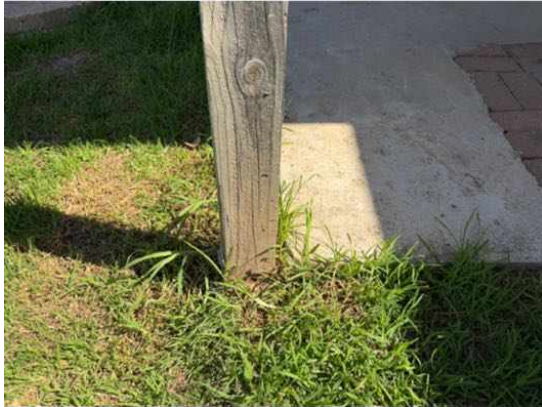
Information: Where timber materials are in direct contact with the ground and consequently moisture, they become conducive to termite activity. The verandah posts, chicken coop, shed framing and trees surrounding the building create an environment conducive to termite infestation.

Where feasible, any timbers in direct contact with the ground should be removed and any trees in close proximity to the building should be removed or test drilled (inspected) at least annually to reduce the risk of termite infestation & detect any early signs of termite activity.

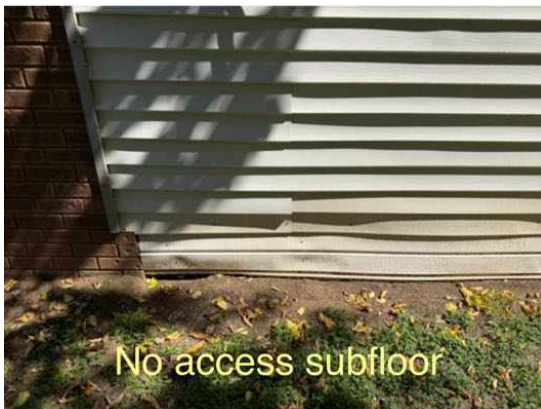
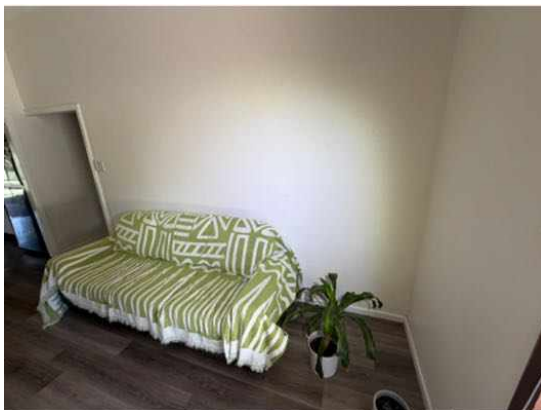
Building: Main Building
Location: All Areas
Finding: Additional Photos - Obstructions and Limitations
Information: These photographs are an indication of the obstructions and limitations which impeded full inspection of the property at the time of inspection. These obstructions can hide an array of defects and should be removed to allow full inspection to be carried out. A re-inspection is recommended once the areas are made accessible.
