# Building and Timber Pest Inspection Report

Inspection Date: Wed, 25 Mar 2026

Property Address: 4 Kurrajong St, Dorrigo NSW 2453,  
Australia

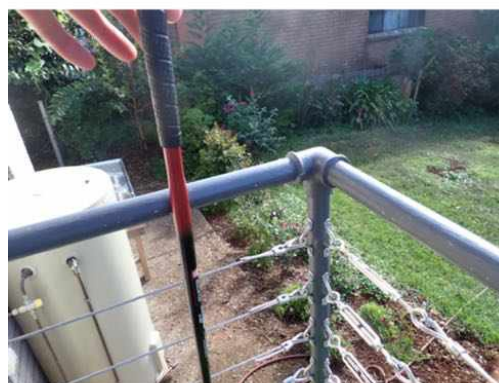
#### Finding 1.01

Building:	Main Building
Location:	Rear external ramp
Finding:	Non Compliant Balustrade To Rear Ramp
Information:	The balustrade to the rear ramp was identified as non compliant at the time of inspection. This may be associated with inadequate height, spacing, or construction that does not meet current building standards. Non compliant balustrades can present a safety risk. This is a common defect with a home of this age. Rectification should be carried out by a licensed builder or suitably qualified tradesperson to ensure compliance with current standards and improve safety. Repairs should be carried out as soon as possible.

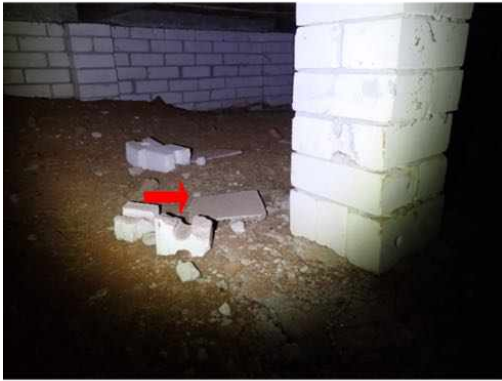
#### Finding 1.02

Building:	Main Building
Location:	Subfloor
Finding:	Suspected Asbestos Containing Materials To Subfloor
Information:	Suspected asbestos containing building materials were identified within the subfloor area at the time of inspection. Materials of this nature were commonly used in older construction and may pose a health risk if disturbed. No sampling or testing was carried out as part of this inspection. A licensed asbestos assessor or hygienist should be engaged to confirm the presence of asbestos, and if required, removal or management should be carried out by a licensed asbestos removal contractor in accordance with relevant regulations. Further action should be carried out at the owner's discretion.

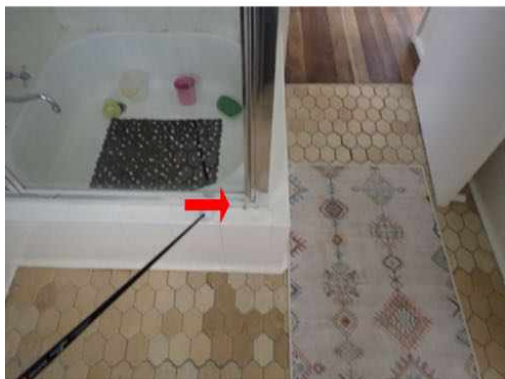
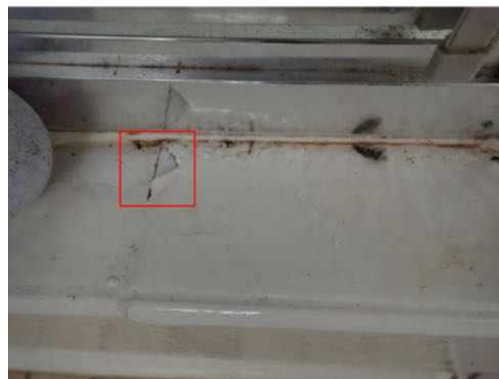
Building:	Main Building
Location:	Bathroom
Finding:	Peeling Paint to Shower Hob Tiles

Information: Paint peeling was identified to the painted tiles around the shower hob. This is likely due to moisture exposure and inadequate surface preparation or unsuitable coatings, and may lead to further deterioration and reduced water resistance in the area. A licensed painter or suitably qualified tradesperson should be engaged to remove the failing coating, prepare the surface correctly, and apply an appropriate moisture-resistant finish.

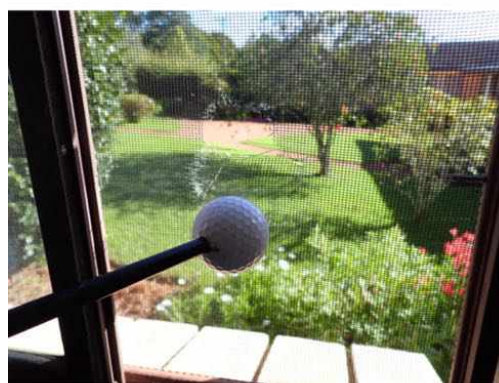
### Finding 3.03

Building: Main Building  
 Location: Bedroom  
 Finding: Damaged Flyscreen to Bedroom Window  
 Information: Damage was identified to the flyscreen on the bedroom window. This may allow insect ingress and is likely due to general wear and tear or impact. A handyman or suitably qualified tradesperson should be engaged to repair or replace the flyscreen. Repairs may be carried out at the owner's discretion.

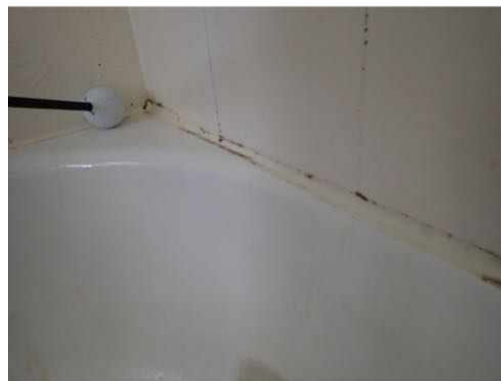
### Finding 3.04

Building: Main Building  
 Location: Bathroom  
 Finding: Deteriorated Silicone to Bath Tub Tiled Area  
 Information: Deteriorated silicone was identified around the bath tub tiled area. This appears

consistent with age-related deterioration and may allow moisture ingress, potentially leading to damage of adjoining building materials. A licensed tiler or suitably qualified tradesperson should be engaged to remove and replace the silicone to ensure a watertight seal. Maintenance should be carried out in due course.

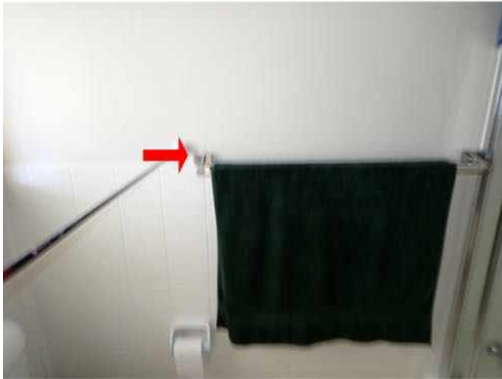
Building:	Main Building
Location:	Bathroom
Finding:	Loose Towel Rail
Information:	The bathroom towel rail was loose at the time of inspection. This is commonly

associated with loose fixings, deterioration of the wall lining or mounting points, or general wear and tear from use over time. The towel rail should be repaired or refixed by a handyman or suitably qualified tradesperson to restore proper function and help prevent further damage to the wall surface. Repairs should be carried out at the owner's discretion.

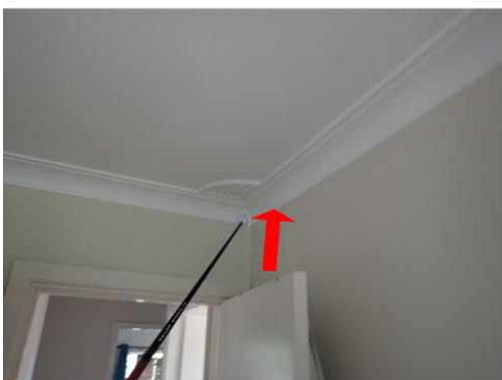
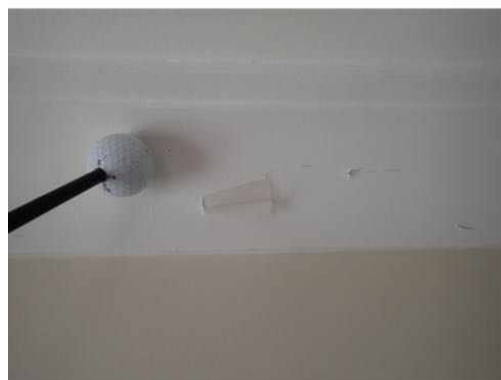
### Finding 3.07

Finding: Minor Paint Deterioration To Laundry Walls

Information: Paint deterioration was identified to the laundry walls at the time of inspection. This is typically associated with age related wear and tear, moisture exposure, or inadequate surface preparation during previous painting works. Maintenance and repainting should be carried out by a painter or suitably qualified tradesperson to protect the underlying surfaces and improve overall condition. Repairs should be carried out at the owner's discretion.

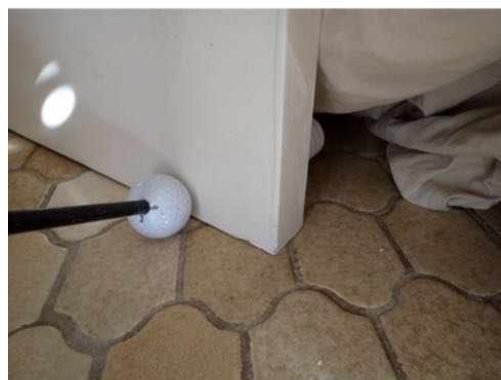
### Finding 3.08

Building:	Main Building
Location:	Laundry
Finding:	Laundry Door Catching On Floor Tiles
Information:	The laundry door was observed catching on the floor tiles at the time of inspection. This is commonly associated with movement in the building, swelling of the door material due to moisture, or misalignment of hinges or door frame. Adjustment or repair should be carried out by a carpenter or suitably qualified tradesperson to ensure smooth operation and prevent further wear or damage. Repairs should be carried out at the owner's discretion.

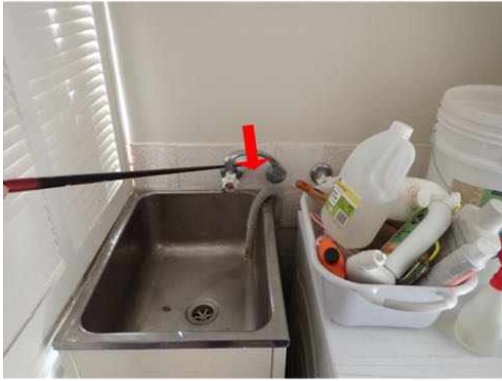
### Finding 3.09

Building:	Main Building
Location:	Laundry
Finding:	Cracked Laundry Splashback Tile
Information:	A cracked tile was identified to the laundry splashback at the time of inspection. This is commonly associated with impact damage, movement in the wall substrate, or poor installation. The affected tile should be replaced by a tiler to maintain the integrity of the splashback and help prevent moisture ingress to the underlying materials. Repairs should be carried out at the owner's discretion.

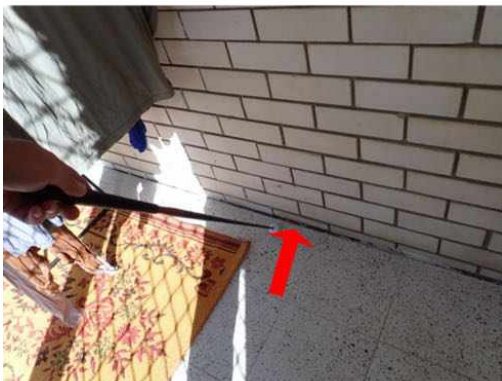
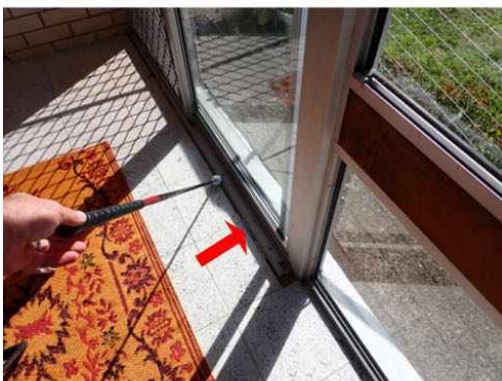
### Finding 3.10

Finding: Poorly Finished And Drummy Tiles To Enclosed Rear Balcony

Information: Poorly finished tiling and sections of drummy tiles were identified to the enclosed rear balcony at the time of inspection. This is commonly associated with inadequate surface preparation, insufficient adhesive coverage, or poor installation practices. Drummy tiles may become loose over time and can lead to further deterioration if not addressed. Repairs should be carried out by a tiler or suitably qualified tradesperson to rectify the affected areas and ensure a durable finish. Repairs should be carried out at the owner's discretion.

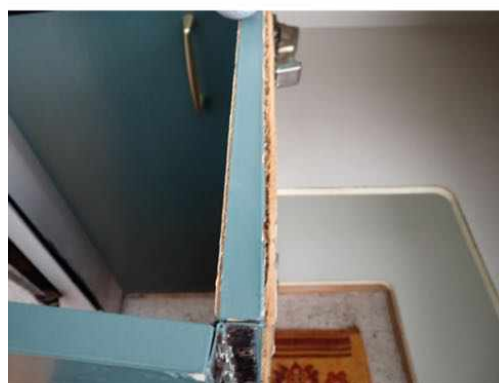
### Finding 3.12

Building:	Main Building
Location:	Kitchen
Finding:	Swelling To Kitchen MDF Cupboard Doors
Information:	Swelling was identified to several kitchen MDF cupboard doors at the time of inspection. This is commonly associated with moisture ingress, prolonged exposure to humidity, or general age related deterioration of the material. Continued exposure may lead to further deterioration and reduced functionality of the doors. Repairs or replacement should be carried out by a cabinet maker or suitably qualified tradesperson to restore condition and functionality. Repairs should be carried out at the owner's discretion.

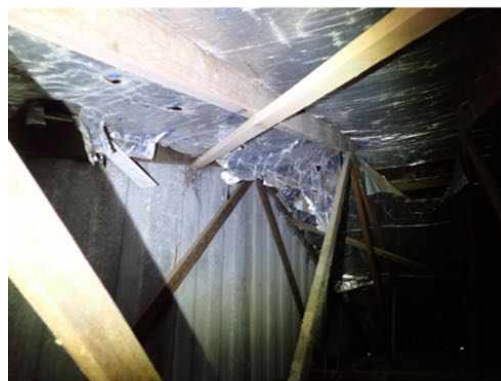
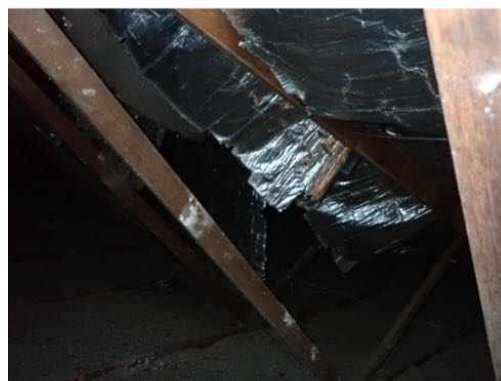
### Finding 3.13

Building:	Main Building
Location:	Ceiling space
Finding:	Damaged Ceiling Foil
Information:	Damage to the ceiling foil insulation was identified at the time of inspection. This is commonly associated with previous works in the roof space or age related deterioration and is a common defect with a home of this age. Damaged foil may reduce the effectiveness of insulation and can impact the thermal performance of the

building. Repairs or replacement should be carried out by an insulation installer or suitably qualified tradesperson to restore performance. Repairs should be carried out at the owner's discretion.

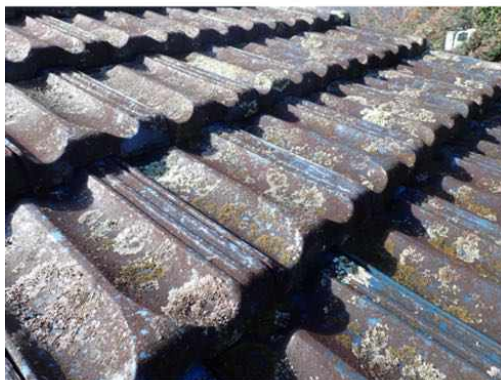
### Finding 3.14

Building:	Main Building
Location:	Roof
Finding:	Lichen Growth To Roof Tiles
Information:	Lichen growth was identified to the roof tiles at the time of inspection. This is commonly associated with age related deterioration, moisture retention, and lack of regular maintenance. Lichen can retain moisture on the tile surface which may contribute to accelerated wear and potential deterioration over time. Cleaning and maintenance should be carried out by a roofing contractor or suitably qualified tradesperson to restore condition and prolong the lifespan of the roof covering. Repairs should be carried out at the owner's discretion.

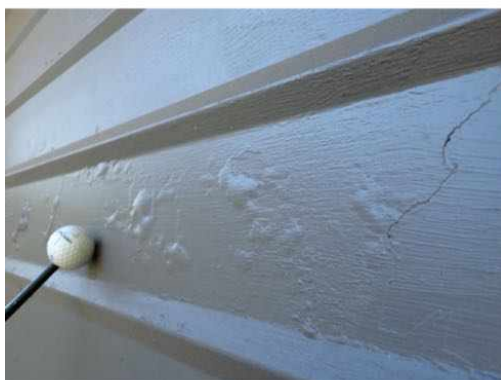
**Finding 3.15**

Building: Main Building  
 Location: Garage door  
 Finding: Bubbling Paint To Garage Door  
 Information: Bubbling paint was identified to the garage door at the time of inspection. This is commonly associated with moisture ingress, inadequate surface preparation, or age related deterioration of the coating. Continued deterioration may lead to further paint failure and potential corrosion of the underlying material. Preparation and repainting should be carried out by a painter or suitably qualified tradesperson to restore protection and appearance. Repairs should be carried out at the owner’s discretion.

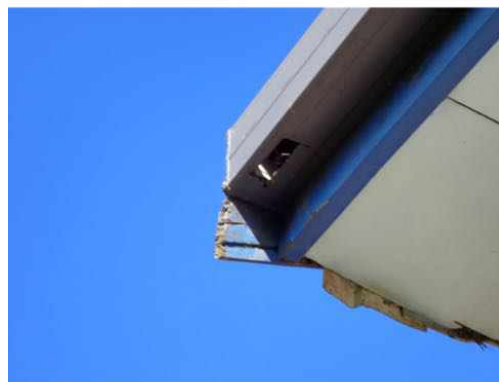
### Finding 3.18

Building:	Main Building
Location:	Roof rear right hand corner
Finding:	Missing Downpipe To Rear Right Hand Corner
Information:	A downpipe was missing to the rear right hand corner of the building at the time of inspection. This is commonly associated with previous damage, removal, or incomplete installation. The absence of a downpipe may result in uncontrolled discharge of roof water which can contribute to moisture issues around the building, including potential damage to footings, walls, or surrounding surfaces. Installation of a compliant downpipe should be carried out by a licensed plumber or suitably qualified tradesperson to ensure proper drainage. Repairs should be carried out at the owner's discretion.

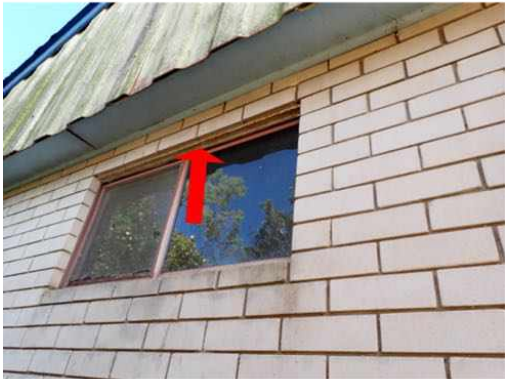
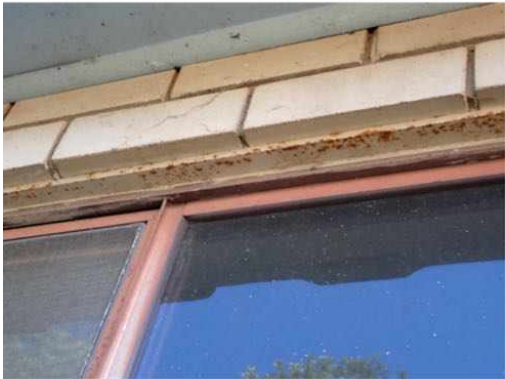
### Finding 3.19

Building:	Main Building
Location:	Garage window
Finding:	Surface Rust To Garage Window Lintel
Information:	Surface rust was identified to the garage window lintel at the time of inspection. This is commonly associated with exposure to moisture, weathering, or deterioration of protective coatings. While currently superficial, continued corrosion may lead to further deterioration over time if not addressed. Cleaning, treatment, and repainting should be carried out by a painter, metal fabricator, or suitably qualified tradesperson to restore protection and prevent further corrosion. Repairs should be carried out at the owner's discretion.

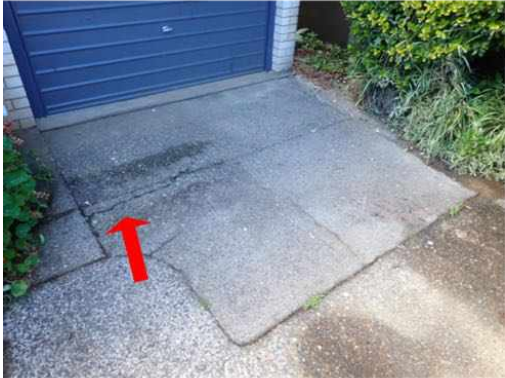
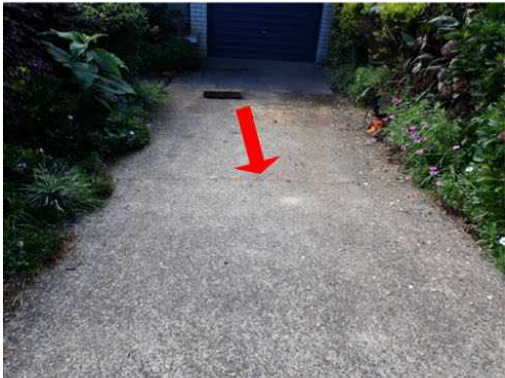
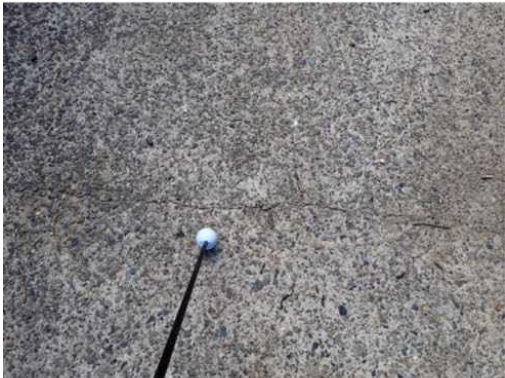
**Finding 3.20**

Building: Yard  
Location: Driveway  
Finding: Cracks To Concrete Driveway  
Information: Cracks were identified in the concrete driveway at the time of inspection. This is commonly associated with age related shrinkage, ground movement, or normal settlement of the supporting materials. Such cracking is a common defect in concrete surfaces over time. Repairs or sealing should be carried out by a concreter or suitably qualified tradesperson if considered necessary to maintain condition and limit further deterioration. Repairs should be carried out at the owner's discretion.

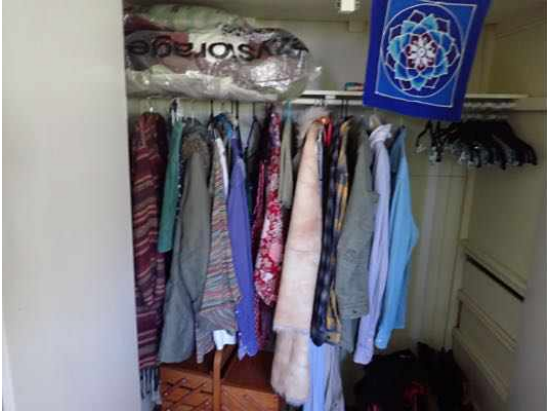
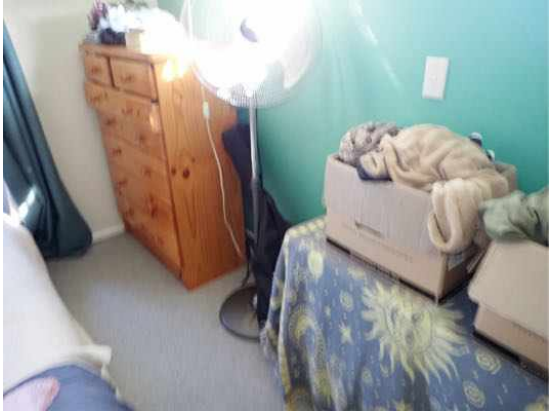
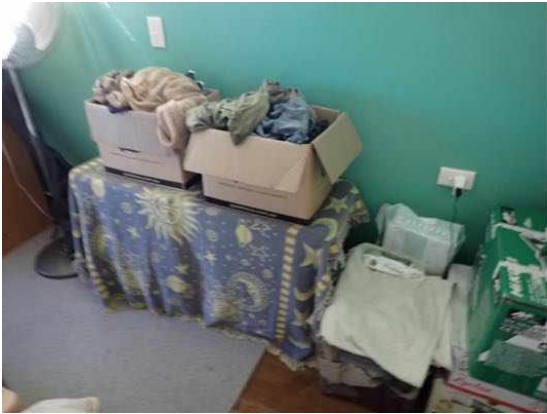
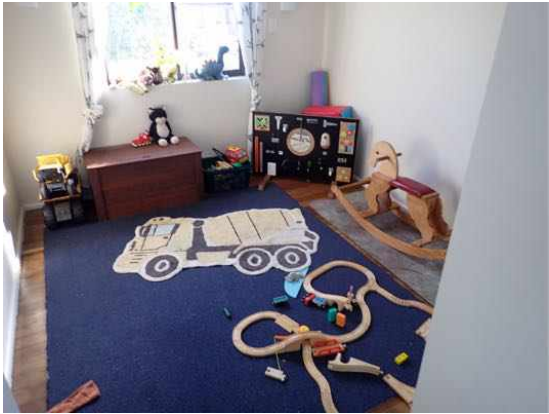
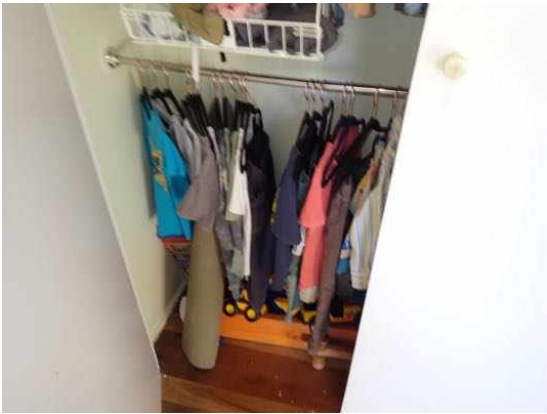
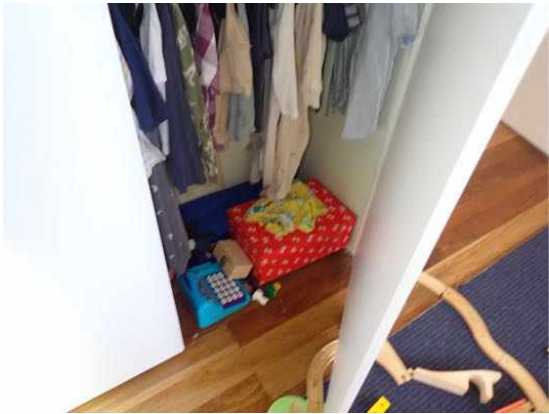
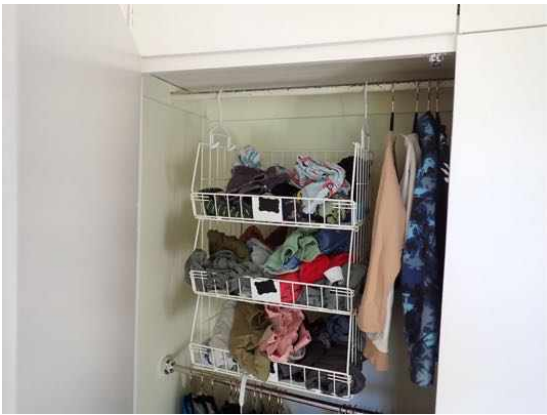
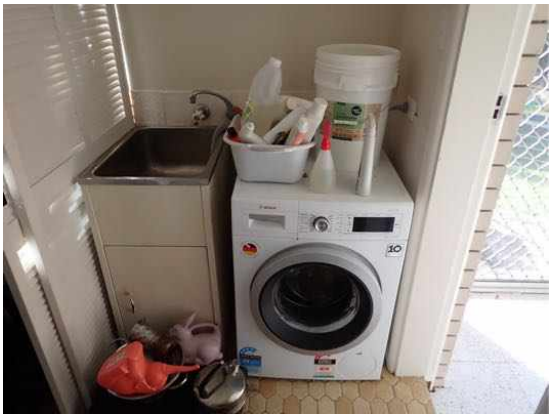
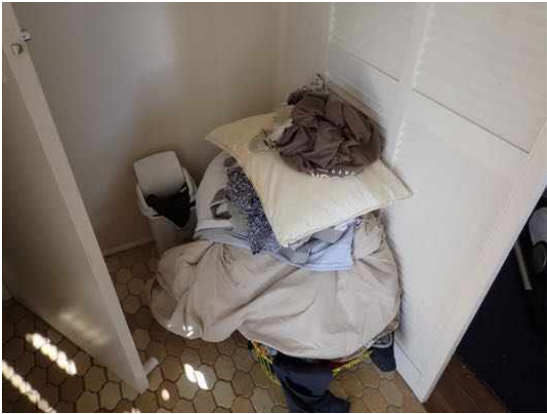
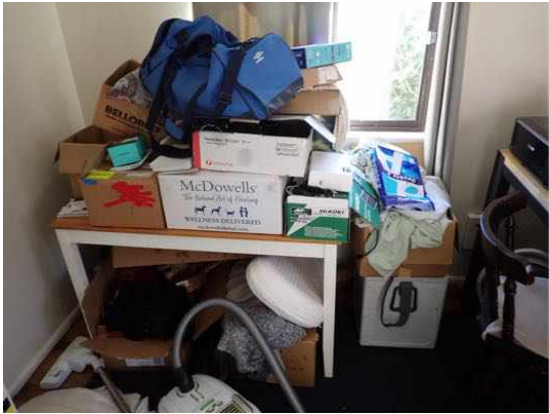
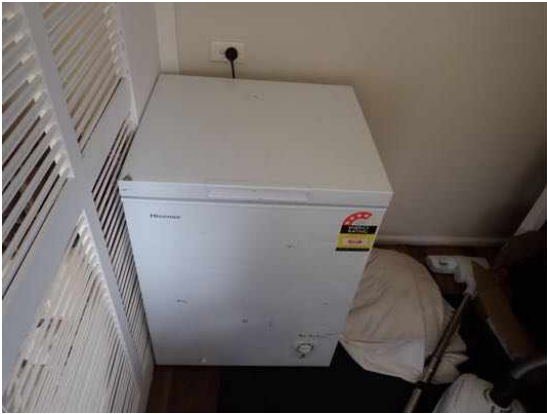
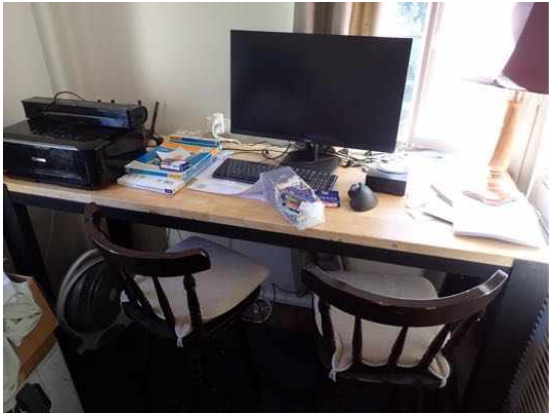
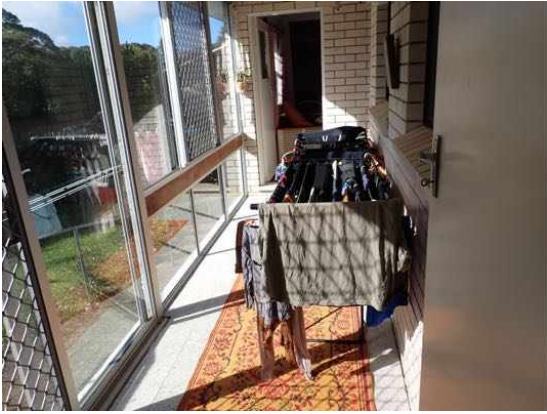
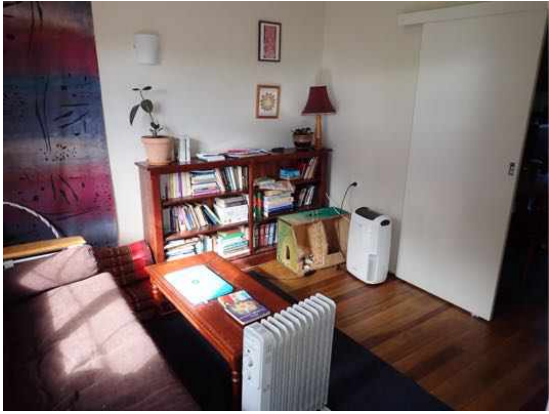
#### Noted Item

Building: Main Building  
Location: All Areas  
Finding: Additional Photos - Obstructions and Limitations  
Information: These photographs are an indication of the obstructions and limitations which impeded full inspection of the area at the time of inspection. These obstructions can hide an array of defects and should be removed to allow full inspection to be carried out. A re-inspection is recommended once the areas are made accessible.

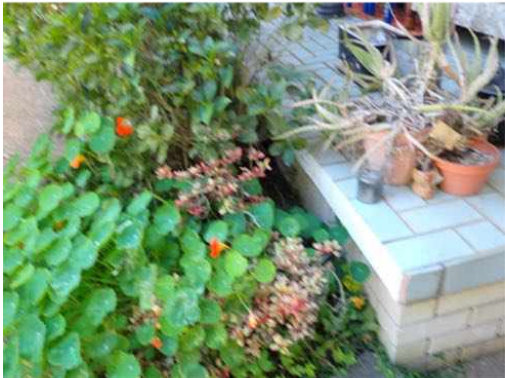
Building: Main Building  
Location: All Areas  
Finding: Additional Photos - Obstructions and Limitations  
Information: These photographs are an indication of the obstructions and limitations which impeded full inspection of the area at the time of inspection. These obstructions can hide an array of defects and should be removed to allow full inspection to be carried out. A re-inspection is recommended once the areas are made accessible.
