# Building and Timber Pest Inspection Report

Inspection Date: Thu, 26 Mar 2026

Property Address: 79/69-73 Elizabeth Dr, Liverpool NSW  
2170, Australia

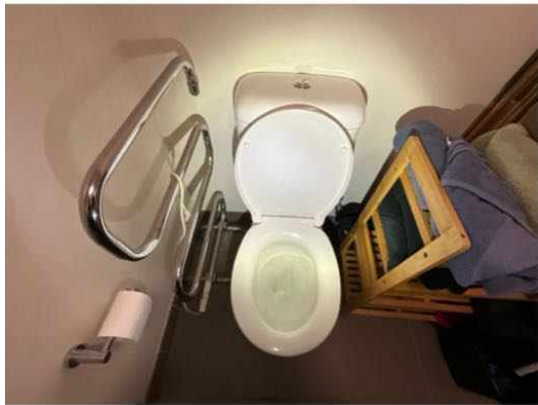
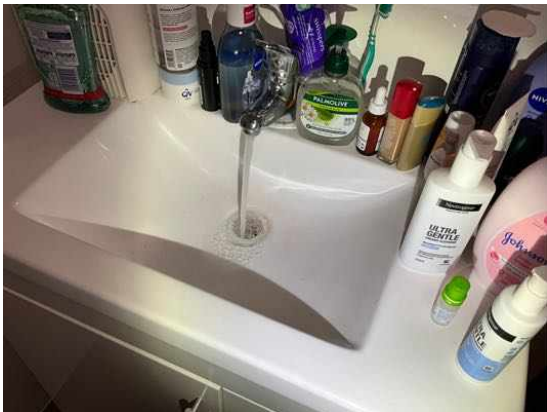
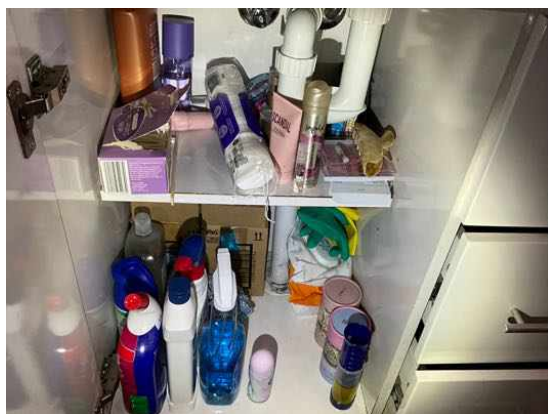
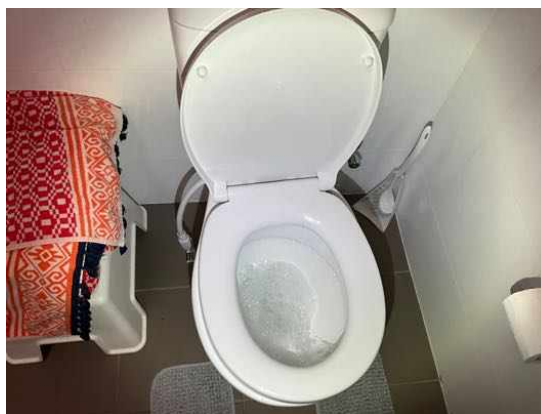
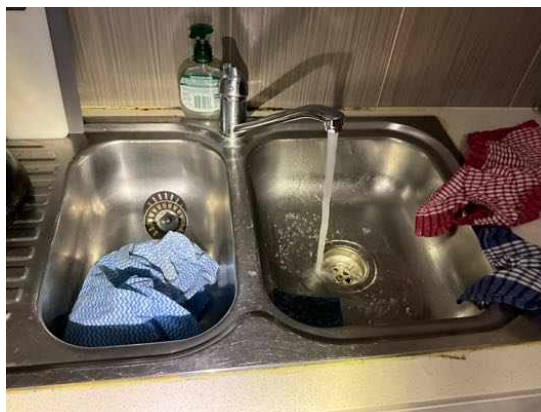
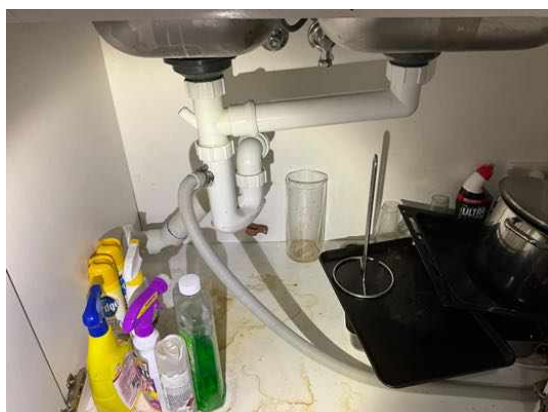
Building: Main Building  
Location: All Wet Areas  
Finding: Additional Photos  
Information:

Additional photos are provided for your general reference.

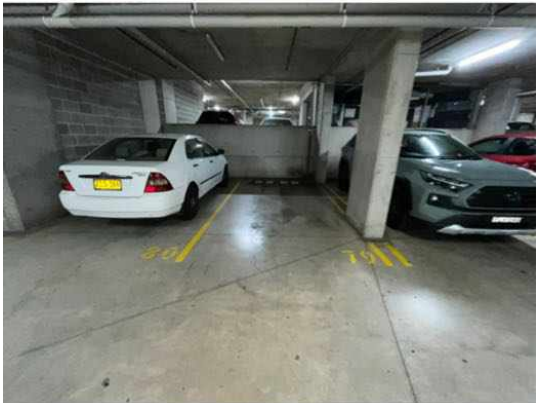
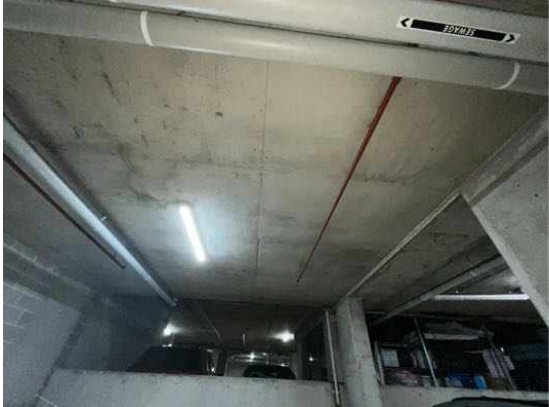
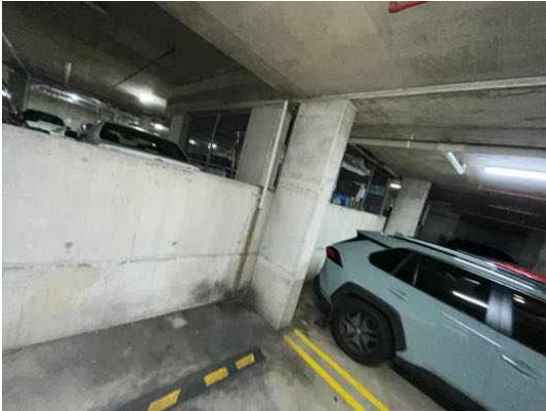
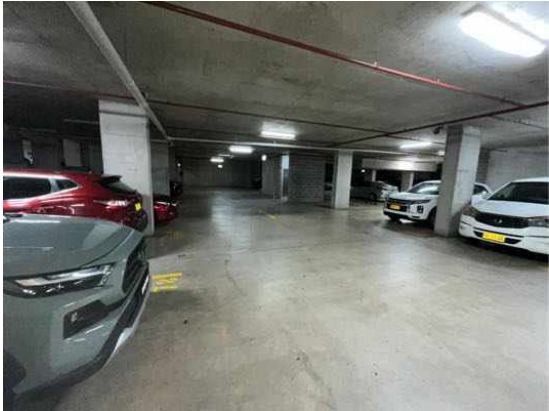
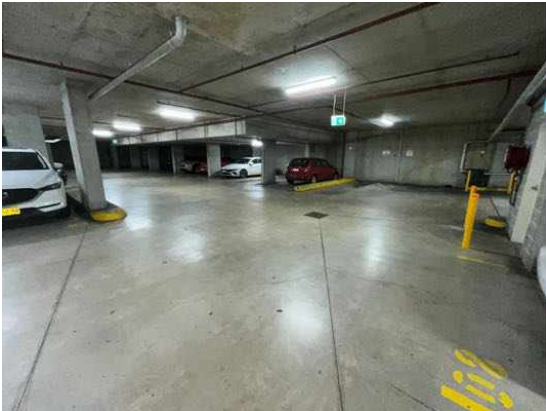
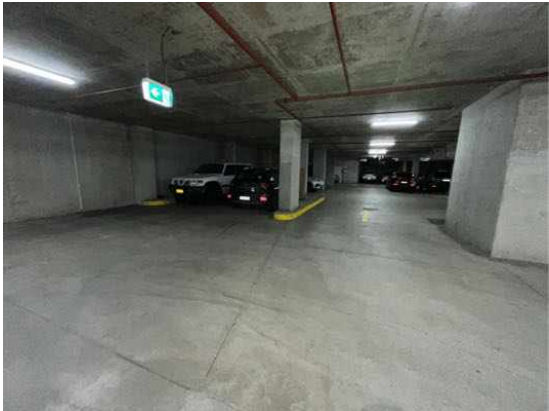
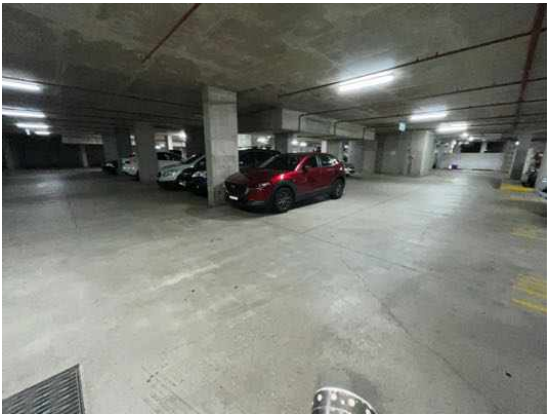
Building: Main Building  
Location: Garage  
Finding: Additional Photos- Garage  
Information: Additional photos are provided for your general reference. Arrows may have been included to highlight areas of importance. Please discuss these photos with your building consultant for clarification.

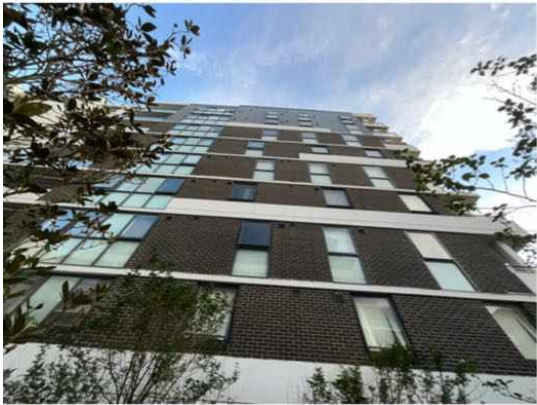
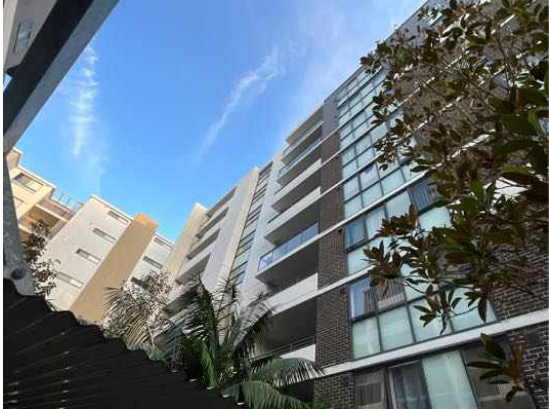
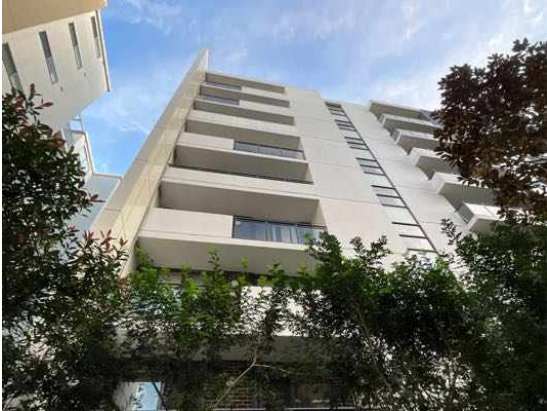
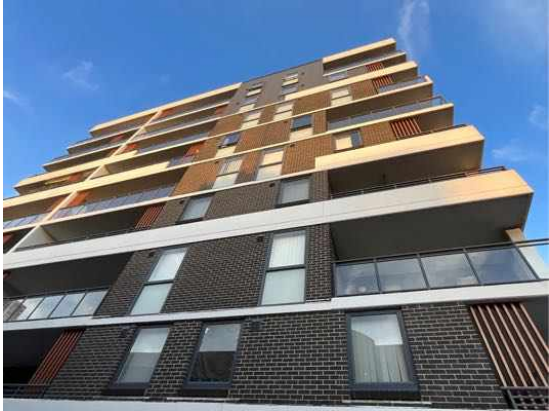
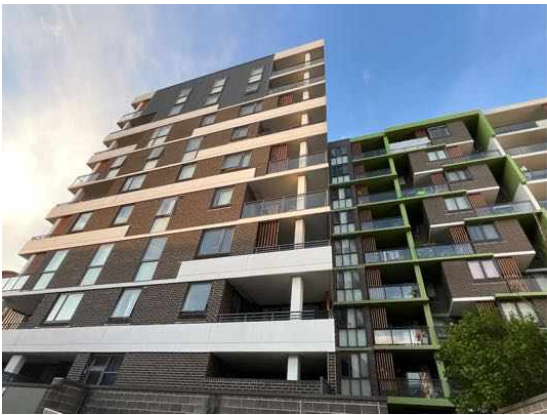
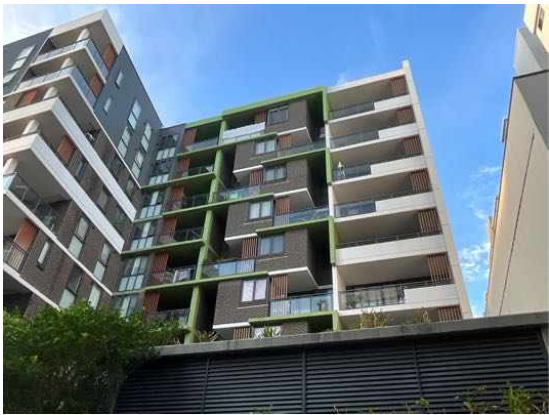
Building: Main Building

Finding: Additional Photos

Information: Additional photos are provided for your general reference.
