Building and Timber Pest Inspection Report

Inspection Date: Mon, 9 Feb 2026

Property Address: 8 Karina Ln, Vermont South VIC 3133,
Australia

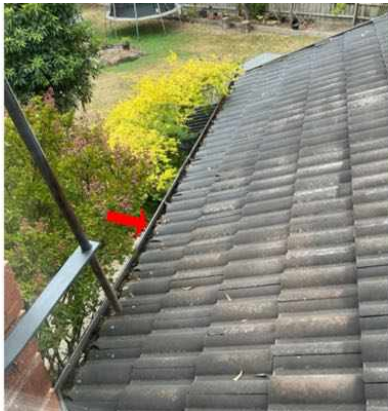
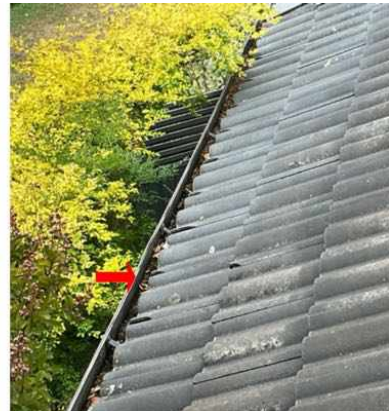
Finding 3.01

Building:	Main Building
Location:	Roof Exterior
Finding:	Gutter debris accumulation and inadequate drainage
Information:	The gutters exhibit debris accumulation (e.g., leaves, dirt) and green organic growth (algae/moss), indicating water pooling due to inadequate drainage. This poses risks of blockages, overflow during rainfall, and potential damage to fascia boards, walls, or foundations. Prolonged moisture retention may accelerate corrosion and attract pests. Immediate action is advised: clear debris, flush gutters and downpipes, remove organic growth, and inspect gutter slope/downpipe functionality.

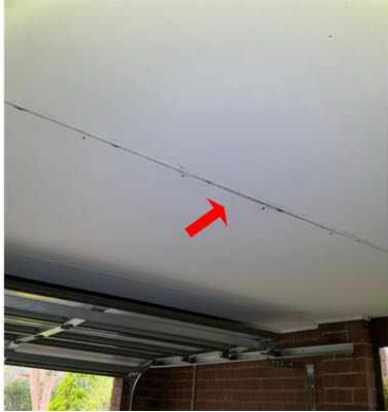
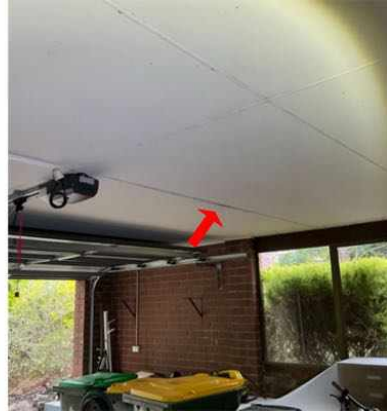
Building:	Main Building
Location:	Garage
Finding:	Detached ceiling lining in garage
Information:	The garage ceiling lining is loose and appears to be detaching from the ceiling framing, with noticeable sagging in sections.

If left unrectified, the lining may continue to drop and could become a safety hazard and may indicate fixing failure and/or moisture-related deterioration.

Engage a qualified plasterer/builder to investigate the cause and re-secure/replace the affected ceiling lining as required.

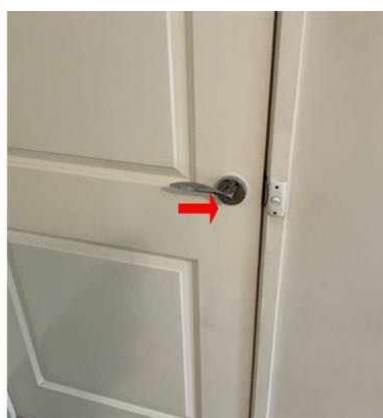
Finding: Door handle - Not latching
 Information: It was noted that the door in this area was not latching during operation at the time of inspection. Whilst detracting from the functionality of this building element, this minor defect may also be a security risk, and may therefore have serious implications if left unattended.

It is suspected that this defect has occurred due to minor issues with the associated hinges. Such damage is identified as general wear and tear, which is expected for building elements of this age.

A qualified carpenter or general handyperson may be appointed to perform rectification works as necessary, at client discretion. If left unattended, further functional impairment is likely to occur.

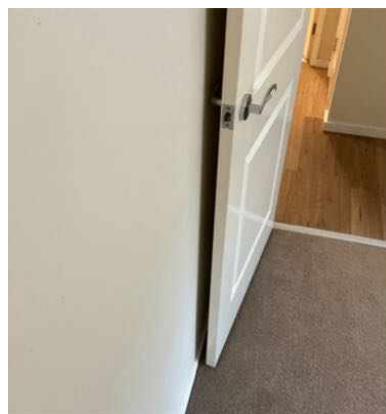
Finding 3.06

Building: Main Building
 Location: Bedroom
 Finding: Door stop - Missing
 Information: The door stop is missing or is inadequate to stop the door handle from damaging the wall. Although some building elements may seem irrelevant or unnecessary, all building elements play a key role in the operation and function of the overall structure and its performance.

Re-installation or replacement of the door stop is advised as soon as possible to prevent any subsequent damage to the door or associated structures. A general handyman may be appointed to perform these works at client discretion.

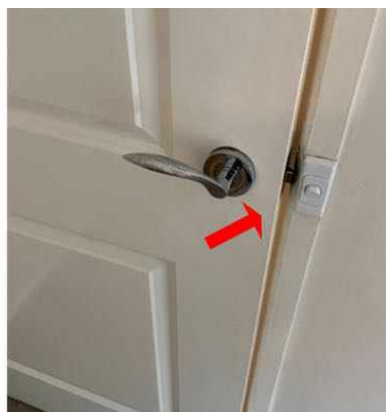
Finding 3.07

Building: Main Building
 Location: Bedroom 2
 Finding: Door handle - Not latching
 Information: It was noted that the door in this area was not latching during operation at the time of inspection. Whilst detracting from the functionality of this building element, this minor defect may also be a security risk, and may therefore have serious implications if left unattended.

It is suspected that this defect has occurred due to minor issues with the associated hinges. Such damage is identified as general wear and tear, which is expected for building elements of this age.

A qualified carpenter or general handyperson may be appointed to perform rectification works as necessary, at client discretion. If left unattended, further functional impairment is likely to occur.

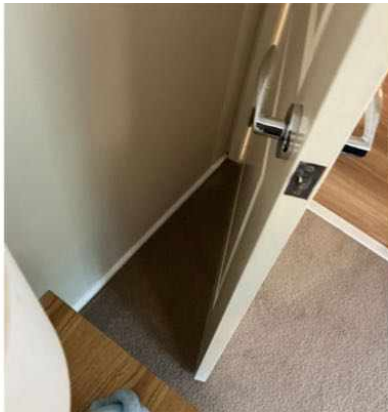
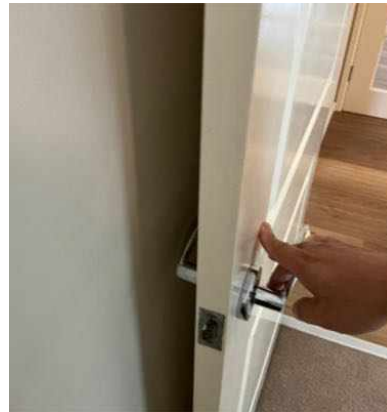
Finding 3.08

Building: Main Building
 Location: Bedroom 2
 Finding: Door stop - Missing

Information: The door stop is missing or is inadequate to stop the door handle from damaging the wall. Although some building elements may seem irrelevant or unnecessary, all building elements play a key role in the operation and function of the overall structure and its performance.

Re-installation or replacement of the door stop is advised as soon as possible to prevent any subsequent damage to the door or associated structures. A general handyman may be appointed to perform these works at client discretion.

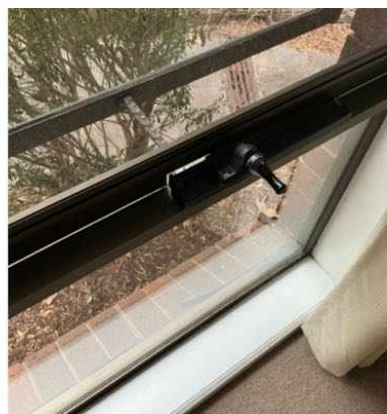
Finding 3.09

Information: The majority of window winder handles within the property are loose and can easily detach from the spindle during normal operation.

This may prevent reliable opening/closing of windows and can create a safety and security concern if windows cannot be properly operated or secured.

Arrange a qualified handyman or window contractor to inspect the window winders/handles and carry out repair or replacement as required to ensure the handles remain securely fixed and windows operate normally.

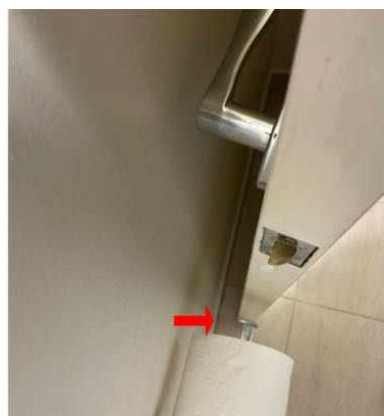
Finding 3.10

Building:	Main Building
Location:	Toilet (WC)
Finding:	Door stop - Missing
Information:	The door stop is missing or is inadequate to stop the door handle from damaging the wall. Although some building elements may seem irrelevant or unnecessary, all building elements play a key role in the operation and function of the overall structure and its performance.

Re-installation or replacement of the door stop is advised as soon as possible to prevent any subsequent damage to the door or associated structures. A general handyman may be appointed to perform these works at client discretion.

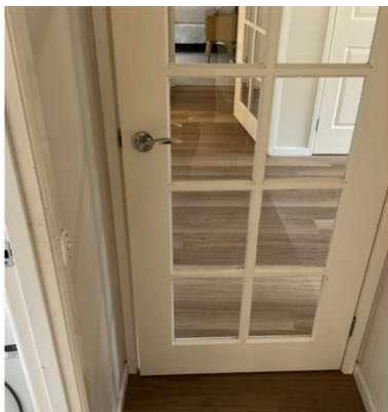
Information: It was noted that the door in this area was not latching during operation at the time of inspection. Whilst detracting from the functionality of this building element, this minor defect may also be a security risk, and may therefore have serious implications if left unattended.

It is suspected that this defect has occurred due to minor issues with the associated hinges. Such damage is identified as general wear and tear, which is expected for building elements of this age.

A qualified carpenter or general handyperson may be appointed to perform rectification works as necessary, at client discretion. If left unattended, further functional impairment is likely to occur.

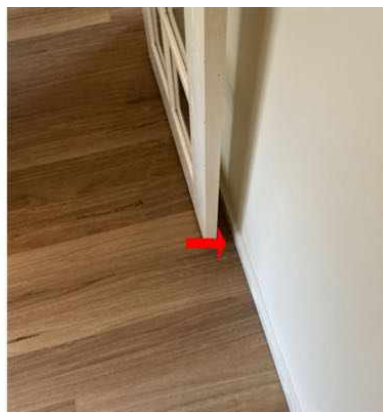
Finding 3.13

Finding: Door stop - Missing

Information: The door stop is missing or is inadequate to stop the door handle from damaging the wall. Although some building elements may seem irrelevant or unnecessary, all building elements play a key role in the operation and function of the overall structure and its performance.

Re-installation or replacement of the door stop is advised as soon as possible to prevent any subsequent damage to the door or associated structures. A general handyman may be appointed to perform these works at client discretion.

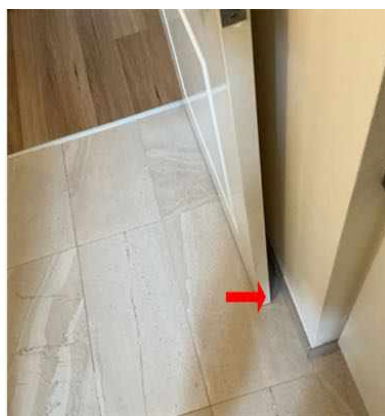
Building:	Main Building
Location:	Laundry
Finding:	Door stop - Missing
Information:	The door stop is missing or is inadequate to stop the door handle from damaging the wall. Although some building elements may seem irrelevant or unnecessary, all building elements play a key role in the operation and function of the overall structure and its performance.

Re-installation or replacement of the door stop is advised as soon as possible to prevent any subsequent damage to the door or associated structures. A general handyman may be appointed to perform these works at client discretion.

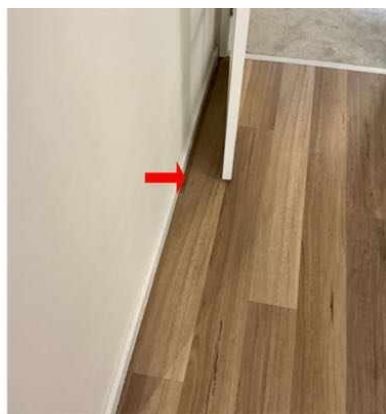
Finding 3.16

Building:	Main Building
Location:	Living Room
Finding:	Door stop - Missing
Information:	The door stop is missing or is inadequate to stop the door handle from damaging the wall. Although some building elements may seem irrelevant or unnecessary, all building elements play a key role in the operation and function of the overall structure and its performance.

Re-installation or replacement of the door stop is advised as soon as possible to prevent any subsequent damage to the door or associated structures. A general handyman may be appointed to perform these works at client discretion.

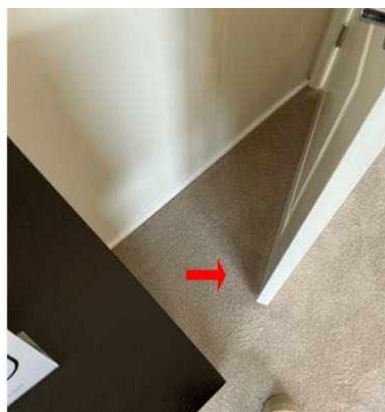
Building:	Main Building
Location:	Bedroom - Master
Finding:	Door stop - Missing

Information: The door stop is missing or is inadequate to stop the door handle from damaging the wall. Although some building elements may seem irrelevant or unnecessary, all building elements play a key role in the operation and function of the overall structure and its performance.

Re-installation or replacement of the door stop is advised as soon as possible to prevent any subsequent damage to the door or associated structures. A general handyman may be appointed to perform these works at client discretion.

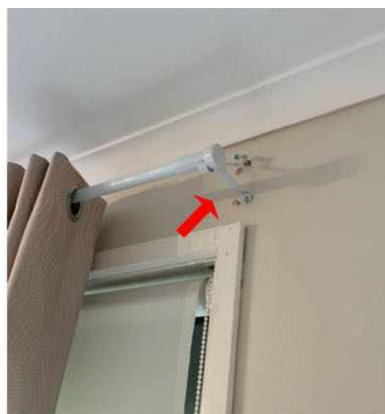
Finding 3.19

Building: Main Building
 Location: Bedroom - Master
 Finding: Curtain rod detached
 Information: The curtain rod bracket has detached/partially detached from the wall, with fixings pulled loose and visible damage around the mounting points.

The curtain rod may become unstable and could fall, creating a minor safety hazard and potentially causing further damage to the wall and window furnishing.

Engage a handyman to reinstate the bracket securely into a suitable fixing point (e.g. stud/toggle anchors as required) and make good the wall surface, ensuring the curtain rod is stable and fit for use.

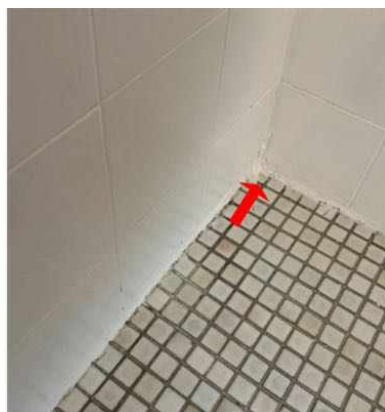
Finding 3.20

Building:	Main Building
Location:	Ensuite - Master
Finding:	Substandard work— shower junction sealant
Information:	Poor-quality and inconsistent sealant was observed to the bathroom wall/floor junctions and shower perimeter, appearing as an unprofessional/DIY application with uneven finishing and localised gaps.

Defective sealant at wet area junctions can allow moisture to penetrate into the substrate, which may lead to ongoing water damage and, over time, compromise the effectiveness of the waterproofing system.

Engage a qualified contractor to remove and re-apply wet-area grade sealant to all relevant junctions, and investigate/repair any underlying moisture damage before cosmetic re-finishing if required.

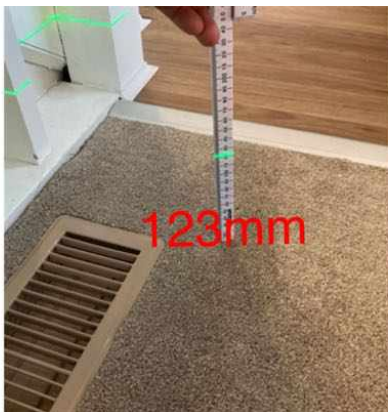
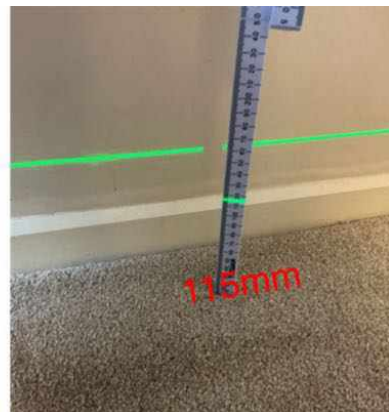
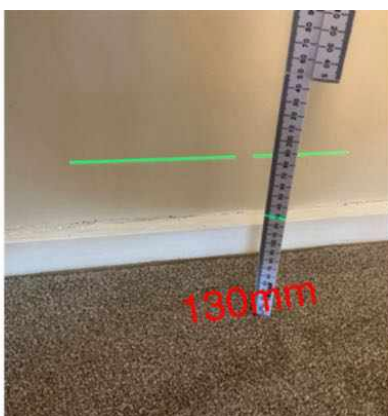
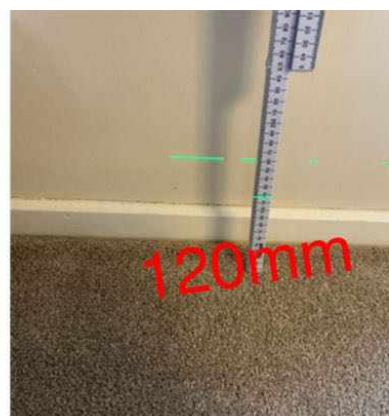
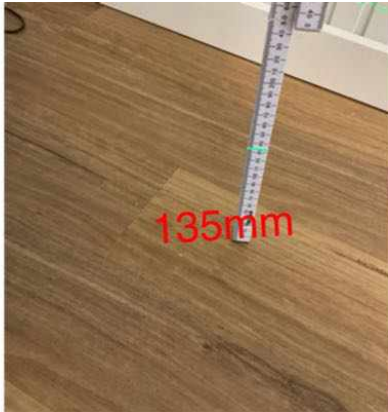
Finding 3.21

Building:	Main Building
Location:	All Areas
Finding:	floor unevenness - v4
Information:	The standard laser level was positioned 125 mm above the floor, as shown in the

Considering the age of the property and no visible significant cracks were observed at time of inspection. This degree of settlement is generally within an acceptable range for a building of its era. However, for buyers who have higher expectations regarding floor levelness or sensitivity to uneven floors, it should be noted that restumping or re-leveling can involve a considerable cost. This should be taken into account when planning the overall purchase budget.

For further information or investigation, contact a licensed builder for cost estimation and a structural engineer to assess the extent of settlement and the condition of the stumps.

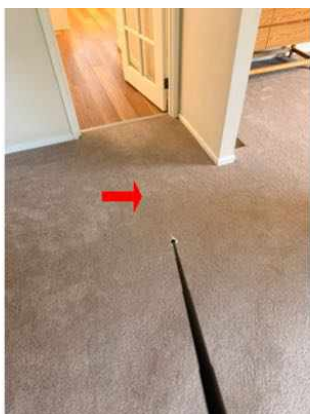
Finding 3.22

Building:	Main Building
Location:	Living Room
Finding:	Localised floor noise
Information:	Localised “squeaky/squishy” sound and slight movement is noted when pressure is applied to the floor surface in the affected area. This is typically consistent with minor flooring movement, loose fixings, or subfloor friction/movement.

Ongoing movement may lead to worsening noise, loosening of floor finishes, and potential damage to joints/edges over time.

Engage a licensed carpenter/builder (or flooring contractor) to investigate the flooring

fixings and rectify as required (e.g., re-fix, pack/level, add adhesive, or address subfloor movement).

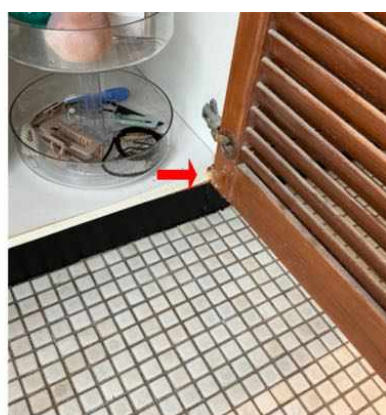
Finding 3.23

Building:	Main Building
Location:	Ensuite - Master
Finding:	Timber swelling- minor
Information:	The swelling observed at the base of the cabinet appears to be caused by moisture exposure, likely due to inadequate sealing or water ingress from nearby wet areas. It may also result from water splashing onto the floor after showering and not being wiped up promptly. Typically, the base of cabinetry should be sealed with a waterproof coating or raised slightly above the floor surface to prevent direct contact with moisture. It is recommended to engage a qualified carpenter to repair or replace the affected timber and ensure appropriate sealing or clearance is provided to prevent future water-related damage.

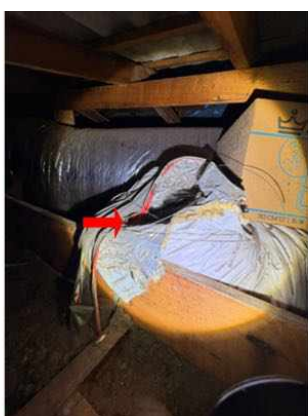
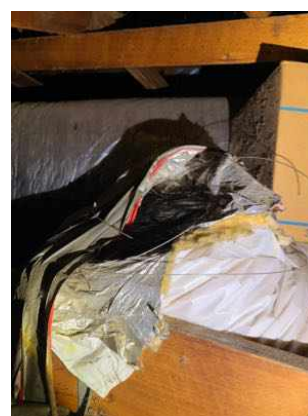
Finding 3.24

Building:	Main Building
Location:	Roof Void
Finding:	Disconnected duct
Information:	A disconnected flexible duct was observed within the ground floor roof void, with the

If this duct is part of an active ventilation or heating/cooling system, the disconnection may reduce system performance and efficiency, and may discharge air (and potentially moisture) into the roof space, which can contribute to condensation or maintenance issues.

Engage a qualified HVAC technician to confirm whether the duct is active or redundant, and reinstate/terminate it correctly as required (including securing and sealing connections) to ensure the system operates as intended.

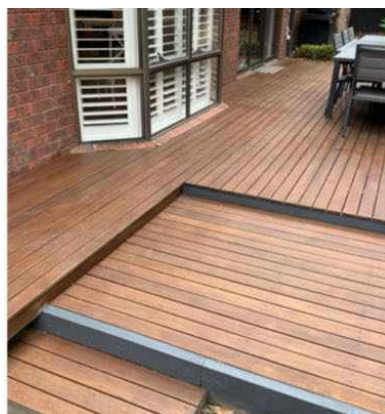
If any attachment to the building—such as a hot water unit, downpipe, deck, verandah, fence, steps, or service conduit—is not properly isolated and lacks a minimum 25mm inspection gap from the building, it is considered a potential bridging point.

These attachments can provide concealed termite entry and should be regularly inspected for signs of termite activity by a qualified pest inspector.

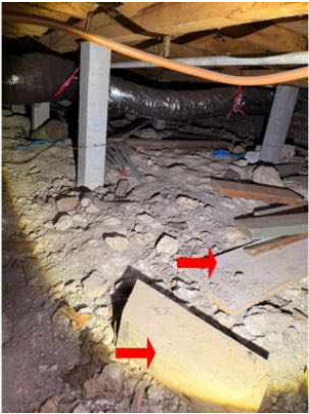
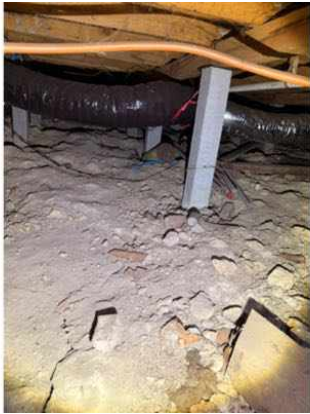
Finding 6.03

Building:	Main Building
Location:	All Areas
Finding:	Stored timbers - subfloor space or external area
Information:	The storing of timbers in the subfloor space or around the external property (including bark mulch) increases the risk of termite activity being present. As they are likely to come into contact with weather conditions or excessive moisture wood rot is likely to develop on timbers that are not treated.

It is highly recommended that any stored timbers be immediately removed from areas in which they may attract any termite / timber pest attack. Minimisation of risk / prevention of termite attack is far more adequate than dealing with the presence of termite activity.

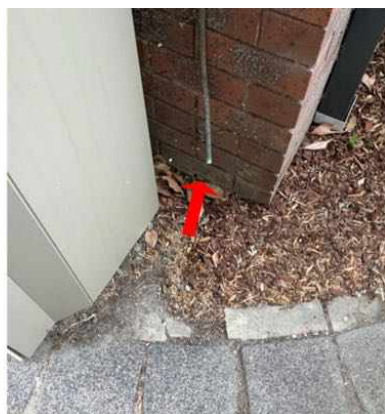
Building: Main Building
Location: Hot water/aircon unit(s)
Finding: The air conditioning overflow pipe is not properly connected and discharges directly into the soil adjacent to the building.
Information: This creates a conducive condition for termite activity by providing a constant moisture source near the structure. It may also lead to soil erosion, mould growth, or damage to nearby building materials.

The overflow should be redirected to an appropriate discharge point—such as a stormwater connection or designated drainage area—away from the building foundation, in accordance with plumbing and termite management standards.

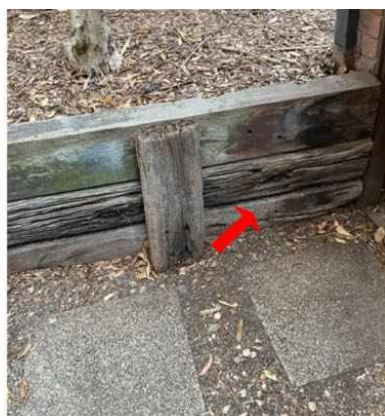
Finding 6.05

Building:	Yard
Location:	Yard
Finding:	Wood rot-external timbers
Information:	Wood rot which is technically known as Fungal Decay occurs when timbers and other cellulose building materials are exposed to damp conditions on an ongoing basis. This could be the result of exposure to weathering in the long term or the pooling of water or absorbed moisture from other abutting building materials. It is advisable to remove these affected timbers to prevent any chance of attack in the future.

Wood decay is more susceptible to termite attack and these timbers should be replaced to limit termite attack.

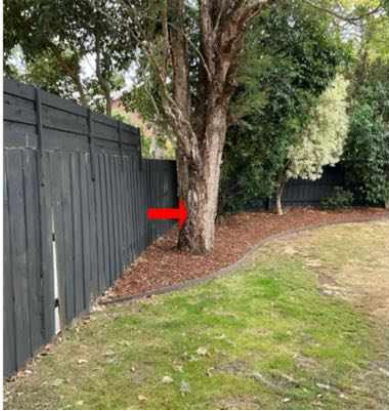
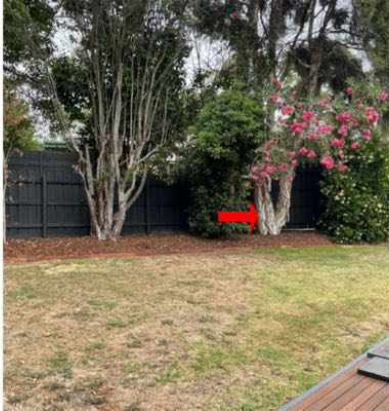
Finding 6.06

Building:	Yard
Location:	Yard
Finding:	Large trees/stumps within 30m of house
Information:	There are a number of large trees/stumps within 30m of the house which may contain natural termite activity. It is important to monitor these areas to ensure no natural activity is allowed to progress into the main house.

Regular inspections are recommended. Consider test drilling any large trees.

A pest controller can be contacted to carry out such testing at the owners discretion.

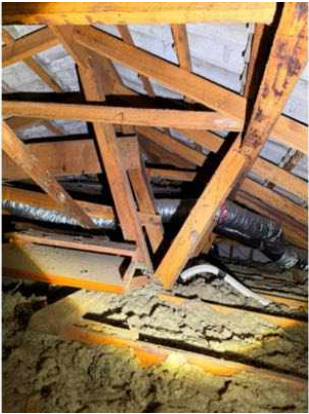
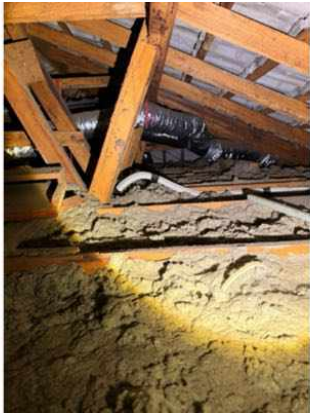
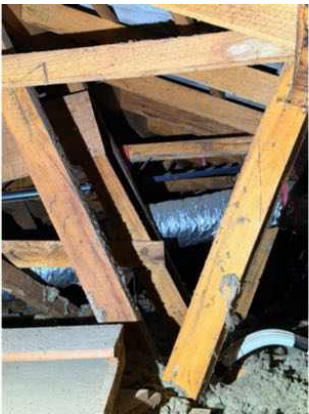
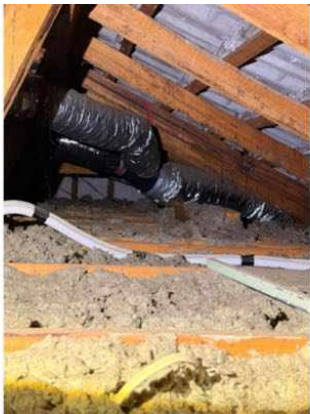
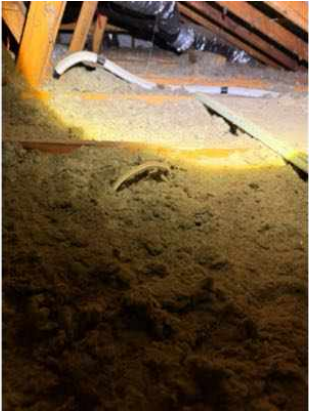
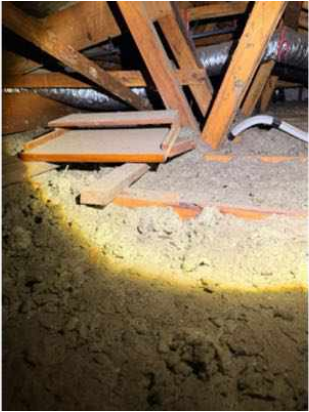
Noted Item

Building: Main Building
Location: Roof Void
Finding: Roof void condition
Information: The roof space was limited accessed and the majority of the roof timbers observed appear to be in generally acceptable condition, with no obvious signs of significant distortion, sagging, or widespread deterioration at the time of inspection. The insulation observed within the roof space also appeared to be in acceptable condition overall.

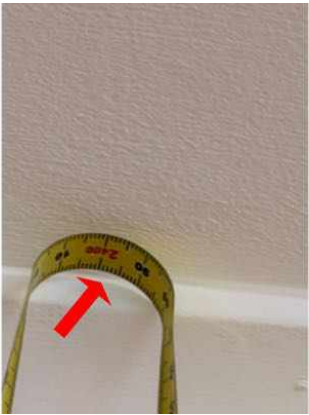
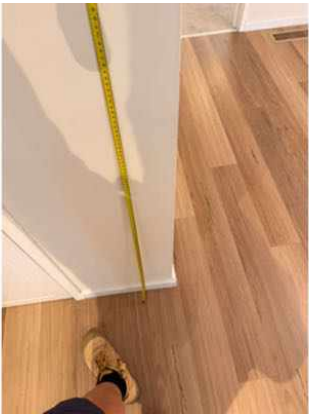
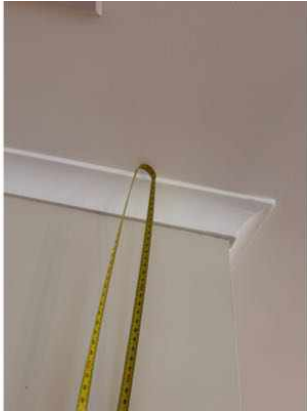
Noted Item

Building: Main Building
Location: All Areas
Finding: Ceiling height less than 2.4 meter
Information: The measured ceiling height within the dwelling is approximately just under 2.4 m (as shown), which is lower than typical modern residential expectations.

While this is common in older properties and is not necessarily non-compliant due to the age of construction, some occupants may find the reduced ceiling height less desirable from an amenity/space perspective.

Note this as a property attribute for purchaser awareness, and confirm ceiling height requirements/acceptability with the relevant authority or a building surveyor if the property is proposed to be altered or used for a different purpose.

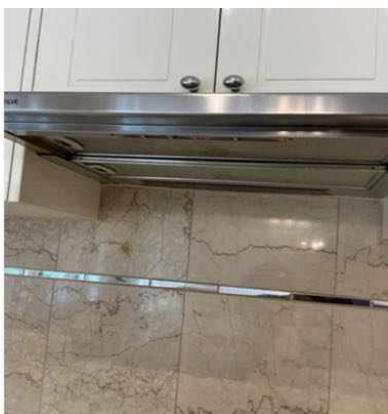
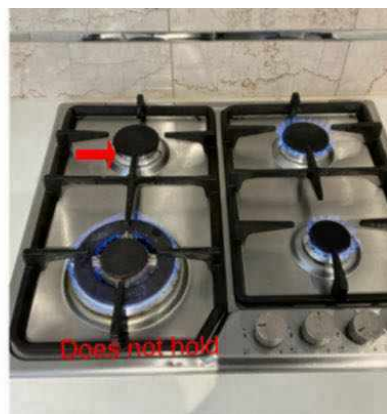
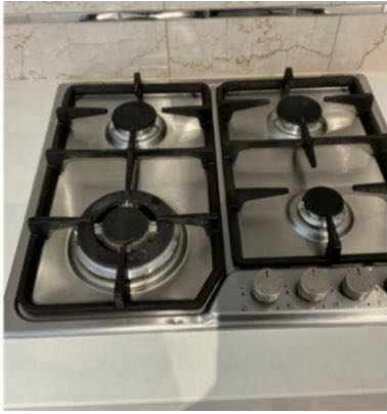
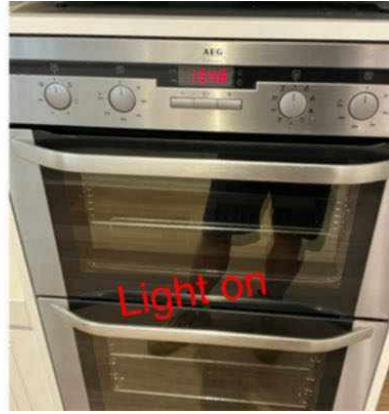
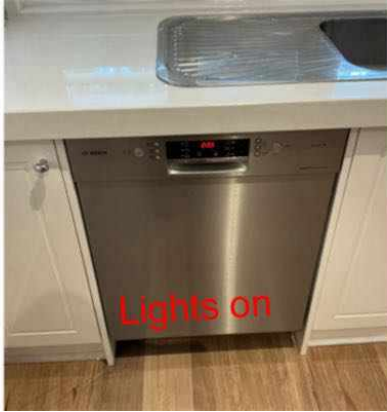
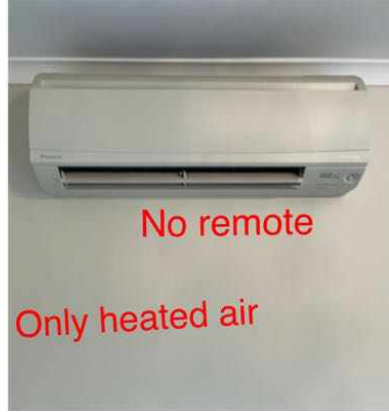
Noted Item

Building:	Main Building
Location:	Plumbing/electrical/gas/aircon/appliances/pool equipment/fire safety etc
Finding:	For your information
Information:	Plumbing and electrical inspections are outside the scope of the building inspection and must be conducted by a Licensed and registered Trades person.

It is highly recommended that the client makes immediate arrangements to have the gas appliances checked by a licensed gas plumber to ensure that the appliances are working safely and efficiently.

We recommend all other installations be checked also.

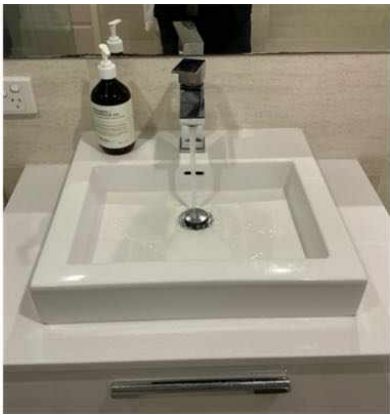
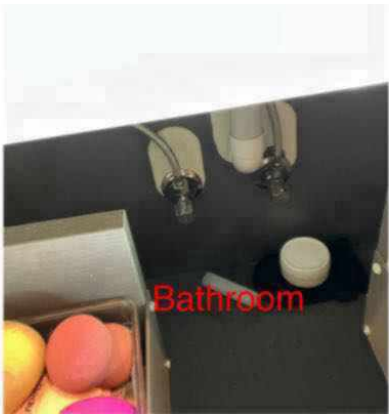
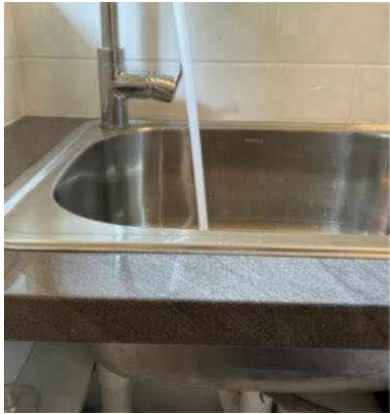
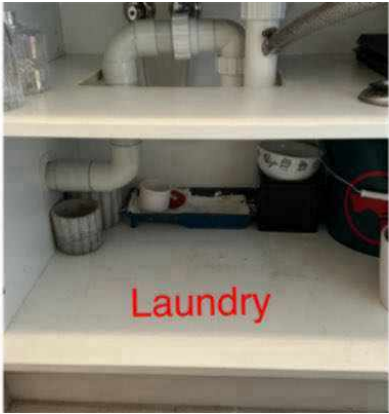
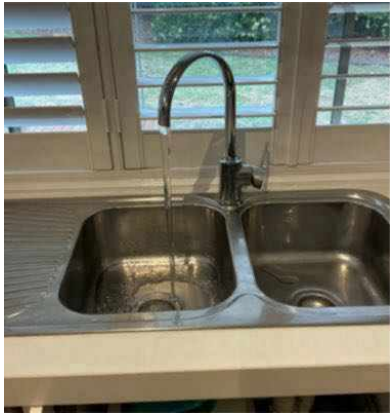
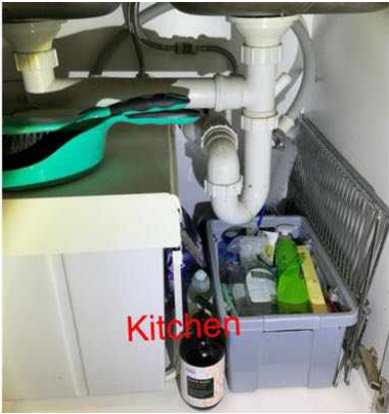
Noted Item

Building:	Main Building
Location:	Cabinetry plumbing
Finding:	For your information
Information:	Cabinetry plumbing - No leaks evident

All cupboards where sinks and basins with drainage plumbing were inspected and no evidence of leaks were present at the time of inspection.

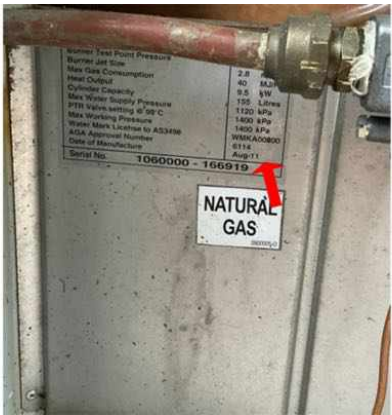
Noted Item

Building: Main Building
Location: Hot water unit
Finding: For your information
Information: The HWS appeared to be in good condition at the time of inspection. For the date of manufacture - (see attached photo)

Water pressure appears to be normal, however, this is not an opinion of a licensed plumber. No water hammer was noted when taps are turned off fast.

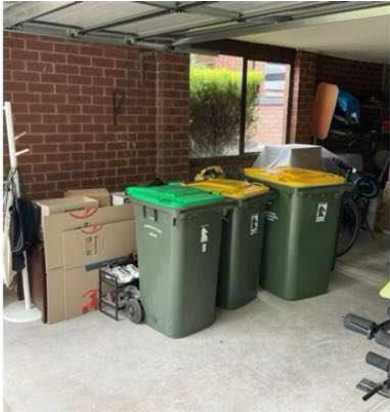
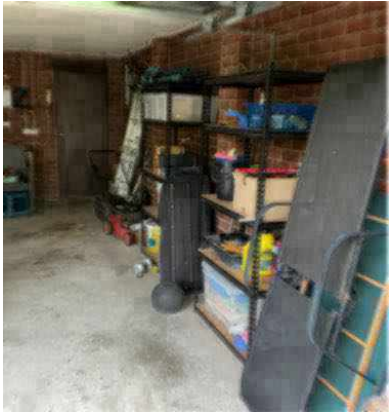
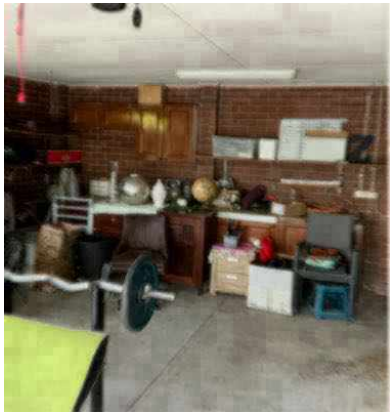
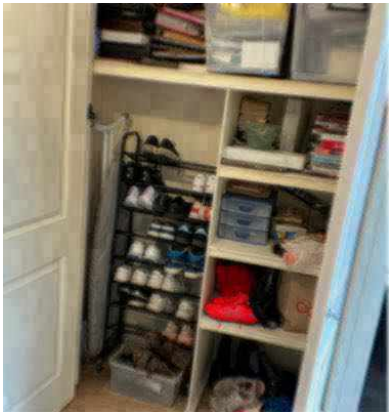
Noted Item

Building: Main Building
Location: All Areas
Finding: Additional Photos - Obstructions and Limitations
Information: These photographs are an indication of the obstructions and limitations which impeded full inspection of the property at the time of inspection. These obstructions can hide an array of defects and should be removed to allow full inspection to be carried out. A re-inspection is recommended once the areas are made accessible. Arrows and highlights have been included to identify minor defects. The purchaser can discuss further with the building inspector.
