Building Inspection Report

Inspection Date: Sat, 10 Jan 2026

Property Address: 39 Monakeeba Bvd, WOODSTOCK, VIC,
3751, Australia

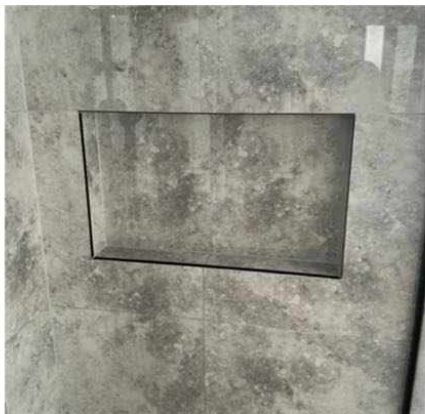
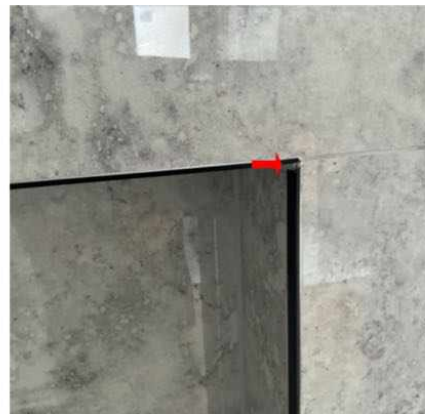
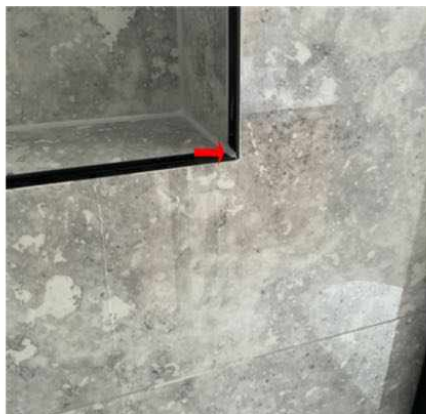
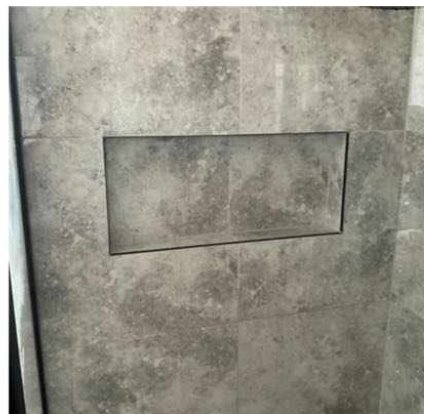
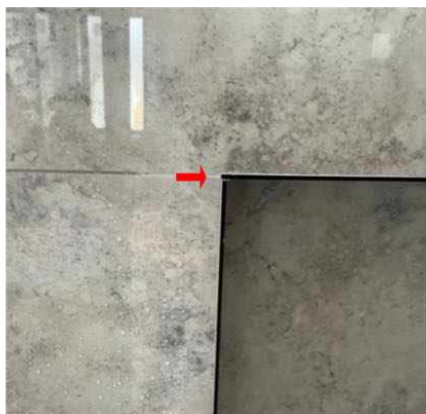
Defects 1.01

- NCC Volume Two – Part 12.06 requires building elements to be installed to provide safe use and avoid hazards arising from sharp edges or protrusions.
- Guide to Standards and Tolerances 2023 – Section 11.09 requires trims, edges and junctions to be finished neatly and free from sharp or hazardous surfaces.
- AS 3958.1 Ceramic Tiling – installation practices require trims to be installed straight, secure, and finished to ensure safe and even edges.

Rectification is required to ensure the tile trim is safely finished and compliant with installation and safety standards.

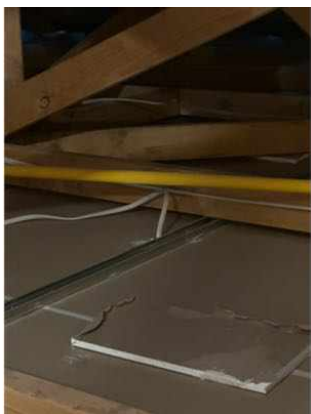
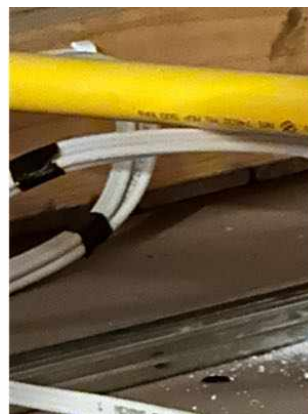
Defects 1.02

Building:	Main Building
Location:	Roof Void
Finding:	Non-Compliant Separation Between Gas and Electrical Services - Lock-up
Information:	During the inspection, it was observed that gas pipes and electrical wiring have been installed within an enclosed space without maintaining the minimum separation distance required by Australian Standards. This arrangement poses a significant safety hazard, including the risk of electrical arcing, damage to gas pipes, and potential fire or explosion hazards.

- Requires that building services be installed to prevent hazards and comply with the relevant gas and electrical safety standards.

The current configuration is non-compliant and presents a risk to occupants and the integrity of the services. Rectification is required to achieve a minimum 25mm clearance or to install an approved insulating barrier between the gas and electrical services prior to completion.

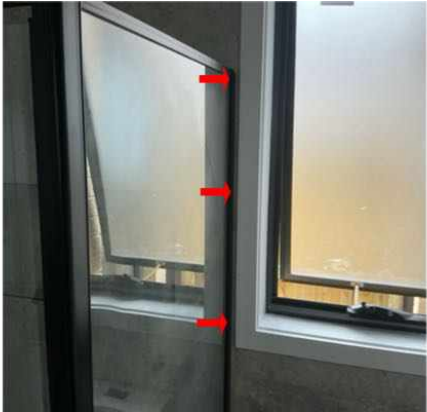
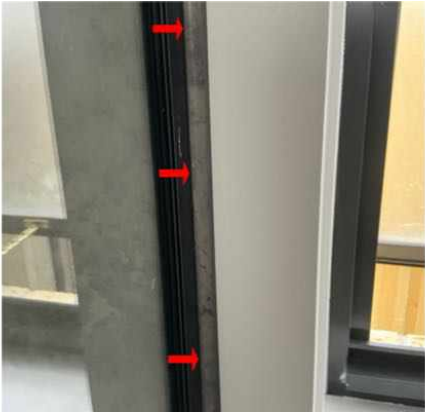
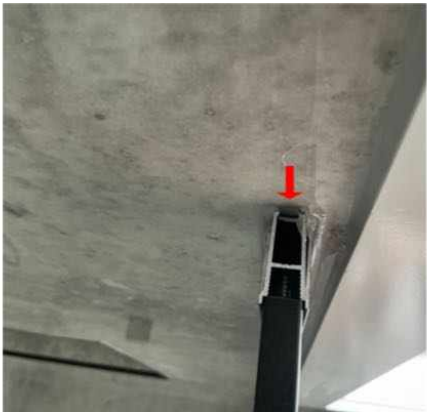
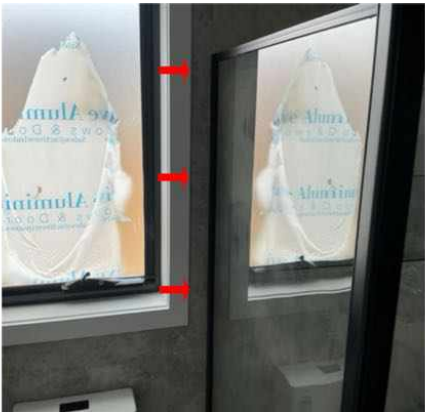
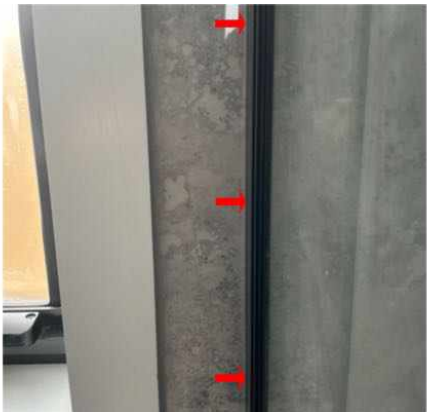
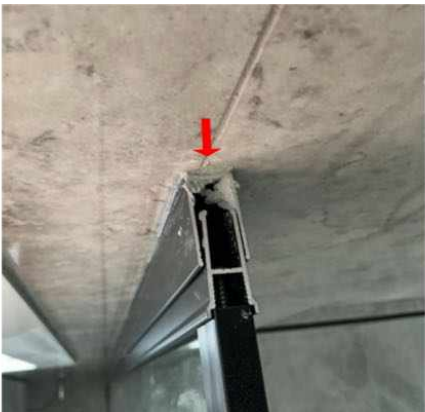
Defects 2.01

Building:	Main Building
Location:	Bathroom & Ensuite
Finding:	Missing Vertical Waterstop at Shower Screen Junction - Fix/PCI
Information:	At the time of inspection, it was noted that a vertical waterstop has not been installed where the shower screen abuts the wall at the extremity of the shower area. The junction is located within 200 mm of the wet area exit, which requires a compliant vertical waterstop to prevent water egress into adjoining building elements. The absence of this waterstop compromises the continuity of the waterproofing system and increases the risk of moisture penetration and subsequent deterioration of wall framing and adjacent finishes.

- AS 3740:2021 – Waterproofing of Domestic Wet Areas, Clause 4.8.5 – Where the extremity of a shower area is within 200 mm of a wet area exit, a vertical waterstop shall be installed at the point where the shower screen abuts the wall.
- NCC Volume Two, Part 10.2.3 – Wet areas must be constructed to prevent water damage to adjoining building elements.
- Guide to Standards and Tolerances 2017, Section 12.07 – Waterproofing is defective if it does not prevent water penetration into adjoining areas or materials.

Rectification is required to ensure compliance by installing a compliant vertical waterstop in accordance with AS 3740:2021 Clause 4.8.5, ensuring that the waterproofing system forms a continuous and sealed barrier at the shower screen junction and along the wet area exit.

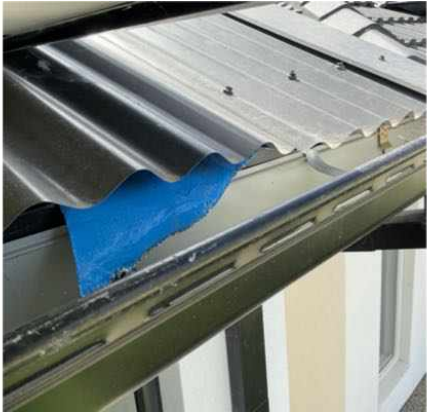
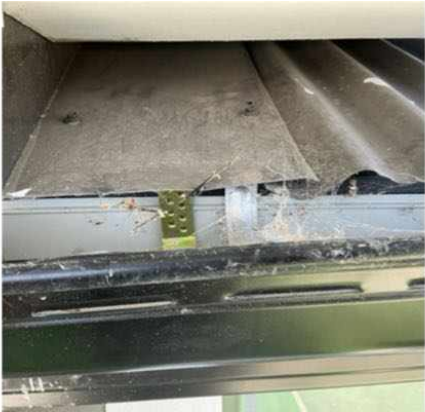
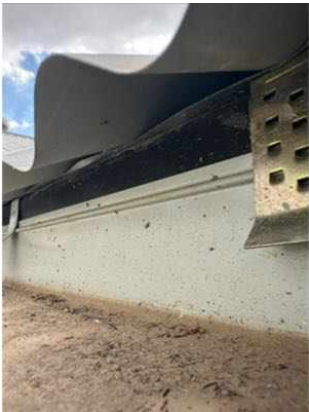
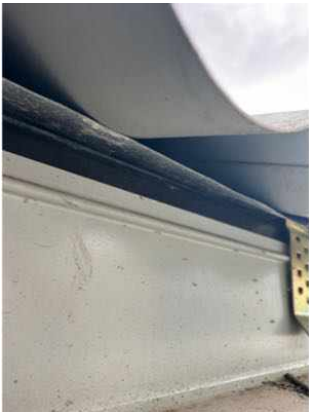
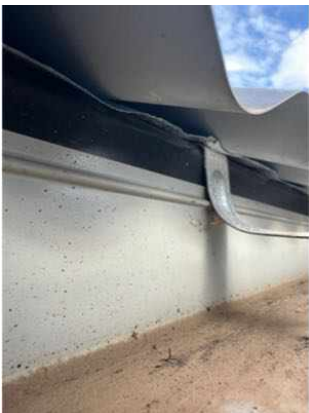
- The sarking membrane must be extended a minimum of 40–50 mm beyond the fascia and into the gutter to provide a continuous drainage path.
- All roofing underlays must be inspected and reinstalled where necessary to meet this requirement and protect the structure from water ingress.

This non-compliant condition must be rectified to meet the minimum standards for roof plumbing and to ensure the building envelope is appropriately protected against moisture-related damage.

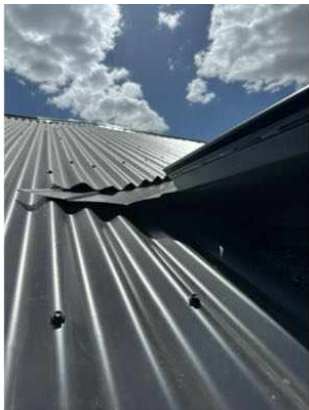
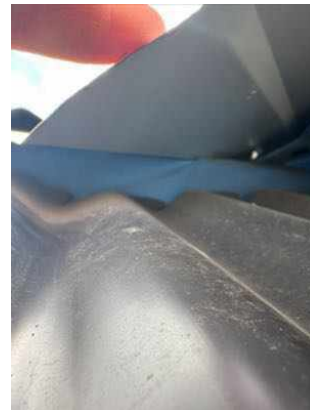
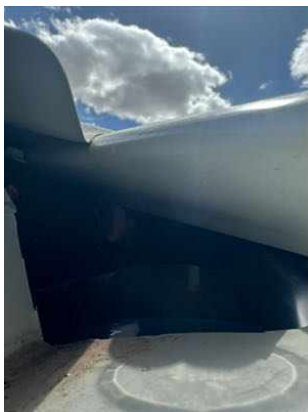
Defects 2.03

Finding: Roof Valley – Inadequate Sheet Coverage and Exposed Sarking

Information: During the inspection, significant gaps were observed beneath both roof valley's where the adjacent roof sheets terminate short of the valley flashing. This condition leaves the roof sarking and the upper edges of the roofing sheets visibly exposed. The sheet profiles do not adequately extend beneath the valley flashing, resulting in incomplete weather overlap and a direct pathway for wind-driven rain, debris, and vermin entry. This installation does not provide continuous weather protection beneath the valley and compromises the intended drainage function of the valley flashing system.

- NCC 2022 Volume Two – Part 3.5.1 & 3.5.2: Roof coverings and flashings must be installed to prevent water penetration and ensure weatherproofing.
- AS 1562.1:2018 – Design and installation of sheet roof and wall cladding: Requires roofing sheets to be installed with adequate side and end laps and continuous weather protection beneath flashings.
- HB 39:2015 – Installation code for metal roof and wall cladding: Valleys must be supported by continuous sheet coverage and effective overlaps to prevent water ingress beneath the valley.

Rectification is required to ensure the roof sheets are correctly extended and detailed beneath the valley flashing to provide continuous weatherproof coverage, prevent exposure of sarking and sheet terminations, and ensure compliance with waterproofing, durability, and performance requirements.

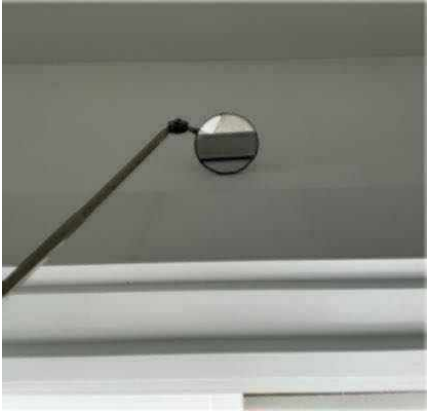
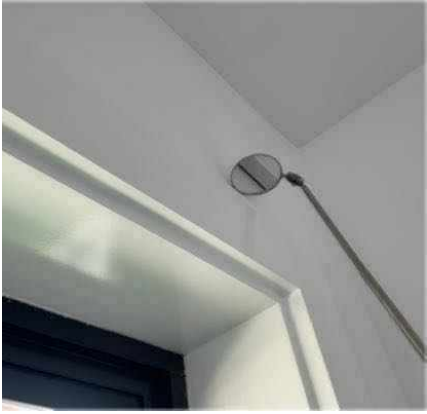
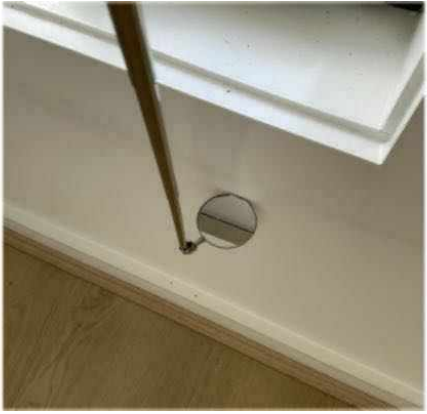
Defects 3.01

Building:	Main Building
Location:	All Internal Areas
Finding:	Unsealed Gaps Around Architraves to Windows and Doors - PCI
Information:	Visible gaps have been identified between the architraves and adjacent plasterwork, particularly above and below window frames and above door heads. These unsealed openings allow for uncontrolled air infiltration, undermining the dwelling's energy efficiency and reducing the overall weathertightness of the internal envelope.

- AS 2047:2014 – Windows in Buildings – Selection and Installation requires window assemblies to be properly integrated into the building envelope to prevent uncontrolled air leakage.
- NCC 2022 Volume Two, Part J5D7 – Sealing of Building Fabric mandates that all gaps around window and door frames must be adequately sealed to maintain airtightness and thermal performance.

The current condition is non-compliant with the relevant Australian Standards and NCC performance requirements. The supplied photos are representative only; a complete review of all window and door installations is recommended to identify and seal all affected areas. All gaps must be properly sealed using an appropriate caulking or sealing product to ensure a durable and continuous air barrier prior to final handover.

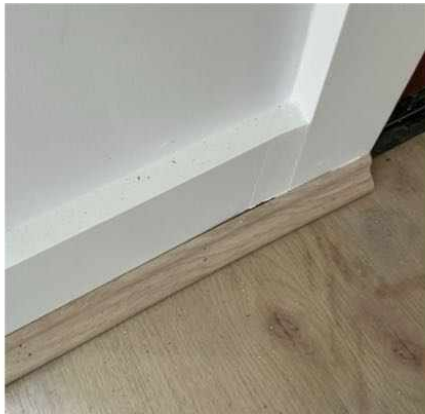
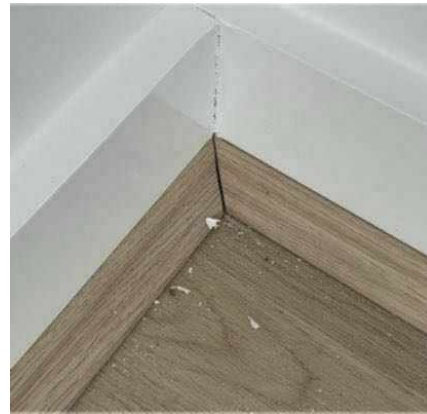
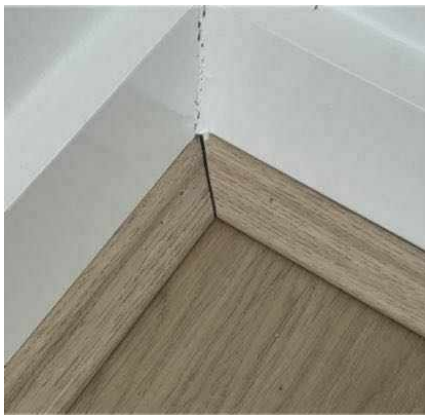
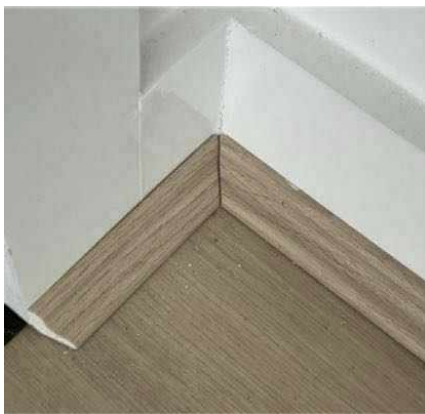
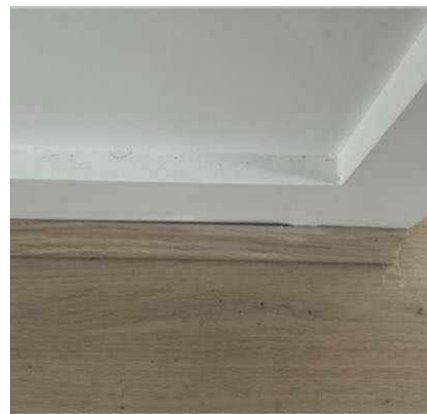
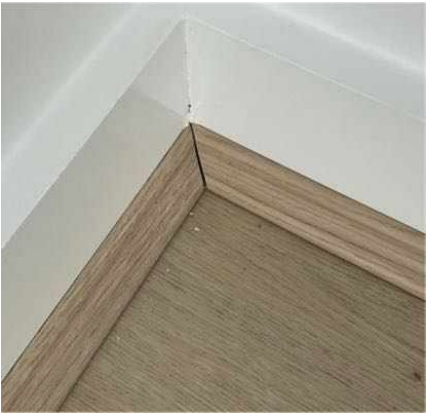
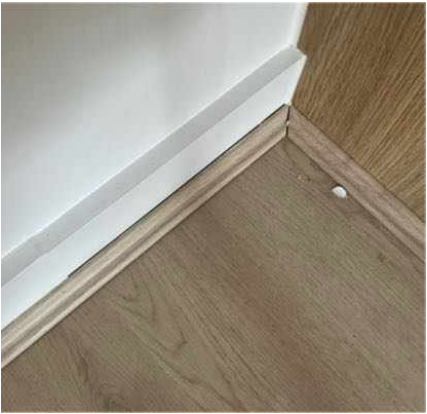
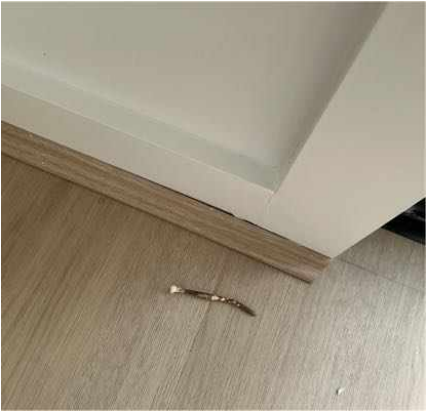
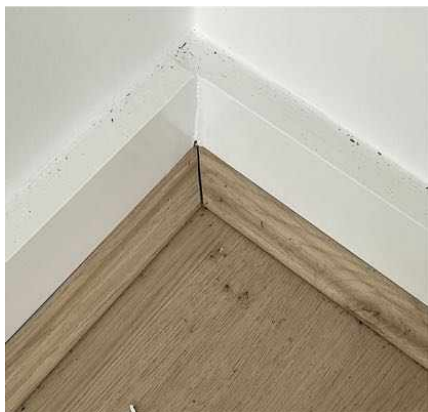
Defects 3.02

Building:	Main Building
Location:	All Internal Areas
Finding:	Substandard Installation of Floating Floor Quad Trim - PCI
Information:	During the inspection, it was noted that multiple areas throughout the property have been finished with floating floor quad trim in a substandard manner. Defects observed may include missing sections of trim, poorly secured (nailed) joints, visible fixings, and exposed or open internal and external corners. These issues detract from the overall finish quality and indicate a lack of workmanship consistency.

- Guide to Standards and Tolerances 2015, Section 12.02 – Finishes to internal joinery and trim must be neat and in accordance with good trade practice.
- NCC Volume Two, Performance Requirement H4P2 – Internal building elements must be installed to avoid loss of amenity due to poor construction quality.

The current installation does not meet the expected standard for new residential construction and requires rework to ensure all trims are securely fixed, neatly joined, and consistently finished throughout. The supplied photographs represent examples only, and a full review of all rooms should be undertaken to identify and rectify similar defects present in other areas.

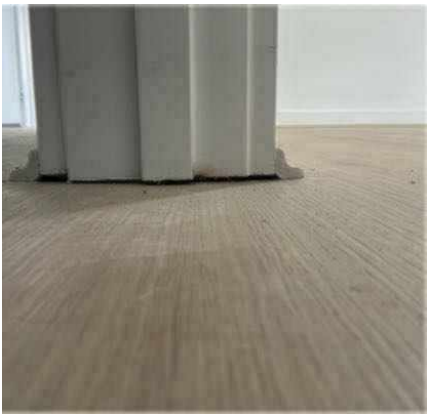
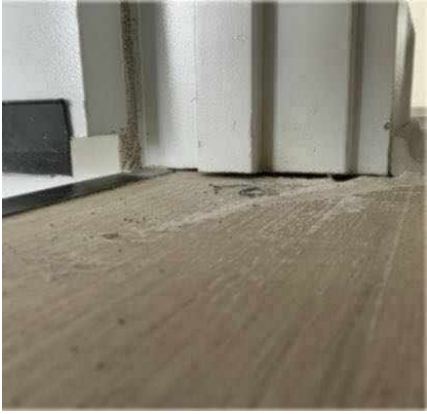
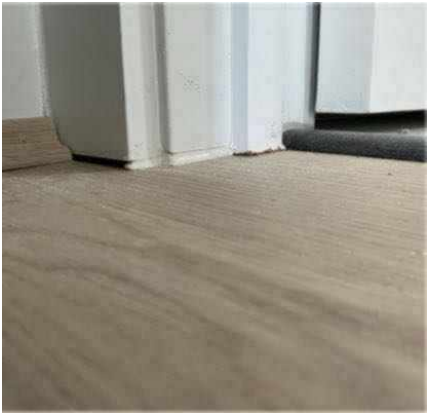
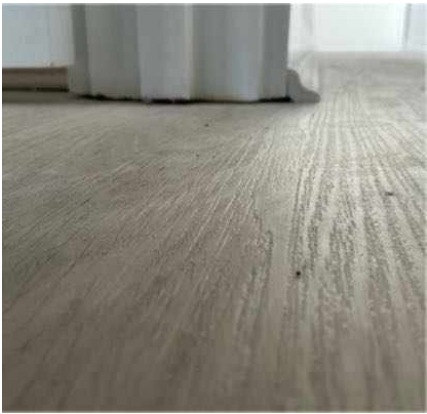
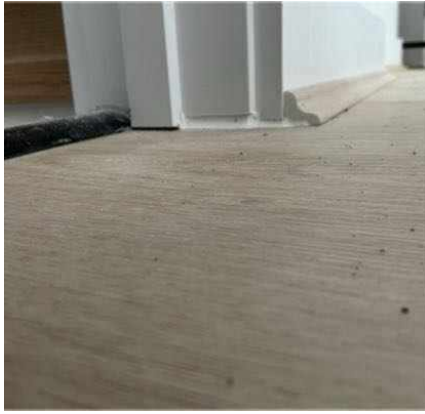
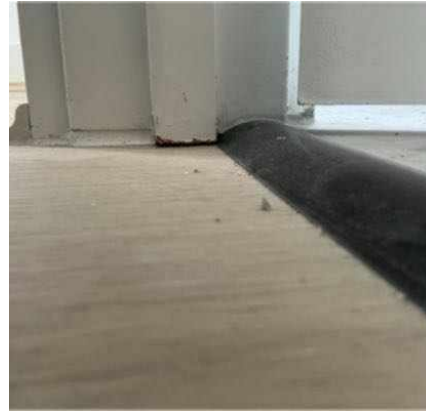
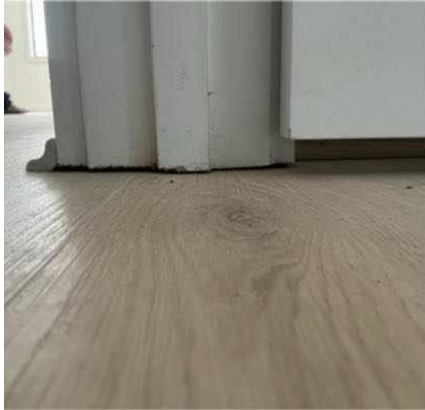
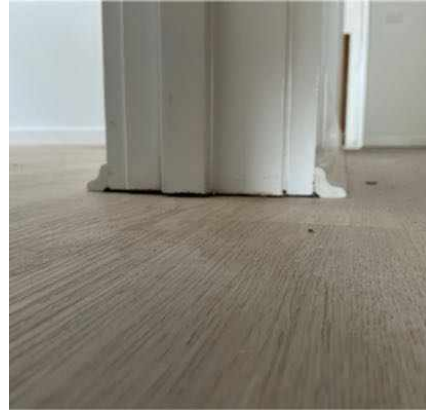
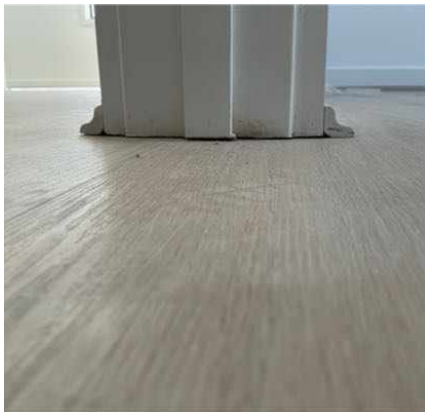
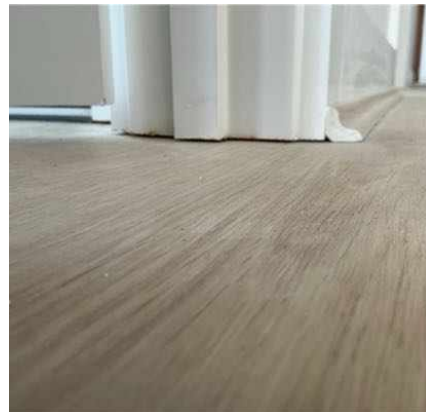
Defects 3.03

Building:	Main Building
Location:	All Internal Areas
Finding:	Gaps Between Floating Floor and Architraves/Door Stiles - PCI
Information:	During the inspection, multiple locations were observed where the floating floor does not meet the architraves or door stiles tightly. While these trims are typically undercut to allow the flooring to slide beneath, several cuts are excessively high, resulting in visible gaps along the junctions. These openings leave the cut edges of the architraves and stiles exposed and create voids that are susceptible to moisture entry during routine floor cleaning or mopping. The termination of the flooring at these points has not been finished to the expected standard and presents as an incomplete installation.

- Guide to Standards and Tolerances 2023 – Section 14.10 requires floor finishes to have neat, consistent, and properly detailed terminations at walls, trims and fixtures.
- Domestic Building Contracts Act 1995 requires all work to be carried out in a proper and workmanlike manner.
- Floating floor manufacturer installation guidelines specify that expansion gaps and undercuts must be concealed or sealed in accordance with finishing requirements to prevent moisture ingress and maintain durability.

The current condition shows incomplete finishing at flooring junctions, with visible gaps and exposed timber edges that may allow moisture penetration and premature deterioration.

Rectification is required to ensure compliance.

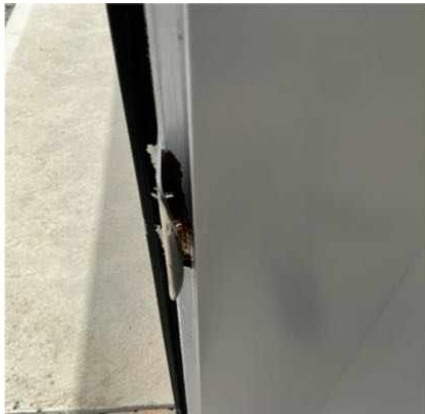
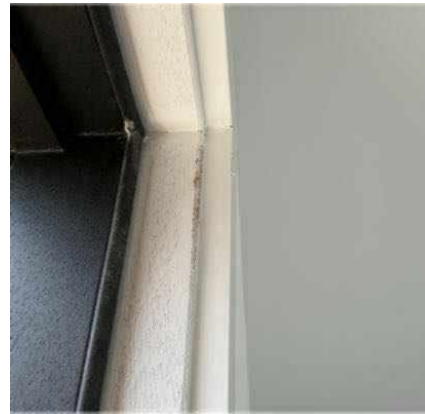
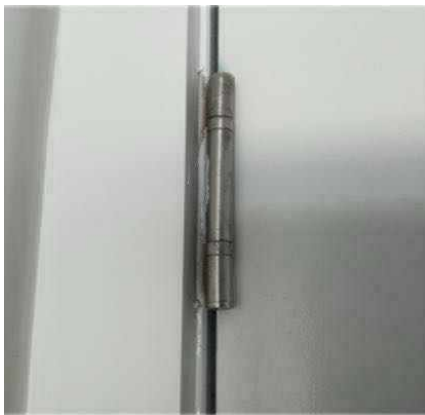
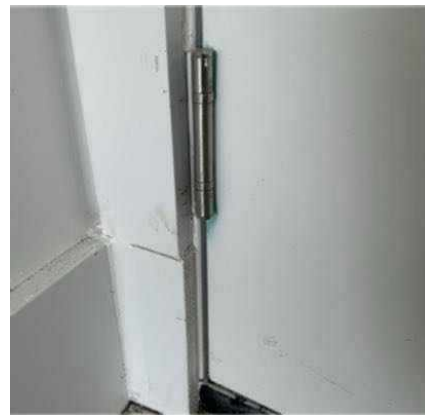
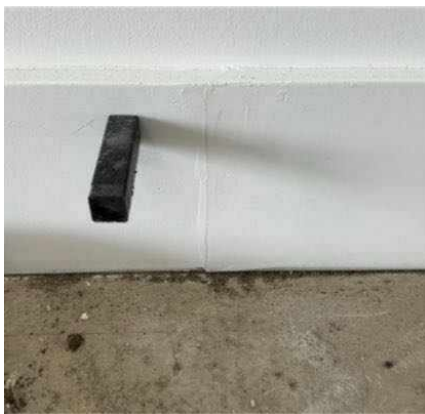
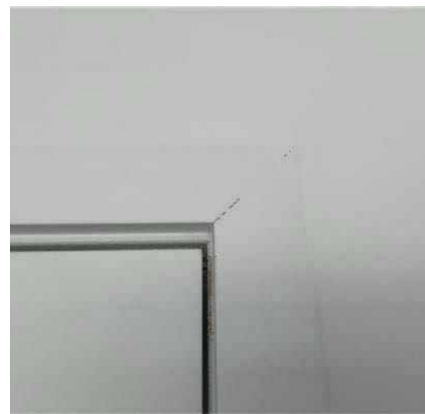
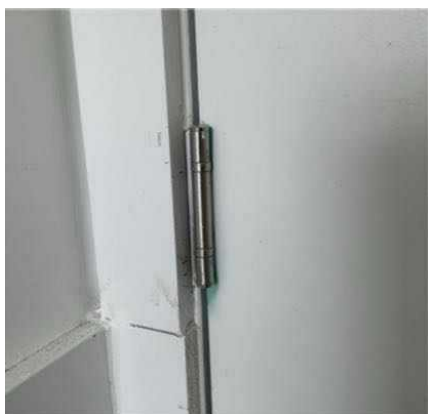
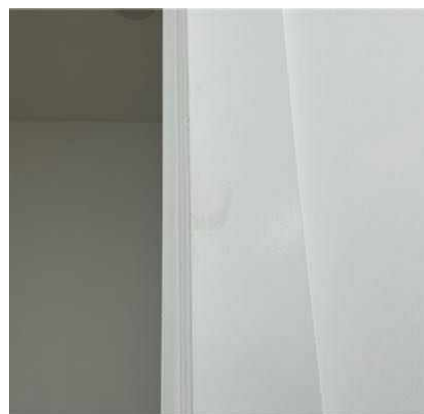
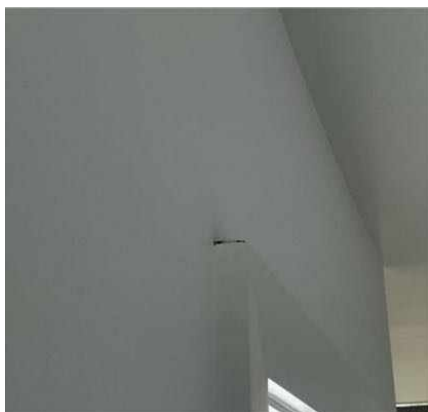
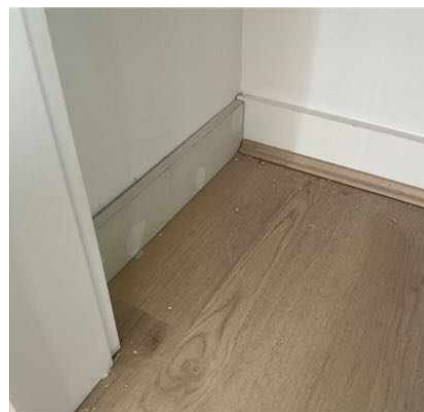
Defects 3.04

Building:	Main Building
Location:	All Internal Areas
Finding:	Incomplete Internal Painting - PCI
Information:	During the inspection, areas of incomplete painting were observed to various internal surfaces throughout the property. These include locations where paint has been entirely missed or cut short, particularly around corners, edges, trims, and junctions. The defects indicate that painting works have not been fully completed at the time of inspection.

- AS 2311:2017 – Guide to the painting of buildings requires that painting systems be applied in full to all designated surfaces, with no omissions or unpainted areas.
- Guide to Standards and Tolerances 2015 – Section 12.02 states that painted surfaces must exhibit complete and consistent coverage when viewed under normal lighting conditions from a distance of 1.5 metres.

Incomplete painting presents an unfinished appearance and may leave surfaces exposed to potential wear or moisture effects. Repainting is required in the affected areas to ensure full coverage and compliance with applicable standards. Photos provided serve as examples and may not capture all areas requiring attention.

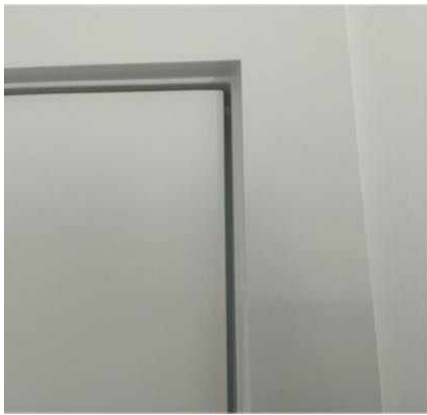
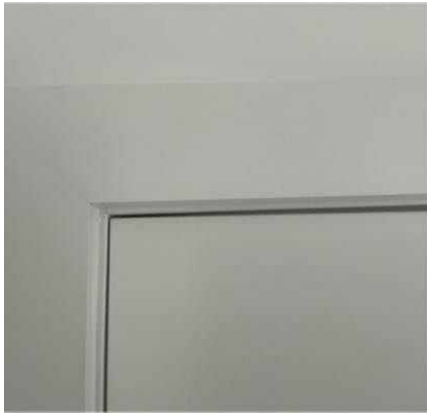
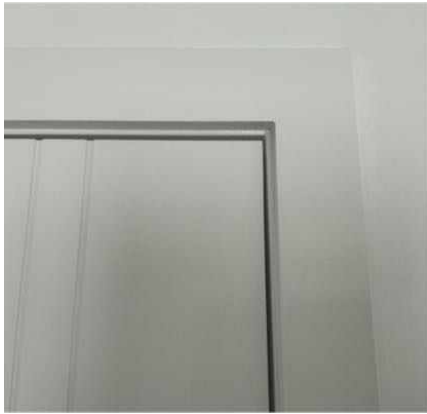
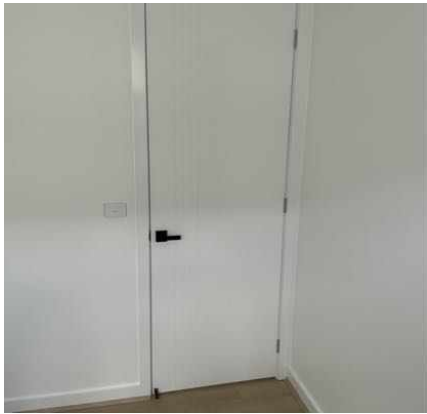
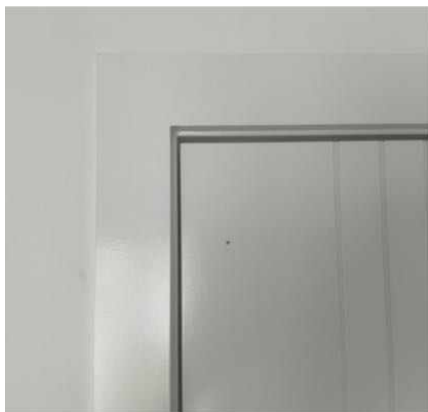
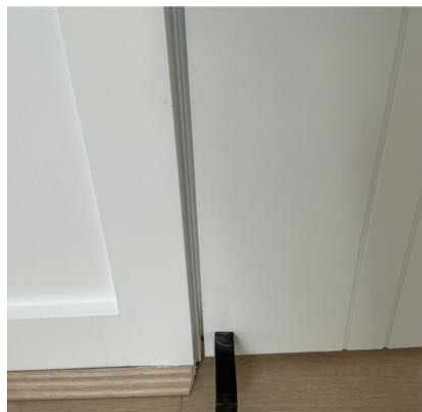
Defects 3.05

Building:	Main Building
Location:	All Internal Areas
Finding:	Inconsistent Door Margins – Non-Compliant Installation - Fix/PCI
Information:	During inspection, the door unit was observed to have inconsistent margin gaps between the door leaf and the surrounding frame and architraves. Visible irregularities were present along the top, sides, and bottom edges, with clearances varying beyond acceptable tolerances. These discrepancies not only detract from the visual presentation but may also interfere with the operation of the door, including risks of binding or hardware misalignment during use.

- Guide to Standards and Tolerances 2017, Section 13.08 – The acceptable tolerance for door clearances is a uniform ± 2 mm unless otherwise specified.
- NCC 2022 Volume Two, Clause 10.7.1 – Fixtures and fittings must be installed to operate as intended and achieve a uniform and functional finish.

Rectification is required to ensure compliance.

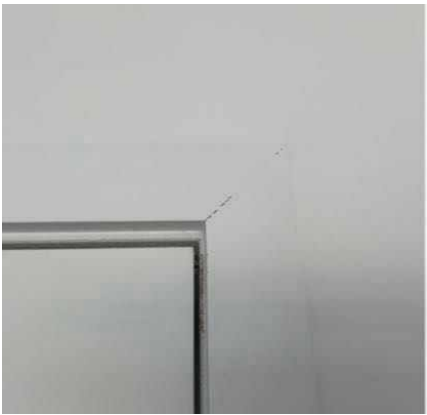
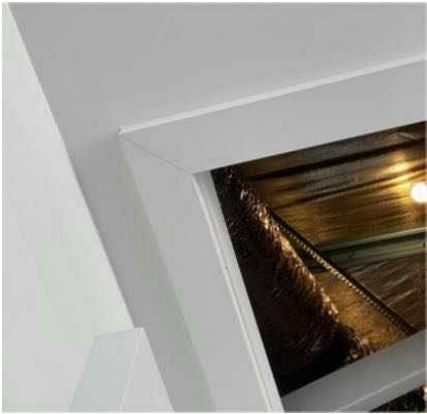
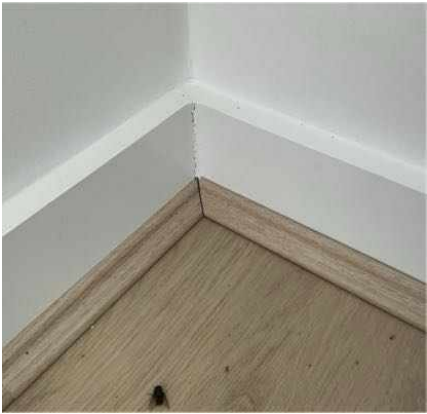
Defects 3.06

Building:	Main Building
Location:	All Internal Areas
Finding:	Cracking to Painted Architraves and Skirting Boards - PCI
Information:	Cracks were observed forming in multiple sections of the painted architraves and skirting boards throughout the property. These cracks are likely the result of minor building movement, natural timber shrinkage, or inadequate surface preparation prior to painting. The defects are visible under normal viewing conditions and detract from the overall internal finish.

- Guide to Standards and Tolerances 2023, Section 10.07 – Surface Damage and Imperfections: Surface cracking that is visible from a normal viewing distance of 1.5 metres under natural lighting is considered a defect.
- NCC Volume Two, Performance Requirement H4P2 – Internal finishes must be completed in a manner that provides an acceptable level of amenity and appearance.

The current condition does not meet the minimum acceptable finish standards for new residential construction. The photos provided show examples only; a full inspection of all internal timber trim should be completed to identify and rectify all affected areas. Cracked sections should be repaired, filled, and repainted to achieve a consistent and professional internal finish.

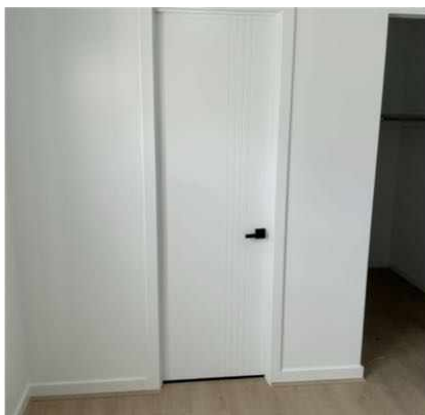
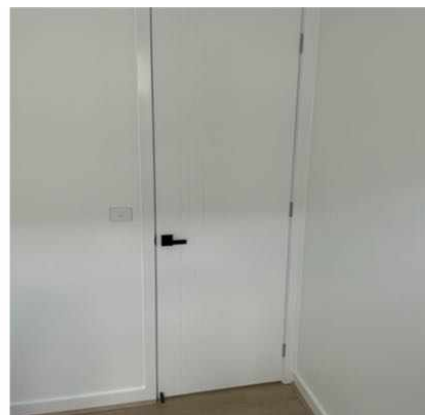
Defects 3.07

Building: Main Building
 Location: All Internal Areas
 Finding: Internal Door Rattle - PCI
 Information: At the time of inspection, one or more internal doors were noted to not latch securely when closed. The affected doors exhibit movement or rattling due to insufficient engagement between the latch and striker plate. This indicates that adjustment is required to ensure the door closes and secures as intended.

- Guide to Standards and Tolerances 2023 – Clause 10.08: Doors and windows must operate as intended without binding, jamming, or failing to latch.
- NCC 2022, Volume Two – Clause 10.7.1: Fixtures and components must be installed to enable proper function and ease of use.

Rectification is required to adjust the door striker and ensure that all internal doors latch securely and operate in accordance with the required performance standards.

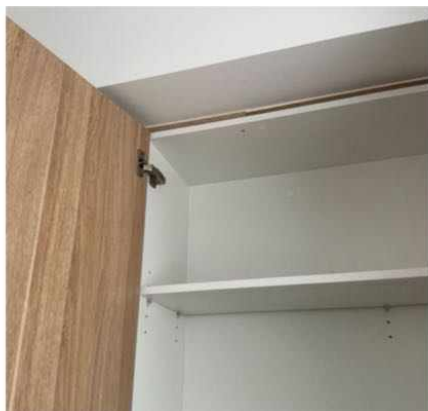
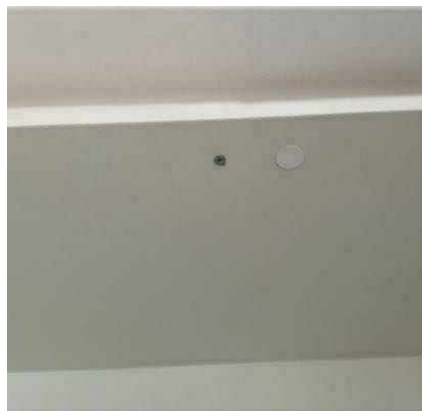
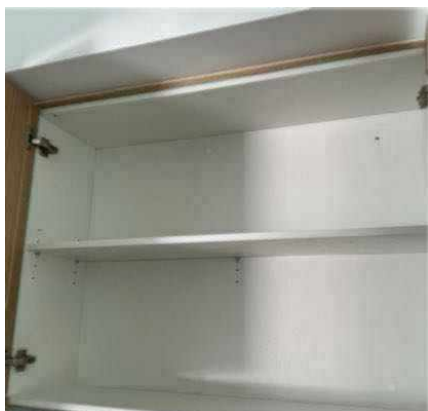
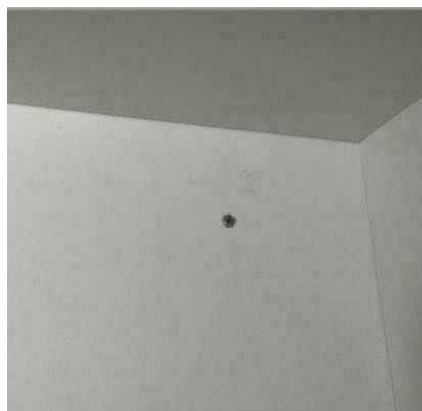
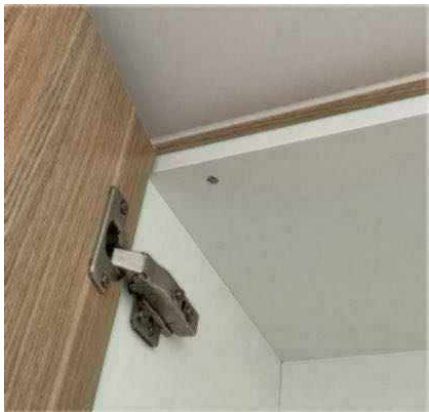
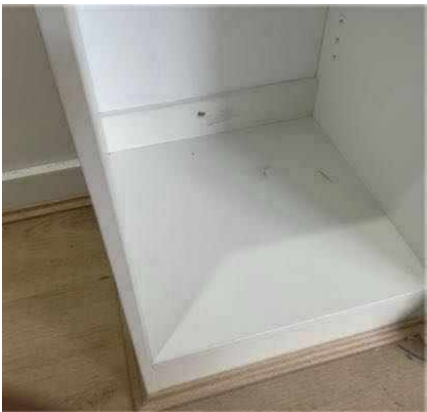
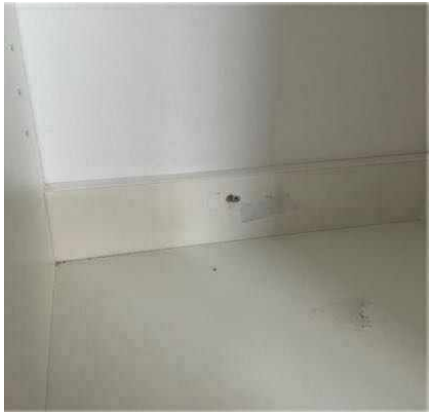
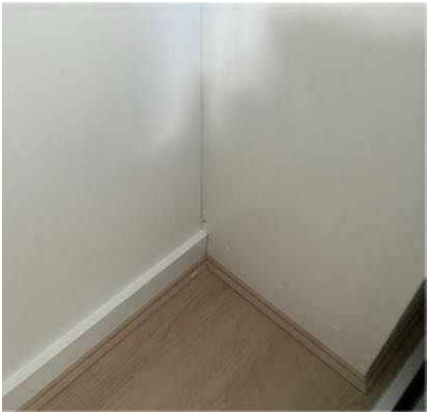
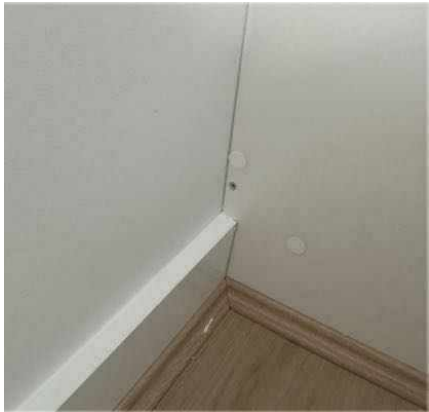
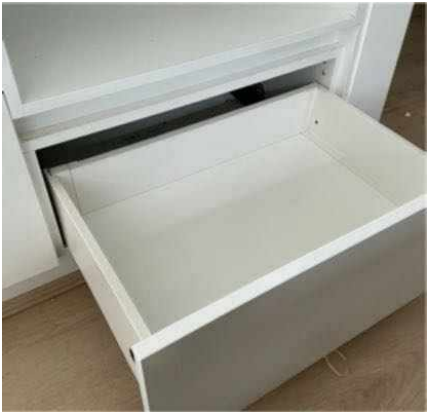
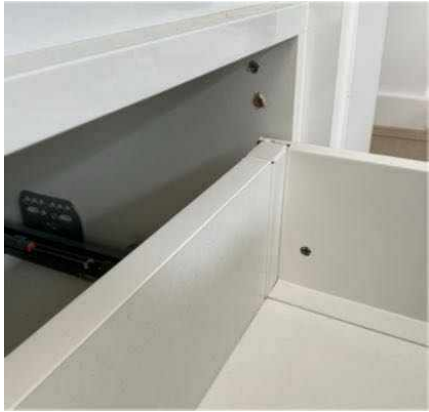
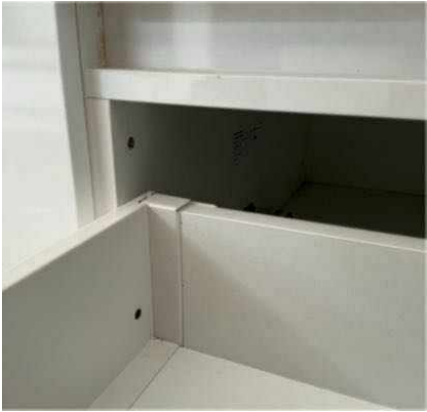
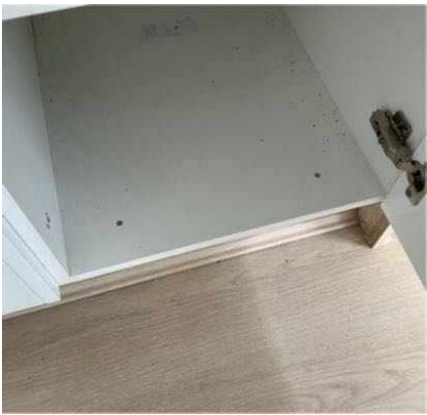
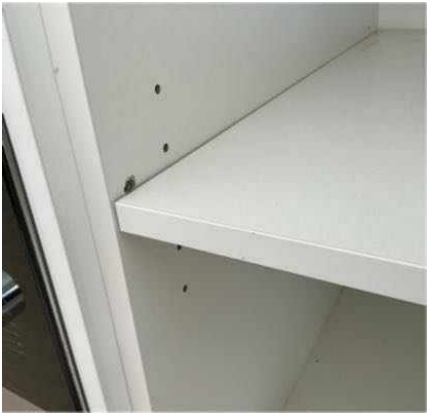
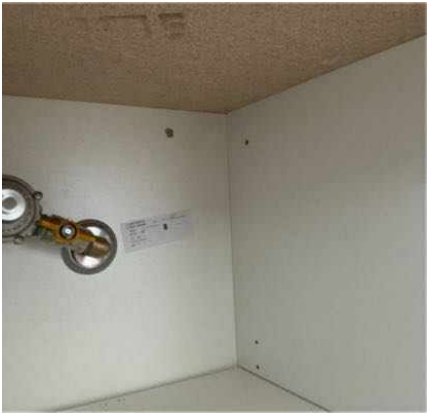
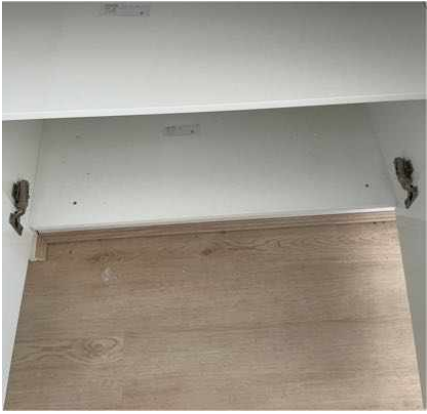
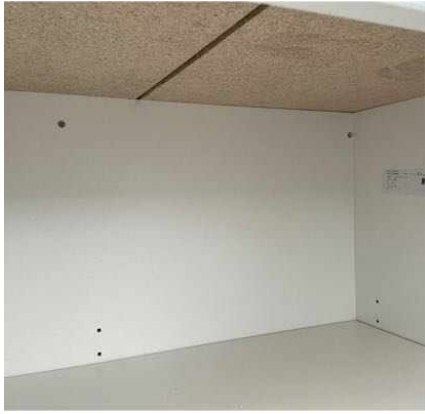
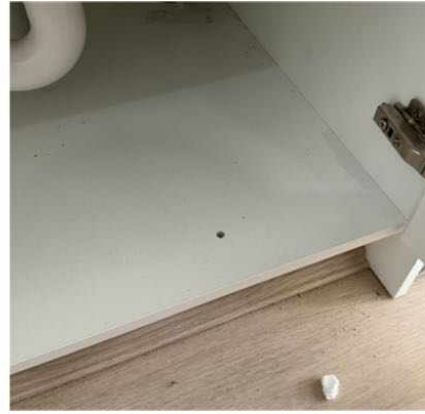
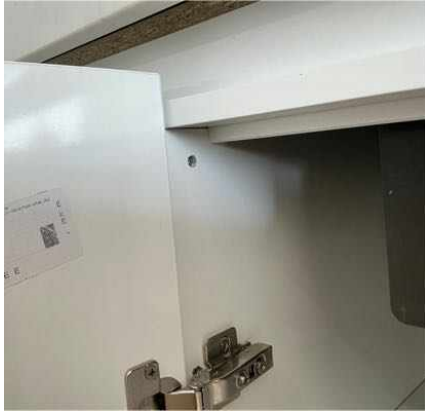
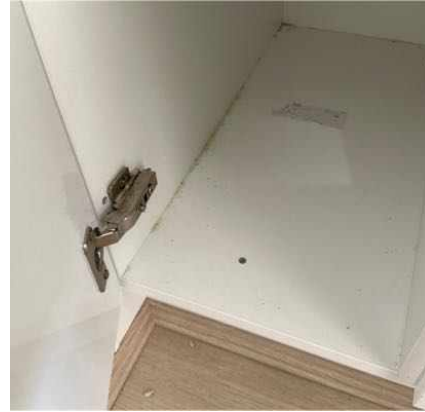
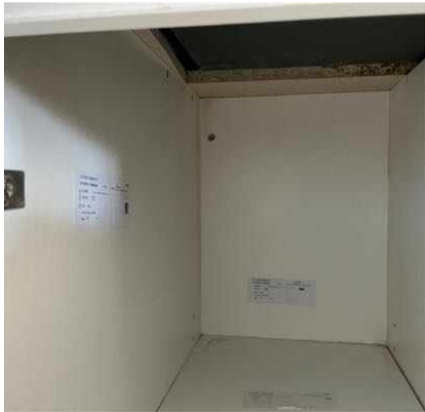
Defects 3.08

Finding: Missing Stick-On Screw Caps to Cupboard Shelving - PCI
Information: During the inspection, it was observed that several cupboard shelving units are missing stick-on screw caps. These caps are intended to conceal exposed fixings, providing a neat and finished appearance while also preventing potential snagging hazards or sharp contact points. Their absence detracts from the overall workmanship and fails to meet an acceptable finish for new construction.

- Guide to Standards and Tolerances 2023,
- Section 10.02 – Cabinets and Built-in Furniture requires cabinetry and associated joinery to be installed in a workmanlike manner and be fit for purpose.
- Section 10.07 – Surface Damage and Imperfections states that visible surface blemishes or defects apparent from a normal viewing distance (1.5m under standard lighting) are considered non-compliant.

The missing caps are clearly visible and detract from the quality and presentation of the cabinetry installation. The supplied photographs represent examples only, and a full inspection of all joinery should be conducted to identify and rectify any other affected areas prior to handover.

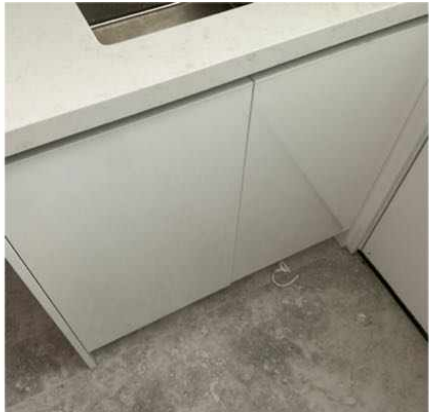
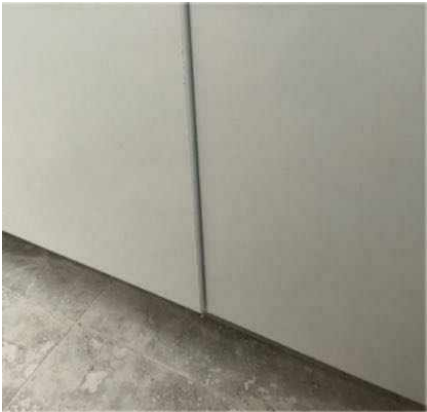
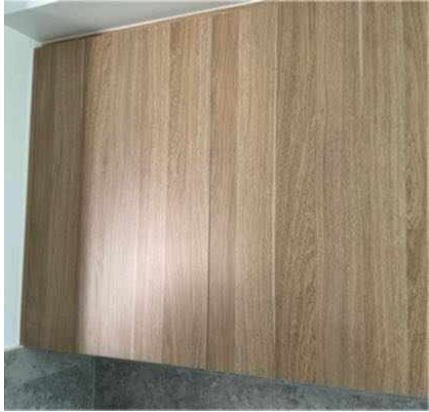
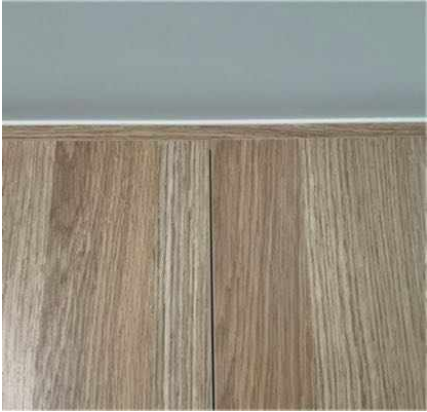
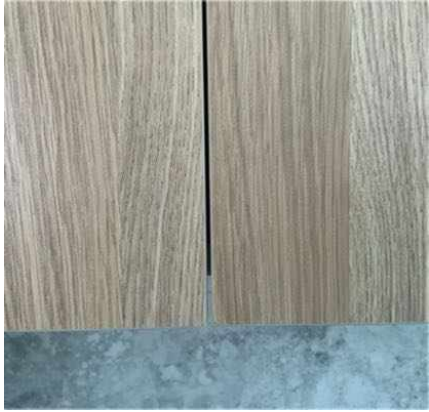
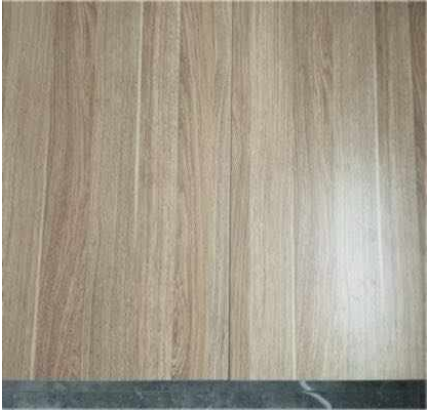
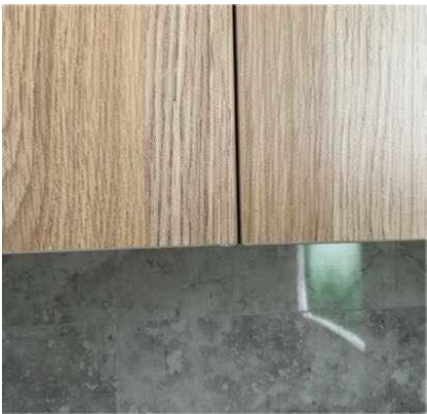
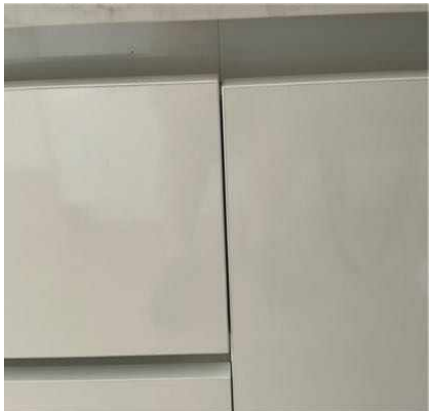
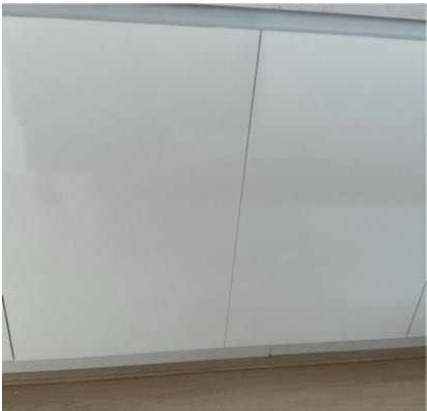
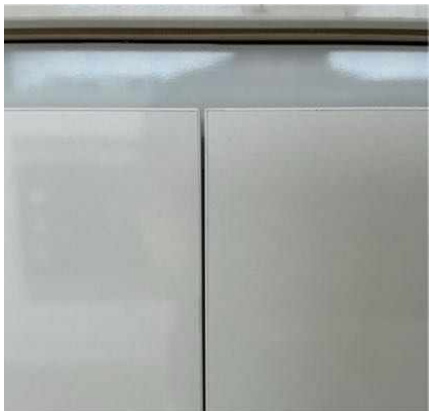
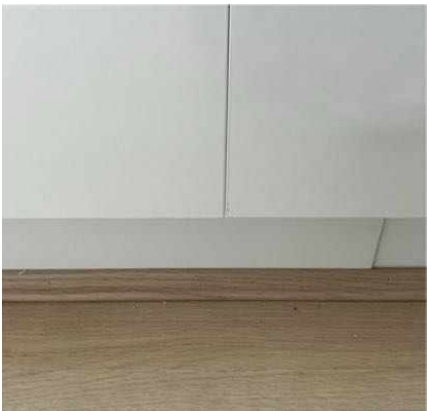
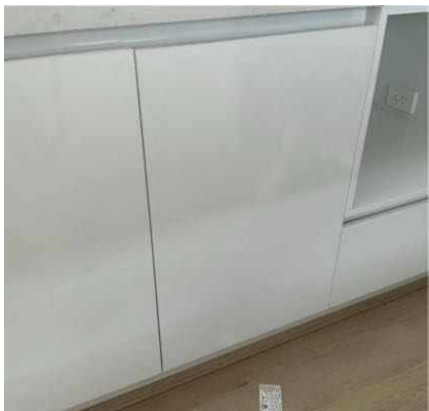
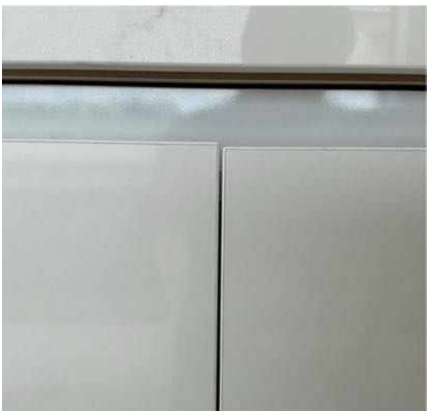
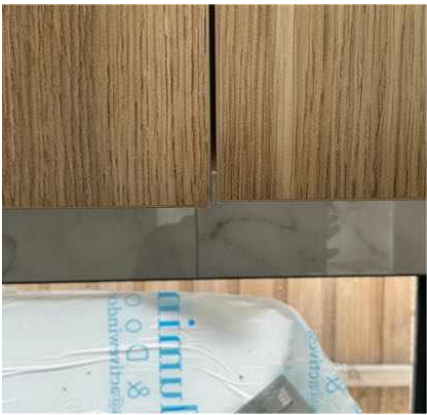
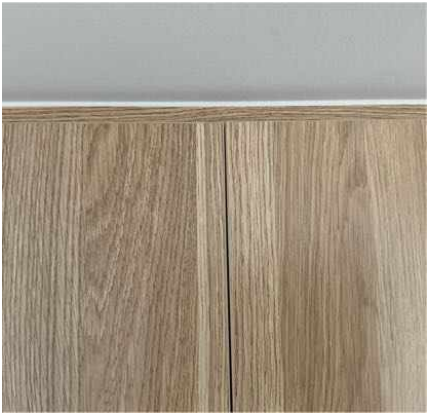
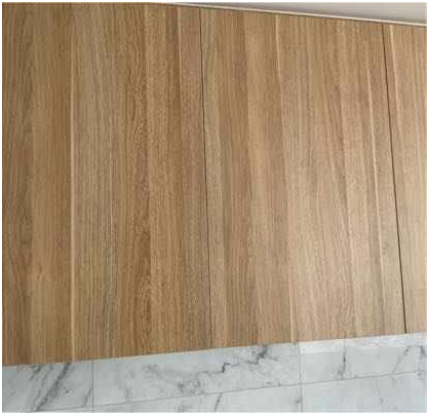
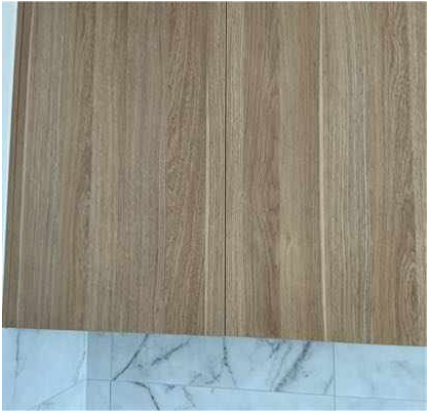
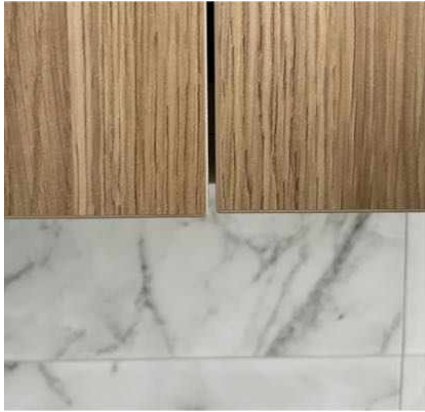
Defects 3.09

Information: During the inspection, it was observed that the kitchen cabinetry presents with visibly uneven margins between adjoining doors, drawers, and panels. These inconsistencies in spacing are apparent under normal viewing conditions and detract from the intended symmetrical and professional appearance of the joinery installation.

Cabinetry must be installed so that doors, drawers, and panels are aligned, flush, and evenly spaced. Variations that are visible and detract from the finished appearance are considered defects.

- Section 10.02 – Cabinets and Built-in Furniture: All joinery must be installed in a workmanlike manner and be fit for purpose.

The observed inconsistencies do not meet acceptable workmanship standards for new residential construction and must be rectified to ensure even alignment and consistent spacing throughout. The supplied photos are provided as examples of the affected areas; a full review of all cabinetry is recommended to confirm and rectify any additional defects.
