Building Inspection Report

Inspection Date: Sat, 10 Jan 2026

Property Address: 39 Monakeeba Bvd, WOODSTOCK, VIC,
3751, Australia

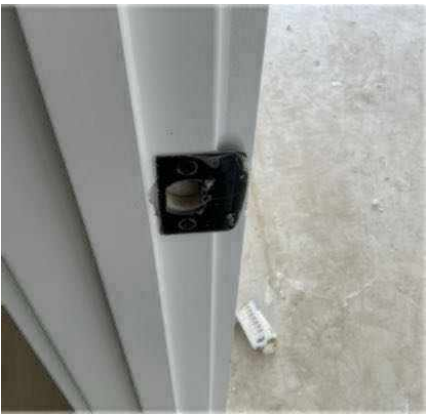
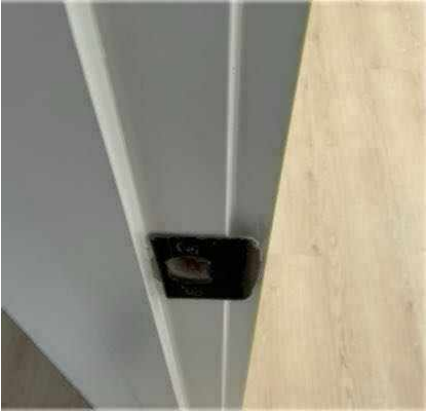
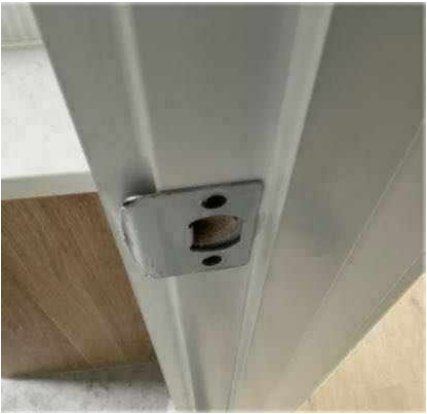
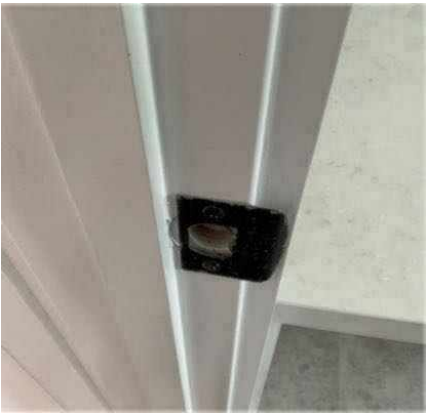
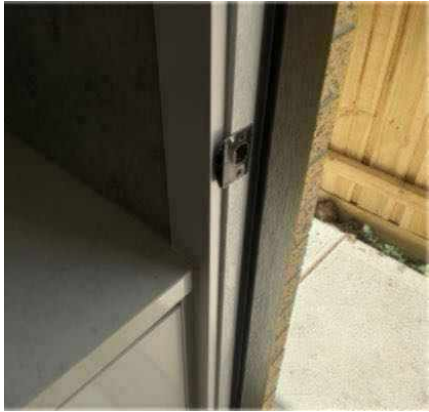
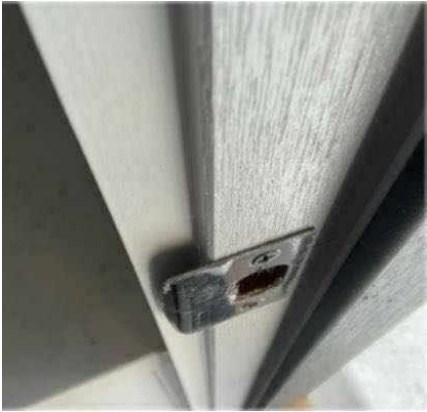
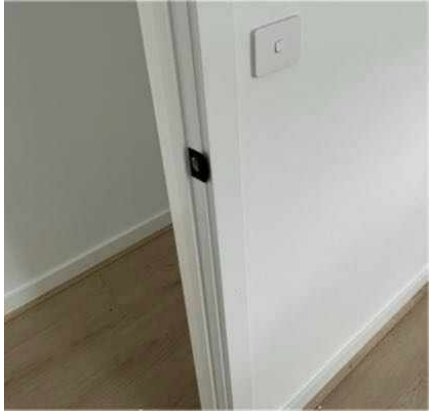
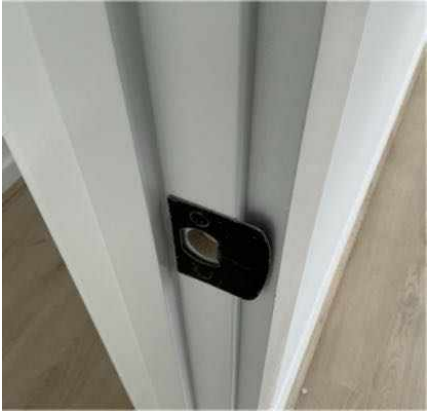
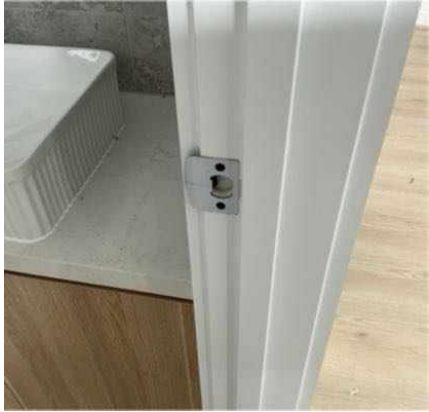
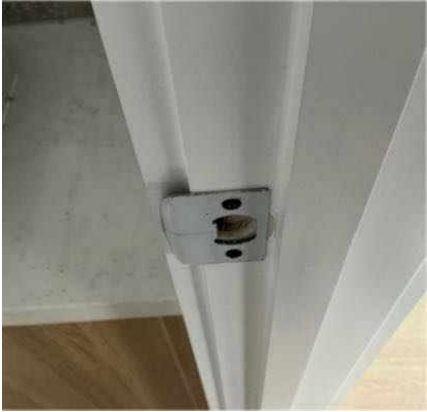
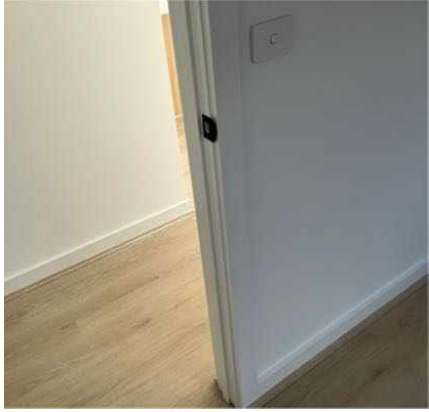
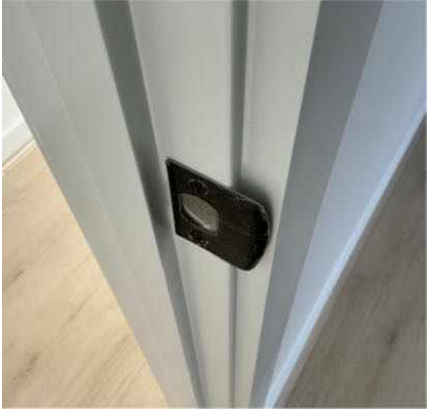
Defects 3.10

Building:	Main Building
Location:	All Doors
Finding:	Striker Plates Not Rebated Into Door Frames - PCI
Information:	At the time of inspection, one or more door striker plates were observed to be surface-mounted to the door frames rather than being rebated flush into the timber. This results in the striker plates sitting proud of the frame surface, causing an inconsistent finish and potential interference with correct door latch engagement and door closure alignment.

Manufacturer installation instructions for door hardware require striker plates to be recessed flush into the frame to ensure correct latch operation, proper alignment, and an acceptable finished appearance. Surface-mounted striker plates do not achieve the intended installation outcome and may contribute to latch wear, poor door operation, and premature hardware deterioration.

Rectification is required to ensure striker plates are correctly rebated into the door frames so that door hardware operates as intended and complies with acceptable installation and finish standards.

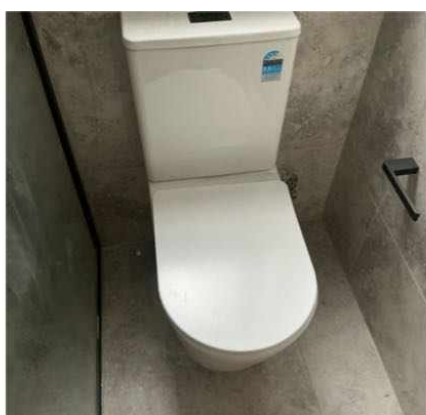
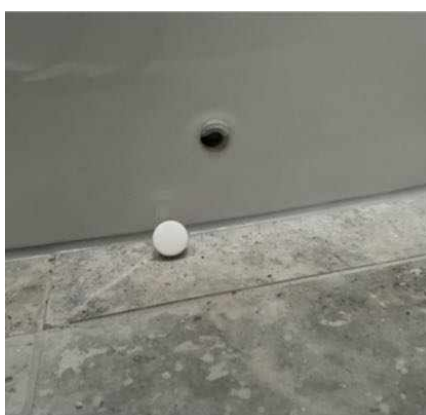
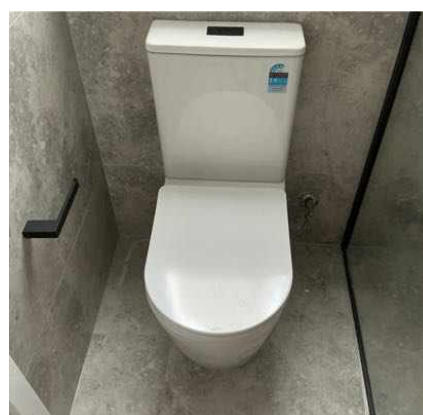
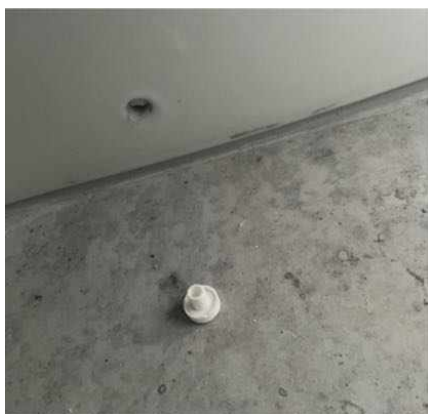
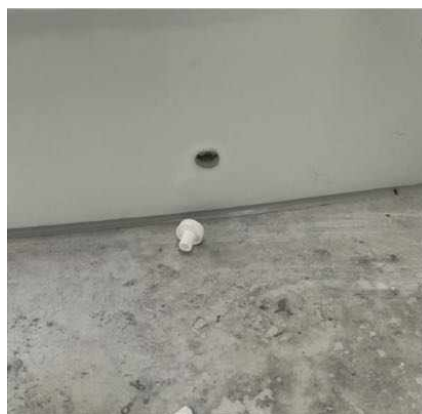
Defects 3.11

Building: Main Building
Location: All Toilets
Finding: Toilets Not Secured to Floor – Incomplete Installation - PCI
Information: During inspection, it was observed that the toilets had not been secured to the floor. Fixing points were visible but had not been fastened, indicating that the sanitary fixtures remain loose and incomplete at the time of assessment. All sanitary fixtures, including toilets, must be fixed in a stable and secure manner to ensure proper function, prevent movement, and avoid damage to adjoining finishes or plumbing connections.

- AS/NZS 3500.2:2021 – Plumbing and Drainage – Sanitary Plumbing and Drainage – Requires fixtures to be installed to prevent movement and ensure long-term stability.
- AS/NZS 6400:2016 – Water Efficient Products – Requires compliance with installation requirements including fixture stability.
- NCC 2022 Volume Three – Plumbing Code of Australia, Clause A2.2(2)(f) – Sanitary fixtures must be installed in a manner that prevents damage, instability, and leakage.

Rectification is required to ensure compliance.

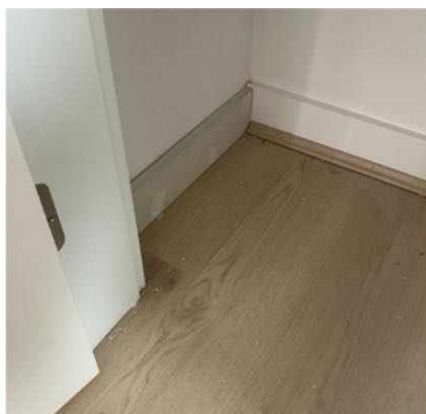
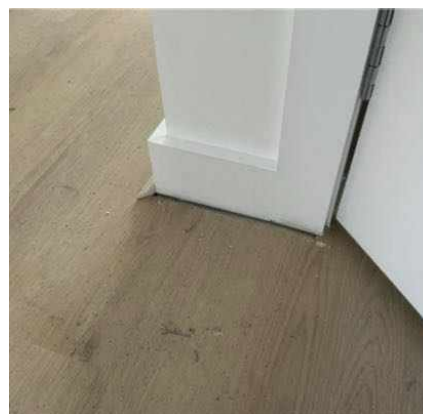
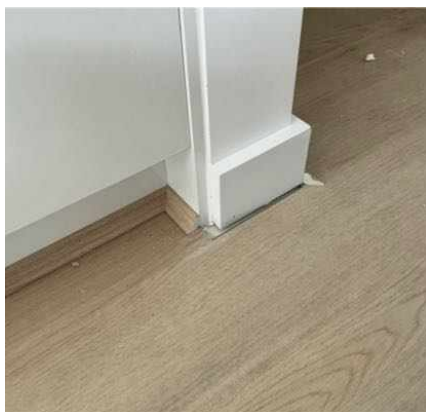
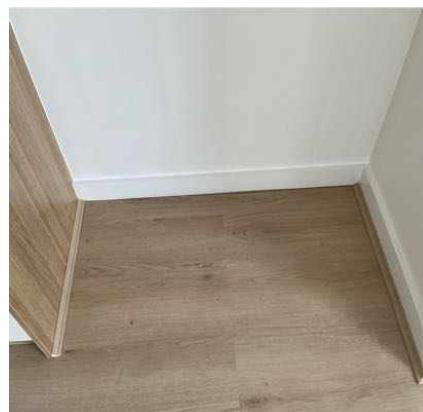
Defects 3.12

Building:	Main Building
Location:	Internal Areas
Finding:	Floating Floor Trim Not Installed in One or More Areas - PCI
Information:	At the time of inspection, it was noted that sections of the floating floor trim have not been installed or securely fixed in one or more areas. These trims are either missing or left loose, leaving an incomplete finish at floor junctions. This does not meet the required standard of workmanship and leaves the flooring installation vulnerable to movement, lifting, or damage during normal use.

- NCC 2022, Volume Two – Part 3.5.3 (Floor Finishes) requires floor finishes to be installed to provide a serviceable and durable surface.
- AS 1884:2021 – Floor Coverings, Resilient Sheet and Tiles – Installation Practices (applied to trims and transitions) requires trims and accessories to be fixed securely and neatly.
- Guide to Standards and Tolerances 2022, Section 12.10 states that trims and accessories must be installed so they are secure and neatly finished at the time of handover.

The current condition is non-compliant. All floating floor trims must be properly installed and secured to provide a complete, durable, and workmanlike finish. Rectification is required to ensure compliance.

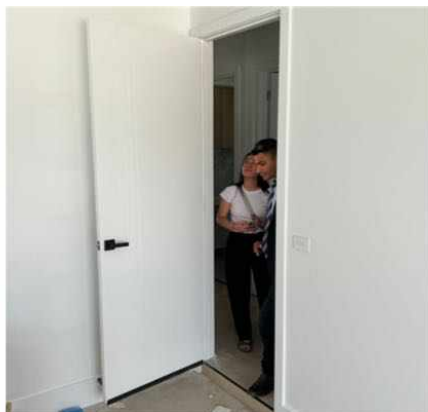
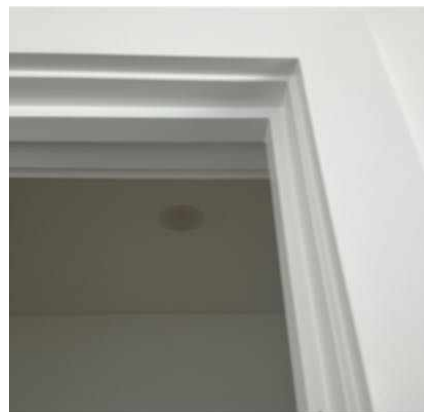
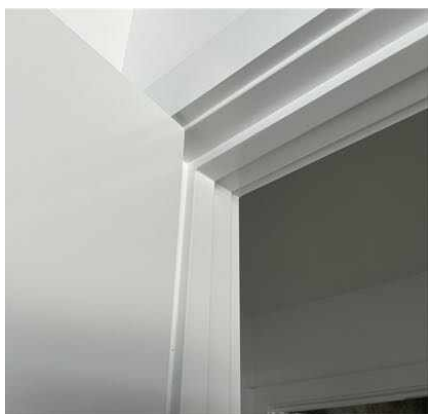
Defects 3.13

Building:	Main Building
Location:	Internal Garage Access Door
Finding:	Missing Door Seals to External Openings - PCI
Information:	During the inspection, it was noted that required door seals were not installed to one or more external door openings. Door seals play a critical role in preventing water ingress, air leakage, dust intrusion, and thermal loss. They are also essential for ensuring compliance with energy efficiency requirements and maintaining the weatherproofing performance of the building envelope.

- AS 2047 – Windows and External Glazed Doors in Buildings
- AS 2688 – Timber and Composite Doors
- NCC Volume Two, Part 3.12.3.3 – Building Sealing
- NCC Volume Two, Part 3.10.1 – Weatherproofing

The absence of appropriate seals does not comply with the minimum requirements set out in the NCC and Australian Standards. All external doors must be fitted with compliant seals in accordance with manufacturer specifications to maintain performance, energy rating compliance, and long-term durability.

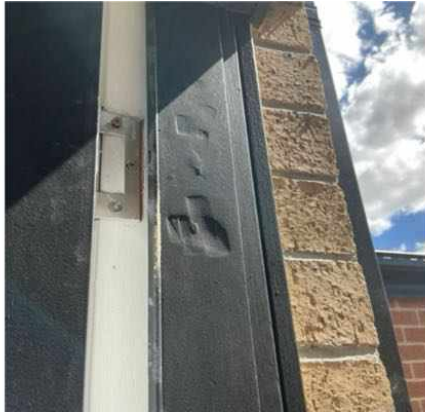
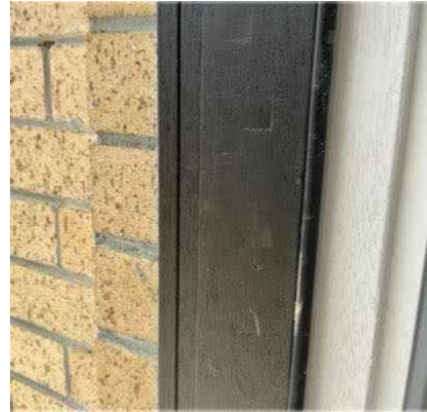
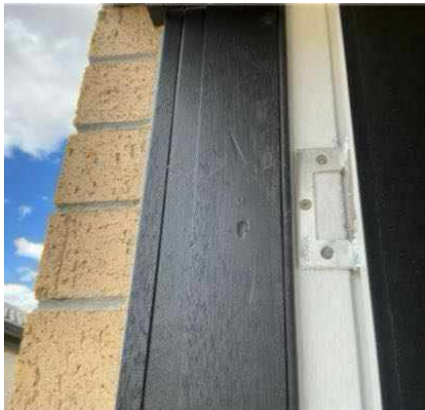
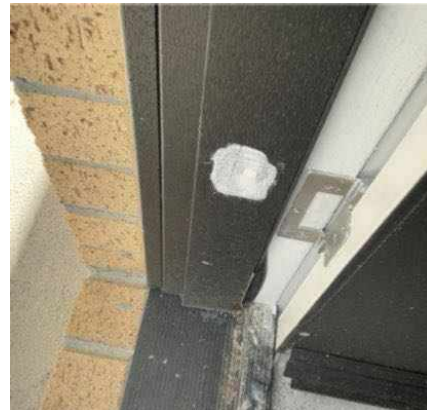
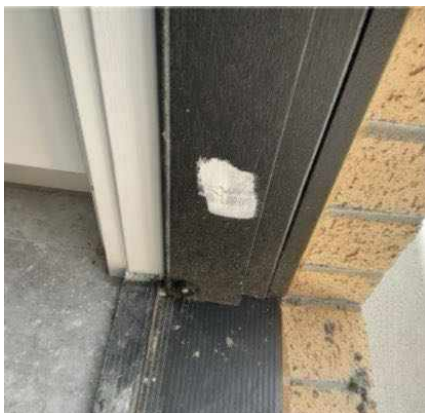
Defects 3.14

Building:	Main Building
Location:	External Door Frames
Finding:	Damaged and Incomplete External Door Frame Finishes
Information:	At the time of inspection, multiple external door frames were observed to have damaged, patched, and incompletely finished surfaces. Defects included visible impact marks, surface indentations, poorly blended filler repairs, inconsistent paint finish, and incomplete detailing at junctions with adjoining components. These conditions detract from the visual presentation of the installation and indicate that final finishing works have not been completed to an acceptable standard for new construction.

Paint finishes must be uniform, free from visible defects, patchiness, or poorly

repaired areas when viewed from a normal viewing distance.

Joinery and trim finishes are defective if poorly fitted, damaged, or visually inconsistent.

Rectification is required to ensure the external door frames are repaired, refinished, and presented to a standard consistent with compliant workmanship, durability expectations, and acceptable visual finish for new construction.

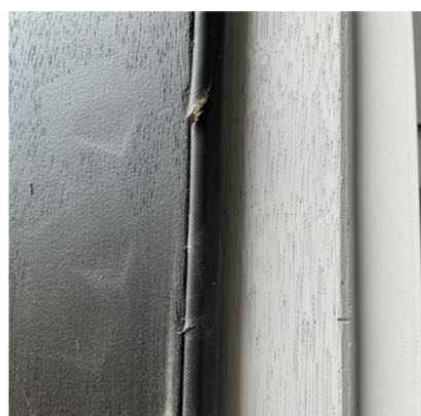
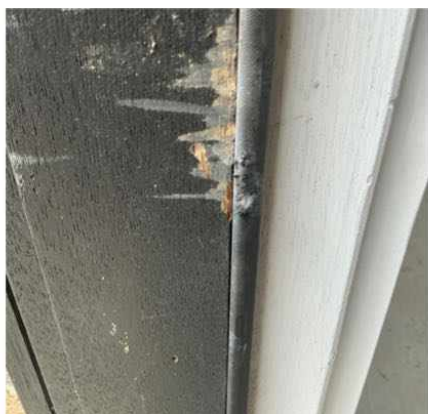
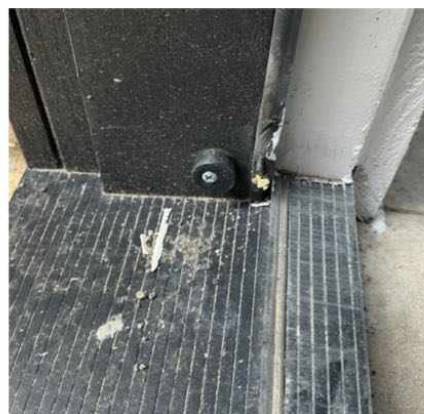
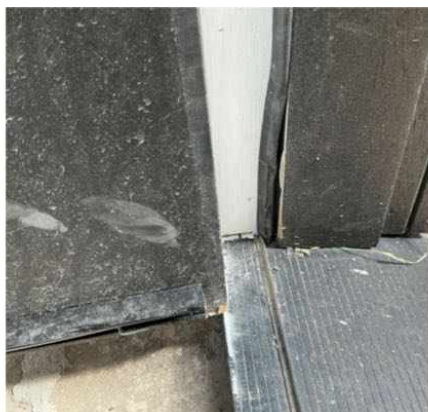
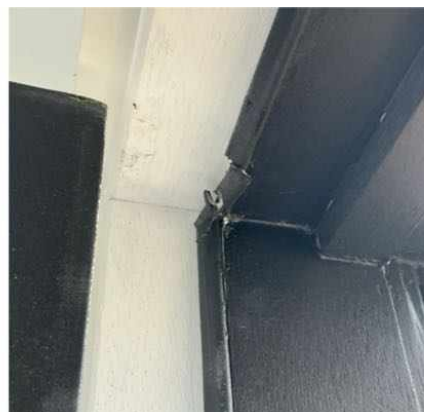
Defects 3.15

Building: Main Building
Location: Rear Garage Door
Finding: Damaged, Paint-Contaminated and/or Poorly Installed Door Seals - PCI
Information: The door seals installed to various door frames throughout the dwelling have been observed to be contaminated with paint, poorly installed and/or physically damaged. This typically occurs when seals are not removed or adequately protected during painting works, leading to reduced flexibility, poor compression, and impaired sealing performance.

Door seals are essential components of the door system, contributing to weatherproofing, thermal efficiency, acoustic performance, and compliance with the manufacturer's product certification. Paint contamination and damage may compromise these functions and may also void the door system's warranty if not rectified in accordance with manufacturer specifications.

- AS 2688:2017 – Timber and Composite Doors, outlines requirements for correct installation and maintenance of door seals to preserve system performance.
- NCC 2022, Volume Two – Clause 3.12.3 requires that external openings, including doors, be adequately sealed to minimise air leakage and water ingress.
- NCC 2022, Volume Two – H1P1 mandates that building elements be installed to maintain their intended performance for the life of the building.

The current condition is non-compliant. All affected door seals must be cleaned or replaced in accordance with the manufacturer's guidelines to restore full performance and maintain compliance.

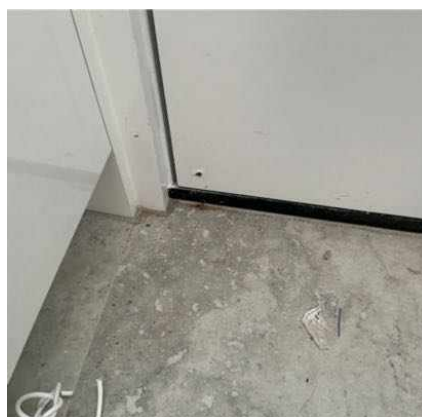
Defects 3.16

Building:	Main Building
Location:	Laundry
Finding:	Missing Door Stop – Internal Door - PCI
Information:	During the inspection, a door stop was found to be missing from an internal door location. In the absence of a functioning door stop, the door is left vulnerable to contact damage from walls or adjacent surfaces when opened fully. This presents a risk of avoidable impact damage to both the door and surrounding finishes.

Fittings and fixtures are considered defective if damaged or not installed neatly and in accordance with good trade practice.

The absence of a door stop does not meet the expected standard of internal fit-off and leaves building elements at risk of damage. Installation of a compliant door stop is required to ensure appropriate protection of finishes and to achieve a complete and

functional installation.

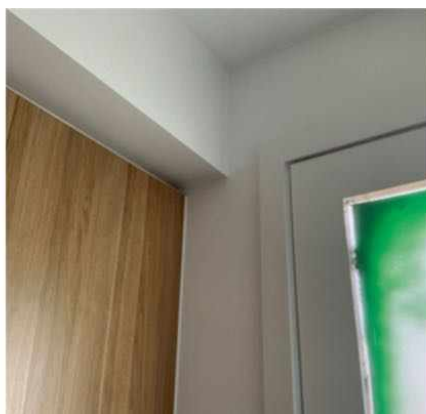
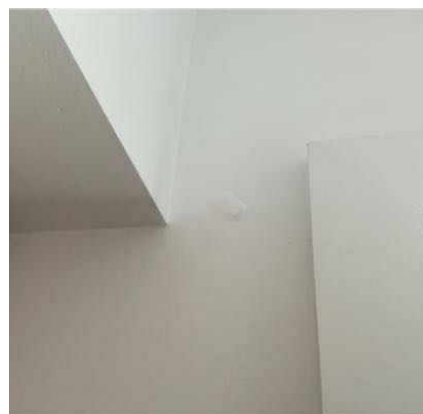
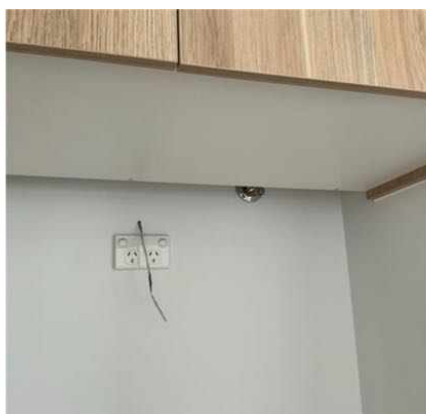
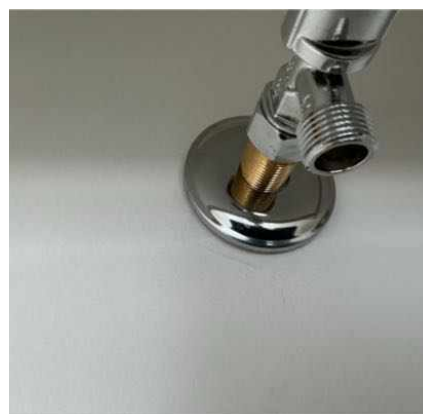
Defects 3.17

Building:	Main Building
Location:	Laundry & Fridge Recess
Finding:	Substandard Plasterwork Failing to Meet Level 4 Finish - PCI
Information:	The plasterwork throughout the dwelling displays a range of surface defects, including visible swirls, dents, creases, pinholes, sanding marks, and poorly finished joints. These imperfections are inconsistent with the required Level 4 finish and significantly detract from the visual quality and expected presentation of new construction.

- AS 2589:2021 – Gypsum Plasterboard Installation and Finishing, defines a Level 4 finish as suitable for areas intended to receive a paint finish, and requires that surfaces be smooth, free of visible imperfections, and adequately prepared for the final coating.
- Guide to Standards and Tolerances 2017, Section 13.04 states that defects in plasterboard finishes, including visible joints and surface irregularities, are not acceptable when visible from a normal viewing distance under natural lighting.

The current condition is non-compliant. All affected plasterboard surfaces must be re-skimmed, patched, or otherwise refinished to eliminate visible imperfections and achieve a true Level 4 finish. While the photos provided highlight selected examples, a full review of all internal wall and ceiling surfaces is recommended to ensure uniform quality and compliance prior to painting and final handover.

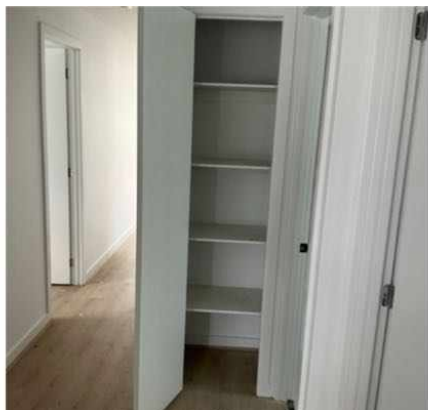
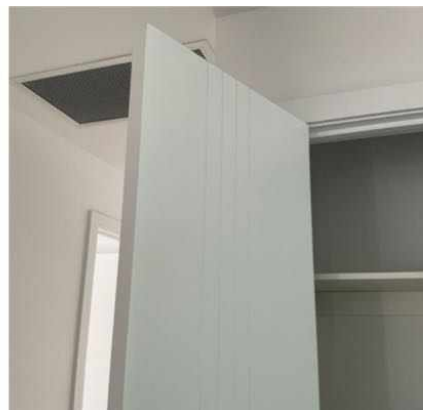
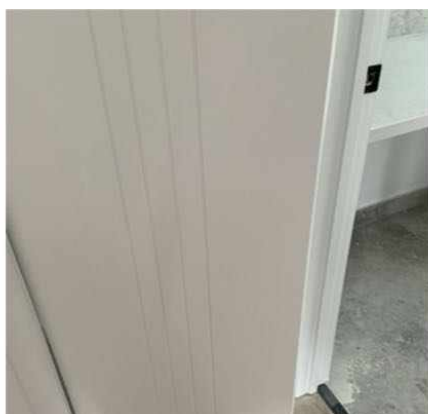
Defects 3.18

Building:	Main Building
Location:	Storage Cupboard
Finding:	Missing Door Handle and Door Catch Installation
Information:	During the inspection, it was observed that a door has not been fitted with a handle and no door catch or latch mechanism has been installed. As a result, the door cannot be properly operated, secured, or retained in the closed position. This condition represents an incomplete installation and prevents the door from functioning as intended.

Rectification is required to ensure the door is fitted with appropriate handle and door catch hardware so that it operates correctly, safely, and in accordance with applicable standards.

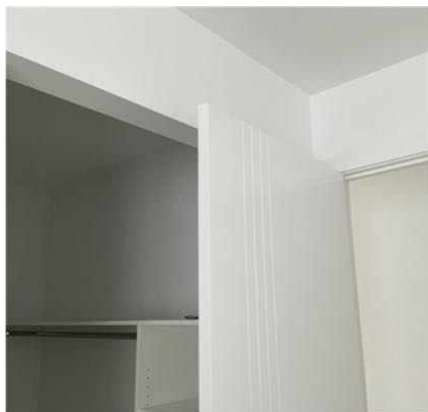
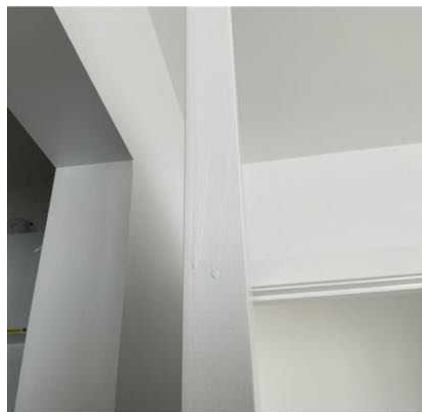
Defects 3.19

Building:	Main Building
Location:	Bedroom
Finding:	Excessive Paint Application - Paint Runs - PCI
Information:	Paint runs were observed on internal surfaces. These occur where paint has been applied too heavily without being properly levelled, resulting in visible streaking or raised surface irregularities. The finish does not meet the required standard of workmanship for new construction.

- NCC 2022, Volume Two – Part 12.5.3 (Internal Finishes): Requires surfaces to be finished to provide a uniform appearance.
- AS/NZS 2311:2017 – Guide to the Painting of Buildings: Paintwork must be free of runs, sags, and other visible defects when viewed under normal conditions.

- Guide to Standards and Tolerances 2022, Section 11.11: Paint finishes are defective if runs or sags are visible from a normal viewing position.

Rectification is required to ensure compliance. While selected examples have been photographed, a full inspection of all painted surfaces is recommended to ensure all imperfections are identified and addressed.

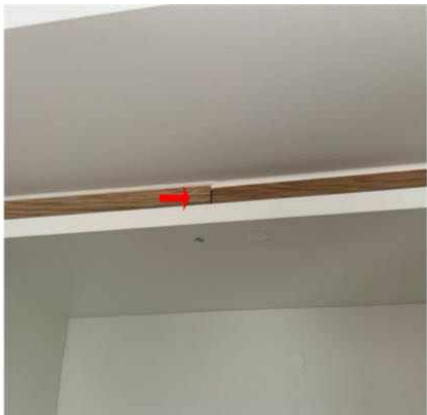
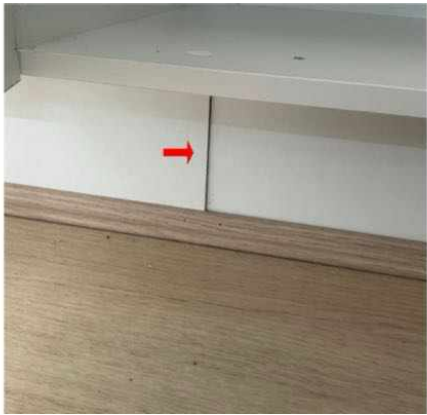
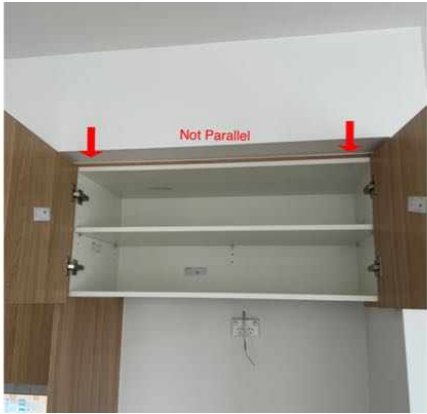
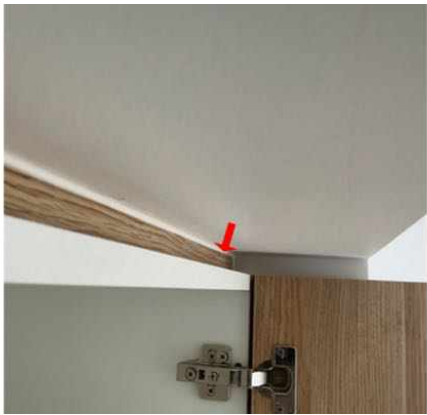
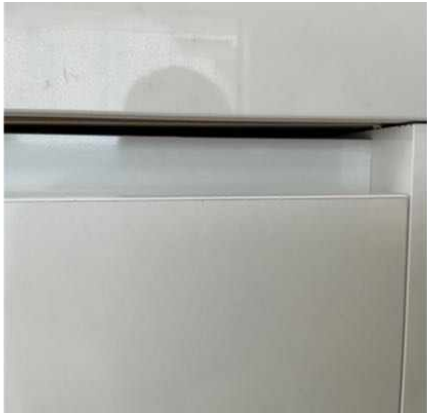
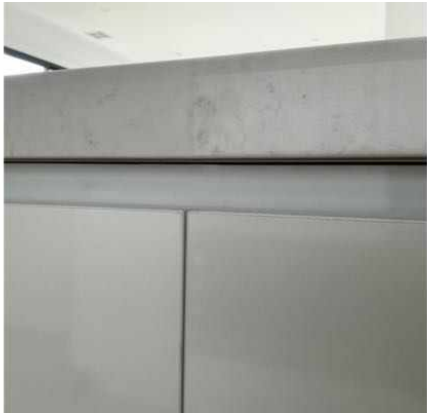
Defects 3.20

Building:	Main Building
Location:	Kitchen
Finding:	Cabinetry Gaps, Uneven Joints and Inconsistent Infill Finishes - PCI
Information:	During the inspection, multiple gaps were observed between cabinetry panels, carcass edges, and surrounding framing elements. Several joints were noted to be uneven, out of parallel, and finished with inconsistent infill materials. These conditions are visually apparent from a normal viewing position and are inconsistent with acceptable standards of cabinetry installation and finish. The overall presentation of the joinery is adversely affected due to poor alignment, irregular junctions, and inconsistent detailing.

The observed gaps, uneven joints, and infill finishes exceed acceptable tolerances for completed cabinetry work and do not reflect a neat or workmanlike installation consistent with new residential construction standards.

- Guide to Standards and Tolerances 2017, Section 10.01 – Gaps associated with the fixing of cabinets and benches are defective if they exceed 1 mm in width within 12 months of completion and are visible under normal lighting and viewing conditions.
- NCC 2022 Volume Two, Clause 10.7.1 – Fixtures and fittings must be installed in a neat and workmanlike manner that ensures functional integrity.
- AS/NZS 4386.1:1996 – Domestic kitchen assemblies must be installed with consistent clearances, alignment, and junctions to maintain visual uniformity and

Rectification is required to ensure compliance.

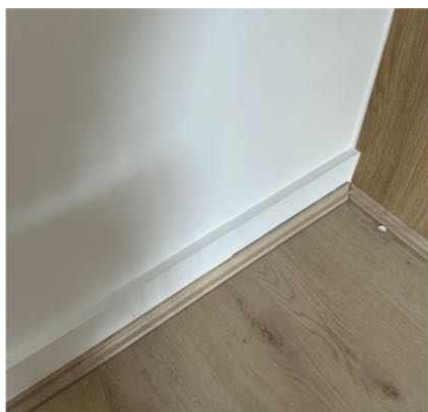
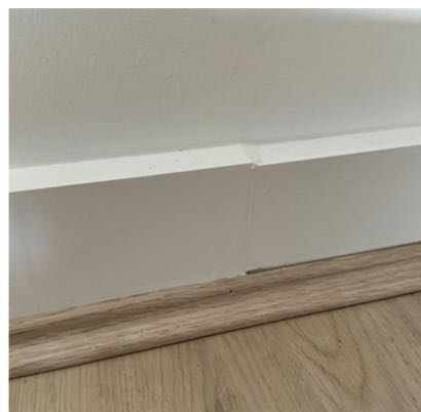
Defects 3.21

Building: Main Building
Location: Kitchen Bench
Finding: Poor Skirting Board Join – Butt Joint Used Instead of Mitre Joint
Information: During the inspection, a poorly finished joint was observed to the skirting board. The joint has been formed as a butt joint rather than a mitred joint, resulting in a visible and uneven junction. The joint is not flush, is visually apparent from a normal standing position, and detracts from the overall quality of the internal finish.

Mitred joints are standard trade practice for skirting board terminations as they provide a tighter, neater, and more durable finish. Butt joints are prone to opening, cracking, and becoming visually inconsistent over time due to timber movement and shrinkage.

- Guide to Standards and Tolerances 2023 – Section 13.02, which requires internal trims and mouldings to be neatly and accurately fitted with no visible gaps or poor joints.
- Guide to Standards and Tolerances 2023 – Section 13.08, which states that visible surface finish defects are unacceptable when viewed under normal lighting conditions.
- NCC 2022 Volume Two – Part 10.7.1, which requires fixtures, fittings, and finishes to be installed in a neat and workmanlike manner.

Rectification is required to ensure the skirting board joint is correctly re-formed using a mitred joint and finished to achieve a neat, flush, and durable appearance in accordance with acceptable trade practice and compliance standards.

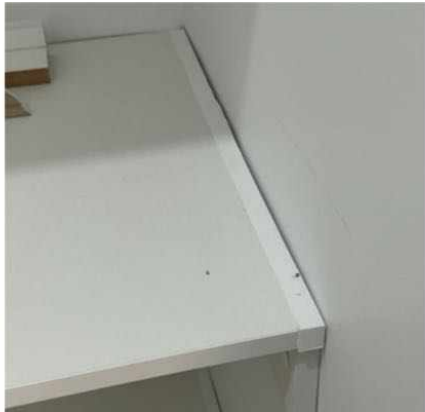
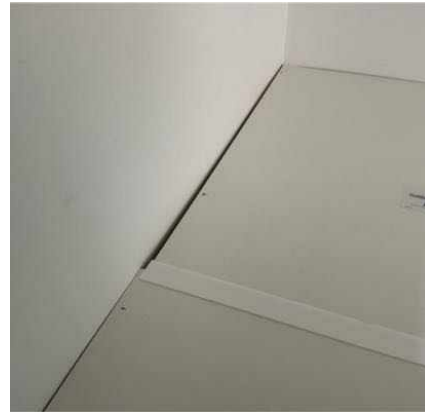
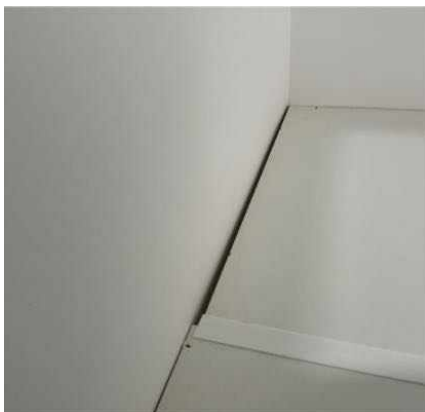
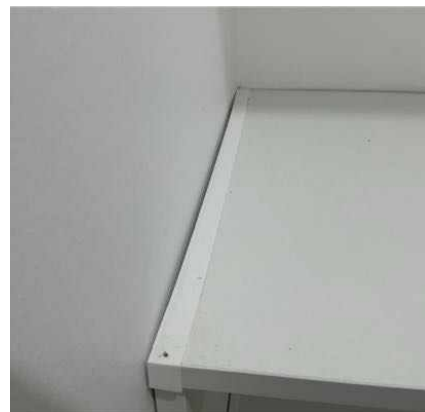
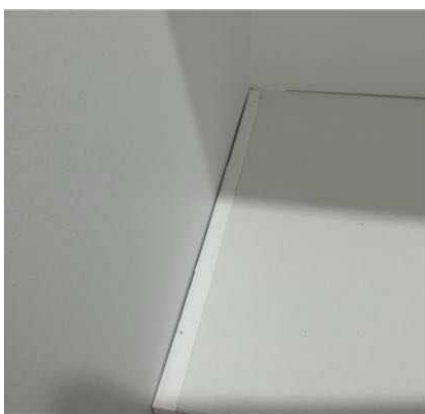
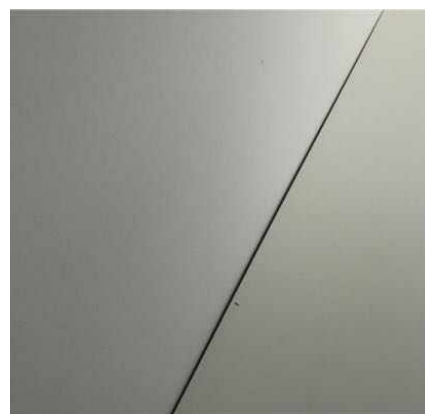
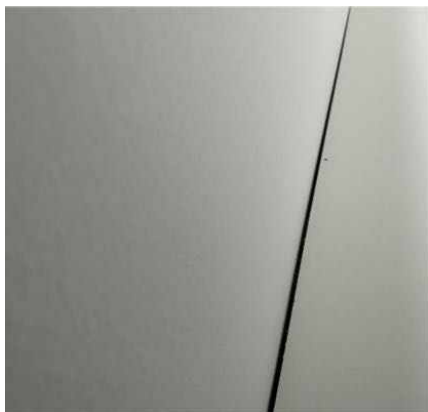
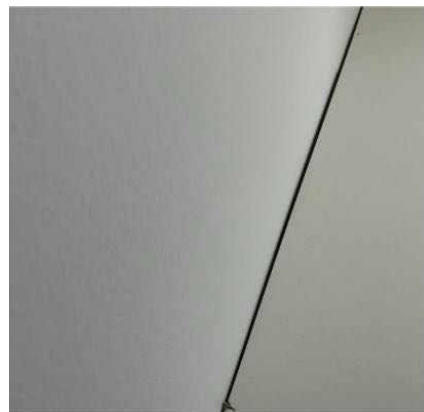
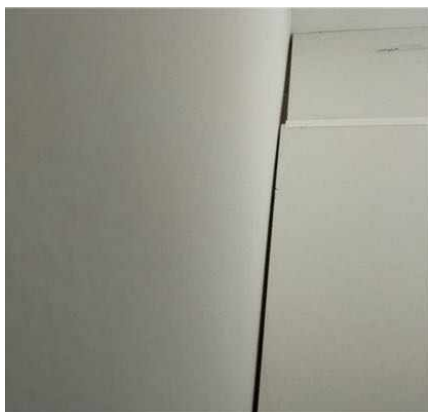
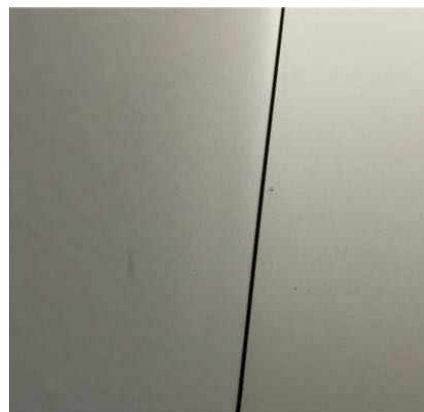
Defects 3.22

Building:	Main Building
Location:	Pantry - Walk In
Finding:	Substandard Installation of Shelving and Cabinetry - PCI
Information:	At the time of inspection, multiple joinery and shelving installations were noted to be poorly executed. Defects included misaligned shelves, inconsistent screw fixings, visible gaps between cabinetry and adjoining walls, poorly fitted drawer fronts, uneven shelf levels, and unfinished or poorly detailed corners. These inconsistencies are not in line with acceptable workmanship standards for new residential construction and detract from both the appearance and function of the cabinetry.

- Guide to Standards and Tolerances 2023 – Section 14.02: Joinery is defective if it is not installed in accordance with documented plans and specifications, or if visible surfaces exhibit poor workmanship such as gaps, misalignment, or poor fit.

- Guide to Standards and Tolerances 2023 – Section 14.03: Cabinet doors, panels, and drawers must be aligned and fitted with uniform gaps unless otherwise specified.
- AS/NZS 4386.1:1996 – Domestic kitchen assemblies: Cabinets and shelving must be constructed and installed to maintain fit, alignment, and durability under normal use.

Rectification is required to adjust, realign, and finish all affected shelving and joinery units to ensure they are securely installed, correctly fitted, and consistent with the workmanship quality expected in a new residential build.

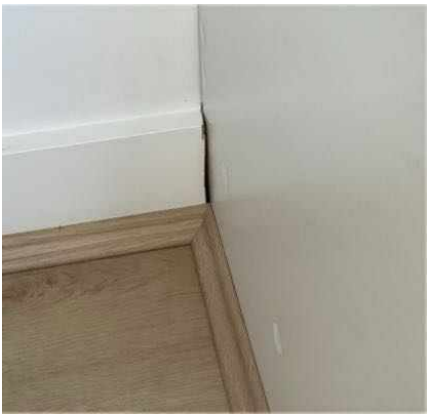
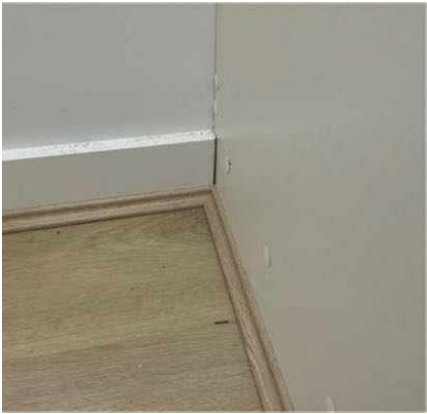
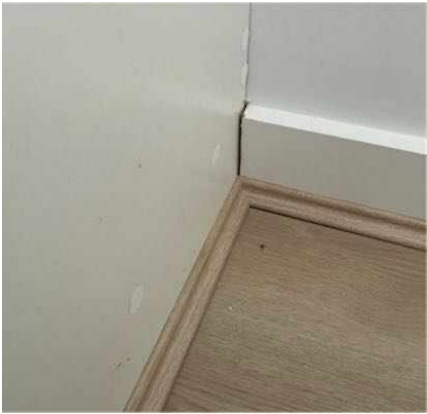
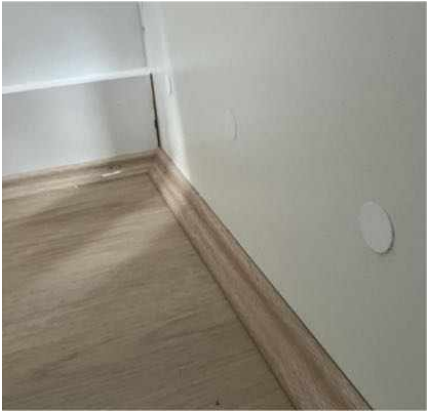
Defects 3.23

Building: Main Building
Location: Built In Robe
Finding: Gaps at Skirting Board Junctions with Robe Uprights - PCI
Information: Inspection identified gaps where skirting boards have been cut and installed against robe uprights. The junctions have not been finished to an acceptable standard, leaving visible openings.

- Guide to Standards and Tolerances 2015 – Section 13.08 requires skirting and other trims to be installed neatly and without visible gaps.

Skirting boards at these locations should be properly adjusted and sealed to provide a consistent and professional finish. Rectification is required to ensure compliance.

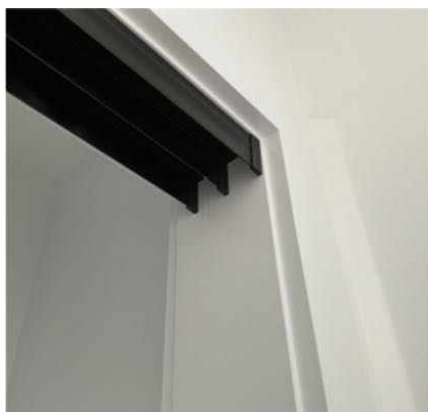
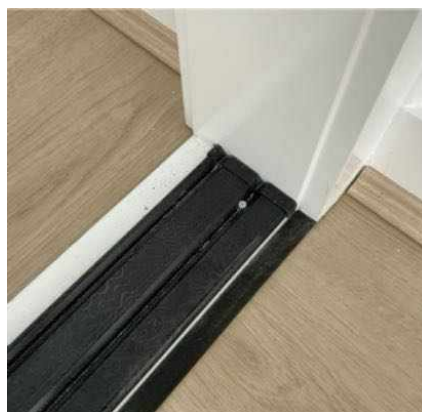
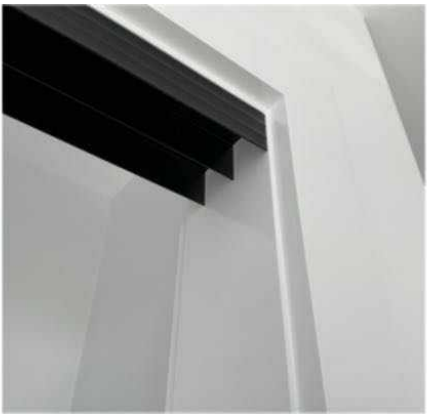
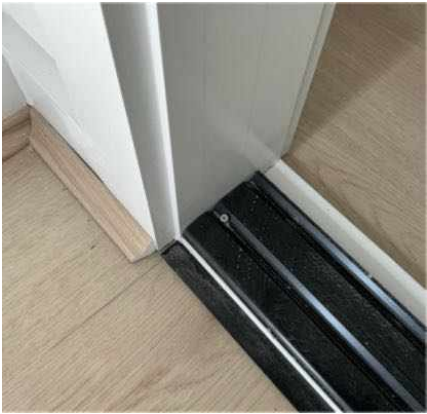
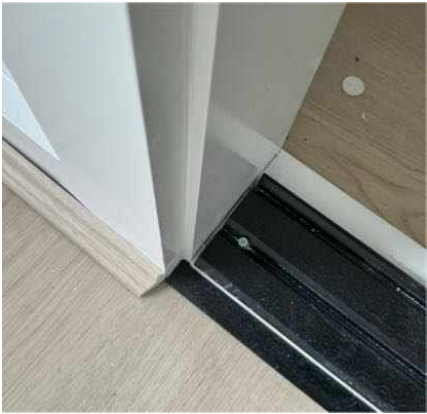
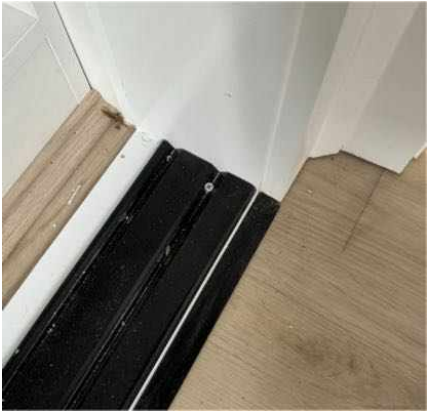
Defects 3.24

Building: Main Building
Location: Built In Robe
Finding: Incomplete Wardrobe Sliding Door Track Terminations - PCI
Information: At the time of inspection, it was observed that several wardrobe sliding door top and bottom tracks were not fitted with the required rubber end caps. Only one wardrobe set was noted to have the correct rubber terminations installed. In multiple locations, the aluminium tracks were also cut short of the door frame, leaving exposed track ends and incomplete terminations. This results in an inconsistent finish and reduces the functional and protective performance of the track system.

- Guide to Standards and Tolerances 2023 – Section 14.02: Joinery and trims are defective if they are poorly fitted, incomplete, or finished in a manner that detracts from appearance or function.
- Guide to Standards and Tolerances 2023 – Section 13.08: Visible surface finish defects are unacceptable where workmanship is inconsistent or incomplete.
- AS 2047.1:2014 – Windows and external glazed doors in buildings (applied by principle to sliding systems): Components must be installed in accordance with manufacturer installation requirements to ensure correct performance and durability.

Rectification is required to ensure all wardrobe sliding door tracks are correctly terminated with manufacturer-approved rubber end caps and trimmed to suit the door frame dimensions, to achieve a compliant, durable, and consistent finished installation.

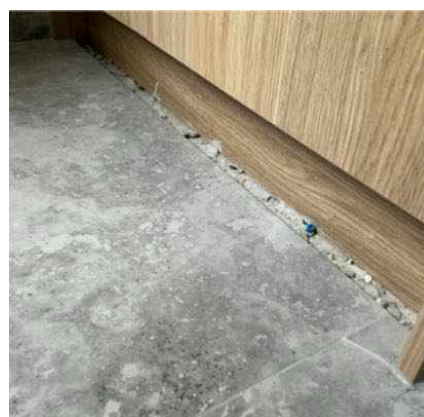
Defects 3.25

Building: Main Building
 Location: Bathroom
 Finding: Incomplete Tiling Installation - PCI
 Information: At the time of inspection, areas of wall and/or floor tiling were observed to be incomplete, with missing tiles and unfinished terminations to edges and junctions. The tiling installation does not present as a fully completed or uniformly finished surface, and visible gaps and inconsistencies remain evident. This condition indicates that the tiling works have not been completed to a standard expected for new residential construction.

- Guide to Standards and Tolerances 2023 – Section 12.01: Tiling must be complete, properly aligned, and finished to a consistent standard without missing components.
- Guide to Standards and Tolerances 2023 – Section 12.06: Tiling is defective if tiles are missing, poorly finished, or incompletely installed.
- AS 3958.1:2007 – Ceramic tiles – Guide to the installation of ceramic tiles: Requires tiles to be fully installed, aligned, and finished in accordance with accepted workmanship practices.
- NCC 2022 Volume Two – Clause 10.2.4: Finishes must be installed in a manner that achieves suitable durability, appearance, and performance.

Rectification is required to ensure all tiling is fully completed, correctly aligned, and properly finished to achieve compliance, durability, and an acceptable construction standard.

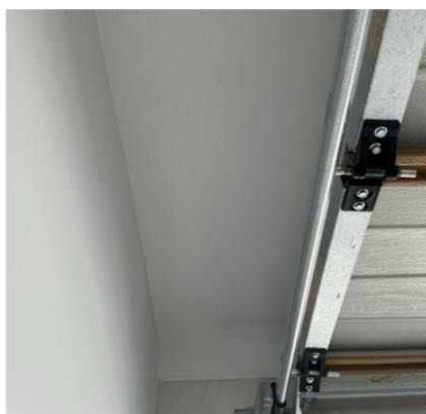
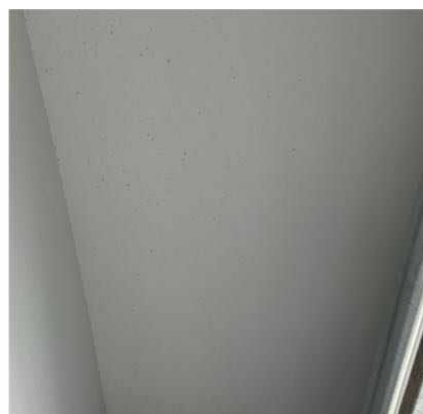
Defects 3.26

Building: Main Building
 Location: Garage
 Finding: Marked Internal Surface Paint Finish - PCI

Information: The internal surfaces in this area were observed to have numerous visible marks, scuffs, and areas of uneven or inconsistent paint coverage. These defects significantly detract from the presentation standard and indicate that either inadequate surface preparation or substandard painting methods were used during application.

These photos are provided as an example of the defects observed. A full inspection of all internal wall and ceiling surfaces is recommended, as similar issues are likely present throughout the dwelling and must be identified and rectified.

- AS 2311:2017 – Guide to the Painting of Buildings: Requires that surfaces be properly prepared and that paint systems be applied evenly to produce a uniform and blemish-free finish.
- Guide to Standards and Tolerances 2015 – Section 12.02: Painted surfaces must be uniform in colour, coverage, and finish when viewed from a normal viewing position under natural light.

Due to the extent of visible imperfections, the affected areas require sanding and repainting to achieve a consistent and acceptable finish in accordance with applicable standards and handover expectations.

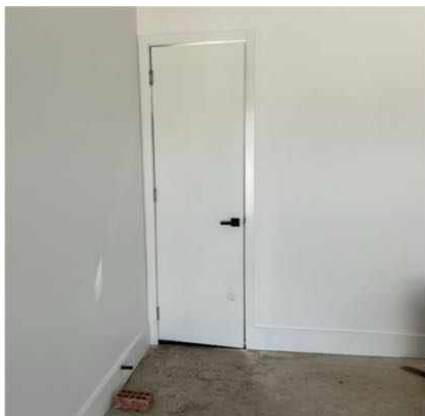
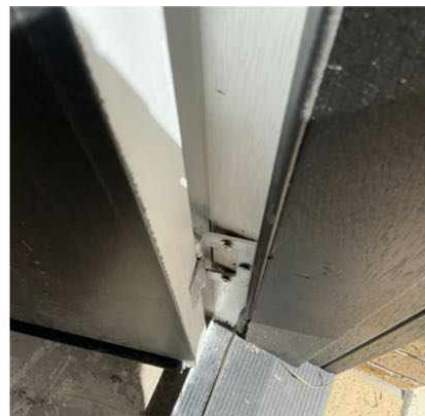
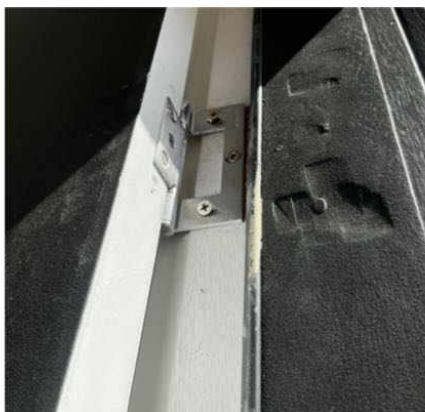
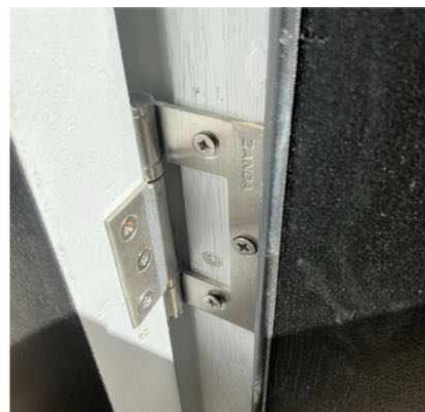
Defects 3.27

Building: Main Building
 Location: Garage
 Finding: Rear Garage Access Door – Incorrect Hinge Fixing
 Information: At the time of inspection, the rear garage access door was observed to be inadequately fixed to the hinges on both the door leaf and frame sides. Several hinge fixings were either missing, loose, or not properly engaged into the supporting substrate. This condition prevents the door from being securely supported and may affect alignment, operation, and long-term durability of the door installation.

Doors and hardware are defective if not securely fixed, poorly fitted, or do not operate as intended.

Requires door assemblies to be installed in accordance with manufacturer's installation requirements and acceptable building practice.

Rectification is required to ensure the door is correctly and securely fixed to the hinges in accordance with manufacturer requirements, to restore proper operation, structural stability, and compliance with accepted construction standards.

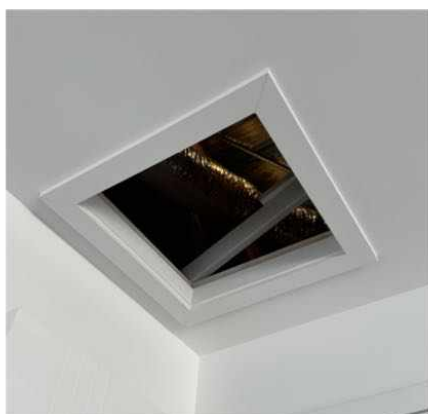
Defects 3.29

Building: Main Building
 Location: Garage
 Finding: Ceiling Manhole Cover Not Installed - PCI
 Information: At the time of inspection, the ceiling manhole cover had not been installed, resulting in an incomplete ceiling finish and unrestricted access to the roof void. The absence of a manhole cover compromises the visual presentation of the ceiling, allows potential unauthorised access, and fails to meet the requirements for a secure and finished internal environment. This condition typically arises due to oversight during final fit-off.

- NCC 2019 Volume 2, Part 3.9.1.2 – Access openings must be constructed and finished to maintain the integrity of the ceiling construction.
- Guide to Standards and Tolerances 2017, Clause 2.03 – All internal fixtures and fittings, including access panels and covers, must be properly installed and finished at the time of handover.

The current condition is considered non-compliant and must be rectified by installing a flush-fitting, secure manhole cover to restore ceiling continuity and restrict unauthorised access to service areas.

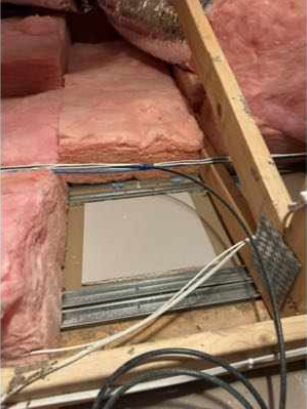
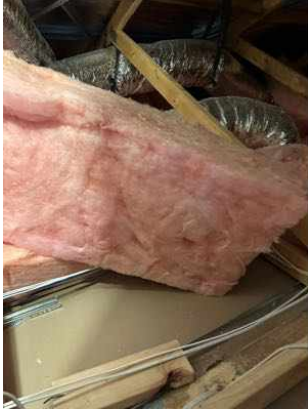
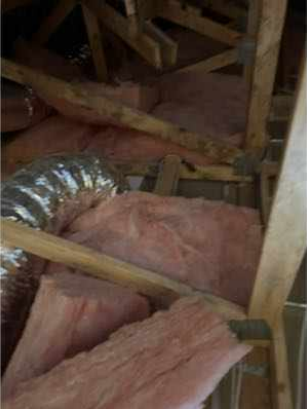
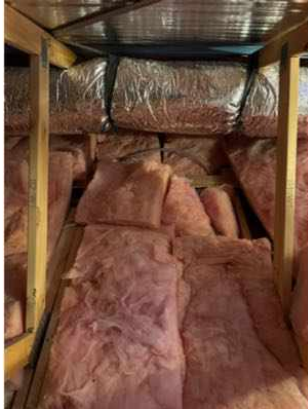
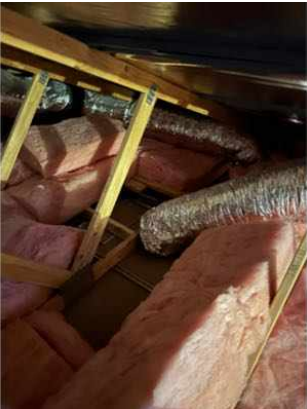
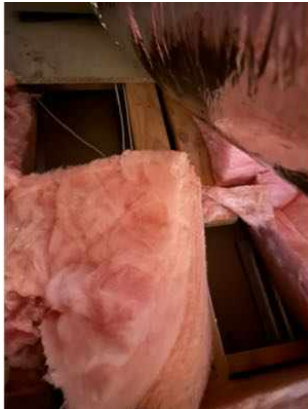
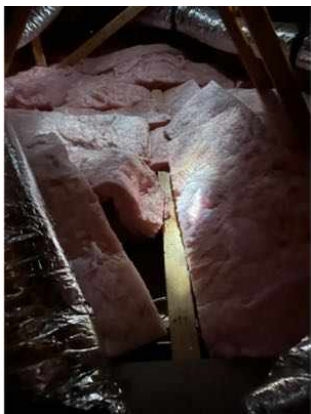
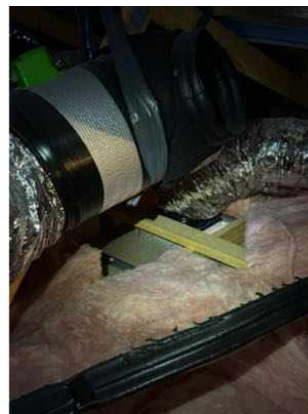
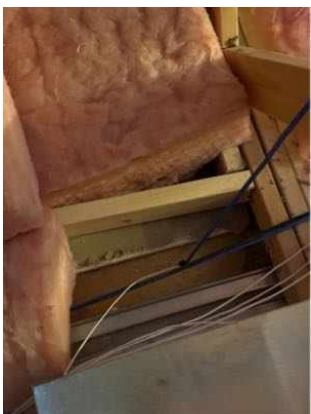
Defects 3.30

Building:	Main Building
Location:	Roof Void
Finding:	Disturbed and Poorly Reinstated Ceiling Insulation - PCI
Information:	Insulation batts in the ceiling space have been disturbed and inadequately reinstated in several areas, likely due to trade access or interference following the initial installation. This has resulted in visible gaps, displacement, and compression of insulation material, compromising the continuity and overall performance of the thermal envelope. Gaps and voids in insulation can significantly reduce energy efficiency and increase the likelihood of thermal bridging.

- ICANZ Insulation Handbook – Notes that thermal efficiency can be reduced by up to 50% when as little as 5% of the insulation area is affected by gaps or poor coverage.

The insulation, as currently installed, is non-compliant and must be reinstated to ensure full coverage, proper positioning, and performance in line with NCC and AS 4859.1 requirements. Rectification is required prior to completion and certification.

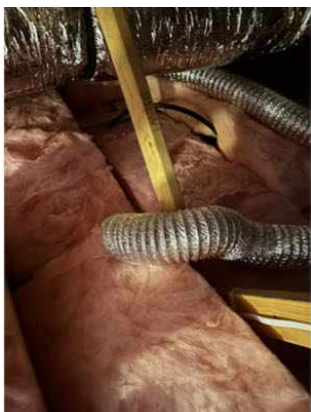
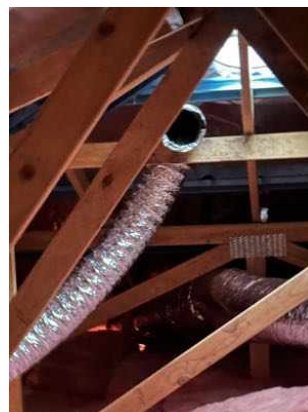
Defects 3.31

Building:	Main Building
Location:	Roof Void
Finding:	Exhaust Fans Not Ducted to Outdoor Air - PCI
Information:	During the inspection, it was observed that the installed exhaust fans within the roof space have not been ducted to discharge directly to outdoor air. Instead, the exhaust vents currently terminate within the roof void. This installation does not comply with the minimum requirements of the National Construction Code and Housing Provisions, which mandate that exhaust systems must be ducted externally to prevent moisture accumulation and protect the integrity of the roof structure.

- NCC 2022, Housing Provisions – Clause 10.8.2: Exhaust systems in kitchens, bathrooms, laundries, and sanitary compartments must discharge directly to outdoor air via a duct or shaft.
- NCC 2022, Volume Two – Part H4D2, Clause 10.8.1: Exhaust systems must not recirculate air into roof spaces or enclosed cavities.
- Guide to Standards and Tolerances 2017, Section 14.10 – Mechanical exhaust systems must be installed to prevent damage to building materials caused by moisture or steam.

All exhaust fans must be ducted to discharge directly to outdoor air in accordance with NCC requirements. This includes all bathroom, laundry, and kitchen exhaust systems. Rectification is required to ensure compliance with the code and to prevent condensation-related damage to the roof space. A follow-up inspection should be carried out to confirm that all ventilation has been appropriately installed.
