Building Inspection Report

Inspection Date: Sat, 10 Jan 2026

Property Address: 39 Monakeeba Bvd, WOODSTOCK, VIC,
3751, Australia

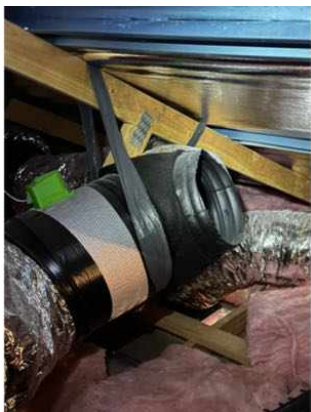
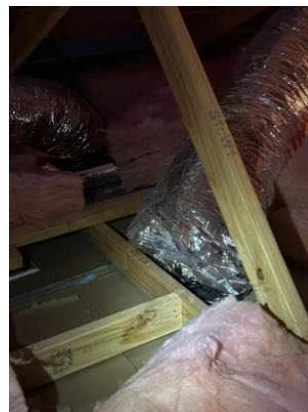
Defects 3.32

Building:	Main Building
Location:	Roof Void
Finding:	Disconnected Air Vent Ductwork Within Roof Space - PCI
Information:	At the time of inspection, an air distribution duct was observed to be disconnected within the roof space. The flexible ducting is not properly sealed or secured to the adjoining fitting, resulting in conditioned air being discharged directly into the roof cavity rather than into the intended habitable space. This installation does not reflect acceptable workmanship or system completion.

Mechanical ventilation and air-conditioning systems must be installed to operate effectively and as intended.

Ductwork must be properly connected, sealed, and supported to prevent air leakage.

Services installations are defective where they are incomplete, improperly fixed, or not operating as intended.

Rectification is required to ensure the ductwork is correctly connected, sealed, and secured so the ventilation system operates efficiently, prevents energy loss, and complies with installation and performance requirements.

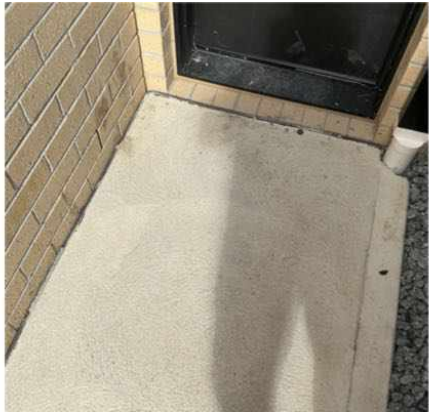
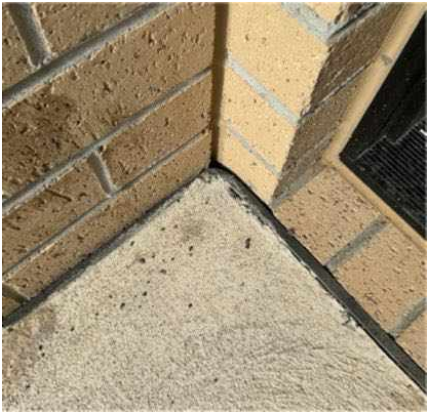
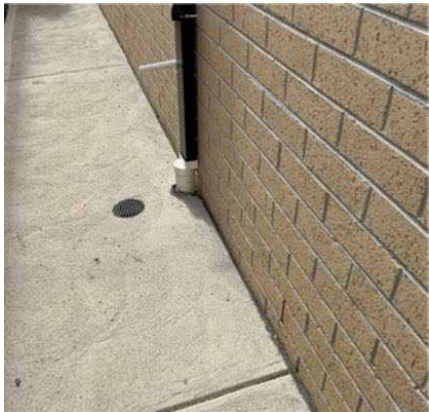
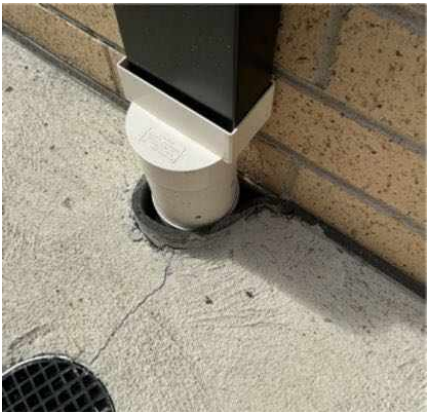
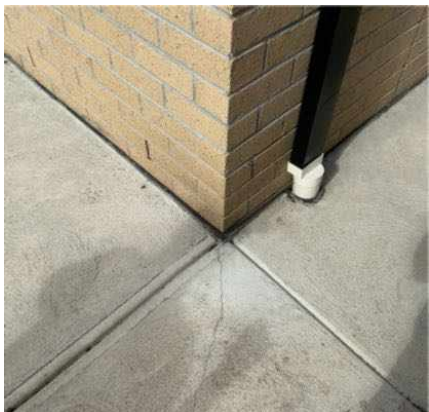
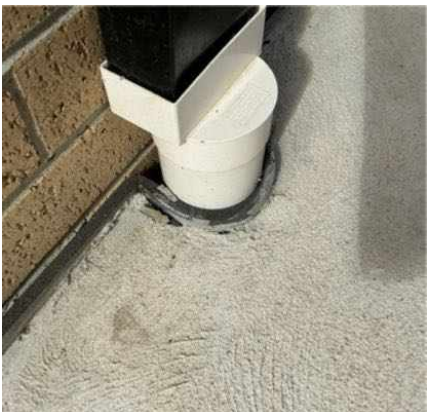
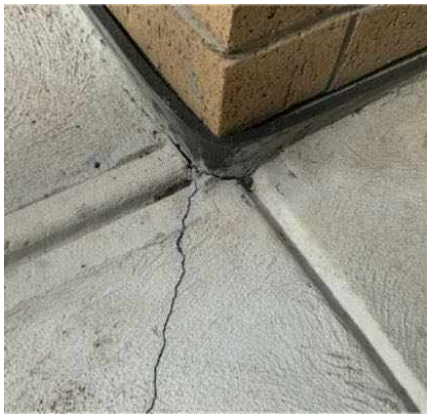
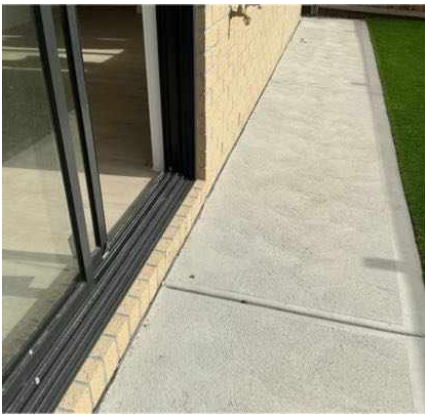
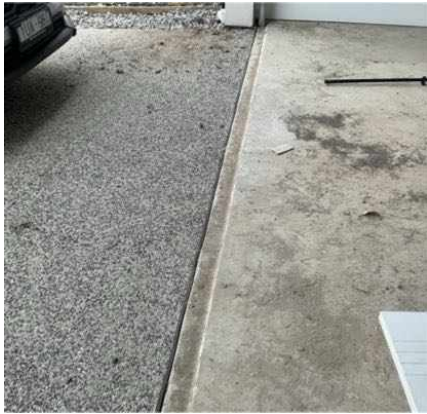
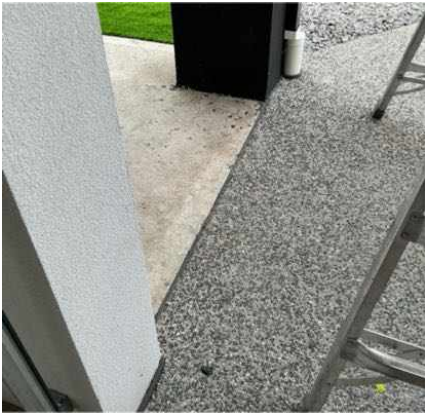
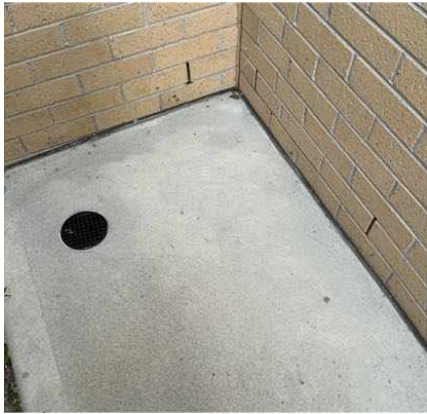
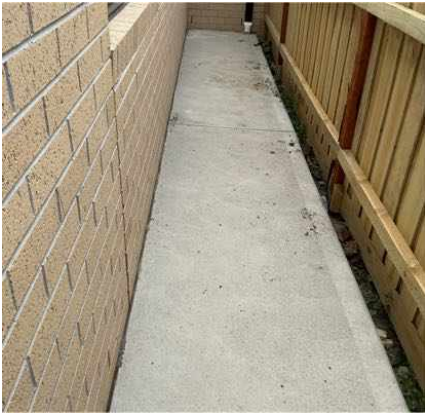
Defects 3.33

Building:	Main Building
Location:	All External Areas
Finding:	Unsealed Perimeter Joints Between Concrete Paths and External Walls - PCI
Information:	During the inspection, it was observed that the perimeter joints between the external concrete paving and the adjacent wall finishes—including brickwork, rendered cladding, door thresholds, and downpipe penetrations—have not been adequately sealed. These joints are critical in allowing for thermal and structural movement between differing materials and in preserving the integrity of the building envelope.

Failure to properly seal these joints can lead to moisture ingress, pest entry, and long-term deterioration of adjoining materials. Furthermore, sealing of such joints is typically a requirement under structural warranty provisions, as it forms part of the builder's obligation to ensure a compliant and durable external envelope.

- AS 3700:2018 – Masonry Structures, Clause 4.7: Requires articulation and perimeter joints to be sealed appropriately to manage expected movement in masonry.
- NCC 2022 Volume Two, Part 3.3.1.8: Specifies that joints in masonry must be sealed using flexible sealant or other proprietary materials to maintain performance and durability.
- Guide to Standards and Tolerances 2022, Clause 2.04: States that unsealed movement joints that compromise performance or allow moisture ingress are deemed

Several photographs have been provided as examples of the observed issue; however, a complete inspection of the perimeter is recommended to identify and address all unsealed joints. These areas should be rectified by applying an appropriate flexible sealant to achieve compliance and maintain building performance.

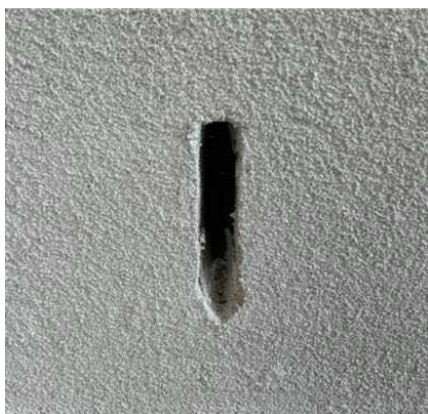
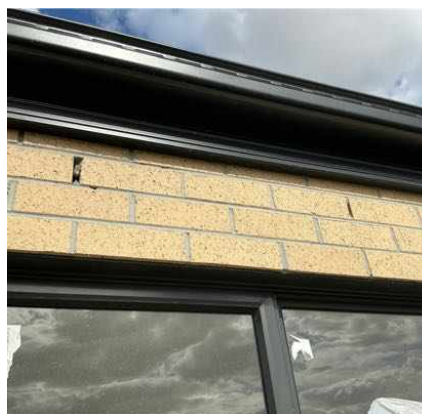
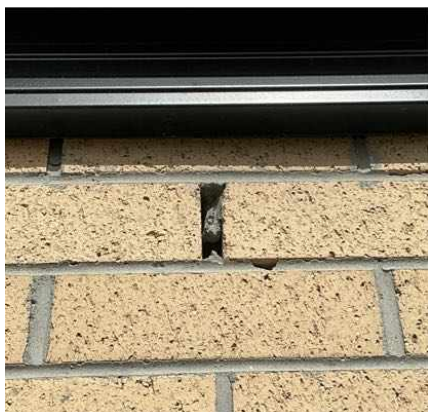
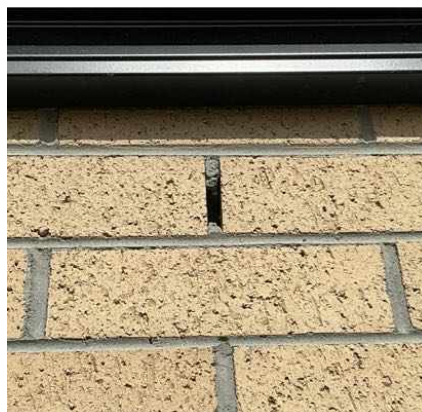
Defects 3.34

Building: Main Building
Location: All External Areas
Finding: Obstructed Weep Holes to External Masonry Walls - PCI
Information: At the time of inspection, multiple weep holes to the external masonry walls were observed to be partially or fully obstructed by applied render, coating finishes, and/or mortar. The obstruction prevents the weep holes from performing their intended function of allowing moisture to drain from the cavity and providing ventilation behind the masonry veneer. This condition was noted at several locations and is inconsistent with acceptable construction practice for masonry wall systems.
Reference:

Requires weep holes to remain clear and functional to facilitate moisture egress from the cavity and reduce the risk of moisture accumulation within the wall system.

Rectification is required to ensure all affected weep holes are cleared, reinstated, and left unobstructed so the masonry wall system functions as intended and complies with NCC and Australian Standard requirements.

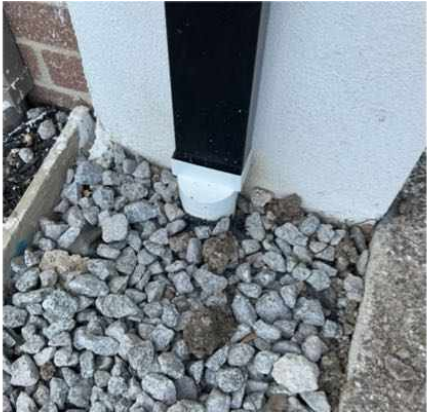
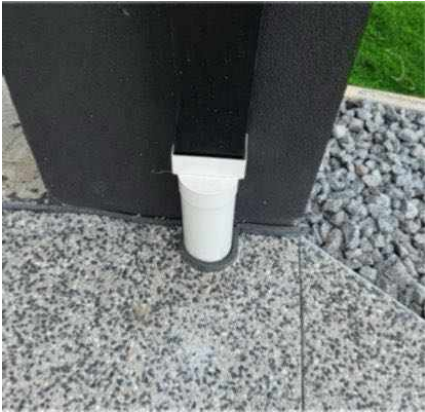
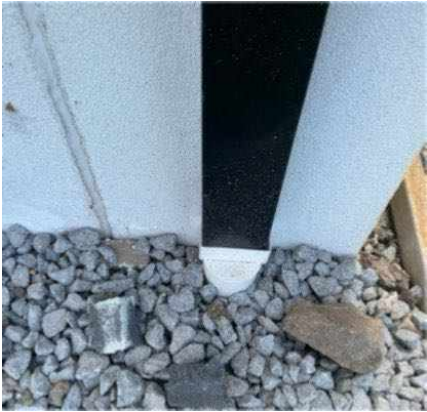
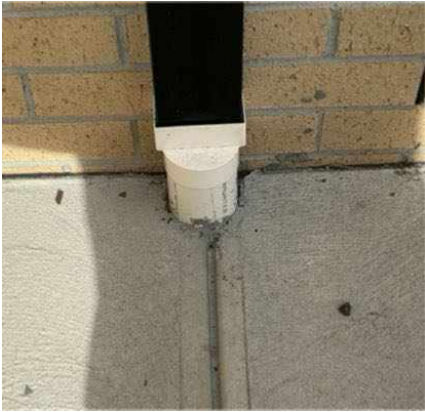
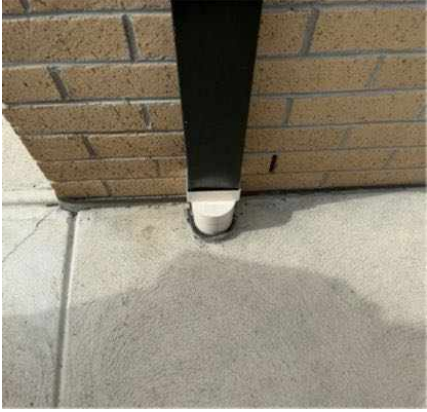
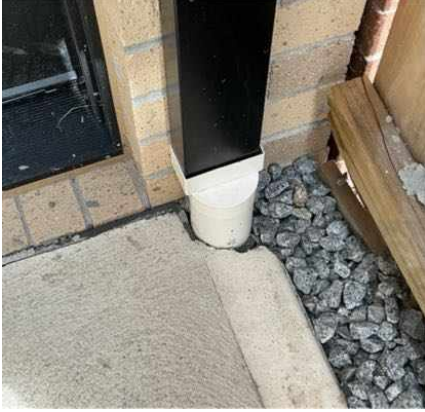
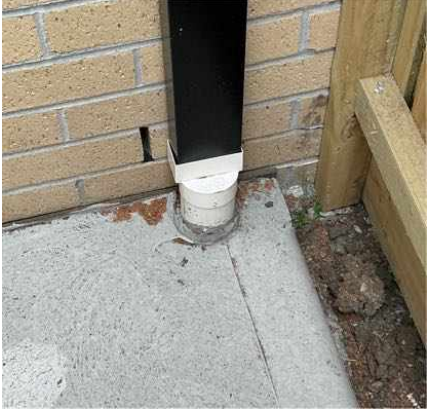
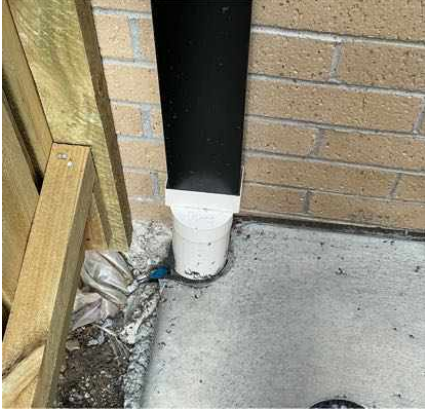
Defects 3.35

Building:	Main Building
Location:	All External Areas
Finding:	Incomplete External Paintwork on PVC Pipes - PCI
Information:	During the inspection, it was noted that one or more external PVC pipes had not been fully painted. This incomplete finish compromises both the visual presentation and the durability of the material. Exterior paint on PVC surfaces serves not only an aesthetic purpose but also provides essential protection against UV exposure, weathering, and staining. Unpainted sections may degrade prematurely, leading to discolouration, surface deterioration, and increased maintenance requirements.

- Guide to Standards and Tolerances 2017, Section 12.02 – Painted surfaces must be consistent, complete, and free of visible defects at handover.
- AS/NZS 2311:2017 – Guide to the Painting of Buildings – Requires that all paintable surfaces be adequately prepared and coated with appropriate systems to ensure performance and protection.

The incomplete paintwork observed does not meet acceptable standards and is considered a defect. All affected PVC surfaces must be properly prepared and coated using an exterior-grade paint system to ensure a uniform and durable finish in

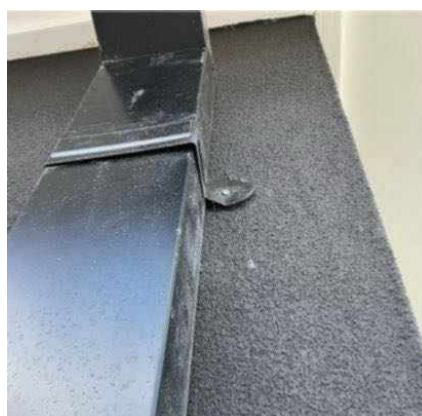
Defects 3.36

Building:	Main Building
Location:	All External Areas
Finding:	Downpipe Brackets – Incorrect Fixings, Poor Installation and Bracket Damage - PCI
Information:	During the inspection, several downpipe brackets were observed to be incorrectly installed. Brackets were noted to be misaligned, inadequately secured, and in some locations fixed using unsuitable or inconsistent fasteners. Evidence of poor installation practice has also resulted in deformation and damage to some brackets. These conditions reduce the ability of the brackets to adequately support the downpipes and may compromise the long-term performance of the stormwater drainage system, particularly during periods of heavy rainfall and wind loading.

- AS/NZS 3500.3:2021 – Plumbing and Drainage – Stormwater Drainage Systems, which requires stormwater pipework and supports to be installed to maintain alignment, stability, and durability.
- NCC 2022 Volume Two – Part 2.2.1, which requires drainage systems to be designed and installed to ensure effectiveness, durability, and structural adequacy.
- Manufacturer installation requirements for downpipe brackets, which require correct fixing types, spacing, and alignment to prevent movement and damage.

Rectification is required to ensure all downpipe brackets are replaced or reinstated where damaged, correctly aligned, and securely fixed using appropriate fixings in accordance with manufacturer requirements and applicable standards to maintain structural support, durability, and drainage performance compliance.

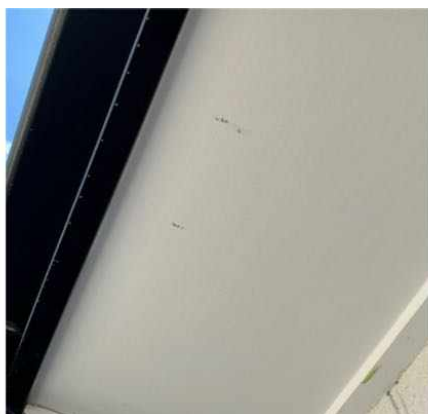
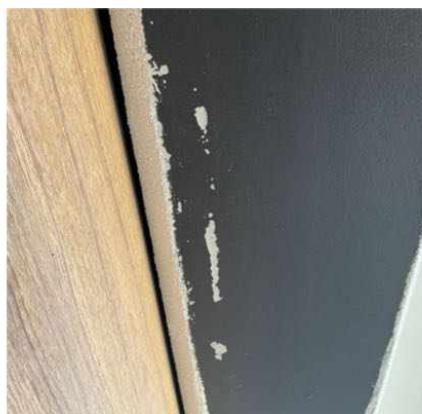
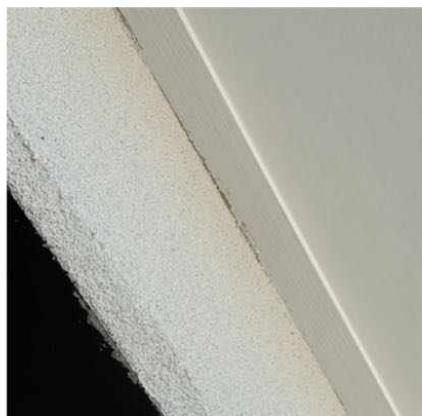
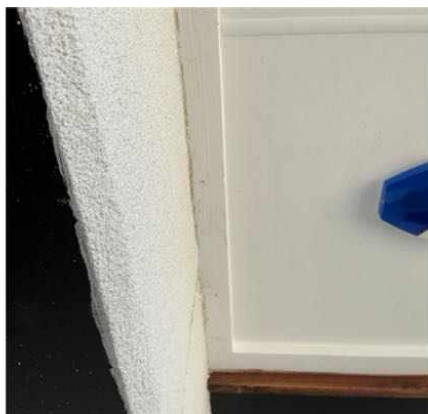
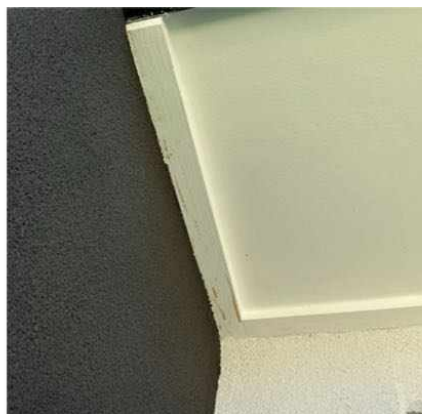
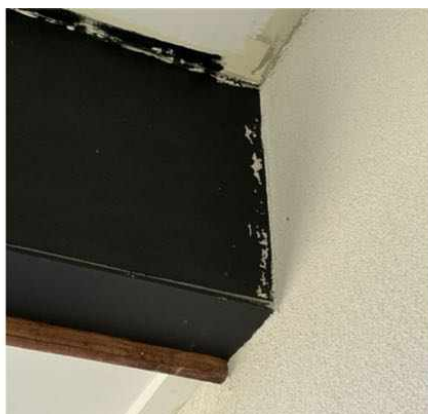
Defects 3.37

Information: During the inspection, it was observed that the external painting of the property had not been completed in several areas, including sections of the façade, trims, and other external elements. These areas present with missing or partial paint coverage, which detracts from the property's appearance and fails to provide adequate protection from weather exposure.

- Guide to Standards and Tolerances 2023, Section 13.02 – Painted surfaces must exhibit a uniform and complete finish when viewed from a normal distance of 1.5 metres under standard lighting.
- AS 2311 – Guide to the Painting of Buildings outlines preparation and application standards necessary to ensure a consistent, durable finish to all painted surfaces.

The current condition does not meet acceptable standards for new residential construction. Rectification is required to complete all external painting in a professional manner, ensuring uniform appearance and weather protection. Supplied photos illustrate examples of the affected areas; a full inspection should be undertaken to ensure all incomplete sections are addressed prior to handover.

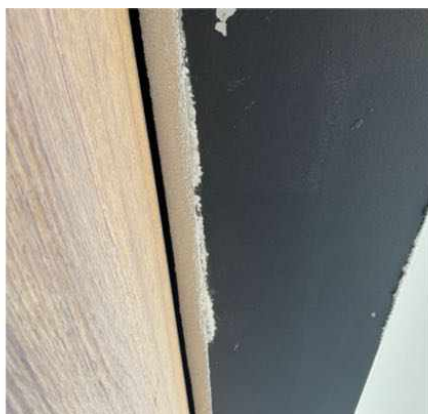
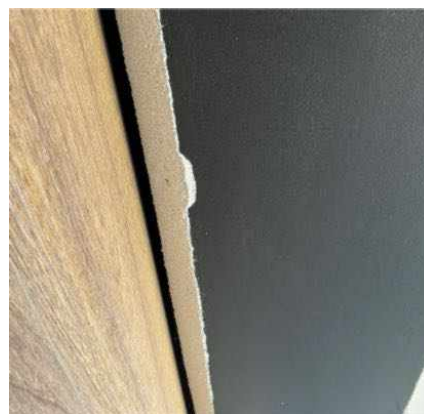
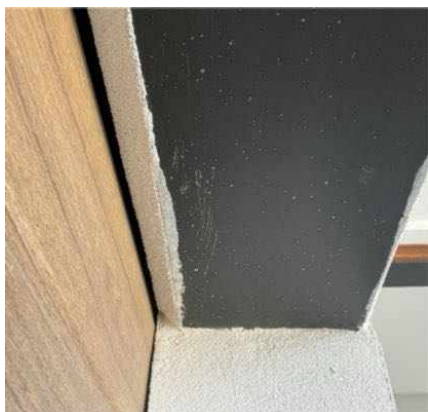
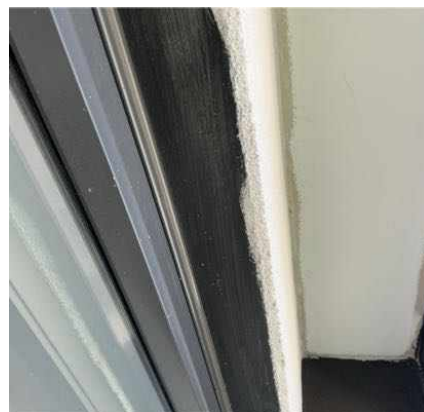
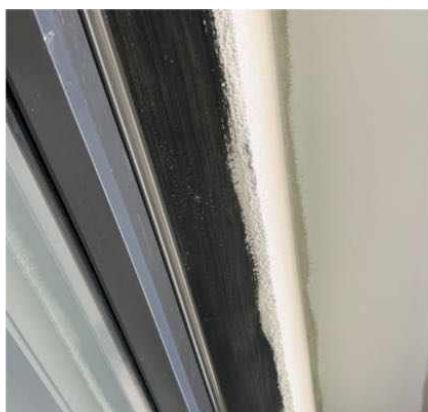
Defects 3.38

Building:	Main Building
Location:	Front Facade
Finding:	Excess Render Build-Up Along Lintels - PCI
Information:	Inspection of the external façade identified excessive and uneven render applied along the lintels above some or all of the windows, doors and garage opening. The render extends beyond the intended edge lines, creating rough, protruding, and inconsistent edges that do not align cleanly with the lintel, window frames, or adjoining wall surfaces. The presentation is irregular and fails to meet the expected standard of finish for a new residential build.

- Guide to Standards and Tolerances 2023 – Section 13.08: External wall finishes are defective where they display uneven, rough, or unsightly workmanship when viewed from a normal viewing position.
- Guide to Standards and Tolerances 2023 – Section 14.02: Cladding and external finishes around openings must be neat, consistent, and correctly aligned with adjacent building elements.

Rectification is required to ensure the render along all affected lintels is cut back, straightened, and finished to a uniform and workmanlike standard consistent with acceptable façade construction.

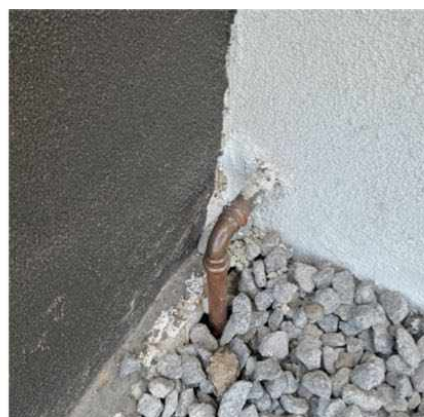
Defects 3.39

Building:	Main Building
Location:	Front Facade
Finding:	Damaged and Inconsistent Rendered Areas - PCI
Information:	During the inspection, visible defects were observed in several rendered areas of the building, including surface marks, chips, scratches, and uneven or compromised sections. These issues detract from the intended finish and fail to meet acceptable construction and presentation standards. Rendered surfaces are required to display a uniform texture, colour, and finish when viewed from a normal distance of 1.5 metres under natural light conditions.
Reference:

- Guide to Standards and Tolerances 2023, Clause 9.09 – Repairs to rendered surfaces must closely match the original in texture, colour, and finish to be considered compliant.
- AS 2311 – Guide to the Painting of Buildings – Requires that surface preparation and finishing result in a consistent and durable appearance.
- NCC 2022 Volume Two, Part 2.1.2 – Materials and finishes must be fit for purpose, maintain durability, and preserve aesthetic integrity.

The current condition is non-compliant and must be professionally rectified. All damaged or poorly finished rendered areas must be repaired to a standard that blends seamlessly with surrounding finishes to restore uniformity and meet regulatory expectations. The attached photographs represent examples only; a full inspection of all rendered surfaces is recommended to identify and address all affected areas.

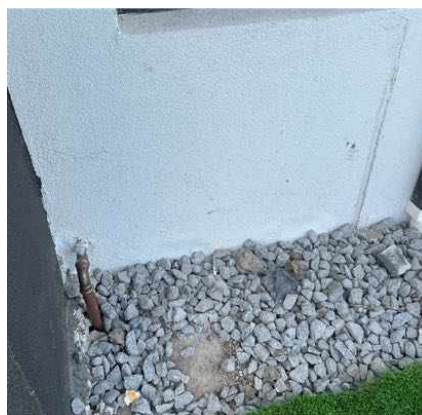
Defects 3.40

Building:	Main Building
Location:	Front Facade
Finding:	Missing and Excessively Spaced Weep Holes to External Masonry Walls - Lock-up/Fix/PCI
Information:	During the inspection, weep holes to the external masonry walls were observed to be missing and/or installed at spacing greater than acceptable construction standards. In several locations, the separation between weep holes exceeds the maximum recommended spacing, and in other areas no weep holes have been provided. This condition was also noted to short wall segments less than 1200 mm in length, where weep holes are still required when cavity flashings are present.
	The absence and excessive spacing of weep holes restricts effective drainage and ventilation of the masonry cavity, increasing the risk of moisture accumulation behind the brick veneer and reducing the long-term durability of the wall system.
Reference:

- NCC 2022 Volume Two – Part 3.3.5.13, which requires weep holes to be provided to masonry walls to allow drainage and ventilation of the cavity.
- AS 3700:2018 – Masonry Structures, which requires weep holes to be installed at maximum 1200 mm centres and to be provided where flashings terminate, including short wall sections.
- Guide to Standards and Tolerances 2023 – Section 2.04, which considers masonry work defective where required weep holes are missing, blocked, or incorrectly spaced.

Rectification is required to ensure weep holes are installed where missing and/or reinstated at compliant spacing, including to short wall segments, so the masonry wall cavity can drain and ventilate as intended and comply with durability and performance requirements.

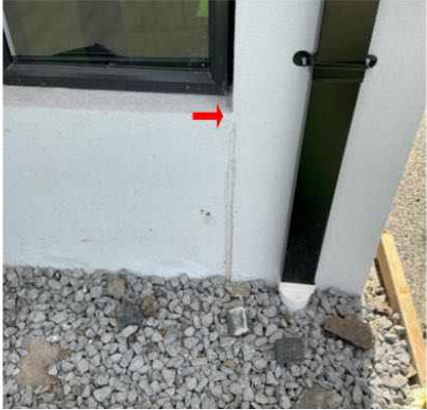
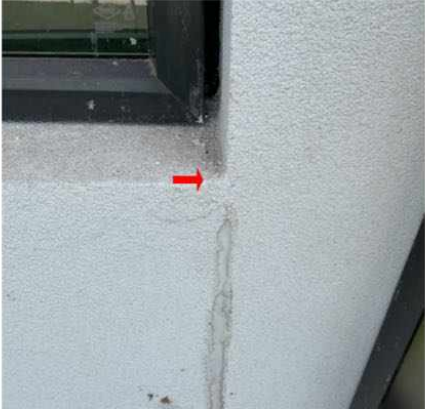
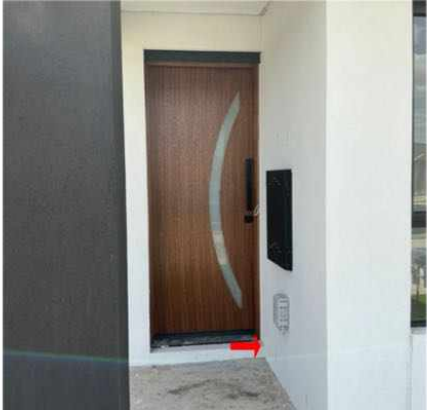
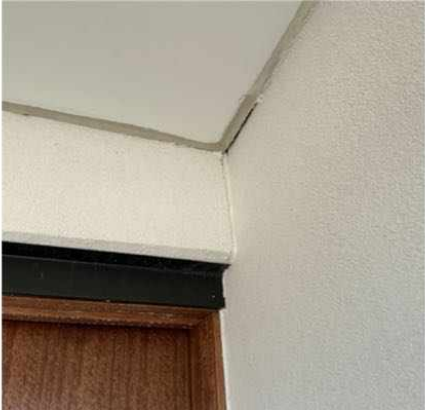
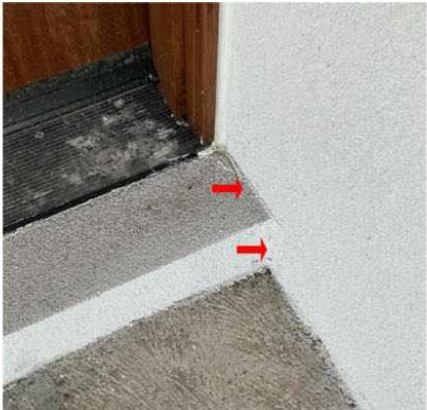
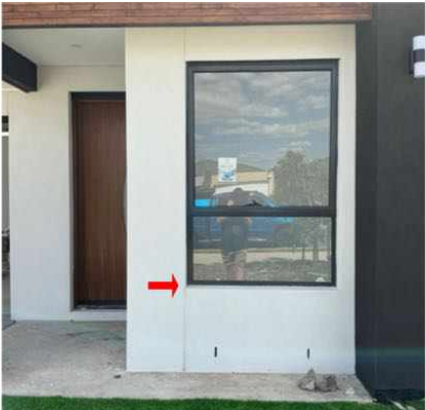
Defects 3.41

Building:	Main Building
Location:	Front Windows
Finding:	Discontinuous Articulation Joint – Rendered Wall
Information:	During the inspection, it was noted that the vertical articulation joint adjacent to the window within the rendered façade is not continuous from the slab rebate to the underside of the eaves. This non-compliant termination disrupts the joint's intended function. Articulation joints are critical for accommodating differential movement and thermal expansion in masonry/rendered systems, and a break in continuity can result in cracking and stress accumulation within the wall structure.

- AS 3700:2018 – Masonry Structures, Clause 5.3.3 – Articulation joints must extend the full height of the wall to effectively relieve stress and prevent cracking.
- Guide to Standards and Tolerances 2022, Clause 3.02 – Masonry, including rendered finishes, must be constructed to minimise cracking associated with building

The current condition does not meet structural or functional requirements. The articulation joint must be reinstated as a continuous element to restore compliance and ensure the long-term integrity of the rendered wall.

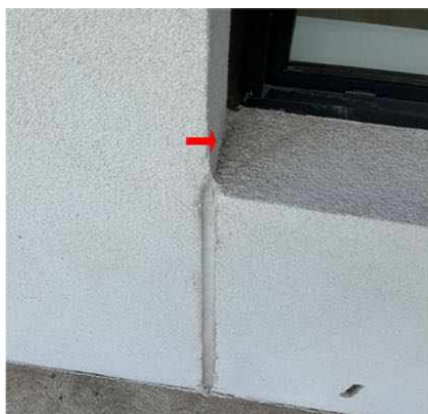
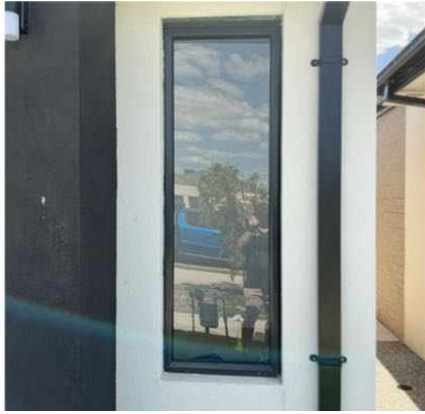
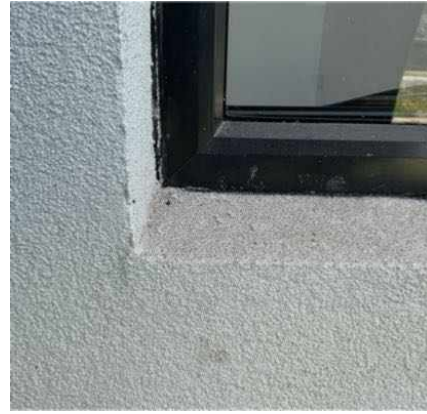
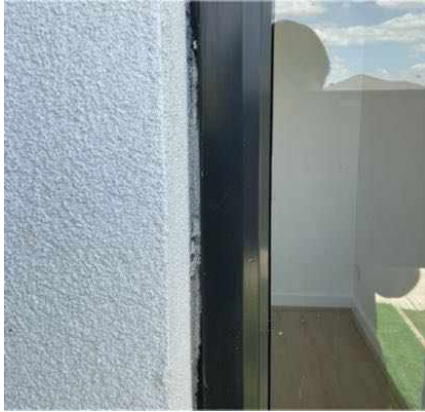
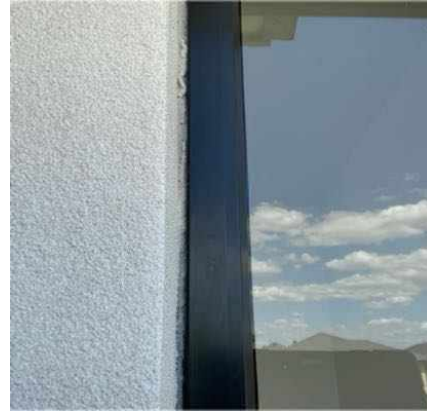
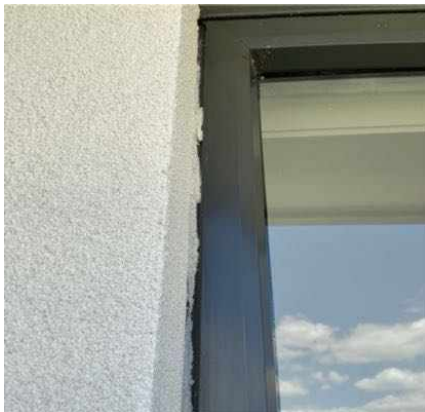
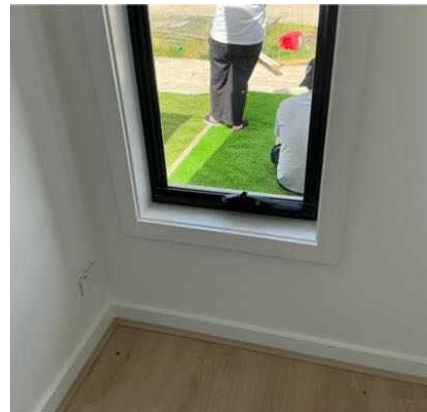
Defects 3.42

Building:	Main Building
Location:	Front Window
Finding:	Front Window Obstructed by Excessive Render Build-Up
Information:	During the inspection, the front window was unable to be opened due to excessive render build-up along the window perimeter. A considerable accumulation of render was also observed along the edge of the aluminium window reveal, restricting the sash movement and interfering with the intended operation of the window.

The render application has not been adequately controlled or trimmed to maintain functional clearances between the window frame and surrounding wall finish. This condition prevents normal window operation and indicates poor workmanship to the window-to-wall interface.

- NCC 2022 Volume Two – Part 3.4.1, which requires windows to be installed so they remain operable and functional.
- AS 2047:2014 – Windows in buildings, which requires windows to operate freely without obstruction from surrounding finishes.
- Guide to Standards and Tolerances 2023 – Section 12.05, which considers windows defective where they cannot be opened or closed correctly due to poor installation or finishing.

Rectification is required to ensure excess render is removed, window clearances are reinstated, and the window can be operated as intended while maintaining an acceptable and durable finished appearance.

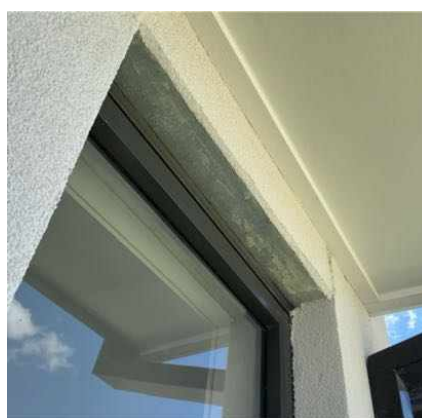
Defects 3.43

Building:	Main Building
Location:	Front Window
Finding:	Unpainted External Galvanised Brick Lintels - PCI
Information:	During the inspection, external galvanised steel brick lintels were observed to be left unpainted. While galvanising provides an initial level of corrosion resistance, it does not provide long-term protection when exposed to weather, moisture, and airborne contaminants. Without a protective paint system, galvanised lintels are susceptible to surface breakdown, white rust formation, and eventual corrosion, which can lead to staining of masonry and deterioration of the lintel over time.

- Guide to Standards and Tolerances 2021 – Section 2.03, which requires exposed metal components to be adequately protected against corrosion.
- NCC 2022 Volume Two – Part 3.5.3, which requires building components to be protected to ensure durability and resistance to environmental exposure.
- AS/NZS 2312.2:2014 – Guide to the protection of structural steel against atmospheric corrosion by the use of protective coatings.

Rectification is required to ensure the lintels are correctly prepared and painted with an appropriate protective coating system, including suitable surface preparation and priming for galvanised steel, to provide long-term corrosion protection and ensure compliance with durability and performance requirements.

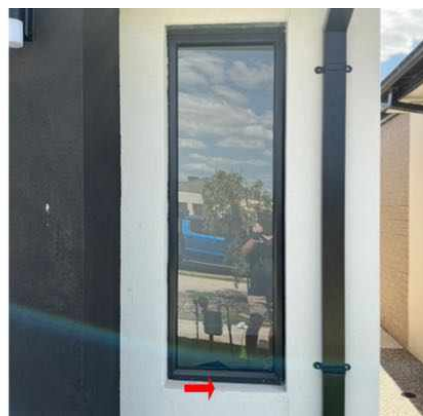
Defects 3.44

Building:	Main Building
Location:	Front Windows & Door
Finding:	Rendered Window and Door Sills Without Fall - PCI
Information:	During the inspection, rendered window and door sills were observed to be finished without a visible fall away from the window and door frames. The sill surfaces appear flat or back-falling toward the frames, which does not allow effective water shedding. This condition increases the likelihood of water ponding against the window and door assemblies and adjacent wall finishes.

Rendered sills are required to be shaped to direct water away from building openings. The absence of fall compromises the weatherproofing performance of the sill detail and increases the risk of moisture penetration into wall systems and frame junctions.

- NCC 2022 Volume Two – Part 3.5.1.6, which requires external wall junctions and openings to be detailed to prevent moisture penetration.

- AS 2047:2014 – Windows in buildings, which requires window installations to prevent water ingress under normal exposure conditions.
- Guide to Standards and Tolerances 2023 – Section 10.04, which considers external finishes defective where sill detailing does not adequately shed water away from openings.

Rectification is required to ensure all rendered window and door sills are re-formed to provide an adequate outward fall and are detailed to effectively shed water away from window and door frames to maintain weatherproofing, durability, and compliance.

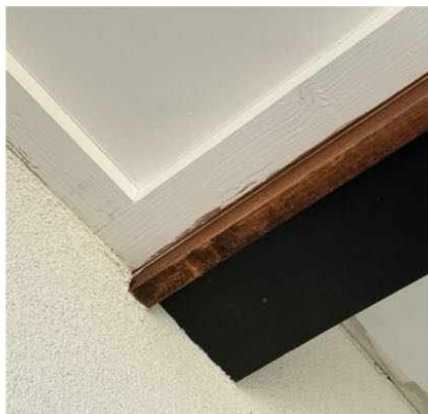
Defects 3.45

Building:	Main Building
Location:	Eave
Finding:	External Paint Marks on Fixtures and Surfaces - PCI
Information:	During inspection, paint marks were observed on external building materials and fixtures, including but not limited to brickwork, downpipes, fascia, and other external finishes. These marks detract from the overall presentation of the dwelling and indicate insufficient protection of adjacent surfaces during painting works. In some instances, marks may also result from trades impacting freshly painted surfaces.
Reference:

- AS 2311:2017 – Guide to the Painting of Buildings, Section 5.3.7 requires that paintwork be neat, with no splashes or smears on adjacent surfaces, and that all surfaces be finished in a clean and workmanlike manner.
- Guide to Standards and Tolerances 2017, Section 13.02 requires finishes to be free of visible blemishes under normal viewing conditions from 1.5 metres.

The current condition is non-compliant. All paint marks must be carefully removed, or the affected surfaces repaired and refinished, to achieve a professional and compliant standard prior to handover. Rectification is required to ensure compliance.

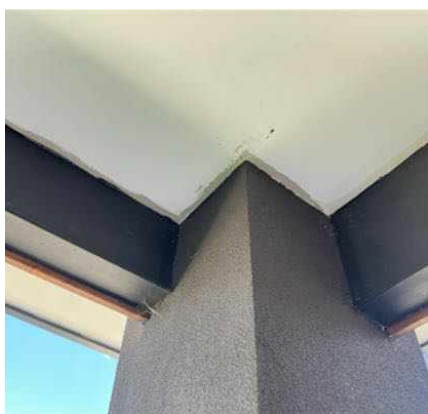
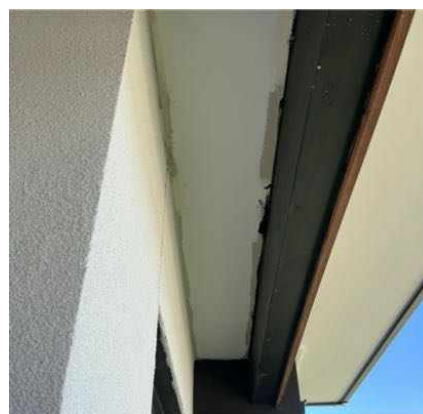
Defects 3.46

Building:	Main Building
Location:	Porch
Finding:	Incomplete Cornice Installation to Porch Area - Fix/PCI
Information:	At the time of inspection, the cornice installation beneath the porch area was observed to be incomplete, with sections missing and terminations not properly finished at wall and ceiling junctions. The cornice does not present as a continuous or fully installed element and exhibits unfinished edges and inconsistent alignment, indicating that the installation has not been completed in accordance with acceptable construction practice.

Cornices are defective if they are missing, incomplete, poorly aligned, or not consistently finished.

Rectification is required to ensure the cornice installation is completed, properly aligned, and uniformly finished to achieve compliance, durability, and an acceptable standard of workmanship.

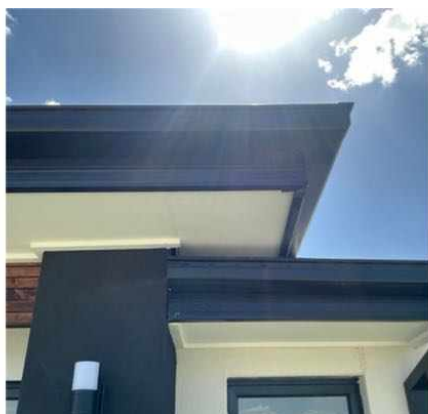
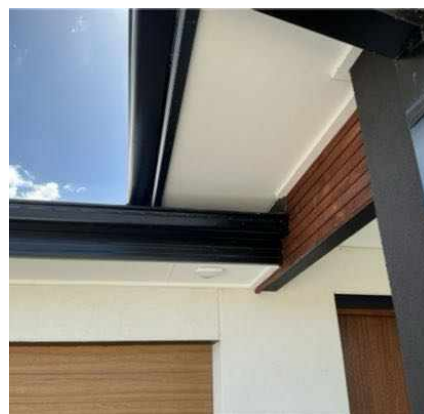
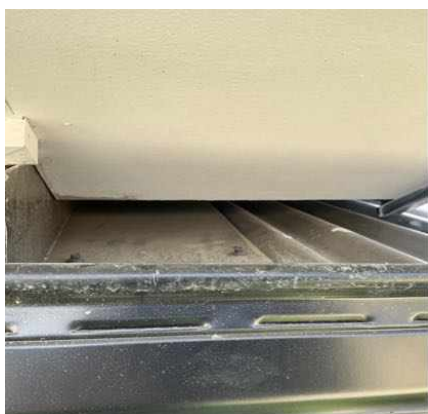
Defects 3.47

Building:	Main Building
Location:	Left & Right Hand of Porch
Finding:	Excessive Gap Between Eave Lining and Roof Sheeting - Fix/PCI
Information:	During inspection of the eaves, an excessive and irregular gap was observed between the underside of the eave lining and the adjacent metal roof sheeting. This gap allows visible daylight penetration into the roof cavity, confirming that the roof space is not adequately enclosed at this location. The condition is not consistent with acceptable construction practice for enclosed eave assemblies and presents multiple risks to the

building envelope, including potential moisture ingress, vermin entry, and thermal inefficiency.

- NCC 2022, Volume Two – Clause 3.5.1.6: Roof construction must prevent the entry of water into the building.
- HB 39:2015 – Installation Code for Metal Roofing and Wall Cladding, Clause 8.6.2: Roof and wall cladding terminations at eaves must be detailed to prevent weather penetration and maintain enclosure.
- Guide to Standards and Tolerances 2023 – Section 13.10: Gaps in external building elements that allow water or pest entry are considered defective if not adequately sealed.

Rectification is required to enclose and seal the junction between the roof sheeting and soffit lining to prevent water penetration, vermin ingress, and heat loss, ensuring compliance with the NCC, installation codes, and acceptable construction standards for weatherproofing and durability.

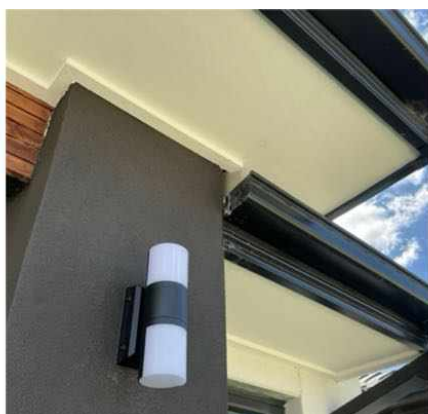
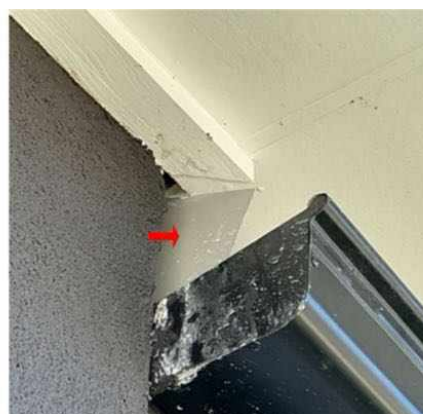
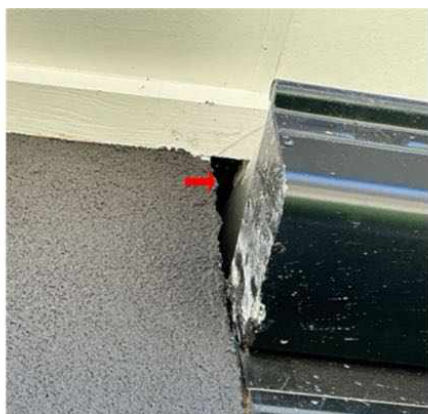
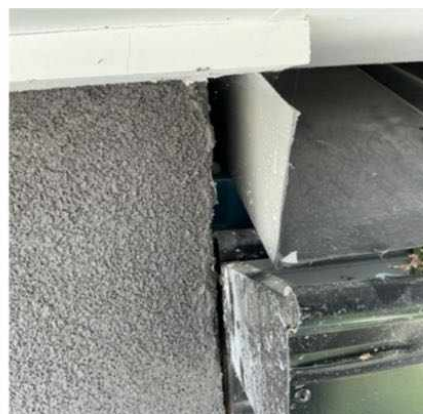
Defects 3.48

Location: Right-hand Porch
Finding: Incomplete and Poorly Terminated Flashing at Eave and Wall Junction
Information: At the time of inspection, the flashing installed at the junction between the external wall, eave lining, and gutter was observed to be excessively long, poorly shaped, and incorrectly terminated. Gaps were present between the flashing and the wall surface, and additional openings were noted extending into the roof void area behind the eave and timber cornice. The flashing does not achieve a close, continuous seal to the adjoining building elements, leaving visible voids and pathways for water, vermin, insects, and wind-driven moisture to enter the roof cavity and wall system.

- NCC 2022 Volume Two – Part 3.5.1.6, which requires external wall junctions and penetrations to be weatherproofed to prevent water ingress.
- AS 1562.1:2018 – Design and installation of sheet roof and wall cladding, which requires flashings to be correctly formed, fitted, and sealed to provide effective weather protection.
- Guide to Standards and Tolerances 2023 – Section 9.03, which states that flashings must be properly installed, neatly finished, and effectively prevent moisture entry.

Rectification is required to ensure the flashing is correctly trimmed, reshaped, sealed, and terminated to eliminate gaps, prevent water and vermin entry, and ensure the junction complies with weatherproofing, durability, and compliance requirements.

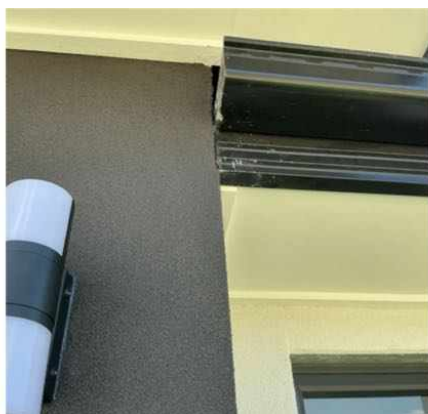
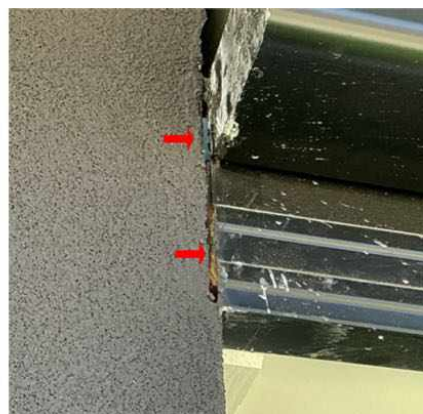
Defects 3.49

Building:	Main Building
Location:	Right-hand Porch
Finding:	Incomplete Fascia Termination and Exposed Timber at Fascia to Rendered Wall Junction
Information:	During the inspection, the fascia was observed to terminate without a proper end closure at its junction with the rendered wall. A visible gap is present between the fascia and the wall, exposing underlying timber framing. The fascia edge has not been sealed or finished to provide a continuous weather-resistant barrier. This condition allows direct exposure of timber components to weather and moisture ingress and does not represent an acceptable standard of external detailing.

- NCC 2022 Volume Two – Part 3.5.1, which requires external building elements to be constructed to prevent the penetration of moisture and to protect structural components.
- NCC 2022 Volume Two – Part 3.5.3, which requires materials to be protected from deterioration due to environmental exposure.
- Guide to Standards and Tolerances 2021 – Section 2.02, which considers external finishing defects unacceptable where components are incomplete, poorly detailed, or expose underlying materials.
- AS 1562.1:2018 – Design and installation of sheet roof and wall cladding, which requires proper termination and sealing of metal components.

Rectification is required to ensure the fascia is correctly terminated, sealed, and finished, and that all exposed timber is fully protected to prevent moisture ingress, deterioration, and long-term durability issues.

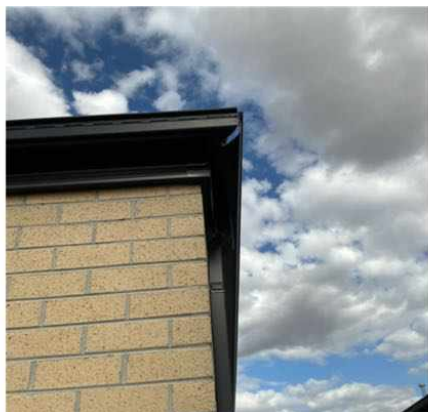
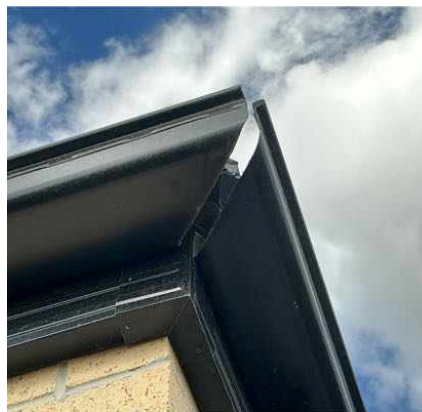
Defects 3.50

Building:	Main Building
Location:	Rear Right-hand Gutter
Finding:	Missing Gutter Corner Bracket to External Gutter Junction - PCI
Information:	During the inspection, it was observed that the external gutter corner junction has been left without the required corner bracket. This bracket forms part of the finished gutter system and is necessary to secure, support, and seal the gutter junction. In its current condition, the gutter corner is incomplete and inadequately supported.

The absence of the corner bracket prevents the gutter from being properly fixed and sealed at the junction. This condition allows for movement, increases the likelihood of sagging over time, and creates a high risk of water leakage at the joint. As installed, the gutter system cannot be considered complete or compliant, as the junction is not finished in accordance with accepted construction practice or manufacturer installation requirements.

- NCC 2022 Volume Two – Part 3.5.3, which requires roof drainage components to be installed to prevent water penetration and ensure durability and performance.
- AS/NZS 3500.3:2021 – Stormwater Drainage, which requires gutter systems to be adequately supported, securely fixed, and installed to allow effective drainage without leakage.
- Guide to Standards and Tolerances 2022 – Section 12.08, which considers gutter systems defective where fixings or components are missing, loose, or not properly installed.

Rectification is required to ensure the correct gutter corner bracket is installed so the gutter junction is properly supported, sealed, and finished, to prevent leakage, sagging, and non-compliant stormwater performance.

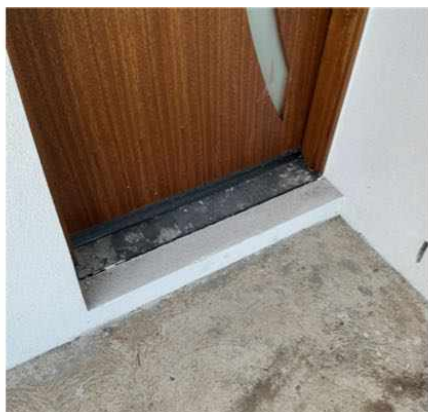
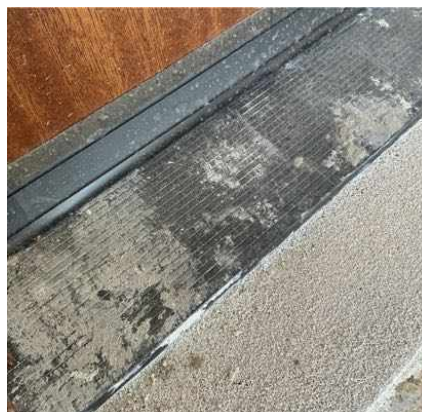
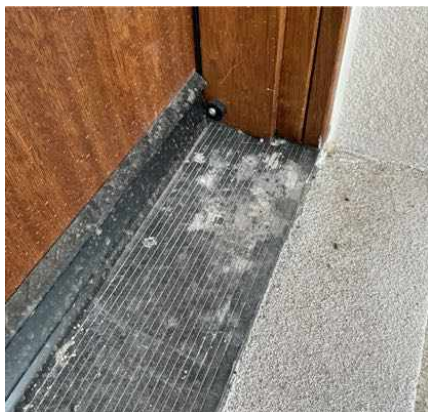
Defects 3.51

Building:	Main Building
Location:	Entry
Finding:	Unclean External Door Sills - PCI
Information:	During the inspection, it was observed that the external bottom door sills have not been adequately cleaned. Visible construction residue, dirt, and mortar remnants remain on the threshold areas, detracting from the finished presentation and leaving the sills in an unacceptable condition for handover.

- Guide to Standards and Tolerances 2017, Section 2.02 – Building work is to be completed to a standard that allows for cleaning and maintenance, free from visible construction residue at handover.
- Guide to Standards and Tolerances 2017, Section 13.09 – External finishes and fittings should be free of builder's debris and construction-related marks at completion.

All external door sill areas must be thoroughly cleaned of debris and construction materials to restore a

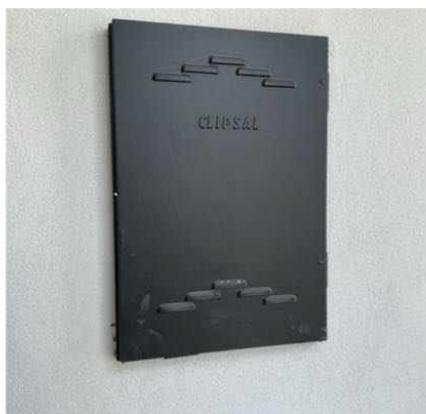
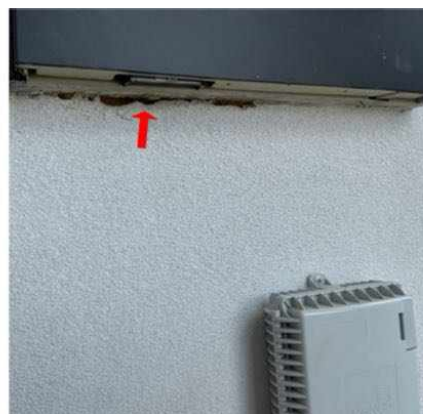
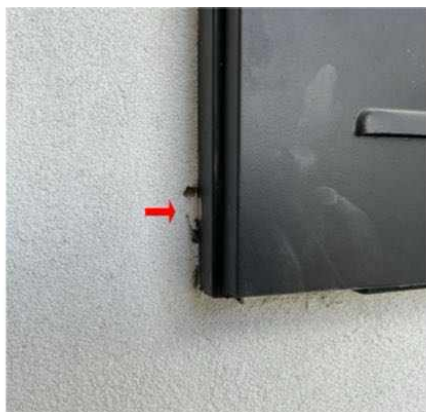
Defects 3.52

Building: Main Building
Location: Porch
Finding: Electrical Meter Box – Perimeter Sealing and Render Termination Defects - PCI
Information: At the time of inspection, the external electrical meter box was observed to have the surrounding render and/or brickwork finished hard against the meter box perimeter, with no flexible sealant joint provided. This installation method does not allow for differential movement between the metal meter box and wall surface, and the current finish is likely to crack and deteriorate over time.

- NCC 2022 Volume Two – Part 3.5.1.6, which requires external wall openings and service penetrations to be weatherproofed to prevent moisture ingress.
- AS 3000:2018 – Electrical Installations, Clause 1.7 and Section 5, which require electrical equipment enclosures to be installed so that they remain protected from moisture entry and environmental exposure.
- Guide to Standards and Tolerances 2023 – Section 10.04, which states that junctions between different materials must be neatly finished and appropriately sealed to allow for movement and prevent cracking or moisture penetration.

Rectification is required to ensure the meter box perimeter is correctly detailed with a flexible sealant joint and the installation is weatherproofed to maintain durability, prevent cracking, and ensure ongoing compliance.

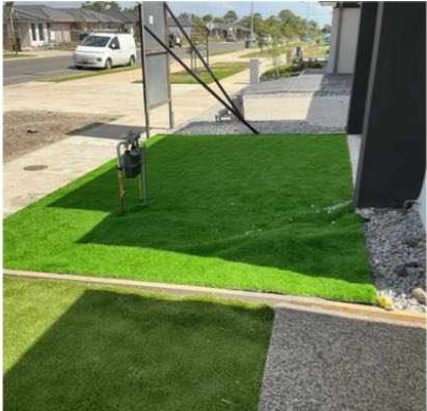
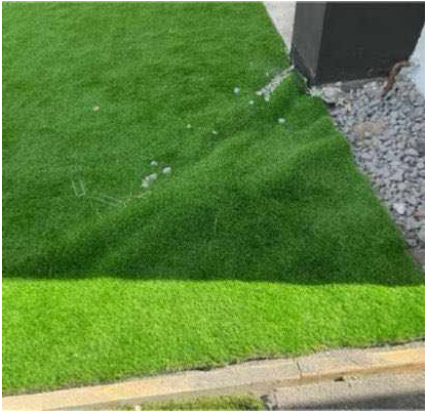
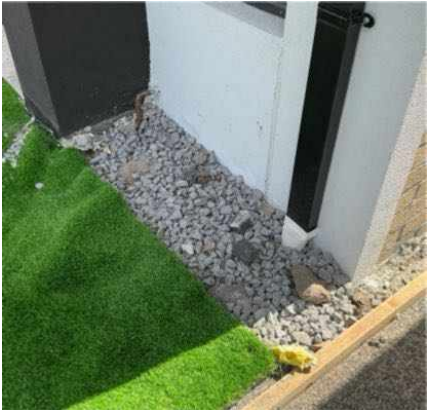
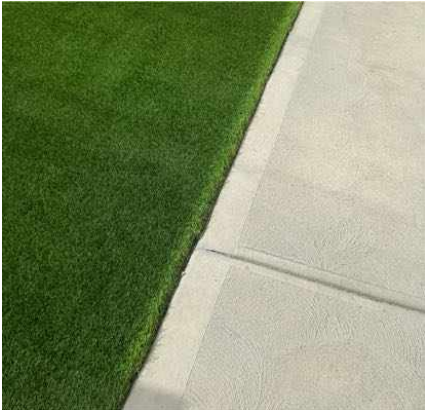
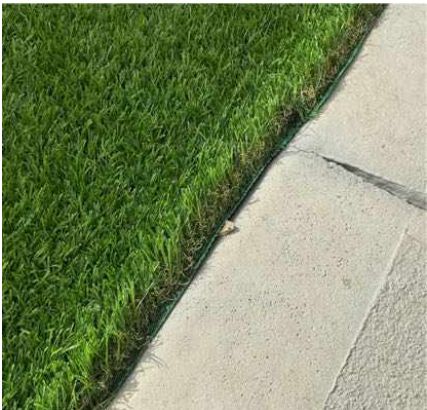
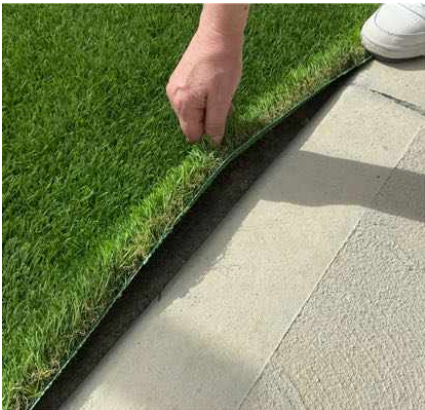
Defects 3.53

Building:	Main Building
Location:	Front & Rear Yard
Finding:	Poorly Installed Artificial Turf and Incomplete Landscaping
Information:	During the inspection, the artificial turf to the rear external area was observed to be poorly installed and incompletely finished. Sections of turf were not adequately secured at the perimeter edges, particularly near adjoining paths and boundaries, leaving the turf susceptible to lifting and movement. In several locations, the turf installation was not carried through to a clean termination, resulting in uneven edges and exposed gaps. The unsecured turf presents a potential trip hazard and indicates incomplete landscaping works.

- Guide to Standards and Tolerances 2023 – Section 14.03, which requires landscaping works to be completed in a proper and workmanlike manner.
- Guide to Standards and Tolerances 2023 – Section 13.02, which requires finishes to present a reasonable standard consistent with new residential construction.
- NCC 2022 Volume Two – Part 3.1.2, which requires external surfaces to be safe, stable, and not create hazards to occupants.

Rectification is required to ensure the artificial turf is correctly secured at all perimeter edges, landscaping works are completed, and the area is finished to a compliant, durable, and safe standard.
