Building Inspection Report

Inspection Date: Sat, 10 Jan 2026

Property Address: 39 Monakeeba Bvd, WOODSTOCK, VIC,
3751, Australia

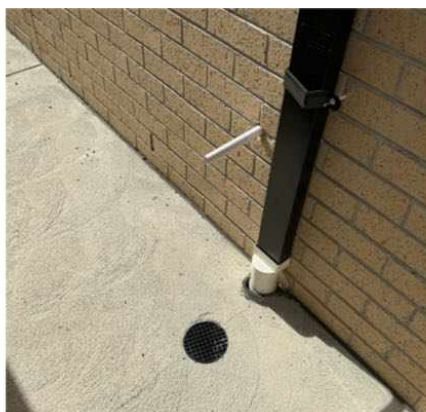
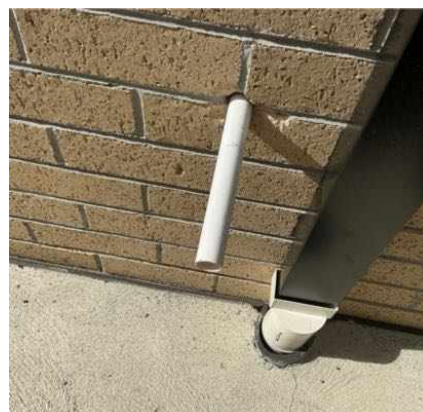
Defects 3.54

Building: Main Building
Location: Left-hand Side
Finding: Air Conditioner Condensate Not Drained to Approved Point - PCI
Information: The air conditioning condensate drain line is not plumbed to a compliant drainage point and currently discharges to an uncontrolled or inappropriate location. This

condition does not meet drainage compliance requirements and may result in surface staining, moisture damage, or nuisance pooling.

- AS/NZS 3500.2:2021 – Plumbing and Drainage – Sanitary Plumbing and Drainage, Clause 13.6: Requires connection of condensate discharge to an approved point of disposal
- NCC 2022 Volume Two, Part B2.2.2 & B2.4.2: Services must be installed in a way that avoids adverse impacts to the building
- Manufacturer installation requirements (as required under NCC Clause A2G2): Mandate proper drainage of condensate to protect system performance and building fabric

The current discharge arrangement is not compliant and may contribute to deterioration of adjacent surfaces or finishes. The condensate line must be redirected to a compliant drain point in accordance with AS/NZS 3500 and NCC requirements to ensure ongoing functionality and compliance.

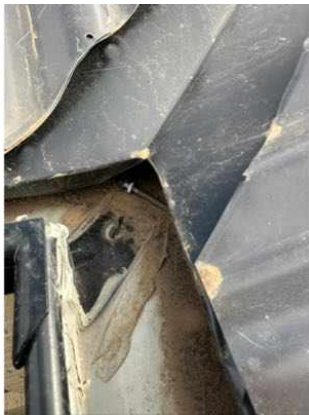
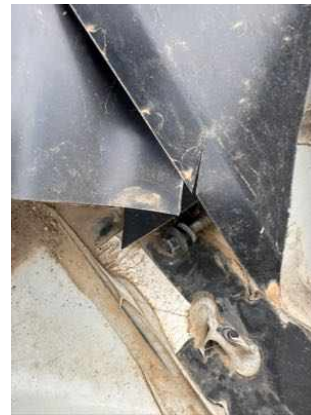
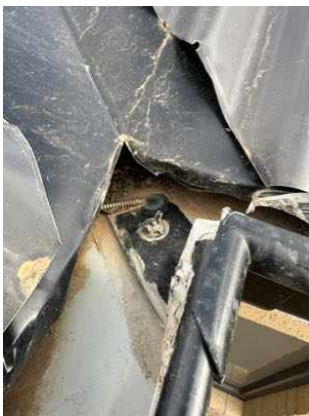
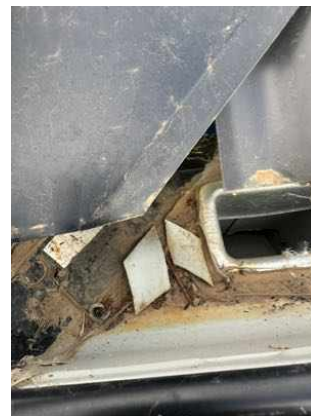
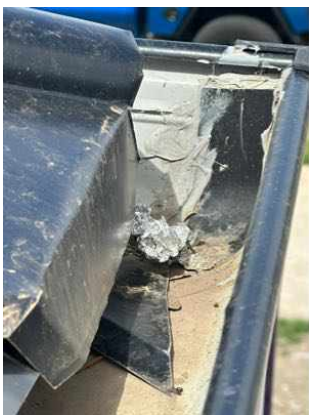
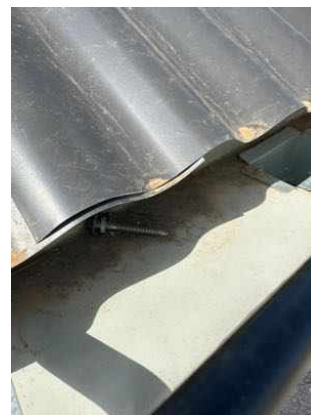
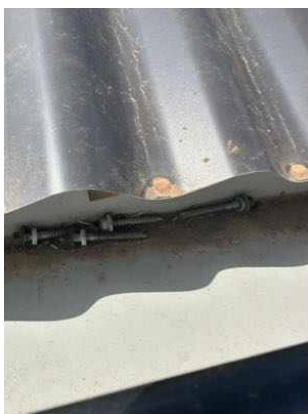
Defects 3.55

Building:	Main Building
Location:	Roof Exterior
Finding:	Residual Construction Debris in Gutters - PCI
Information:	During the inspection, residual construction debris, including metal particles, screws, and other waste materials, was observed within the gutters. The attached photographs serve as an example only and may not represent the full extent of the issue. This condition indicates inadequate post-installation cleaning and presents a risk of premature corrosion, blockages, staining, and compromised drainage performance.

- Clause 8.4.4 – All swarf, fasteners, and construction debris must be removed from gutters at the completion of installation to prevent corrosion and ensure effective drainage.

The current condition does not comply with HB 39 requirements and must be rectified by thoroughly cleaning all gutter areas to remove residual debris and restore full functionality.

Rectification is required to ensure compliance.

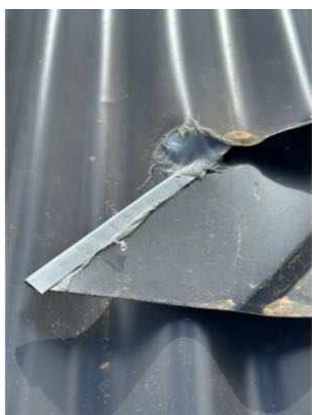
Defects 3.56

Building:	Main Building
Location:	Roof Exterior
Finding:	Poor Termination and Sealing of Roof Sheet to Valley Junction
Information:	During the inspection, the junction between the metal roof sheeting and the valley flashing was observed to be poorly detailed. The roof sheet has been cut back unevenly and terminates inconsistently against the valley, resulting in an irregular junction.

The junction relies predominantly on sealant to achieve weatherproofing. The sealant application is irregular, excessive in some areas, and absent in others, and does not provide a continuous or uniform seal. The roof sheet does not achieve a consistent or controlled termination relative to the valley, creating conditions that are vulnerable to water tracking, capillary action, and debris accumulation.

- NCC 2022 Volume Two – Part 3.5.1, which requires roof coverings and flashings to be installed to prevent water penetration.
- AS 1562.1:2018 – Design and installation of sheet roof and wall cladding, which requires roof junctions to be formed and installed to maintain long-term weatherproofing and drainage performance.
- NCC 2022 Volume Two – Part 10.7.1, which requires building components to be installed in a proper and workmanlike manner.

Rectification is required to ensure the roof sheet termination to the valley is reconstructed with consistent alignment, correct termination detailing, and a compliant waterproofing junction that does not rely on sealant as the primary means of weatherproofing, in order to ensure durability and compliance.

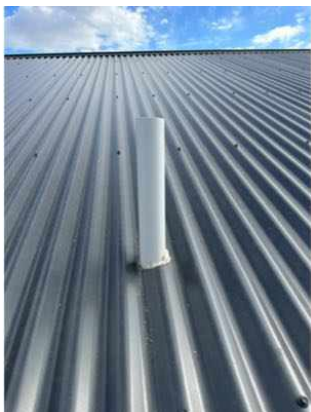
Defects 3.57

Building:	Main Building
Location:	Roof Exterior
Finding:	Uncapped Sanitary Vent Pipe and Non-Compliant Roof Penetration Detailing
Information:	During the inspection, the sanitary vent pipe penetration through the metal roof sheeting was observed to be non-compliant. The pipe terminates without a fitted vent cowl or cap, and the penetration has not been provided with a proprietary flashing boot. The junction between the pipe and roof sheeting has been sealed using sealant only, which does not provide a durable or compliant weatherproofing method.

Sealant alone is not an acceptable primary weatherproofing system for roof penetrations and is prone to early deterioration due to UV exposure, thermal movement, and material incompatibility. The absence of a flashing boot and vent cap increases the risk of water ingress, debris entry, odour issues, and potential blockage of the sanitary vent system.

- NCC 2022 Volume Two – Part 3.5.1, which requires roof coverings and penetrations to prevent water penetration into the building.
- AS 1562.1:2018 – Design and installation of sheet roof and wall cladding, which requires roof penetrations to be weatherproofed using suitable proprietary flashings.
- AS/NZS 3500.2:2021 – Plumbing and Drainage, which requires sanitary vent pipes to terminate with suitable protection against obstruction and weather entry.
- NCC 2022 Volume Two – Part 10.7.1, which requires components to be installed in a proper and workmanlike manner to ensure durability and performance.

Rectification is required to ensure a compliant flashing boot is installed to the roof penetration and a suitable vent cap or cowl is fitted to the sanitary vent pipe to restore weatherproofing, durability, and compliance.

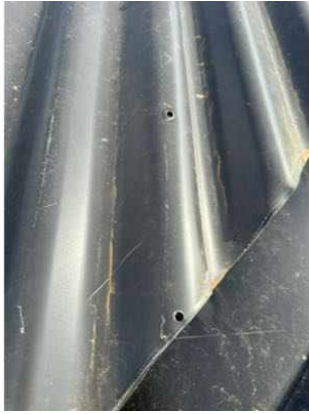
Defects 3.58

Building:	Main Building
Location:	Roof Exterior
Finding:	Open Fixing Holes in Roof Sheetting - PCI
Information:	During the inspection, multiple holes were observed in the roof sheeting where fixing screws have been removed and not reinstated. These openings penetrate the roof cladding and remain unsealed, allowing a direct pathway for water ingress into the roof space. The exact reason for the screw removal could not be determined at the time of inspection.

Open penetrations in roof sheeting compromise the weatherproofing performance of the roofing system and increase the risk of moisture entry, corrosion of surrounding materials, deterioration of insulation, and potential internal water damage.

- NCC 2022 Volume Two – Part 3.5.1, which requires roof coverings to prevent the penetration of water into the building.
- AS 1562.1:2018 – Design and installation of sheet roof and wall cladding, which requires fixings and penetrations to be installed and sealed to maintain weather tightness.
- NCC 2022 Volume Two – Part 10.7.1, which requires building components to be installed in a neat, durable, and workmanlike manner.

Rectification is required to ensure all unused fixing holes are correctly sealed or the roof sheeting replaced as necessary to restore full weatherproof integrity and ensure compliance with durability and performance requirements.

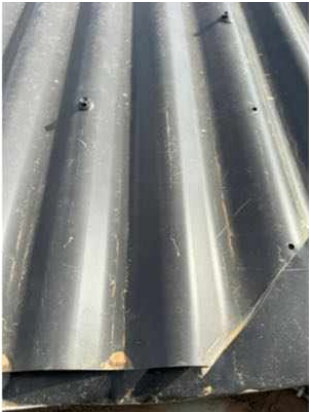
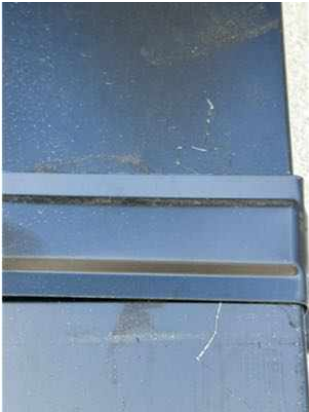
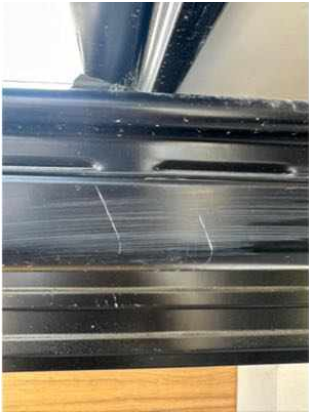
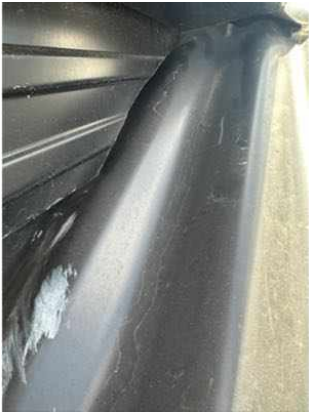
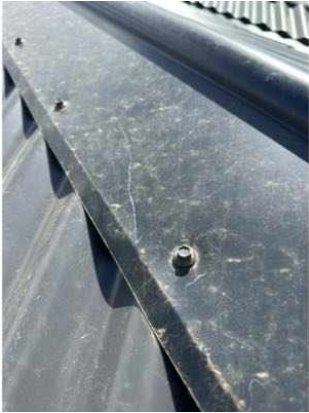
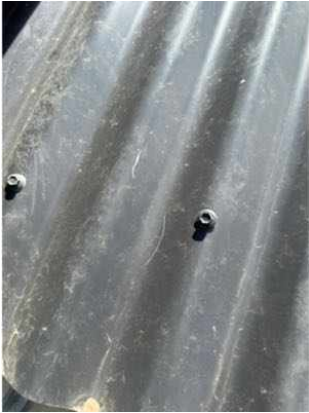
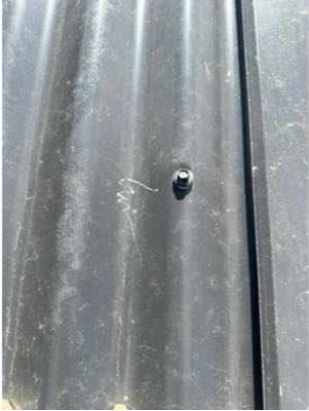
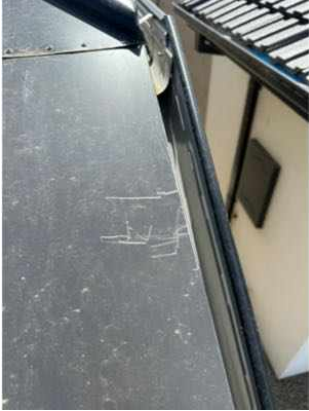
Defects 3.59

Building:	Main Building
Location:	Roof Exterior
Finding:	Scratches to Roof Sheeting , Gutters and Flashings - Lock-up/Fix/PCI
Information:	During the inspection, multiple scratches were observed across the roof sheeting, gutters and associated flashings. The photos provided are a sample only and do not represent the full extent of the issue, which was noted to be widespread. Scratches compromise the protective surface coating of the roof materials, increasing the risk of premature corrosion, particularly in exposed or weather-prone areas.

Specifies that surfaces must not be damaged during installation and that protective coatings must remain intact to ensure service life.

State that scratches and surface damage must be repaired promptly using approved methods to maintain the warranty and corrosion resistance.

Failure to repair or replace scratched roof and flashing surfaces may void the manufacturer's product warranty, leaving the homeowner liable for premature deterioration and costly repairs.

The current condition is non-compliant and requires rectification. Scratched areas must be repaired or replaced to restore protective coatings, preserve manufacturer warranty, and ensure compliance with NCC, Australian Standards, and manufacturer specifications.
