Building and Timber Pest Inspection Report

Inspection Date: Thu, 22 Jan 2026

Property Address: 156A Old Canterbury Rd, Summer Hill NSW
2130, Australia

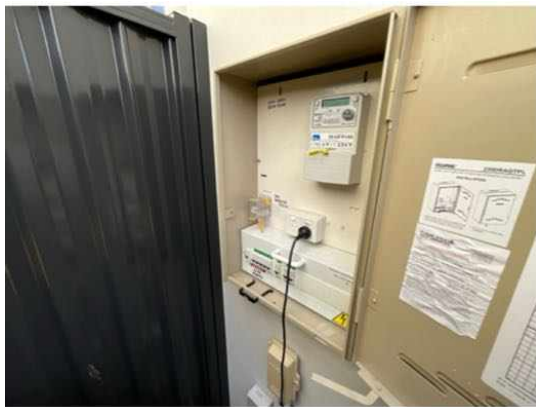
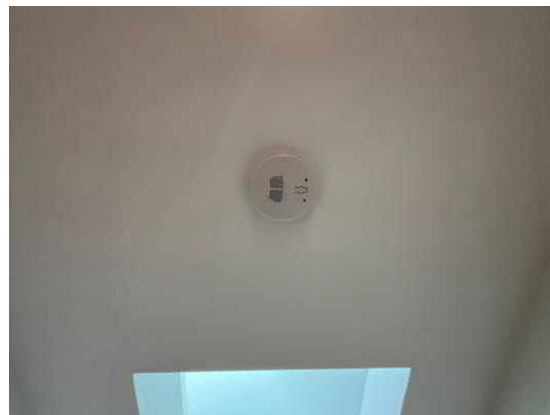
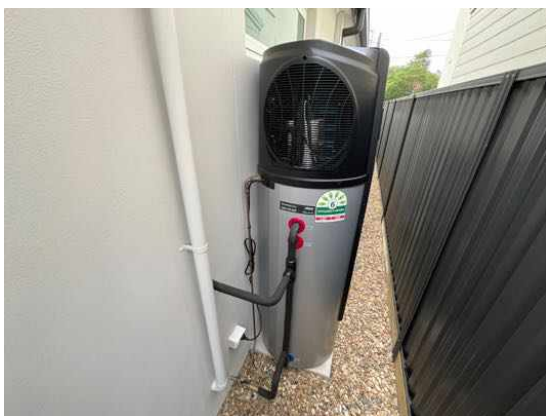
Building: Main Building
Location: All Areas
Finding: Photos Added
Information: Additional photos are provided for your general reference.

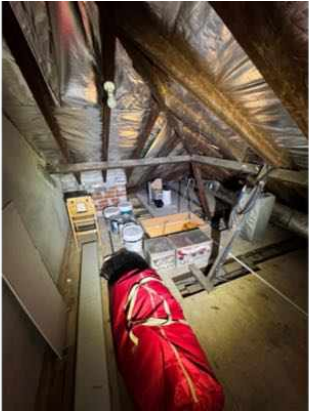
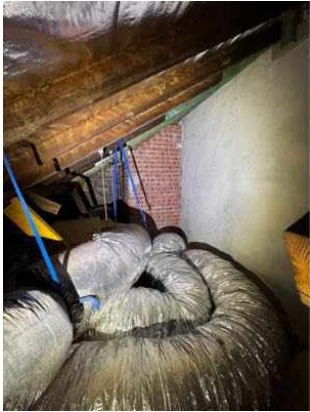
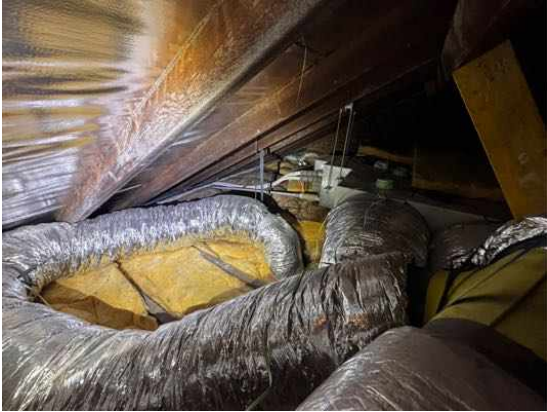
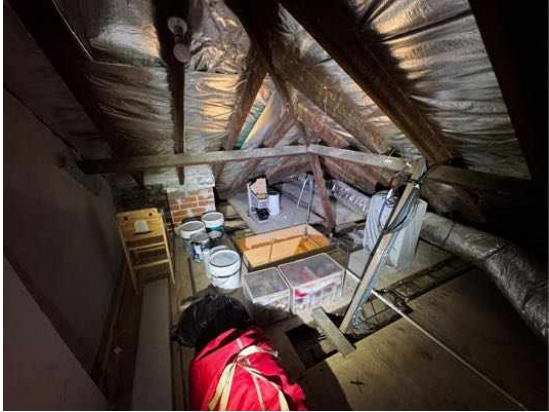
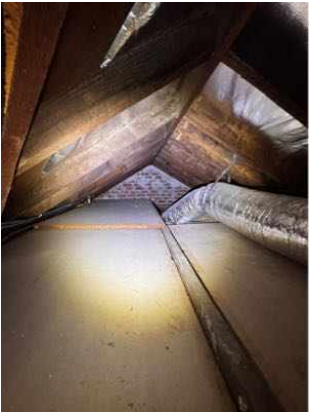
Building: Main Building
Location: Roof Void
Finding: Photos Added
Information: Additional photos are provided for your general reference.

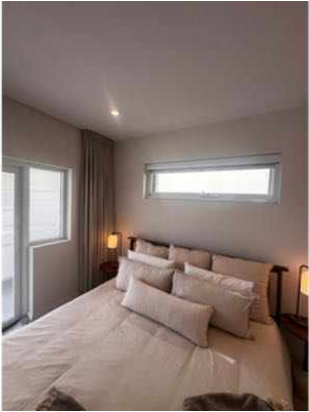
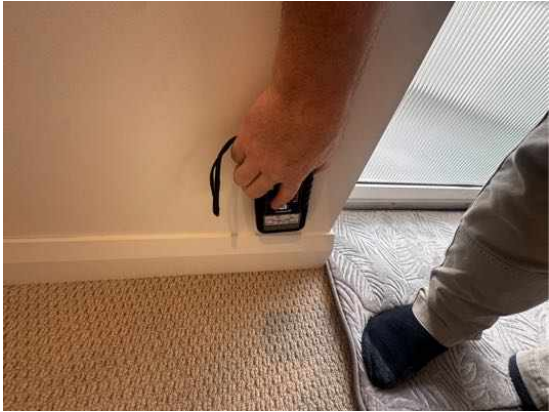
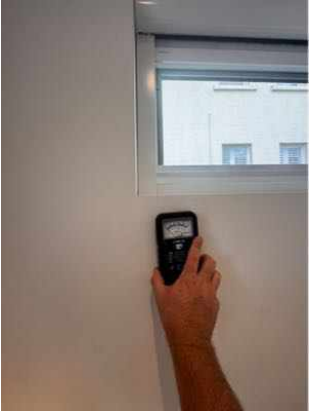
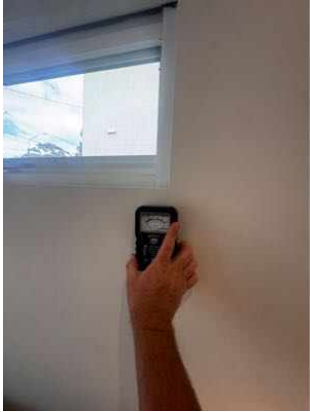
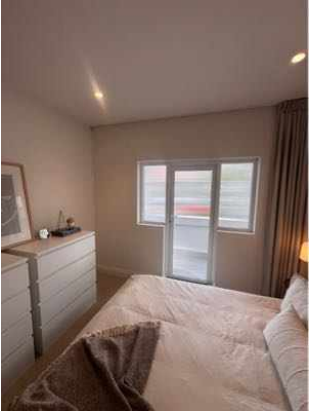
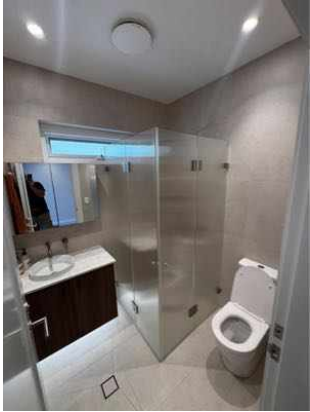
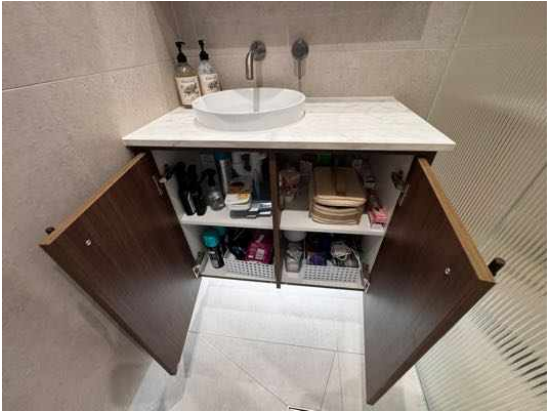
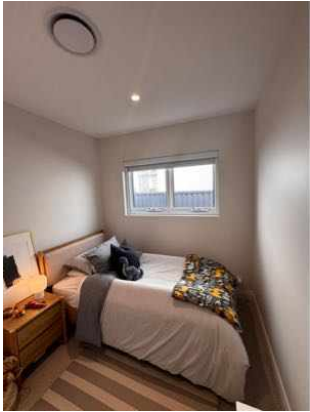
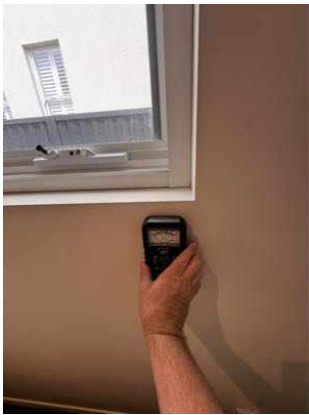
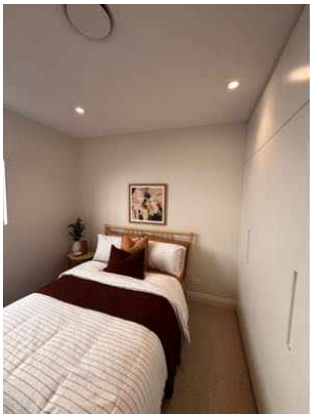
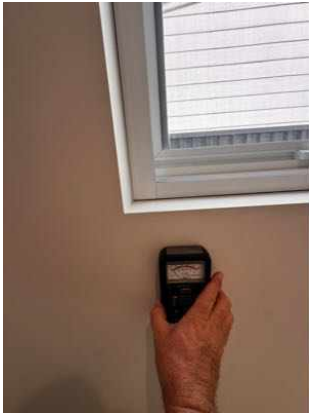
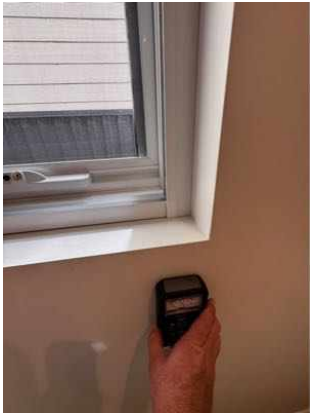
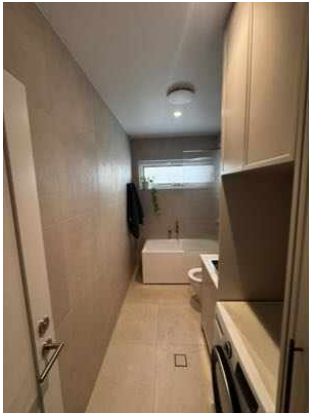
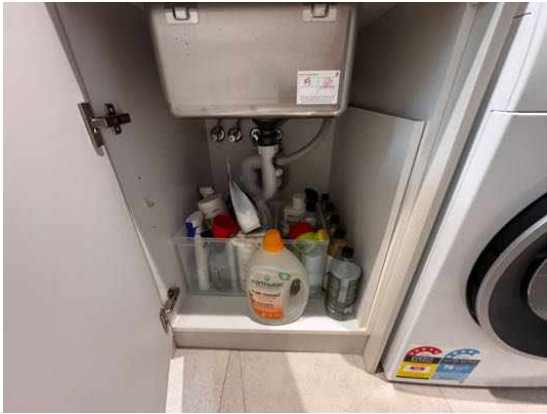
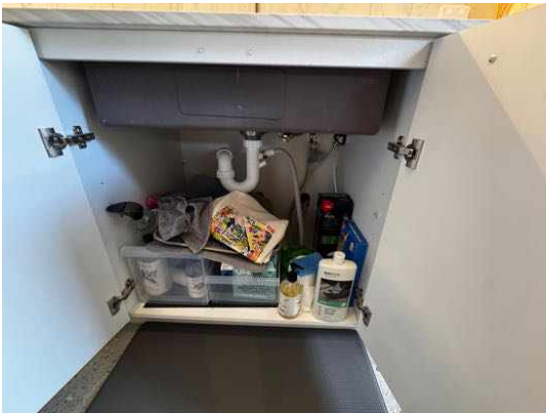
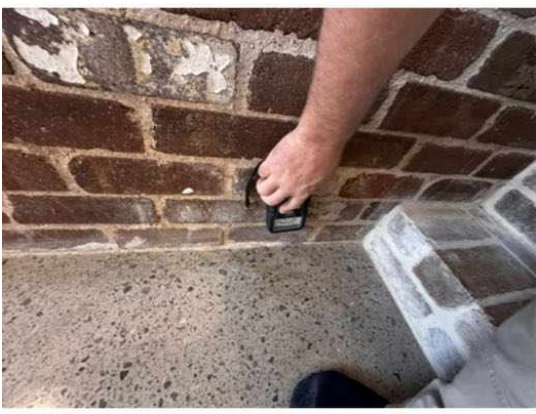
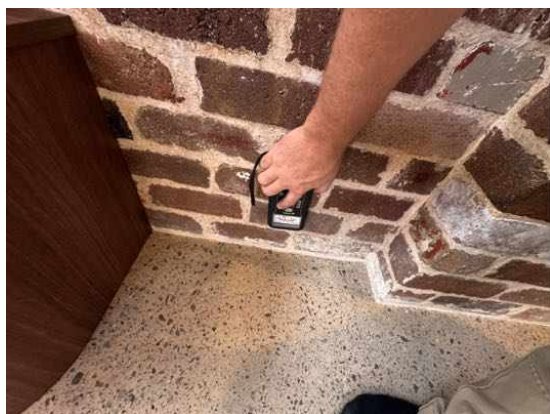
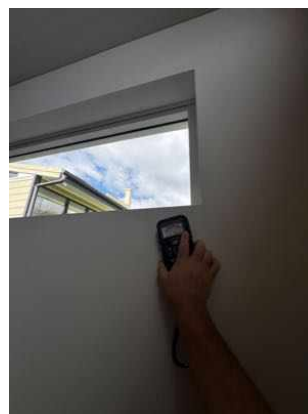
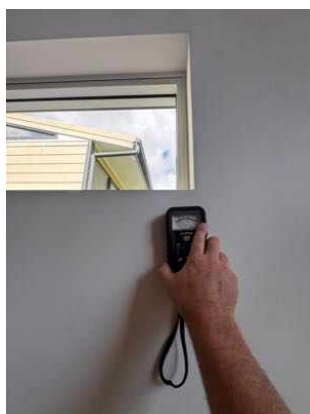
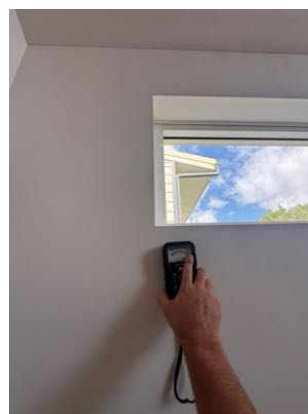
Building: Main Building
Location: Internal Areas
Finding: Photos Added
Information: Additional photos are provided for your general reference.
