# Building and Timber Pest Inspection Report

Inspection Date: Thu, 12 Mar 2026

Property Address: 19 Patherton Place, Narellan Vale NSW  
2567

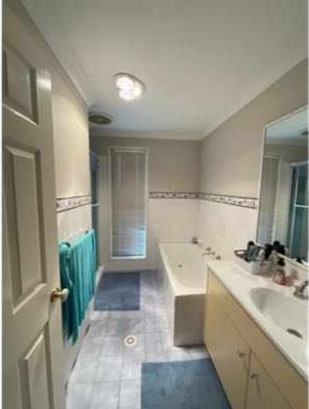
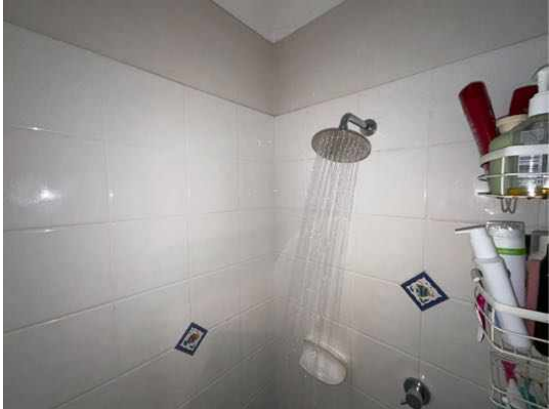
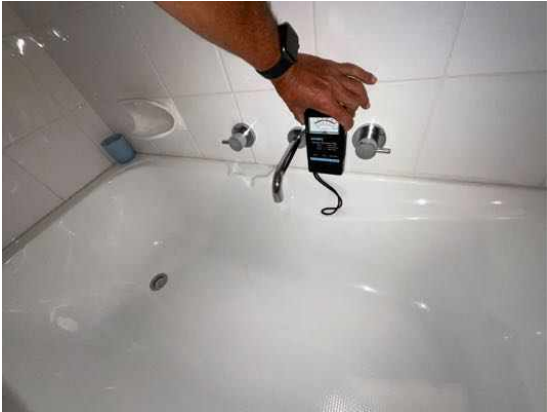
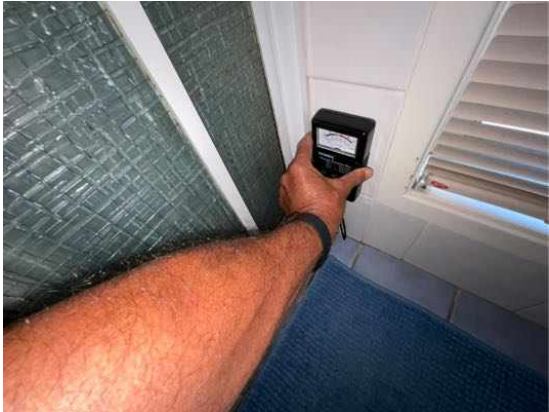
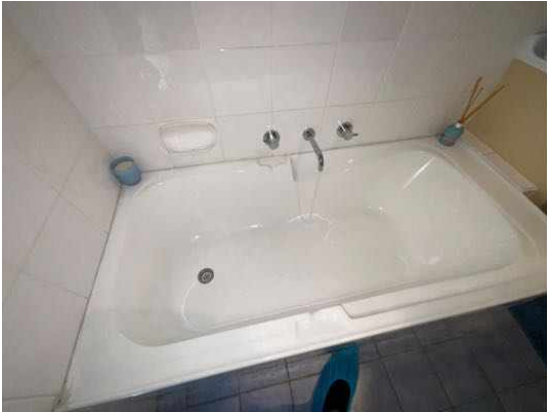
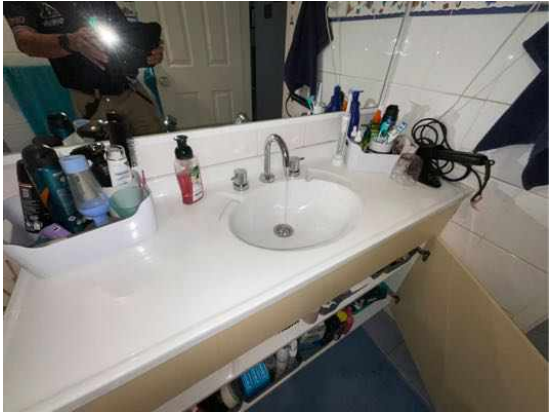
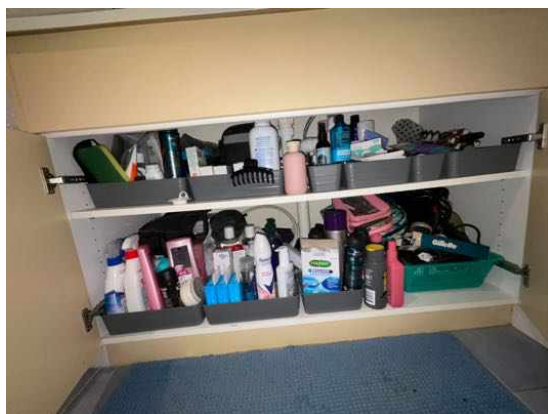
Building: Main Building  
 Location: Ensuite  
 Finding: Wet Areas - Bathroom(s) - Overall Condition & Recommendations.  
 Information: Overall Condition & Recommendations

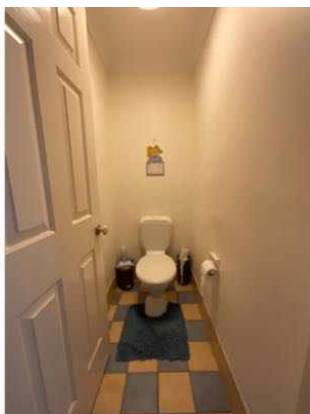
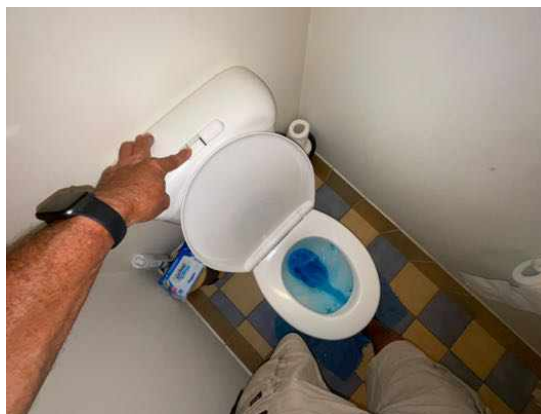
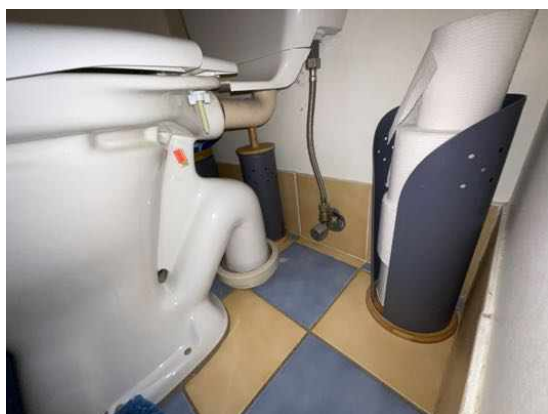
Building: Main Building  
 Location: All Areas  
 Finding: Water Pressure – Observation Only.  
 Information: During the inspection, water pressure appeared to be within a normal operating range based on a basic functional check. However, this observation was made without the use of pressure testing equipment and does not constitute an assessment by a licensed plumber.

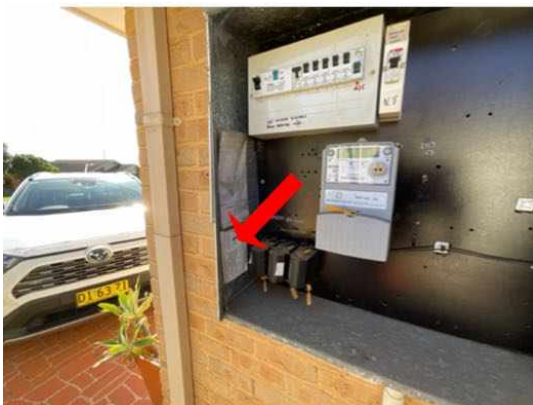
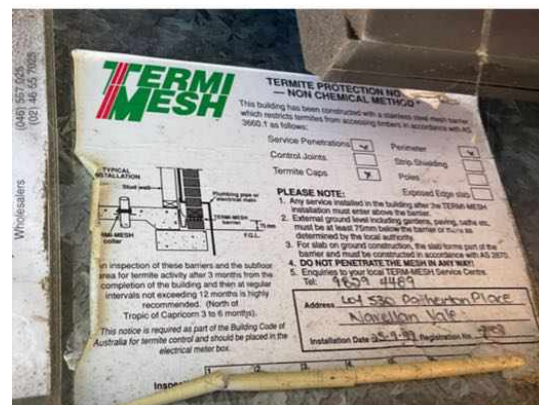
Building: Main Building  
 Location: All Areas  
 Finding: Termite Management System – Previous Barrier Noted..  
 Information: Observation:

At the time of inspection, evidence of a previous termite management system was noted, indicated by the presence of a durable notice affixed to the electrical switchboard.

- The installation of a termite management system is strongly recommended for all properties, particularly those with timber building elements. These systems provide a proactive defence against termite attack and are effective in minimising the risk of concealed termite entry and structural damage.
- The client is advised to contact the pest control provider listed on the durable notice (if identifiable) to obtain further information regarding:
  - The type of system installed (e.g., chemical barrier, baiting system, or physical barrier)
  - The installation date
  - Any warranty conditions, service history, or ongoing maintenance requirements

- If no reliable information can be obtained, or if the existing system is found to be outdated or non-functional, it is recommended that a new termite management system be installed by a licensed pest control professional.
