Building and Timber Pest Inspection Report

Inspection Date: Thu, 26 Mar 2026

Property Address: 416/133 Botany Rd, Waterloo NSW 2017,
Australia

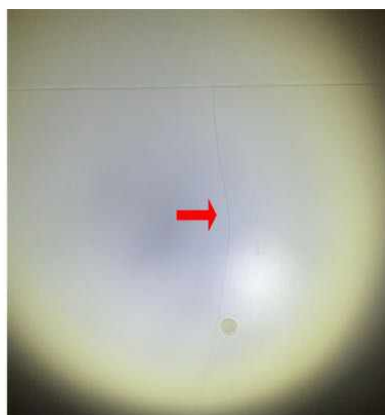
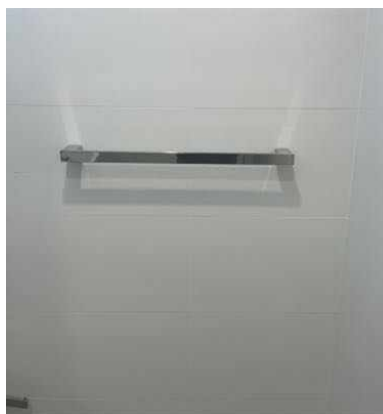
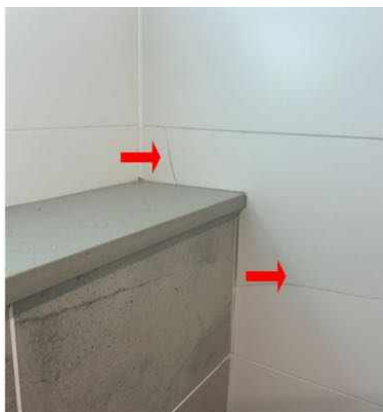
Building:	Main Building
Location:	Bathroom, laundry, ensuite
Finding:	Tiles - Cracked or damaged to some areas (Multiple tiles pattern cracking in both bathrooms)
Information:	Cracking was evident to the tiling in this area at the time of inspection. Tile cracking may occur due to impact, normal wear, or movement within the underlying substrate. In some cases, cracking may indicate issues such as inadequate installation, substrate movement, or stress within the tiled system.

If left unmanaged, water penetration to these areas may lead to subsequent water damage, which is likely necessitate repair work to affected building elements.

A tiling contractor should be appointed to ensure that no further water damage occurs. The re-application of silicone and grouting throughout remaining tile work is also advised, to further protect the area against water penetration.

Where water penetration has led to water damage, appointment of a relevant tradesperson may be required to repair damaged building elements.

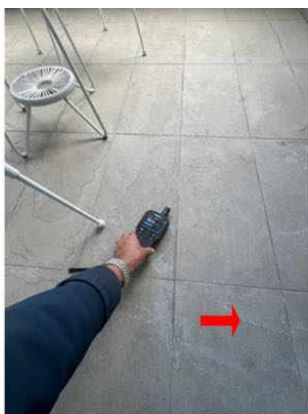
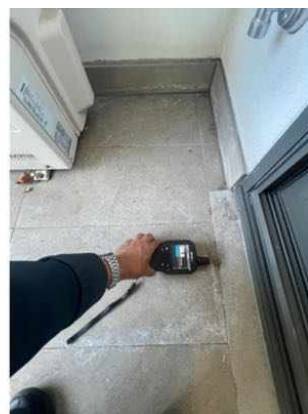
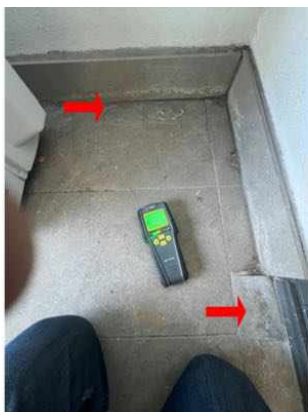
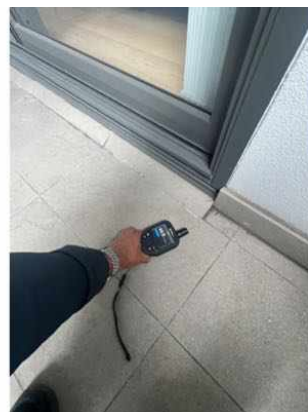
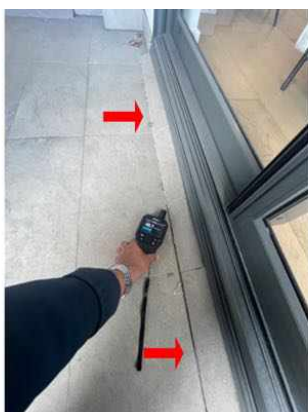
Finding 3.01

Building:	Main Building
Location:	Balcony
Finding:	Efflorescence and grout deterioration - Balcony
Information:	Efflorescence was observed to balcony tiles together with localised grout and sealant deterioration, indicating intermittent moisture movement through the tiled system. Moisture readings were slightly elevated at the time of inspection, the condition suggests past or periodic moisture presence, potentially associated with drainage, waterproofing detailing, or air conditioning discharge. Repairs to grout and sealant and review of drainage are recommended, with ongoing monitoring and further assessment by strata appointed licensed plumber for any progression.

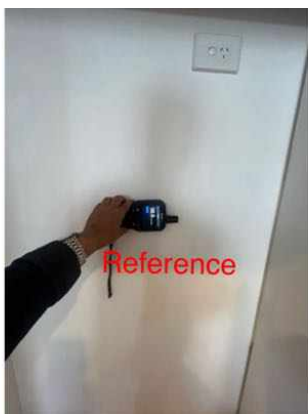
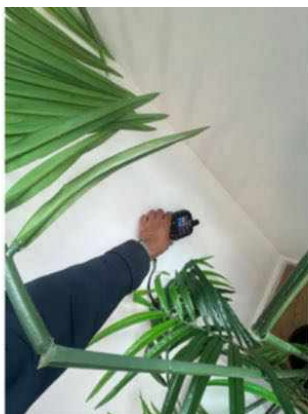
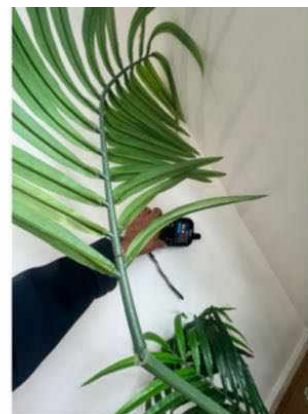
Finding 3.02

Building:	Main Building
Location:	All Internal Areas
Finding:	Elevated Moisture – Further Investigation Recommended
Information:	Slightly elevated moisture readings were detected to lounge left wall with no visible surface issues, although no significant structural damage was evident at the time of inspection, dampness can contribute to deterioration if left unaddressed. Inspector was not able to inspect the external wall due to space constraints. A further investigation by a licensed plumber or waterproofing specialist is recommended to confirm the source and ensure no concealed issues are developing.

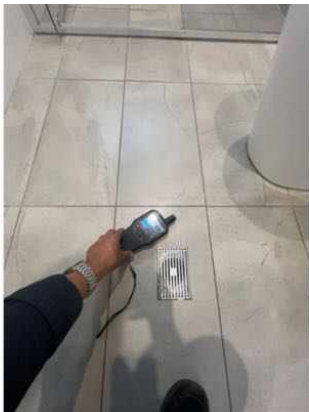
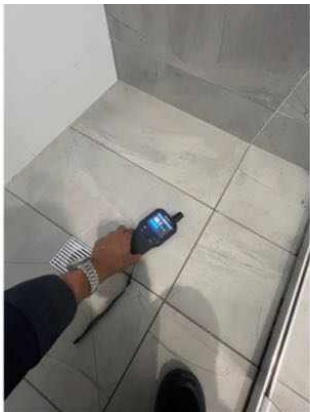
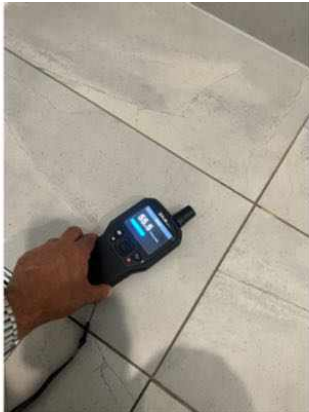
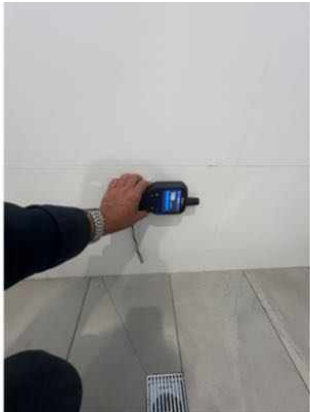
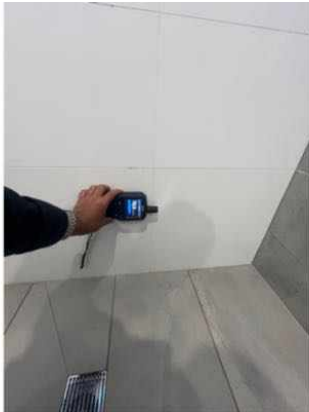
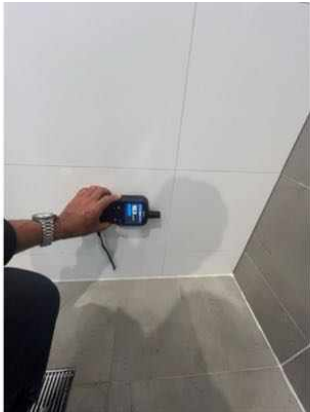
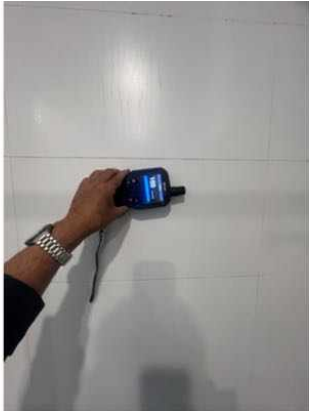
Finding 3.03

Building:	Main Building
Location:	Bathrooms
Finding:	Elevated Moisture Bathroom (No visible deterioration noted)
Information:	Elevated moisture levels were detected to tiled surfaces in bathroom/shower areas. Persistent moisture ingress can lead to concealed damage, including timber rot and mould growth.

Elevated moisture readings in tiled wet areas can occur from normal shower use, age/deterioration of waterproofing membranes, plumbing leaks or moisture absorption through grout lines. While no damage was visible, elevated readings may indicate moisture retention behind tiles, which can be a conducive condition for future deterioration if not monitored.

Monitor the area over time for signs of drumming, efflorescence, tile movement, or grout deterioration. A further inspection by a licensed waterproofing specialist is recommended to determine cause of elevated moisture (e.g., pressure testing, membrane assessment).

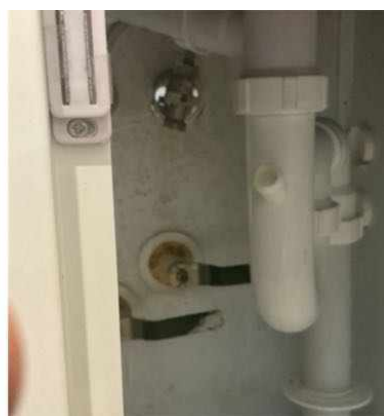
Finding 3.04

Building:	Main Building
Location:	Laundry
Finding:	Moisture staining
Information:	Water staining was evident in this area at the time of inspection. Water staining indicates that surfaces have been exposed to excessive moisture over time. The minerals and other elements in the water lead to staining, which may graduate to corrosion and deterioration if left unmanaged.

While mostly an appearance defect, water staining can be indicative of more serious defects, which may be currently concealed by other building elements.

Where water staining is active, a licensed plumber must be consulted to identify the cause of the staining and to provide advice on any reparation works that may be required. Replacement of any broken or damaged structures is advised.

Conversely, where water staining is old and inactive, affected building materials may be repaired or replaced at client discretion. A qualified carpenter or registered builder may be appointed to perform these works.

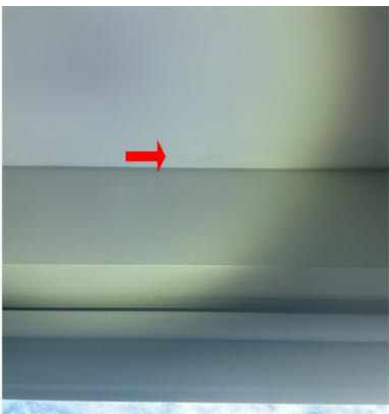
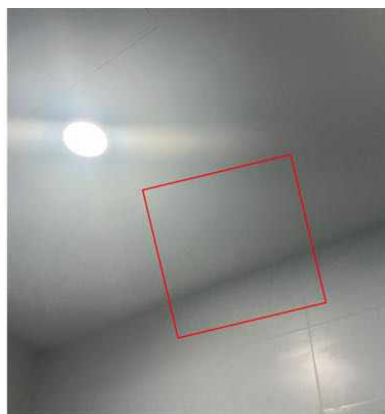
Finding 3.05

Building:	Main Building
Location:	All Internal Areas
Finding:	Paint finish and hairline cracking to some areas
Information:	The paint finish in this area was identified as being incomplete at the time of inspection including some hairline minor cracking.

Whilst incomplete or missing paint and minor cracking and imperfections in finish is generally an appearance defect, it can also lead to the development of secondary building defects over time. Incomplete areas of paint finish expose the area to moisture, potentially accelerating the deterioration of underlying building materials.

Incomplete paint finishes should be sanded back, filled, leveled and painted, as applicable. Where inadequate or missing paint protection has led to the deterioration of the associated building element, repair and/or replacement of this building element

may be required.

A painting contractor should be appointed as soon as possible to perform necessary works to aid the appearance of the affected area and to ensure the area is protected against further deterioration. Alternatively, the homeowner following manufacturer instructions may perform these works.

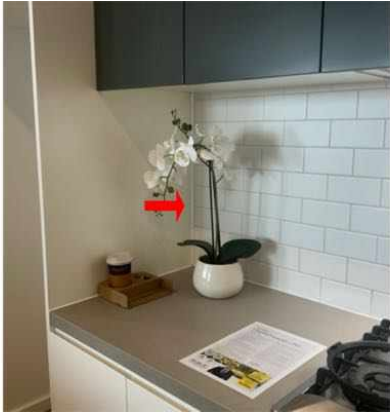
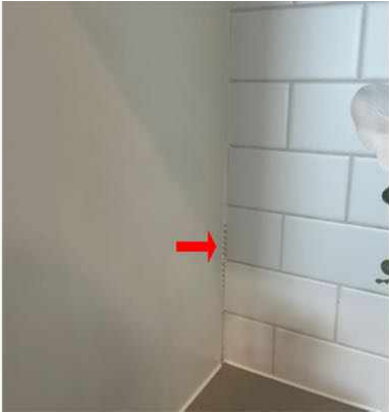
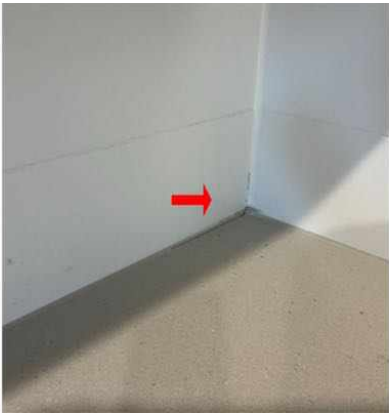
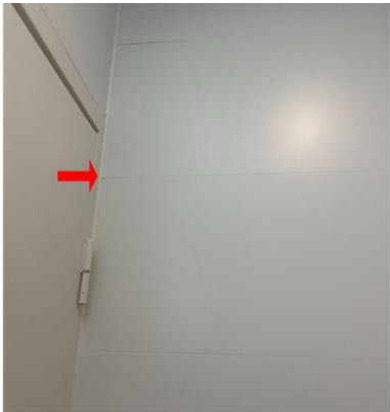
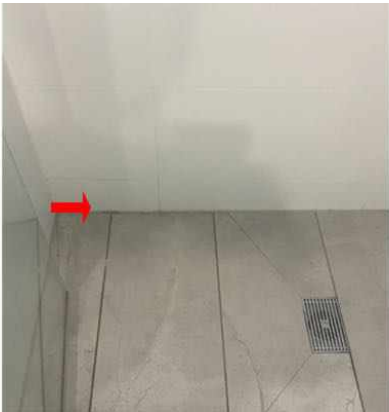
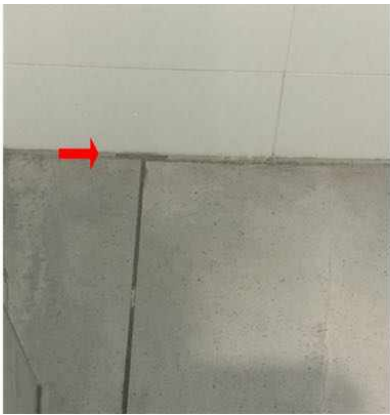
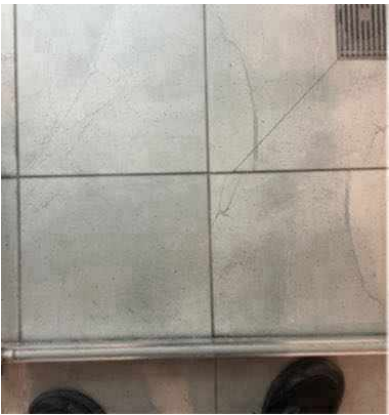
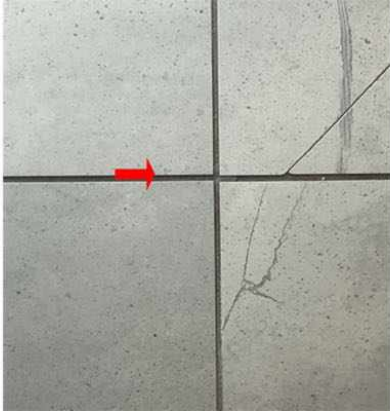
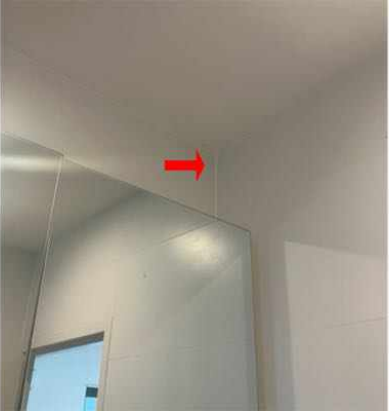
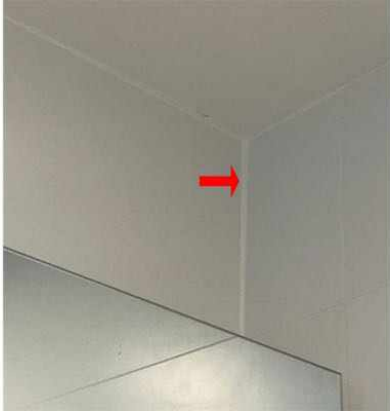
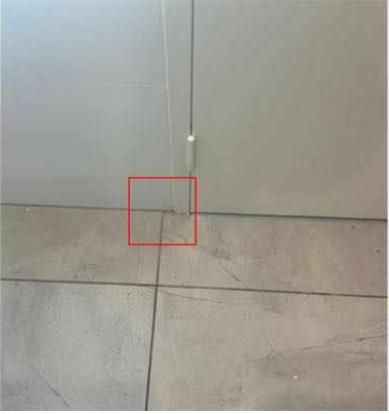
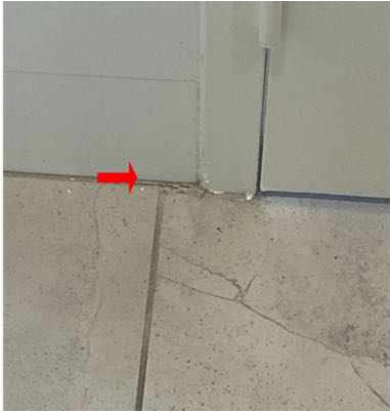
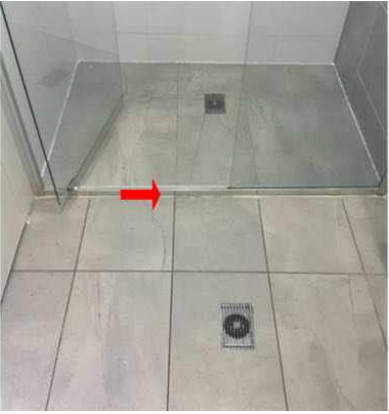
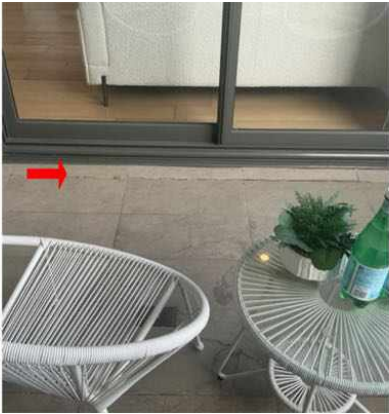
Finding 3.06

Building:	Main Building
Location:	All Internal Areas
Finding:	Sealant and grouting - Missing or degraded to some areas
Information:	It was noted on inspection that sealant or grout is degraded. There is also evidence of poor workmanship and excessive use of sealant. Silicone should never be used as a first line of defence against waterproofing. Further inspection by a licensed waterproofing contractor is highly recommended.

Different materials and floor areas move at different rates, generally causing cracking to grout or sealant at this point. A flexible sealant is required to allow for expected expansion and contraction, while keeping the joint water tight and protective of all associated building materials.

There appears to be excessive mould to the sealant and grout which will likely require scraping out and replacement.

Flexible and mould resistant materials should be applied to affected areas to prevent any subsequent water damage that is likely to occur. Regular maintenance and replacement of damage or missing or damaged sealant and grout is highly recommended to the wet areas, as this is a regular wear and tear defect. Sealant and grouting in areas that come into regular contact with water should be maintained for the long term care of your property.

A sealant specialist or tiling contractor should be appointed to complete these works as soon as possible

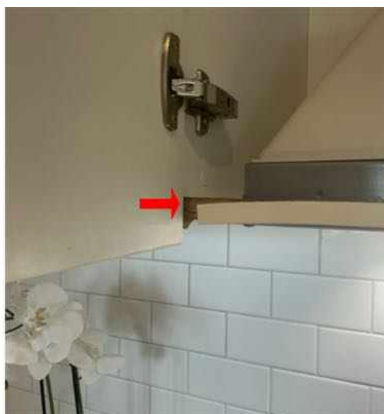
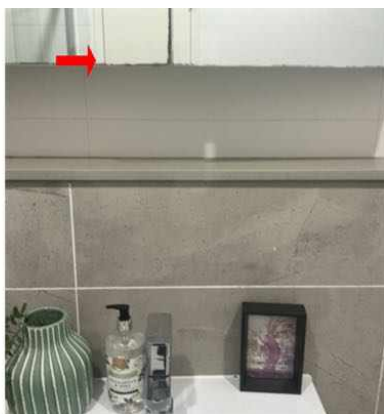
Finding 3.07

Building: Main Building
Location: All Internal Areas
Finding: Building element - Damaged - Kitchen cabinet trim chipped , possible crack window lounge outside, mirror desilvering bathroom
Information: Breakage occurs generally when the building materials have either aged and decayed, or as a result of damage (accidental or deliberate).

Repair and/or replacement of broken elements is advised to ensure that additional secondary defects do not arise as a consequence. Such works are necessary, as all building elements play a key role in the operation and function of the overall structure and its performance.

A relevant tradesperson should be appointed to repair or replace the affected building element prior to any subsequent damage being caused.

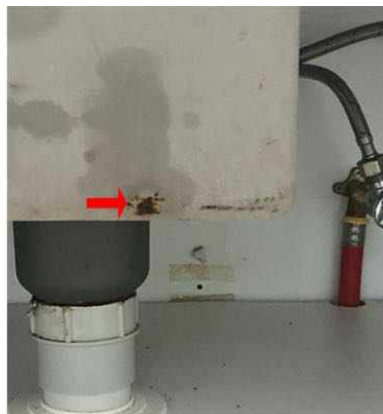
Finding 3.08

Building: Main Building
 Location: Kitchen
 Finding: Building element - Rusted or corroded - Kitchen sink rust staining
 Information: This building element shows evidence of rusting and corrosion, which is likely to have developed as a result of excessive exposure to moisture and or inadequate coatings.

As surface rust provides no protection to the underlying iron, the deteriorating condition is likely to worsen if not addressed in the short-term future.

Where possible, the use of galvanized (treated) metals or aluminium coated metals aid in rust prevention, as does regular general maintenance. Rust formation can be controlled with coatings, such as paint, that isolate the iron from the environment.

Rusting and corrosion should be managed by ideally removing or limiting the affected surface from exposure to moisture. A registered builder may be appointed to replace any building elements that have been severely affected by rust or water damage.

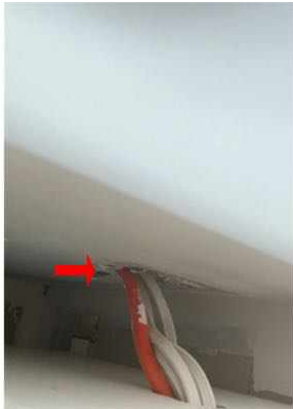
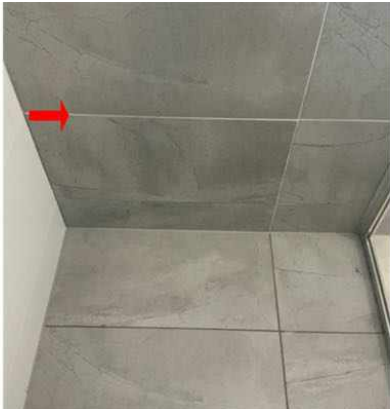
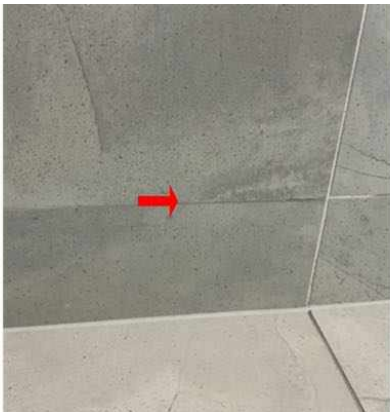
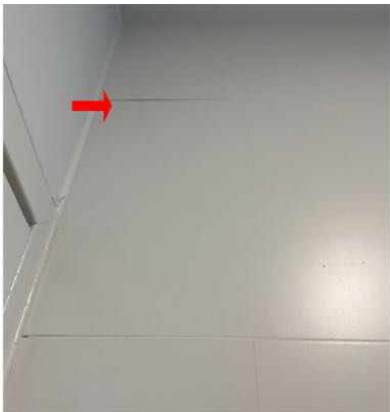
Building:	Main Building
Location:	All External Areas
Finding:	Installation - substandard or incomplete - Hole not sealed behind kitchen cabinet try , tiles workmanship (Uneven finish)
Information:	The installation of this building element appears to have been completed to a substandard level of workmanship or is incomplete. Generally substandard repairs or installation are related to poor workmanship, the use of inappropriate materials, or a failure to complete installation to a suitable standard.

Where installation is substandard and/or incomplete, the client should contact the responsible trade to undertake rectification. Unfinished and substandard building works are likely to degrade more quickly and may create potential for secondary defects to associated building elements.

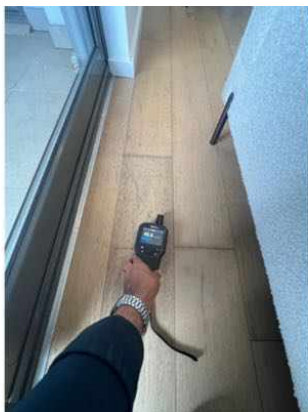
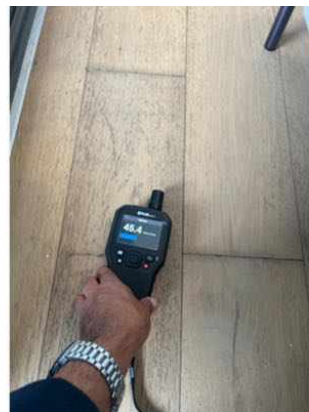
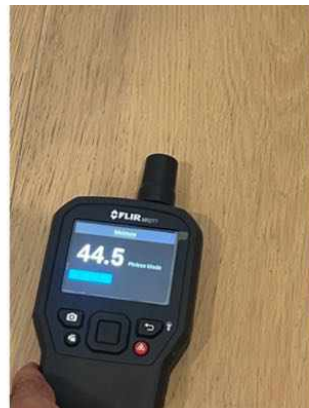
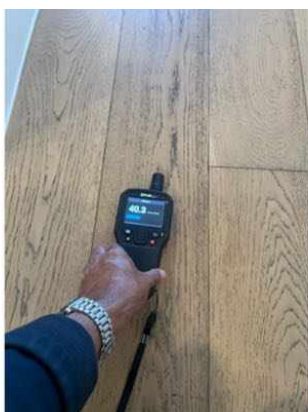
Building:	Main Building
Location:	All Internal Areas
Finding:	Observation – Elevated Moisture Meter Readings (Timber Flooring)
Information:	Moisture meter readings taken to timber flooring using a non-invasive (pinless) meter returned slightly elevated readings across the tested areas.

Pinless moisture meters provide indicative readings only and may be influenced by the type of flooring, subfloor construction, adhesives, and underlying materials. Consistent readings across large areas without visible signs of moisture-related damage typically indicate material characteristics rather than active moisture ingress.

No visible evidence of moisture-related damage to the timber flooring was observed at the time of inspection. Monitoring is recommended for any future signs of distortion, staining, or deterioration. If concerns arise, further assessment using invasive testing methods may be considered.

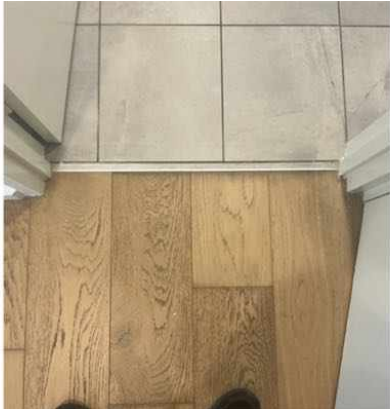
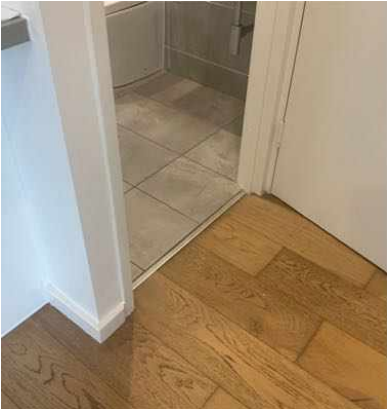
Building: Main Building
 Location: Bathroom
 Finding: Bathroom & external floor threshold
 Information: The bathroom floor is at the same level as the adjoining timber flooring. This configuration is typical in modern apartments and is permitted where compliant waterproofing and floor falls are provided. No evidence of moisture damage was observed at the time of inspection; however, waterproofing performance cannot be confirmed without invasive inspection.

Care should be taken to avoid excessive water migration beyond the bathroom during use.

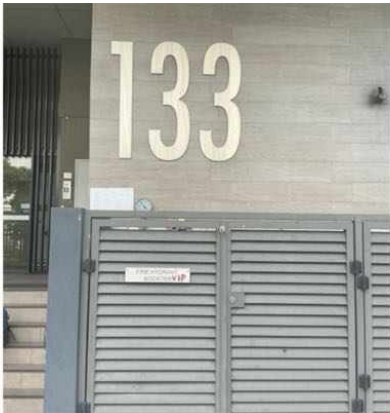
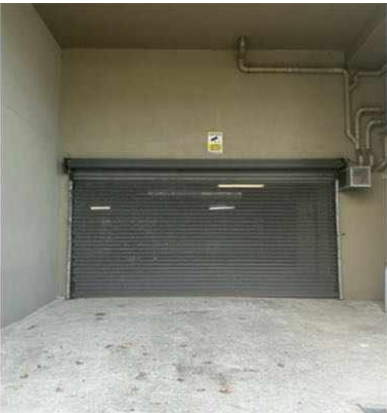
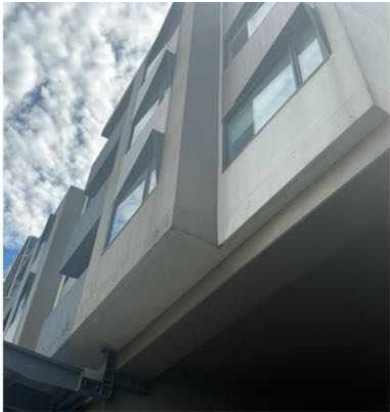
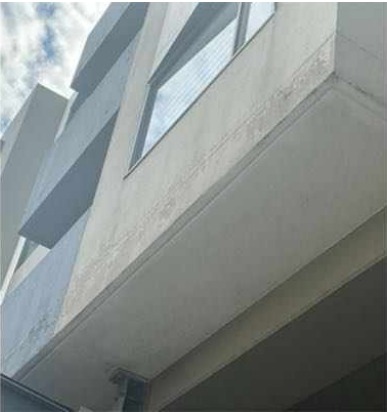
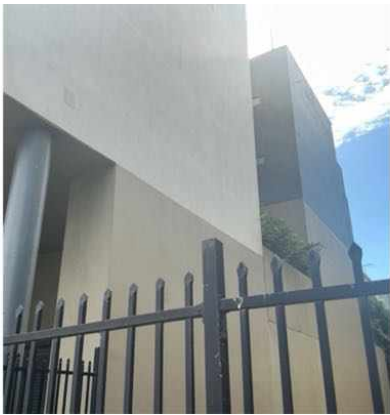
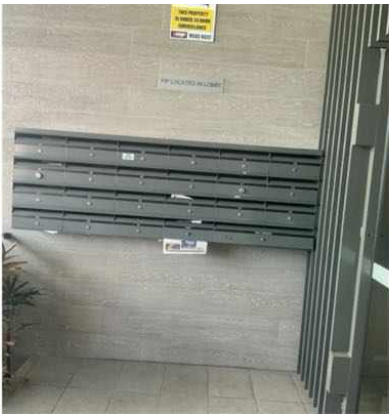
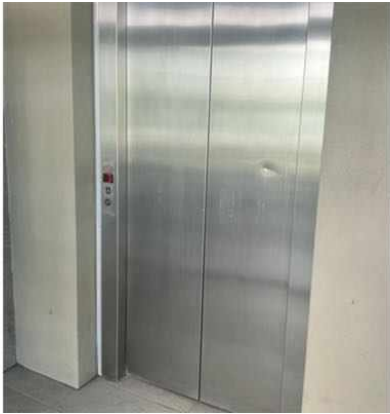
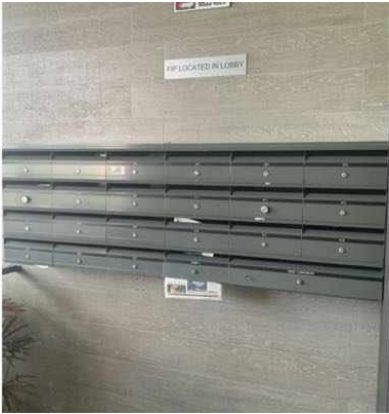
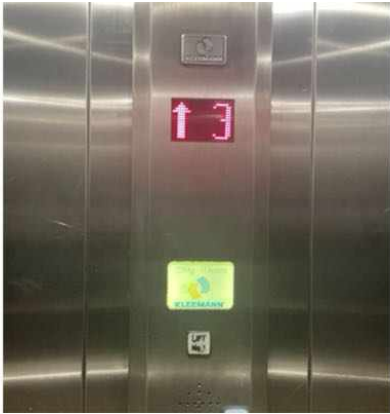
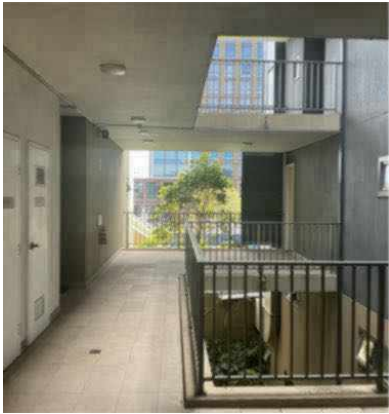
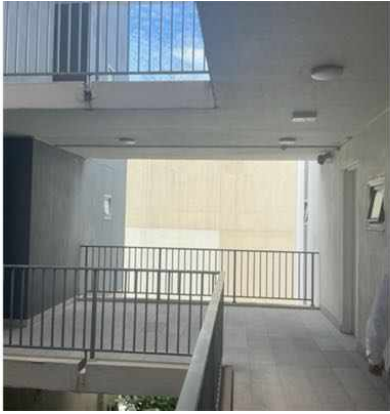
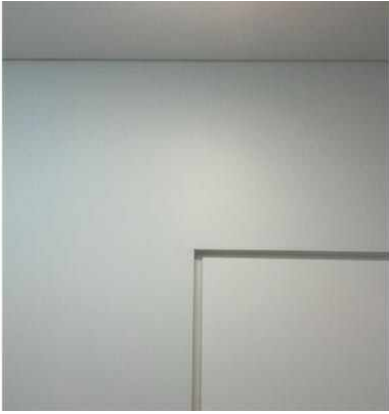
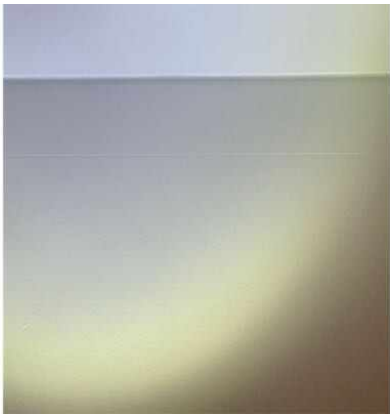
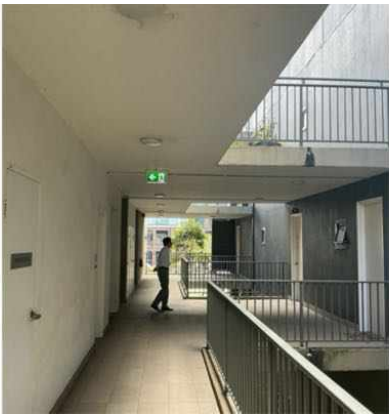
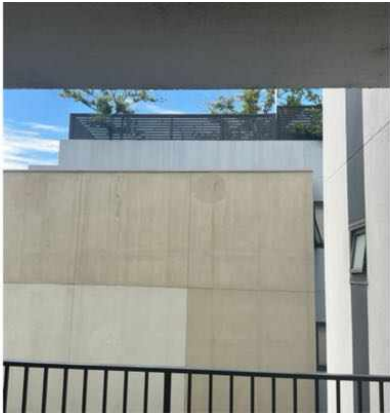
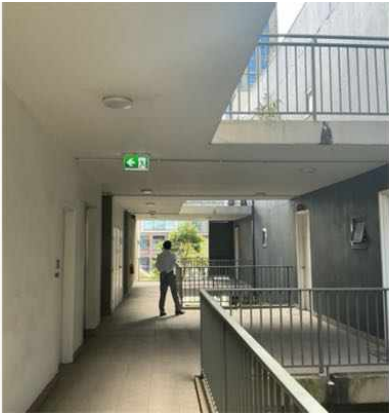
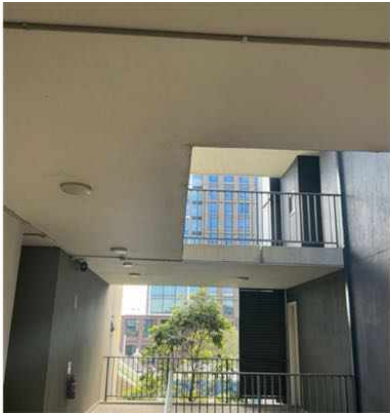
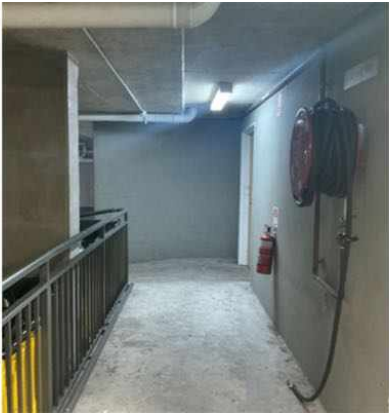
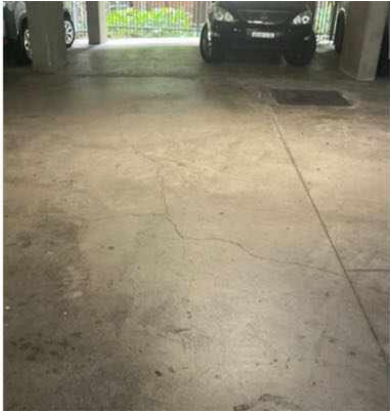
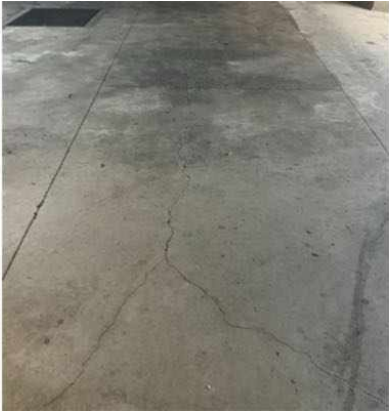
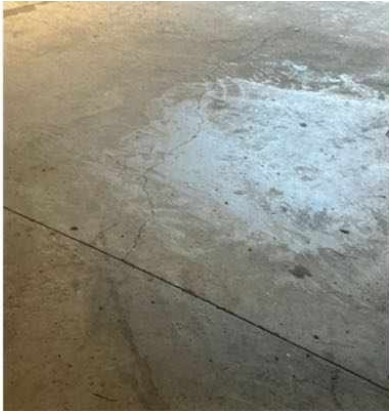
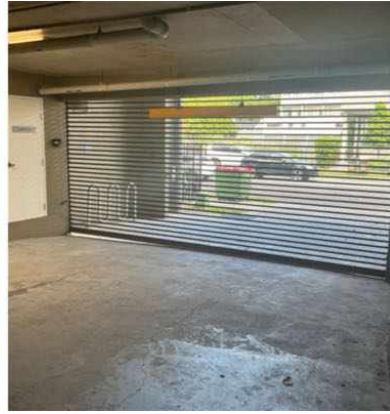
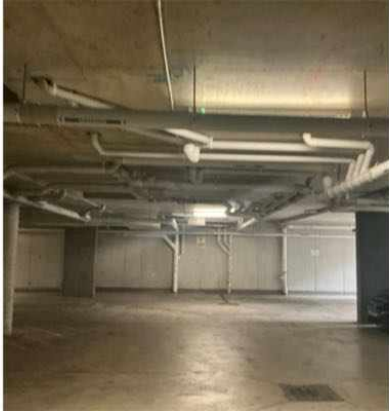
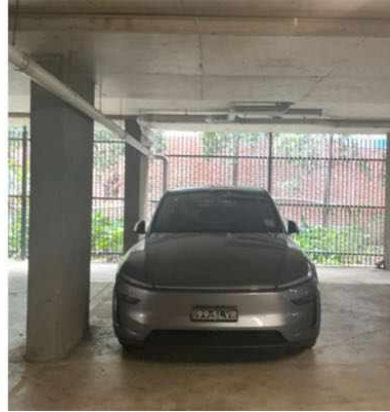
Building: Main Building
Location: All External Areas
Finding: Additional Photos - Obstructions and Limitations
Information: These photographs are an indication of the obstructions and limitations which impeded full inspection of the property at the time of inspection. These obstructions can hide an array of defects and should be removed to allow full inspection to be carried out. A re-inspection is recommended once the areas are made accessible.

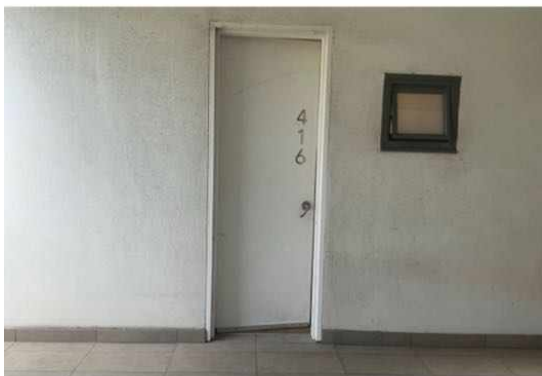
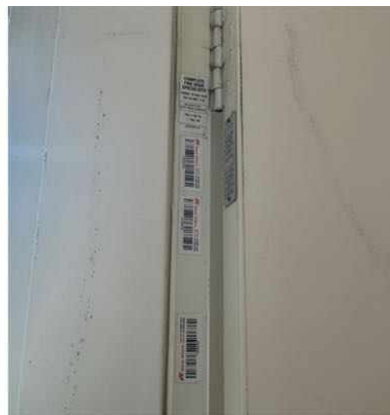
Building: Main Building
 Location: All Internal Areas
 Finding: Additional Photos - Obstructions and Limitations
 Information: These photographs are an indication of the obstructions and limitations which impeded full inspection of the property at the time of inspection. These obstructions can hide an array of defects and should be removed to allow full inspection to be carried out. A re-inspection is recommended once the areas are made accessible.
