Building and Timber Pest Inspection Report

Inspection Date: Tue, 3 Feb 2026

Property Address: 64A Anthony Rd, Denistone NSW 2114,
Australia

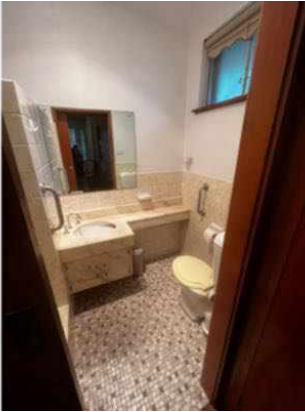
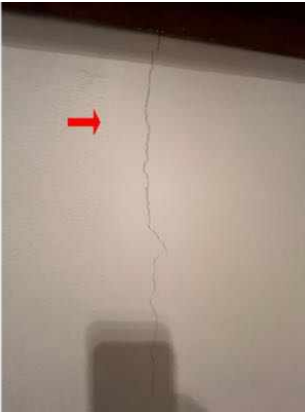
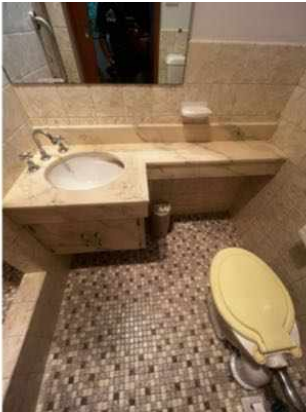
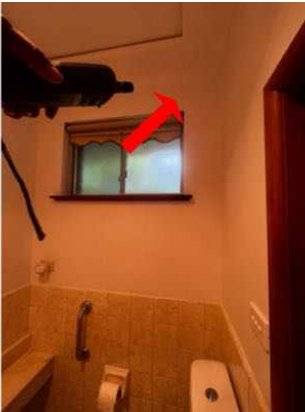
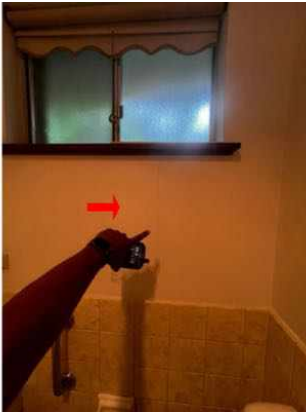
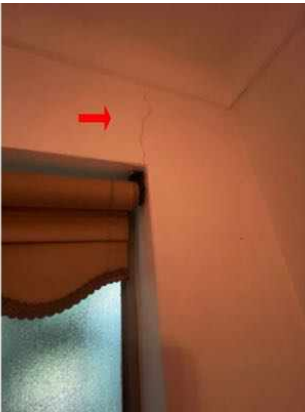
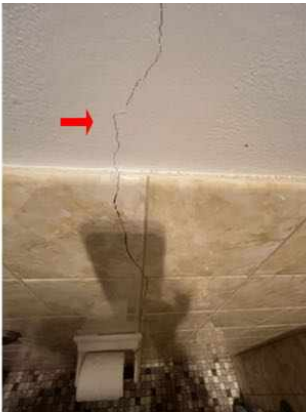
Finding: Cracking - Damage Category 2 - Noticeable (up to 5mm)

Information: Noticeable cracks are a common occurrence as a result of many primary defects. Such causes may include age, general wear and tear, expected building movement, general expansion/contraction of building materials in different weather conditions, and/or minor failings in the installation or application of building materials.

Noticeable cracks may result in minor sticking or jamming of associated doors and windows, which require easement. However, noticeable cracks are easily filled and repaired. A plasterer can be consulted to install an expansion joint at this point to allow for this movement during different weather conditions.

Relevant tradespeople, such as carpenters, painters and plasterers, should be appointed to perform remedial works, as deemed necessary.

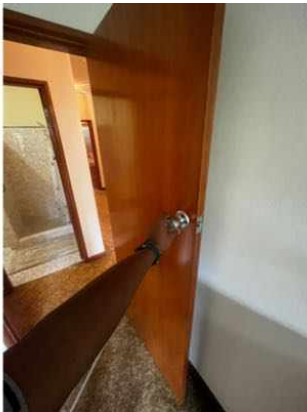
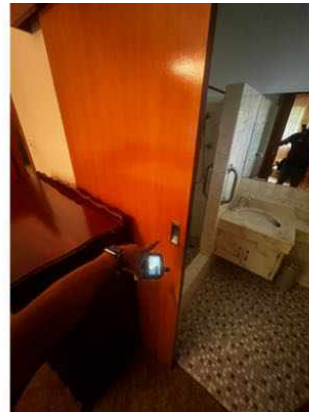
Finding 3.02

Building: Main Building
Location: Laundry door/ Ensuite door/ GF bedroom door
Finding: Door - Binding/jamming
Information: Upon inspection it was noticed that the door was not binding properly.

This defect inhibits the functionality of the affected door as well as creating potential for secondary defects to associated building elements.

A qualified carpenter or general handyperson should be appointed to perform minor rectification works at client discretion.

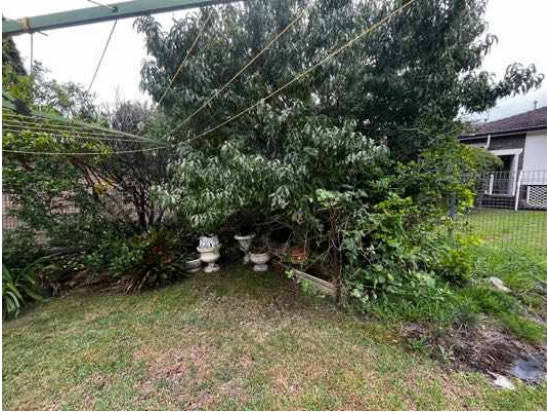
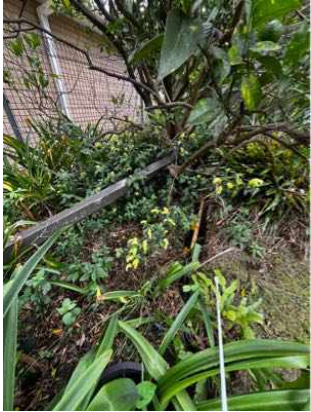
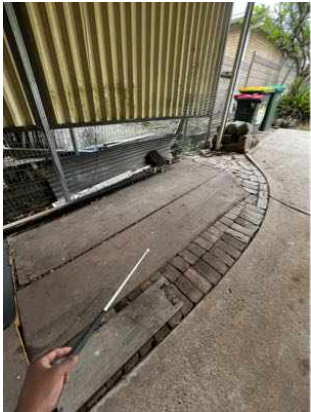
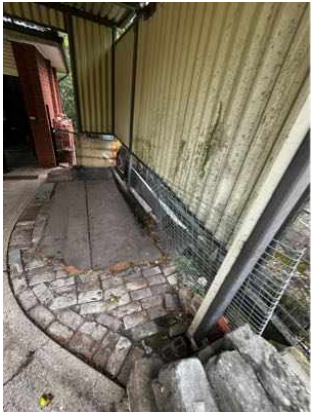
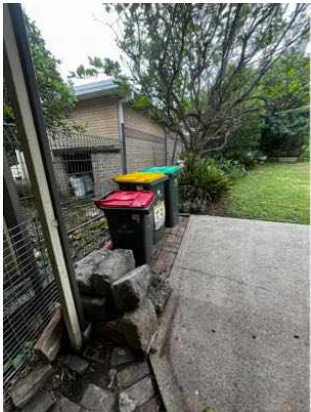
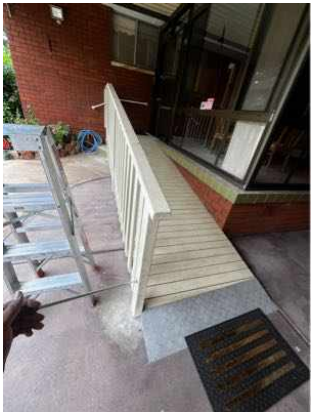
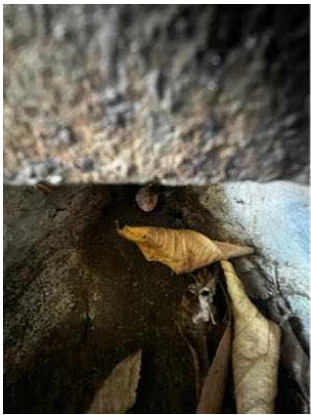
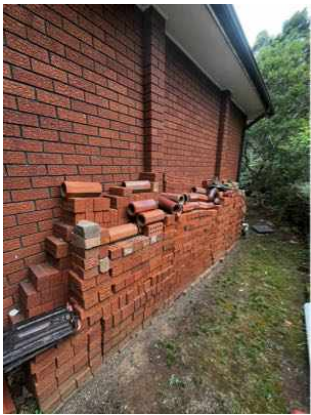
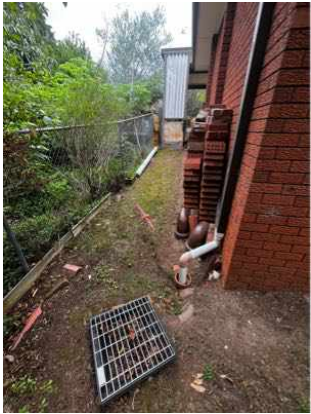
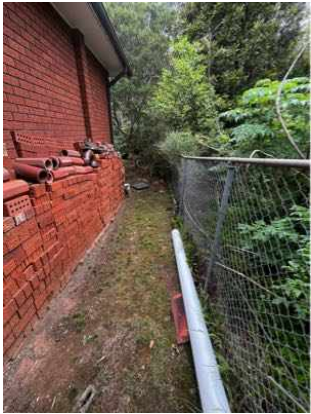
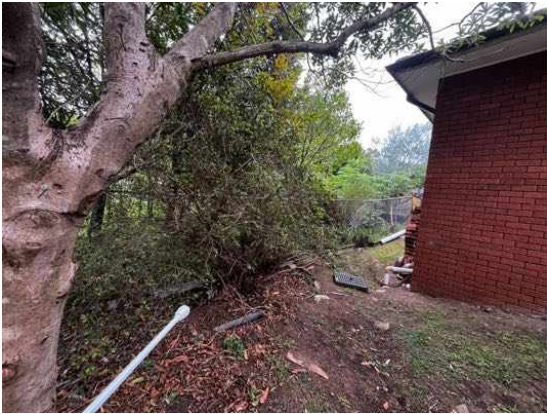
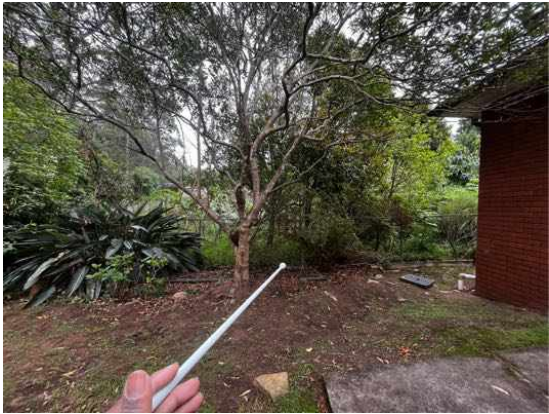
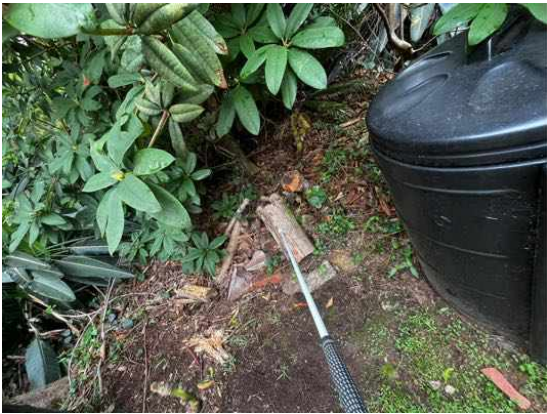
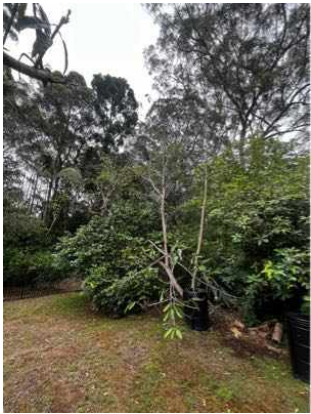
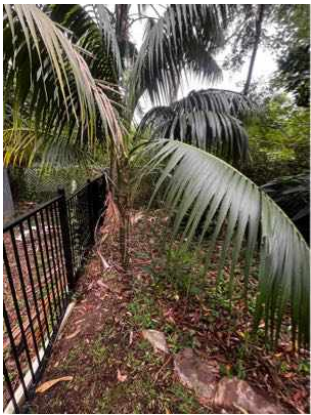
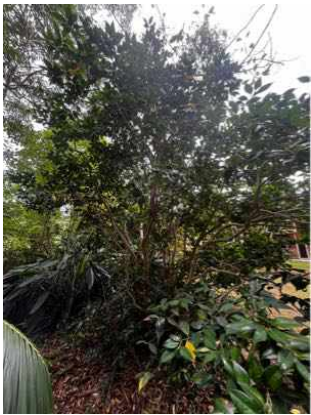
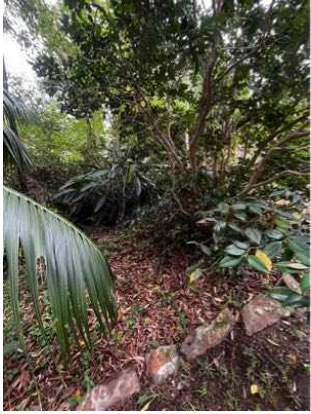
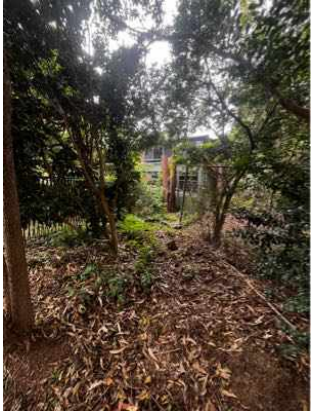
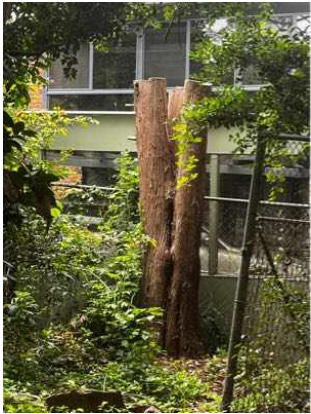
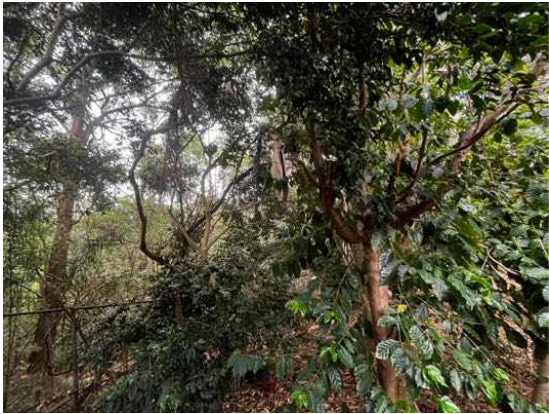
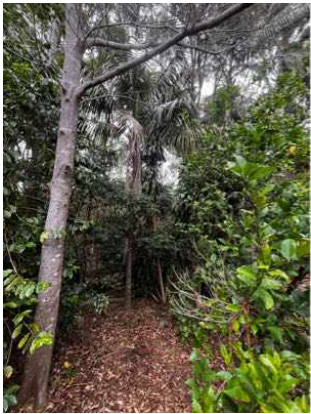
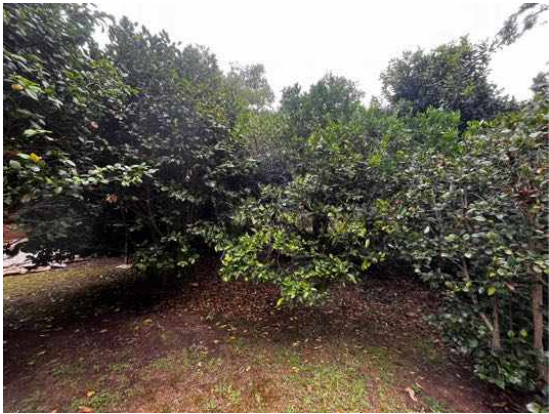
Building: Main Building
Location: All Areas
Finding: Additional Photos - Obstructions and Limitations
Information: These photographs are an indication of the obstructions and limitations which impeded full inspection of the property at the time of inspection. These obstructions can hide an array of defects and should be removed to allow full inspection to be carried out. A re-inspection is recommended once the areas are made accessible.

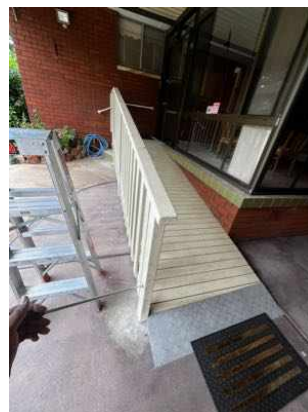
Finding 6.02

Building:	Main Building
Location:	Entrance walkway
Finding:	Building materials in direct ground contact - conducive to termites
Information:	Where timber elements are in direct contact with the ground and consequently moisture or dampness they become conducive to termite activity. Whether timber is used as a building element part of a fencing structure or stored as an unused item they can provide an environment that is attractive to termite infestation.

When met with excessive moisture timber begins to decay and develop wood rot. Any timbers that are in direct contact with external grounds especially if left untreated or non-durable also provide ingress for subterranean termites into that particular element.

The removal of any such materials that may be conducive to termite activity should be removed as soon as possible to minimise the risk of termite attack.

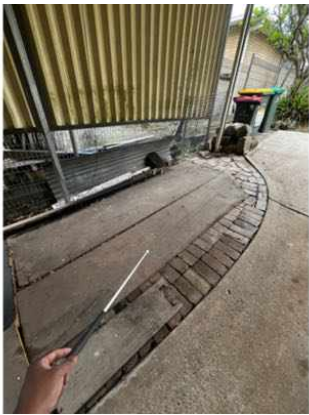
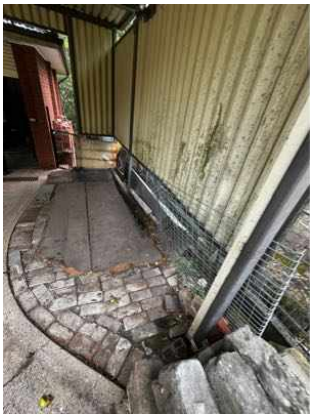
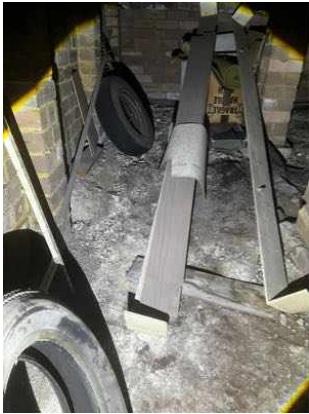
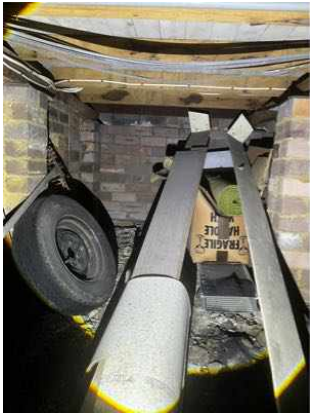
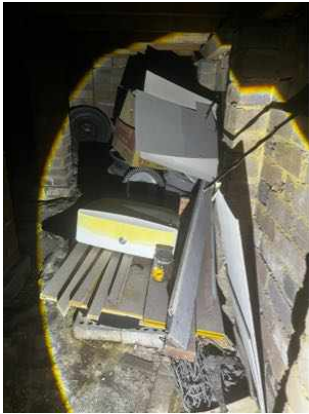
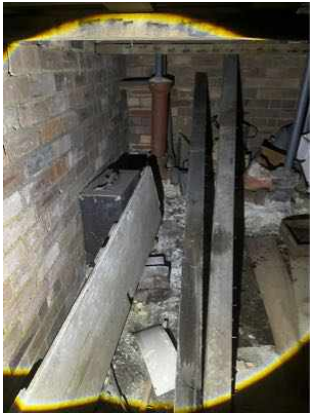
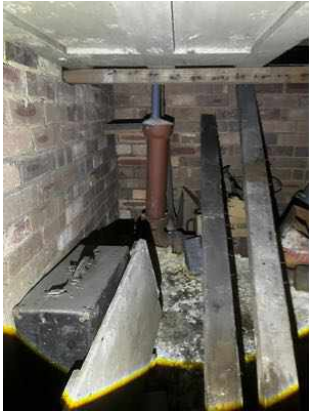
Finding 6.03

Building:	Main Building
Location:	All External Areas/subfloor
Finding:	Bridging - Attachments to Buildings
Information:	Bridging occurs when items against a building provide a concealed entry point for termites into the building or by passing around a termite management system.

Where any part of an attachment to a building is not isolated and is not provided with a clear gap of not less than 25mm from the building occurs. Attachments to buildings such as hot water services, downpipes, verandahs, decks, steps, fences and service conduits provide the opportunity for concealed entry.

Building attachments of this nature need to be frequently inspected for termite activity by a qualified inspector.

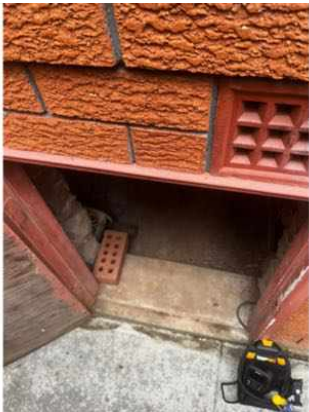
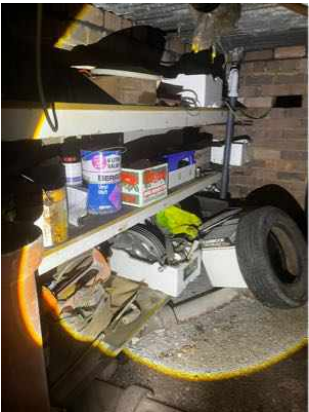
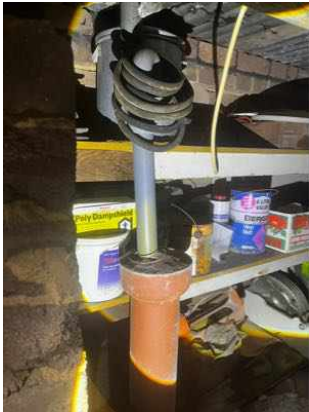
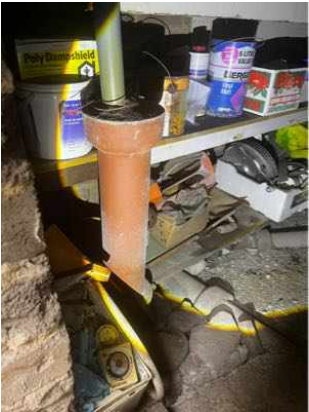
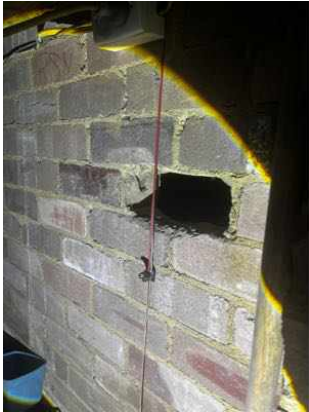
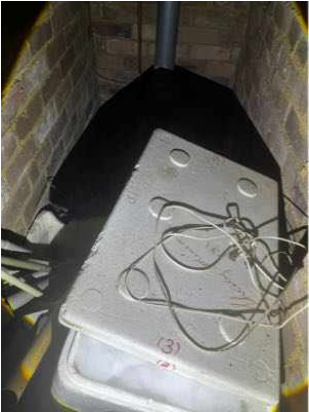
Finding 6.04

Building: Main Building
Location: Subfloor
Finding: Obstructions and Limitations - Subfloor
Information: These photographs are an indication of the inspected Subfloor.

These obstructions can hide an array of defects and should be removed to allow full inspection to be carried out.

A re-inspection is recommended once the areas are made accessible.

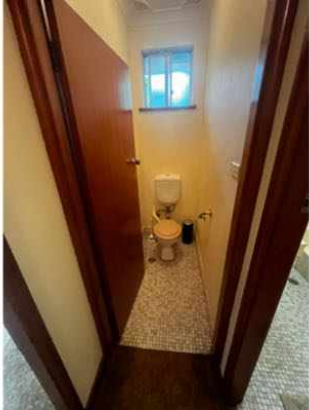
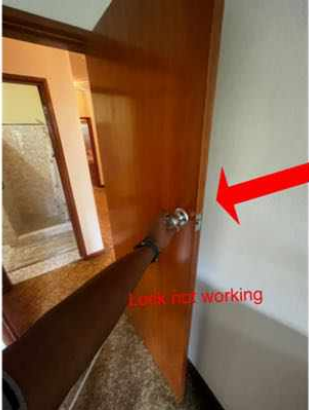
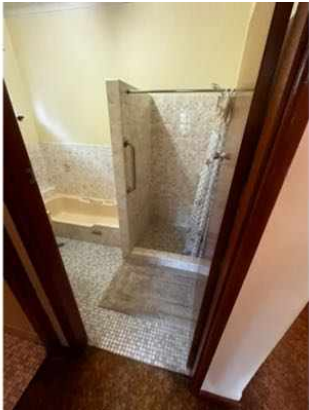
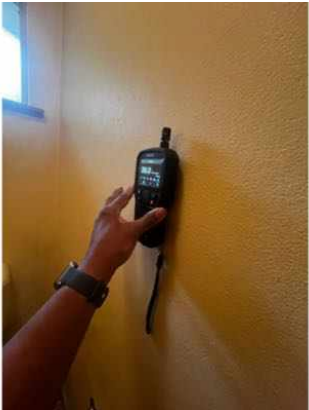
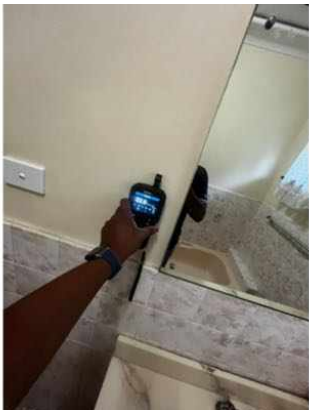
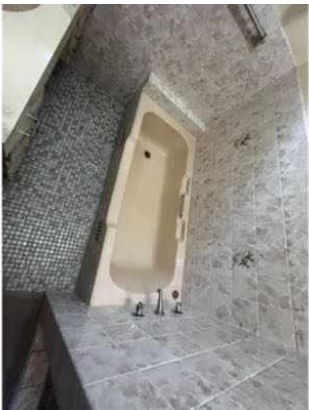
Noted Item

Building: Main Building
Location: Main Bathroom >
Finding: For information only
Information: A Cluster of Photos taken at the time of inspection.

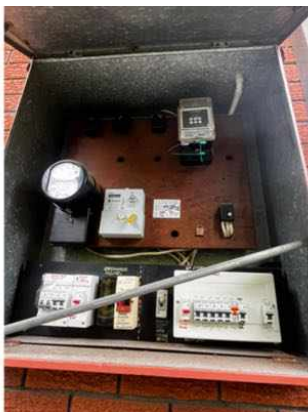
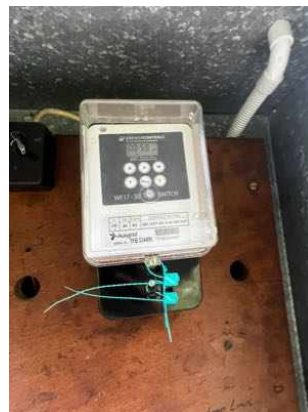
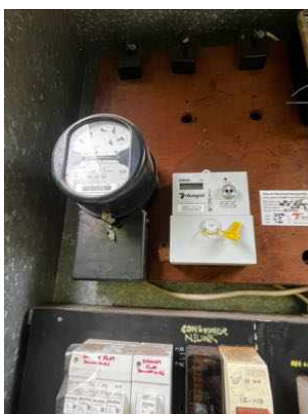
Building: Main Building
 Location: Electrical Box
 Finding: Evidence of a previous termite management system was identified
 Information: Upon Inspection There was a Durable Notice of Termite treatment identified but the date and the information in the notice was not readable/ identifiable - So It is highly recommended to have a termite treatment organised and to follow a termite treatment proposal and keep note of the system every 12 months in duration.

Most chemical termite management systems expire and require replenishment and all physical systems are primarily designed to prevent concealed entry.

Where a Termite Management System has been identified you should refer to the type of barrier date of installation warranty conditions and any documentation provided by a builder or past owner. Consult the company who installed the barrier to confirm whether the system is still under warranty.

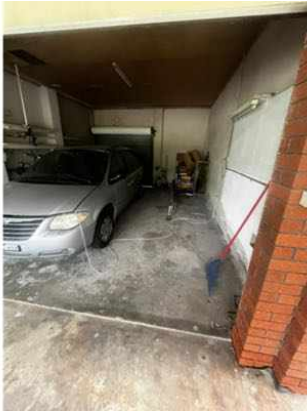
Building:	Main Building
Location:	Roof Void
Finding:	Obstructions and Limitations - Internal Areas
Information:	The garage roof access was not possible to be inspected as there was obstruction in the premises. A re inspection if made possible after clearing the obstacle can be arranged. These photographs are an indication of the obstructions and limitations which impeded full inspection of the property at the time of inspection.the external areas of the property. These obstructions can hide an array of defects and should be removed to allow full inspection to be carried out. A re-inspection is recommended once the areas are made accessible.

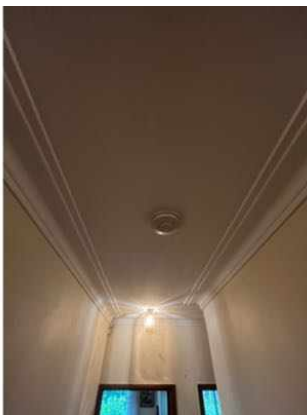
Building: Main Building
 Location: All Internal Areas
 Finding: Smoke Detector and Alarms
 Information: Reporting on Smoke Detectors or Alarms, including hard wired smoke detection systems and their legislative requirements, is outside the Scope of this Report.

Additionally, it is advised that all smoke detectors be tested by the homeowner on a monthly basis.

Please refer to AS3786 and state based legislation, which may also apply.

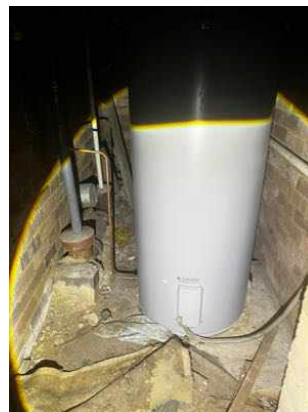
Building: Main Building
 Location: Yard - Side/ Subfloor
 Finding: Hot Water Unit
 Information: The Gas HWS unit appeared to be in good condition during inspection however this is not an opinion on the Licensed Plumber.

No water hammer was noted when taps are turned off fast.

Please consult a licensed Plumber for further information.

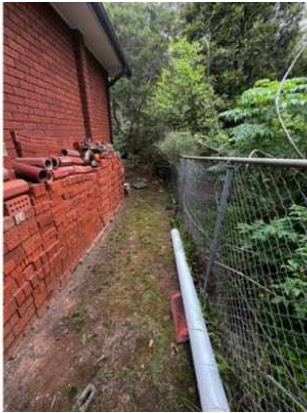
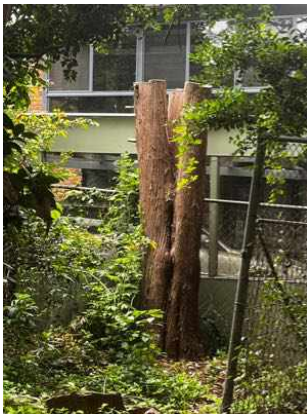
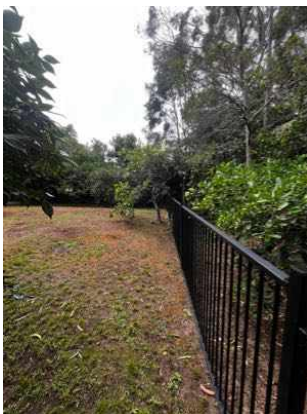
Building: Main Building
 Location: Yard
 Finding: Fencing - Deteriorated
 Information: It was noted at the time of inspection that sections of the fencing throughout the property have deteriorated. Typically fencing deteriorates due to age and or wear, rot and or rust which is generally expected for a structure of this age, due to prolonged exposure to weather conditions. Sometimes inadequate installation or maintenance can be to blame.

If left unattended, it is likely that further damage will occur. It is suspected that repair of several elements of the fencing may be required however replacement may be a

consideration of the client also.

A licensed fencing contractor should be appointed to provide further advice and perform rectification works as necessary.

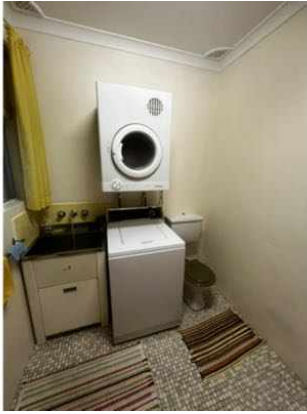
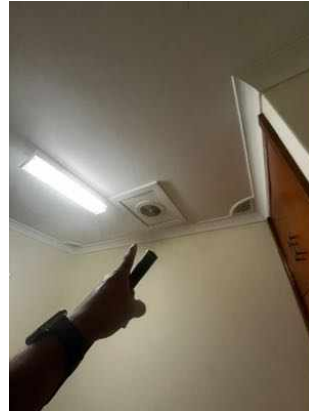
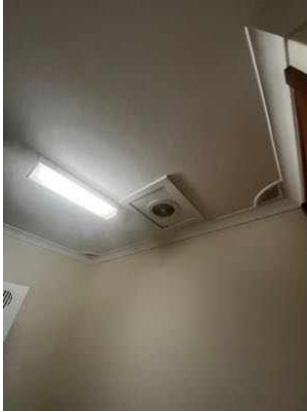
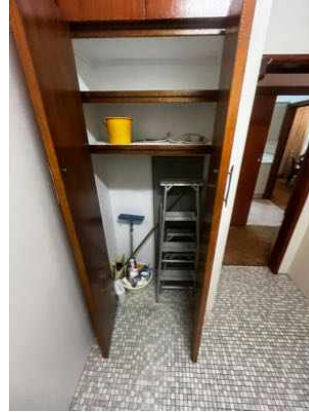
Building:	Main Building
Location:	Laundry
Finding:	For information only
Information:	No remedial works are required at the current time.

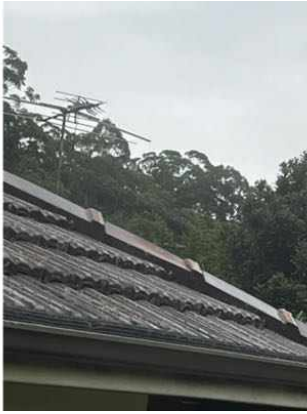
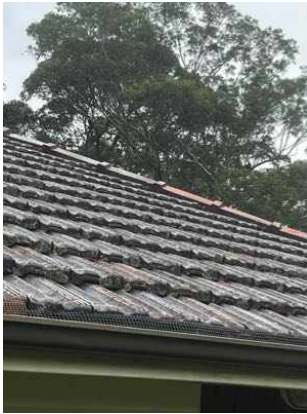
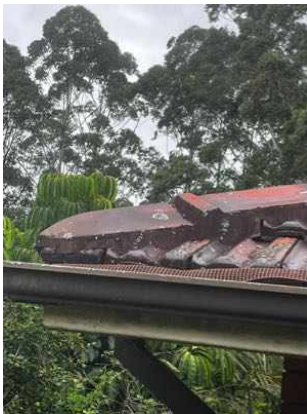
Building: Main Building
 Location: Roof
 Finding: Roof tiles - Weathered
 Information: Upon inspection of the exterior roofing, the majority of roof tiles were considered to be in a fair condition. While weathering of the tiles is consistent with the age of the property, maintenance works are required.

Isolated areas of mortar have come loose in the valleys and minor cracking is also present. Re-pointing and re-sealing the may be considered as an interim solution by the client to help preserve and extend the life span of the tiles.

Where left unmanaged, deteriorating roof tiles are likely to lead to a number of secondary defects, including minor water leaks and weather exposure to internal roofing structures.

Consultation with a roofing contractor is highly advised to gain advice on cost of remedial works that may be required in the short to medium term. Remedial works are likely to increase the longevity of the exterior roofing structure.

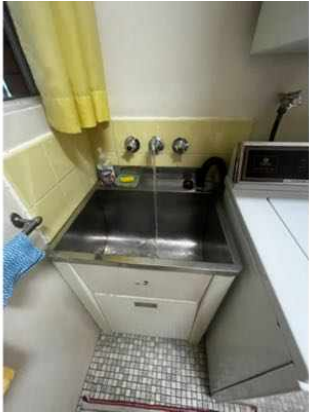
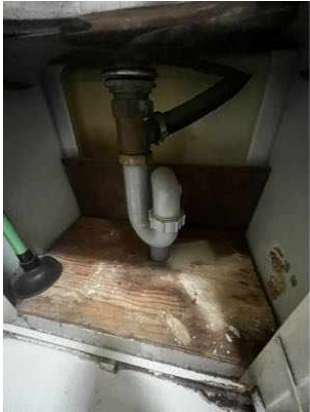
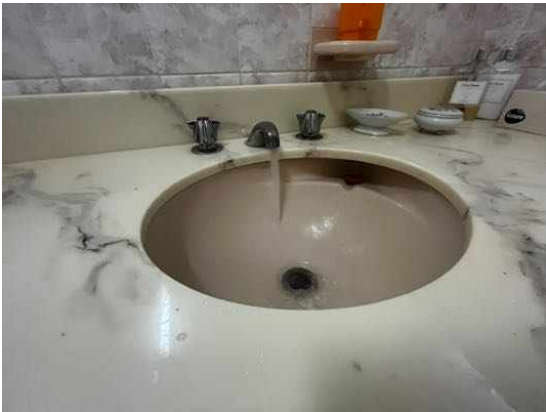
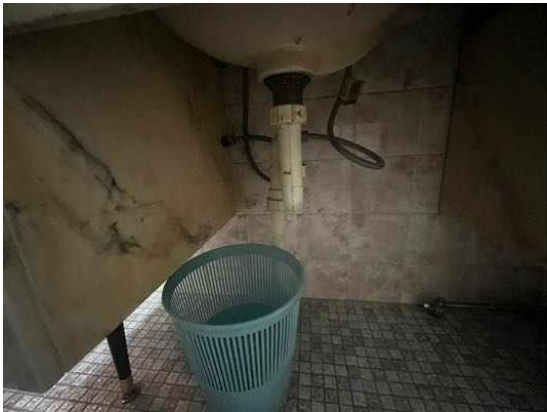
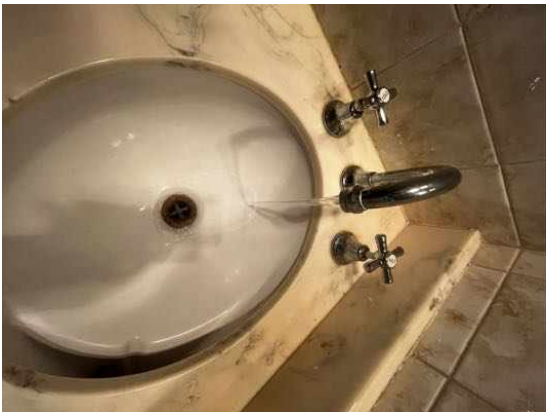
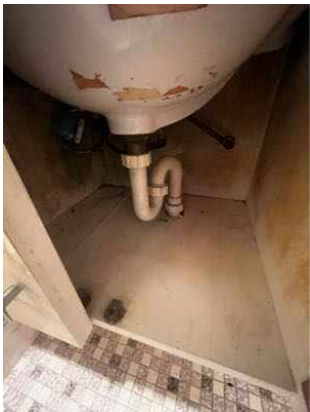
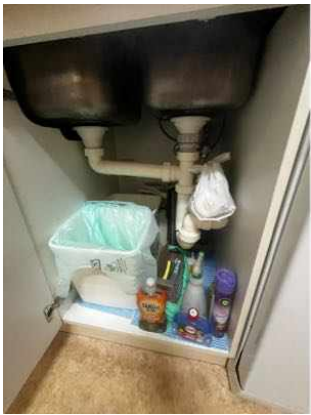
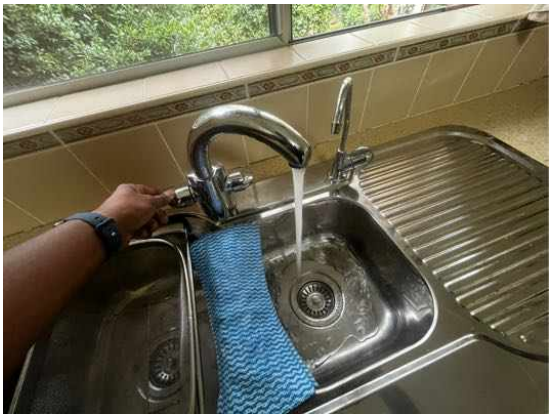
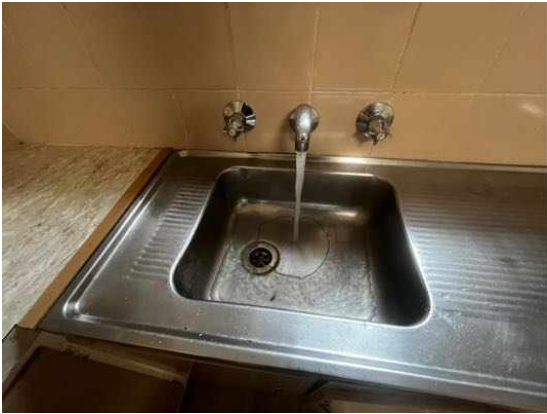
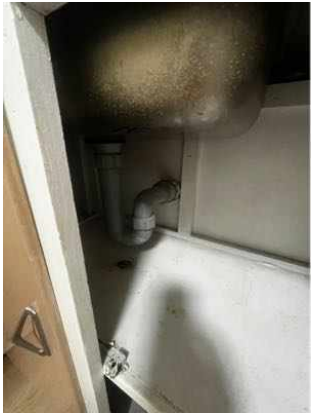
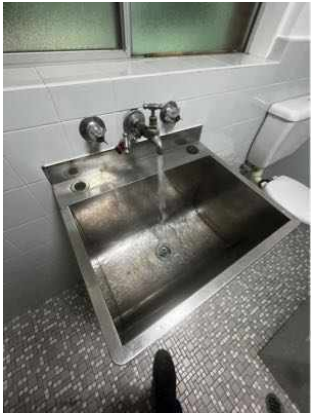
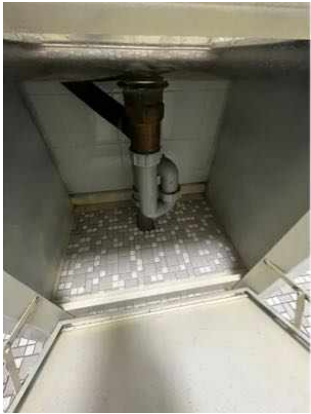
Building: Main Building
 Location: All Internal Areas
 Finding: Cabinetry Plumbing - Kitchen/ Laundry/ Bathroom/ Ensuite/ Gf Bathroom
 Information: Upon Inspection of all cupboards where sinks and basins with drainage plumbing were inspected and no evidence of leaks were present at the time of inspection.

For your information only no remedial works are required at the time of inspection.
