Building Inspection Report

Inspection Date: Fri, 30 Jan 2026

Property Address: 33 Tecoma Rd, Risdon Vale TAS 7016,
Australia

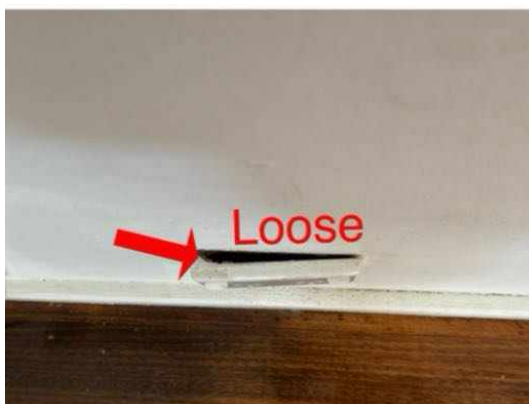
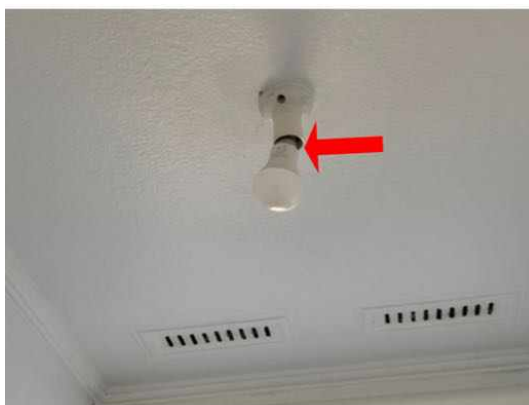
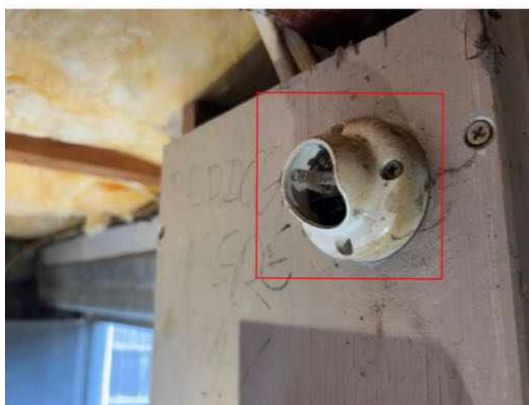
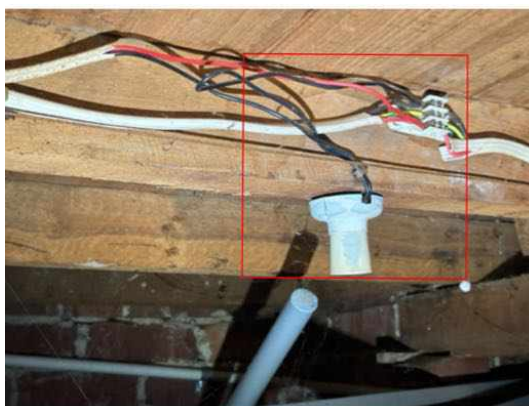
Defects 3.02

Building: Main Building
 Location: Multiple locations
 Finding: Electrical items to be rectified - including unorthodox wiring in the subfloor
 Information: In multiple locations there are electrical items that need to be rectified, as soon as possible. There is a loose power point in the living room, probably damaged batten holder in the toilet. Damaged batten holder in the laundry. A power point has been taped over in the sun room. The back porch light has no cover.

Failure to rectify could lead to a safety hazard.

Recommend client engage Lic Electrician to rectify as soon as possible.

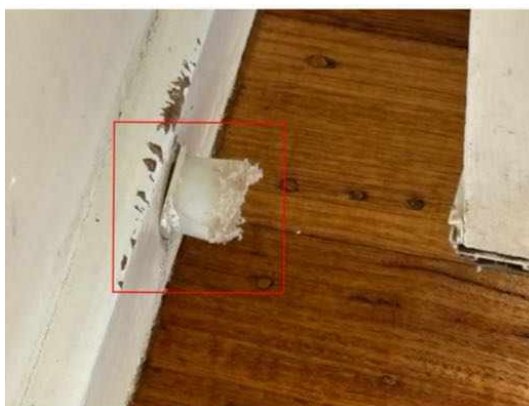
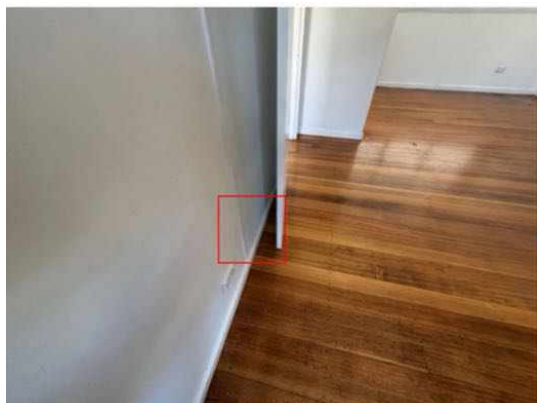
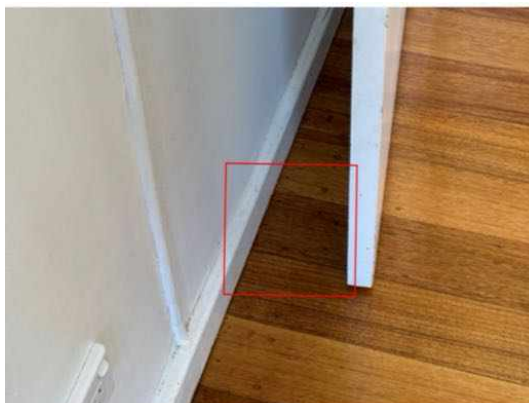
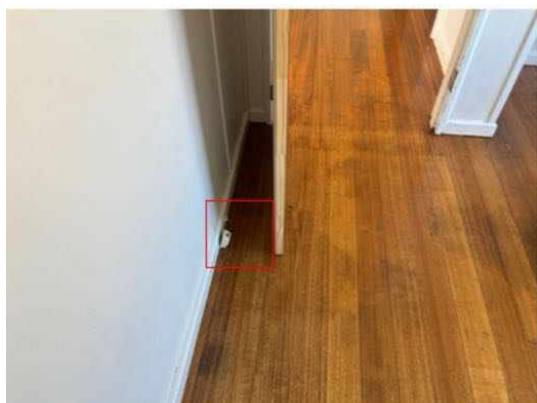
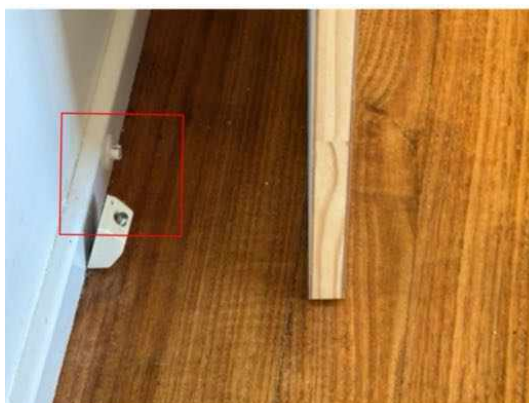
Defects 3.03

Building:	Main Building
Location:	Multiple locations
Finding:	Door stops - missing & damaged
Information:	In multiple locations the door stops are missing or have been damaged.

Recommend client engage a Handy Person to rectify at clients convenience, to prevent any further damage to the doors or walls.

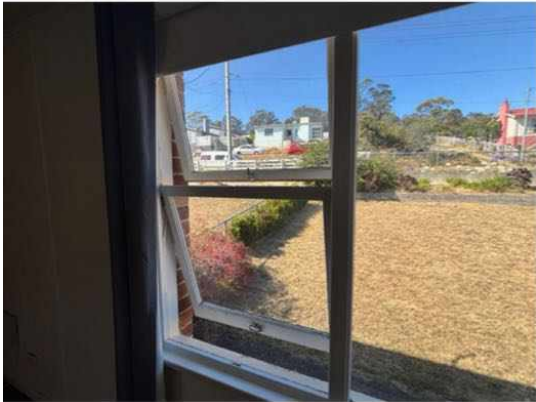
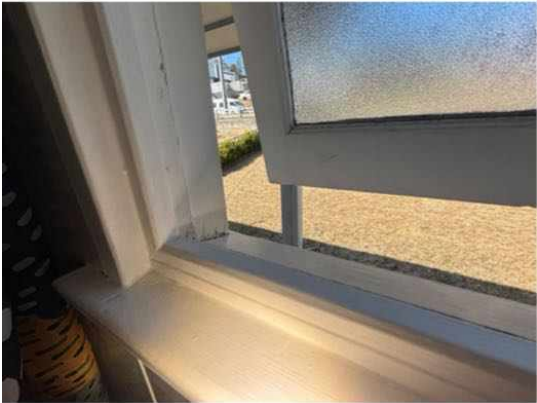
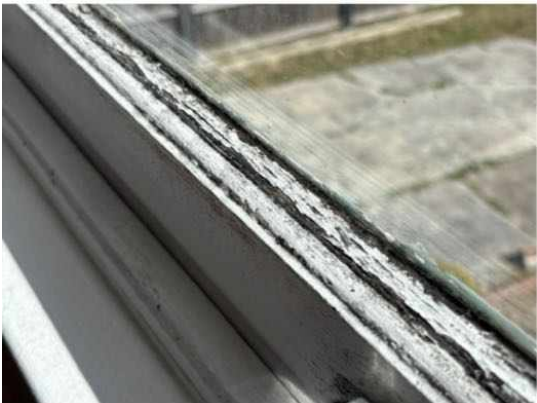
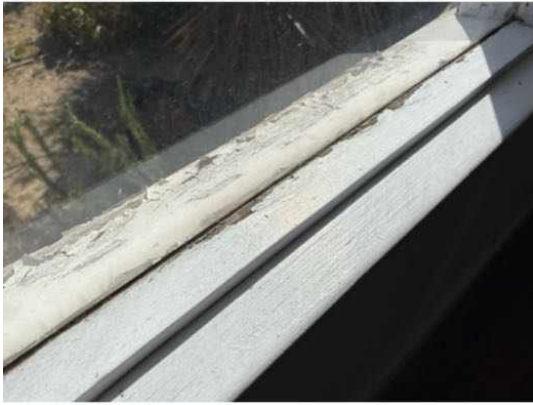
Defects 3.04

Building:	Main Building
Location:	Multiple locations
Finding:	Windows - cleaning & maintenance required
Information:	In multiple locations throughout the property the windows would benefit from cleaning, maintenance and painting.

Windows provide ventilation to the adjoining area and should be at a fully operational level to ensure user comfort. Restricted function of the window may also pose as a potential safety hazard if required for emergency egress from the building.

Generally, factors such as general age of the building element and a lack of maintenance are the usual causes for this type of defect.

Recommend client engage a Handy Person to rectify as soon as practicable.

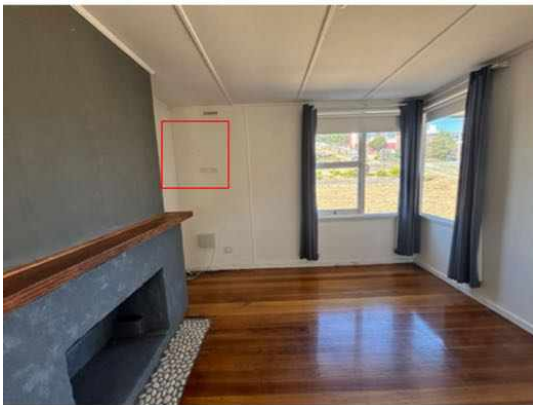
Defects 3.05

Building:	Main Building
Location:	Multiple locations
Finding:	FYI interior walls
Information:	FYI the interior walls are predominately masonite. A timber based products.

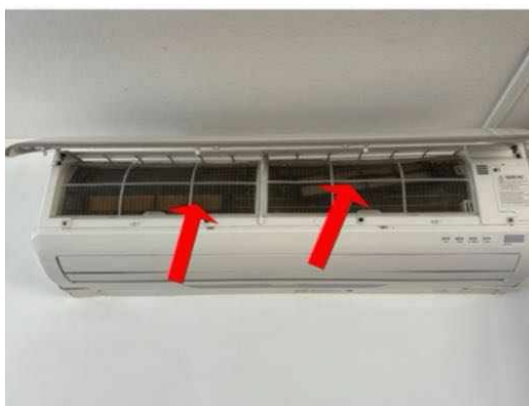
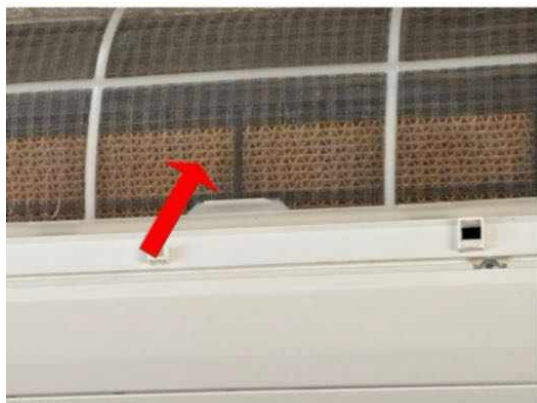
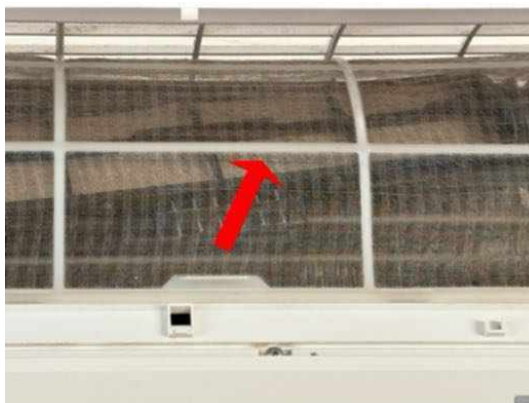
Defects 3.06

Building:	Main Building
Location:	Multiple locations
Finding:	Heat pump filters
Information:	The filters to the heat pump in the living room, appear to be loose. Recommend client engage an Air Conditioning Contractor to rectify as soon as practicable. Failure to rectify could potentially lead to damage to the unit.

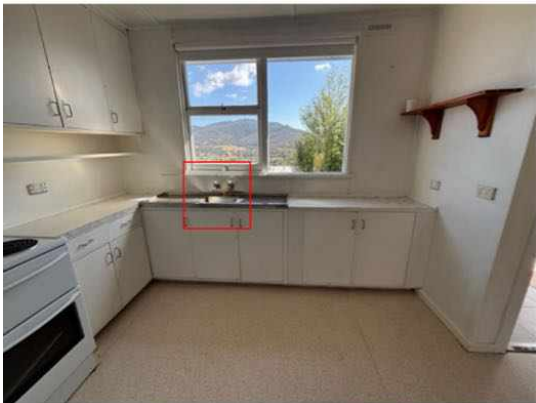
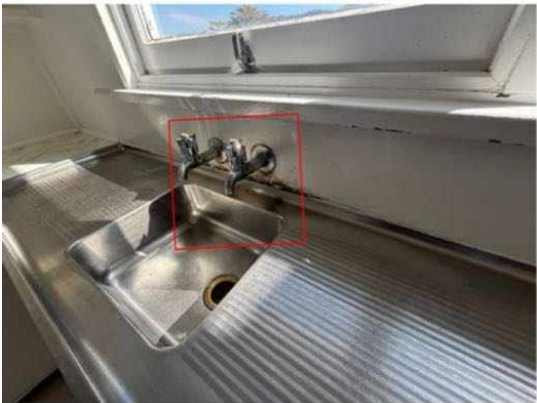
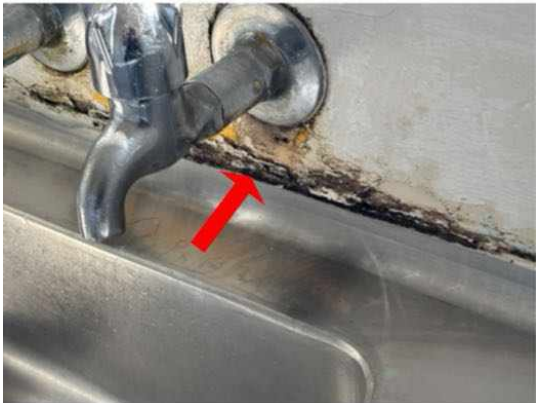
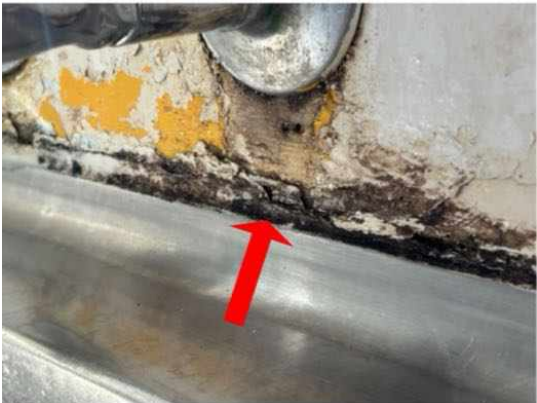
Defects 3.07

Building:	Main Building
Location:	Kitchen
Finding:	Water damage to kitchen backsplash
Information:	In the kitchen there is water damage to the kitchen back splash. The paint and silicone is badly deteriorated. This is most likely from water splashes.

Paint deterioration is due to a lack of regular maintenance. Early intervention will prolong the useful life of these building elements. Paint is the only protection that the backsplash has from water ingress.

Recommend client engage a Handy Person to rectify as soon as possible, to prevent further deterioration.

Always ensure that silicone, sealants and/or grout is in good condition to prevent any moisture issues occurring in the future.

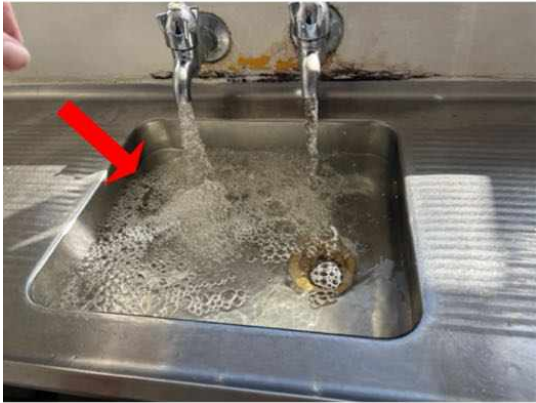
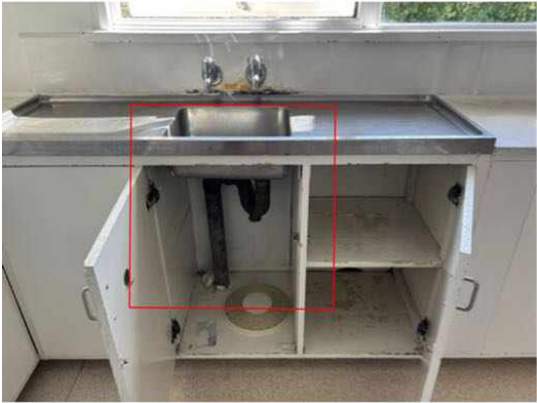
Defects 3.08

Building: Main Building
Location: Kitchen
Finding: Kitchen sink slow to drain
Information: The kitchen sink was very slow to drain. It was filling faster than it could drain. This could be due to a partial blockage in the system.

Failure to rectify could lead to water damage to surrounding building elements.

Recommend client engage a Lic Plumber to rectify as soon as possible.

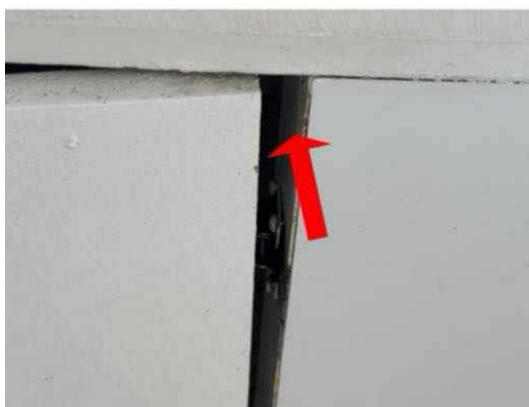
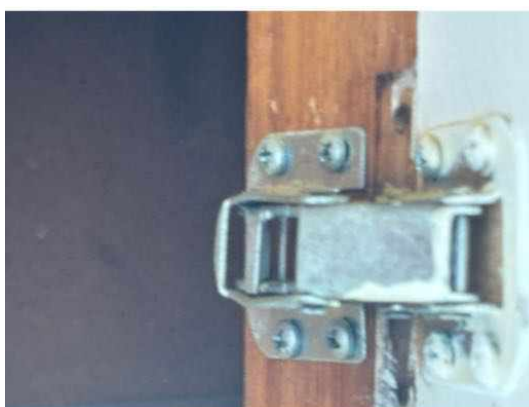
Defects 3.09

Building:	Main Building
Location:	Kitchen
Finding:	Kitchen cabinets maintenance
Information:	The kitchen cabinets require some maintenance. Multiple hinges are loose and doors are sagging.

Recommend client engage a Handy Person to rectify as soon as practicable, to prevent further deterioration to the cabinets.

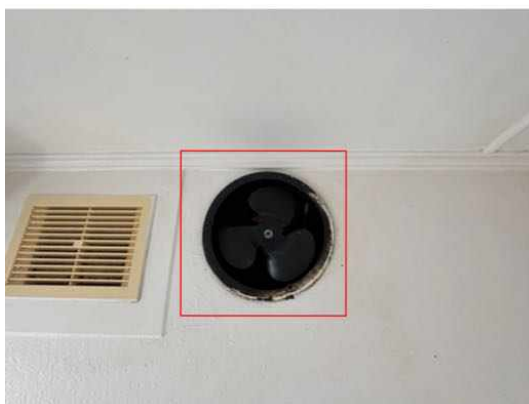
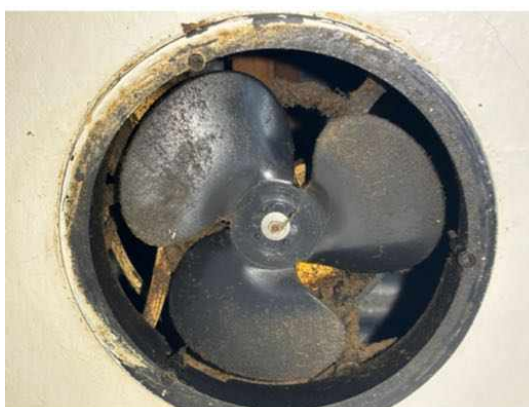
Defects 3.10

Building:	Main Building
Location:	Kitchen
Finding:	Kitchen exhaust fan
Information:	The exhaust fan in the kitchen is very dirty and oily. The cover is also missing. This will

cause a build up of oil in the roof void which is a vermin attractant. Recommend client have the exhaust fan replaced.

Recommend client engage a Lic Electrician to rectify as soon as possible.

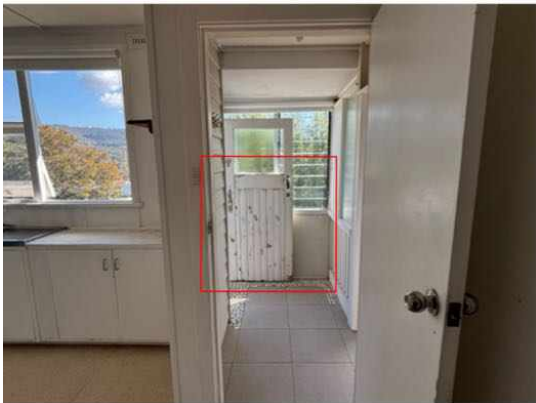
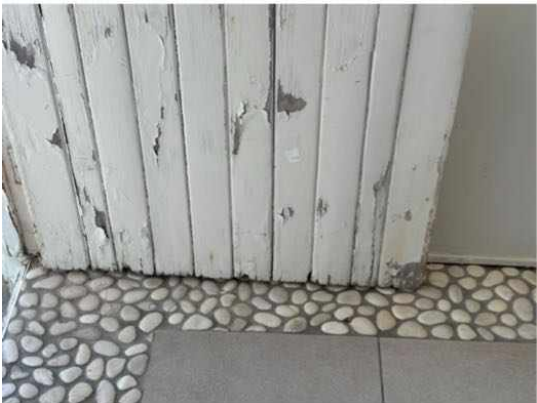
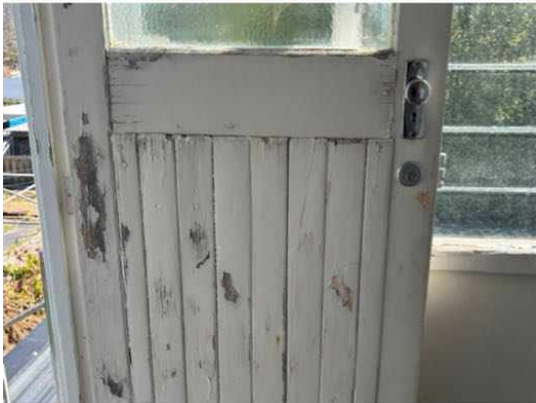
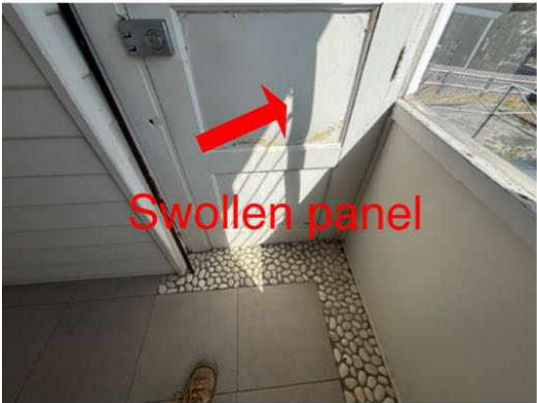
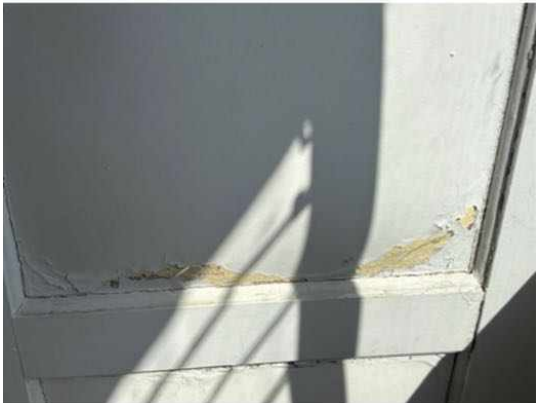
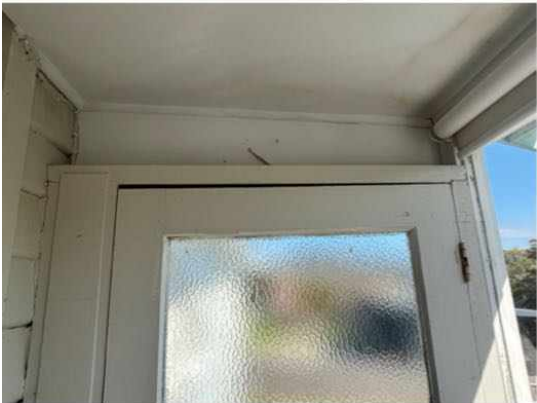
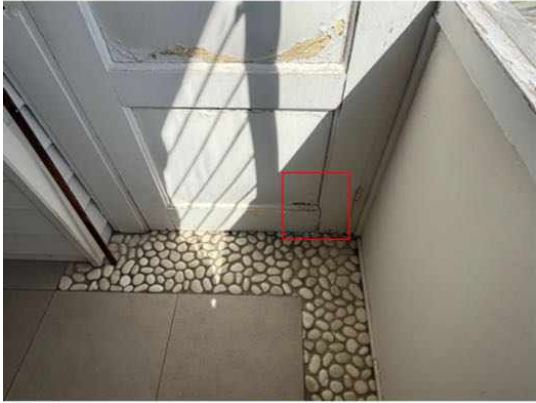
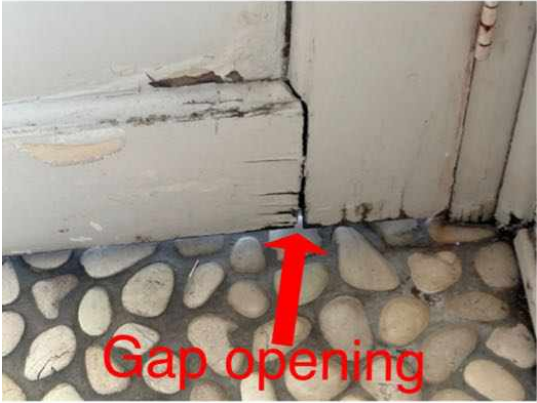
Defects 3.11

Building: Main Building
 Location: Back porch
 Finding: Back door
 Information: The paint to the back door is badly deteriorated, the panelling on the back of the door is water damaged and swollen. The door is also sagging. It is probably more economical to replace the door than to try to repair it.

Failure to rectify will allow further deterioration to the door.

Recommend client engage a Handy Person to rectify as soon as practicable.

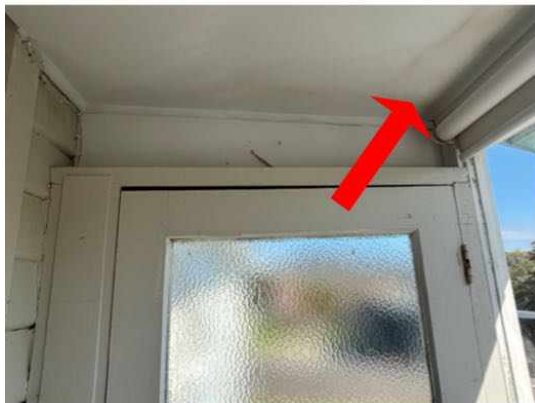
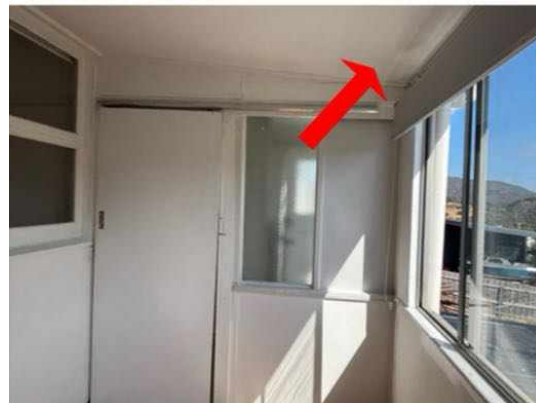
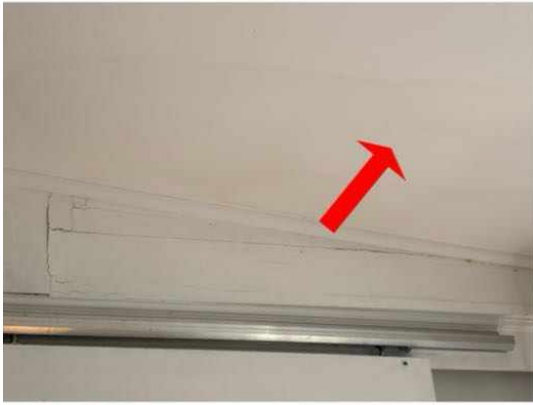
Defects 3.12

Finding: Water staining

Information: In the laundry and sun room there is water staining to the ceilings. They were dry at the time of inspection. There is new roofing installed above these areas. Suspect leaks have been resolved.

Recommend client monitor. Recommend client engage a Handy Person to paint at clients convenience. Client should note that suspected Asbestos containing materials (ACM) was identified in these areas. Client should ensure contractors are made aware of the ACM before any works commence.

If moisture re-occurs recommend client engage a Lic Plumber as soon as possible.

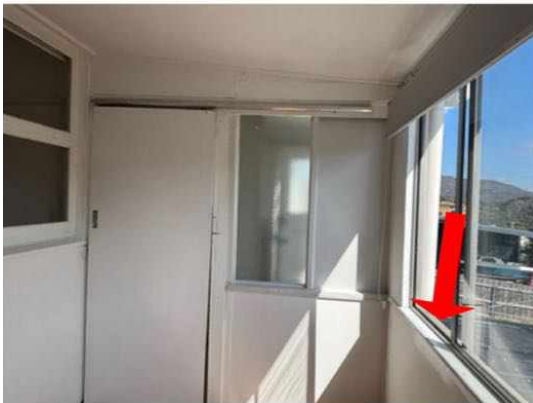
Defects 3.13

Building: Main Building
 Location: Back porch
 Finding: Paint deterioration to windows
 Information: On the interior of the house, the paint is very deteriorated to the back porch windows.

Paint deterioration is due to a lack of regular maintenance. Early intervention will prolong the useful life of these building elements.

Paint is the only protection that timbers have from water ingress.

Recommend client engage a Handy Person/Painter to rectify as soon as practicable.

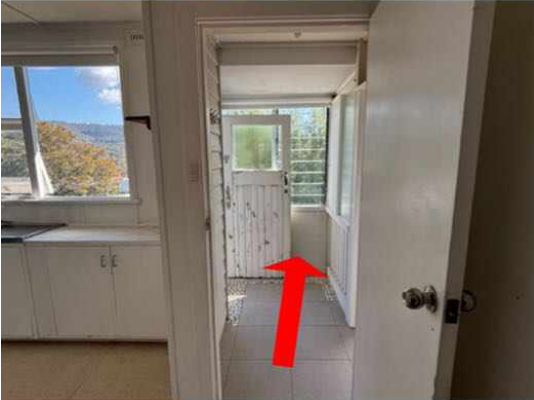
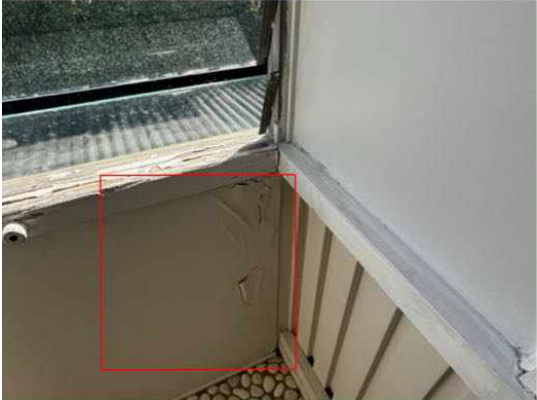
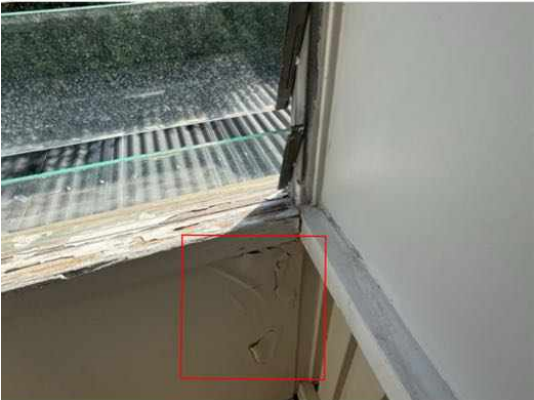
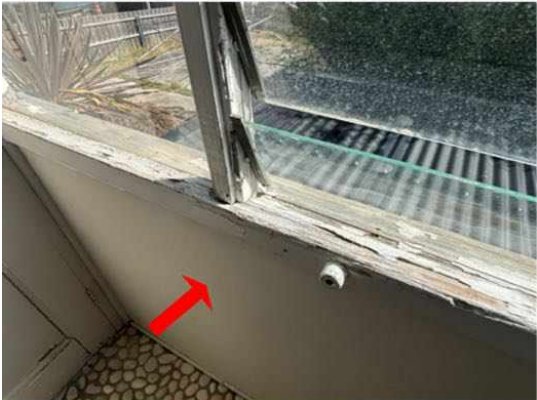
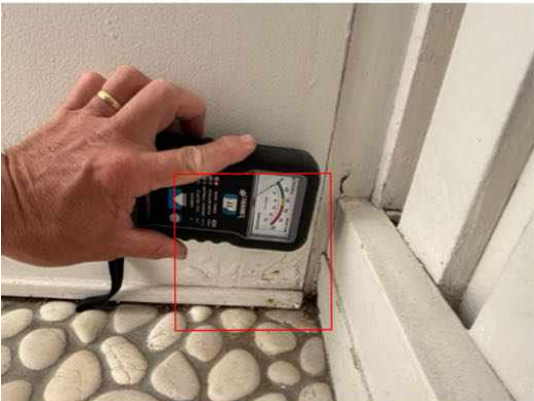
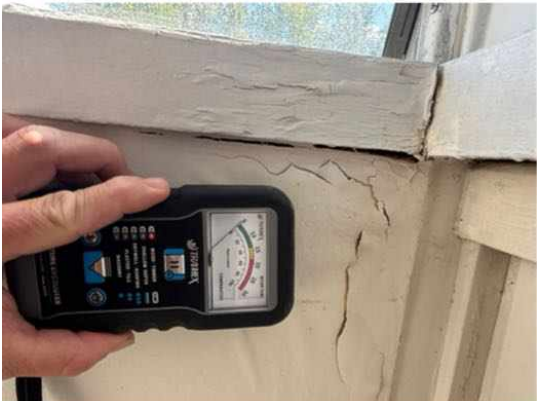
Defects 3.14

Building: Main Building
 Location: Back porch
 Finding: Paint deterioration walls of back porch
 Information: On the interior of the house, the paint is very deteriorated to back porch wall linings. This area has been identified as suspected Asbestos Containing Materials (ACM). Client should make any contractors aware of the suspected ACM before any works

Paint deterioration is due to a lack of regular maintenance. Early intervention will prolong the useful life of these building elements.

Paint is the only protection that timbers have from water ingress.

Recommend client engage a Handy Person/Painter to rectify as soon as practicable.

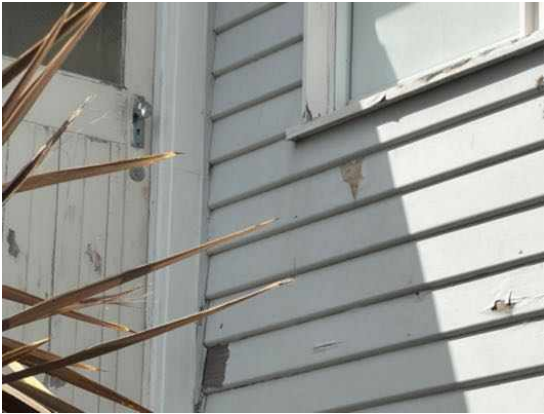
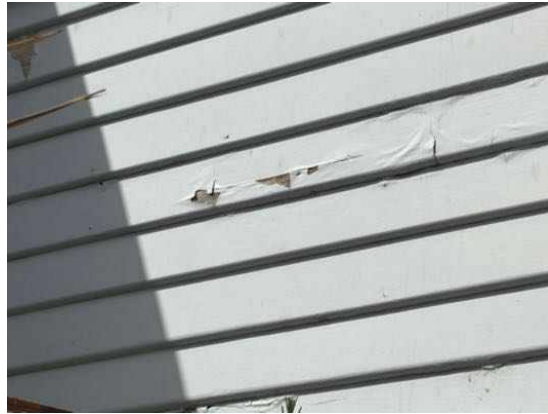
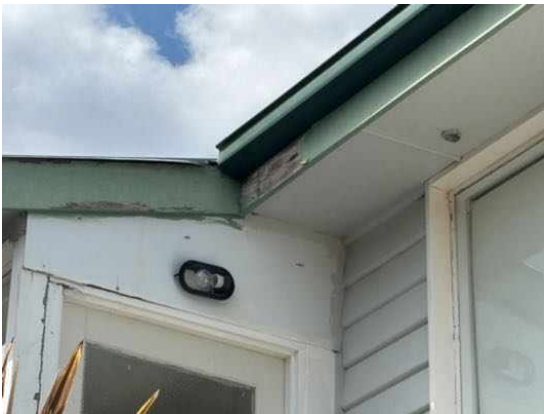
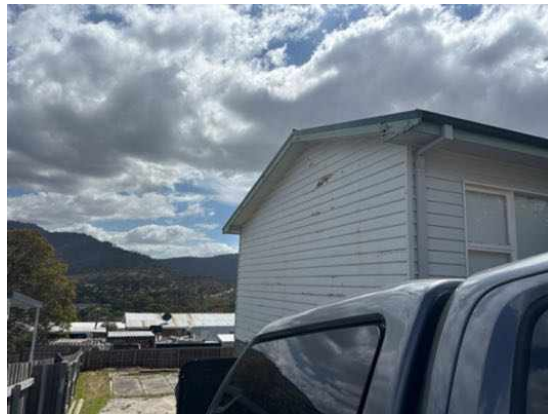
Defects 3.15

Building: Main Building
Location: Multiple locations
Finding: Paint Deterioration to exterior timbers
Information: On the exterior of the house, the paint is very deteriorated to timbers (windows, fascias, fascia infills, barge boards, trims, weatherboards, weatherboard stops etc).

It is likely that paint deterioration has developed as a result of frequent exposure to rain and other weather conditions. It is suspected that failure to maintain the timbers over a prolonged period has resulted in them deteriorating at an accelerated rate, increasing their susceptibility to the development of wood rot. Early intervention and regular maintenance will prolong the useful life of these building elements.

Recommend client engage a Handy Person/Painter to rectify as soon as practicable.

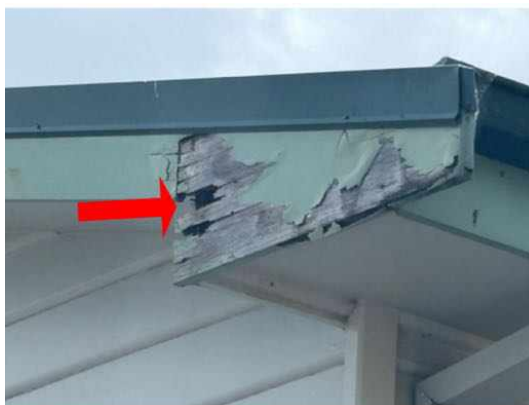
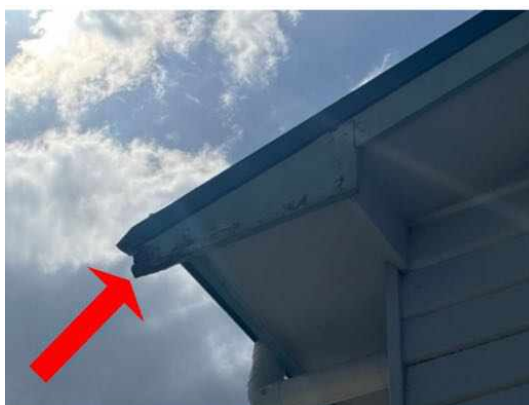
Defects 3.16

Building:	Main Building
Location:	Roof
Finding:	Wood rot & paint deterioration to fascias
Information:	There is wood rot and paint deterioration to the front and back fascias.

Wood rot, also known as Fungal Decay, occurs when timbers and other cellulose

building materials are exposed to damp conditions on an ongoing basis. This could be the result of exposure to weathering over a prolonged period of time, or the attraction of excessive moisture from other abutting building materials.

Paint is the only protection the timbers have from water ingress.

Recommend client engage a Carpenter to rectify the wood rot as soon as possible.

Once the timbers have been replaced, recommend client engage a Painter to prep and paint as soon as possible.

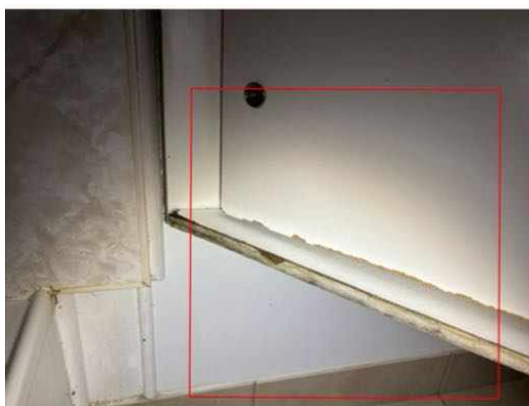
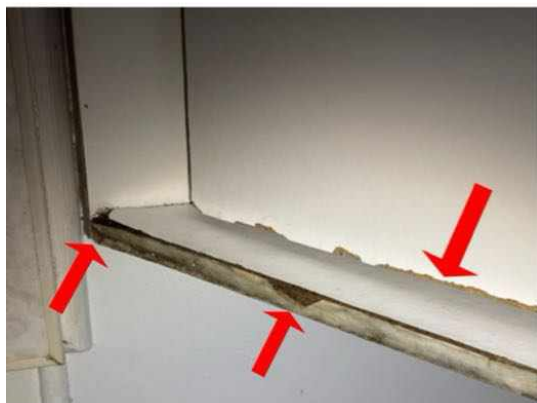
Defects 3.17

Building:	Main Building
Location:	Bathroom
Finding:	Water damage to vanity cabinet
Information:	In the bathroom there is water damage to the vanity cabinet, most likely from water splashes. Recommend these areas are painted to protect from further water ingress.

Recommend client engage a Handy Person to rectify as soon as practicable.

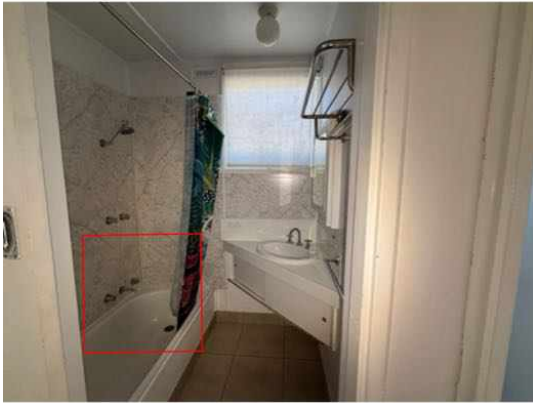
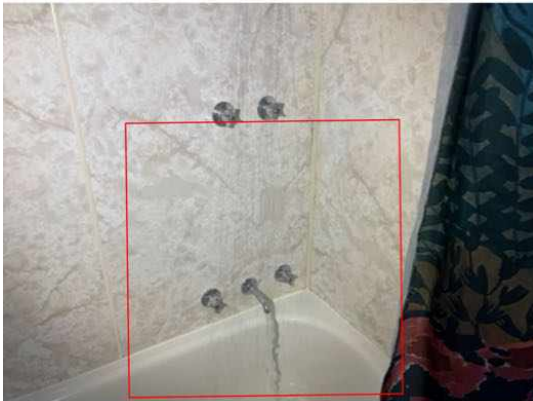
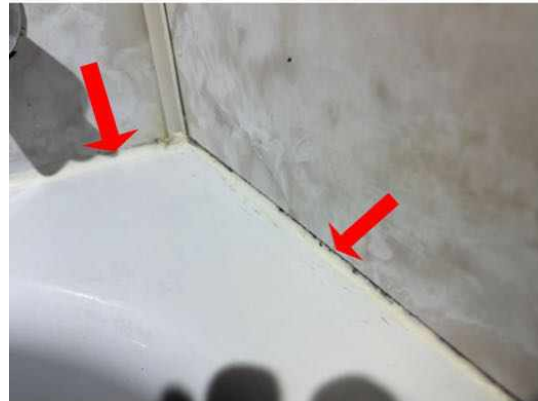
Defects 3.18

Building:	Main Building
Location:	Bathroom
Finding:	Silicone deteriorated to shower over bath
Information:	In the bathroom the shower over the bath silicone has deteriorated. The silicone needs to be removed and re-caulked.

Regular maintenance and replacement of damage or missing or damaged sealant and grout is highly recommended to the wet areas, as this is a regular wear and tear defect. Sealant and grouting in areas that come into regular contact with water should be maintained for the long term care of your property.

Failure to remedy could result in damage to surrounding building elements.

Recommend client engage a Handy Person to rectify as soon as possible.

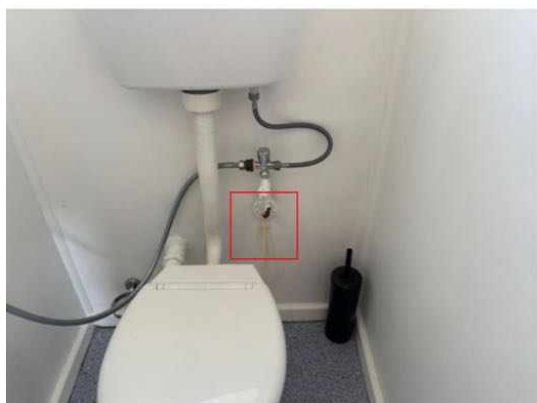
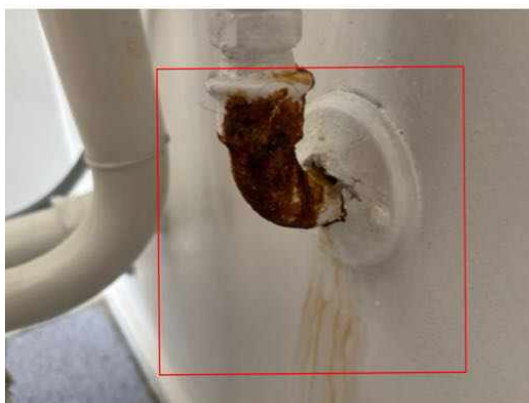
Defects 3.19

Building:	Main Building
Location:	Toilet
Finding:	Corrosion to galvanized pipe
Information:	There is water staining to the wall behind the toilet. There is badly corroded galvanized plumbing pipe.

Rusting and corrosion, is likely to have developed as a result of excessive exposure to moisture and or inadequate coatings.

As surface rust provides no protection to the underlying iron, the deteriorating condition is likely to worsen if not addressed in the short-term future.

Recommend client engage a Lic Plumber to rectify as soon as possible.

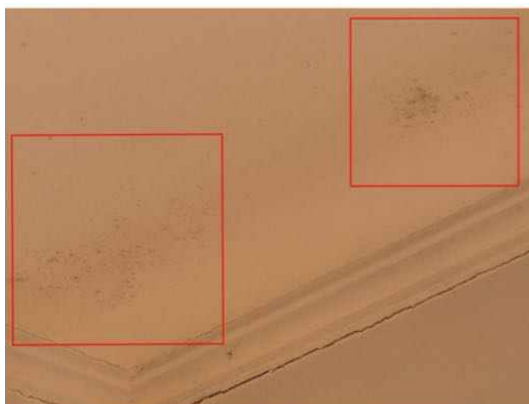
Defects 3.21

Building: Main Building
 Location: Back bedroom
 Finding: Mould, clean, treat and paint
 Information: There is mould staining to the corner of the back bedroom. This needs to be cleaned, treated and painted.

Failure to rectify could cause health related issues.

Recommend client engage a Handy Person to rectify as soon as practicable.

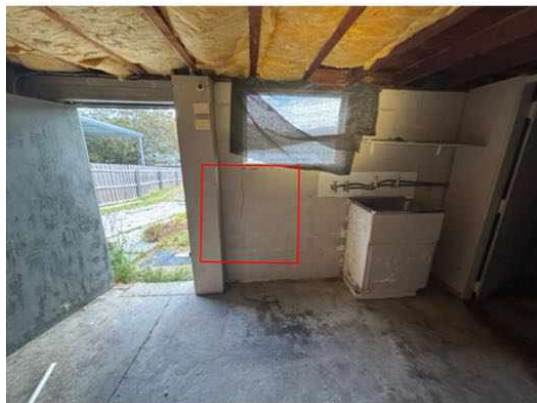
Defects 3.22

Building:	Main Building
Location:	Laundry
Finding:	Minor brick cracking
Information:	There was minor brick cracking identified to the brickwork inside the laundry. When this property was constructed, there were no control joints installed. Therefore the bricks crack where there is pressure.

Brick cracking, which is similar to other forms of cracking, has a variety of possible causes. However, the most common is the subsidence of adjacent footings. Minor brick cracking can be used as a warning sign to address factors causing stress to the wall, which can include the effect of surrounding trees, water leaks, soil erosion, or even the presence of reactive soils in the surrounding area. The cracking can also be seasonal with the size of cracks increasing or decreasing in response to moisture levels changing.

Brick cracking is a relatively common defect, and is most likely to occur adjacent to windows, doors and other openings. Mortar failure in the gaps between affected bricks indicates the stresses and tensions affecting the wall.

Recommend client monitor.

If the cracking increases contact a Building Inspector to assess as soon as possible.

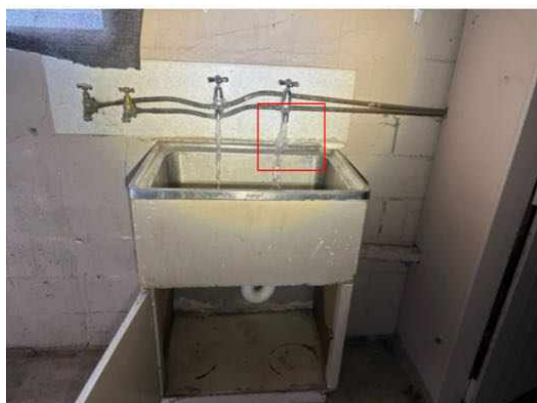
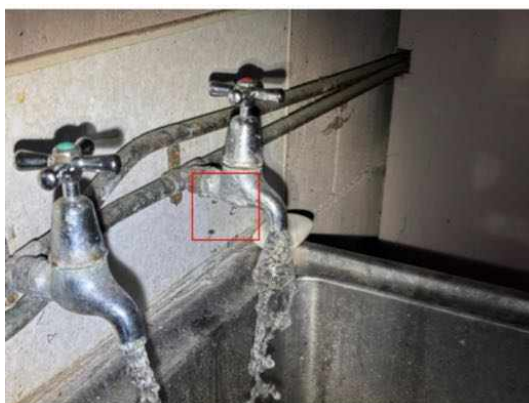
Defects 3.23

Building: Main Building
 Location: Laundry
 Finding: Laundry hot tap leaking
 Information: In the laundry the hot tap is leaking.

Internal water leaks can be detrimental to surrounding building elements. Rust, corrosion, decay and water damage are potential outcomes where a water leak is left unattended. In extreme cases, structural damage may develop due to a prolonged water leak.

Recommend client engage a Lic Plumber to rectify as soon as possible.

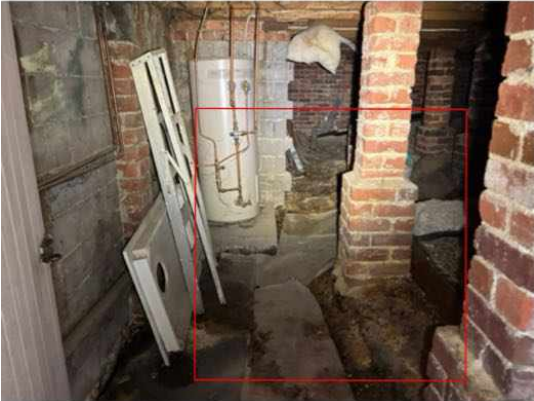
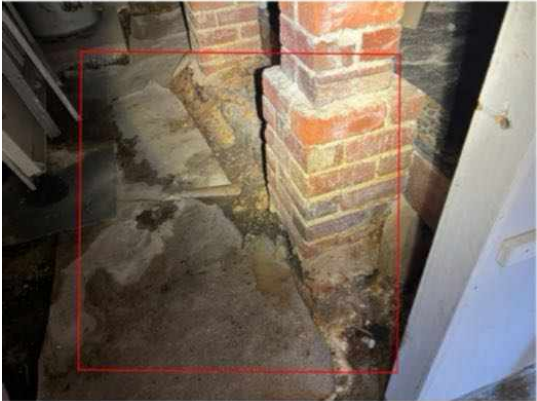
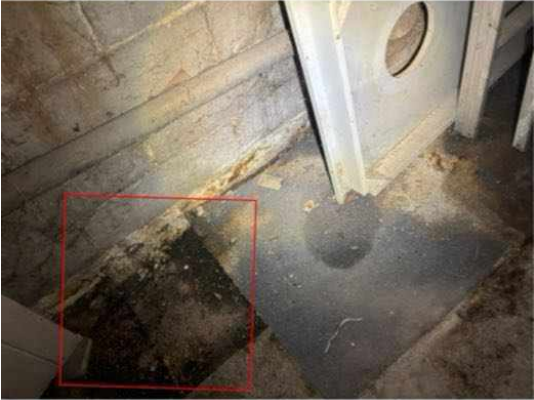
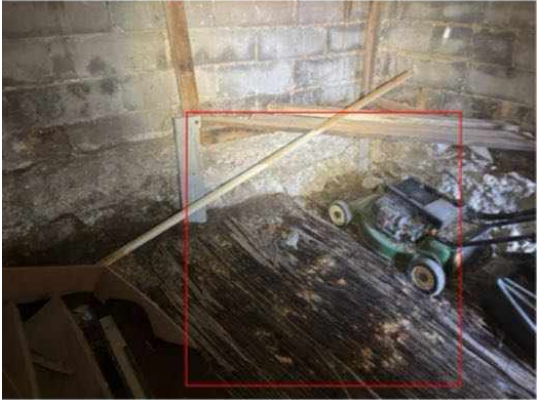
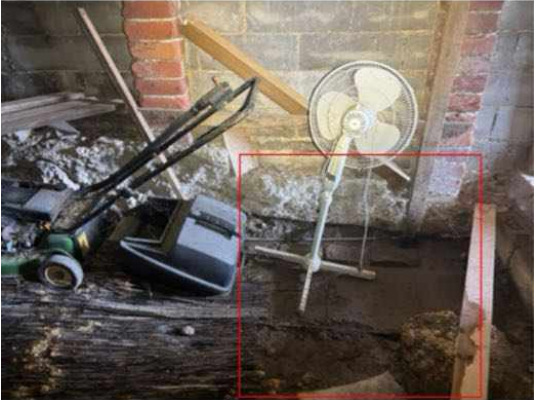
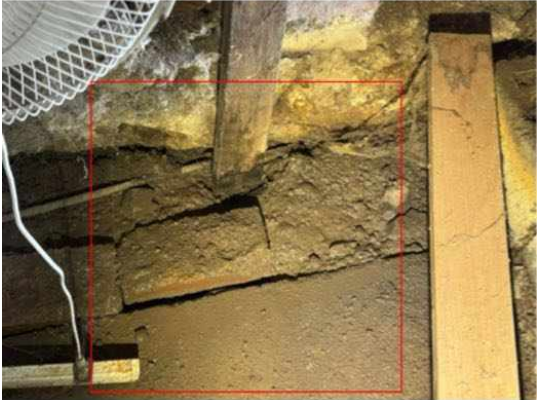
Defects 3.24

Building: Main Building
 Location: Subfloor
 Finding: FYI subfloor dampness
 Information: FYI there is dampness in the subfloor. This is most likely from ground water, because the house is on a down slope. Plus from persons excavating below the natural ground level. Recommend that client does not store items in this area as they could become

damaged from the moisture.

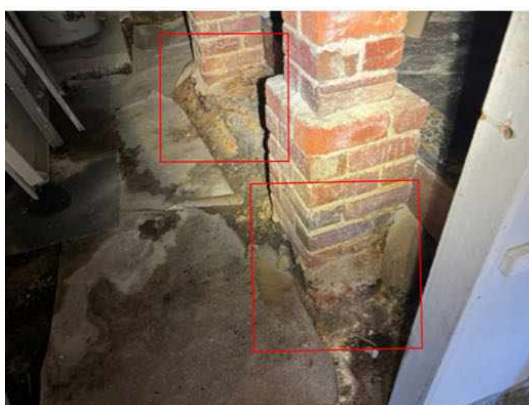
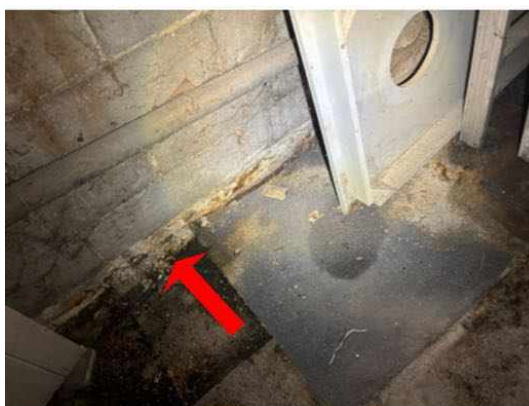
Defects 3.25

Information: In the subfloor there are some piers and footings that have been partially or fully undermined. Dirt has been excavated away exposing portions of the footings, which reduces stability of the foundations and increases the likelihood of subsidence. There was no. Significant damage identified at this time, but there was lots of vegetation obscuring access at the front of the property where the deepest excavation was.

The soil holds up the concrete foundation/ footing which in turn holds up the brickwork, which holds up the house.

Failure to rectify could potentially lead to damage of the structural building elements.

Recommend client engage a Lic Builder to assess and rectify as soon as possible.

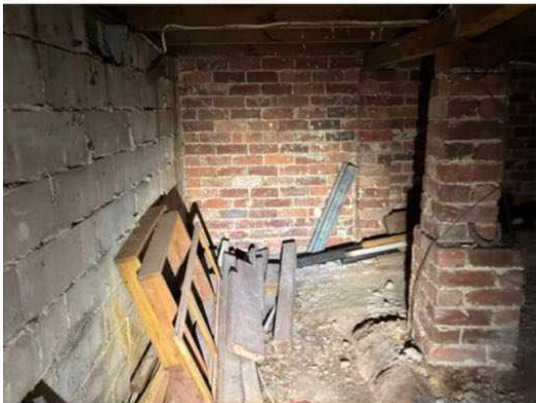
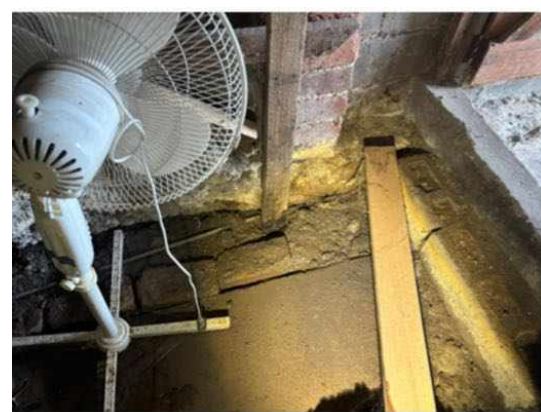
Defects 3.26

Building: Main Building
Location: Subfloor
Finding: FYI Subfloor stored items
Information: FYI there are stored items in the subfloor. This restricts ventilation and creates potential for concealed pest entry. A clear and empty subfloor will be better ventilated and easier to maintain in a dry condition.

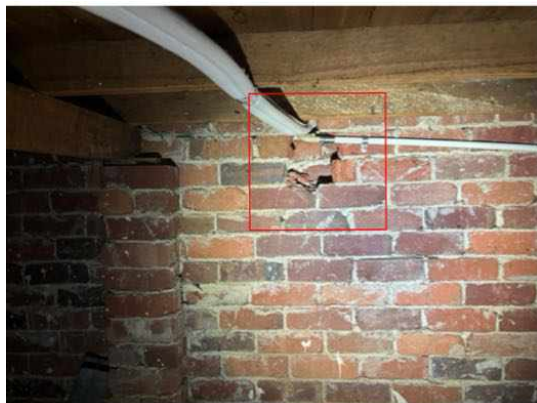
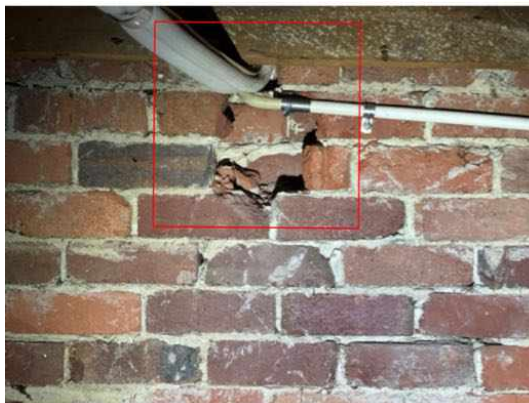
Defects 3.27

Building:	Main Building
Location:	Subfloor
Finding:	Holes to brick work
Information:	There are some holes in the brick work to the party wall in between the properties. This appears to be due to the installation of the heat pump.

This double skinned brick wall is designed to provide fire separation between the dwellings. To Maintain the as designed fire separation, I recommend that the client engage a handy person to seal the hole with suitably fire resistant materials. Such as brick and mortar to the extent possible, mineral wool and then fire resistant mastic(like a tube of silicone) for the remaining small gaps.

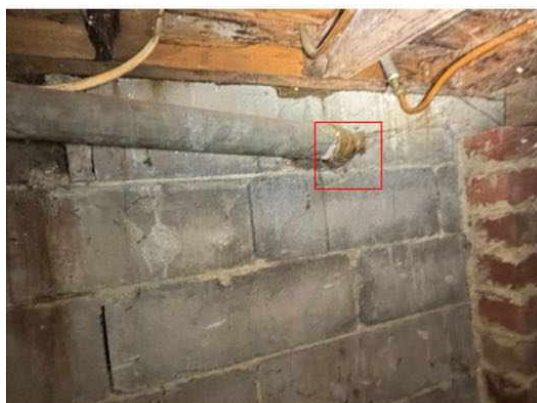
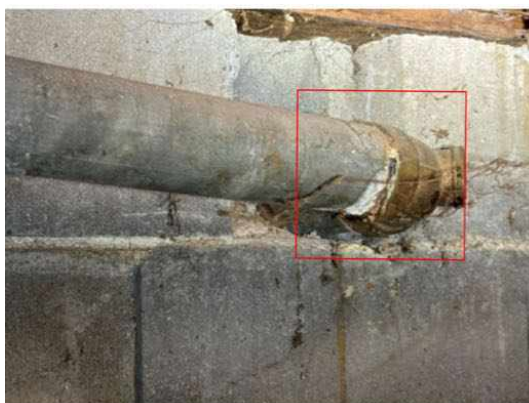
Defects 3.28

Building: Main Building
 Location: Subfloor
 Finding: Corrosion to galvanized plumbing pipe
 Information: In the subfloor there is corrosion the galvanized plumbing pipe for the bath waste.

Rusting and corrosion, is likely to have developed as a result of excessive exposure to moisture and or inadequate coatings.

As surface rust provides no protection to the underlying iron, the deteriorating condition is likely to worsen if not addressed in the short-term future.

Recommend client engage a Lic Plumber to inspect when on site for other plumbing items and to rectify if required.

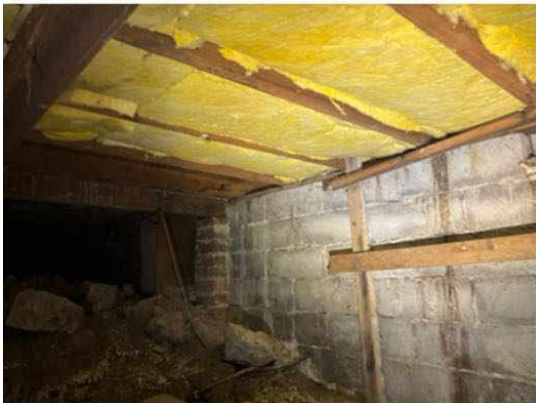
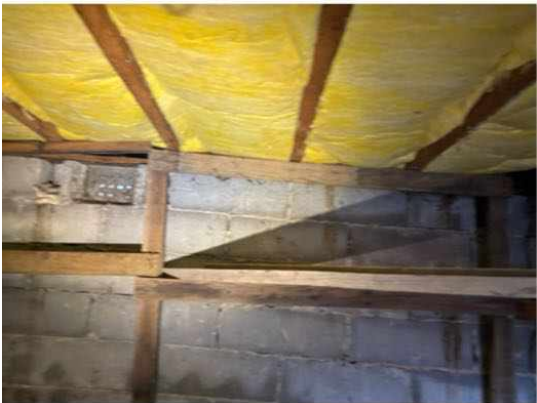
Defects 3.29

Building: Main Building
 Location: Subfloor
 Finding: FYI under floor insulation
 Information: FYI under floor insulation batts have been fitted in the subfloor under the bedrooms.

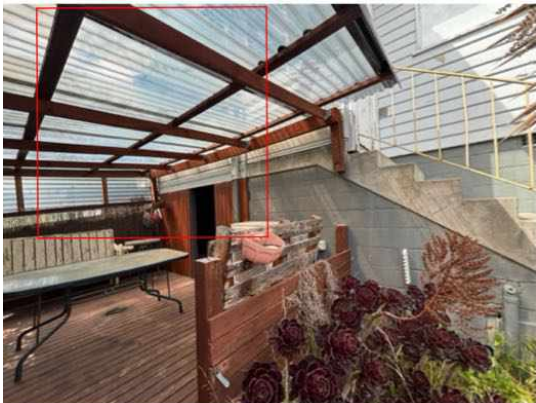
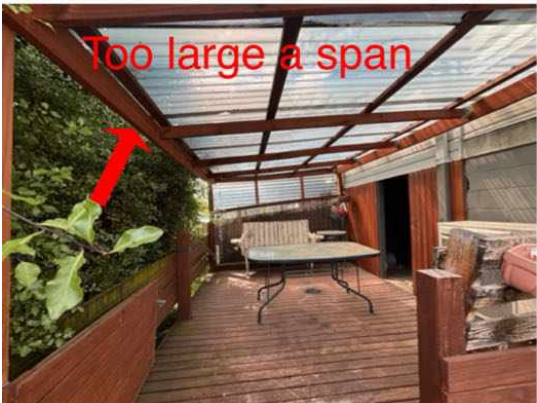
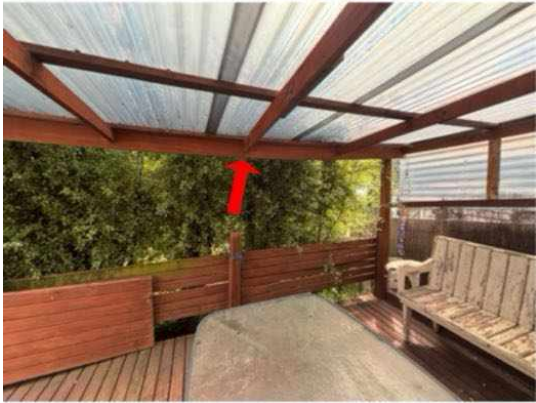
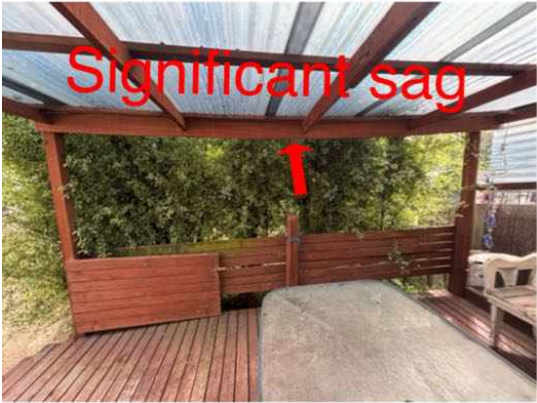
Defects 3.30

Building: Main Building
 Location: Patio
 Finding: Patio roof timbers
 Information: The patio roof is sagging significantly. The timbers don't appear to be large enough to support this area.

Failure to rectify could lead to roof timbers collapsing

Recommend client engage a Carpenter to rectify as soon as possible.

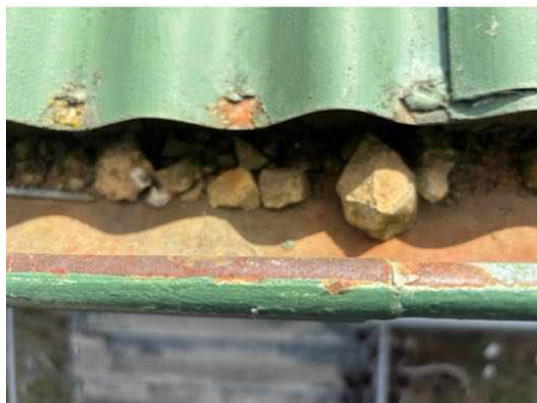
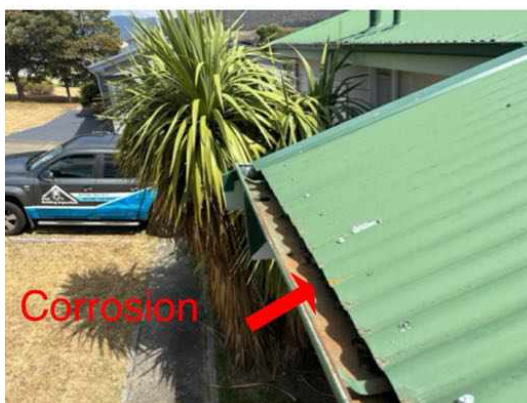
Defects 3.31

Building:	Main Building
Location:	Roof
Finding:	Gutters - debris
Information:	There is some debris in the gutters. FYI the back gutters have been replaced. The front gutters are corroded but are still functioning at the moment, however they will need replacement in the near future.

Blocked gutters are likely to lead to high levels of moisture in the affected areas. Such moisture can cause rust and decay of the associated building materials. Blockages in gutters should therefore be removed immediately to ensure dry conditions are maintained.

Recommend client engage a Handy Person to clean the gutters as soon as possible.

Recommend client ensure that all gutters be maintained on a frequent basis to ensure the condition of roof plumbing.
