Building Inspection Report

Inspection Date: Fri, 30 Jan 2026

Property Address: 33 Tecoma Rd, Risdon Vale TAS 7016,
Australia

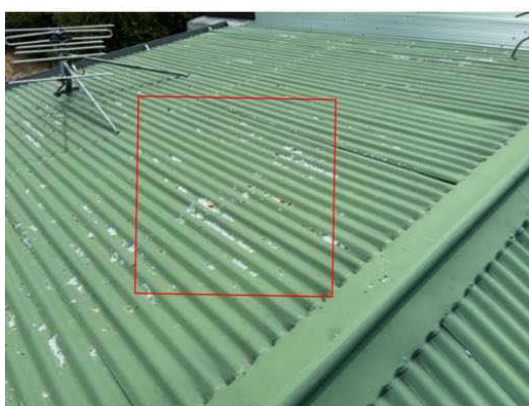
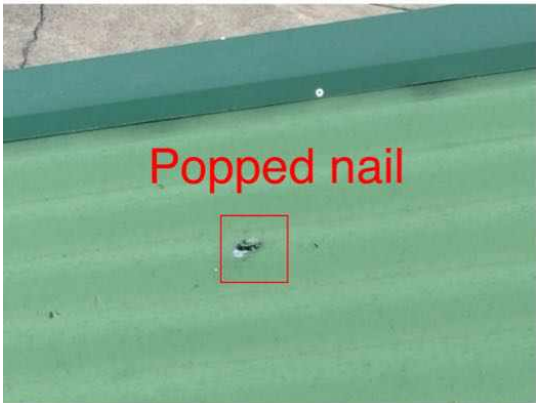
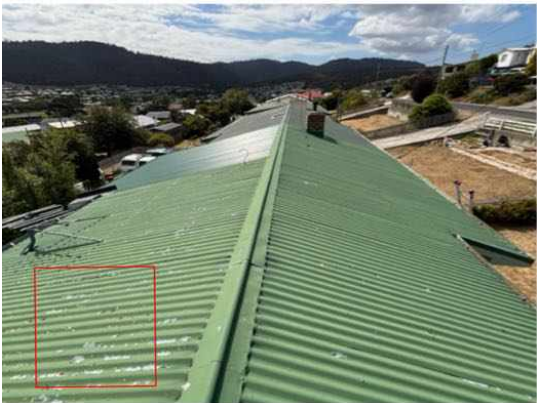
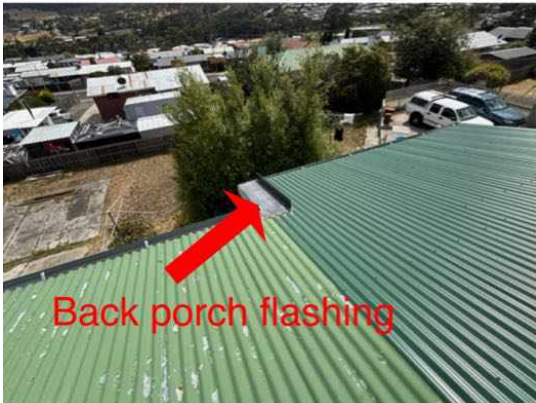
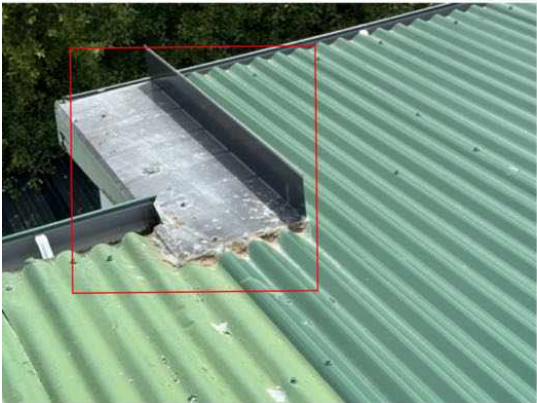
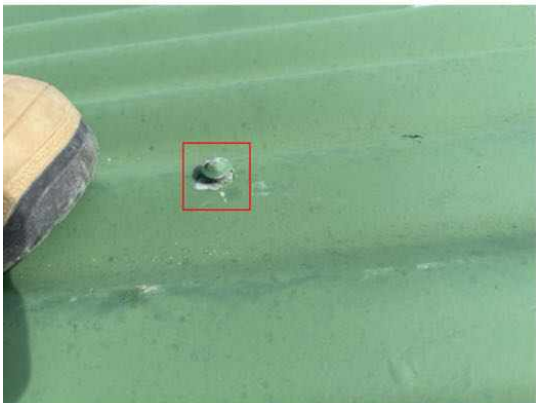
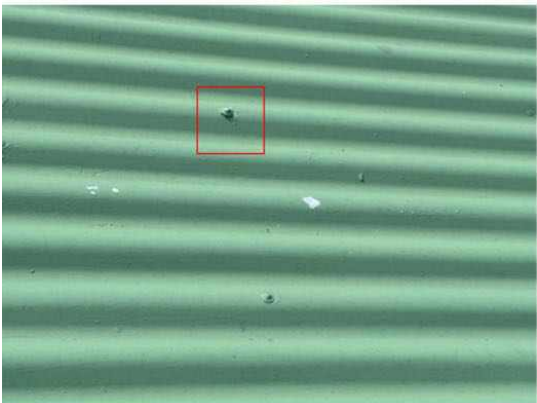
Defects 3.32

Building:	Main Building
Location:	Roof
Finding:	Roof maintenance required
Information:	The roof requires some maintenance work. There are loose nails, corrosion and silicone repairs. There is also an unorthodox flashing to the back porch which is relying purely on silicone.

The roof is held down by nails, which was normal practice at the time of construction. However as the timber dries and shrinks the nails and timber loose friction and the suction of the roof by winds, works the nails loose. Some have been replaced by roof screws.

Recommend client engage a Lic Roof Plumber to rectify as soon as possible.

Any loose nails should be replaced by roof screws which offer superior hold down power.

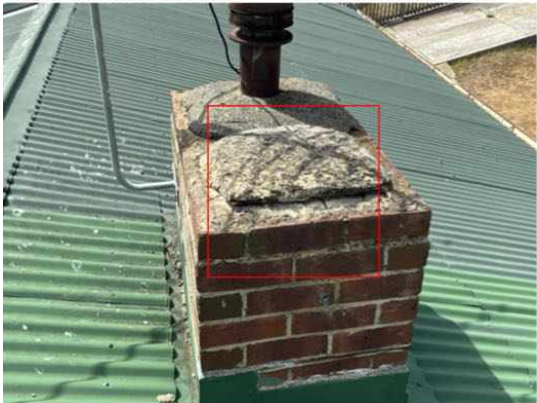
Defects 3.33

Building: Main Building
 Location: Roof
 Finding: Mortar degraded to chimney capping
 Information: The mortar (pointing) on the brickwork to the chimney capping has deteriorated and is in need of repair.

Degraded pointing is likely due to weather and movement. Also some mortar mixes may not have been equal at time of construction. Failure to repair will potentially allow more movement of brickwork and lead to water ingress.

Recommend client engage a Handy Person to rectify at clients convenience.

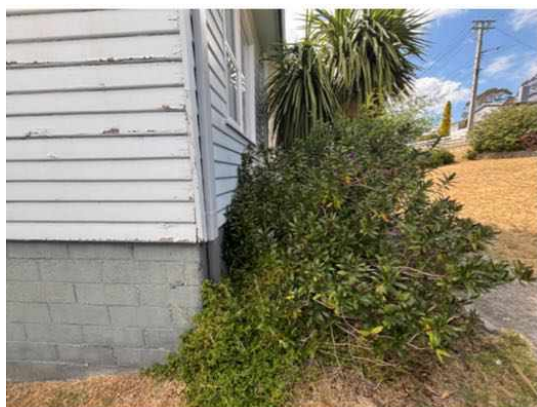
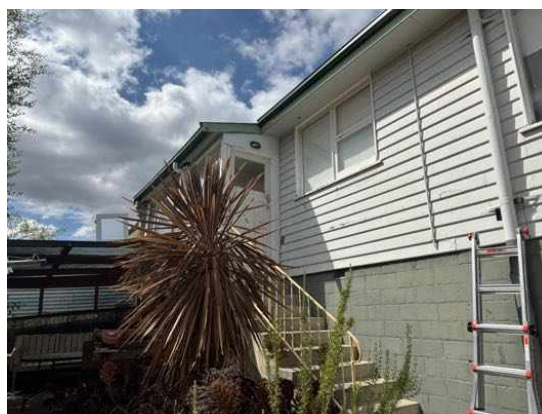
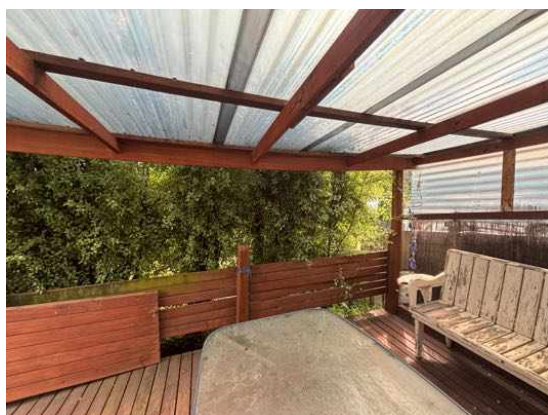
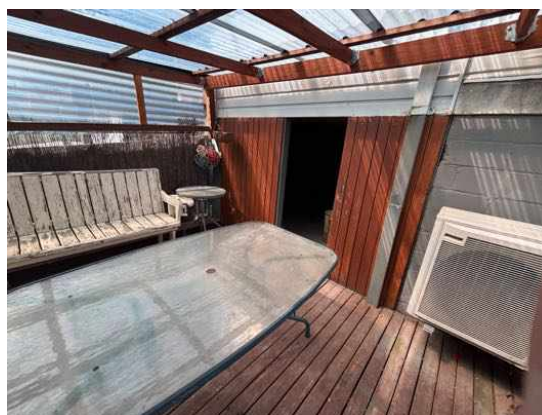
Noted Item

Building:	Main Building
Location:	All External Areas
Finding:	Additional Photos - Obstructions and Limitations
Information:	These photographs are an indication of the obstructions and limitations which impeded full inspection of the property at the time of inspection. These obstructions can hide an array of defects and should be removed to allow full inspection to be carried out. A re-inspection is recommended once the areas are made accessible.

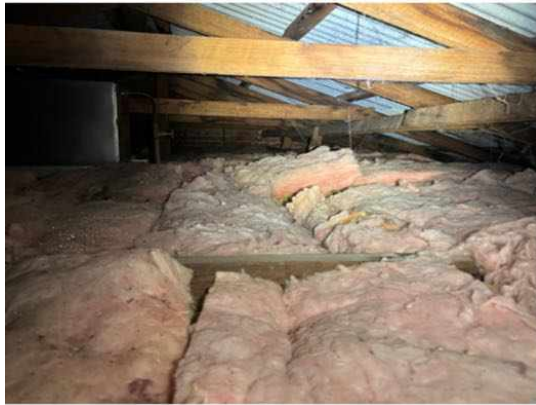
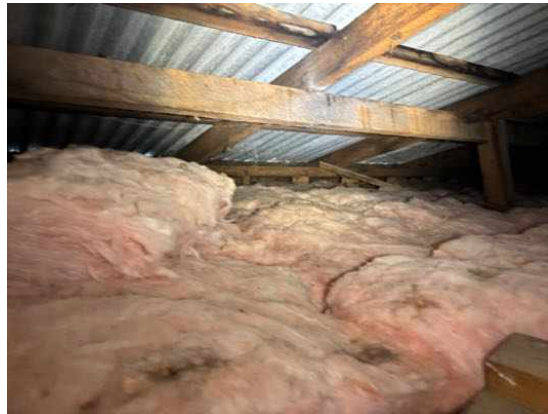
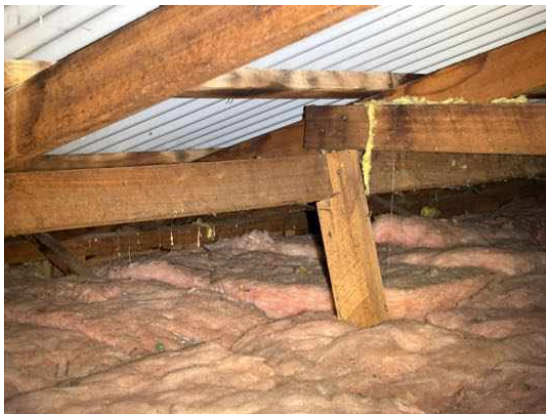
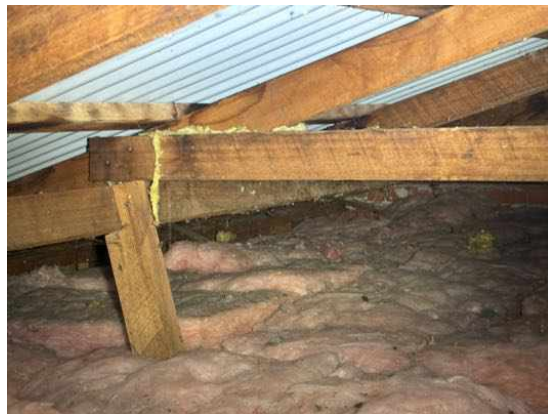
Noted Item

Building:	Main Building
Location:	Roof Void
Finding:	Additional Photos - Obstructions and Limitations
Information:	These photographs are an indication of the obstructions and limitations which impeded full inspection of the property at the time of inspection. These obstructions can hide an array of defects and should be removed to allow full inspection to be

carried out. A re-inspection is recommended once the areas are made accessible.

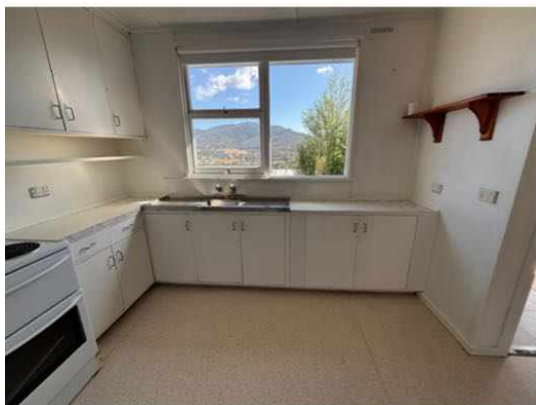
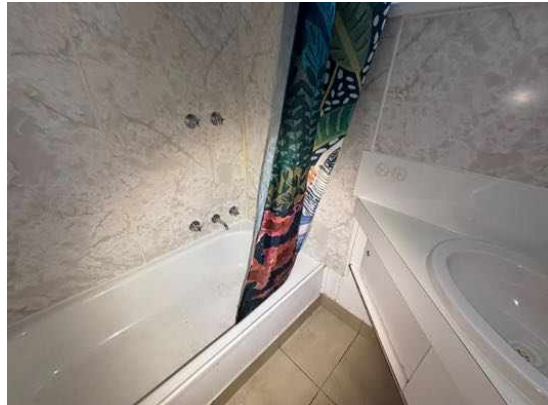
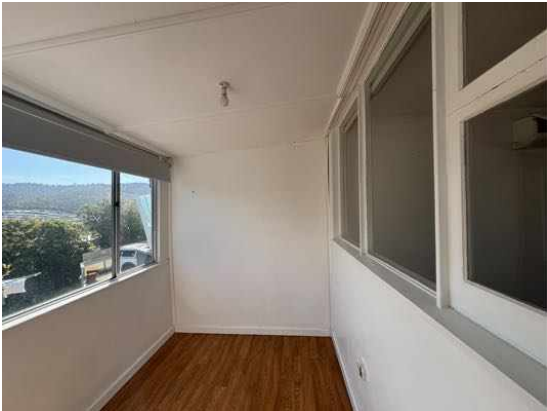
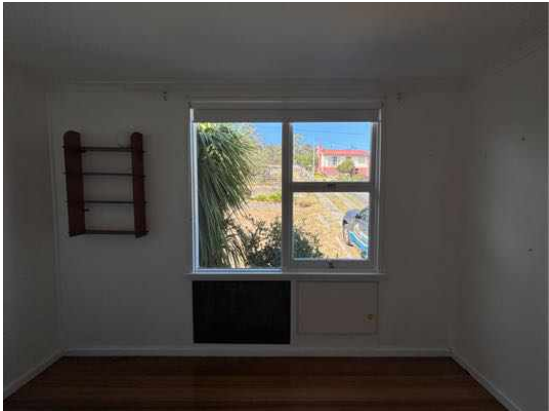
Building:	Main Building
Location:	All Internal Areas
Finding:	Additional Photos - Obstructions and Limitations
Information:	These photographs are an indication of the obstructions and limitations which impeded full inspection of the property at the time of inspection. These obstructions can hide an array of defects and should be removed to allow full inspection to be carried out. A re-inspection is recommended once the areas are made accessible.

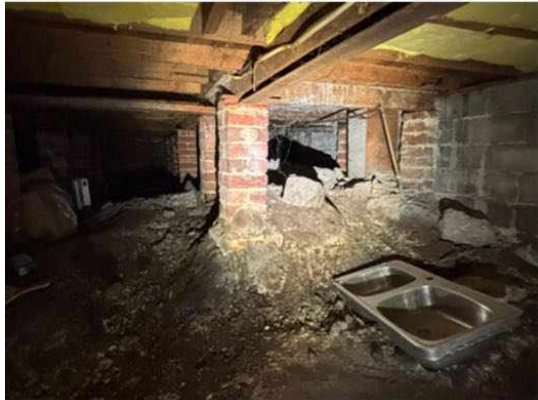
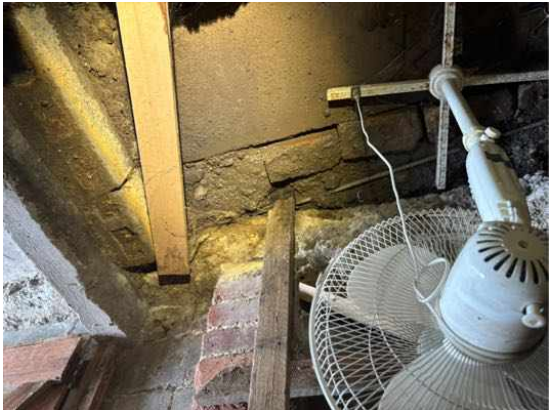
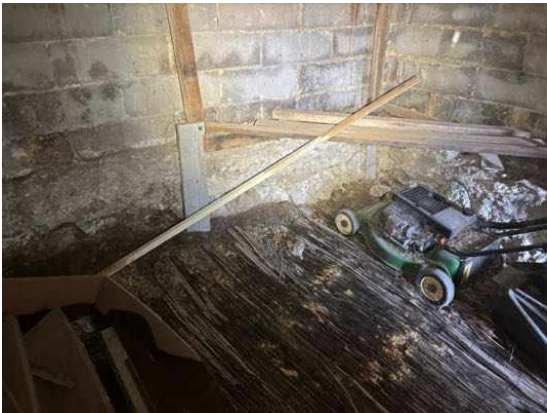
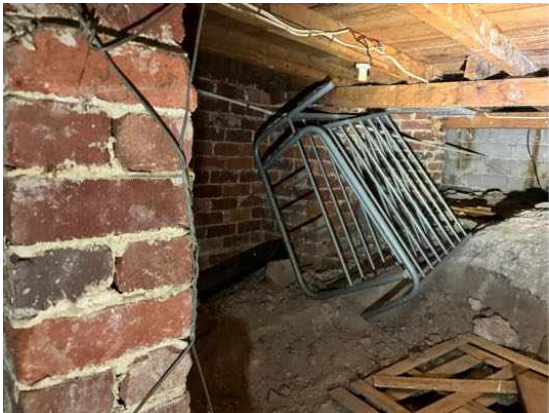
Building: Main Building
Location: Subfloor
Finding: Additional Photos - Obstructions and Limitations
Information: These photographs are an indication of the obstructions and limitations which impeded full inspection of the property at the time of inspection. These obstructions can hide an array of defects and should be removed to allow full inspection to be carried out. A re-inspection is recommended once the areas are made accessible.

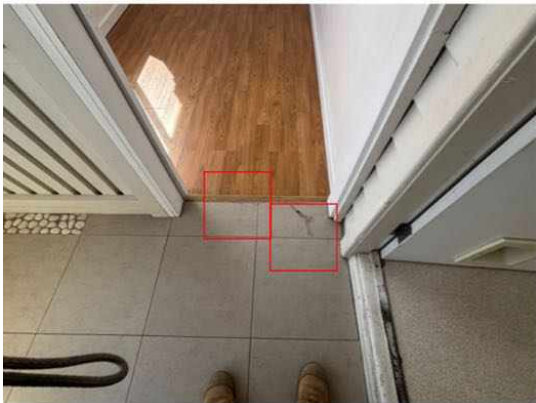
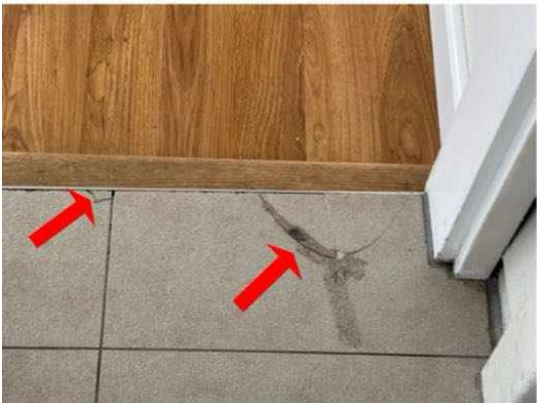
Building: Main Building
Location: Sun room
Finding: Broken floor tiles
Information: FYI In the sun room there are broken floor tiles to the threshold.

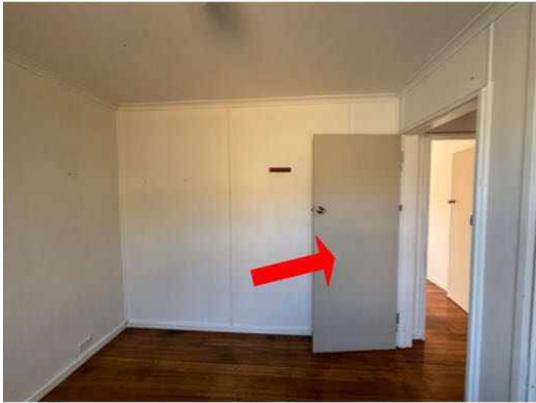
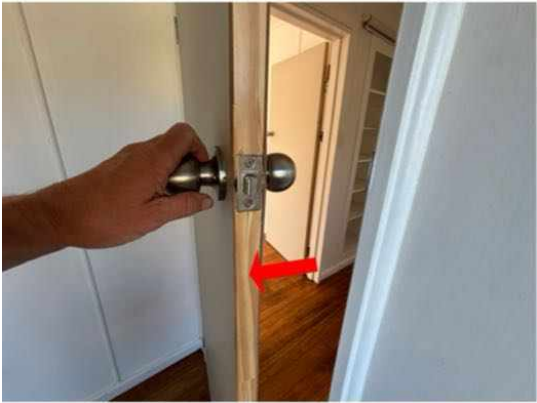
Building: Main Building
Location: Multiple locations
Finding: FYI Unpainted doors
Information: The bedroom doors have not been painted.

Paint provides protection to building materials.

Recommend client engage a Handy Person/Painter to rectify at clients convenience.

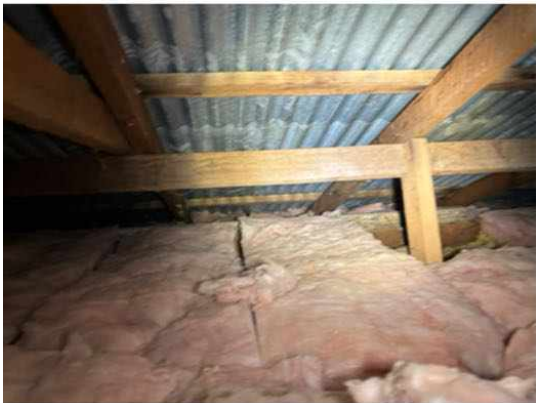
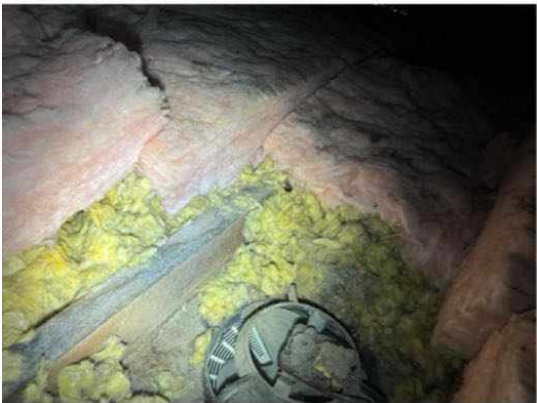
Building: Main Building
Location: Roof void
Finding: FYI roof void
Information: FYI there is "blown in" style insulation covered by insulation batts.
