**BEFORE YOU BUY**  
**BEFORE YOU BUILD**

## Building and Timber Pest Inspection Report

Inspection Date: Fri, 2 Jan 2026

Property Address: 20 Riddell Cres, Blackett NSW 2770,  
Australia

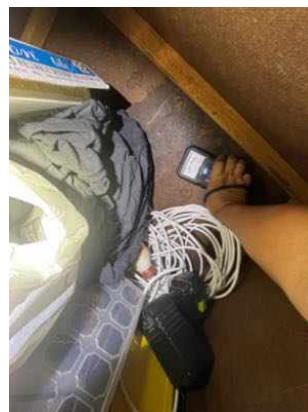
Building:	Main Building
Location:	Roof Void
Finding:	Condition of Building Elements in the Roof Void
Information:	Following completion of the inspection, the roof void was observed to comprise timber-framed roof construction with timber trusses, rafters and battens supporting concrete roof tiles. The primary timber members appeared generally serviceable at the time of inspection, with no visible signs of significant structural failure, active timber decay, or termite damage noted within the accessible areas. However, the roof void was dusty and poorly maintained, with extensive cobwebs present, which is typical of older roof spaces and indicates limited recent access.

The bulk insulation was present but unevenly laid and compressed in areas, reducing its overall thermal effectiveness. Some sections appeared displaced, with gaps and inconsistent coverage across the ceiling joists. No reflective sarking or foil insulation was noted beneath the roof covering, which is consistent with older construction and may contribute to reduced thermal performance and condensation risk. Roof tiles visible from within the roof space appeared generally intact, with no obvious daylight penetration observed at the time of inspection. The hot water storage unit located within the roof void showed advanced surface corrosion to the base, indicating age-related deterioration and a potential risk of leakage, and should be monitored and assessed by a licensed plumber. Overall, while the roof structure appeared functional at the time of inspection, maintenance, insulation improvement, and further servicing

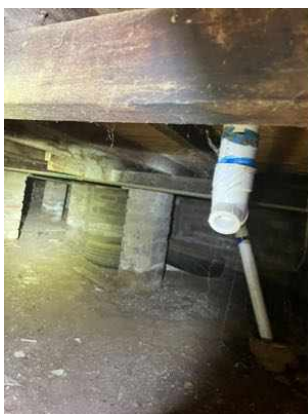
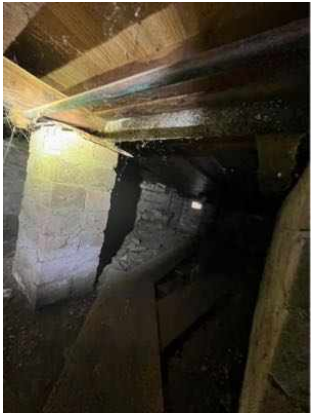
Building: Main Building  
Location: Subfloor  
Finding: Condition of Building Elements in the Subfloor  
Information: Following completion of the inspection, the subfloor area was observed to comprise brick piers supporting timber bearers and joists, consistent with typical older-style construction. The brick piers appeared generally serviceable, although some showed signs of age-related deterioration and minor surface wear, which is common in subfloor environments. The timber bearers and joists were generally intact at the time of inspection, with no visible evidence of significant structural failure; however, some members exhibited age-related staining and surface marking consistent with historical moisture exposure.

The subfloor ground conditions were dry in accessible areas, though debris, stored materials, and limited clearance restricted inspection in parts. Ventilation appeared limited, which may contribute to moisture retention and odour build-up. Notably, an unpleasant odour was detected within the subfloor, particularly in the vicinity of the bathroom area, raising concerns regarding a possible plumbing issue such as a leaking waste pipe, inadequate trap sealing, or sewer gas escape. While no active leaks were visually confirmed at the time of inspection, the presence of odour warrants further investigation by a licensed plumber to identify the source and prevent potential hygiene issues, moisture-related deterioration, or concealed damage to building elements.

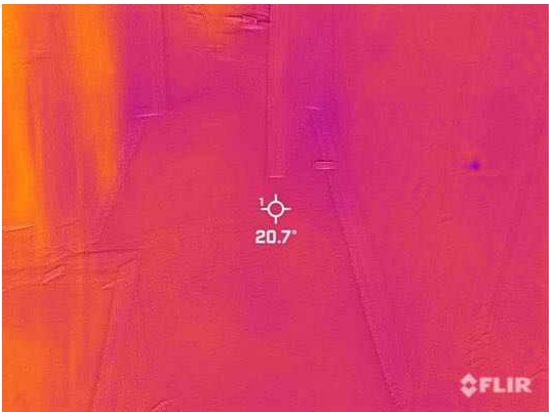
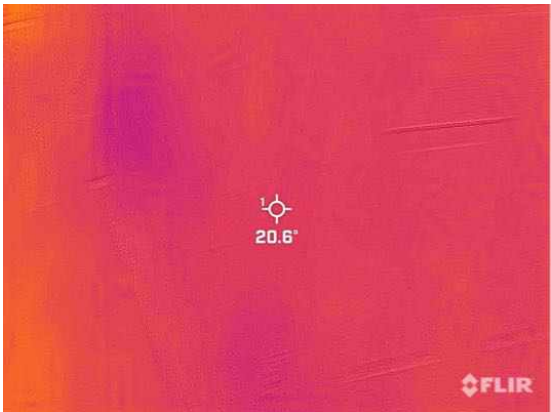
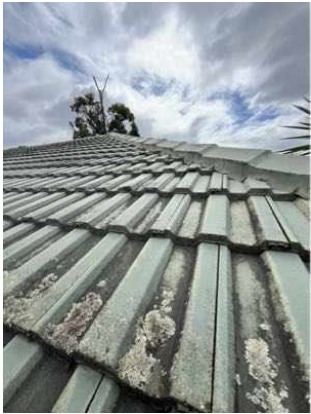
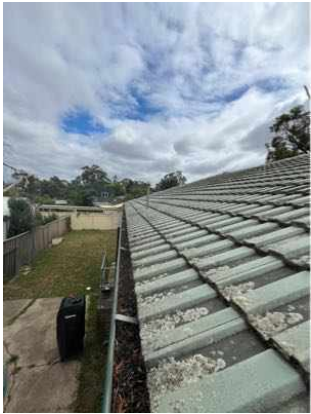
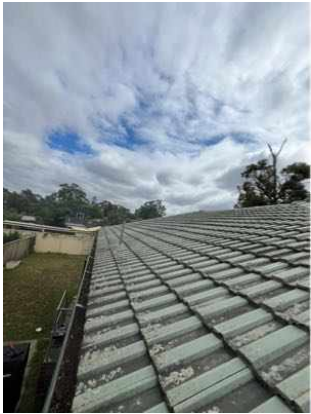
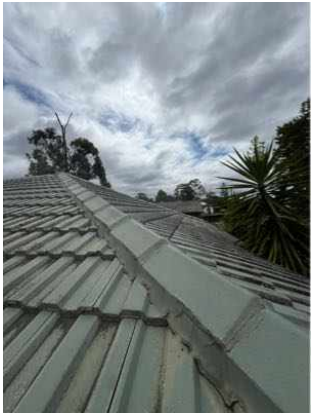
Building: Main Building  
Location: All Areas  
Finding: Additional Photos  
Information: Thermal imaging camera was used to detect any active water leaks or/ and termite activities in the property. No water leaks or termite activities were found from inspection by thermal imaging camera. Additional photos are attached for general reference.
