# Building and Timber Pest Inspection Report

Inspection Date: Mon, 23 Feb 2026

Property Address: 9 Clarendon Ave, Wodonga VIC 3690,  
Australia

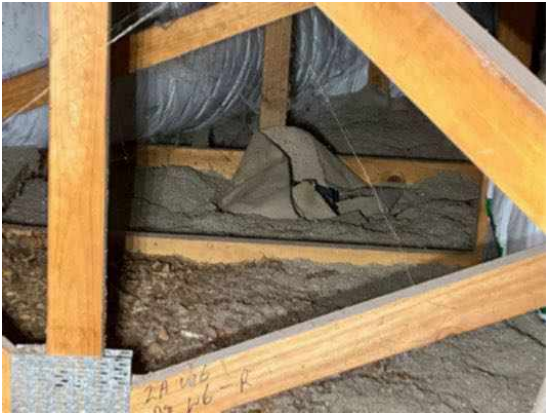
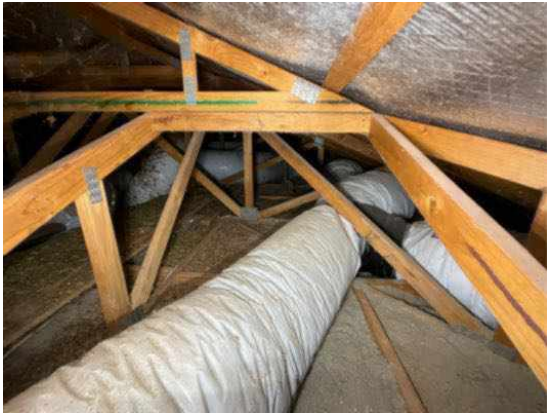
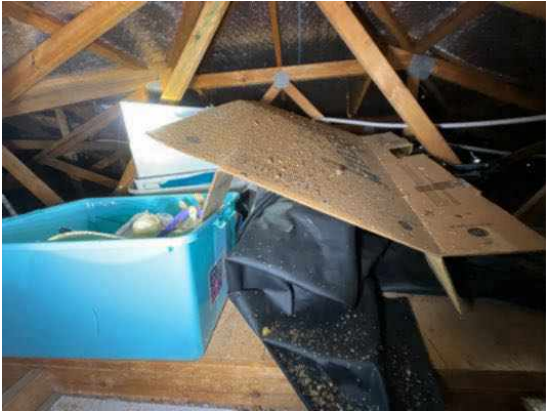
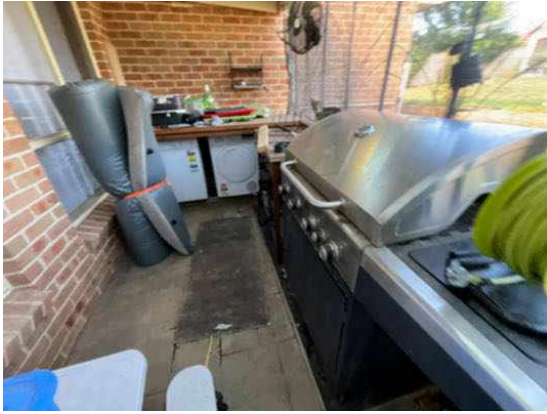
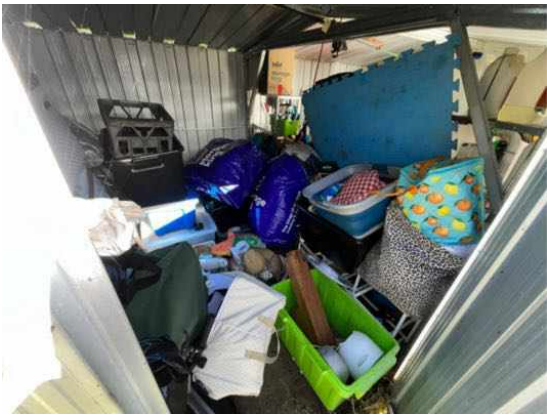
Building: Building 1  
Location: All Areas  
Finding: Additional Photos - Obstructions and Limitations  
Information: These photographs are an indication of the obstructions and limitations which impeded full inspection of the property at the time of inspection. These obstructions can hide an array of defects and should be removed to allow full inspection to be carried out. A re-inspection is recommended once the areas are made accessible.
