Building and Timber Pest Inspection Report

Inspection Date: Fri, 20 Mar 2026

Property Address: 46 Affleck Ave, Petrie QLD 4502, Australia

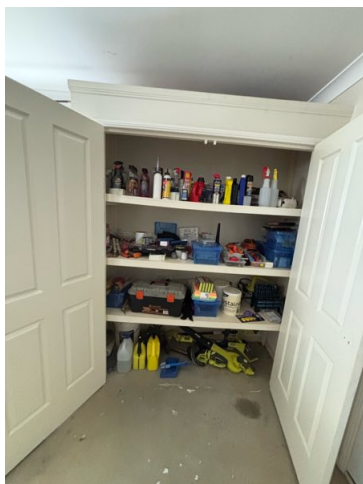
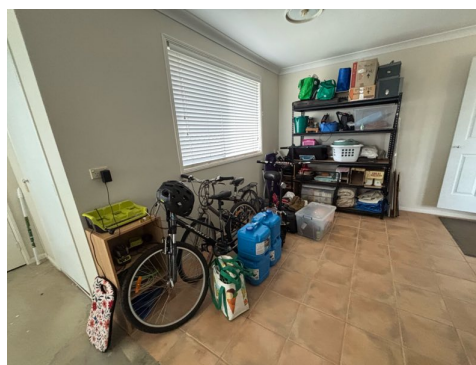
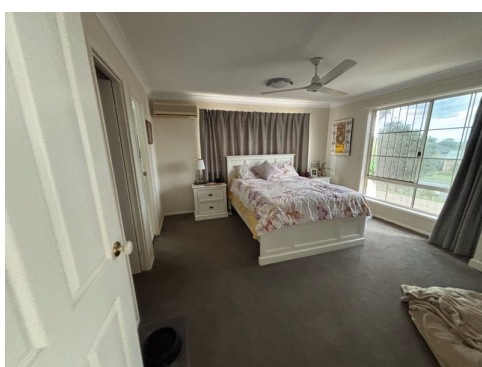
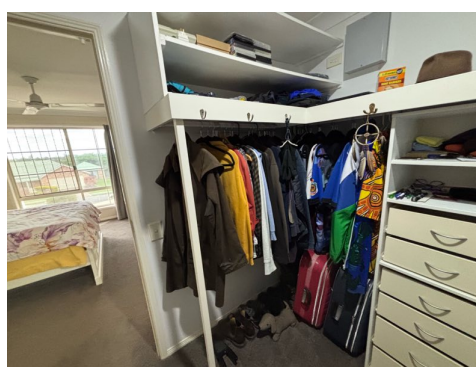
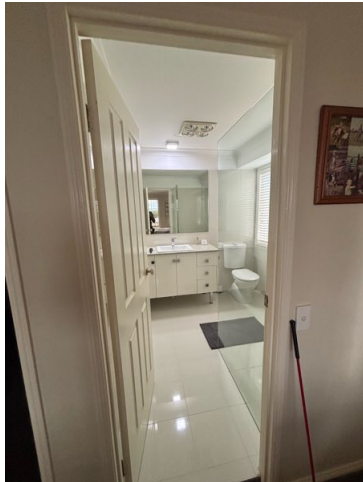
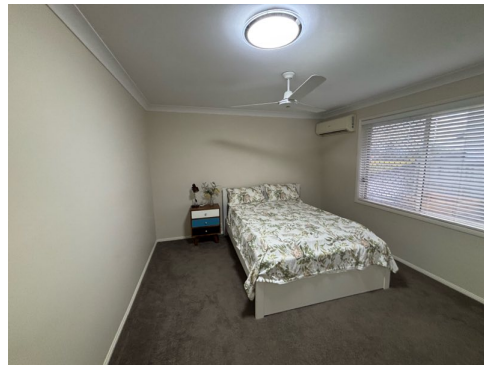
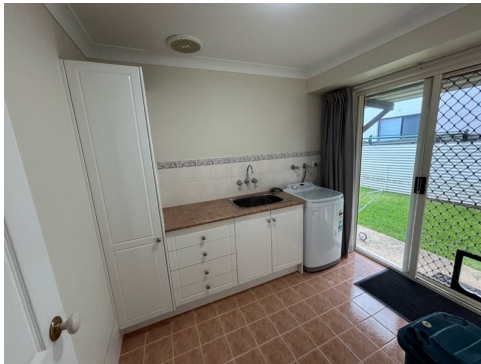
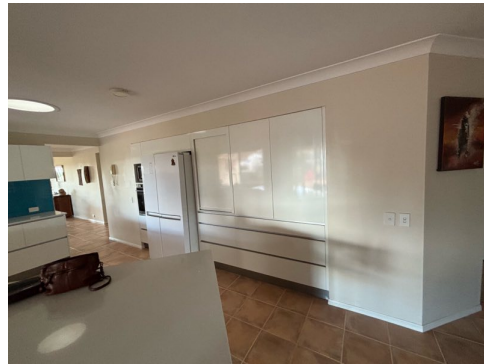
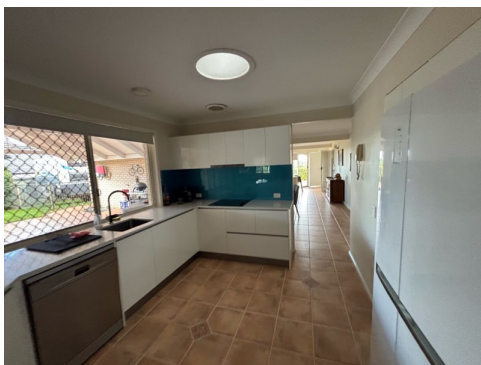
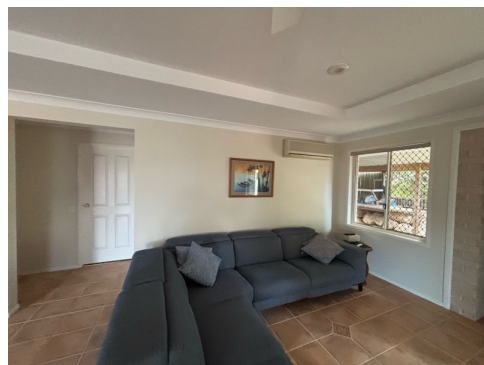
Finding: Obstructions and Limitations - Internal areas

Information: These photographs are an indication of the obstructions and limitations which impeded full inspection of the property of the internal areas at the time of inspection. These obstructions can hide an array of defects and should be removed to allow full inspection to be carried out. A re-inspection is recommended once the areas are made accessible.

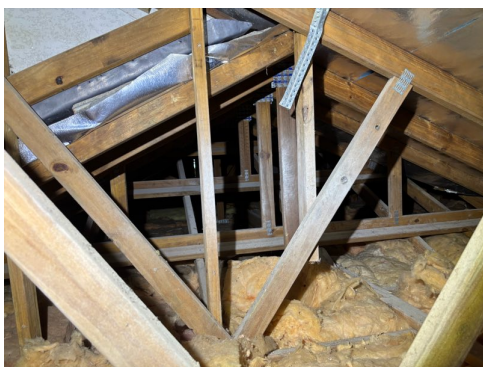
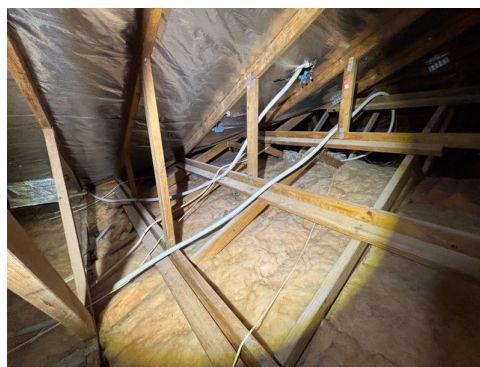
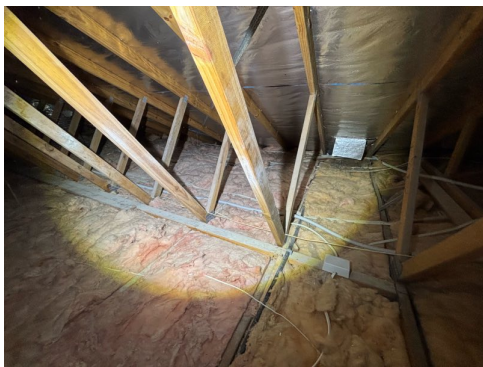
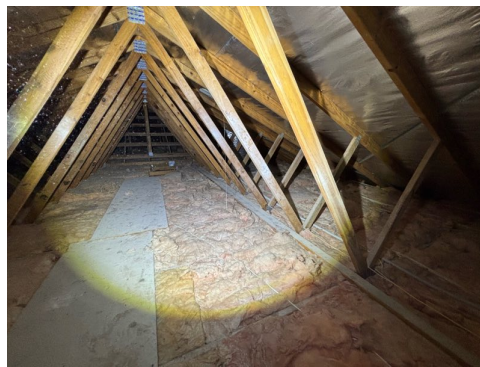
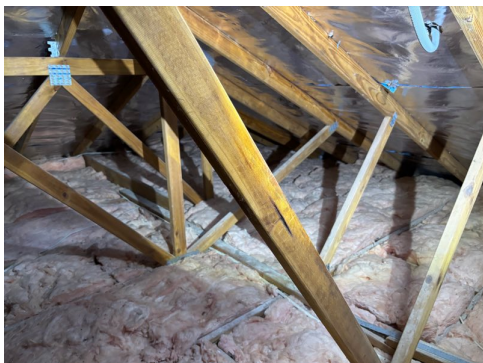
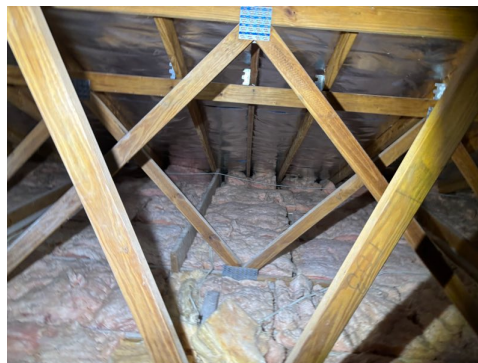
Finding: Obstructions and Limitations - Roof cavity

Information: These photographs are an indication of the obstructions and limitations which impeded full inspection of the property of the roof cavity at the time of inspection. These obstructions can hide an array of defects and should be removed to allow full inspection to be carried out. A re-inspection is recommended once the areas are made accessible.

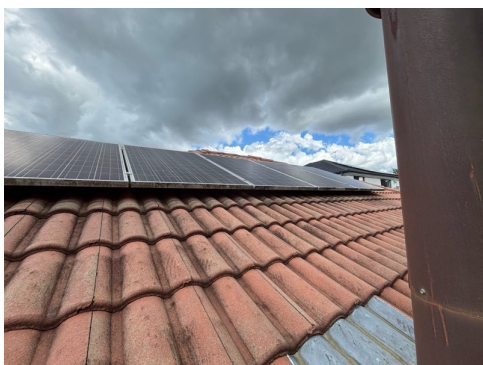
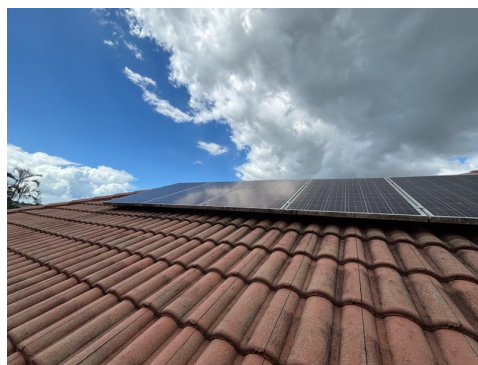
Finding: Obstructions and Limitations - Roof exterior

Information: These photographs are an indication of the obstructions and limitations which impeded full inspection of the property of the roof exterior at the time of inspection. These obstructions can hide an array of defects and should be removed to allow full inspection to be carried out. A re-inspection is recommended once the areas are made accessible.
