Building and Timber Pest Inspection Report

Inspection Date: Wed, 21 Jan 2026

Property Address: 31 Caravan Head Rd, Oyster Bay NSW
2225, Australia

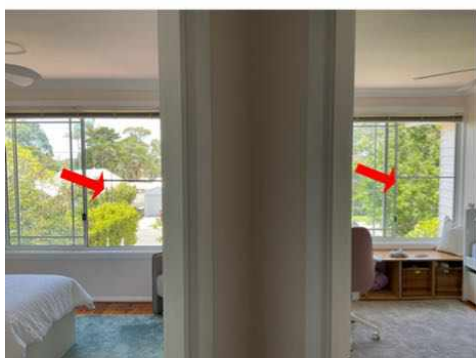
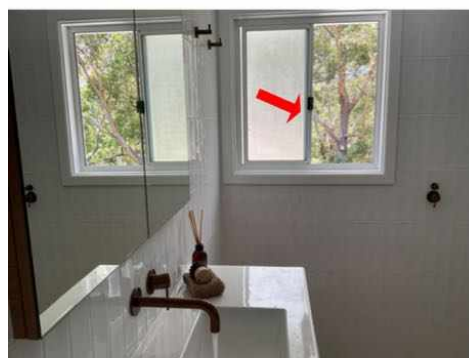
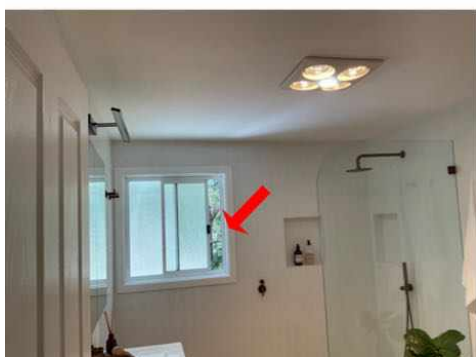
| Finding: | Window opening restrictors missing. |

Window restrictors are required where people who are vulnerable to the risk of falling have access to windows. This means all windows above ground level which do not have another fall prevention safety measure in place, such as a balcony or balustrade should have a restrictor.

These need to be added urgently for the safety of all persons.

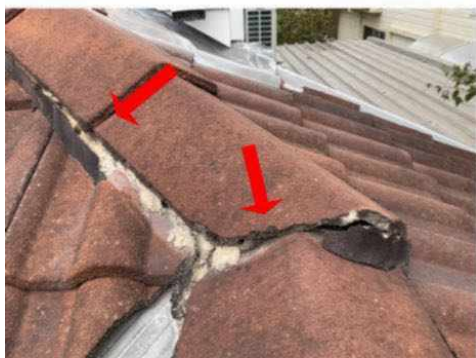
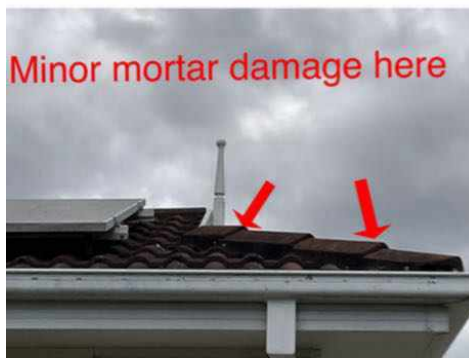
Building: Building 1
Location: All External Areas
Finding: Roofing areas - Weathered
Information: Upon inspection of the exterior roofing, the majority of the roof areas were considered to be in a good condition. While weathering of these pictured areas is consistent with the age of the property, maintenance works are urgently required, particularly on the garage (the upper roof had no safe access).

Re-sealing and replacing some large and small areas of gaps and damage to the roof mortar is required to extend the life span of these roofing areas. Where left unmanaged, deteriorating roofing materials are likely to lead to a number of secondary defects, including minor water leaks and weather exposure to internal roofing structures.

Consultation with a roofing contractor is highly advised to gain advice on cost of remedial works that may be required. Remedial works are likely to increase the longevity of the exterior roofing structure.

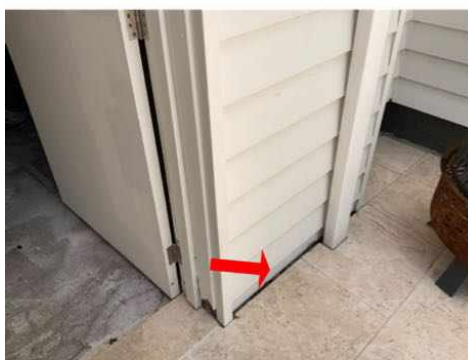
| Finding: | Sealant (external) - Missing. |
| Information: | It was noted on inspection that areas of external sealant was missing to small areas of the external walls. |

Flexible sealants should be applied to these affected areas to prevent any subsequent water damage that is likely to occur.

A sealant specialist or skilled handy person should be appointed to complete these works as soon as possible

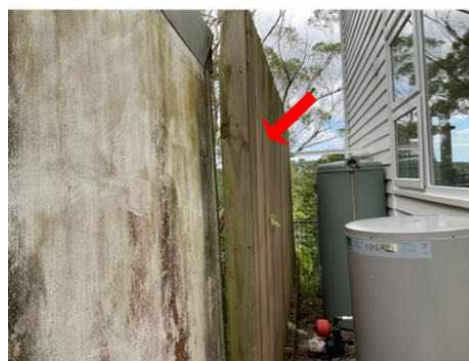
Finding 3.04

Building: Building 1
 Location: Pictured fences
 Finding: Fences damaged - leaning and loose
 Information: Evidence of damage to the pictured fences was identified at the time of the inspection. The likely cause of this fence leaning is not enough concrete used in the post footings.

If left unmanaged this fence may deteriorate further. It is suggest a fencing contractor be engaged for rectification when convenient.

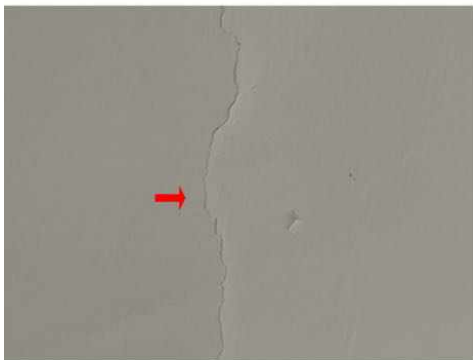
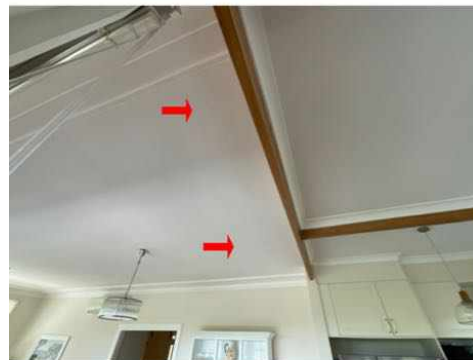
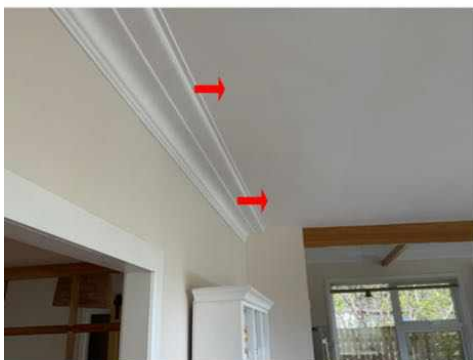
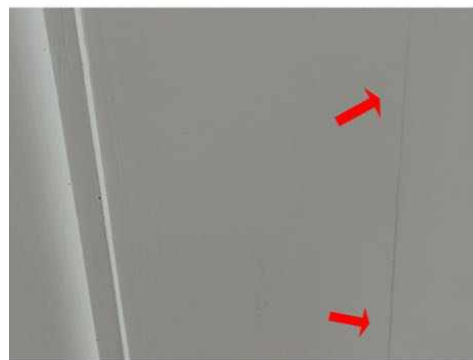
| Finding: | Cracking - Damage Category 1 - Fine (up to 1mm) |
| Information: | Although fine cracks (6-8) are quite noticeable, they are often only considered to be an appearance defect, and usually do not indicate any structural damage. Generally, the cause of a fine crack is indicative of a separation between building materials and finishes (e.g. paint, plaster, etc.) along joins. |

Cracking of this nature can generally be repaired with minor sanding, filling and/or repainting. Such works should be performed by a qualified painter or a general handyman.

Monitoring of all cracking should be conducted frequently. Always contact a building inspector should cracks widen, lengthen, or become more numerous.

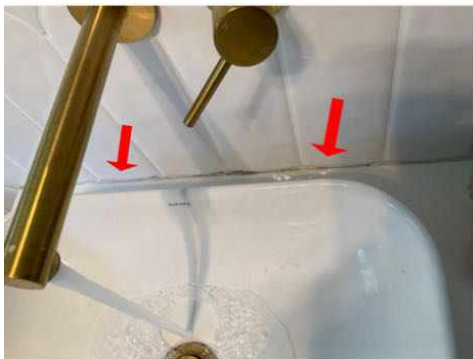
Building: Building 1
 Location: Ensuite - Master
 Finding: Sealant and grouting - Missing or damaged
 Information: It was noted on inspection that sealant or grout is degraded to these pictured wet areas.

Different materials and floor areas move at different rates, generally causing cracking to grout or sealant at this point. A flexible sealant is required to allow for expected expansion and contraction, while keeping the joint water tight and protective of all associated building materials.

Flexible and mould resistant materials should be applied to affected areas to prevent any subsequent water damage that is likely to occur. Regular maintenance and replacement of damage or missing or damaged sealant and grout is highly recommended to the wet areas, as this is a regular wear and tear defect. Sealant and grouting in areas that come into regular contact with water should be maintained for the long term care of your property.

A sealant specialist or tiling contractor should be appointed to complete these works as soon as possible

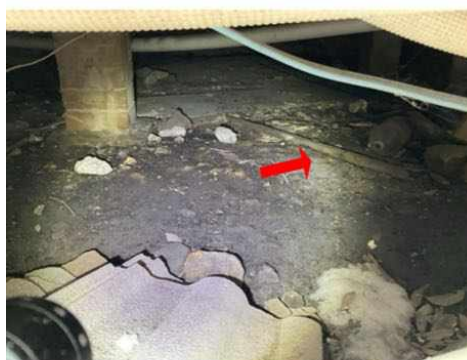
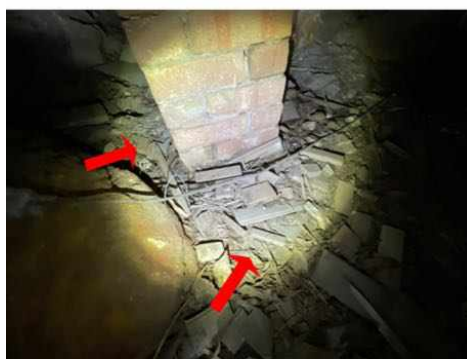
Finding 6.04

Removal of all waste timber that is in direct contact with ground is highly advised. This timber is promoting mould and wood rot and is very attractive to termites.

Frequent pest inspections are advised to readily identify any termite activity in these areas.

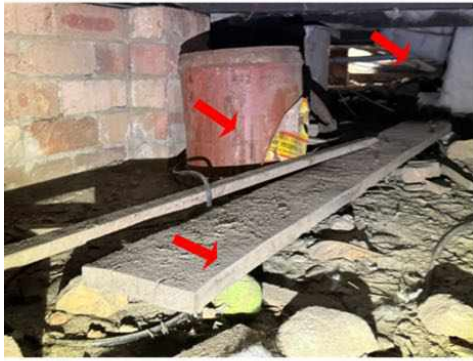
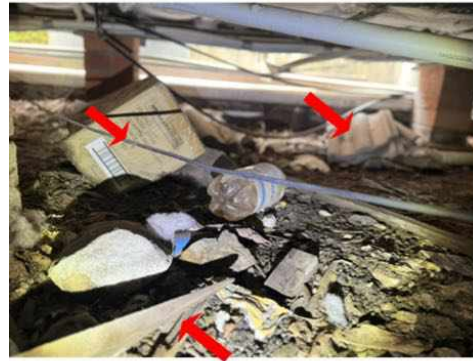
A clear and empty subfloor will be better ventilated and easier to maintain in a dry condition. The removal of any timber debris is vital in minimising the risk of termite or wood borer activity.

Debris in the subfloor should be removed as soon as possible. Depending on the location and amount of debris and stored items, the homeowner may elect to undertake this task. Alternatively there are a large number of rubbish removal subcontractors that could undertake these works.

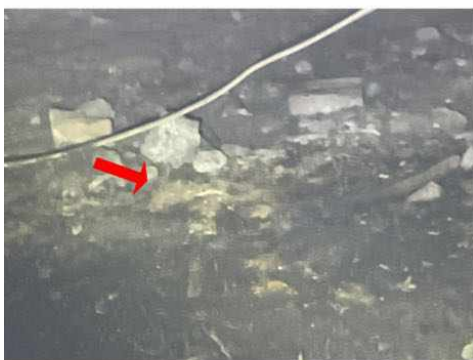
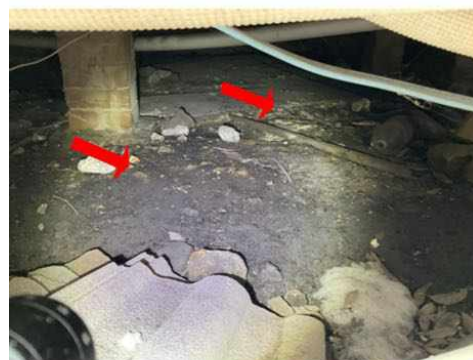
Finding 6.07

Subfloor mould is generally caused by moisture ingress, lack of external drainage, lack of adequate ventilation and subfloor debris present. These issues need rectification

to stop mould development. Any mould found during the inspection should be cleaned immediately by a cleaning contractor or the homeowner as applicable.

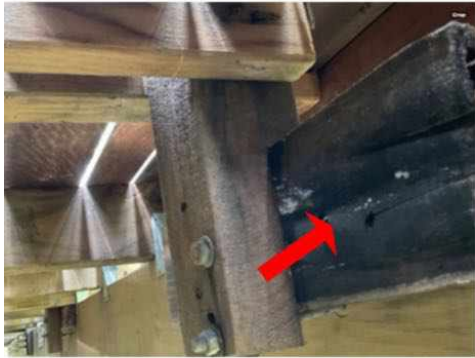
Finding 6.08

In this case although the affected timber element is in a decaying state the extent of any visible damage appears to be localised to a specific area and is yet to spread to other parts of the building element or affect adjoining structures. The fungal decay is

therefore likely to be of a relatively superficial nature with minimal impact on the structural integrity or tensile strength of the timber element.

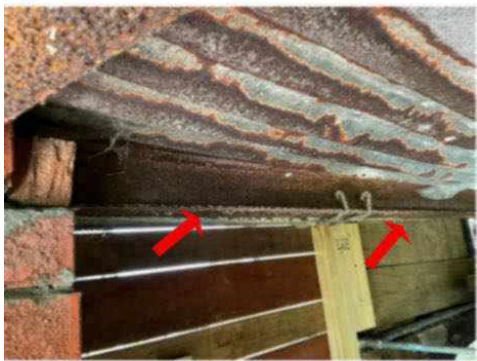
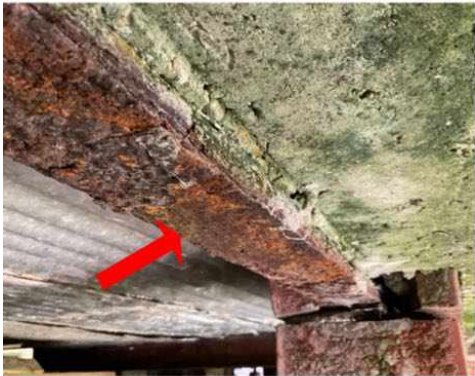
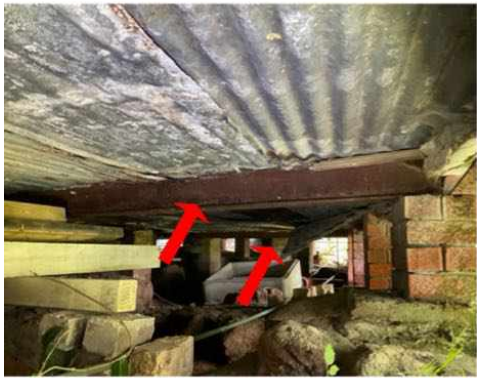
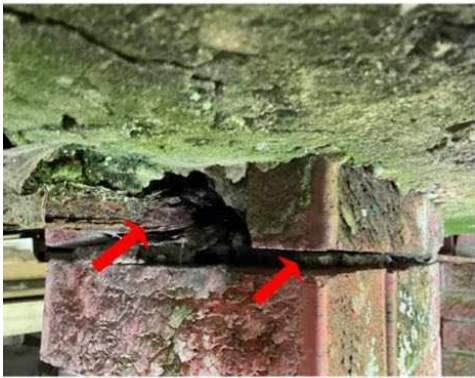
The rear lower deck is supported by both the old concrete verandah and new steel piers. The steel beams supporting the lower end of the north concrete and timber deck show severe rust in some areas requiring an engineers assessment. Minor mortar damage was also found in some piers. One middle rear pier shows very little support from the underlying sandstone (picture 11). One central pier is leaning significantly.

The rear lower deck is supported by both the old concrete verandah and new steel piers. The steel beams supporting the lower end of the north concrete and timber deck show severe rust in some areas requiring engineers assessment. Minor mortar damage was also found in some piers. One middle rear pier shows very little support from the underlying sandstone (picture 11). One central pier is leaning significantly.

A structural engineer may describe these decks as major or minor defects requiring repair.

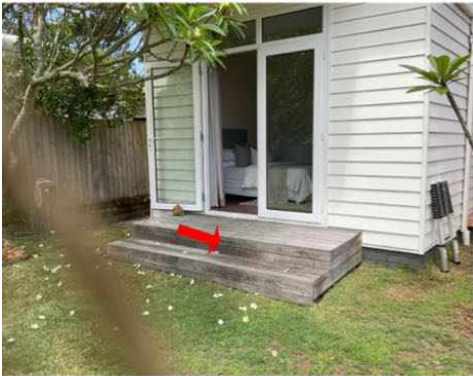
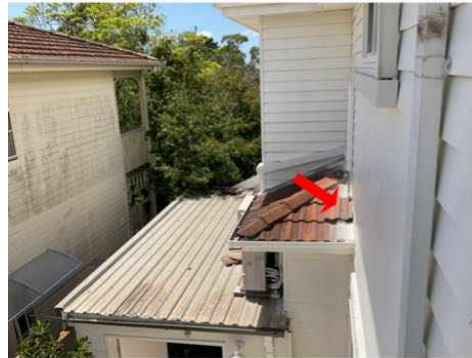
| Finding: | Additional Photos - Obstructions and Limitations of EXTERNAL AREAS |
| Information: | These photographs are an indication of the obstructions and limitations which impeded full inspection of external areas at the time of inspection. These obstructions can hide an array of defects and should be removed to allow full inspection to be carried out. A re-inspection is recommended once the areas are made accessible. |

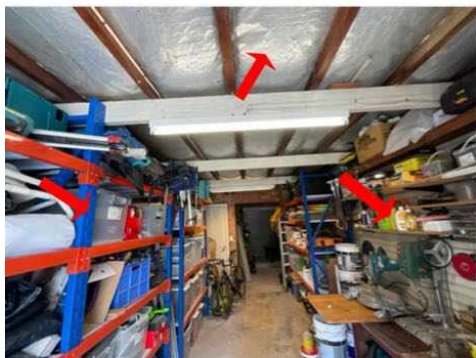
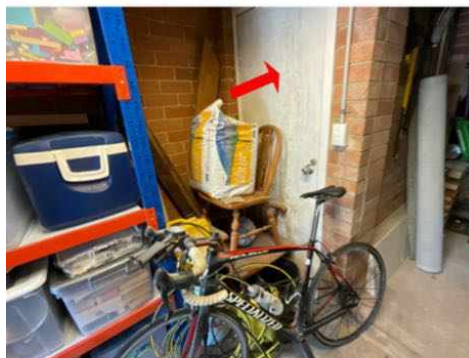
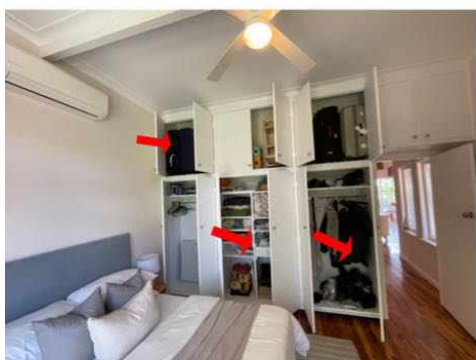
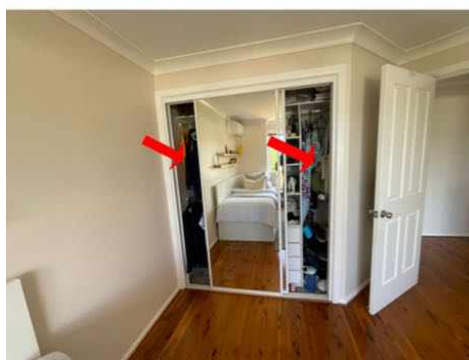
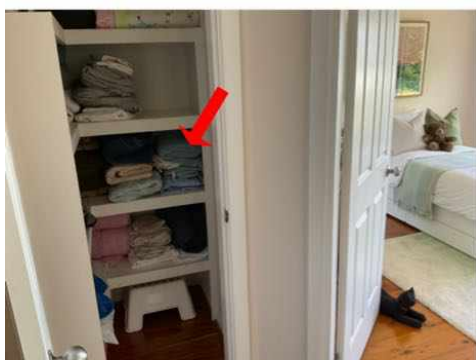
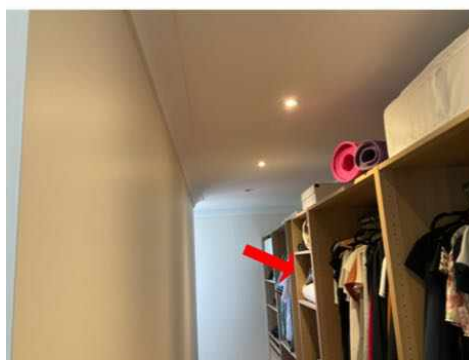
| Finding: | Additional Photos - Obstructions and Limitations of INTERNAL AREAS |
| Information: | These photographs are an indication of the obstructions and limitations which impeded full inspection of Internal areas at the time of inspection. These obstructions can hide an array of defects and should be removed to allow full inspection to be carried out. A re-inspection is recommended once the areas are made accessible. |

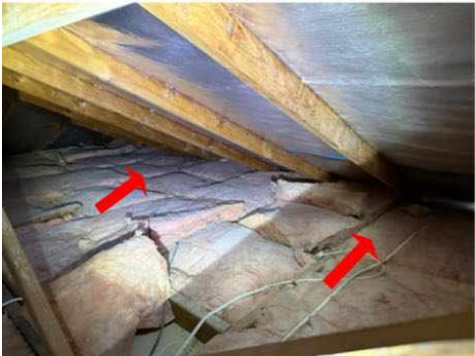
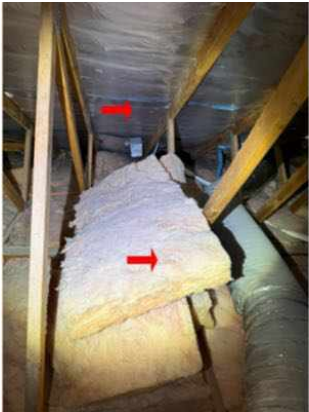
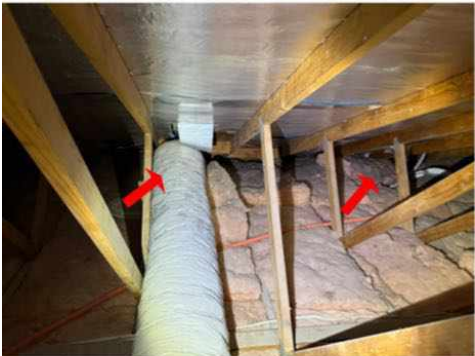
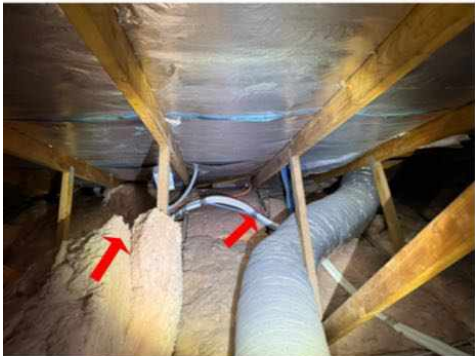
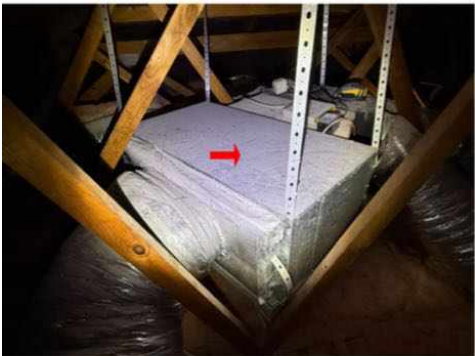
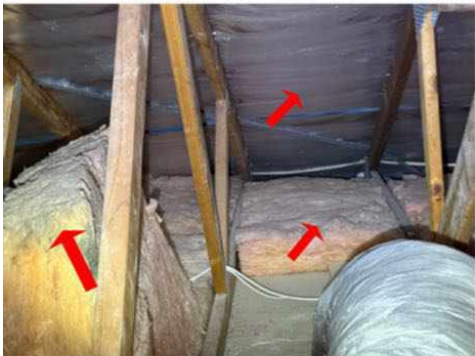
Building: Building 1
 Location: All Roof cavity areas
 Finding: Additional Photos - Obstructions and Limitations of the ROOF CAVITY
 Information: These photographs are an indication of the obstructions and limitations which impeded full inspection of roof cavity areas at the time of inspection. These obstructions can hide an array of defects and should be removed to allow full inspection to be carried out if applicable. A re-inspection is recommended once the areas are made accessible.

The inspection was also limited to areas with an allowable crawl space of 600mm x 600mm, in particular towards the external walls where the roof line diminishes, these

areas were not accessible.

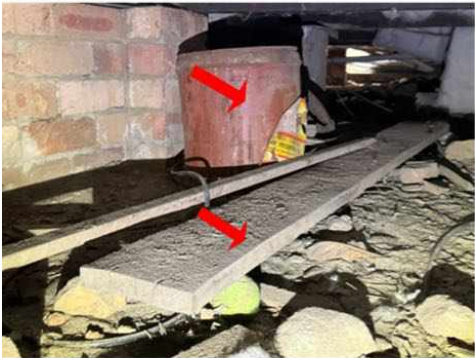
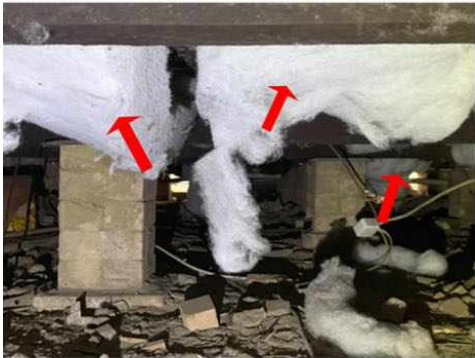
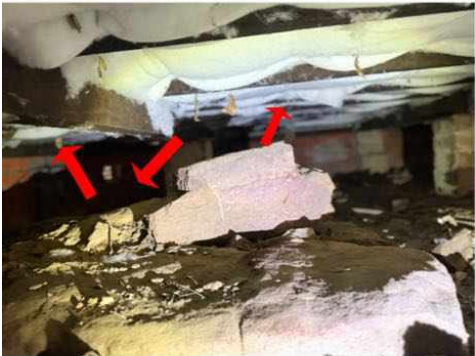
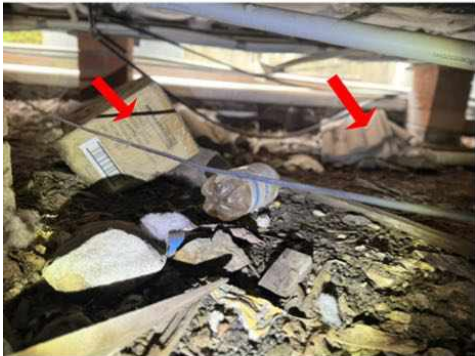
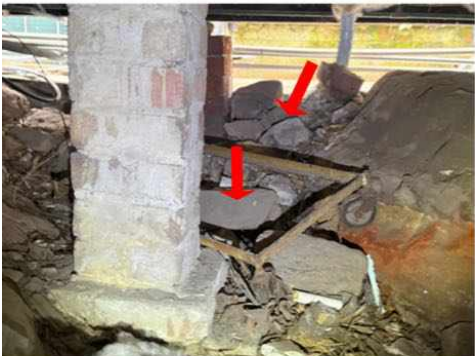
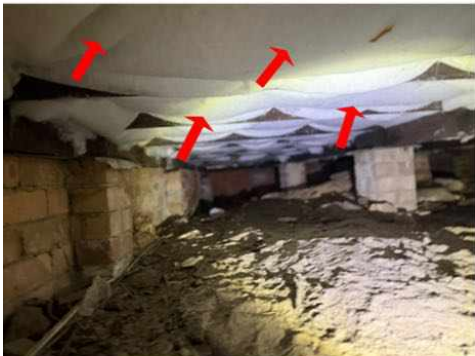
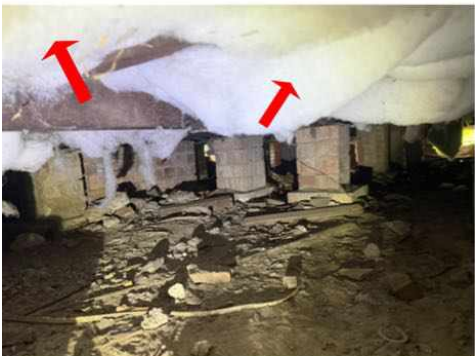
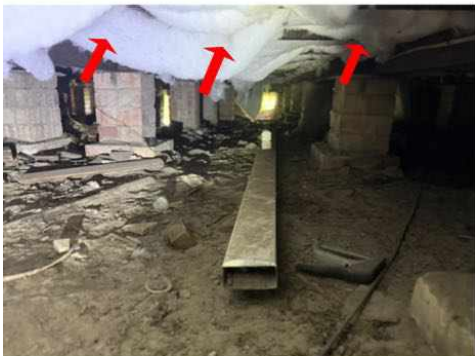
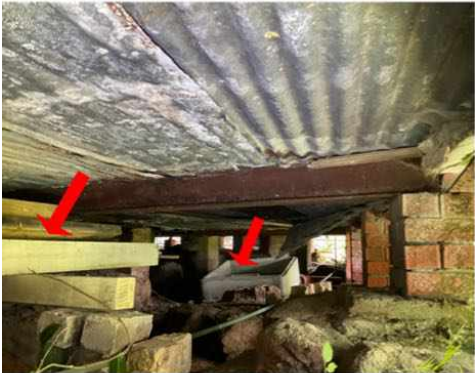
Building: Building 1
 Location: All Subfloor Areas
 Finding: Additional Photos - Obstructions and Limitations of SUBFLOOR AREAS
 Information: These photographs are an indication of the obstructions and limitations which impeded full inspection of subfloor areas at the time of inspection. These obstructions can hide an array of defects and should be removed to allow full inspection to be carried out. A re-inspection is recommended once the areas are made accessible.

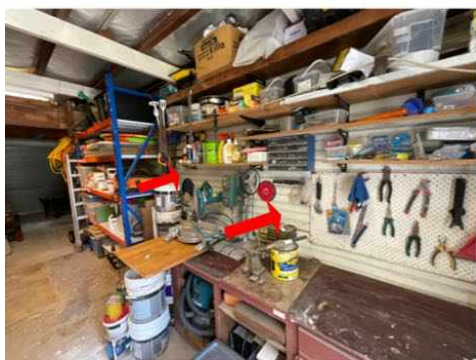
| Information: | Reporting on Asbestos is outside the Scope of this Report. This suspected defect is highlighted as a caution only. We suspect, based on our experience in the building industry, that there is a higher risk of the identified building element containing asbestos. |

As Asbestos Reporting is outside the scope of this report, we advise that you consider a separate Asbestos Inspection and Condition Audit, which can include the taking of samples for definitive confirmation of the presence of Asbestos.

In the interim, the client is advised to act with caution, especially when considering any damage to building materials general wear and tear renovations extensions demolition and general maintenance activities due to the suspected presence of Asbestos.

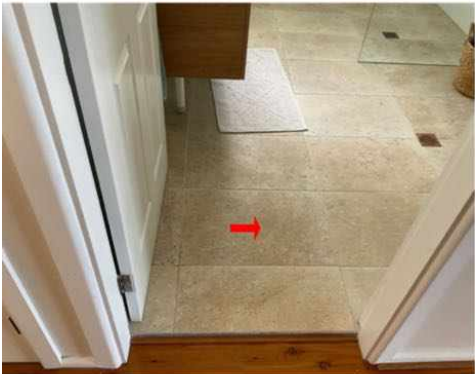
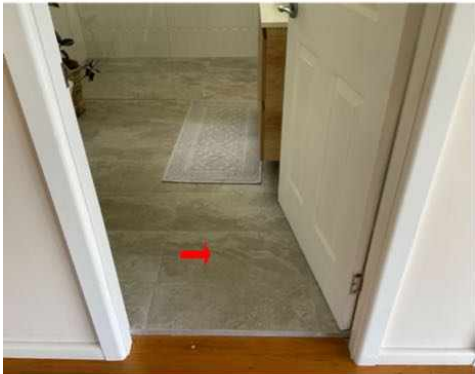
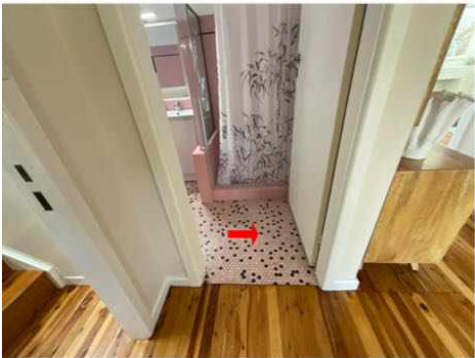
With older property's where this information is unavailable all wet areas should be

monitored. If any leaks, water staining, peeling or bubbling of the paint become evident to any adjacent walls or ceilings below a licensed builder or waterproofing specialist is recommended to investigate further.
