# Building and Timber Pest Inspection Report

Inspection Date: Sat, 21 Feb 2026

Property Address: 197 Meade St, Glen Innes NSW 2370,  
Australia

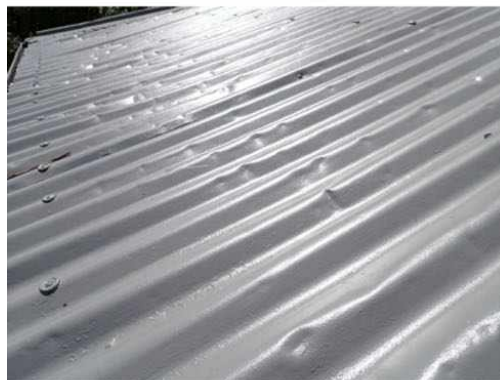
Building:	Main Building
Location:	Roof
Finding:	Original Roof Cladding in Poor Condition – Treated and Painted
Information:	The roof iron appears to be the original roof cladding. While no active leaking was identified at the time of inspection, the cladding is in poor condition consistent with its age and general wear and tear, including multiple dents and surface irregularities. The roof sheeting has been treated and painted, which may improve appearance and provide short-term protection; however, this does not reinstate the original structural integrity of the metal. In simple terms, the roof is old, dented and worn, and although it has been painted, it is still aged roofing iron. Deterioration of this nature is common in roofs of this age. It is recommended that a licensed roofing contractor monitor the

condition of the cladding and carry out repairs or replacement as required. Ongoing maintenance and budgeting for future replacement should be anticipated, with works undertaken at the owner's discretion.

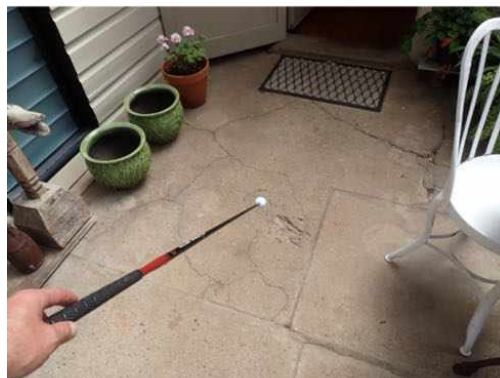
**Finding:** Concrete Area to Rear Alfresco — Poor Condition

**Information:** The concrete floor to the rear alfresco area was found to be in poor condition. Defects observed include cracking, surface deterioration and general wear consistent with age and environmental exposure. In simple terms, the concrete at the back outdoor area is worn and breaking down. This condition is commonly associated with long-term weather exposure, ground movement and/or inadequate original installation. If left unaddressed, cracking and deterioration may worsen over time. It is recommended that a qualified concreter or landscaper assess the concreted area and carry out repairs, resurfacing or replacement as required. Rectification works can be undertaken at the owner's discretion as part of property maintenance.

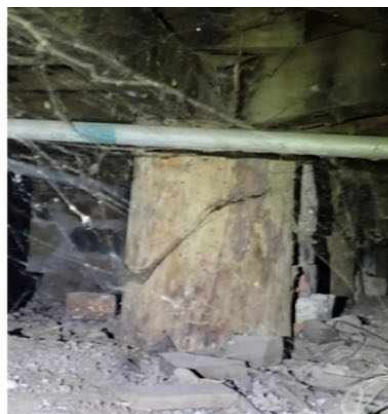
Building:	Main Building
Location:	Subfloor
Finding:	Several Old Timber Subfloor Stumps Identified – Limited Access
Information:	Several old timber stumps were identified within the subfloor area; however, subfloor access was too small to safely crawl into, limiting a full inspection of all supports. The visible areas appeared dry at the time of inspection. The stumps appear aged and may be subject to decay or termite risk depending on site conditions. In simple terms, some of the timber supports under the house are old, but the access opening was too small to get underneath properly and check everything, although what could be seen looked dry at the time. This is a common condition in homes of this age. If deterioration is present or progresses, it may contribute to uneven floors or structural movement. It is recommended that a qualified builder provide improved access if required and carry out a more comprehensive assessment of the subfloor supports, replacing any deteriorated stumps as necessary. A licensed timber pest controller should be consulted to inspect the subfloor area for current or past termite activity and provide advice regarding any treatment or ongoing protection measures. Further investigation and rectification can be undertaken at the owner's discretion.

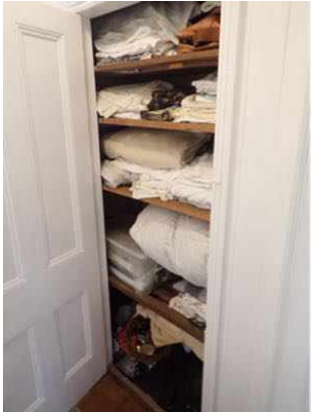
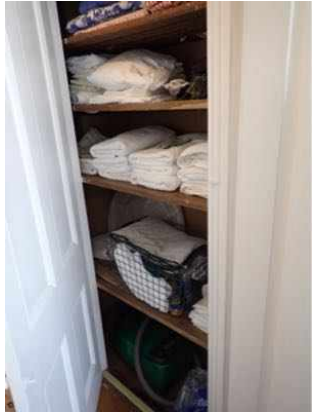
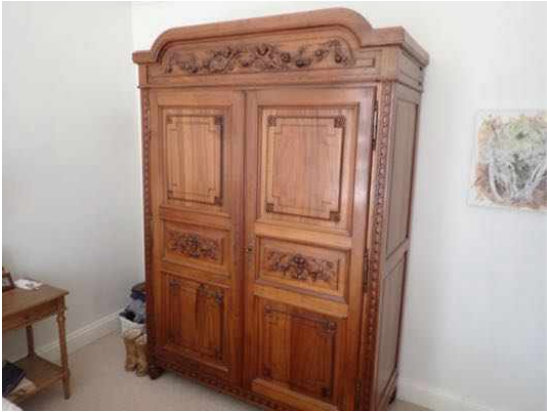
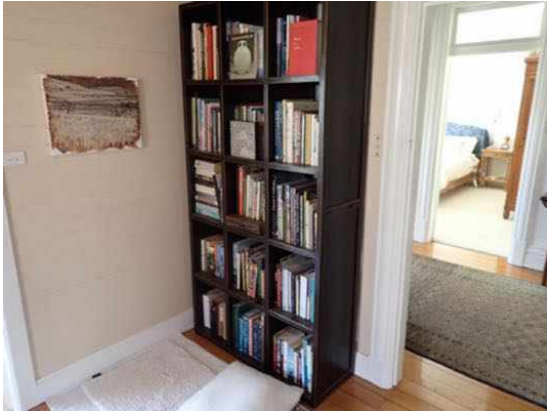
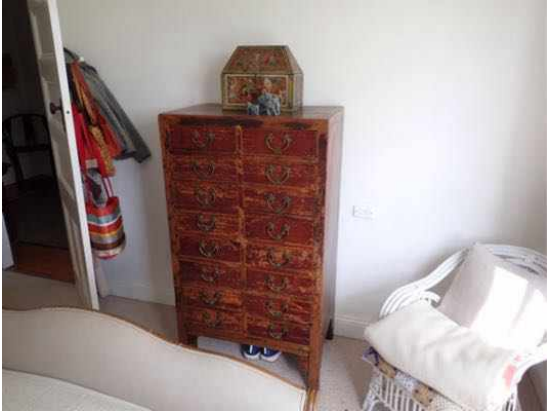
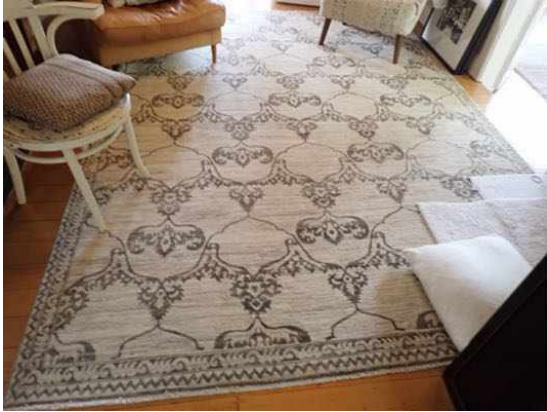
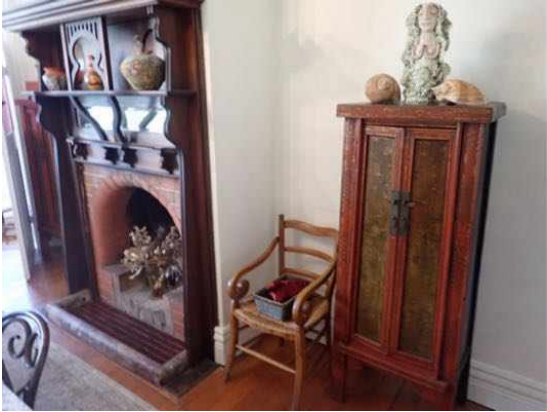
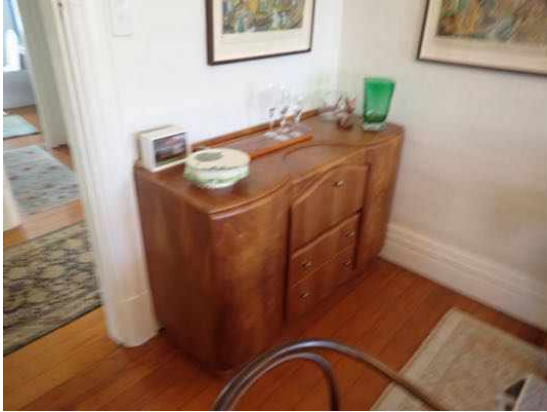
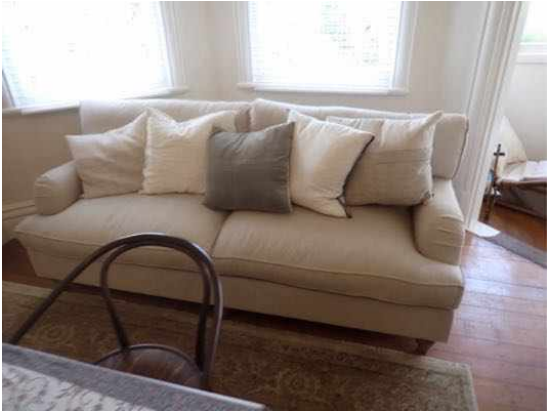
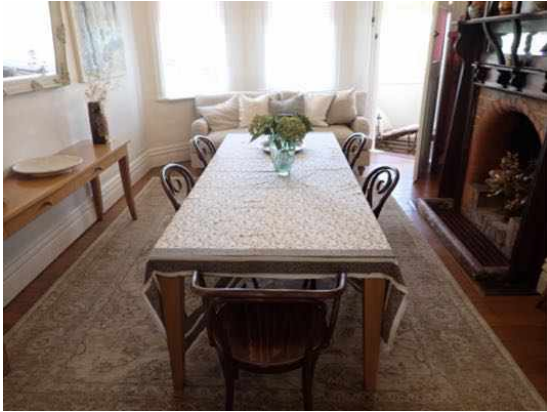
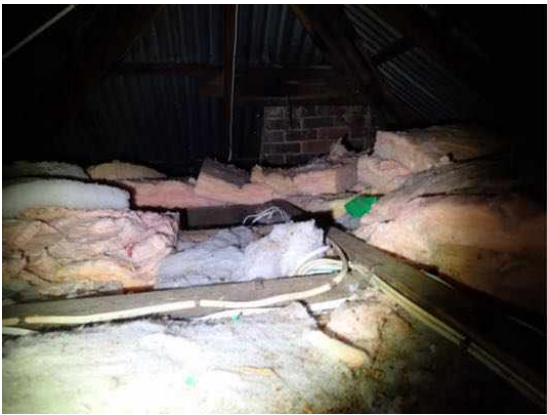
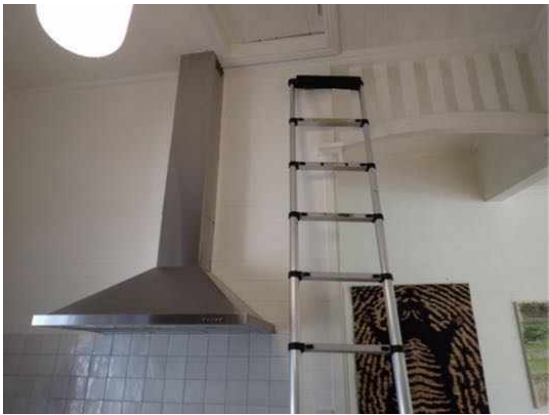
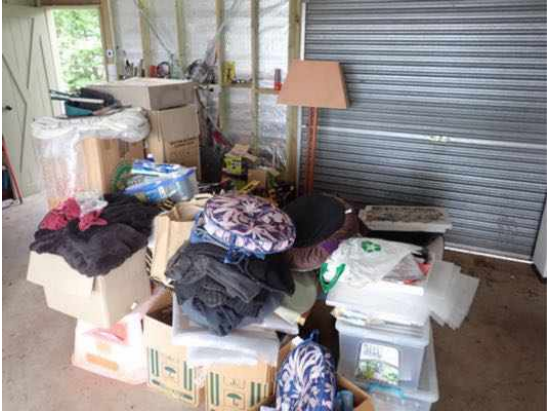
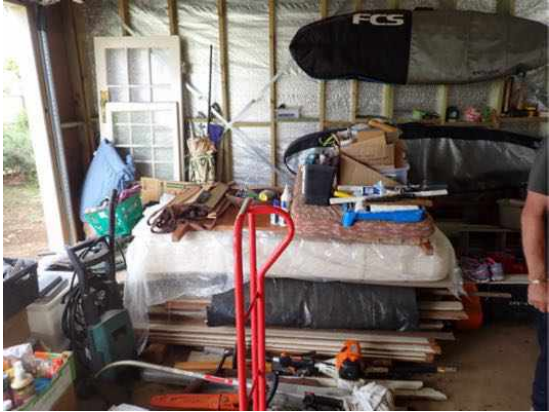
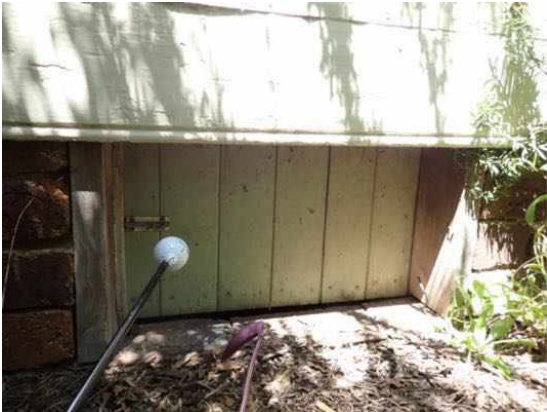
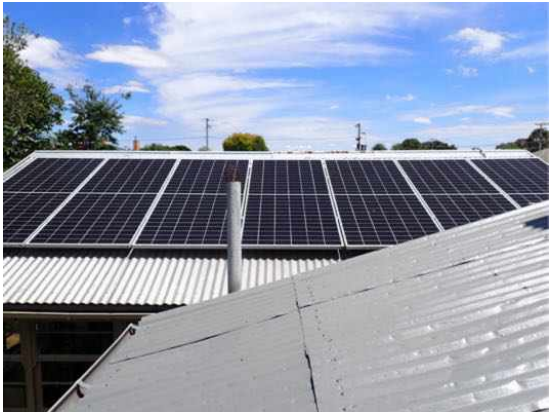
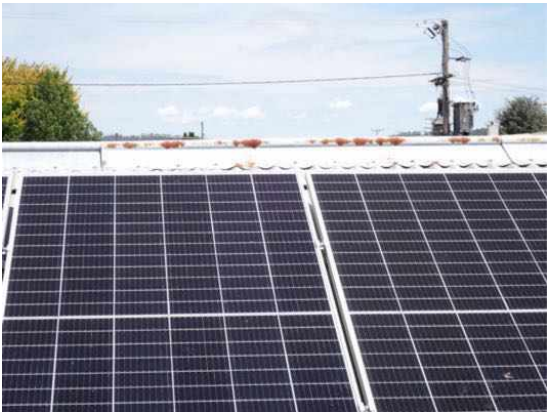
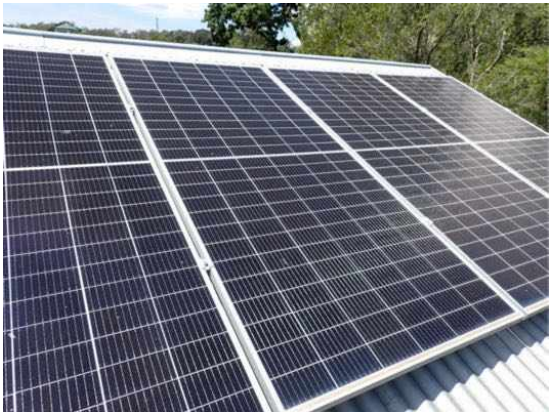
Information: These photographs are an indication of the obstructions and limitations which impeded full inspection of the area at the time of inspection. These obstructions can hide an array of defects and should be removed to allow full inspection to be carried out. A re-inspection is recommended once the areas are made accessible.
