Building and Timber Pest Inspection Report

Inspection Date: Mon, 23 Feb 2026

Property Address: 31/147 Fryar Rd, Eagleby QLD 4207,
Australia

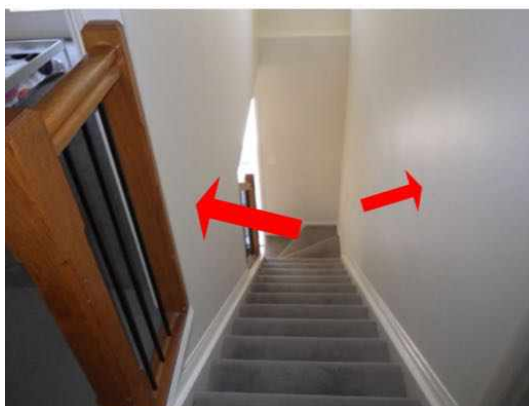
Building: Main Building
 Location: Stairs - Internal > Existing
 Finding: Stairs - Handrail
 Information: At the time of inspection it was noted there was no handrail in the internal stairway. The absence of a handrail in the stairway compromises the safety and accessibility of the stairs for all users.

This is noted as a safety concern and this regulation may not have been in place at the time of construction.

A licensed builder could be consulted for further information on stairway requirements.

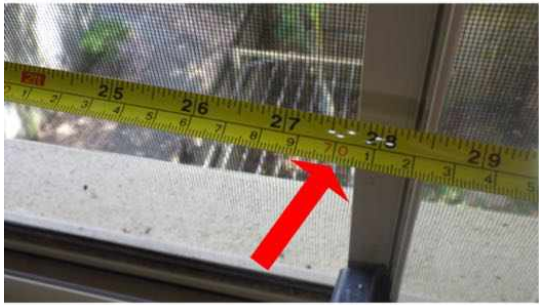
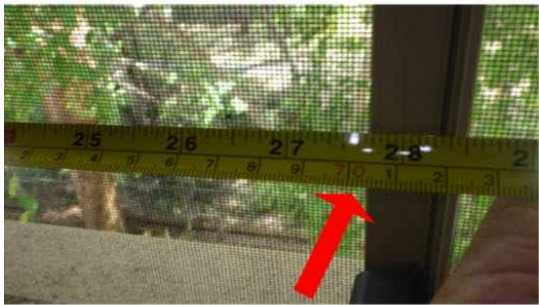
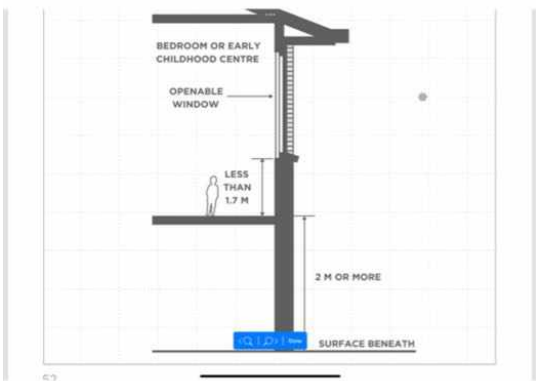
Finding 1.02

Building: Main Building
 Location: Bedrooms > Existing
 Finding: Window safety
 Information: It was noted that the windows of the upper level bedrooms are less than 1.7m from the floor and have a fall greater than 2m on the exterior from the sill and as such are required to only open upto 125mm or have security grills fitted.

This is noted as a safety concern and this regulation may not have been in place at the time of construction.

Windows to be protected

Windows are defective if they do not comply with provision 3.9.2.5 of Volume 2 of the BCA that requires that a window opening must have protection if the floor below the window in a bedroom is 2 m or more above the ground surface beneath.

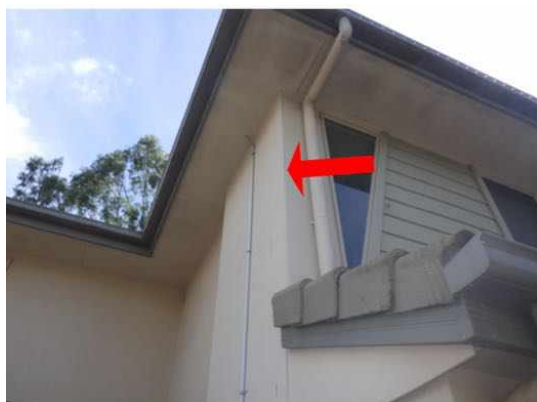
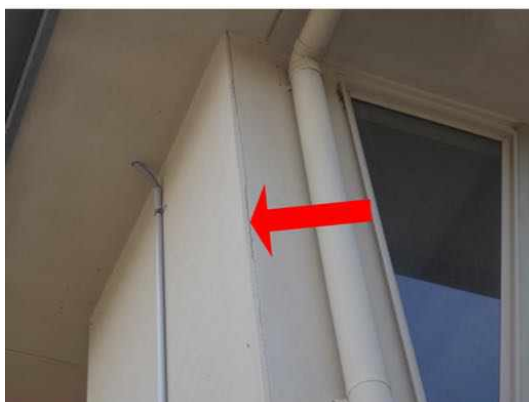
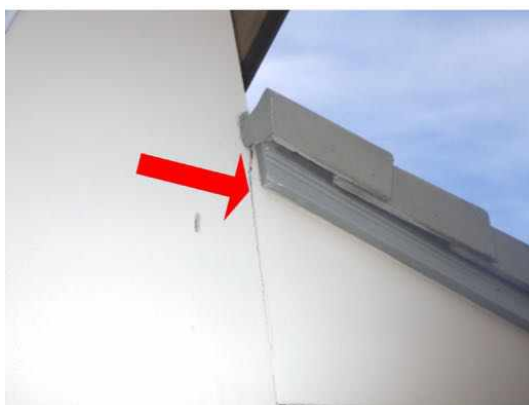
Building: Main Building
Location: Exterior walls - front > Centre Left
Finding: Cracking - Walls
Information: There is cracking to areas of the exterior wall cladding (as per example photos). The cracking appears to be concentrated at the vertical joints of the wall sheeting and is generally minor in nature. It is assumed the cracking is the result of normal building movement or substandard workmanship at the time of construction.

A licensed solid plasterer or qualified painter could be consulted regarding rectification options.

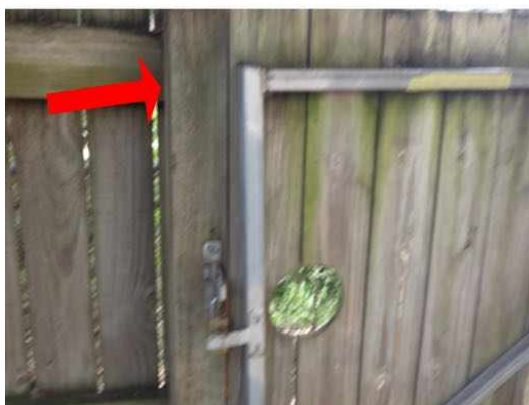
Finding 3.02

Building: Main Building
Location: Yard - Back > Existing

Finding: Gate - Sticking/ jamming
 Information: At the time of inspection the gate to the rear of the property was sticking or jamming during standard operation.

A fencing contractor or general handyman could be engaged to adjust or repair the gate as required.

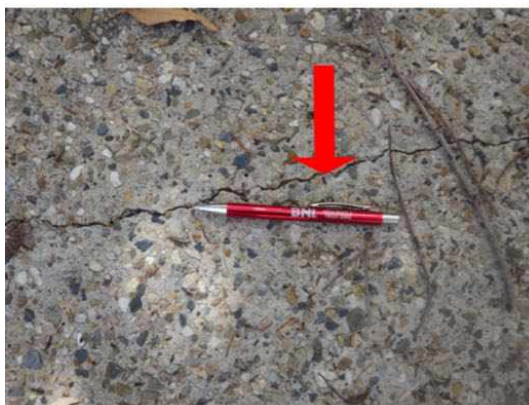
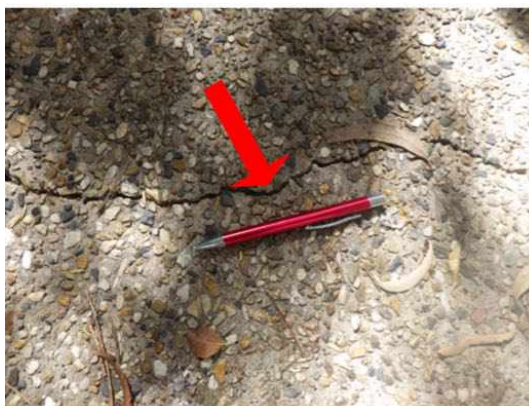
Finding 3.03

Building: Main Building
 Location: Yard - Back > Ground Level
 Finding: Cracking in concrete slab - Category 1
 Information: Cracking coded as Category 1 was identified in the driveway and footpaths concrete slabs (as per example photos). A Category 1 crack is described as a fine but noticeable crack, with the slab at an otherwise reasonable level.

To be considered Category 1, the approximate width of the crack is less than 1.0mm, or a less than 10mm change in offset when a 3m straight edge is placed over the defect.

Category 1 cracks should be monitored for a period of 12 months. At the end of the monitoring period, identified cracks that are rated greater than Category 2 are considered defects, and require rectification.

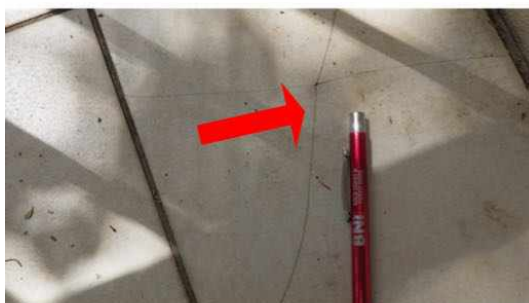
Finding 3.04

Finding: Tile - Cracked

Information: A cracked tile to the rear stair landing area was identified at the time of inspection. Such defects are generally caused by impact. Cracked or broken tiled areas may also be a direct result of poor workmanship during the construction process.

A tiling contractor could be appointed to perform repair works at the clients discretion.

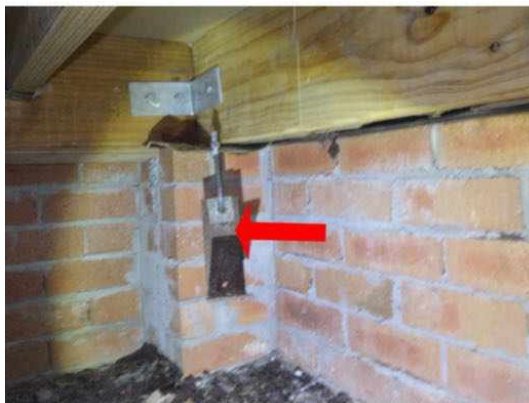
Finding 3.05

Information: At the time of inspection a metal tie down bracket to the subfloor area of the property was disconnected from the timber floor joist or bearer (reason unknown).

A qualified carpenter or general handyman should be engaged to re-attach the metal tie down bracket to the floor structure.

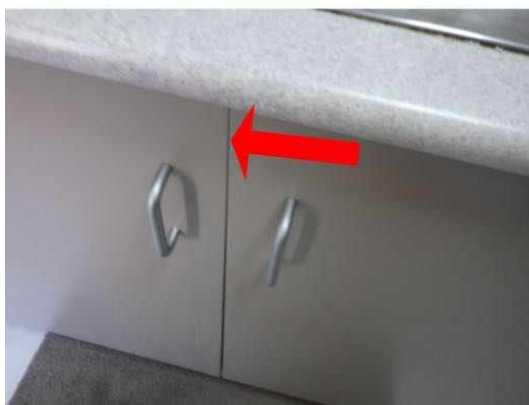
Finding 3.06

Building:	Main Building
Location:	Kitchen > Centre Left
Finding:	Cabinetry - Door jamming
Information:	The undersink cupboard doors in the kitchen area were found to be binding at the time of inspection. To improve operation of the affected cupboard doors, a cabinet maker or general handyman may be appointed to make adjustments to the hinges of the affected door. Such works should be completed at discretion of the client.

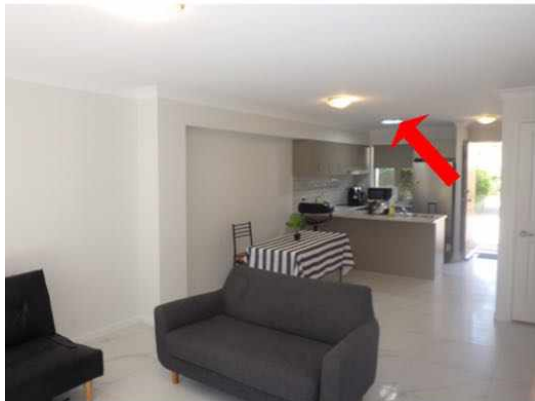
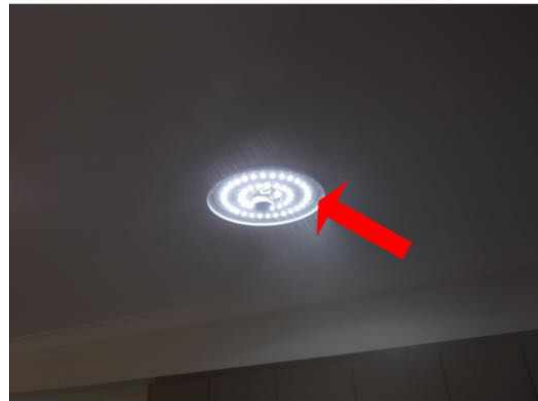
Building:	Main Building
Location:	Kitchen > Centre
Finding:	Light fitting - Missing cover
Information:	The ceiling light fitting cover in the kitchen area was found to be missing at the time of inspection. Damage occurs generally when the building materials have aged and decayed, but may also be indicative of impact damage to the building element (accidental or deliberate).

A Licensed electrician or general handyman could be appointed to replace the light fitting cover at the client's discretion.

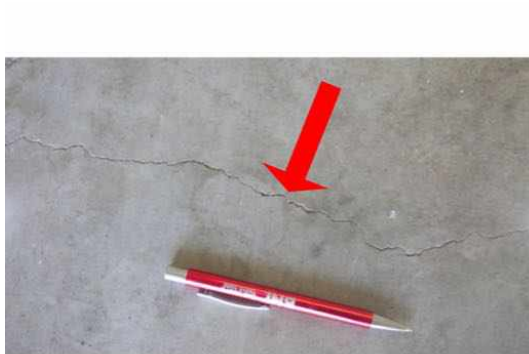
Finding 3.09

Building:	Main Building
Location:	Garage > Existing
Finding:	Cracking in concrete slab - Category 1
Information:	Cracking coded as Category 1 was identified in the garage floor concrete slab. A Category 1 crack is described as a fine but noticeable crack, with the slab at an otherwise reasonable level.

To be considered Category 1, the approximate width of the crack is less than 1.0mm, or a less than 10mm change in offset when a 3m straight edge is placed over the defect.

Category 1 cracks should be monitored for a period of 12 months. At the end of the monitoring period, identified cracks that are rated greater than Category 2 are considered defects, and require rectification.

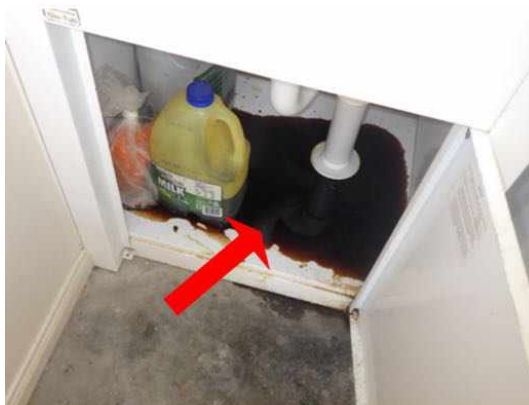
Finding 3.10

Building:	Main Building
Location:	Laundry > Existing
Finding:	Surface requires cleaning
Information:	At the time of inspection there was evidence of a leaking container (contents unknown) affecting the metal laundry tub and concrete floor surface.

The client should notify the real estate agent or occupants of the leaking container for removal and cleaning of the area.

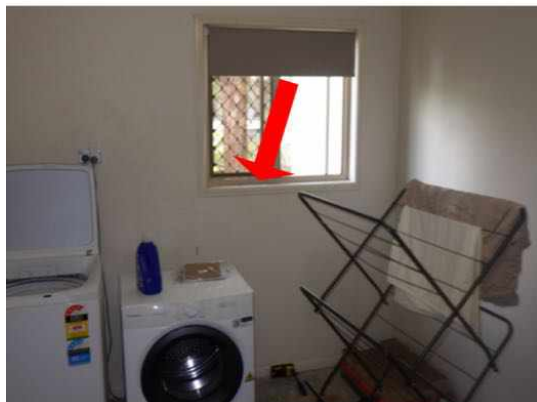
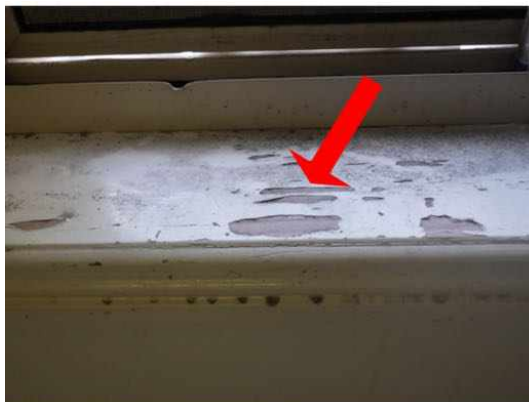
Finding 3.11

Finding: Painted surface - Deteriorated
 Information: At the time of inspection sections of paint to the timber window frame in the laundry was found to have deteriorated. Deteriorated internal paint is generally an indication of excessive moisture exposure or poor workmanship.

It is advised that the affected paint work be rectified by a qualified painter.

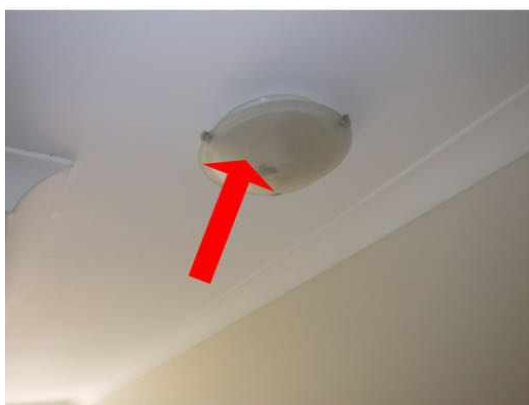
Finding 3.12

Building: Main Building
 Location: Stairs - Internal > Existing
 Finding: Light not operating
 Information: The ceiling light in the upper level stair area was not operating at the time of inspection.

It is assumed the light globe needs replaced. A general handyman could be engaged to undertake minor works at the clients discretion.

Alternatively a licensed electrician may be required.

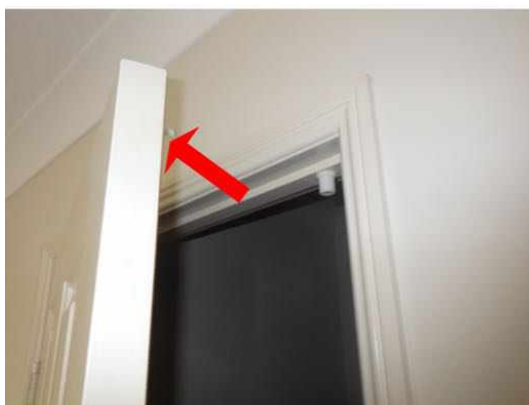
Finding 3.13

Location:	Walk In Robe > Front
Finding:	Door - Broken latch
Information:	The door latch to the walk in robe door was found to be broken at the time of inspection. Breakage occurs generally when the building materials have aged and decayed, but may be indicative of impact damage (accidental or deliberate).
	Replacement of the broken door catch is advised to improve the operational state of the associated door.
	A general handyman could be appointed to replace the door latch at the client's discretion.

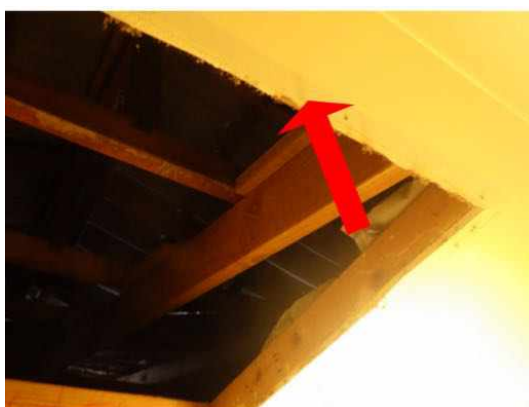
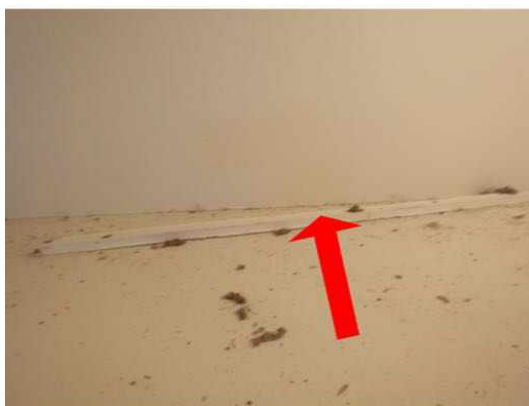
Finding 3.14

Building:	Main Building
Location:	Walk In Robe > Centre
Finding:	Manhole Cover
Information:	At the time of inspection the manhole cover boarding and/or frame showed signs of deterioration.
	A general handyman should be engaged to repair/replace the manhole cover frame.

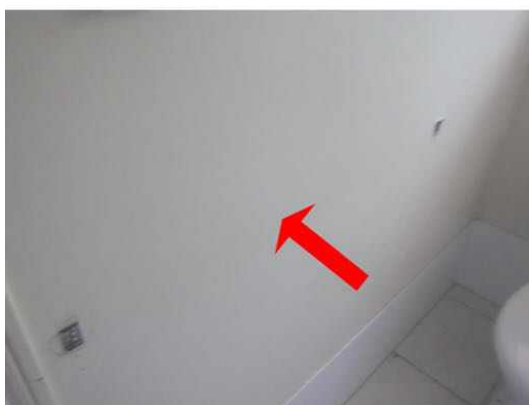
Finding 3.15

Building: Main Building
 Location: Ensuite > Front Left
 Finding: Fitting or fixture - Missing
 Information: A fixture was missing from the ensuite wall at the time of inspection

It is assumed the missing fixture was a towel rail or similar.

A general handyman could be appointed to replace the missing fixture at discretion of the client.

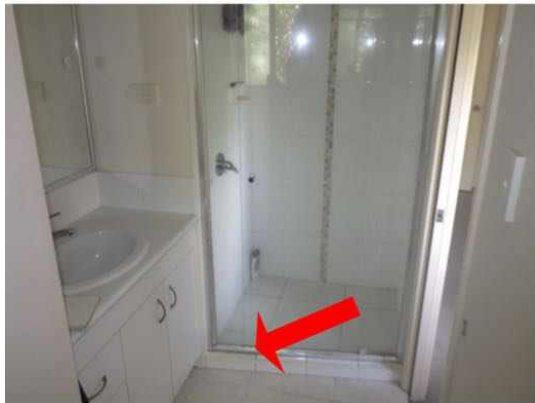
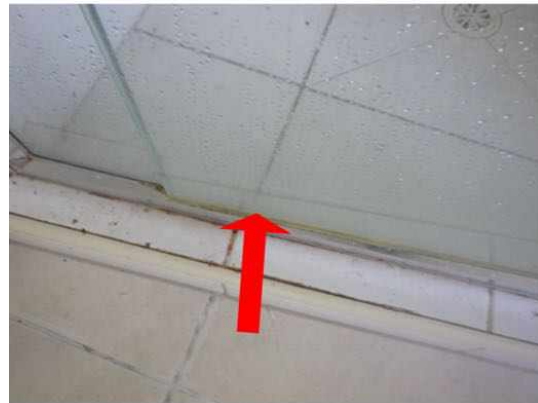
Finding 3.16

Building: Main Building
 Location: Ensuite > Centre Right
 Finding: Shower Screen door - Sticking
 Information: The shower screen door was binding on the frame in the ensuite at the time of inspection. Although some building elements may seem irrelevant or unnecessary, all building elements play a key role in the operation and function of the overall structure and its performance.

Adjustment of the shower screen door hinges may rectify the issue.

A shower screen door supplier or installer may be appointed to perform these works at client discretion.

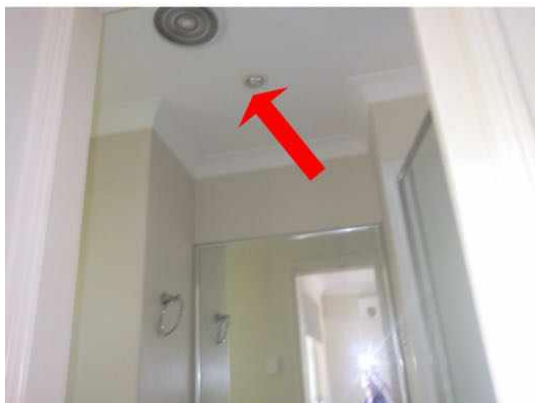
Finding 3.17

Building: Main Building
 Location: Ensuite > Centre
 Finding: Light not operating
 Information: The ceiling light in the ensuite area was not operating during standard operation.

It is assumed the light globes need replaced. A general handyman could be engaged to undertake minor works at the clients discretion.

Alternatively a licensed electrician may be required.

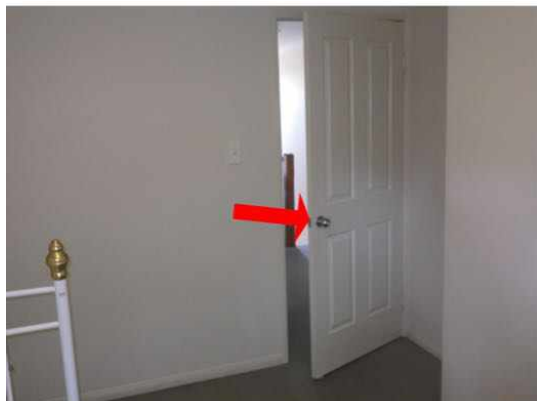
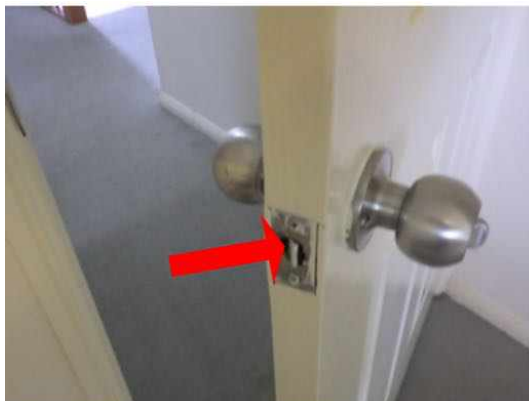
Finding 3.18

Building: Main Building
 Location: Bedroom 2 > Front
 Finding: Door - Broken latch
 Information: The door latch to the bedroom 2 door was found to be broken at the time of inspection. Breakage occurs generally when the building materials have aged and decayed, but may be indicative of impact damage (accidental or deliberate).

Replacement of the broken door latch is advised to improve the operational state of the associated door.

A general handyman could be appointed to replace the door latch at the client's discretion.

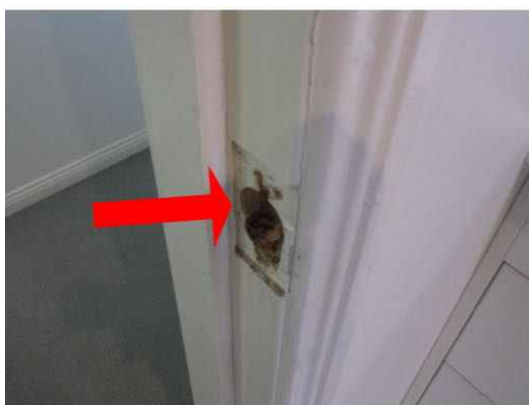
Finding 3.19

Building:	Main Building
Location:	Bathroom > Front Left
Finding:	Striker Plate - Missing
Information:	The bathroom door handle striker plate was missing from the door frame at the time of inspection. Although some building elements may seem irrelevant or unnecessary, all building elements play a key role in the operation and function of the overall structure and its performance.

Re-installation or replacement of the striker plate is advised to prevent any subsequent damage to the door frame or associated structures. A general handyman may be appointed to perform these works at client discretion.

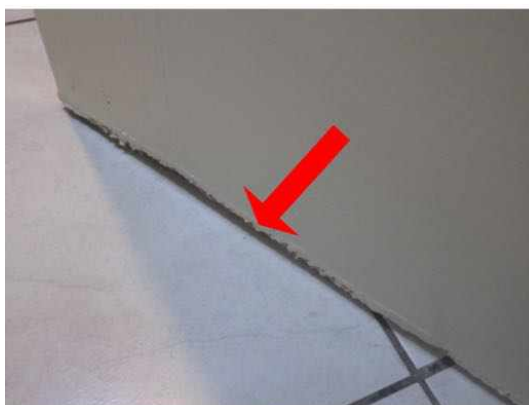
Finding 3.20

Location: Bathroom > Front
 Finding: Damaged Door
 Information: The door leading into the bathroom has suffered damage to the bottom edge.

Damage occurs generally when the building materials have aged and decayed, but in this instance the damage appears to be the result of exposure to moisture, possibly from the bottom and/or top edges of the door not being sealed with a suitable paint or sealant at the time of construction.

A qualified carpenter or general handyman could be appointed to repair/replace the door at the clients discretion.

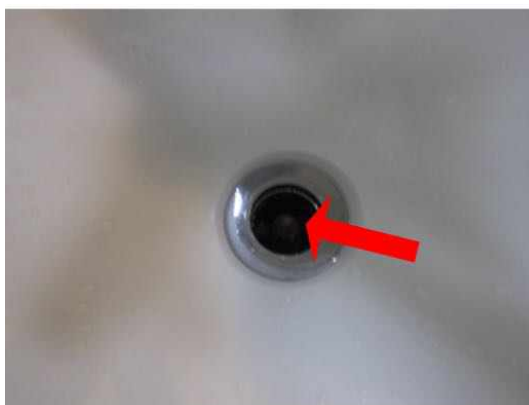
Finding 3.21

Building: Main Building
 Location: Bathroom > Centre Left
 Finding: Basin - Pop up waste
 Information: The bathroom basin pop up waste was damaged or missing at the time of inspection. It is advised that maintenance is carried out on the waste so as it functions as intended.

A handyman could be appointed to perform any remedial works where required.

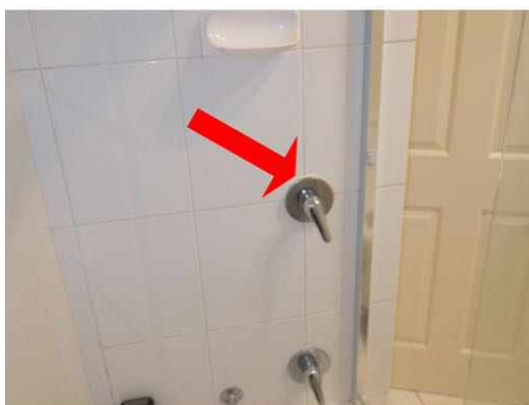
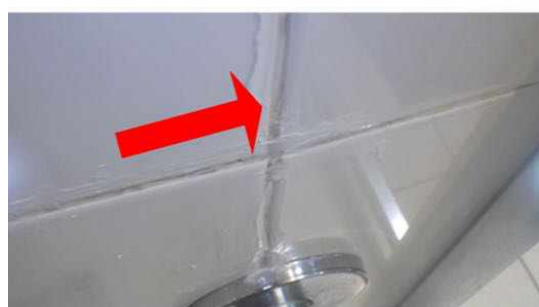
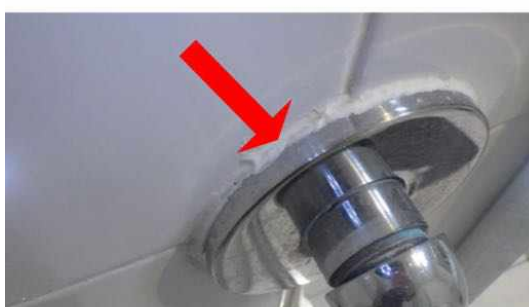
Finding 3.22

Building: Main Building
 Location: Bathroom > Centre Right
 Finding: Sealant
 Information: It was noted on inspection that sealant in the bathroom shower cubicle area has been poorly applied to wall tiles and fixtures. The reason for the sealant application is unknown, but may be to stop water penetrating the shower area flick mixer back plate.

A sealant specialist should be appointed to undertake repair work.

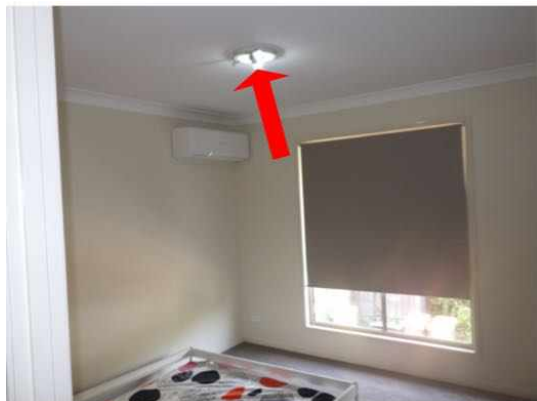
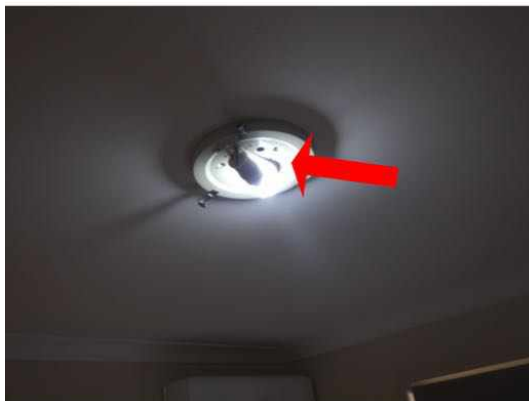
Finding 3.23

Building: Main Building
 Location: Bedroom 3 > Centre
 Finding: Light fitting - Missing cover
 Information: The ceiling light fitting cover in the bedroom 3 area was found to be missing at the time of inspection. Damage occurs generally when the building materials have aged and decayed, but may also be indicative of impact damage to the building element

(accidental or deliberate).

Replacement of the missing light cover fitting is advised.

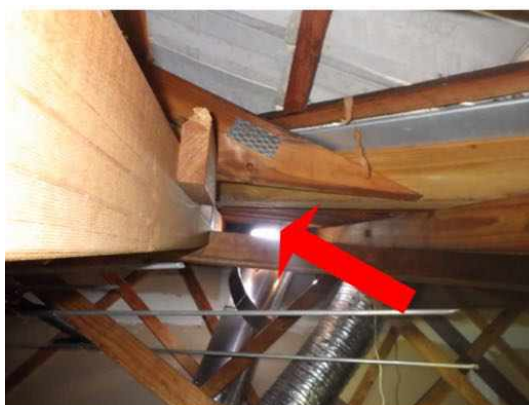
Finding 3.24

Building:	Main Building
Location:	Attic > Centre
Finding:	Skylight - Damaged/blocked shaft
Information:	It was noted at the time of inspection that the skylight shaft has been blocked/damaged, and is therefore not fully functional.

While seemingly minor, skylights allow natural light to filter into the surrounding area. Without such light, the area may be susceptible to the formation and development of mould, which creates a respiratory health hazard for all persons that come into contact with the area.

Where the skylight shaft has been blocked (even partially) or damaged, it is recommended that a carpenter or general handyperson be appointed to perform rectification works as necessary.

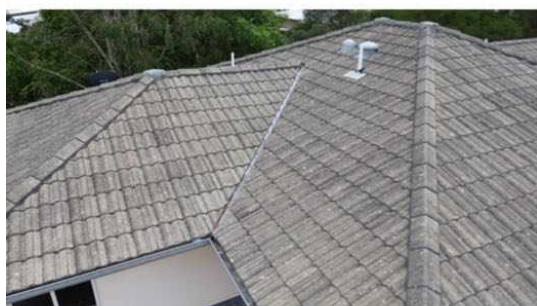
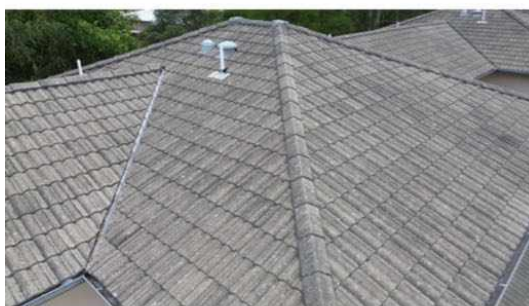
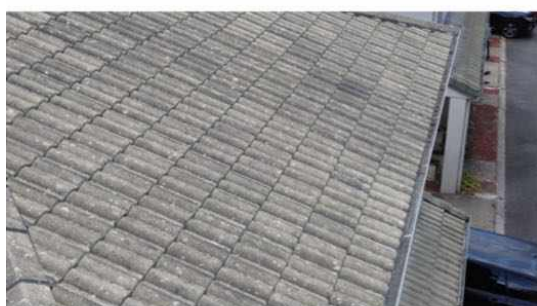
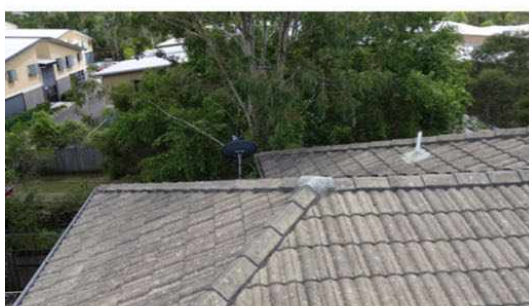
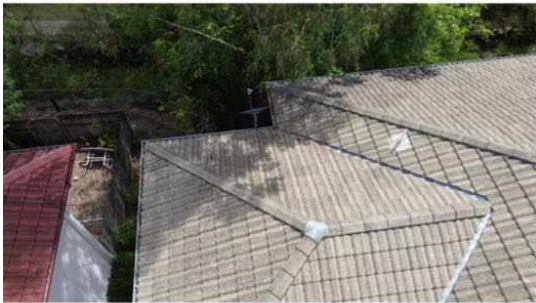
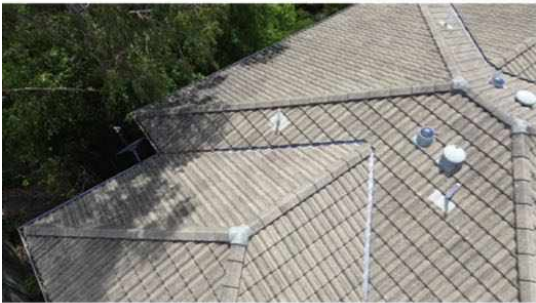
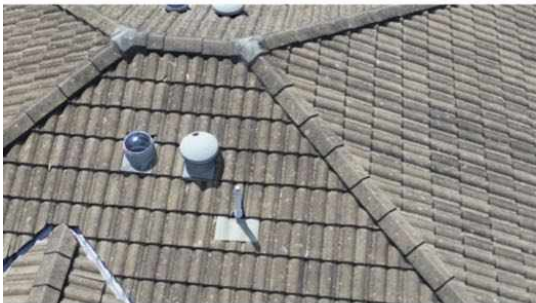
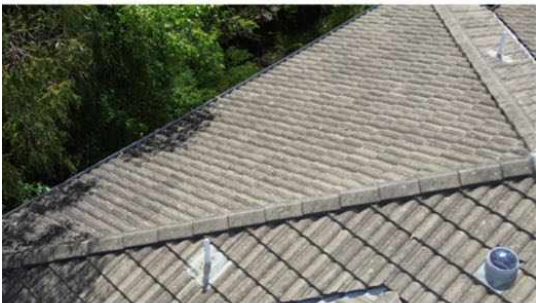
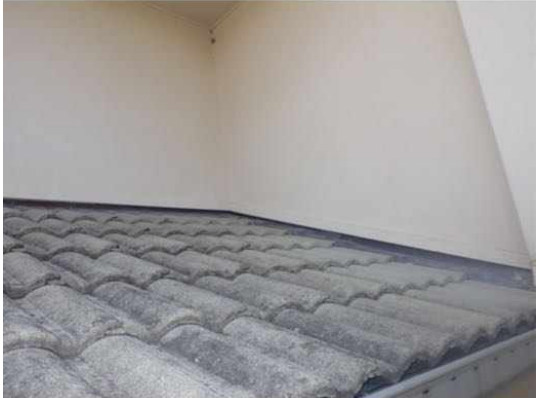
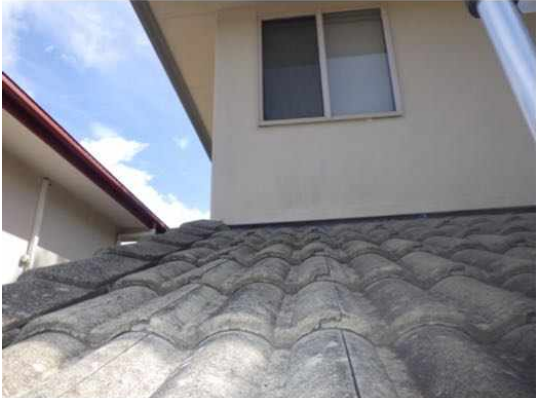
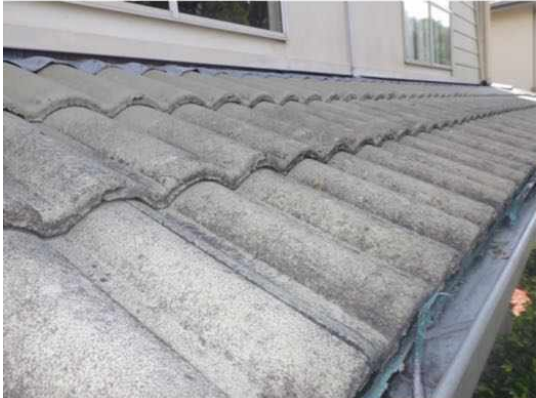
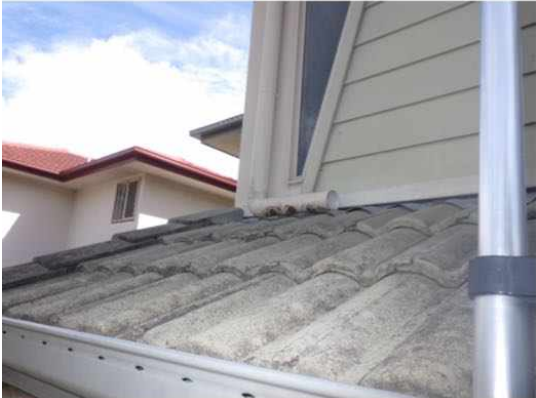
Building: Main Building
Location: Roof Exterior > Existing
Finding: Roof tiles - Weathered
Information: Upon inspection of the exterior roofing photos (taken with the DLI mini 3 drone), the majority of roof tiles were considered to be in a fair - good condition. While weathering of the tiles is consistent with the age of the property, maintenance works may be required.

The client could consult a roofing contractor to gain advice on costs of any remedial works that may be required in the short to medium term. Remedial works are likely to increase the longevity of the exterior roofing structure.

NOTE - The roof exterior maintenance or repairs may be the responsibility of the buildings body corporate managers.

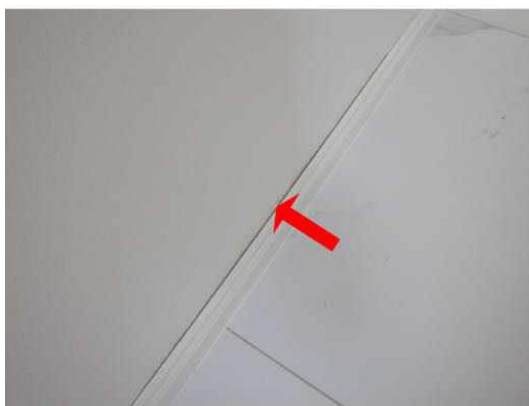
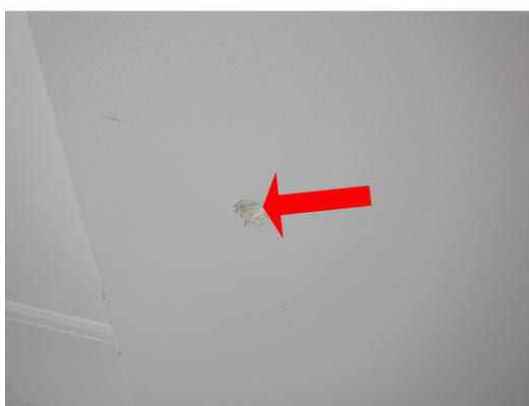
Finding 3.26

Building: Main Building
 Location: Internal Areas > Existing
 Finding: Wear and Tear
 Information: At the time of inspection the building interior showed signs of minor cracking and/or scuffing to floors, walls, ceilings and cornices (as per example photos).

The level of damage appears consistent with general deterioration and/or wear and tear.

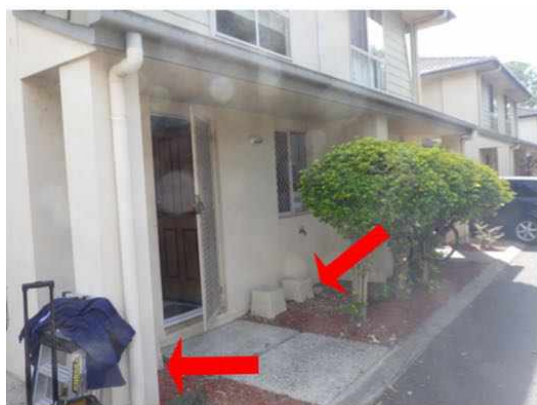
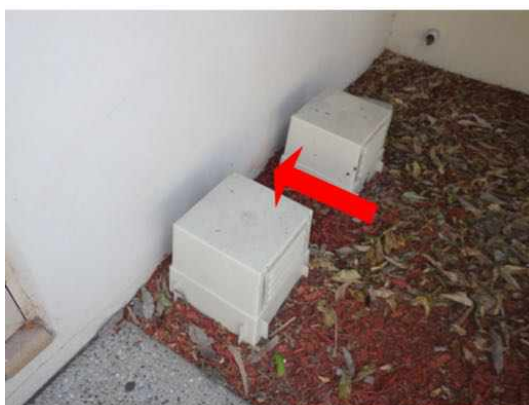
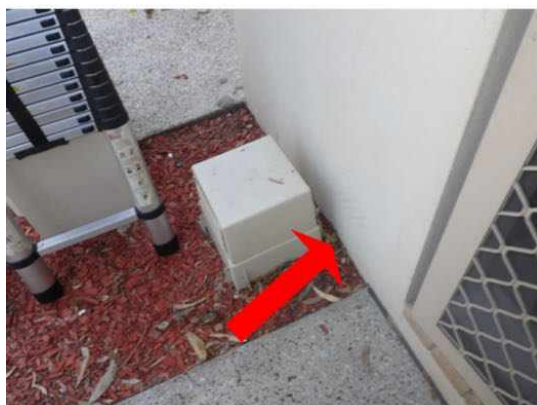
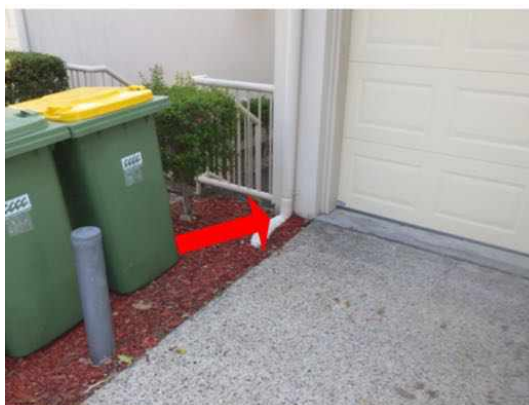
Location: Exterior walls - front > Ground Level
 Finding: Gardens
 Information: At the time of inspection it was observed there is garden beds directly against external walls. Generally placing garden beds directly against a property walls should be avoided as it creates potential nesting sites for termites or rodents and/or moisture related issues.

Any areas where garden beds are directly against exterior walls are considered high risk for timber termite activity.

Frequent pest inspections are advised to readily identify any termite activity in these areas.

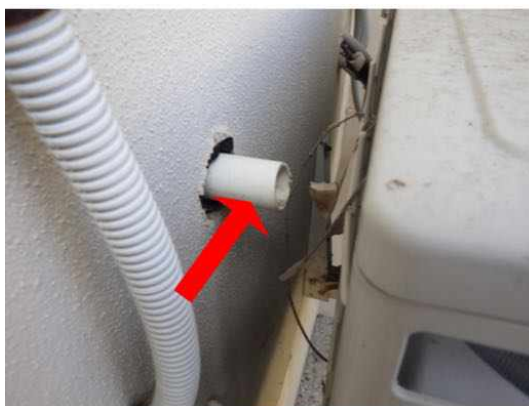
Finding 6.04

Building:	Main Building
Location:	Yard - Back > Rear Left
Finding:	Overflow - Not plumbed for drainage
Information:	The hot water system overflow is not plumbed or connected to suitable drainage, which can result in the surrounding area becoming excessively damp. These damp conditions can lead to secondary defects such as rot, rust or corrosion of associated building elements, the formation of fungal decay, or even the creation of potential slip hazards. When coupled with poor site drainage, pooling of water may also attract termite activity to this area. It is highly recommended that a qualified plumber be appointed to install adequate drainage to the overflow. These works will ensure that the area remains dry and free of any secondary defects.

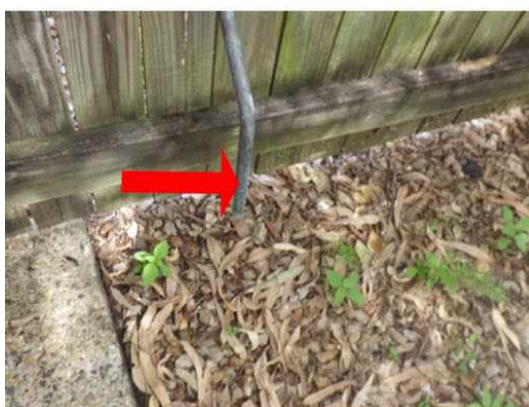
Finding 6.05

Building:	Main Building
Location:	Yard - Back > Ground Level
Finding:	Stormwater Grates
Information:	The stormwater grate to external ground area at the rear of the property appeared to be blocked or damaged at the time of inspection.

potentially creating an environment that is susceptible to rust and corrosion of surrounding building elements, as well as attracting termites and other pests.

It is recommended that a general handyman be appointed to clear and/or repair the stormwater line grate as necessary.

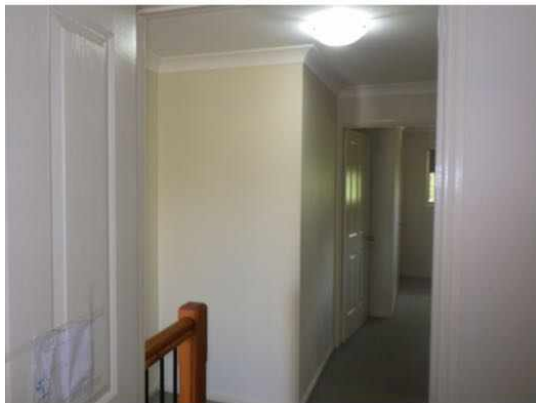
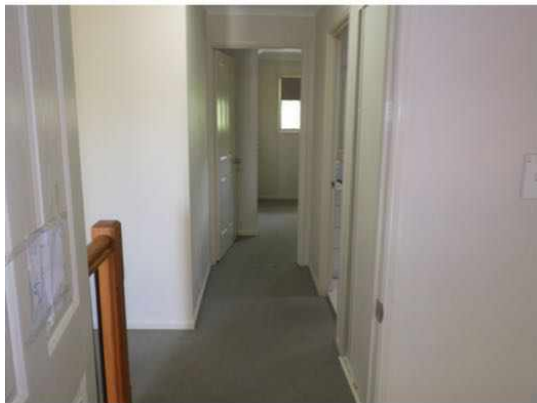
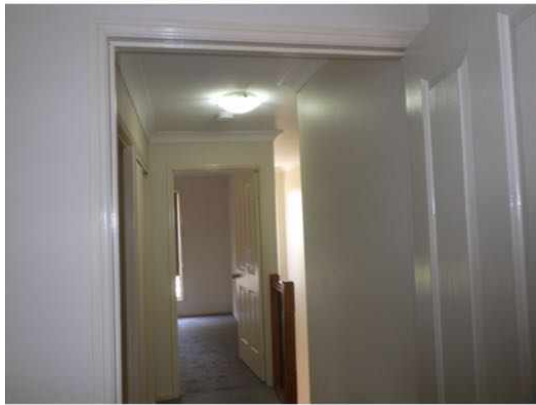
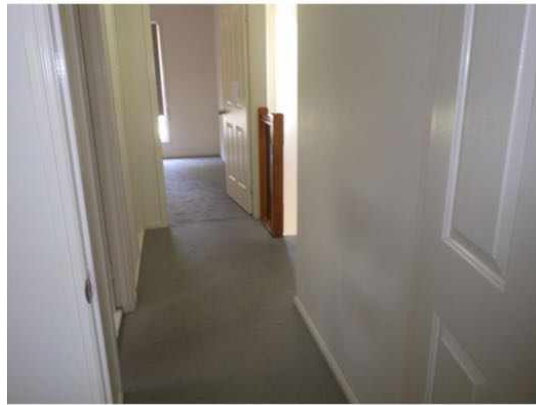
Building: Main Building
Location: Stair Landing > Existing
Finding: No obvious defect
Information: No obvious defects found at the time of inspection.

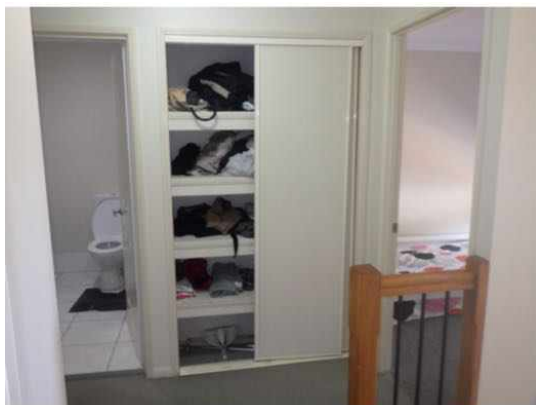
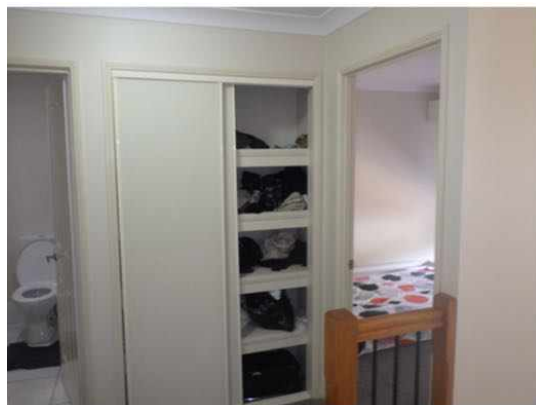
Building: Main Building
Location: Linen Cupboard > Existing
Finding: No obvious defect
Information: No obvious defects found at the time of inspection.

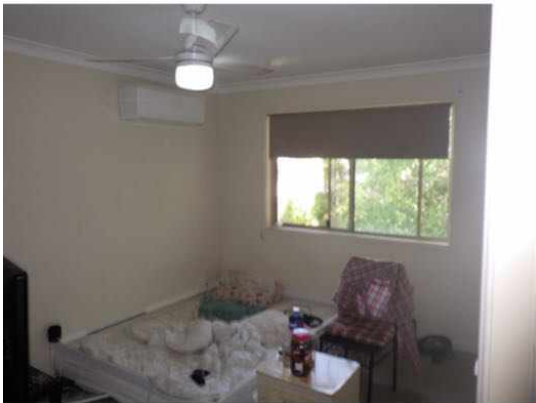
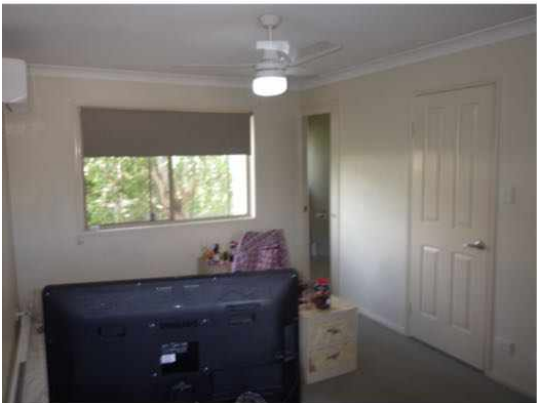
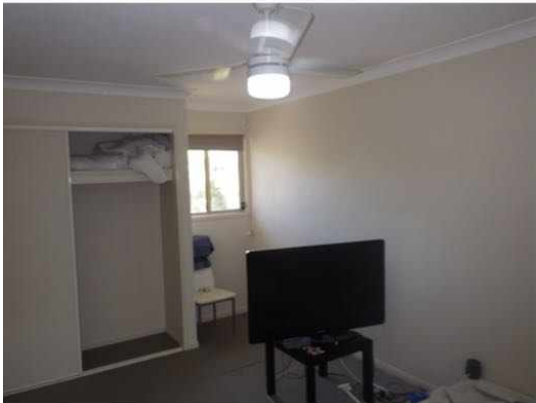
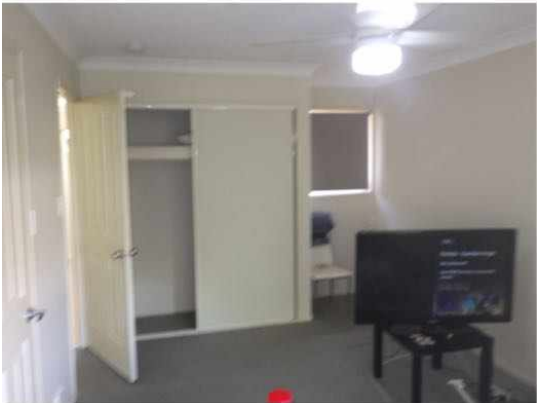
Building: Main Building
Location: Bedroom - Master > Existing
Finding: No obvious defect
Information: No obvious defects found at the time of inspection.

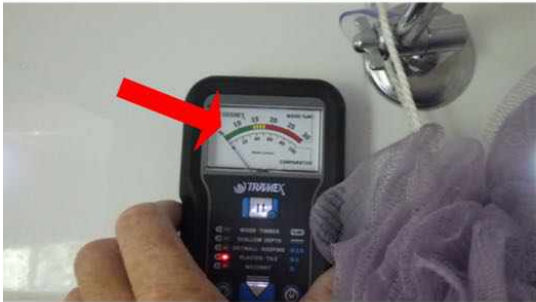
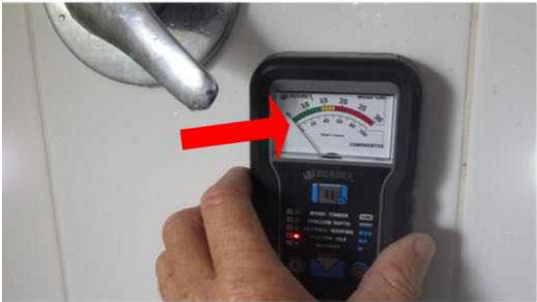
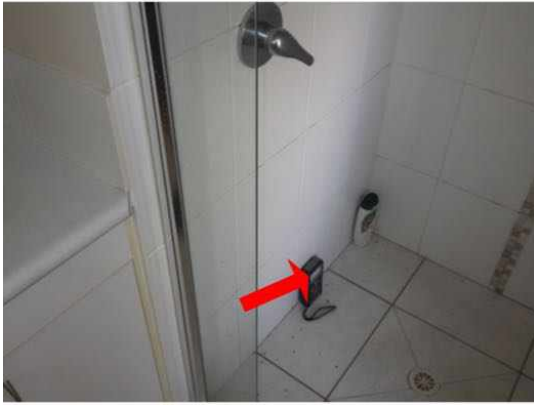
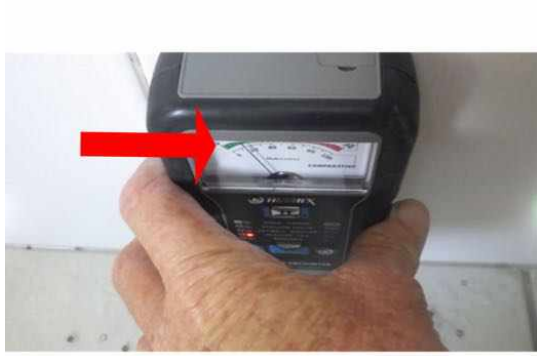
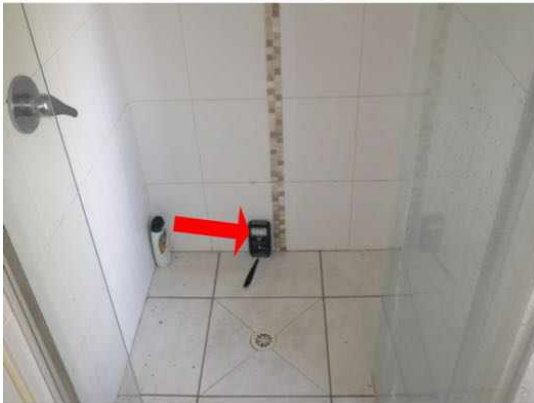
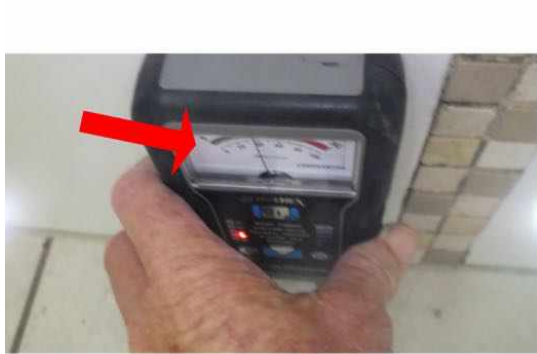
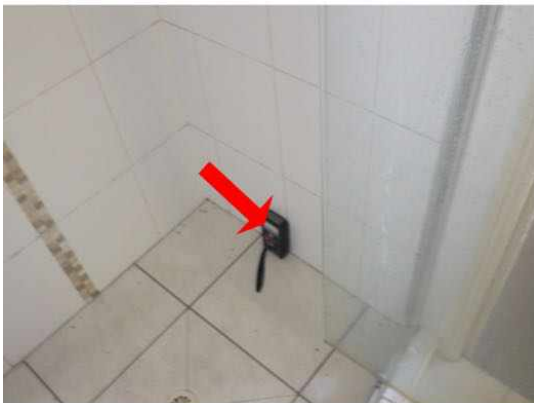
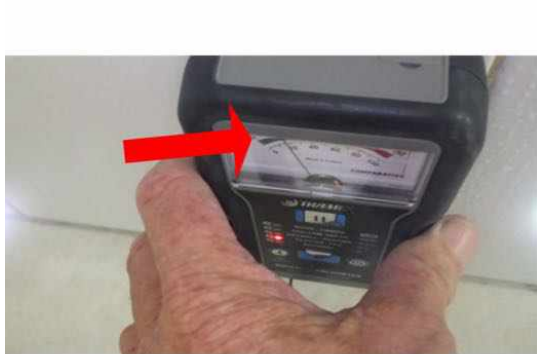
Building: Main Building
Location: Ensuite > Existing
Finding: Moisture Level Readings
Information: At the time of inspection the ensuite shower cubicle areas checked with the Tramex Moisture Meter returned low - normal moisture level readings.

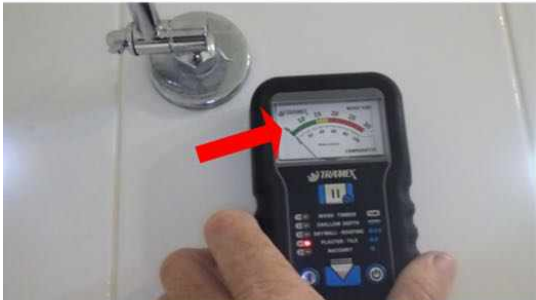
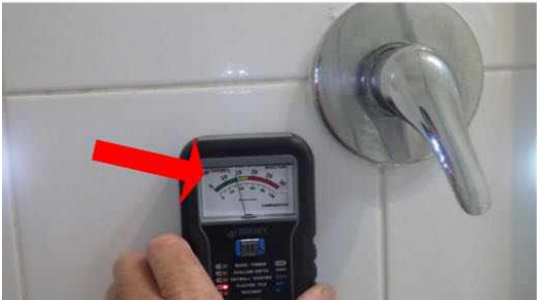
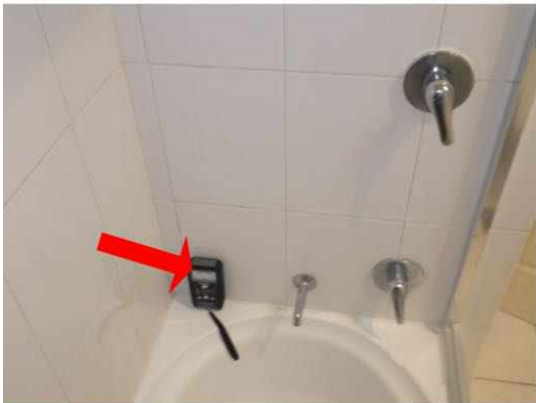
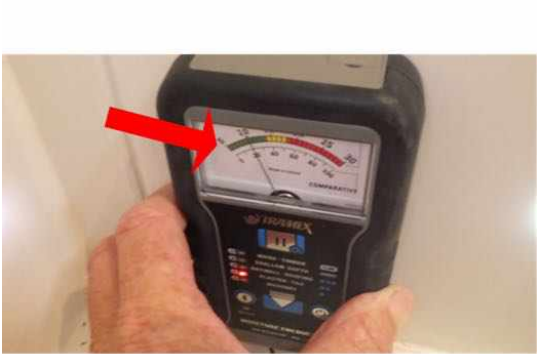
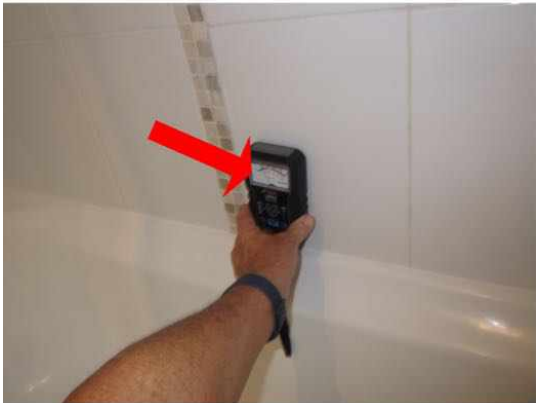
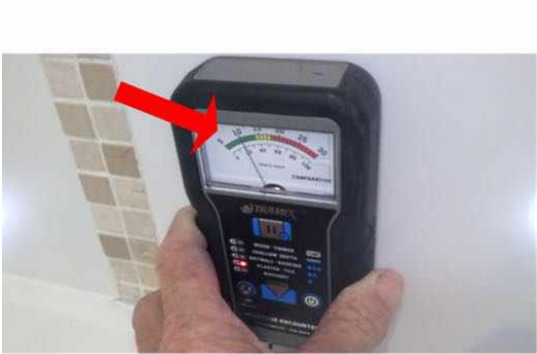
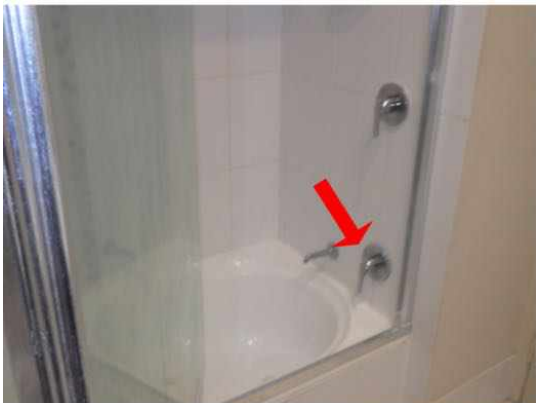
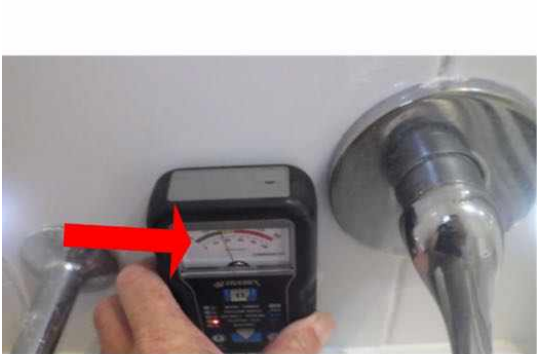
Building: Main Building
Location: Bathroom > Centre Right
Finding: Moisture Level Readings
Information: At the time of inspection the bathroom shower cubicle areas checked with the Tramex Moisture Meter returned low - normal moisture level readings.

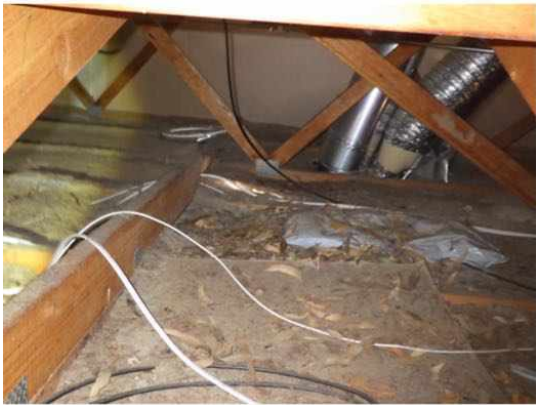
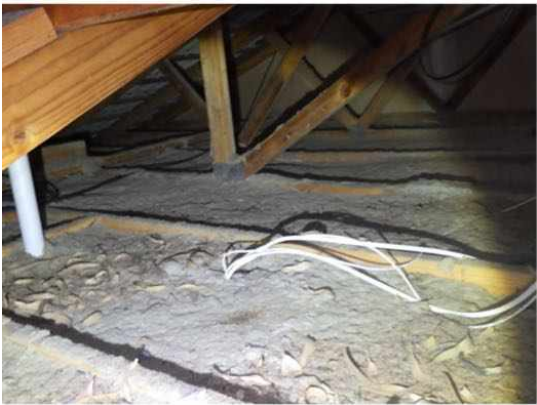
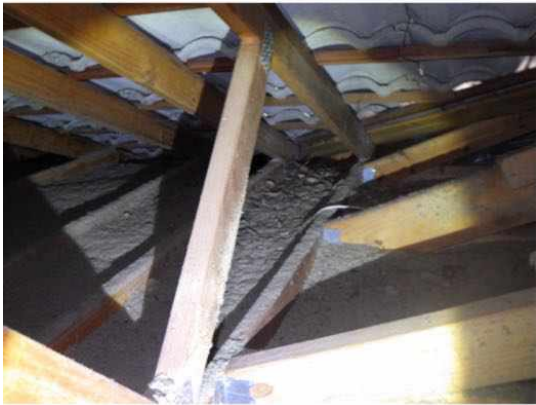
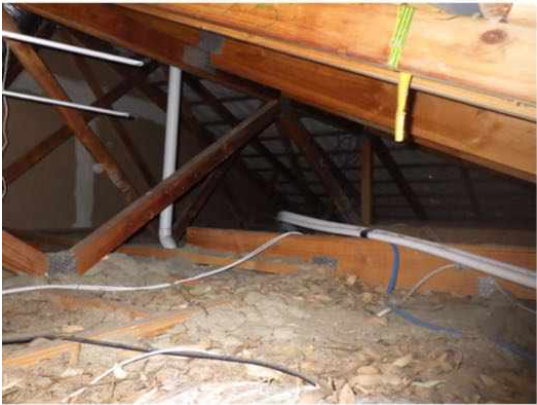
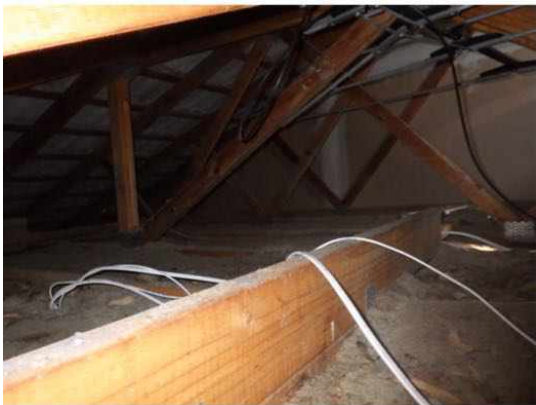
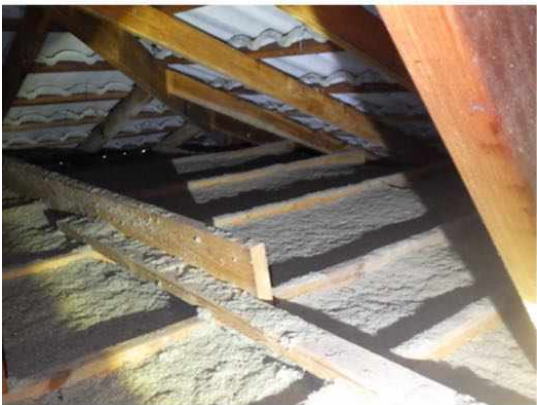
Building: Main Building
Location: Attic > Existing
Finding: Additional Photos
Information: Additional photos are provided for your general reference
