Building and Timber Pest Inspection Report

Inspection Date: Mon, 23 Feb 2026

Property Address: 31/147 Fryar Rd, Eagleby QLD 4207,
Australia

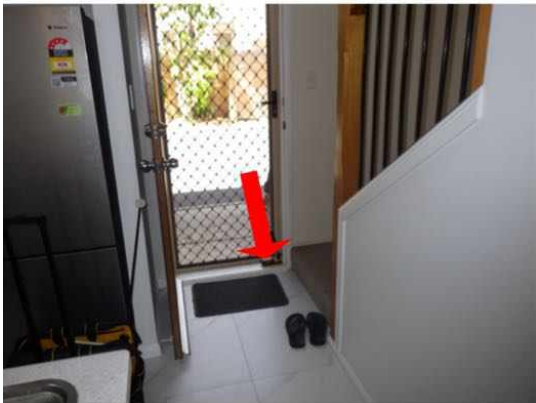
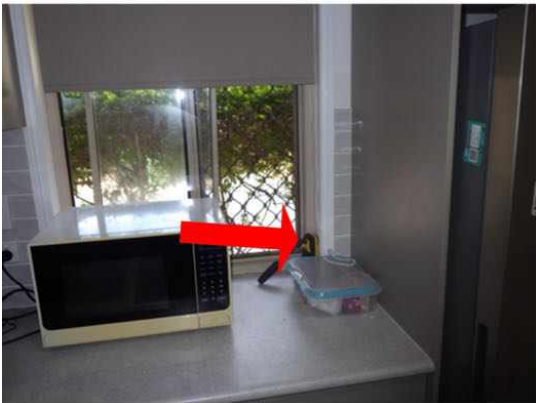
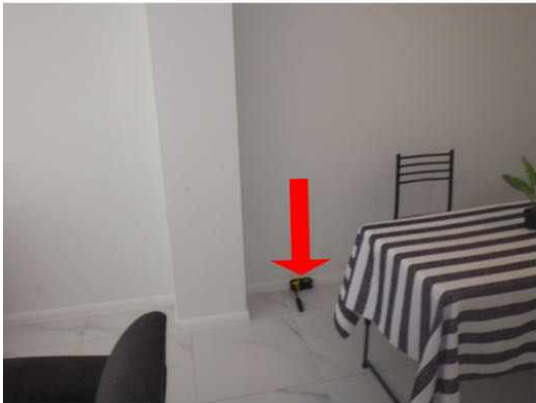
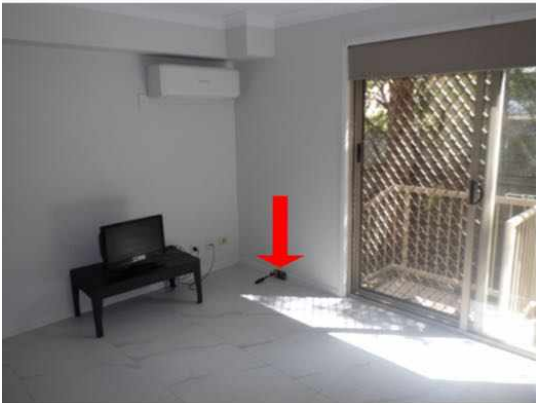
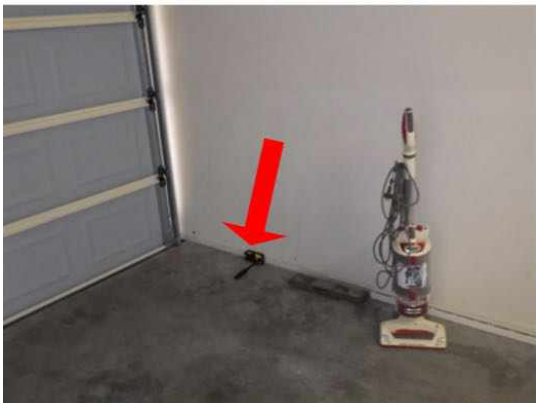
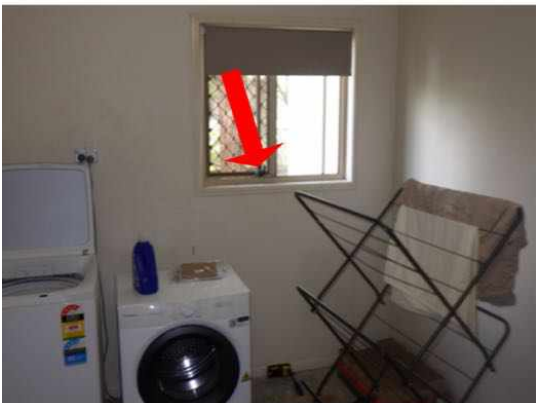
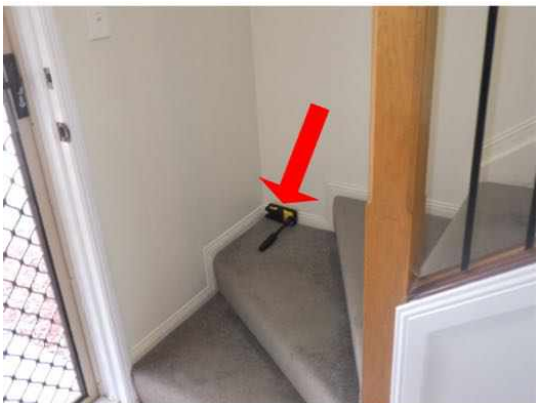
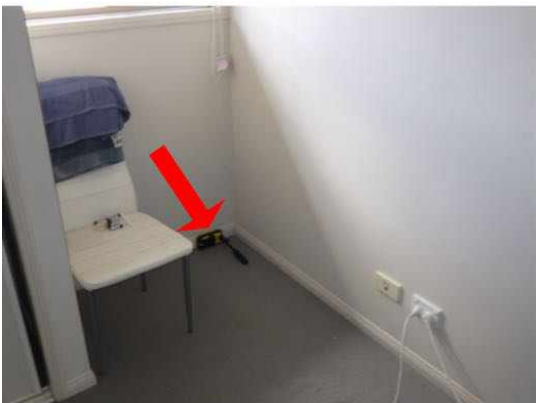
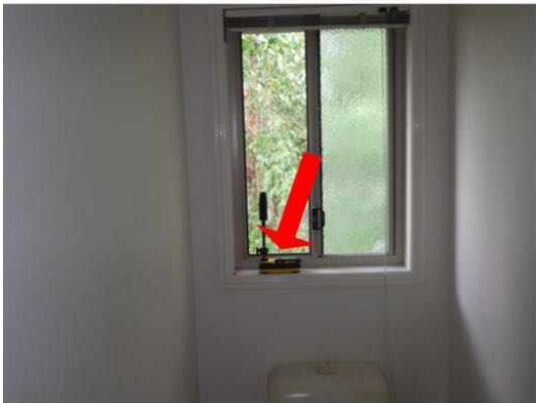
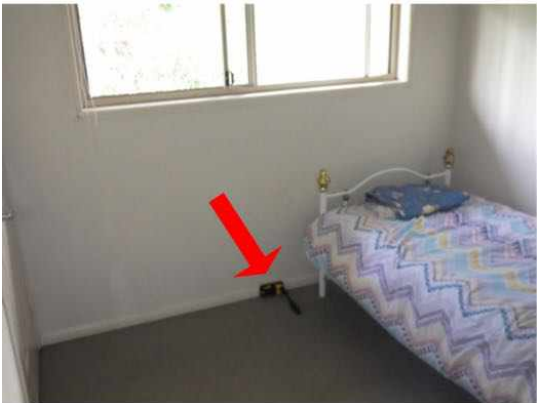
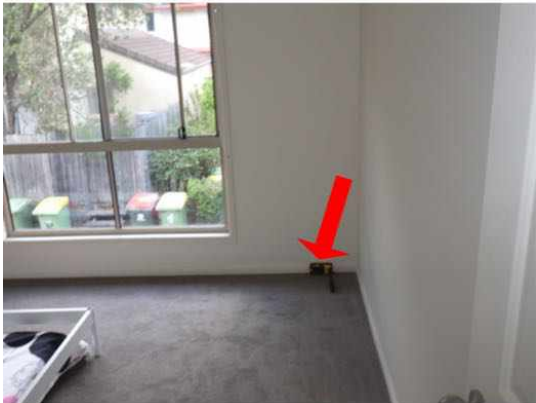
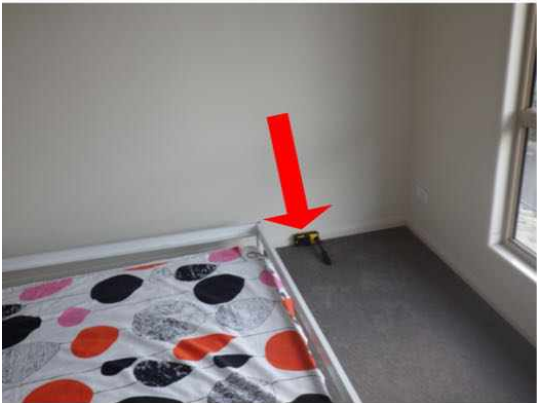
Building: Main Building
Location: Internal Areas > Existing
Finding: Termitracker
Information: The termitracker itracker was positioned randomly to internal wall, timber skirting and window frame areas checking for signs of termite activity.

No activity was recorded at the time of inspection.

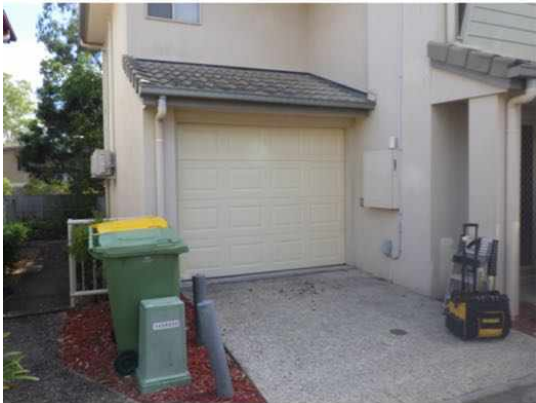
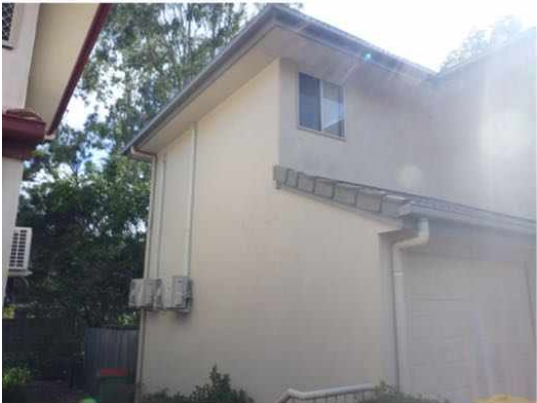
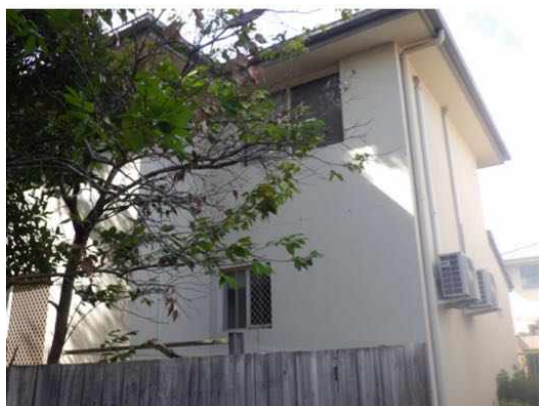
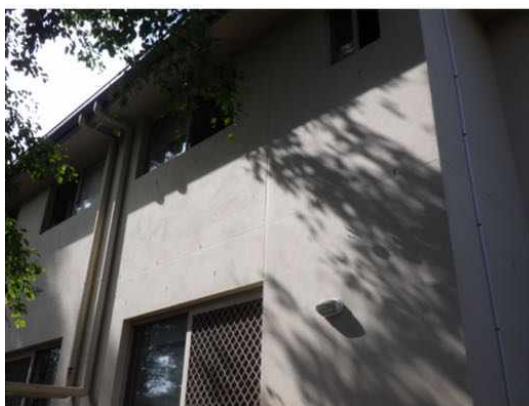
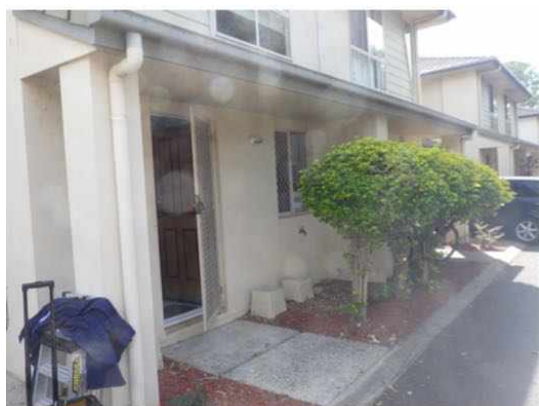
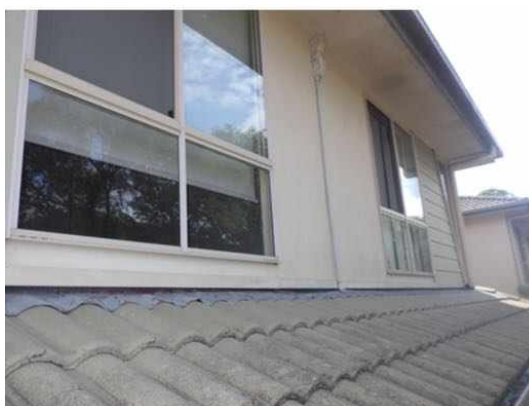
Building: Main Building
Location: External Areas > Existing
Finding: Additional Photos
Information: Additional photos are provided for your general reference

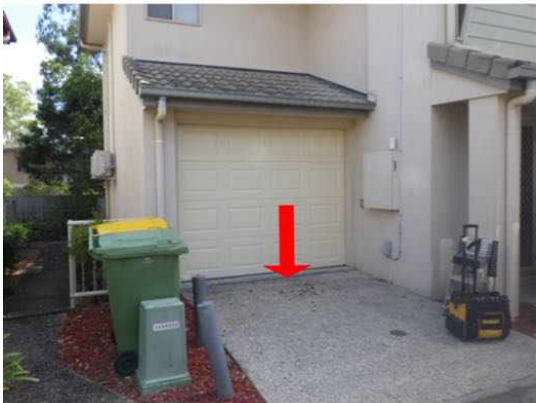
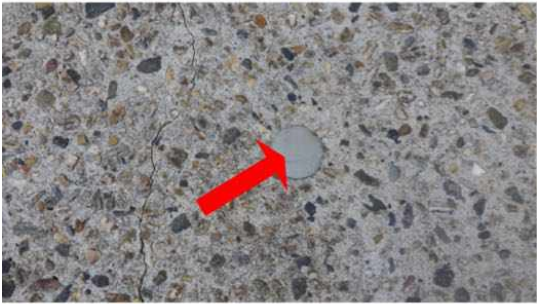
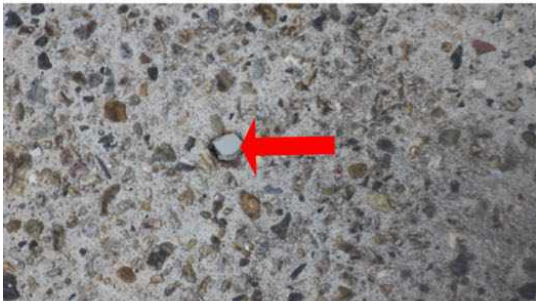
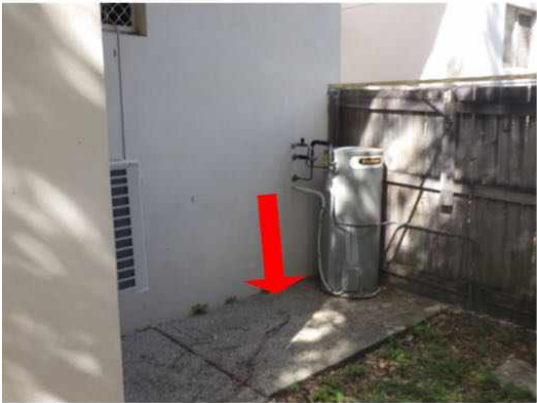
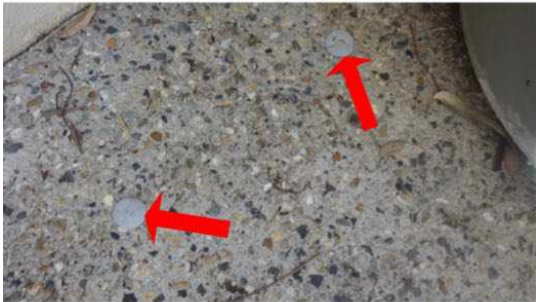
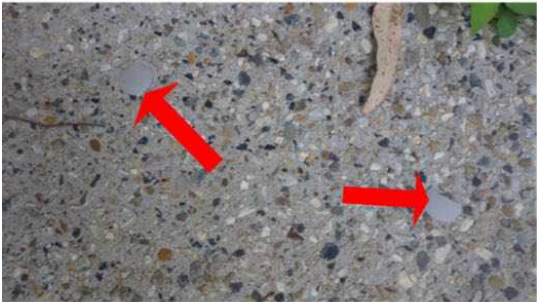
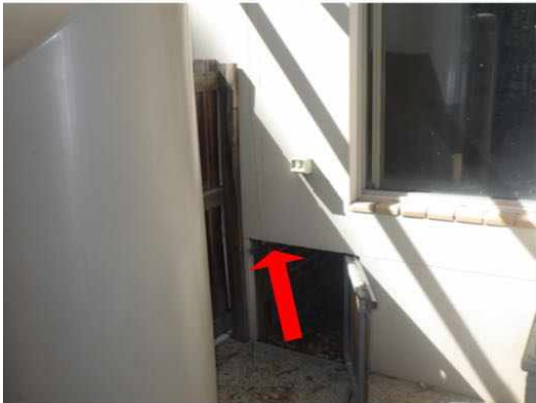
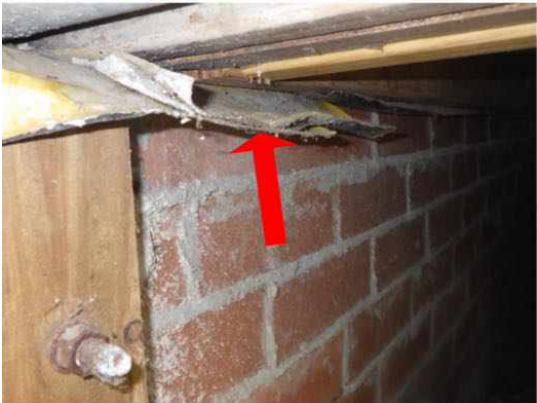
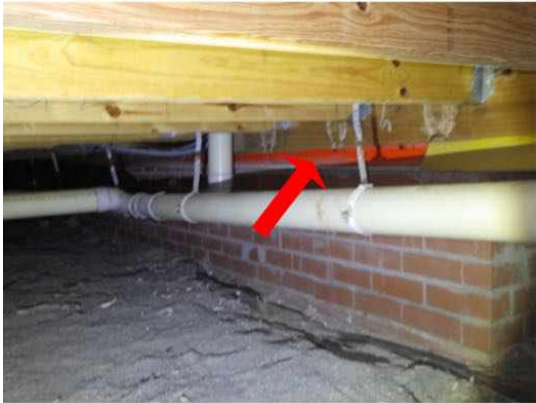
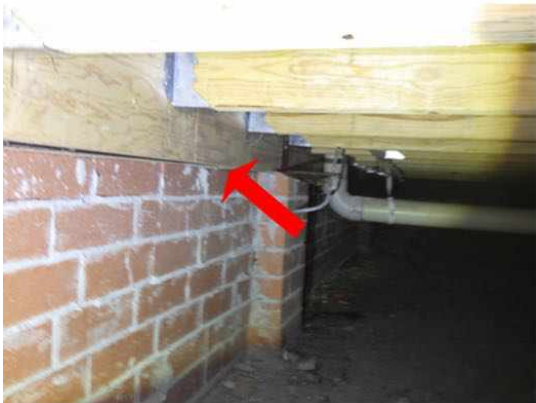
The following items were noted as - Evidence of a previous termite management program

In this instance evidence of previously installed physical and chemical barriers were observed. This system requires regular annual inspections.

No durability notice and no evidence of regular or annual inspections was found.

Where a Termite Management System has been identified you should refer to the type of barrier date of installation warranty conditions and any documentation provided by a past owner or the buildings body corporate managers.

NOTE - Maintenance and/or replenishment of the timber termite management systems

may be the responsibility of the buildings body corporate managers.
