## Building Inspection Report

Inspection Date: Tue, 24 Mar 2026

Property Address: 39 Links St, Sunshine West VIC 3020,  
Australia

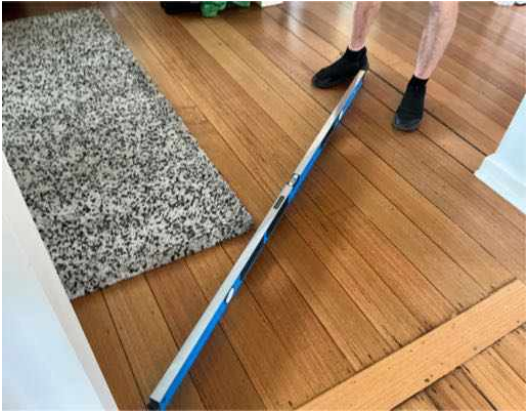
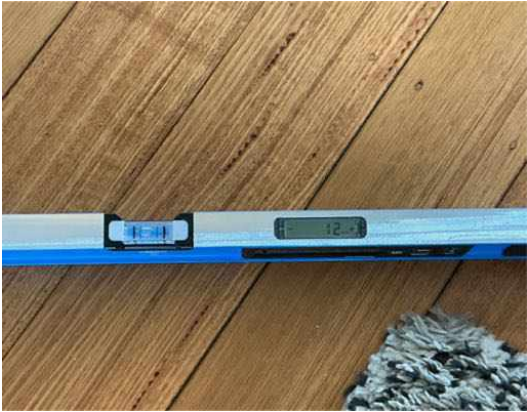
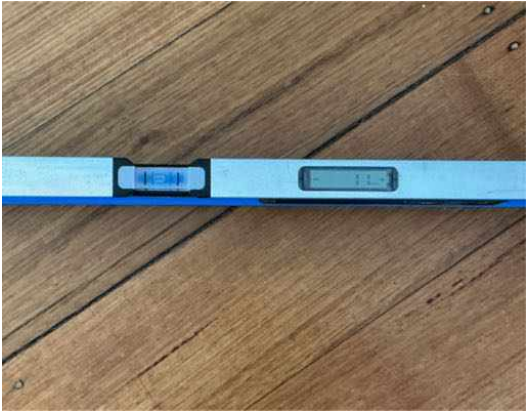
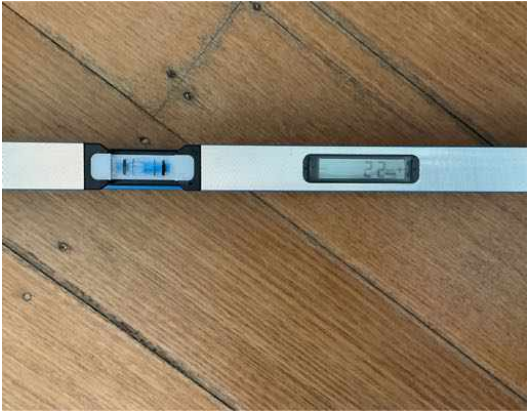
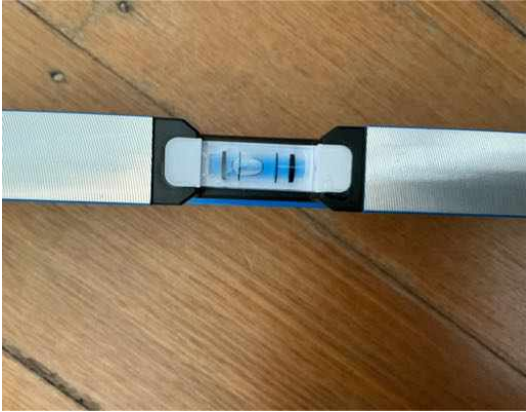
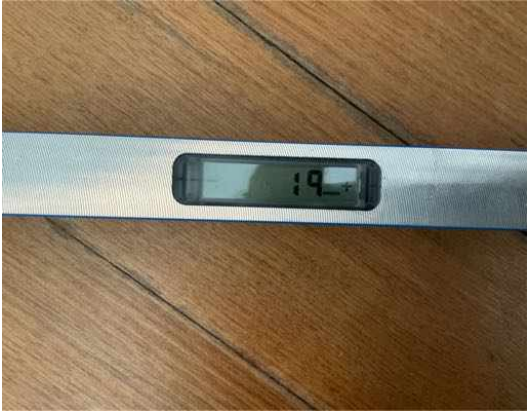
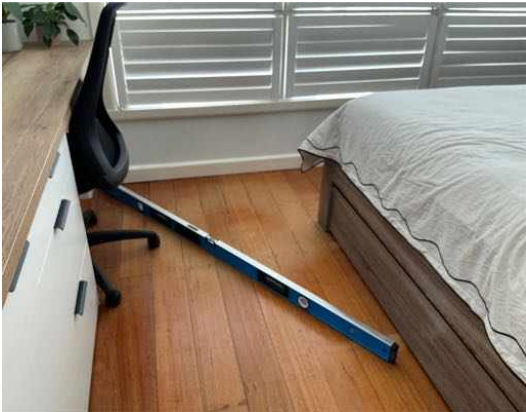
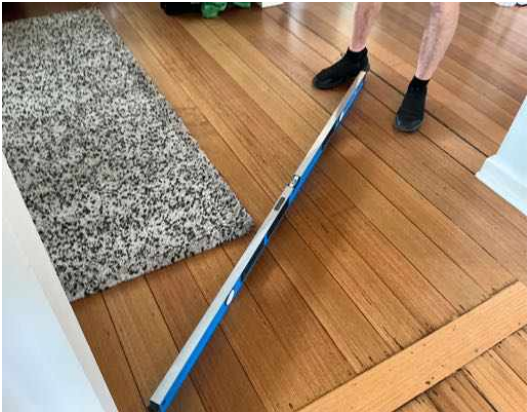
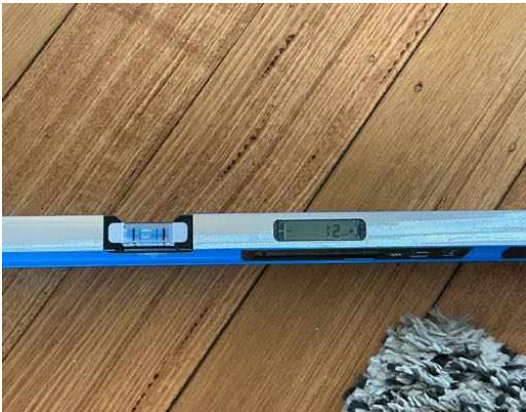
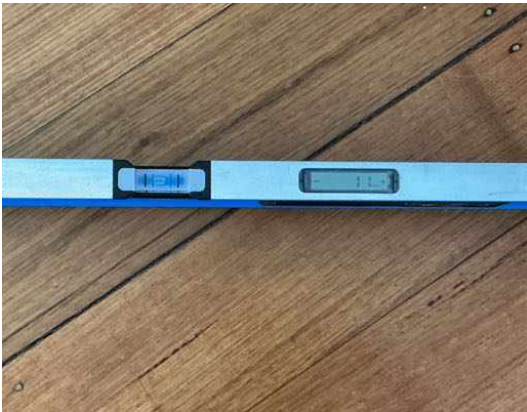
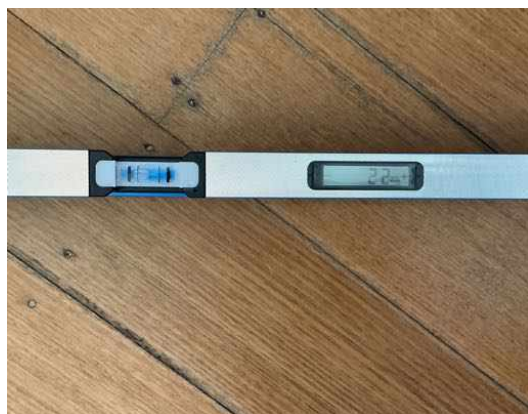
### Defects 2.01

Building:	Main Building
Location:	All Areas
Finding:	Flooring - Uneven and beyond tolerance
Information:	The internal flooring in this area is out of level and uneven. Uneven flooring is likely to may minor defects such as expected movement of the foundations of the property, but may also indicate subsidence of the associated subfloor stumps.

It is advised that the flooring be closely monitored to identify any further movement. Where flooring remains relatively unchanged for an extended period of time (i.e. several months), it is likely that this defect has been caused by expected movement of the foundations of the property.

However, where flooring is uneven further, potentially invasive inspection of the subfloor structures and stumps in this area is required. In this case, works to repair are likely to be required, and would be carried out by a registered builder specialising in re-stumping.

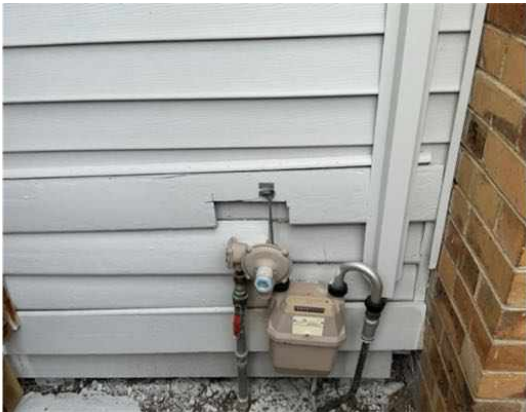
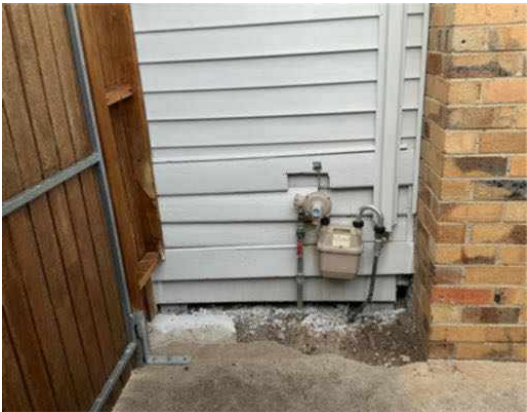
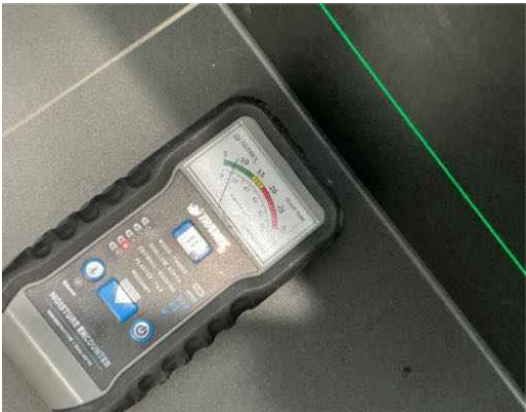
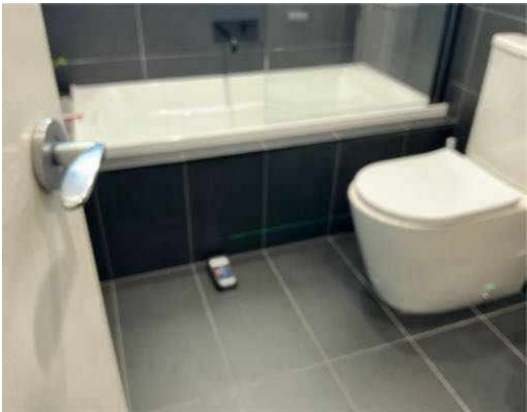
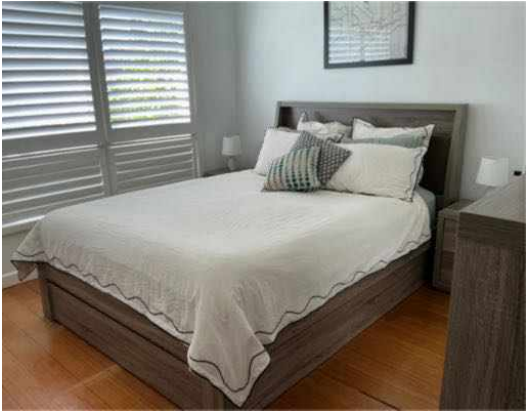
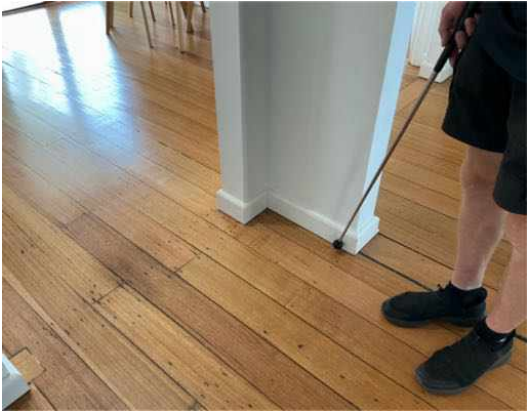
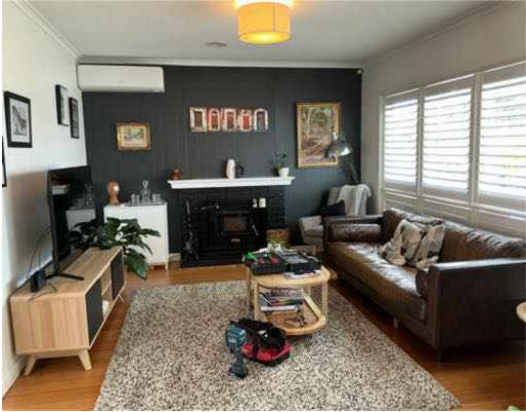
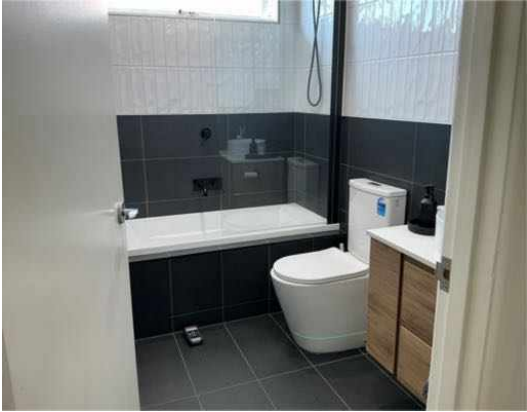
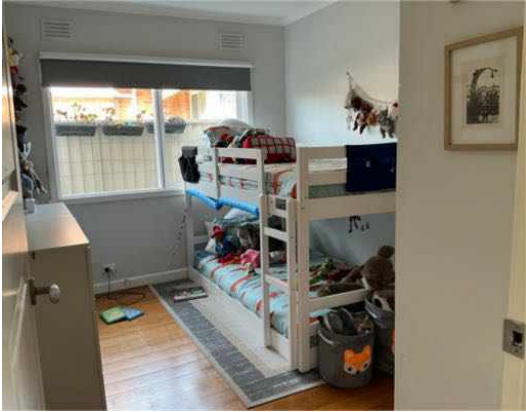
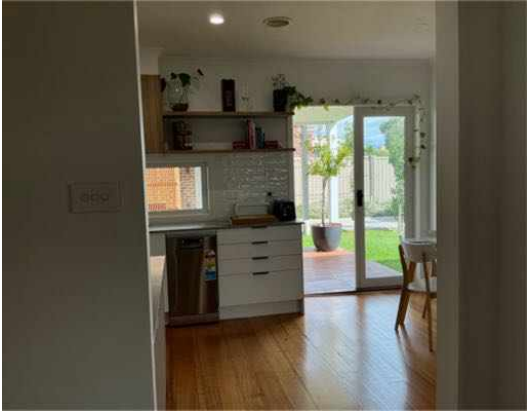
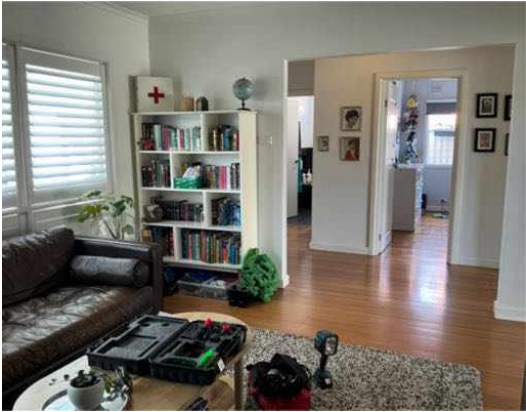
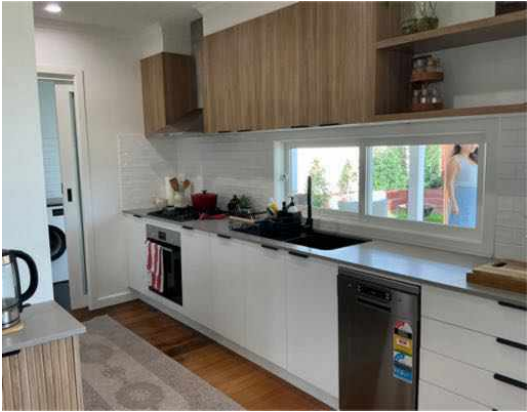
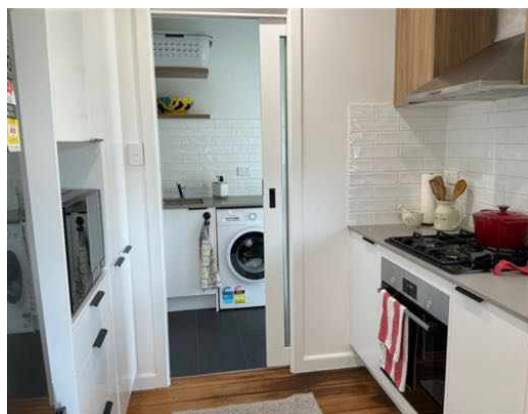
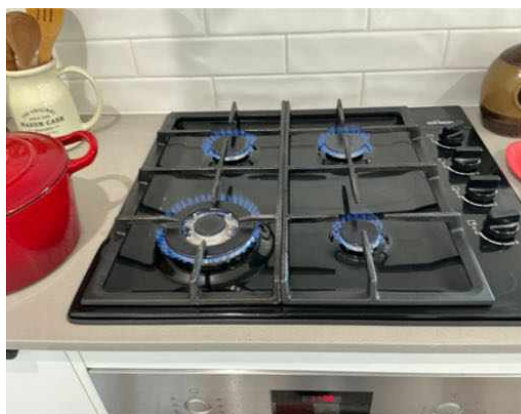
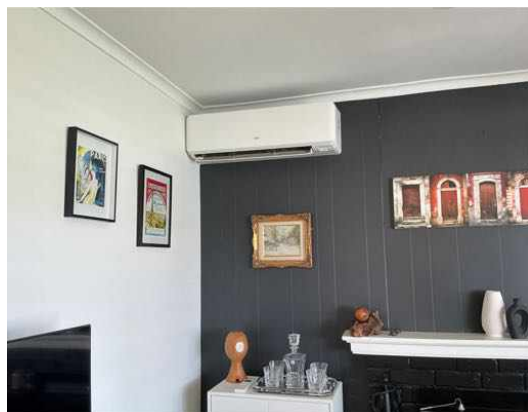
Building: Main Building  
Location: All Areas  
Finding: Additional Photos and Obstructions and Limitations  
Information: These are additional photographs and photographs of the obstructions and limitations inside and outside (furniture, landscaping etc) which may impede full inspection of the property at the time of inspection. These obstructions can hide an array of defects and may be removed to allow full inspection to be carried out. A re-inspection may be made if clients require once the areas are made accessible.

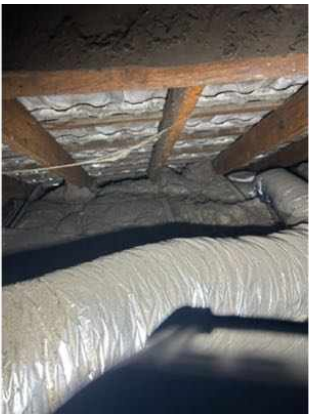
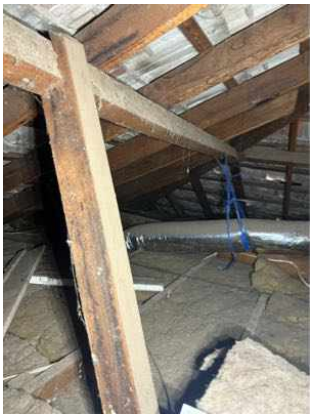
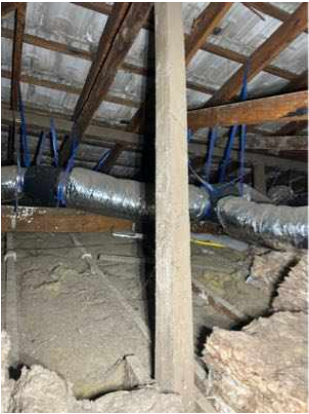
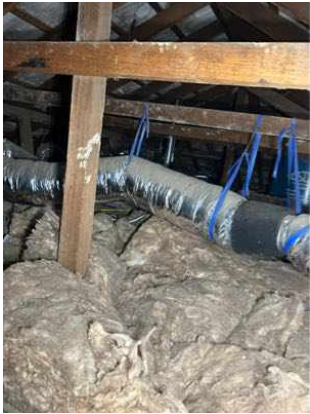
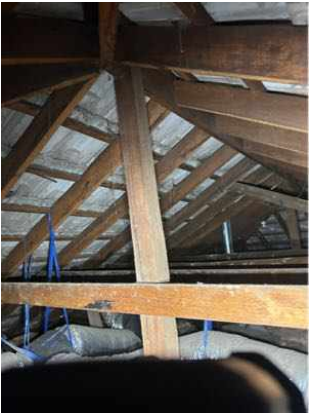
Building:	Main Building
Location:	All Areas
Finding:	Additional Photos - Obstructions and Limitations
Information:	These photographs are an indication of the obstructions and limitations which impeded full inspection of the property at the time of inspection. These obstructions can hide an array of defects and should be removed to allow full inspection to be carried out. A re-inspection is recommended once the areas are made accessible.

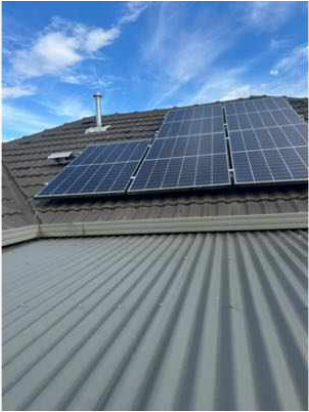
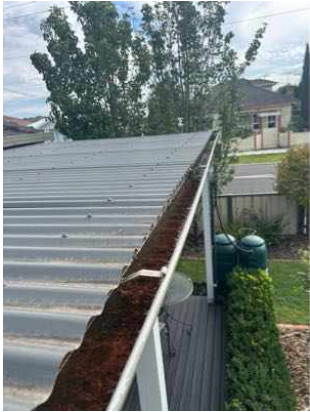
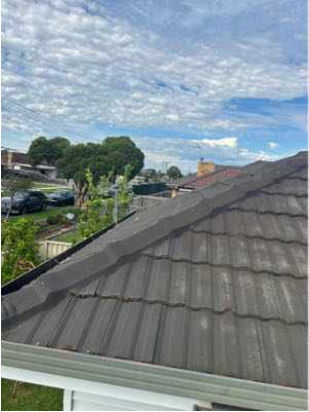
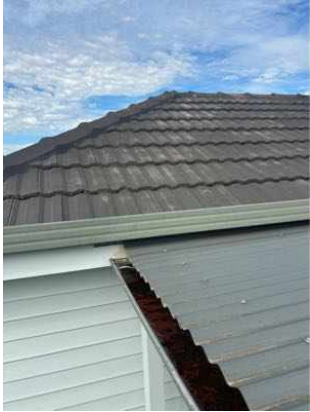
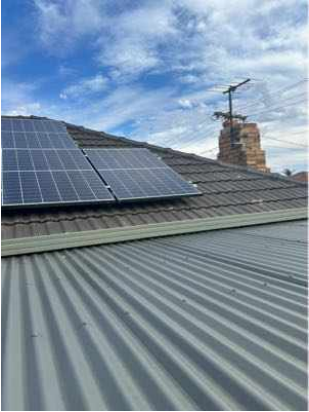
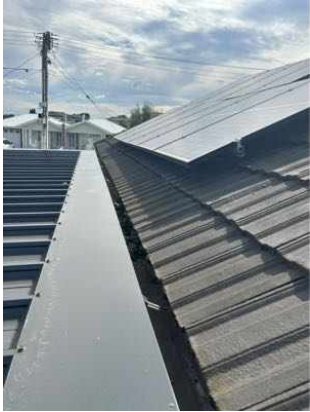
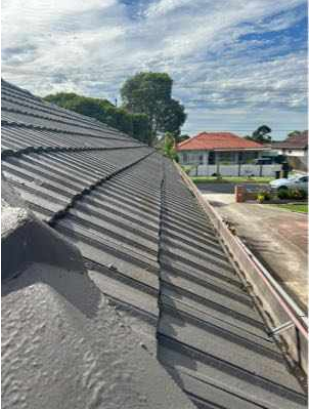
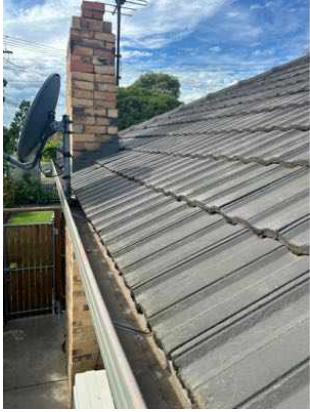
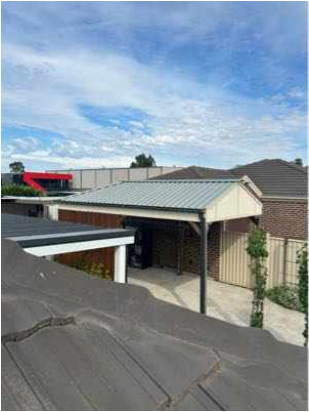
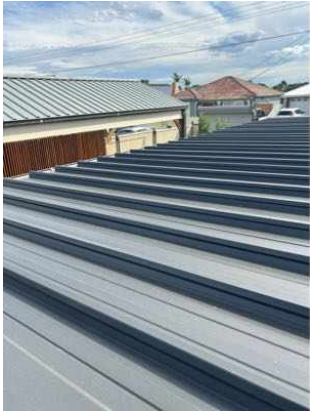
Building: Main Building  
Location: All Areas  
Finding: Additional Photos  
Information: Additional photos are provided for your general reference
