# Building and Timber Pest Inspection Report

Inspection Date: Thu, 2 Apr 2026

Property Address: 21/30-34 Cambridge St, Epping NSW 2121, Australia

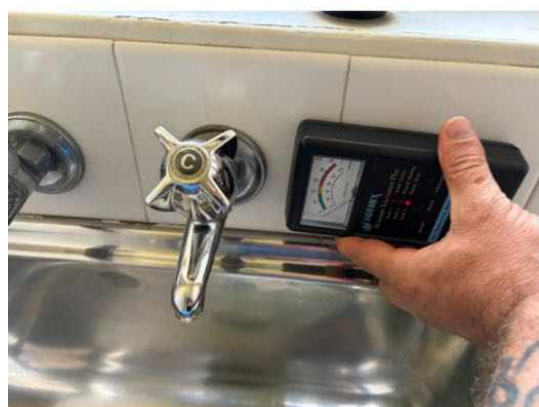
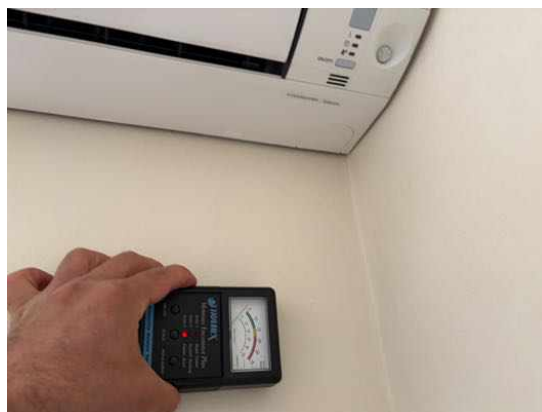
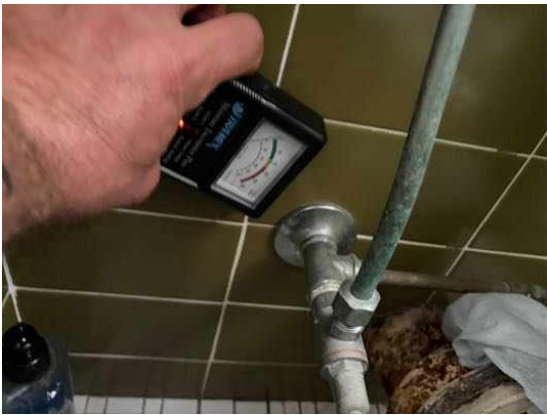
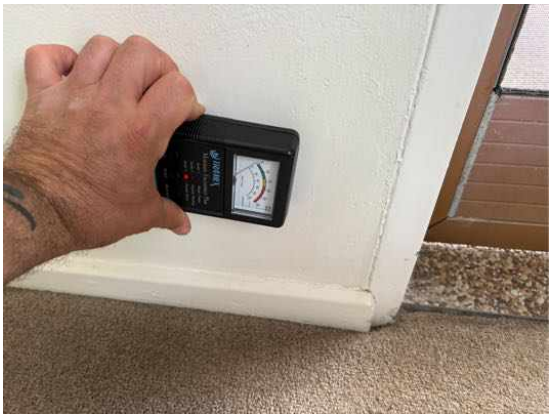
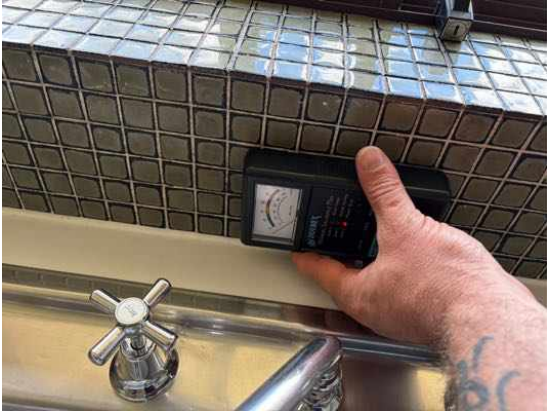
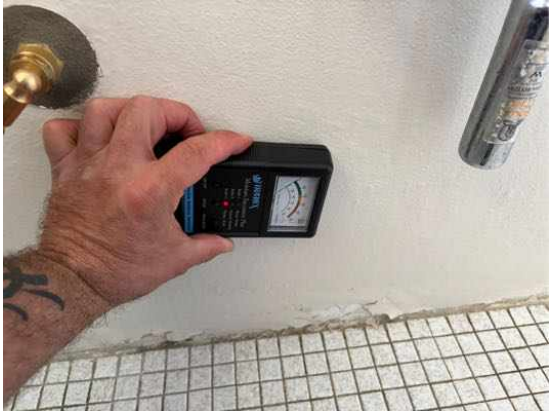
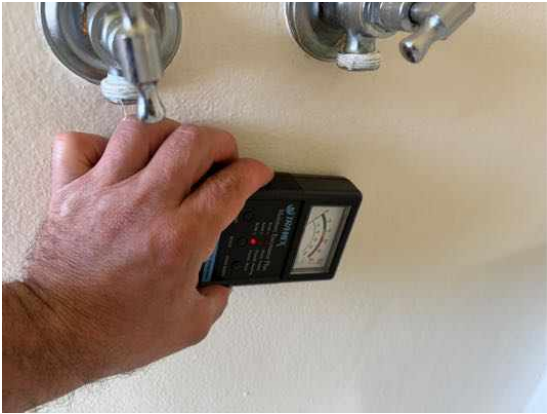
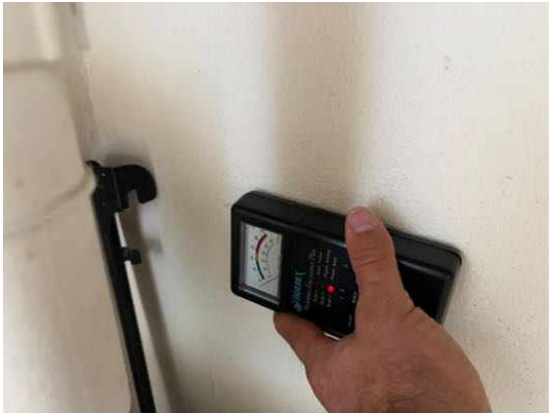
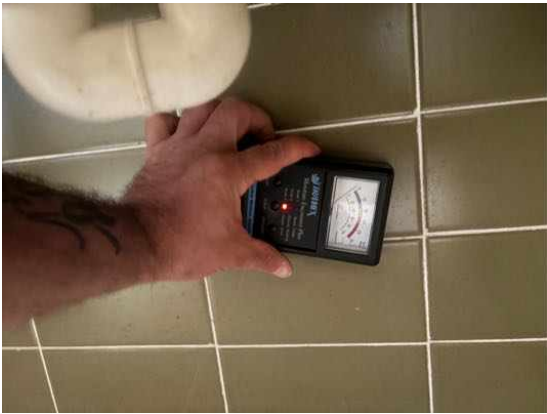
Building: Main Building  
 Location: All Areas  
 Finding: Moisture metre  
 Information: During the inspection the property was checked for moisture using a moisture metre.

This is for information only.

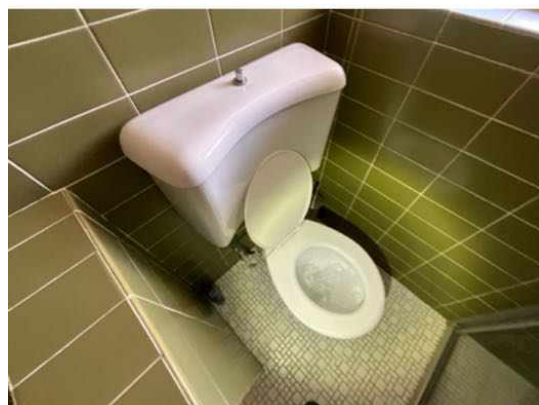
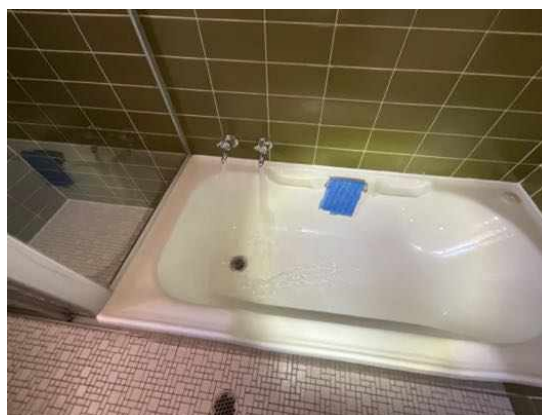
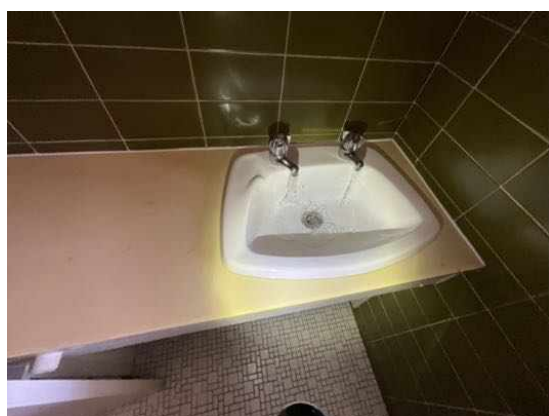
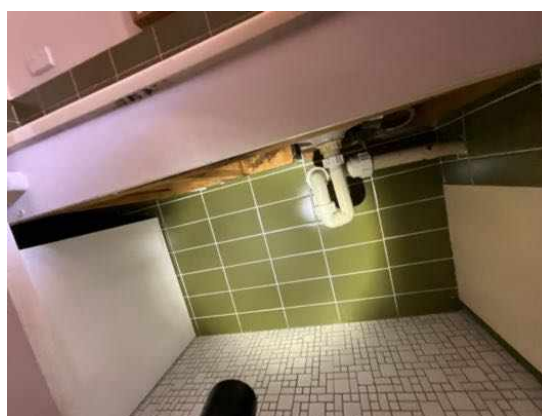
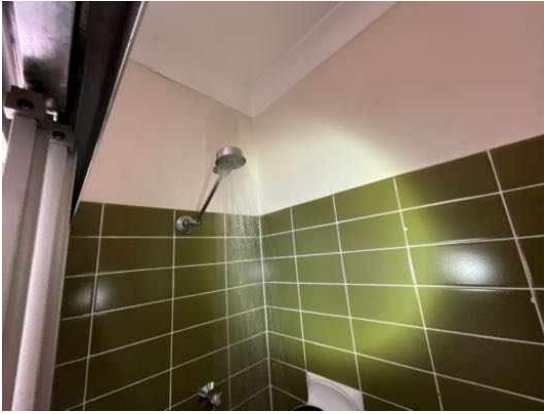
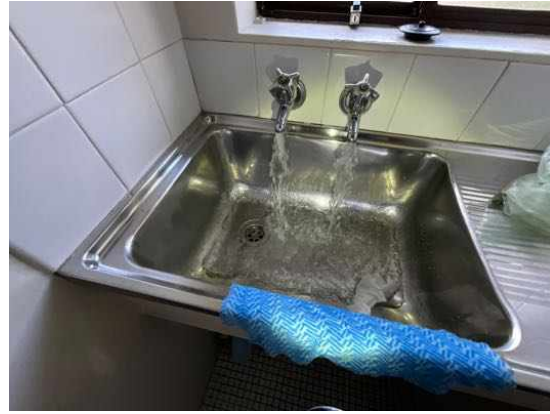
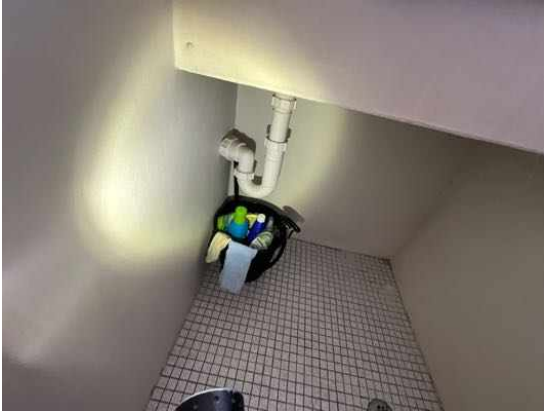
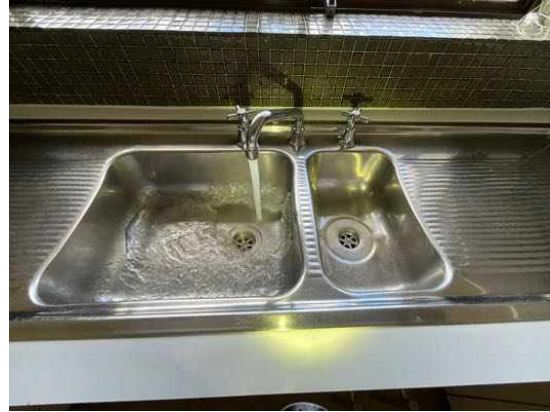
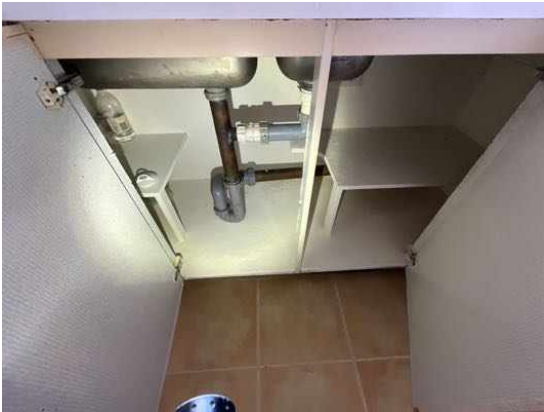
Noted Item

Building: Main Building  
Location: All Wet Areas  
Finding: Waterproofing  
Information:

All taps, mixers and toilets were tested for operation, except for those obstructed. The waterproofing to the shower recess was assessed by checking the walls in and around the shower recess for varying moisture content. There were no significant variations across the tested areas. No sign of recent water damage was evident upon a visual inspection of the surrounding walls, where the visual nature of the inspection was possible.

Consequently, there is no conclusive evidence of any current shower recess leakage other than those which may have already been mentioned earlier in this report. It is reasonable to assume the shower waterproofing is sound. Note that if the shower is not used, or has not been used for some time, moisture readings would not vary significantly and this can lead to erroneous results. It is not possible under the visual inspection criteria (under which a prepurchase inspection is carried out) to categorically determine if there are leaks. If a more accurate assessment is required, a special purpose inspection should be requested. Alternatively, the assumption should be made that the shower may leak.

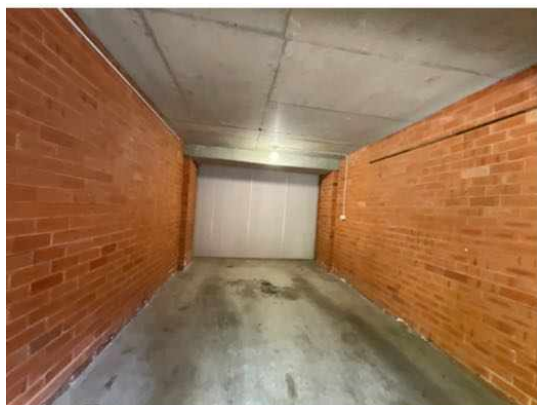
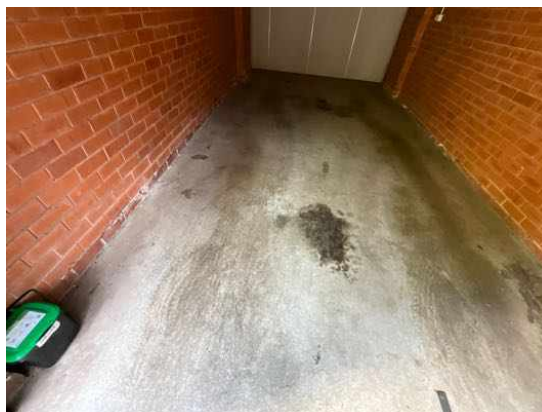
Building: Main Building  
Location: Garage  
Finding: Additional Photos- Garage  
Information: Additional photos are provided for your general reference. Arrows may have been included to highlight areas of importance. Please discuss these photos with your building consultant for clarification.

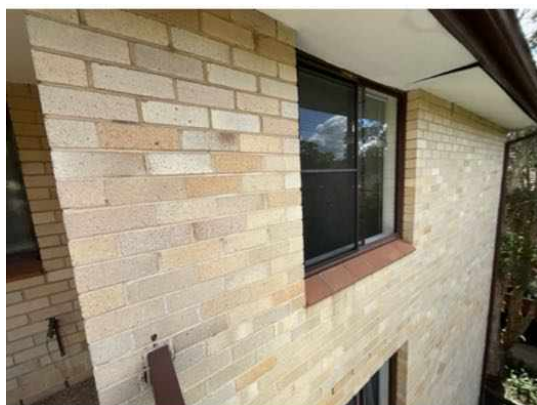
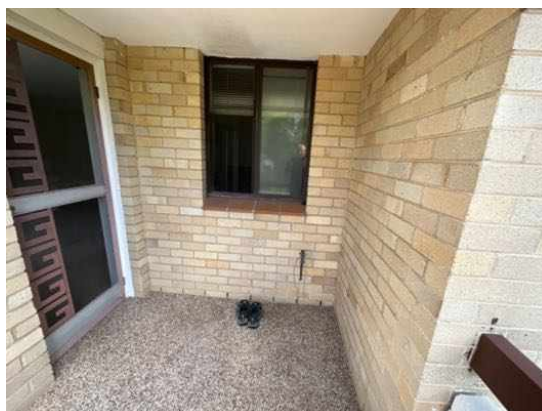
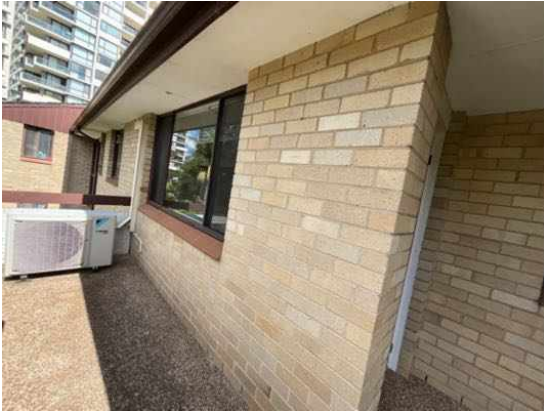
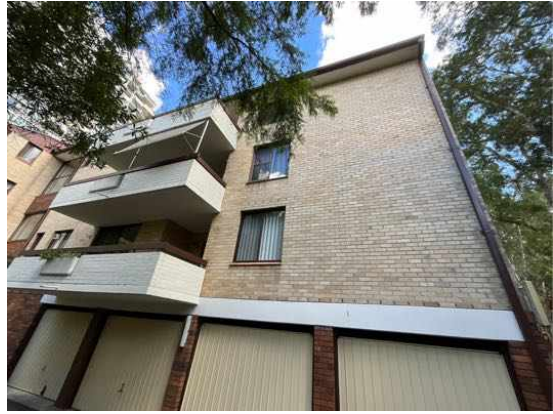
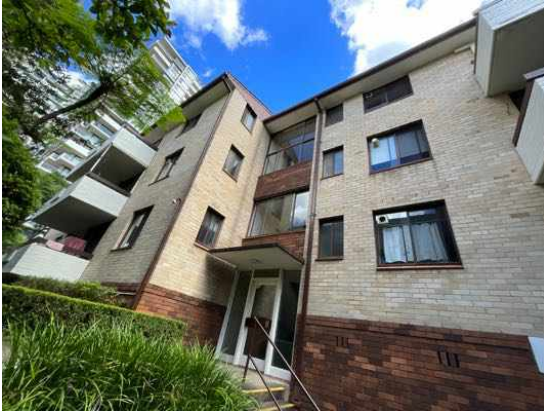
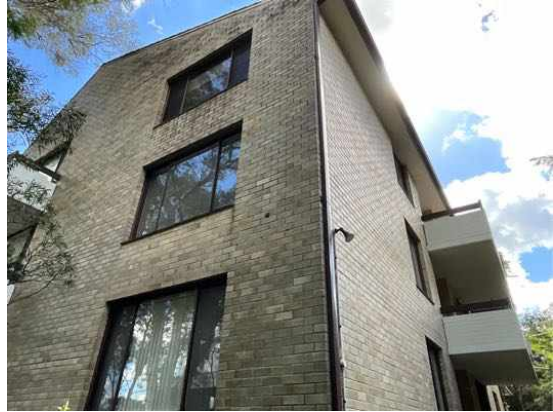
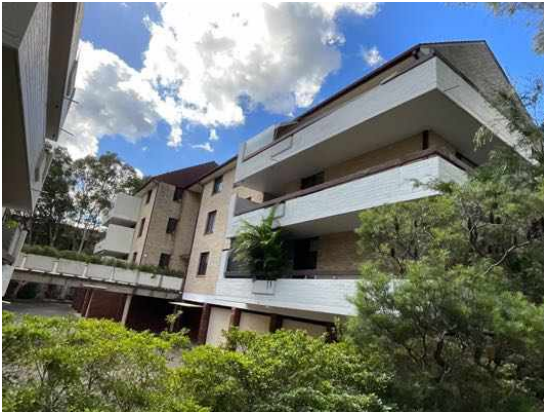
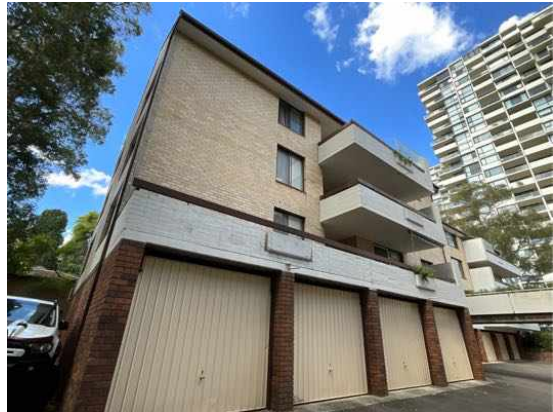
Building: Main Building  
Location: Exterior  
Finding: Additional Photos  
Information: Additional photos are provided for your general reference.

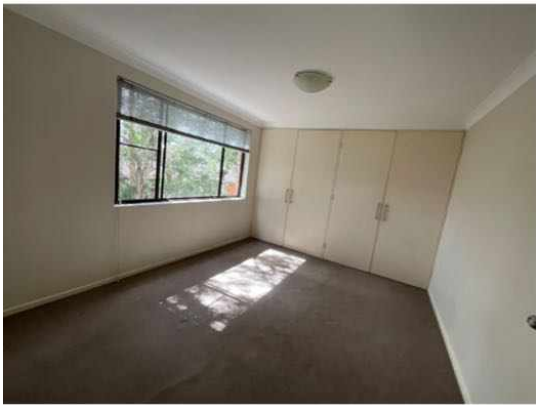
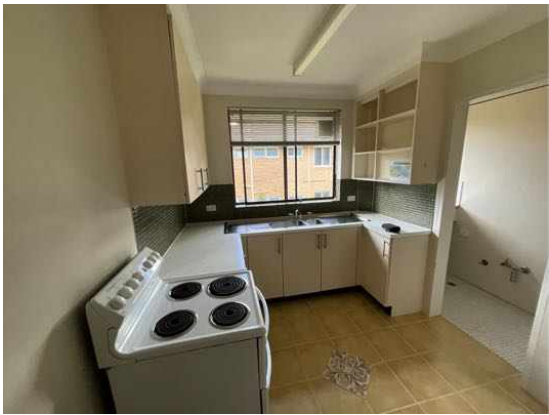
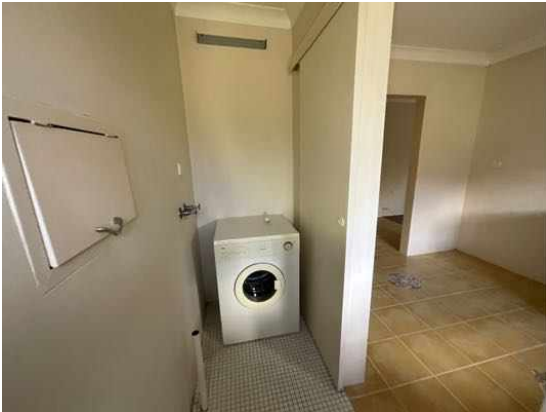
Building: Main Building  
Location: All Areas  
Finding: Additional Photos - Obstructions and Limitations  
Information:

These photographs are an indication of the obstructions and limitations which impeded full inspection of the property at the time of inspection. These obstructions can hide an array of defects and should be removed to allow full inspection to be carried out. A re-inspection is recommended once the areas are made accessible.
