Building and Timber Pest Inspection Report

Inspection Date: Thu, 2 Apr 2026

Property Address: 50 Richmond St, Earlwood NSW 2206,
Australia

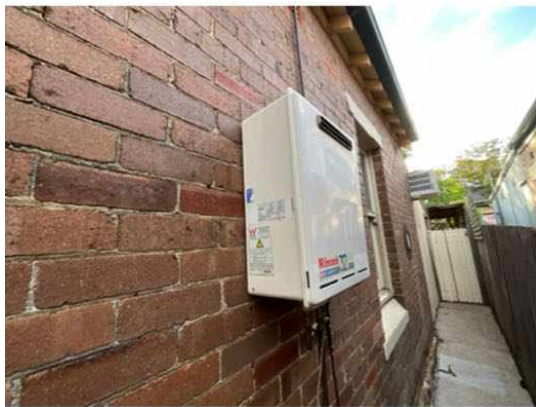
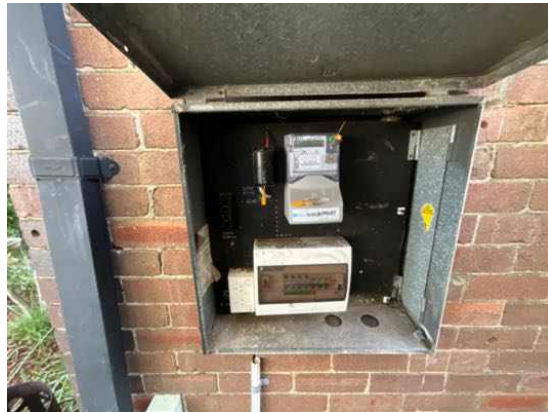
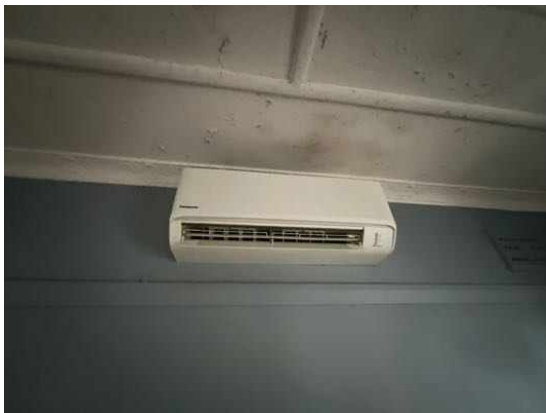
Building: Main Building
Location: All Areas
Finding: Photos Added
Information: Additional photos are provided for your general reference.

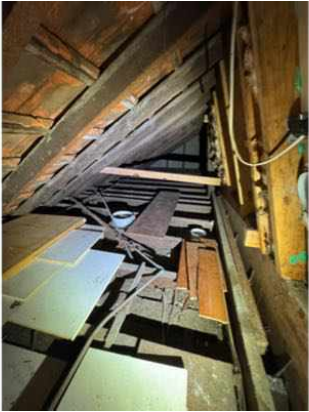
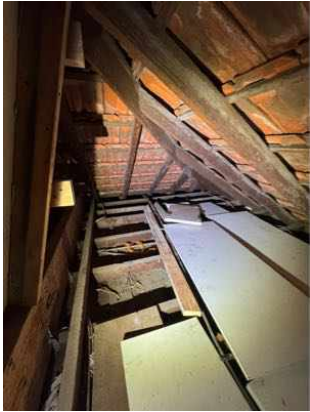
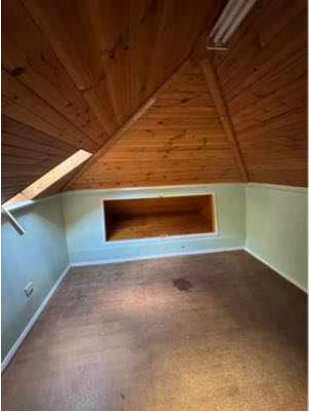
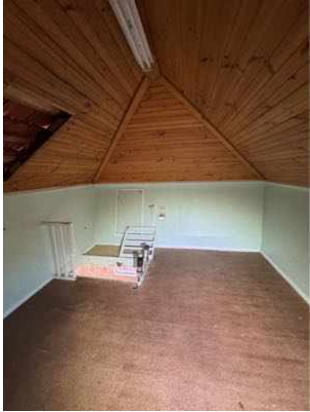
Building: Main Building
Location: Roof Void
Finding: Photos Added
Information: Additional photos are provided for your general reference.
