# Building and Timber Pest Inspection Report

Inspection Date: Tue, 3 Mar 2026

Property Address: 1/945 High St, Reservoir VIC 3073, Australia

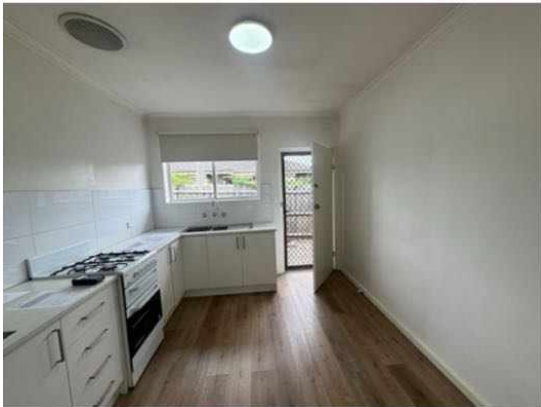
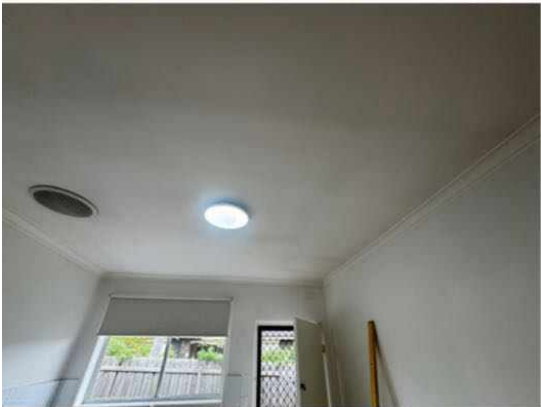
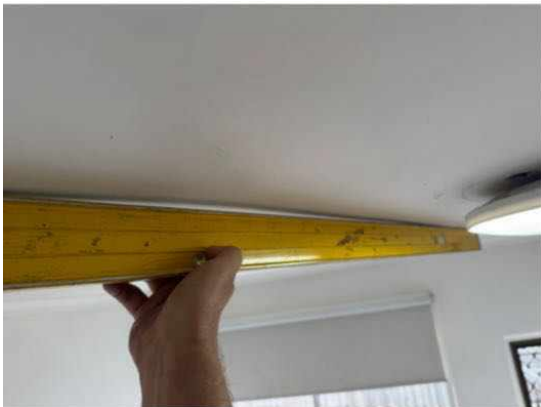
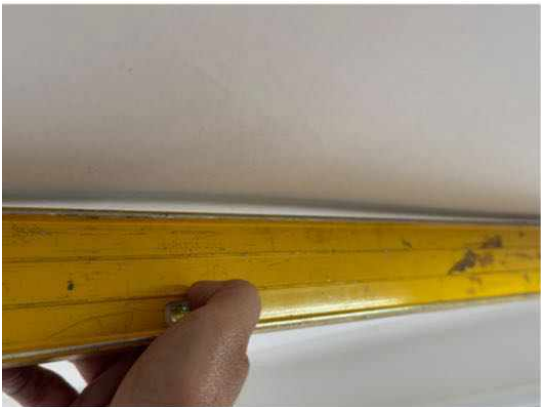
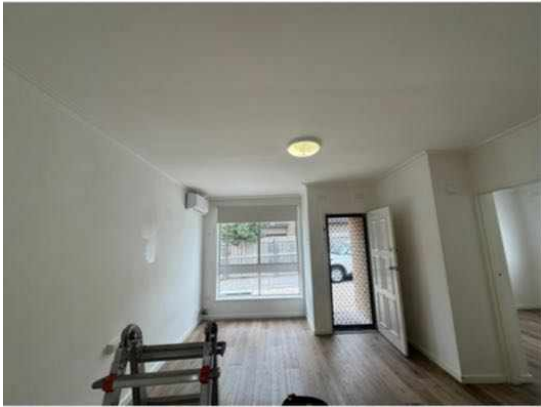
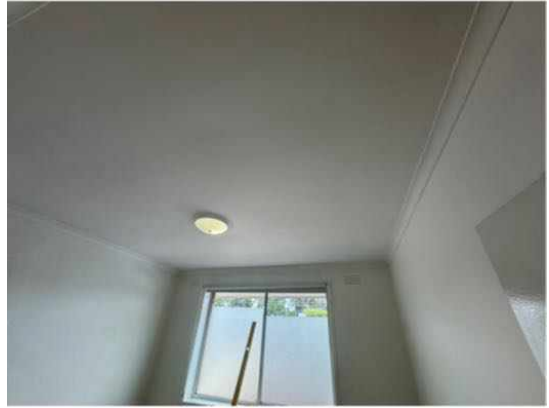
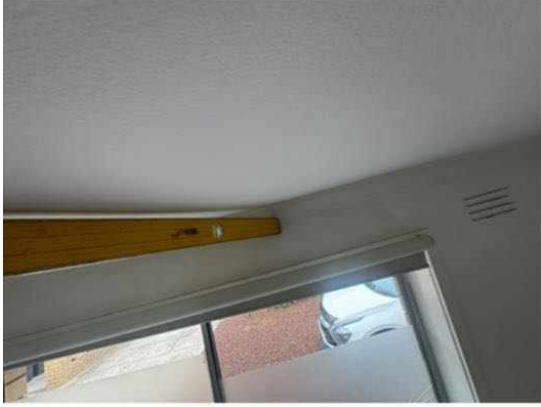
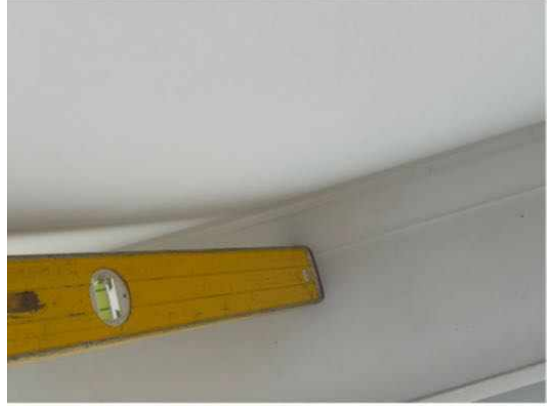
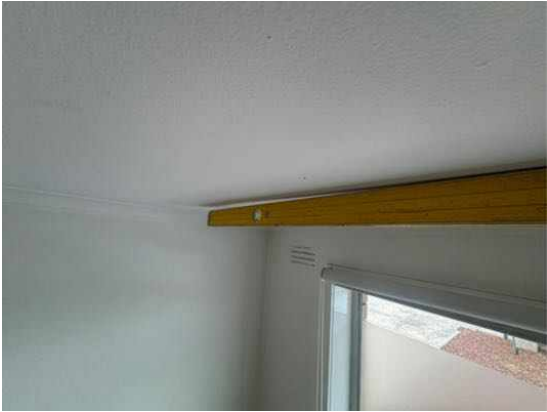
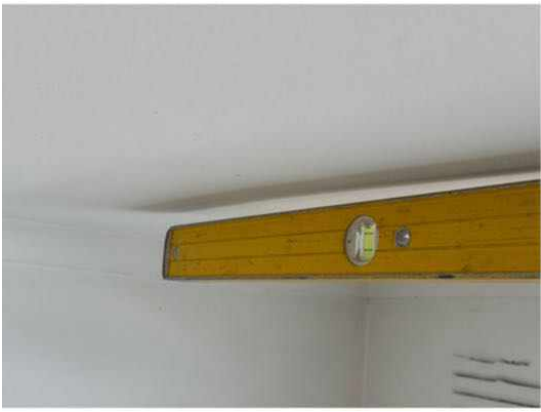
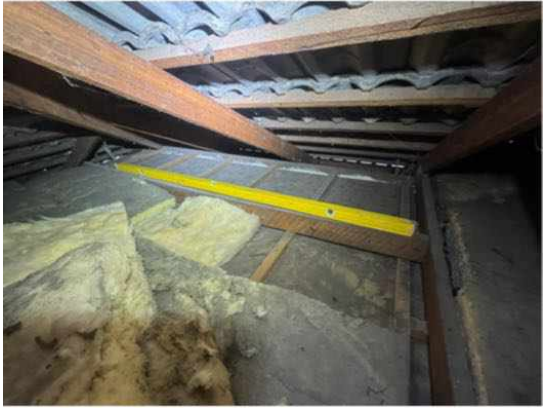
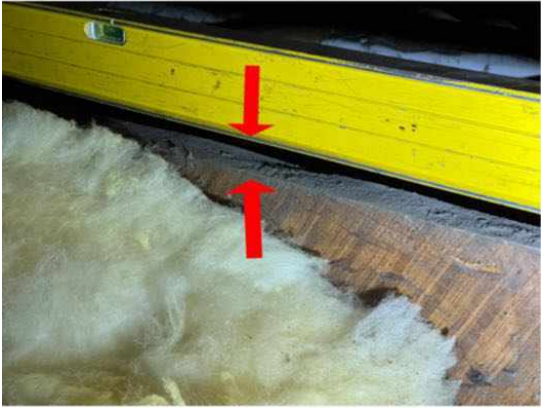
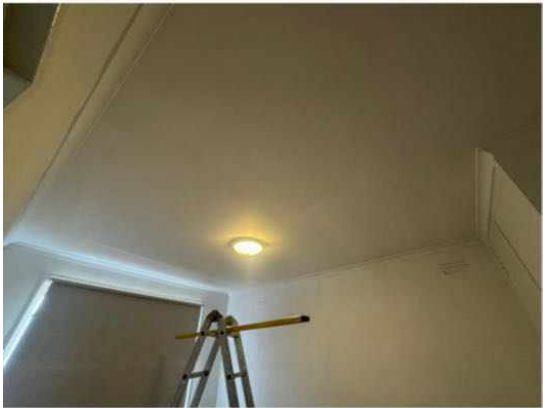
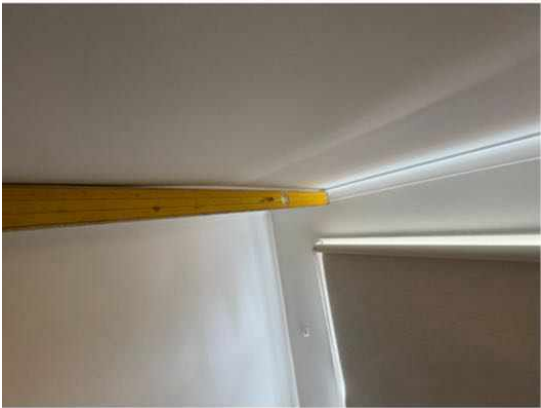
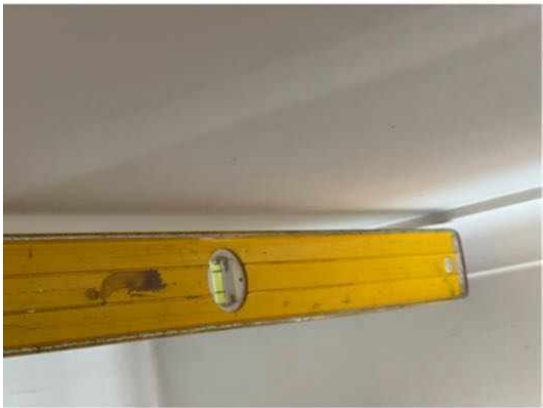
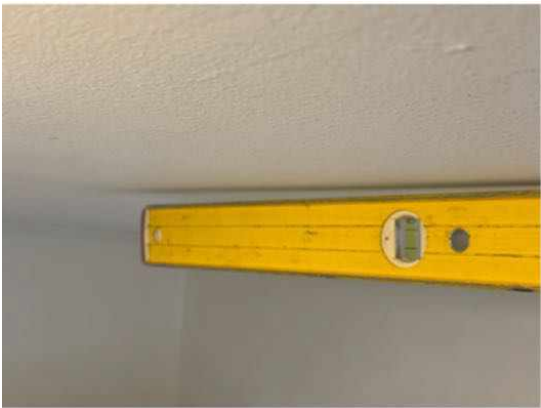
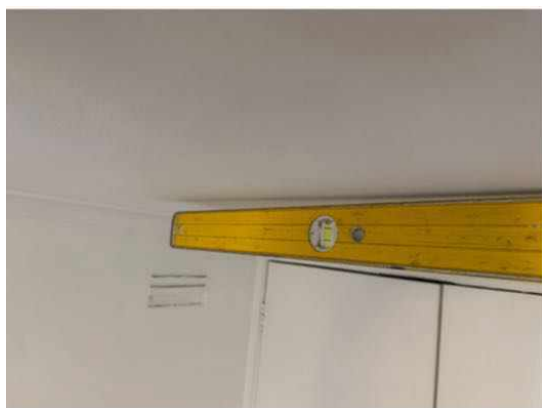
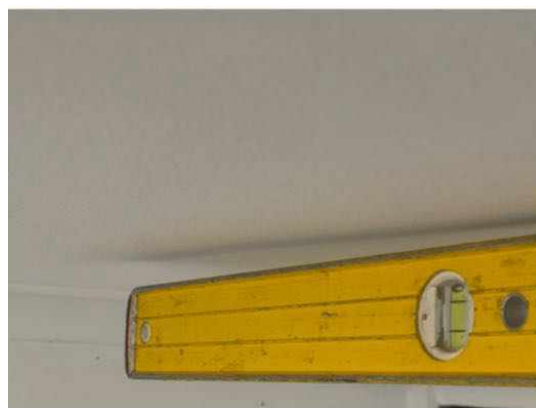
Building: Main Building  
 Location: All Internal Areas  
 Finding: Sagging ceiling - Lack of support  
 Information: The roofing structure was found to be sagging in sections at the time of inspection. This sagging is likely due to the lack of support to the ceiling members (joists). These support members are referred to as hanging beams. While this type of construction is common for the era of building, additional support may be required.

Sagging roof structures are likely to create strain on associated building elements, creating potential for secondary damage including the deterioration of roof coverings. The roof is also unlikely to have sufficient support, which may lead to further sagging if left unmanaged.

It is advised that a Structural engineer be appointed to provide remedial advice which could then be carried out by a licensed builder.

While it would appear that this defect has been present for a long period of time repair is recommended in the short term to ensure the longevity and structural integrity of the dwelling.

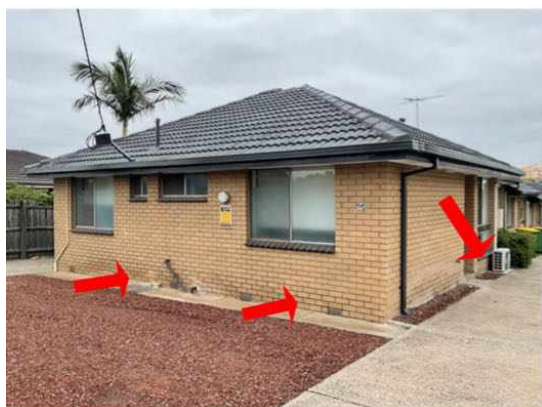
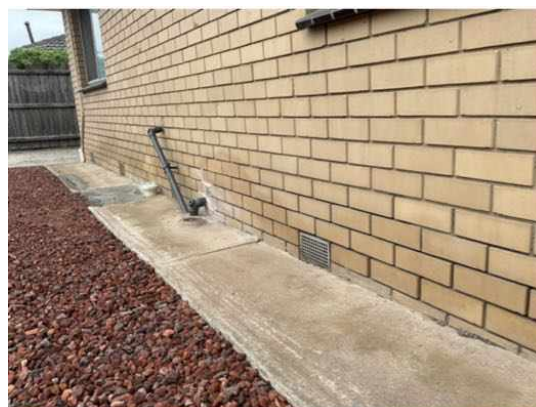
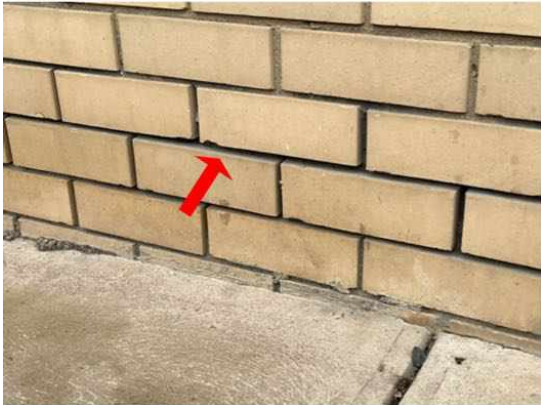
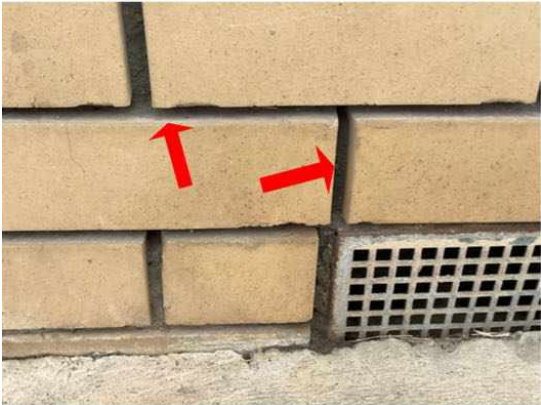
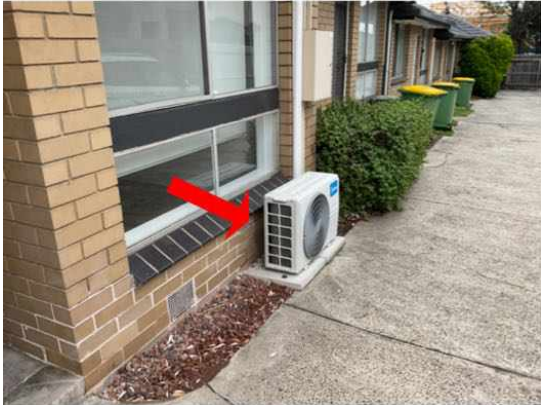
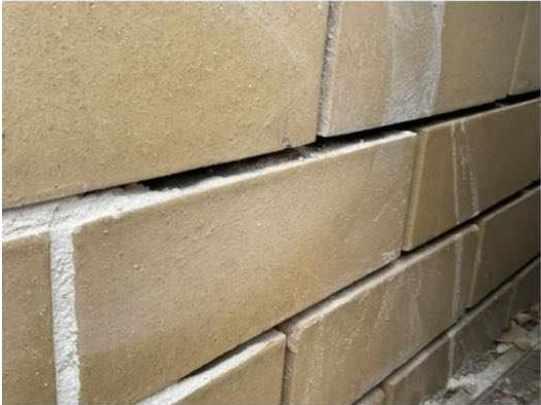
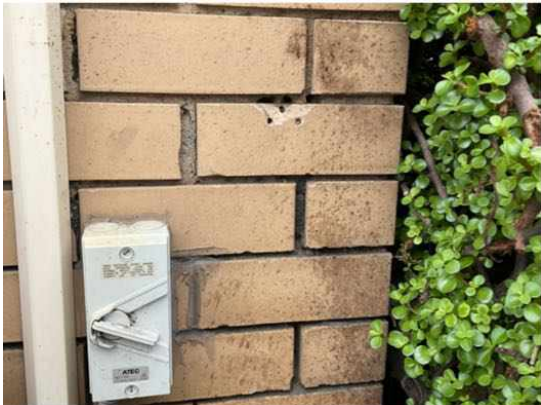
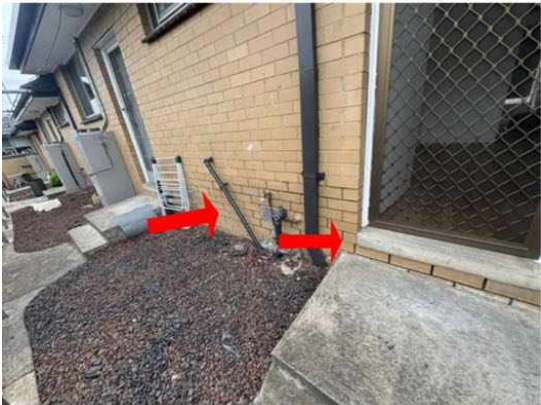
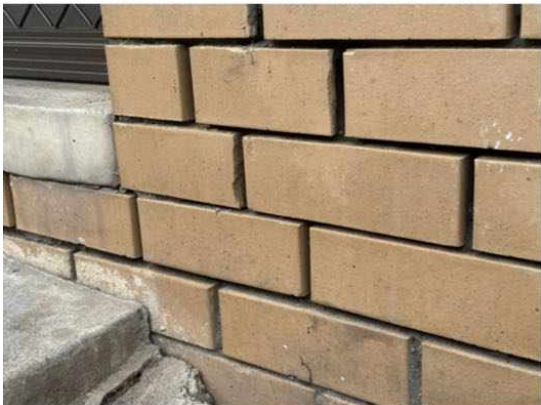
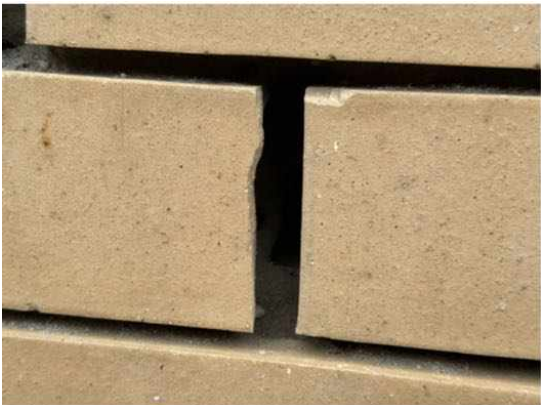
### Finding 3.01

Building:	Main Building
Location:	All External Areas
Finding:	Brickwork - Deteriorated mortar
Information:	Mortar, or 'bedding', is the material which fills joints and intersections between bricks in masonry walls and structures. Sections of mortar in this brickwork were identified as having deteriorated, which is generally expected for a property of this age and condition.

Mortar may deteriorate as a result of age of building materials, minor movement of bricks, or frequent exposure to weathering. Mortar should be replaced to ensure that bricks remain in their intended location and to prevent gaps, which would allow water or moisture ingress and secondary damage as a result.

Mortar deterioration can be addressed by a bricklayer where areas of deterioration are localised and easily accessible. Alternatively, appointment of a registered builder is advised, to repoint large areas of decaying mortar. Where secondary structural defects have become evident, consultation with a structural engineer may be required.

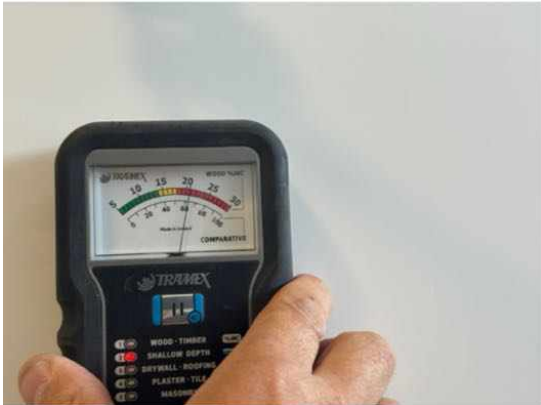
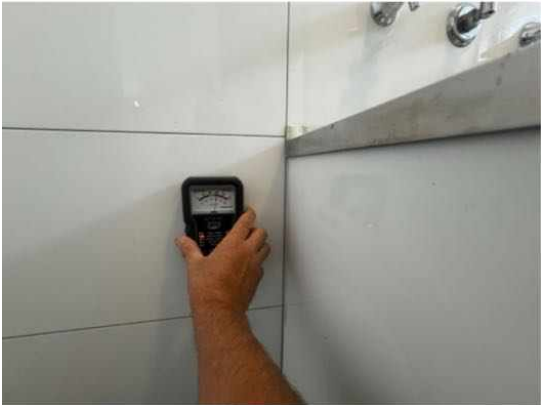
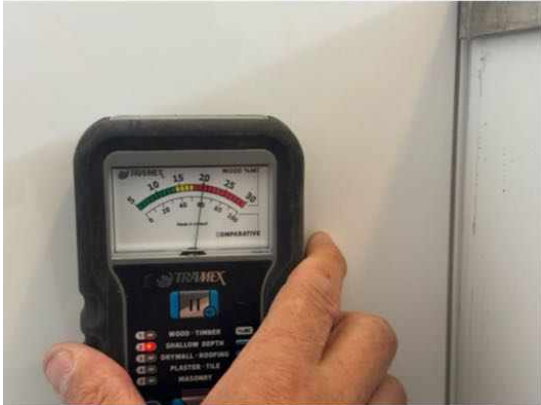
Finding: Water leak - Active

Information: Generally, water leaks occur when a particular area of the property is not weather or water tight. As the surrounding area was found to be damp at the time of inspection, the leak is considered ongoing and hence requires urgent action.

Regardless of the location, even minor leaks that are left unmanaged can lead to serious damage of associated building elements and result in the need for replacement of building materials. Mould and other hazards such as electrical hazards may also arise if the leak is left to develop.

It is highly advised that the cause of the leak be identified and resolved immediately by a licensed plumber to prevent any further damage. Depending on the extent of the damage previously sustained, repair and/or replacement of any affected building materials may be required.

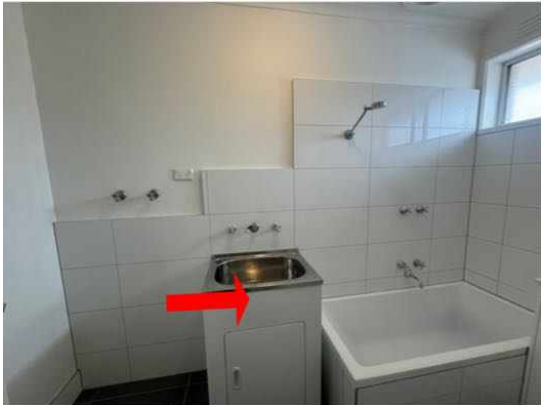
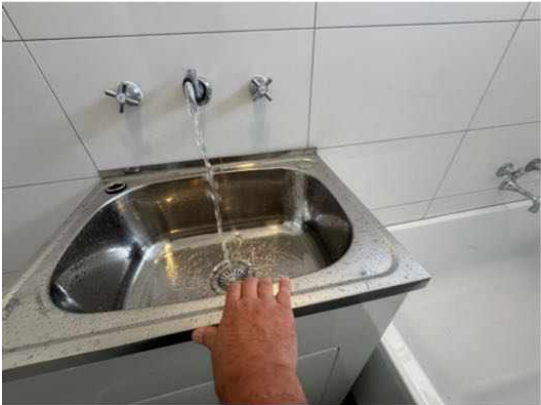
**Finding 3.04**

Building: Main Building  
 Location: Bathroom  
 Finding: Cabinet - not attached to the wall  
 Information: The installation of the cabinet has been carried out to a substandard level, resulting in the cabinet not being securely fixed to the adjoining wall. Where cabinets are loose, they are more susceptible to movement and impact damage, and may also cause damage to the adjoining wall surfaces.

The cabinet requires re-securing to the wall to prevent further damage. Rectification works should be carried out by a suitably qualified tradesperson as soon as possible

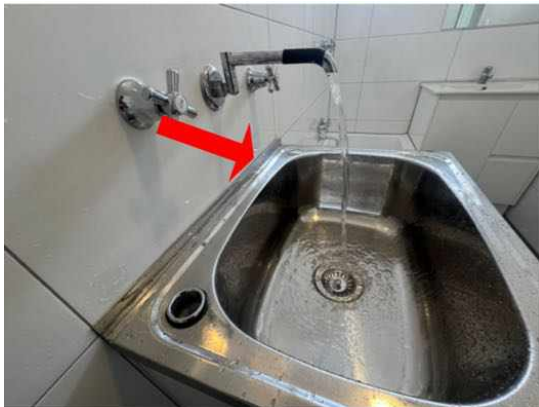
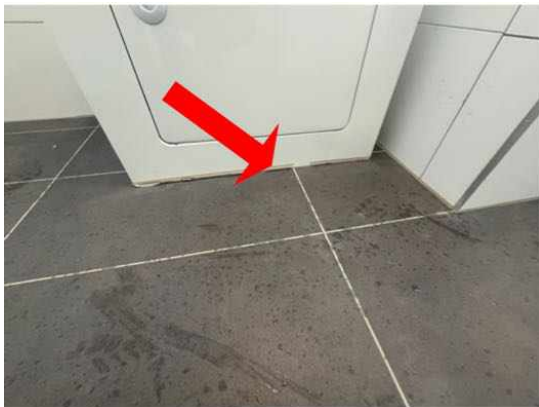
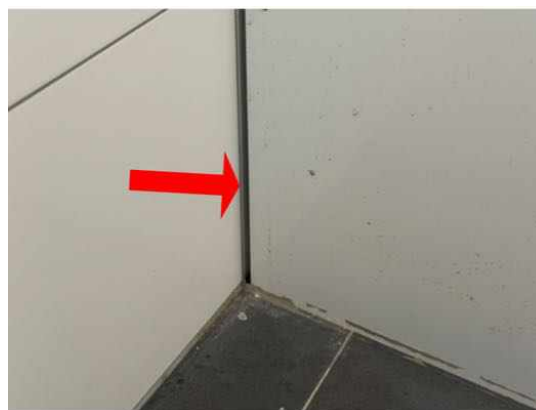
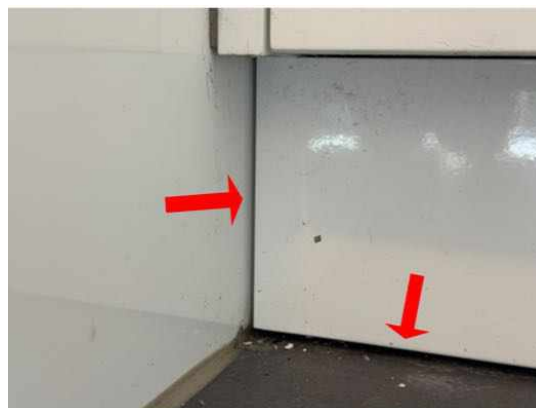
### Finding 3.05

Finding: Sealant - Missing

Information: On inspection it was noted that the sealant is missing to areas of the bathroom.

Flexible and mould-resistant sealant should be applied to the affected areas to reduce the risk of water ingress and subsequent damage that is likely to occur.

A sealant specialist or general handy person should be appointed to complete these works as soon as possible

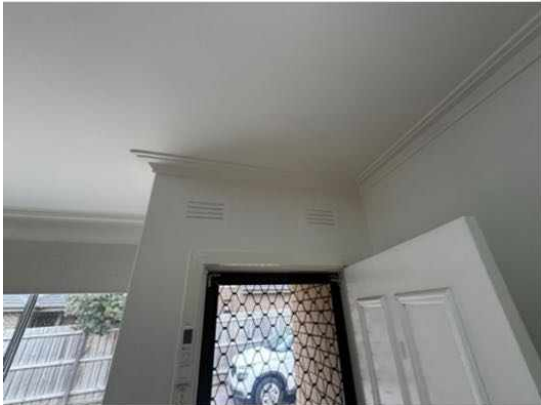
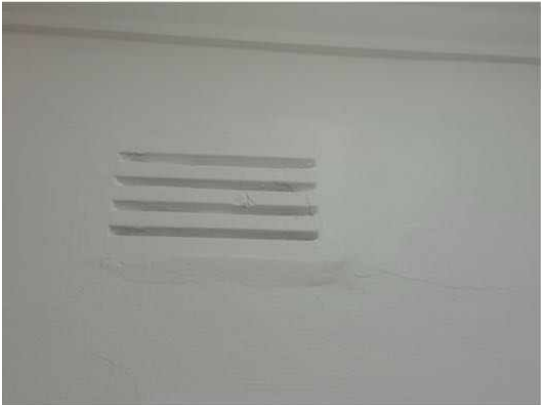
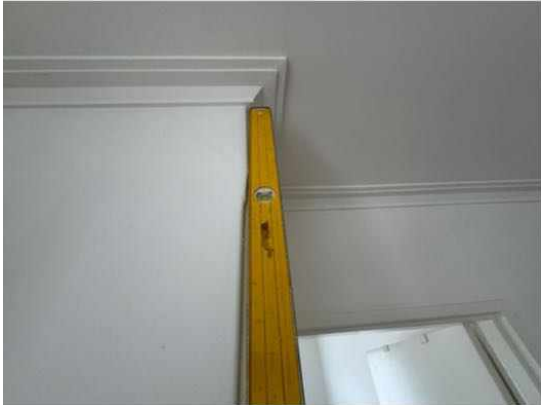
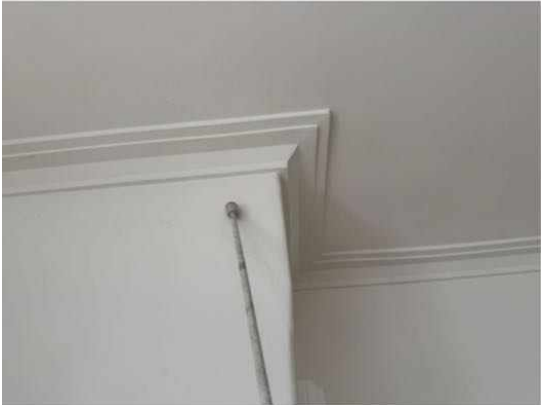
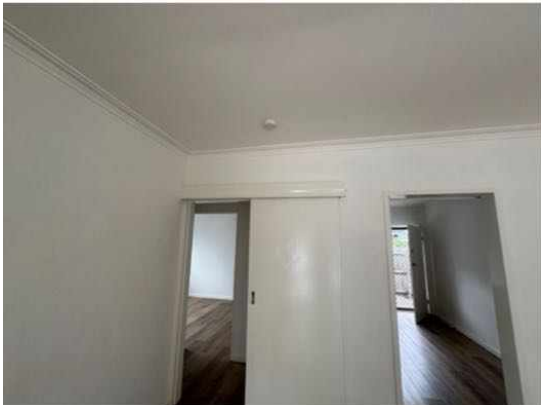
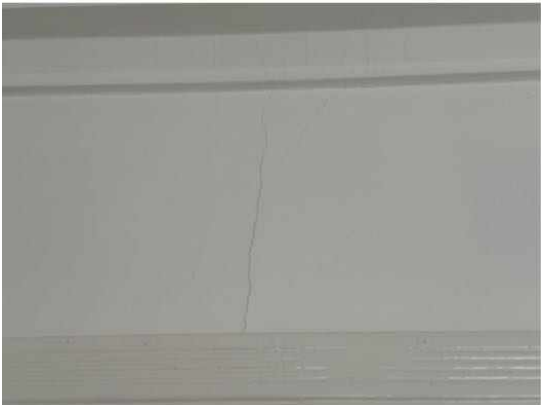
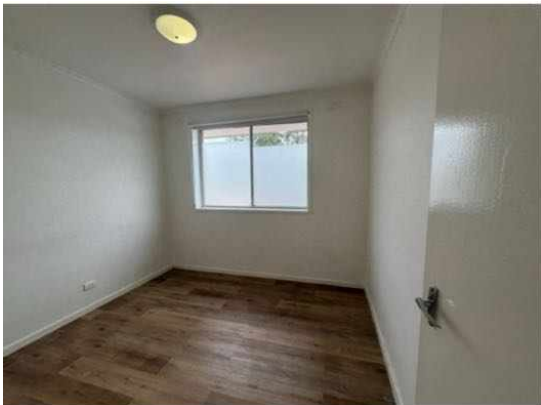
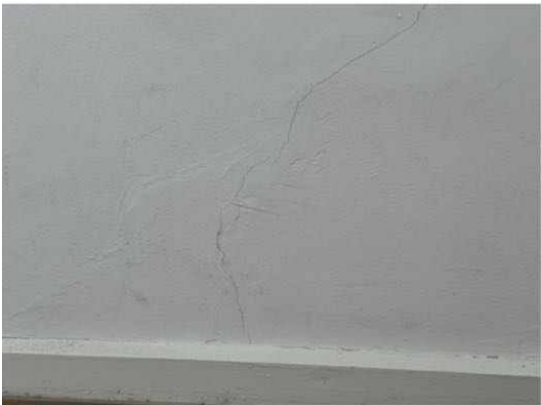
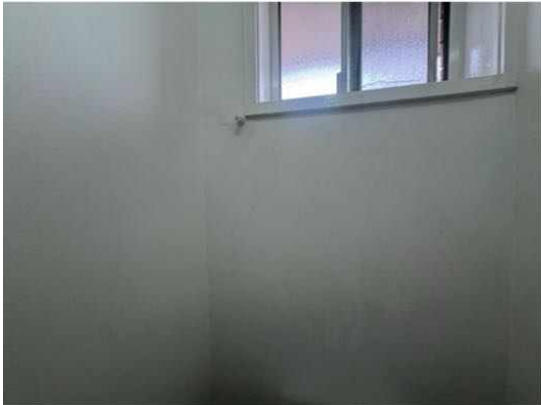
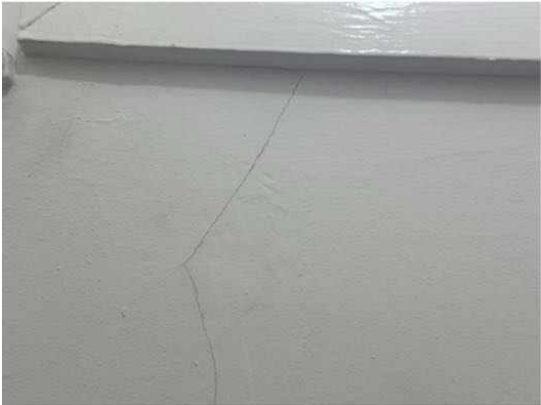
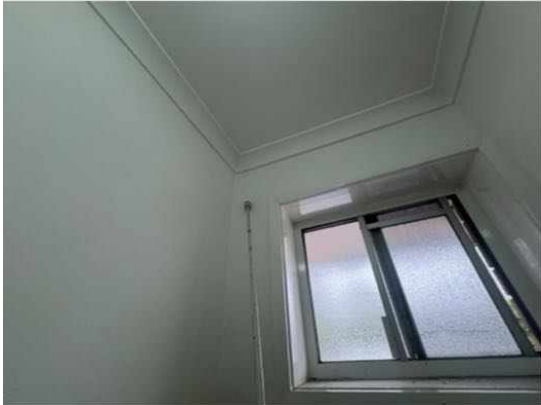
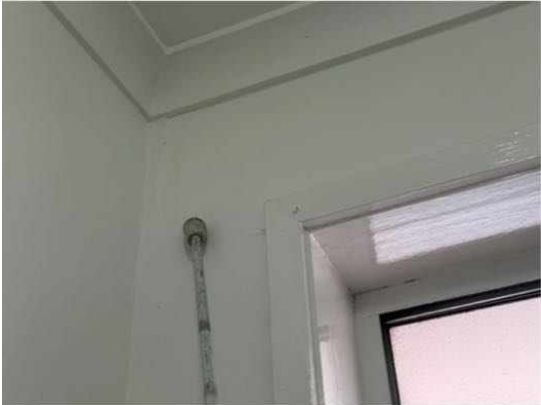
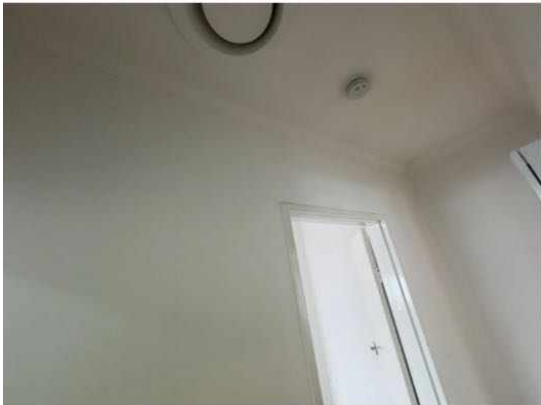
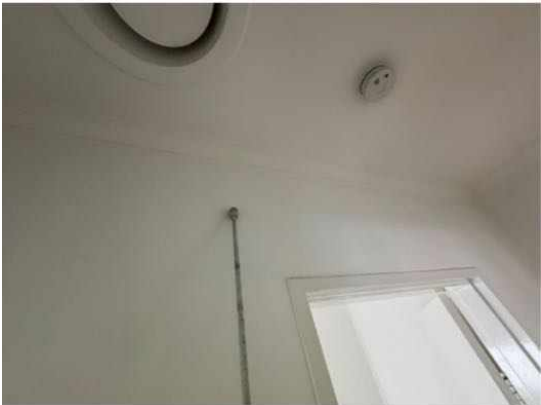
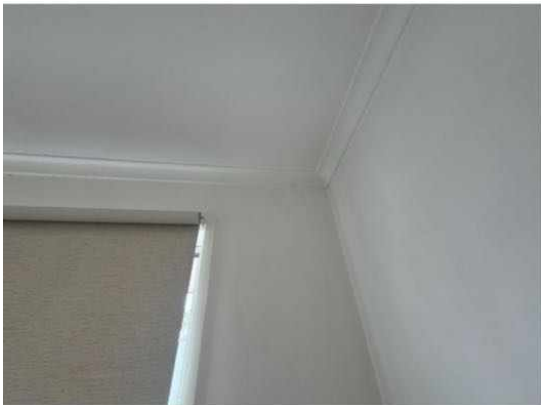
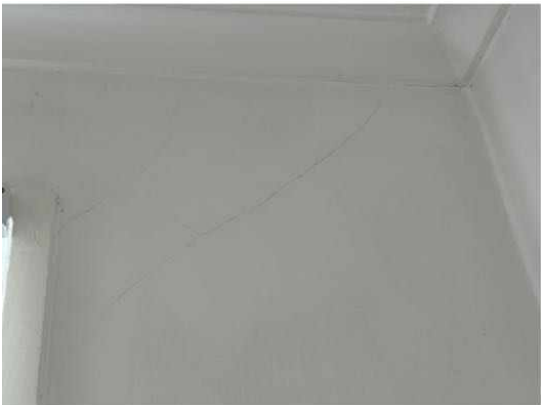
### Finding 3.06

Building:	Main Building
Location:	All Internal Areas
Finding:	Render - Drummy
Information:	Drummy rendered areas were identified at the time of inspection. The term 'drummy' refers to render that has become detached from its fixing, despite it still being solid. Such defects are generally caused by physical or moisture damage to the area. Drummy render may also be a direct result of poor workmanship during the construction process.

Render may swell and shrink with changes in air humidity if the area has sustained moisture damage. Any exposure to moisture is capable of causing rendered areas to become drummy and/or cracked over a prolonged period of time. Drummy render generally requires chipping off and re-rendering or painting.

Specialist trades are available for these types of services. A registered builder may be required to undertake works if damage is extensive, or if secondary building defects have resulted. Immediate action is recommended to ensure that no further damage is sustained in the affected area.

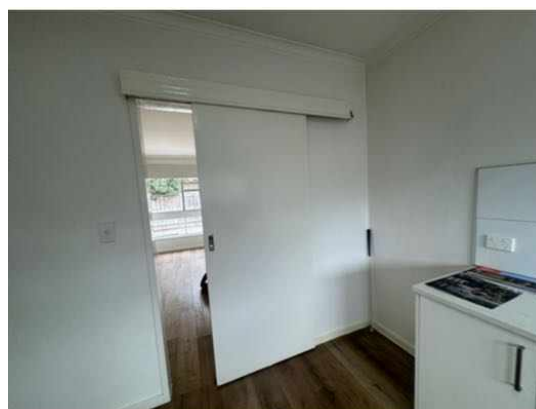
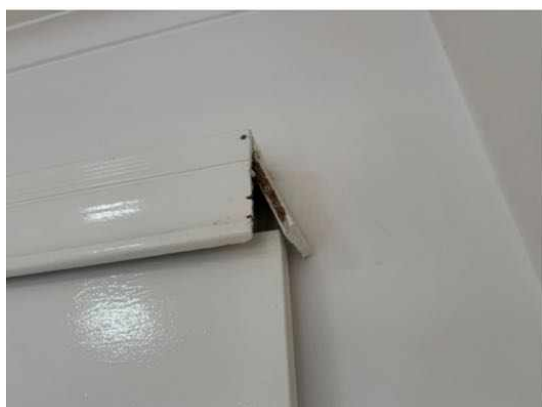
Finding 3.07

Building: Main Building  
 Location: Kitchen  
 Finding: Door - Binding/jamming  
 Information: Binding and/or jamming of this door is evident during standard operation. This defect inhibits the functionality of the affected door as well as creating potential for secondary defects to associated building elements.

A qualified carpenter or general handyperson should be appointed to perform minor rectification works to improve the operational state of the associated door as soon as possible.

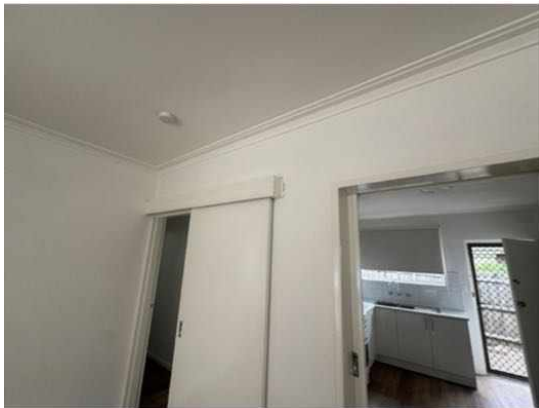
### Finding 3.08

Building: Main Building  
 Location: Lounge Room  
 Finding: Paint finish - Substandard  
 Information: The paint finish in this area was found to have been completed to a substandard level. Substandard painting is generally classified as an appearance defect. However, the substandard appearance may also be indicative of poor surface preparation and substandard workmanship.

If this applies, further areas of poor and incomplete finishes could develop over time. Furthermore, substandard paint finishes in areas exposed to moisture, e.g. external

areas or wet areas, could lead to deterioration of underlying building materials.

Substandard paint finishes should be sanded back, filled, leveled and repainted, as applicable. Where inadequate paint protection has led to the deterioration of the associated building element, repair and/or replacement of this building element may be required.

A painting contractor should be appointed as soon as possible to perform necessary works to aid the appearance of the affected area and to ensure that the area is protected against further deterioration. Alternatively, the homeowner following manufacturer instructions may be able to provide this service.

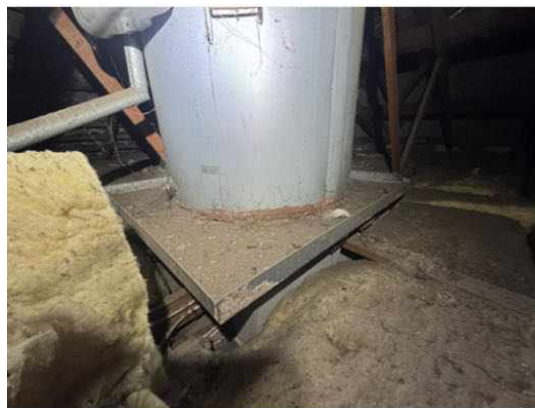
Building:	Main Building
Location:	Roof Void
Finding:	Gravity-Fed HWS - Disconnected
Information:	It was noted at the time of inspection that a disconnected gravity-fed hot water system (HWS) remains in this area.

Despite this plumbing structure being unused, it is likely to be storing residual water, and is therefore susceptible to rust and corrosion. If allowed to continue, rust and corrosion is likely to lead to damage to adjoining building elements, and may also make the area susceptible to termite or timber pest activity.

While it is a costly exercise to remove the disused gravity-fed HWS, it is advisable in

the short-term future to prevent any further damage to the area. Further consultation with a licensed plumber is required to gain further advice on removal of the structure.

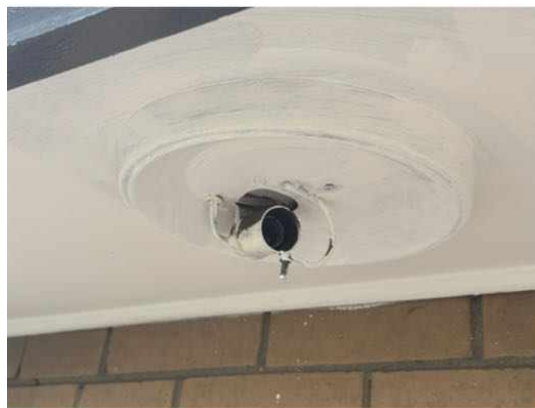
### Finding 3.11

Building:	Main Building
Location:	Rear Elevation
Finding:	Light fitting - Damaged
Information:	The light fitting in this area was found to be damaged at the time of inspection. Damage occurs generally when the building materials have aged and decayed, but may also be indicative of impact damage to the building element (accidental or deliberate).

Left unmanaged, the fitting is unlikely to cause further damage to surrounding building elements. However, the broken light fitting may expose electrical works, and may create a minor safety hazard if there is potential contact with persons in the area.

Repair and/or replacement of the damaged fitting is advised. A Licensed electrician should be appointed to repair/replace the light fitting at the client's discretion.

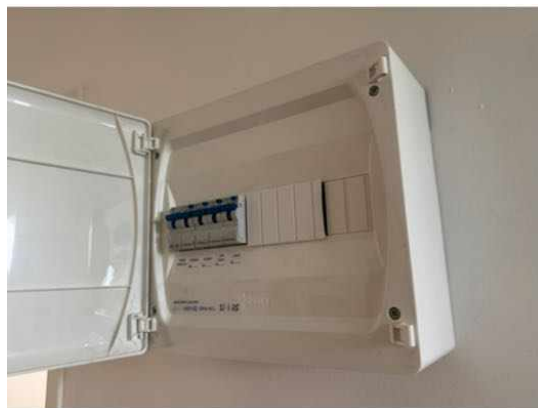
Building: Main Building  
 Location: Meter Box  
 Finding: Termite Management System - no evidence of a chemical installation  
 Information: The application of a post-construction chemical termite barrier is highly recommended for all properties, particularly if live termite activity has been found on the site previously. Such barriers are highly effective in preventing termite attack on any timber building elements throughout the property.

A durable notice should be placed in the switchboard unit to indicate current termite barriers. At the time of inspection, it appeared as though no termite management system has been installed, with no evidence to suggest preventative works taking place.

The client may consider gaining further advice from a pest controller as to the costs and procedures involved with this application. It is recommended that obtaining such advice be a short-term priority.

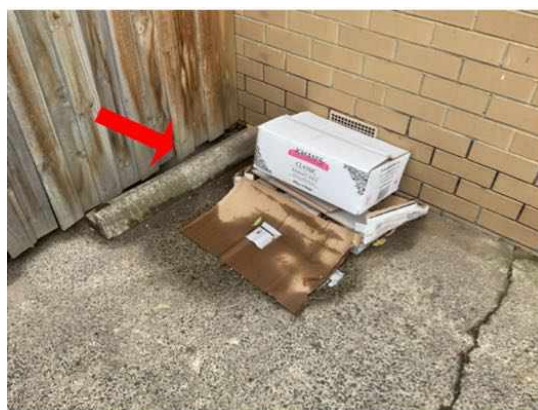
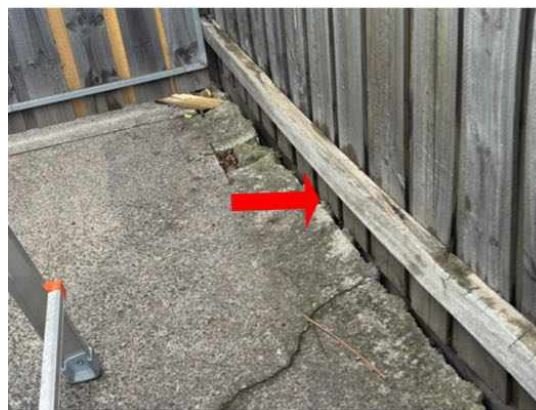
### Finding 6.02

Building: Main Building  
Location: All External Areas  
Finding: Building materials in direct ground contact - conducive to termites  
Information: Where timber elements are in direct contact with the ground and consequently moisture or dampness they become conducive to termite activity. Whether timber is used as a building element part of a fencing structure or stored as an unused item they can provide an environment that is attractive to termite infestation.

When met with excessive moisture timber begins to decay and develop wood rot. Any timbers that are in direct contact with external grounds especially if left untreated or non-durable also provide ingress for subterranean termites into that particular element. Consider replacement with more durable materials i.e. treated timber or non timber elements.

The removal of any such materials that may be conducive to termite activity should be removed as soon as possible to minimise the risk of termite attack. Where it is not possible frequent inspections of these areas shall be undertaken to provide early detection of infestation

It is highly recommended that termite or timber pest inspections be carried out every 6-12 months to aid protection of the property against infestation.

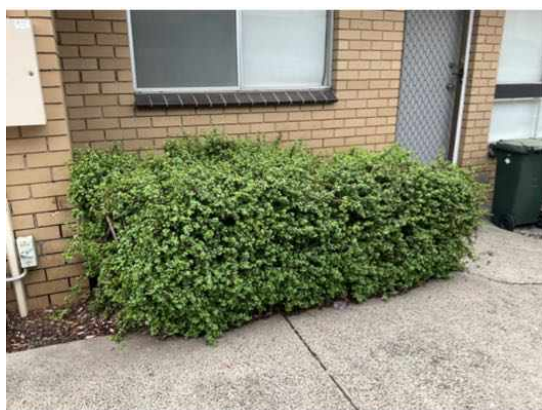
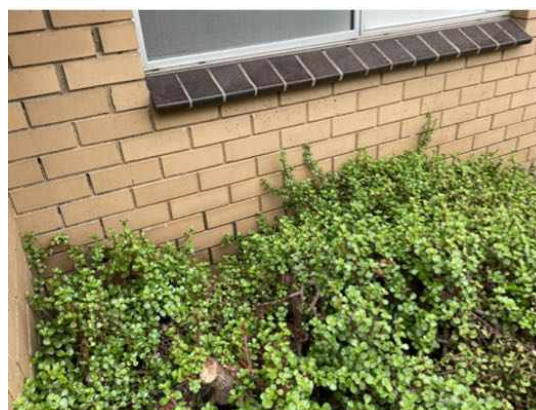
### Finding 6.03

Information: A complete inspection cannot be achieved when vegetation obstructs the inspection of building elements, also known as bridging, as it provides a bridging point for termite access. Consequently, moisture or dampness may be present, and the area becomes conducive to termite activity. Plants against or very close to buildings provide cover and shade and can provide an environment that is attractive to termite infestation.

The removal and replanting of species that do not provide "cover" or cutting back of existing vegetation will greatly assist in preventing bridging.

To minimise the risk of termite attack, materials conducive to termite activity should be removed as soon as possible, and re-inspection should be arranged.

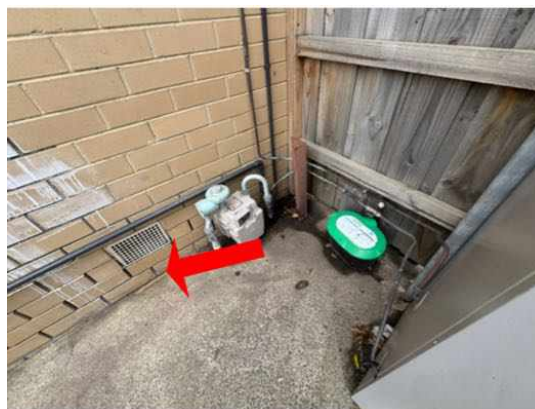
### Finding 6.04

If the slab edge is not properly exposed there is a high risk of termite attack. Sometimes, in order to determine the type of slab, a suitably qualified person such as an architect or builder may be required to consult the construction plans.

Where the slab edge cannot be properly inspected, it is highly recommended that termite or timber pest inspections be carried out every 6-12 months to aid protection of the property against infestation.

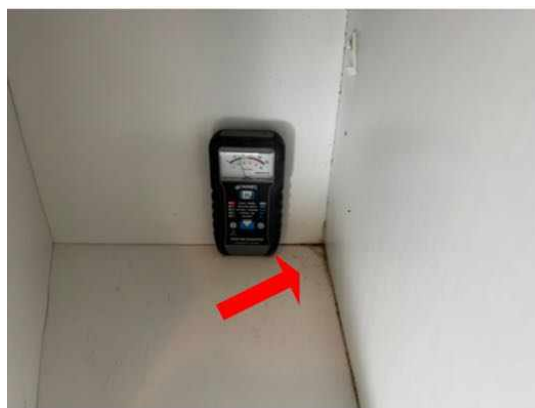
Building: Main Building  
 Location: Bathroom  
 Finding: Water leak - Inactive  
 Information: Water leaks generally occur when a particular area of the property is not weather- or water-tight. While the damage in this area appears to be from an old inactive water leak, the area should be monitored frequently for the recurrence of any dampness.

Repair and / or replacement of previously affected building elements is at client discretion. Consider a further invasive inspection: removal of obstructions around the damaged area may reveal further damage which has been concealed. A more significant or major defect may be identified at this time.

Where recurrence of an active water leak is identified, a qualified plumber should be appointed immediately to rectify the leak and advise on any further preventative works as necessary.

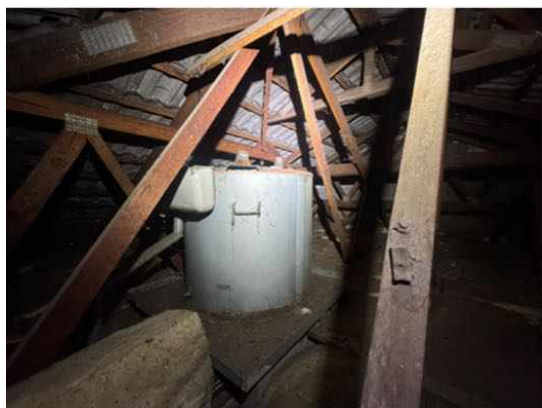
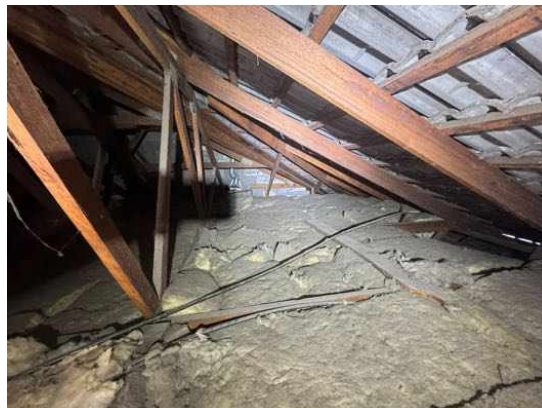
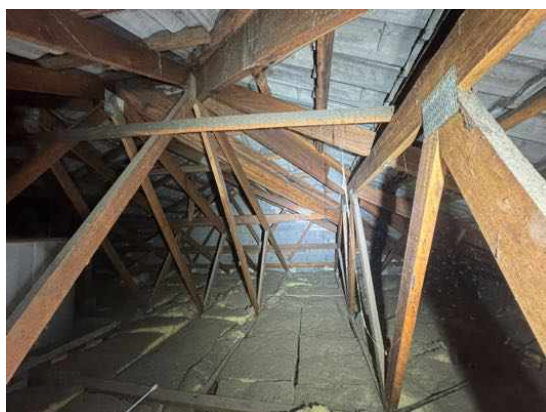
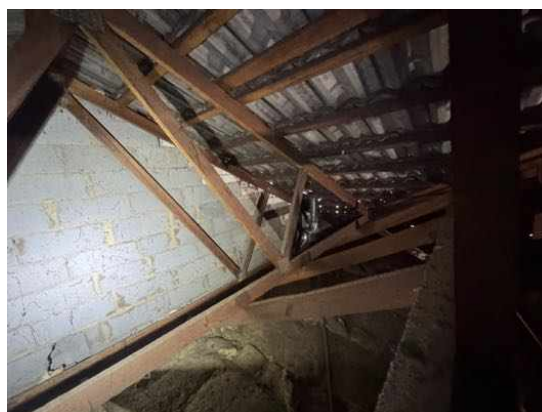
Building: Main Building  
Location: Roof Void  
Finding: Additional Photos - Obstructions and Limitations  
Information: These photographs are an indication of the obstructions and limitations which impeded full inspection of the property at the time of inspection. These obstructions can hide an array of defects and should be removed to allow full inspection to be carried out. A re-inspection is recommended once the areas are made accessible.

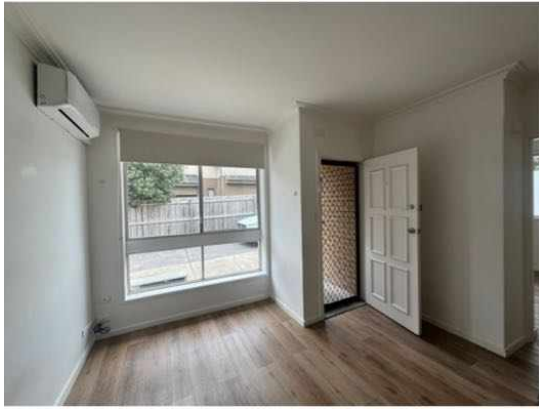
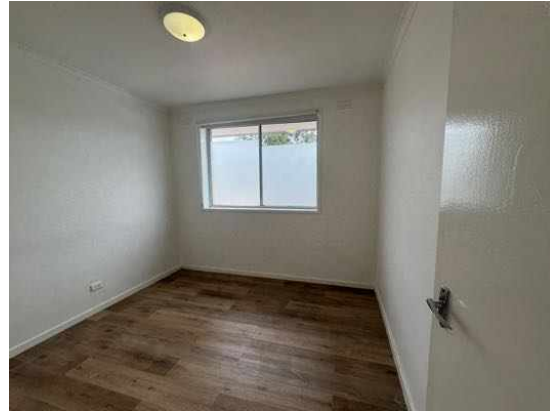
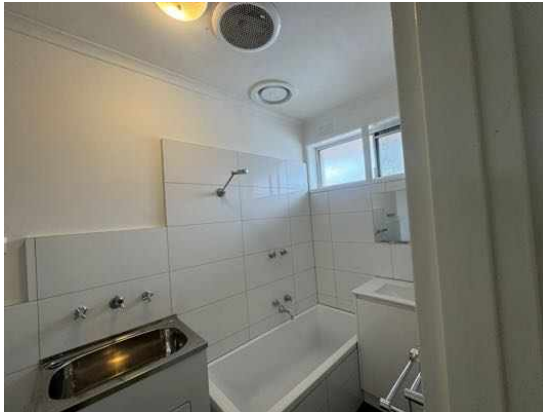
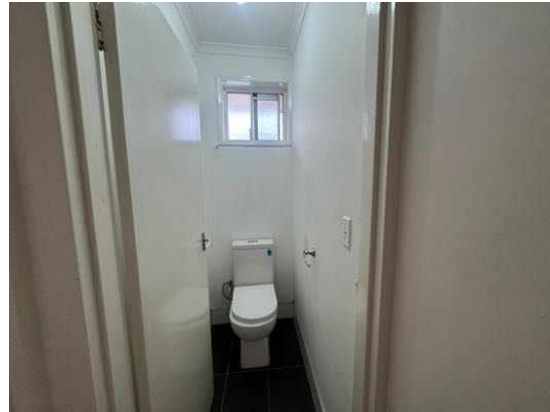
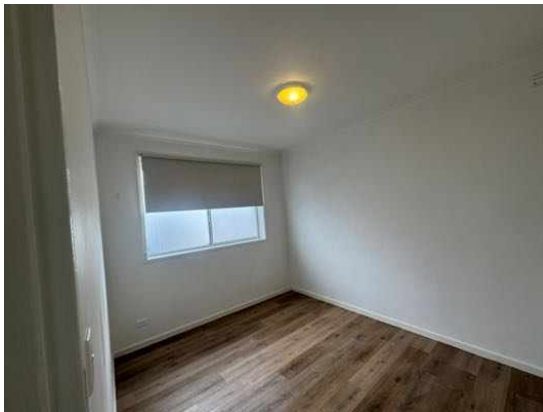
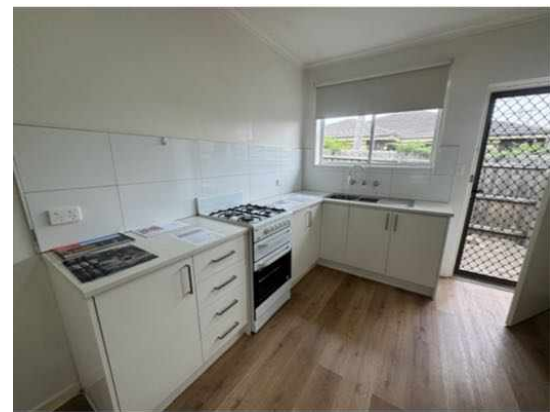
Building: Main Building  
Location: All Internal Areas  
Finding: Additional Photos - Obstructions and Limitations  
Information: These photographs are an indication of the obstructions and limitations which impeded full inspection of the property at the time of inspection. These obstructions can hide an array of defects and should be removed to allow full inspection to be carried out. A re-inspection is recommended once the areas are made accessible.

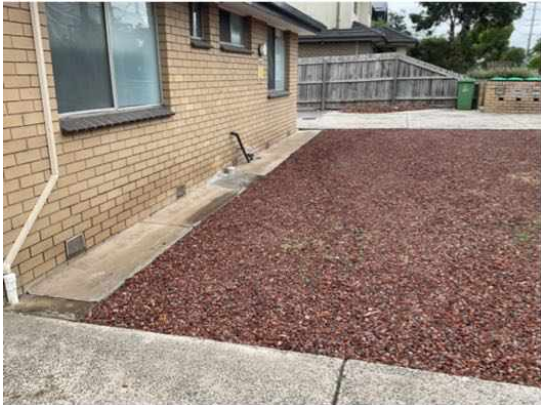
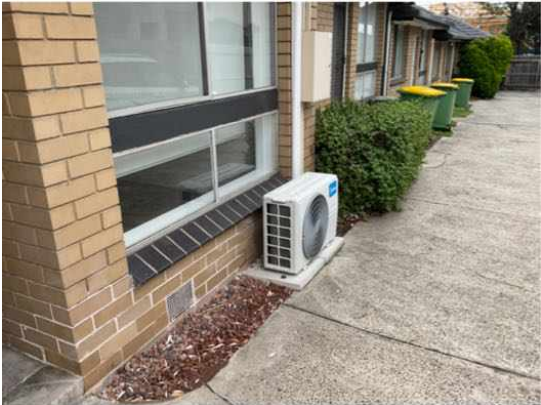
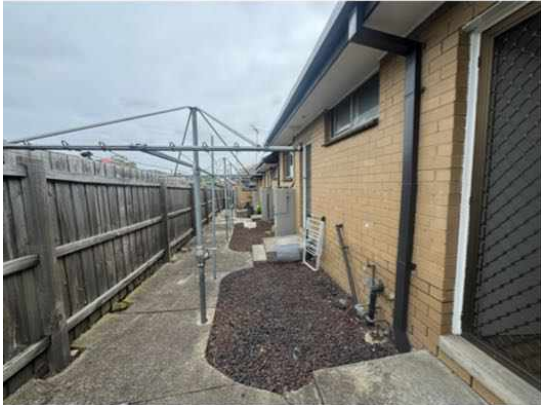
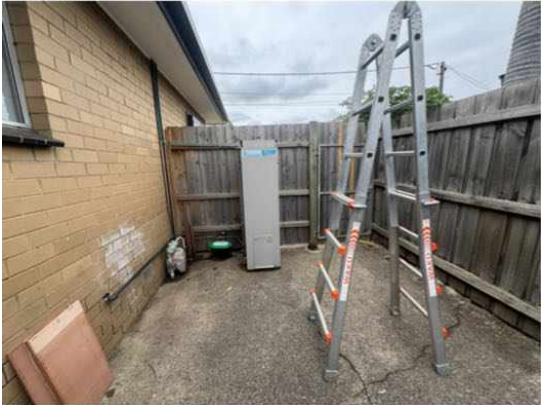
Building: Main Building  
 Location: All External Areas  
 Finding: Additional Photos - Obstructions and Limitations  
 Information: These photographs are an indication of the obstructions and limitations which impeded full inspection of the property at the time of inspection. These obstructions can hide an array of defects and should be removed to allow full inspection to be carried out. A re-inspection is recommended once the areas are made accessible.
