Building and Timber Pest Inspection Report

Inspection Date: Sat, 7 Feb 2026

Property Address: 18 Regent St, Paddington NSW 2021, Australia

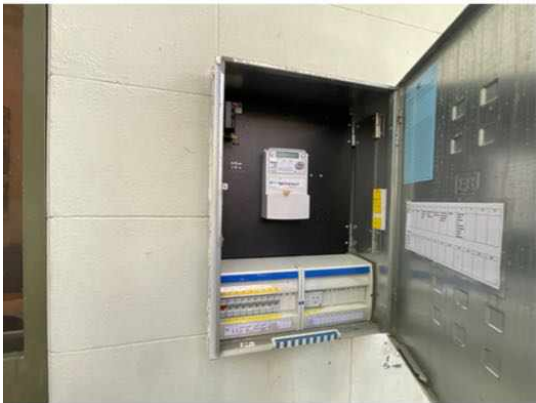
Building: Main Building
 Location: Meter Box
 Finding: FYI - Additional Photos (Bv1)
 Information: Additional photos are provided for your general reference and may include obstructions, testing of water & windows, moisture readings or minor maintenance items.

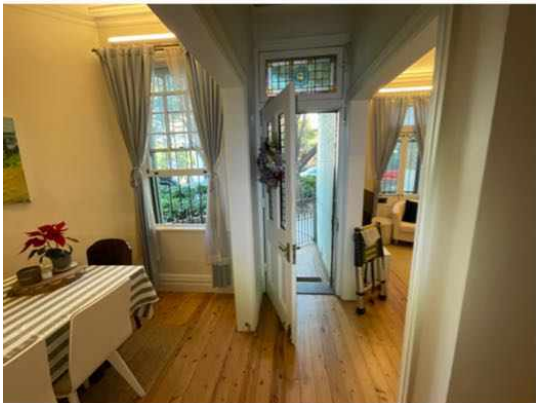
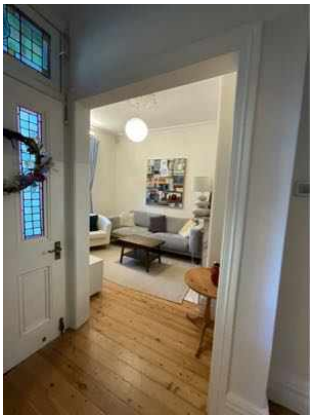
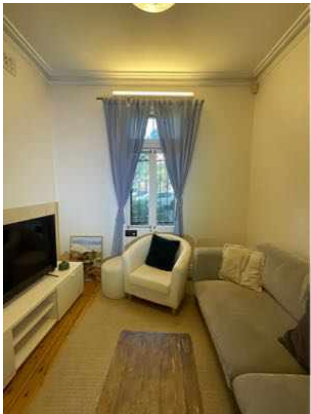
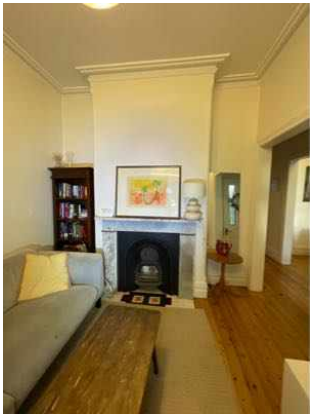
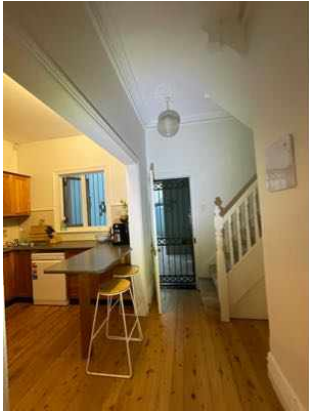
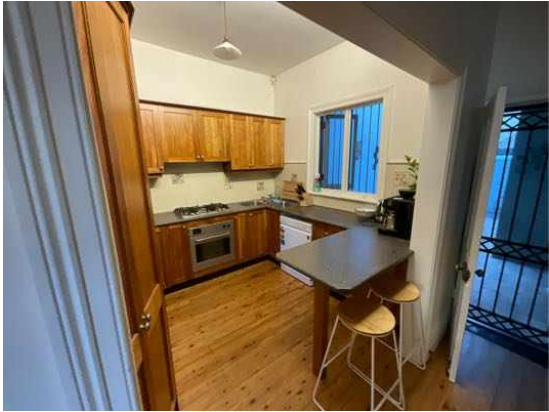
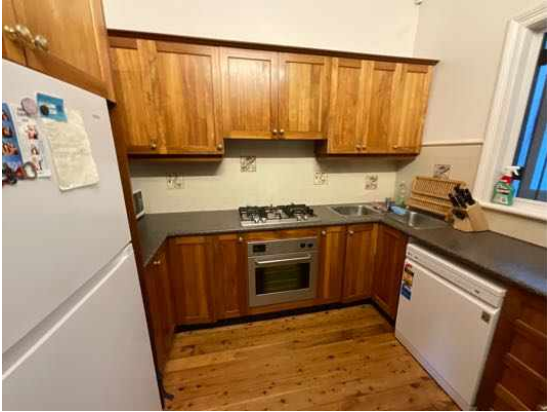
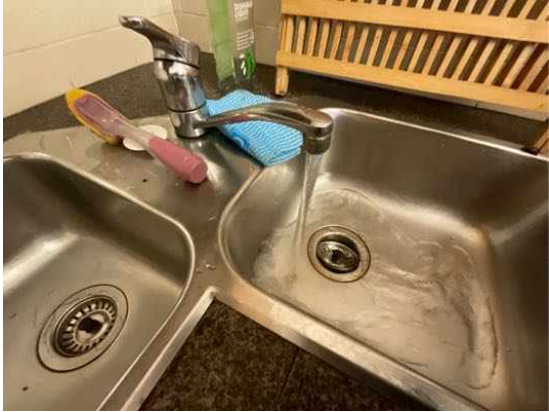
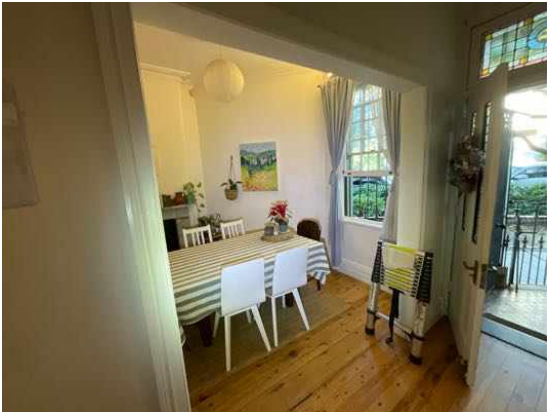
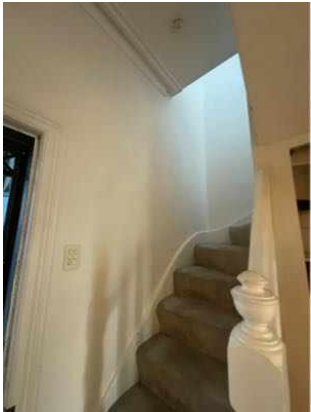
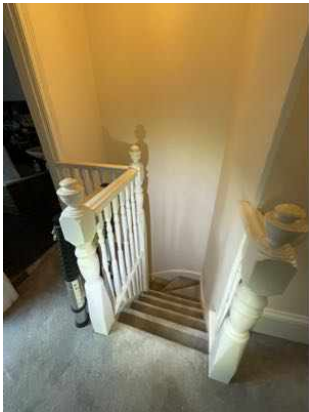
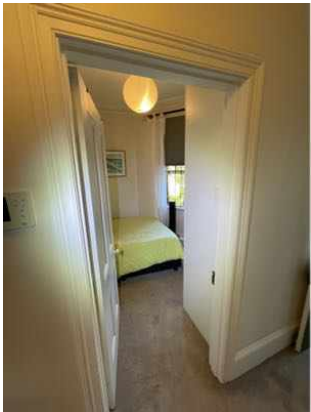
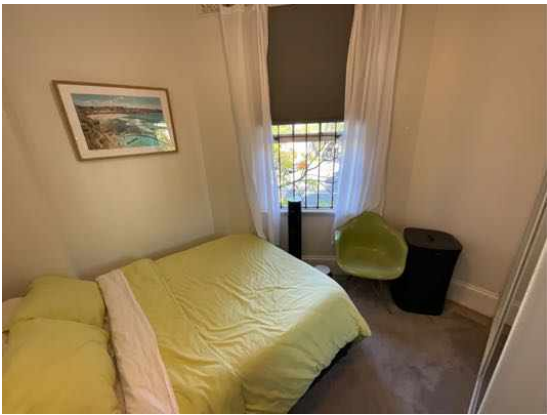
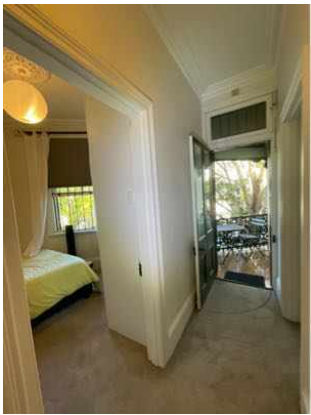
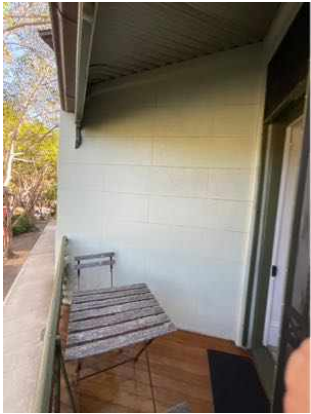
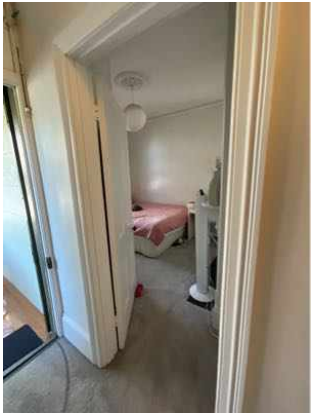
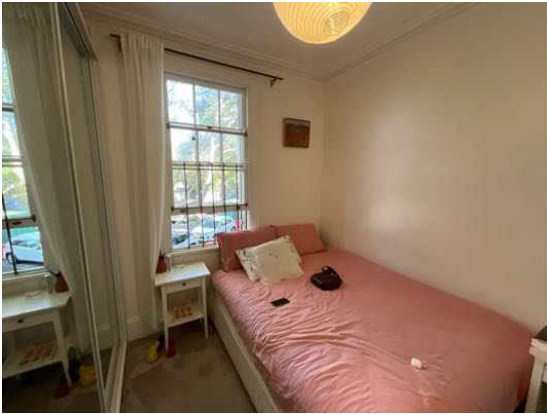
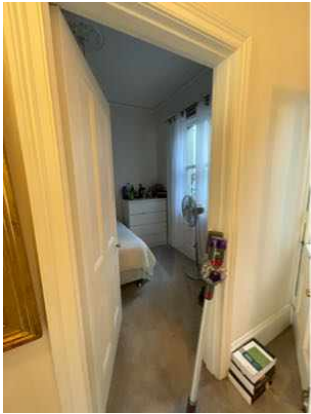
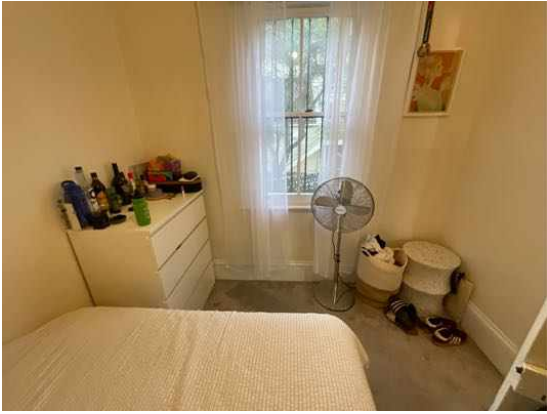
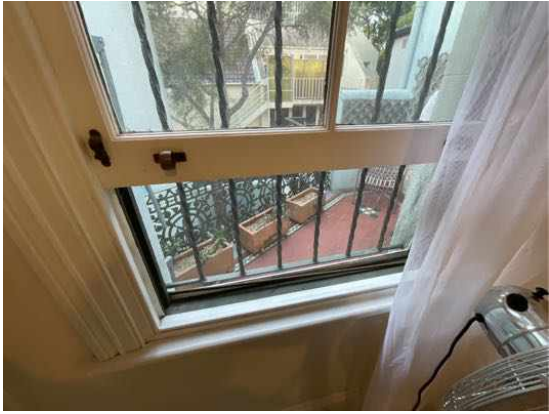
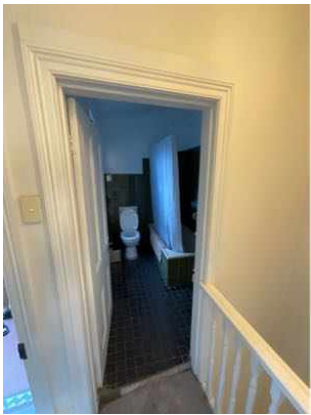
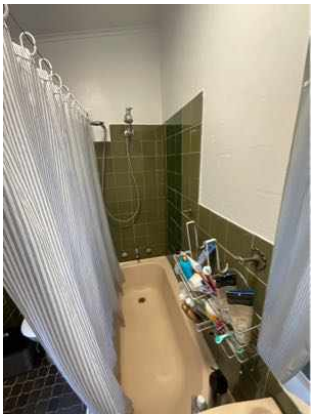
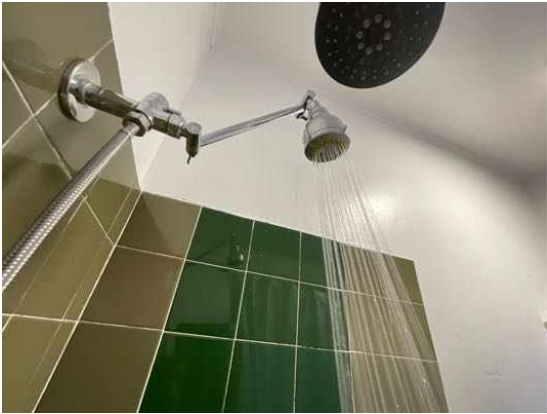
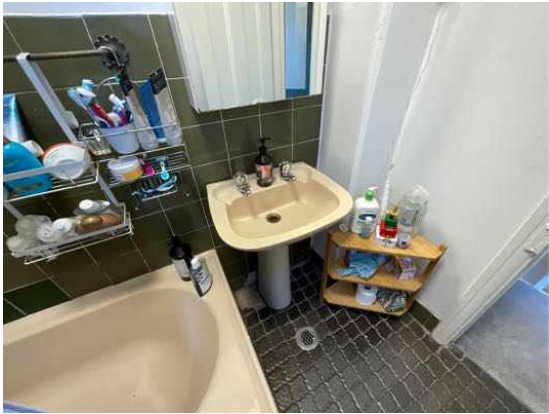
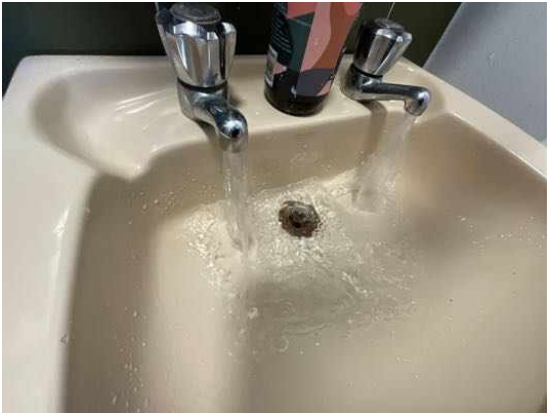
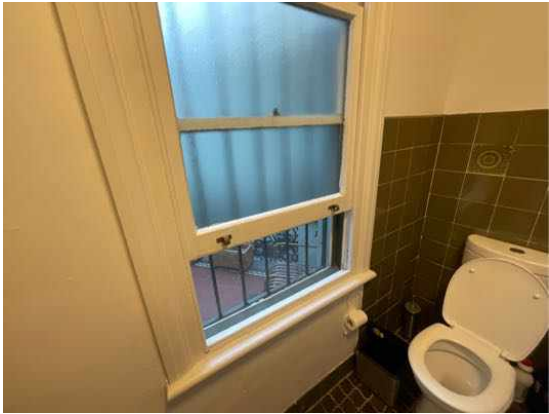
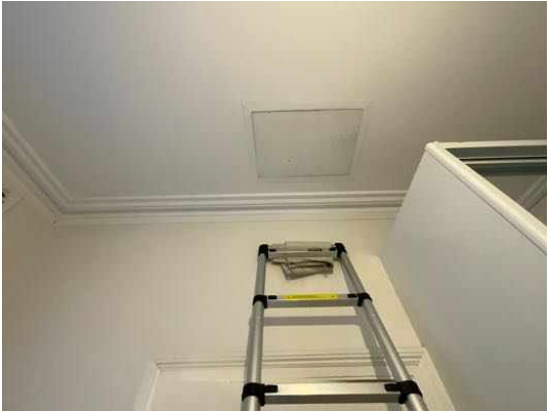
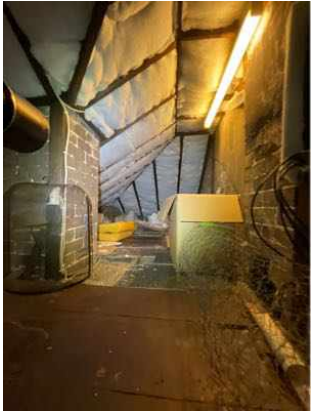
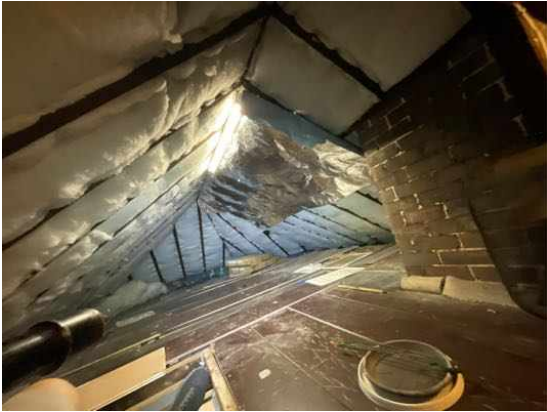
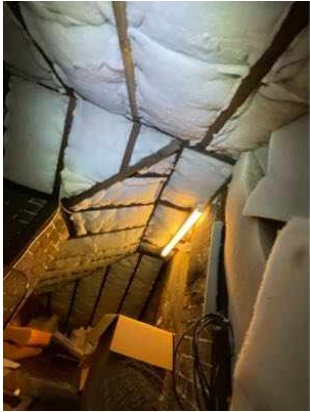
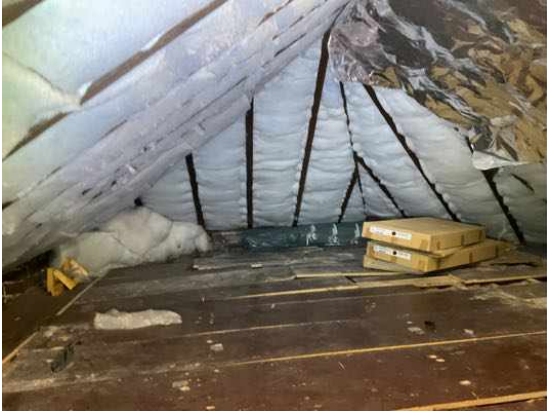
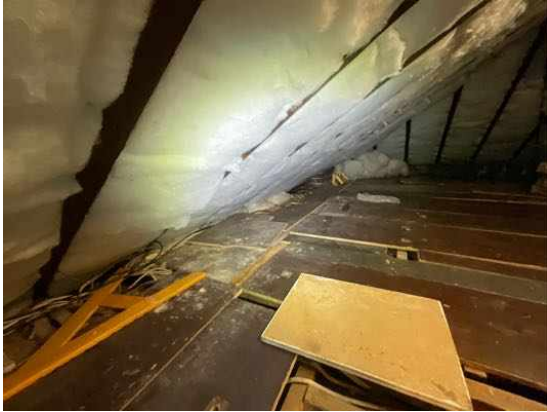
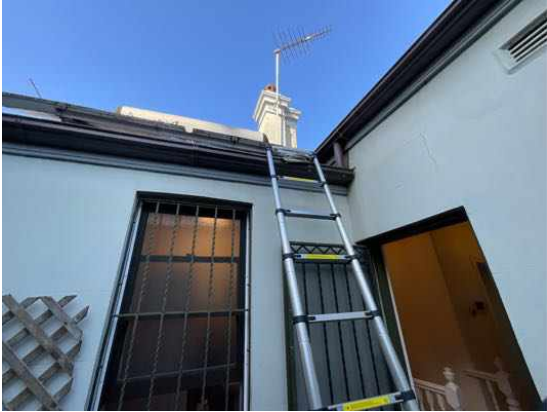
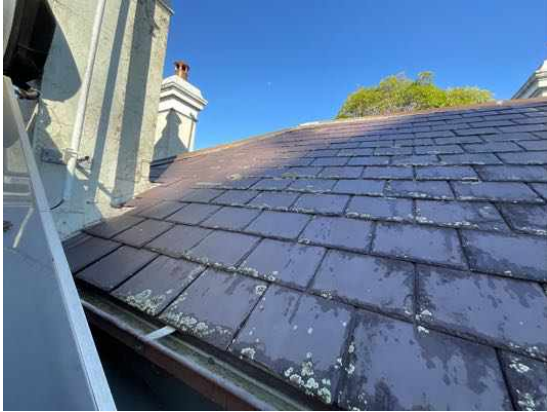
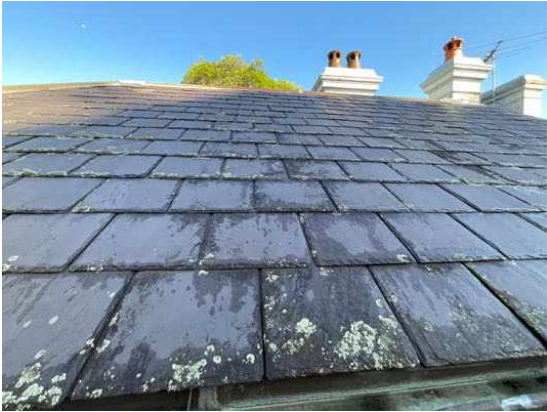
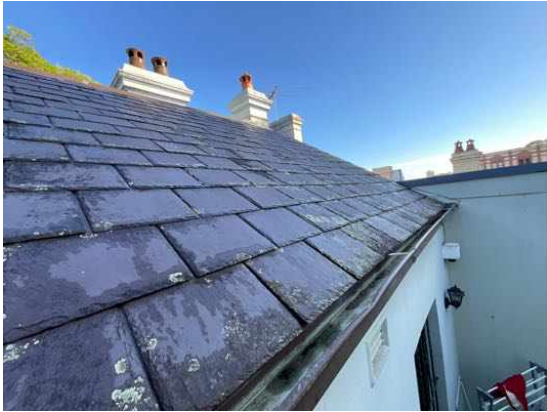
Building: Main Building
Location: All Areas
Finding: FYI - Additional Photos (Bv1)
Information: Additional photos are provided for your general reference and may include obstructions, testing of water & windows, moisture readings or minor maintenance items.
