Building and Timber Pest Inspection Report

Inspection Date: Tue, 31 Mar 2026

Property Address: 4A Barton St, Ermington NSW 2115,
Australia

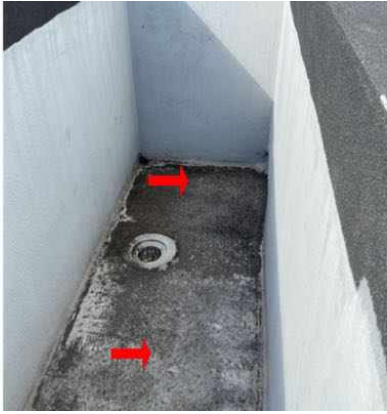
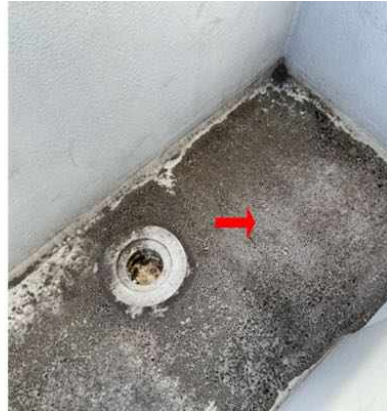
Finding 2.01

Building: Main Building
Location: Balcony
Finding: Balcony – Efflorescence and deterioration (Possible waterproofing defect)
Information: Tiled balcony floor with visible efflorescence and discolouration to grout lines indicating prolonged or recurring moisture presence beneath the tile finish. This condition is commonly associated with failed grout or sealant joints, insufficient surface drainage and/or inadequate waterproofing allowing moisture to become trapped within the balcony substrate. Some tiles also appear to have been damaged or removed leaving behind poor detailing which can cause moisture ingress. The external parapet and front elevation also appears to have deteriorated waterproofing and poor detailing along with flanges. While no internal water ingress was evident at the time of inspection with the potential to escalate if moisture migration continues, and further assessment by a suitably qualified waterproofing specialist is highly recommended.

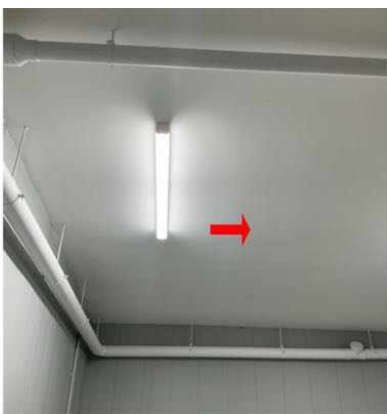
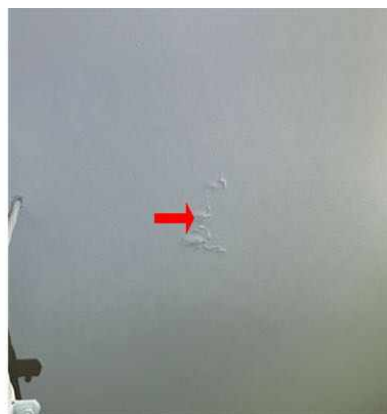
Finding 3.01

Building:	Main Building
Location:	Garage
Finding:	Painted surface - Bubbling & rust staining
Information:	Sections of paint in this area was found to have bubbled and deteriorated. Paint bubbling is generally an indication of excessive moisture in the area, that is currently hidden by the painted surface.

The presence of excessive moisture can have major implications on associated building elements if left unattended. While only seemingly minor at this stage, the damage cannot be determined due to the paint obstructing any further inspection of the damage.

It is highly advised that the affected paint be cleaned to allow a further, more invasive inspection by a licensed plumber. Failure to act on this defect may necessitate major works in the future.

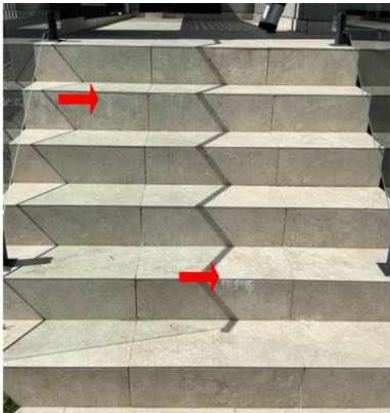
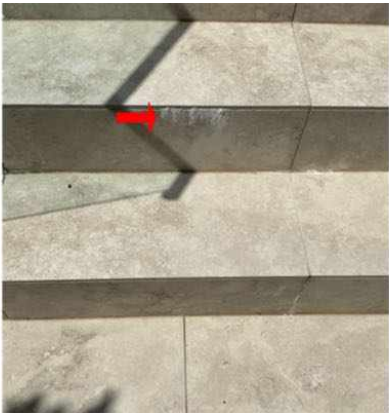
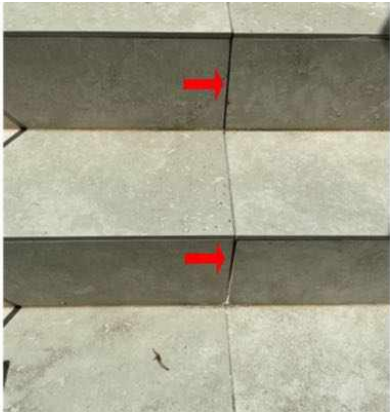
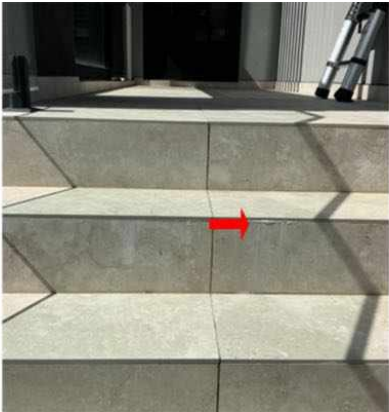
Finding 3.02

Building: Main Building
Location: All External Areas
Finding: Efflorescence and grout deterioration
Information: Efflorescence was observed to tiles together with localised grout and sealant deterioration, indicating intermittent moisture movement through the tiled system. the condition suggests past or periodic moisture presence, potentially associated with drainage or waterproofing detailing. Repairs to grout and sealant and review of drainage are recommended, with ongoing monitoring and further assessment by a licensed plumber for any progression.

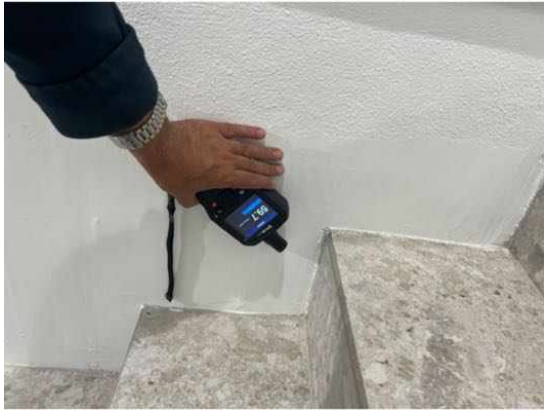
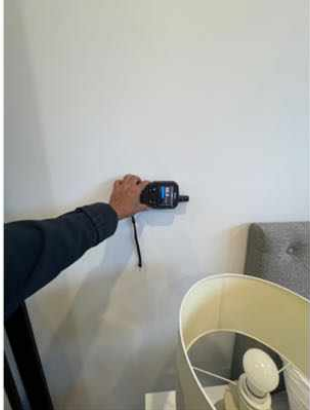
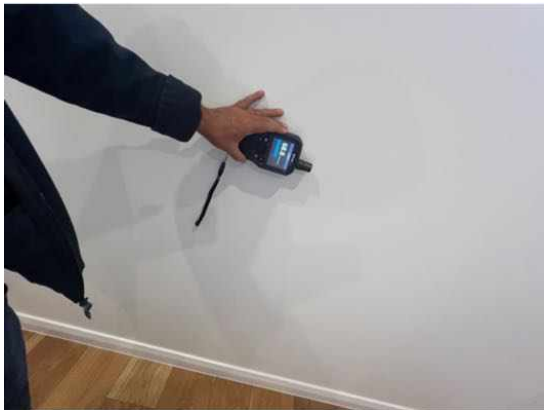
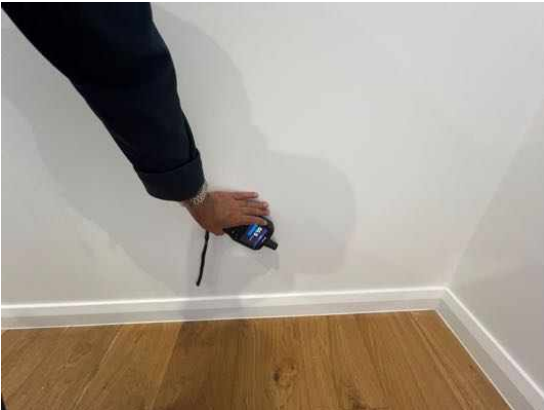
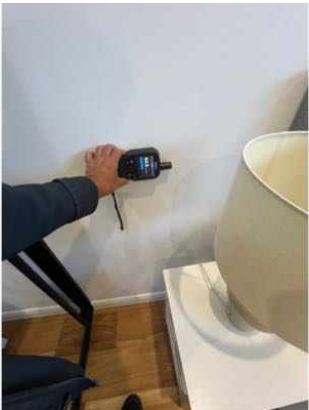
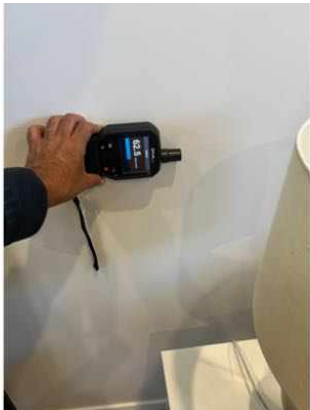
Finding 3.03

Building: Main Building
Location: All Internal Areas - Left parameter wall and rear
Finding: Elevated Moisture – Further Investigation Recommended
Information: Elevated moisture readings were detected in several locations with no visible surface issues, although no significant structural damage was evident at the time of inspection, dampness can contribute to deterioration if left unaddressed. Inspector was not able to inspect the external wall due to space constraints. A further investigation by a licensed plumber or waterproofing specialist is recommended to confirm the source and ensure no concealed issues are developing.

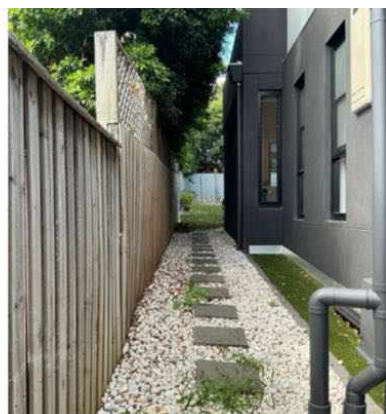
Finding 3.04

Building:	Main Building
Location:	All External Areas
Finding:	Surface Drainage - Gravel
Information:	The setback is finished with loose aggregate. While gravel can assist with surface dispersion of water, it is not a controlled drainage system. The adequacy of falls and stormwater connection could not be confirmed at the time of inspection. Monitoring during rainfall is recommended to ensure no ponding or water discharge occurs toward the slab edge around the property. Further inspection by a licensed plumber is recommended.

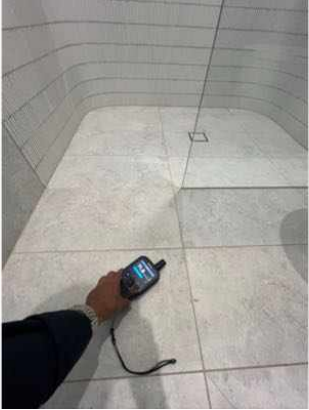
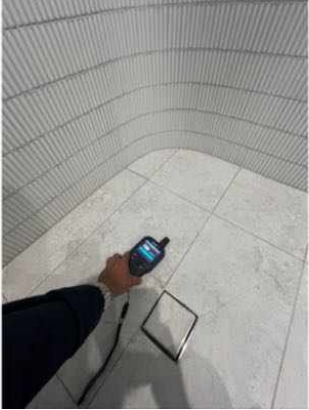
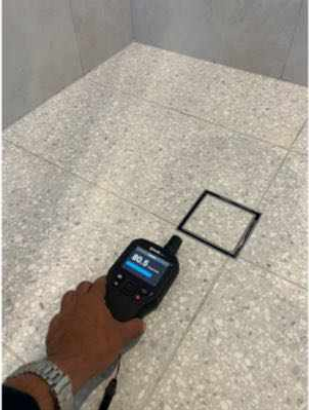
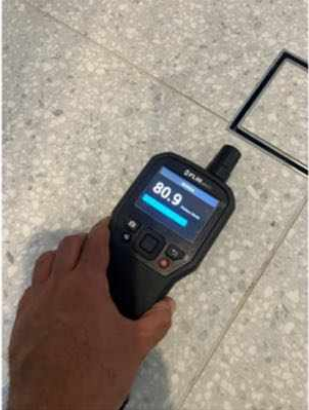
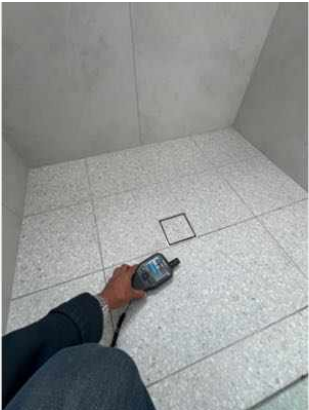
Finding 3.05

Building:	Main Building
Location:	Bathrooms, Ensuite
Finding:	Elevated Moisture Bathroom (No visible deterioration noted)
Information:	Elevated moisture levels were detected to tiled surfaces in bathroom/shower areas. Persistent moisture ingress can lead to concealed damage, including timber rot and mould growth.

Elevated moisture readings in tiled wet areas can occur from normal shower use, age/deterioration of waterproofing membranes, plumbing leaks or moisture absorption through grout lines. While no damage was visible, elevated readings may indicate moisture retention behind tiles, which can be a conducive condition for future

deterioration if not monitored.

Monitor the area over time for signs of drumming, efflorescence, tile movement, or grout deterioration. Further inspection by a licensed waterproofing is recommended (e.g., pressure testing, membrane assessment).

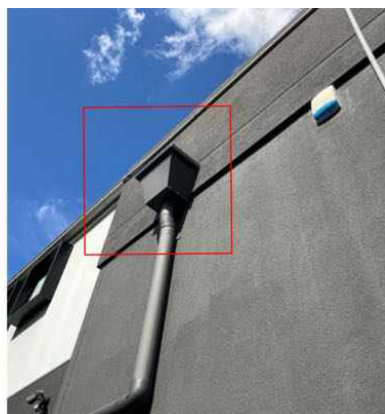
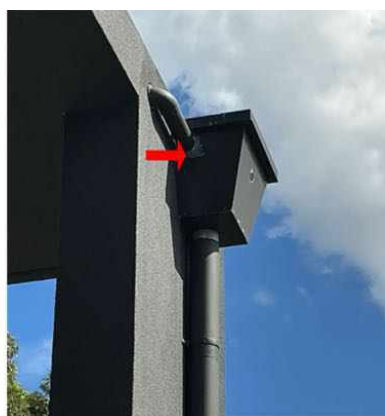
Finding 3.06

Building: Main Building
Location: All External Areas
Finding: Box Gutter Rainhead
Information: The rainhead and downpipe installation were visually intact at the time of inspection,

however, an overflow provision was not visible and may be concealed. The system's overall performance could not be confirmed without further inspection or testing during rainfall. Regular cleaning and maintenance of rainheads and downpipes are recommended to ensure effective roof drainage. Use of excessive sealant was also observed to the second rainhead.

It is recommended to consult with a qualified plumber to ensure it meets NCC requirements.

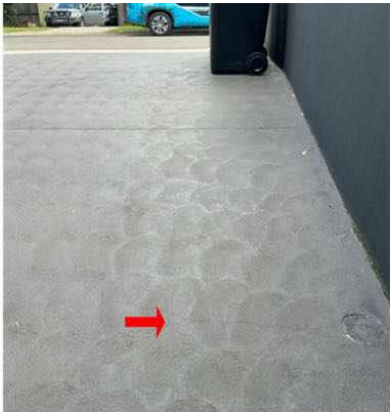
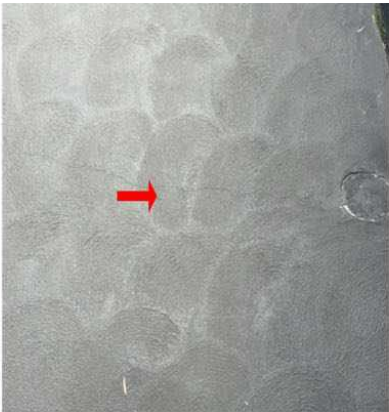
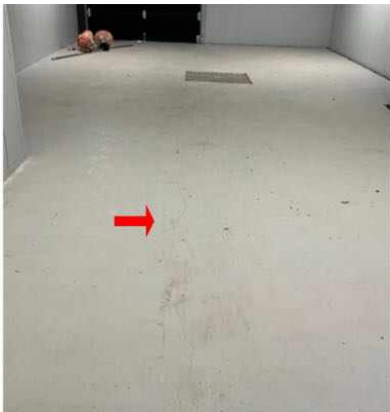
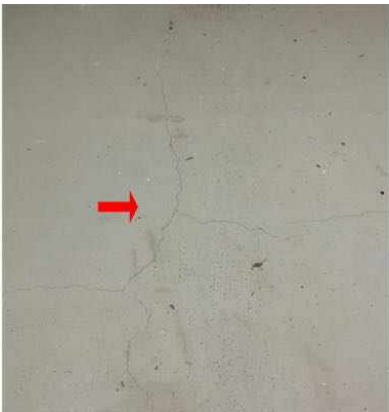
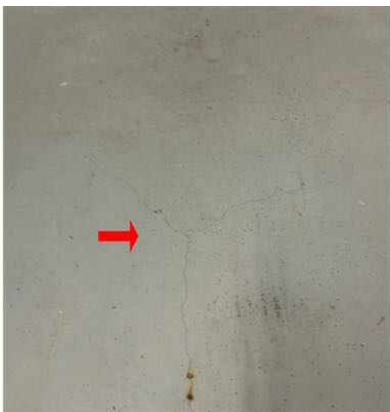
Building:	Main Building
Location:	All External Areas
Finding:	Cracking - External Concrete Paving Damage Category 1 - Fine (less than 2mm)
Information:	Fine cracks were identified in external concrete paving. Although fine cracks are quite noticeable, they are often only considered to be an appearance defect, and usually do not indicate any structural damage. To be considered a Category 1 or fine crack, the crack is found to be less than 2mm in width.

Generally the cause of a hairline crack in existing concrete paving such as driveways and pathways is indicative of the expansion and contraction of the concrete. Such causes are generally due to environmental factors, such as moisture levels, weather conditions, root systems of nearby trees or the soil types on which they are laid.

Fine cracks may also be due to poor original installation of the concrete. Factors such as poor compaction of the sub surface and/or inadequate reinforcing of the slab may create cracking and other secondary defects.

Monitoring of all cracking should be conducted frequently. Always contact a building inspector should cracks widen, lengthen, or become more numerous.

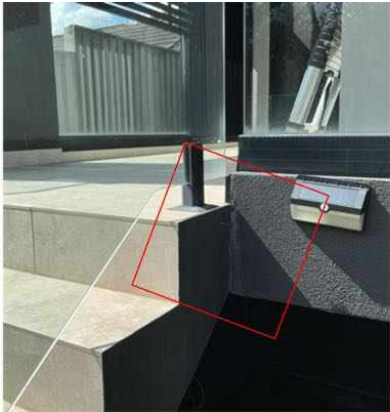
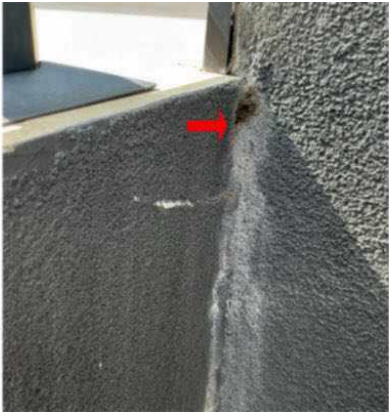
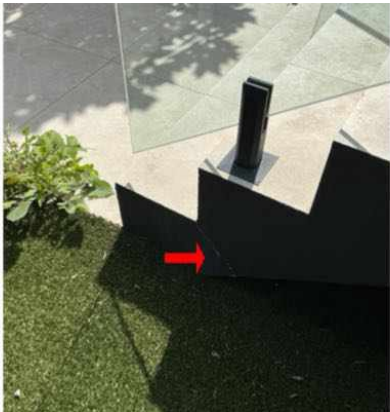
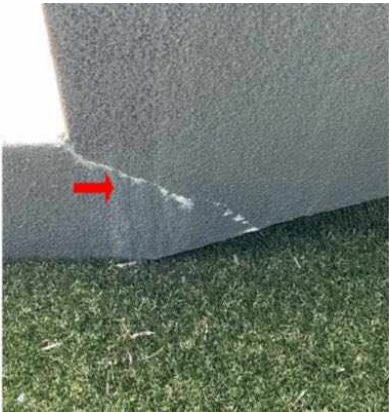
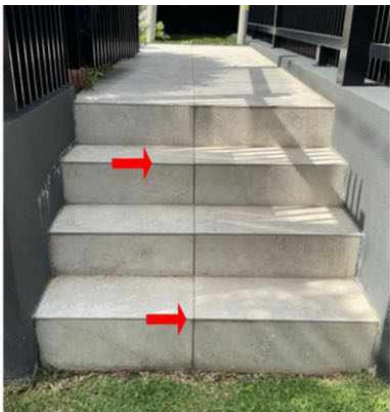
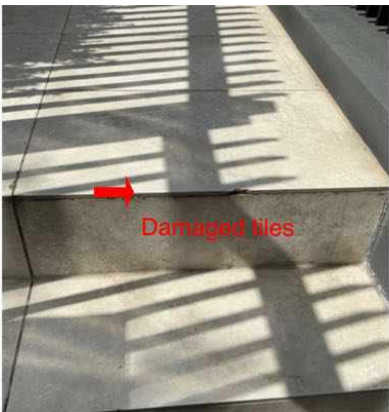
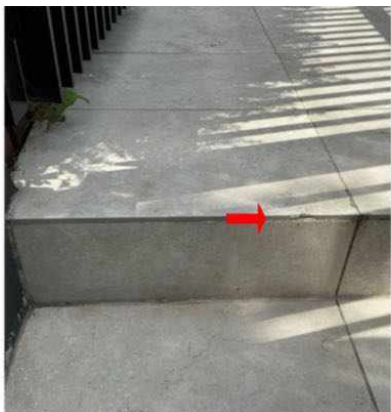
Finding 3.08

Building: Main Building
Location: All External Areas

Finding: Cracks to render - Category 1

Information: It has been observed that cracking to rendered surfaces has occurred. The degree of damage falls within Category 1, described as fine cracks that do not need repair and which are less than 1.0mm in width limit.

Damage of this category is not considered a defect for rectification. Always contact your building inspector should cracks widen, lengthen, or become more numerous.

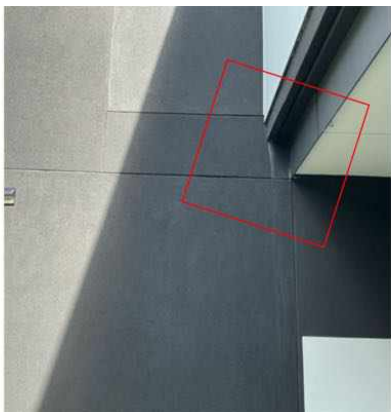
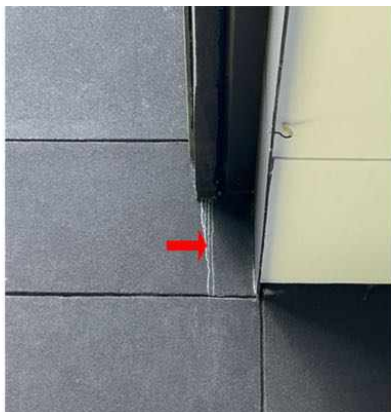
Finding 3.09

Building: Main Building
Location: All External Areas - Rear
Finding: Water staining
Information: Water staining was evident in this area at the time of inspection. Water staining indicates that surfaces have been exposed to excessive moisture over time. The minerals and other elements in the water lead to staining, which may graduate to corrosion and deterioration if left unmanaged.

While mostly an appearance defect, water staining can be indicative of more serious defects, which may be currently concealed by other building elements.

Where water staining is active, a licensed plumber must be consulted to identify the cause of the staining and to provide advice on any reparation works that may be required. Replacement of any broken or damaged structures is advised.

Conversely, where water staining is old and inactive, affected building materials may be repaired or replaced at client discretion. A qualified carpenter or registered builder may be appointed to perform these works.

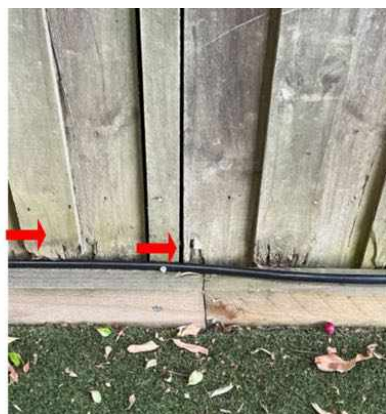
Finding 3.10

Building: Main Building

Location: All External Areas - Fence
 Finding: Wood rot to some areas
 Information: This building element shows evidence of wood rot. Wood rot, also known as Fungal Decay, occurs when timbers and other cellulose building materials are exposed to damp conditions on an ongoing basis. This could be the result of exposure to weathering over a prolonged period of time, or the attraction of excessive moisture from other abutting building materials. Contributing factors also include poor air ventilation in the area.

Wood rot is often associated with general damp problems and is evidenced by a 'musty' smell or mould and mildew occurring on surfaces. If left unmanaged, damp conditions can lead to further health problems and the decay of timbers will continue.

Early intervention and regular maintenance, particularly of exterior timbers, will prolong the useful life of these building elements. Prior to any works being performed, the cause of the moisture that has created the visible wood rot should be identified and addressed in a suitable manner. Replacement of affected timbers may then be a necessary step in protecting surrounding building elements from such deterioration.

A qualified plumber may be appointed to assess the cause of excessive moisture and to provide advice on any remedial works as required. A qualified carpenter or registered builder may also be required to replace affected building materials.

Even though Liverpool termite activity was not visible. A further invasive inspection by a licensed termite technician its also highly recommended to eliminate possibility of potential termite activity.

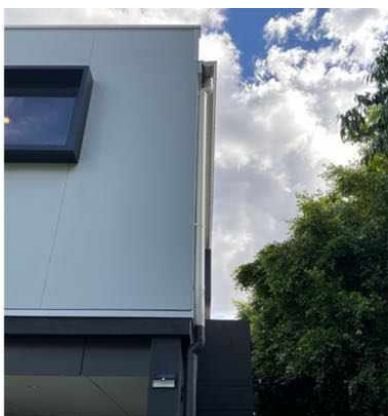
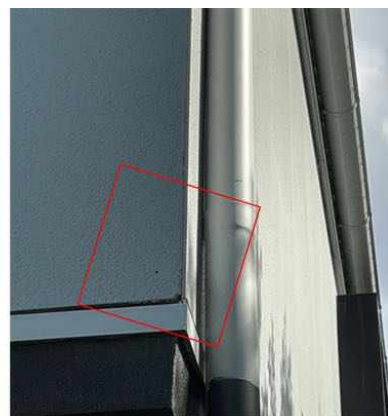
Building: Main Building
 Location: All External Areas - Rear
 Finding: Building element - Damaged (Poor detailing/Trim gap- possible moisture ingress)
 Information: Breakage occurs generally when the building materials have either aged and decayed, or as a result of damage (accidental or deliberate).

Repair and/or replacement of broken elements is advised to ensure that additional secondary defects do not arise as a consequence. Such works are necessary, as all building elements play a key role in the operation and function of the overall structure and its performance.

A relevant tradesperson should be appointed to repair or replace the affected building element prior to any subsequent damage being caused.

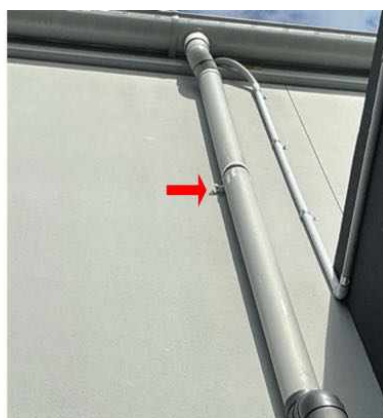
Finding 3.13

Building:	Main Building
Location:	All External Areas
Finding:	Building element - Damaged - Loose fixing
Information:	Breakage occurs generally when the building materials have either aged and decayed, or as a result of damage (accidental or deliberate).

Repair and/or replacement of broken elements is advised to ensure that additional secondary defects do not arise as a consequence. Such works are necessary, as all building elements play a key role in the operation and function of the overall structure and its performance.

A relevant tradesperson should be appointed to repair or replace the affected building element prior to any subsequent damage being caused.

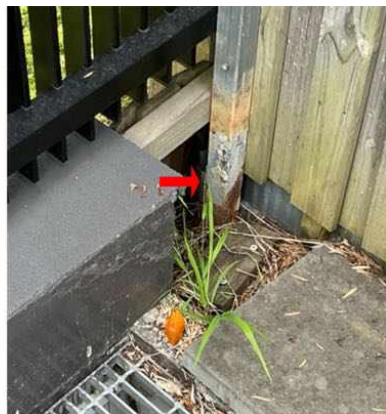
Finding 3.14

Building:	Main Building
Location:	All External Areas
Finding:	Building element - Rusted or corroded - Fence post corroded
Information:	This building element shows evidence of rusting and corrosion, which is likely to have developed as a result of excessive exposure to moisture and or inadequate coatings.

As surface rust provides no protection to the underlying iron, the deteriorating condition is likely to worsen if not addressed in the short-term future.

Where possible, the use of galvanized (treated) metals or aluminium coated metals aid in rust prevention, as does regular general maintenance. Rust formation can be controlled with coatings, such as paint, that isolate the iron from the environment.

Rusting and corrosion should be managed by ideally removing or limiting the affected surface from exposure to moisture. A registered builder may be appointed to replace any building elements that have been severely affected by rust or water damage.

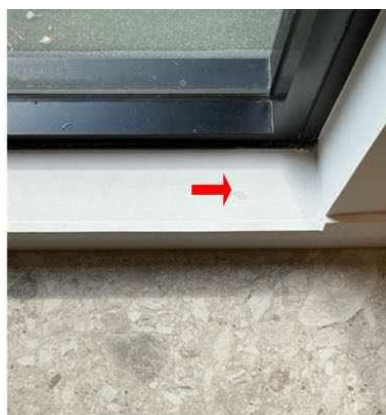
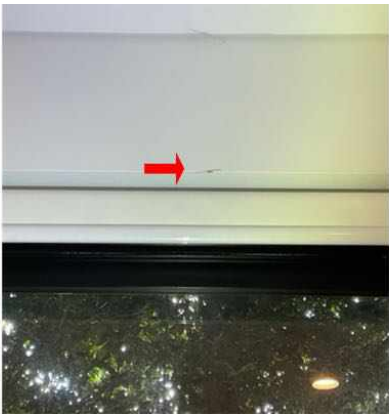
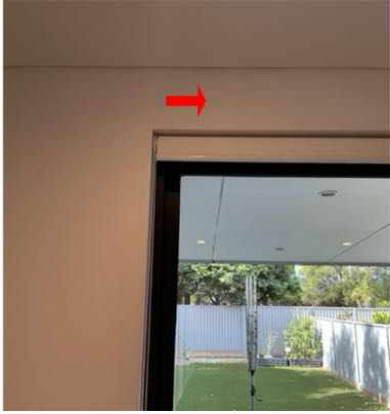
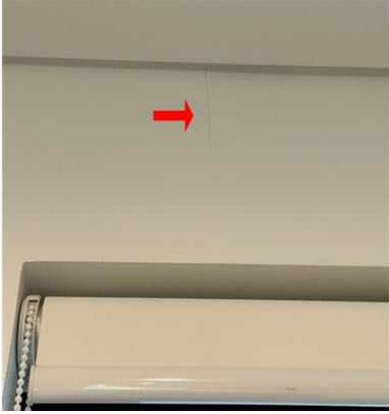
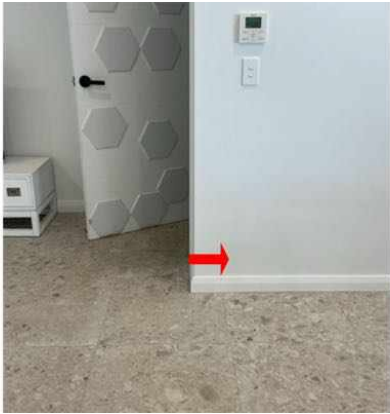
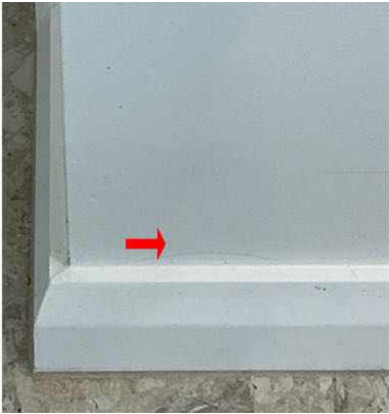
Finding 3.15

Building:	Main Building
Location:	All Internal Areas
Finding:	Paint Finish & Hairline Cracking - To some areas
Information:	The paint finish in this area was identified as being incomplete at the time of inspection including some hairline minor cracking.

Whilst incomplete or missing paint and minor cracking and imperfections in finish is generally an appearance defect, it can also lead to the development of secondary building defects over time. Incomplete areas of paint finish expose the area to moisture, potentially accelerating the deterioration of underlying building materials.

Incomplete paint finishes should be sanded back, filled, leveled and painted, as applicable. Where inadequate or missing paint protection has led to the deterioration of the associated building element, repair and/or replacement of this building element may be required.

A painting contractor should be appointed as soon as possible to perform necessary works to aid the appearance of the affected area and to ensure the area is protected against further deterioration. Alternatively, the homeowner following manufacturer instructions may perform these works.

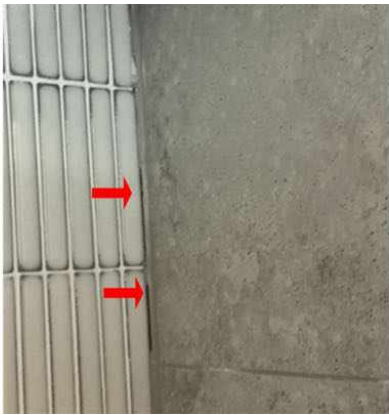
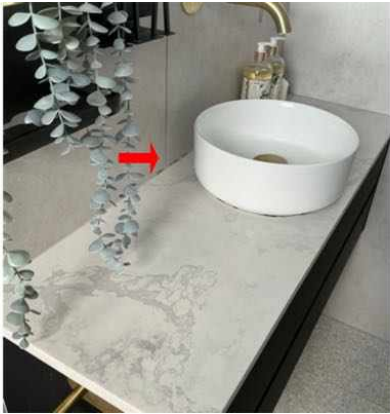
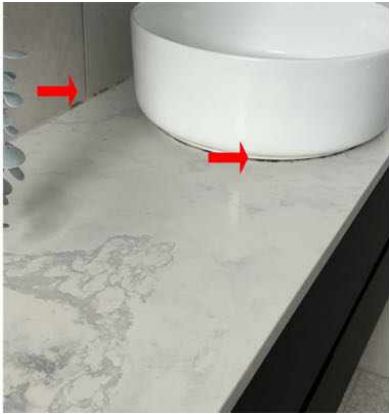
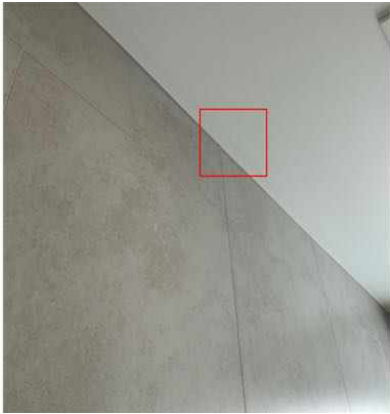
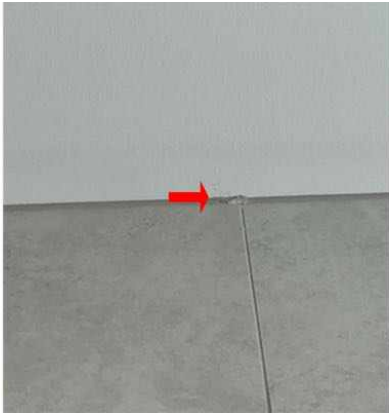
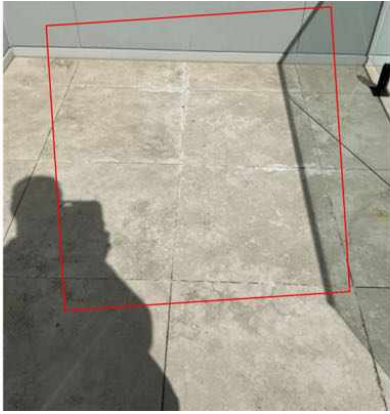
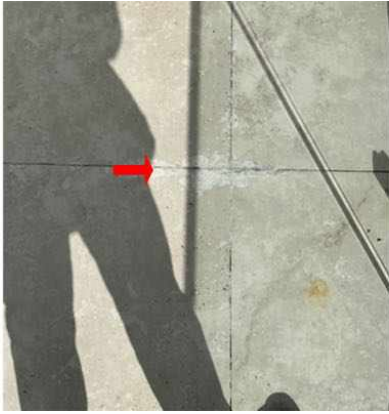
Building:	Main Building
Location:	All Internal Areas
Finding:	Sealant and grouting - Missing or degraded to some areas
Information:	It was noted on inspection that sealant or grout is degraded. There is also evidence of poor workmanship and excessive use of sealant. Silicone should never be used as a first line of defence against waterproofing. Further inspection by a licensed waterproofing contractor is highly recommended.

Different materials and floor areas move at different rates, generally causing cracking to grout or sealant at this point. A flexible sealant is required to allow for expected expansion and contraction, while keeping the joint water tight and protective of all associated building materials.

There appears to be excessive mould to the sealant and grout which will likely require scraping out and replacement.

Flexible and mould resistant materials should be applied to affected areas to prevent any subsequent water damage that is likely to occur. Regular maintenance and replacement of damage or missing or damaged sealant and grout is highly recommended to the wet areas, as this is a regular wear and tear defect. Sealant and grouting in areas that come into regular contact with water should be maintained for the long term care of your property.

A sealant specialist or tiling contractor should be appointed to complete these works as soon as possible.

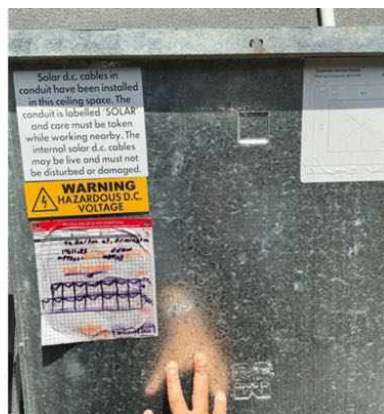
Building:	Main Building
Location:	All External Areas
Finding:	Termite Management System - no evidence of a chemical installation
Information:	The application of a post-construction chemical termite barrier is highly recommended for all properties, particularly if live termite activity has been found on the site previously. Such barriers are highly effective in preventing termite attack on any timber building elements throughout the property.

A durable notice should be placed in the switchboard unit to indicate current termite barriers. At the time of inspection, it appeared as though no termite management system has been installed, with no evidence to suggest preventative works taking place.

The client may consider gaining further advice from a pest controller as to the costs and procedures involved with this application. It is recommended that obtaining such advice be a short-term priority.

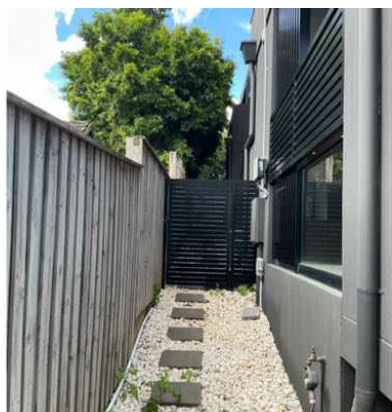
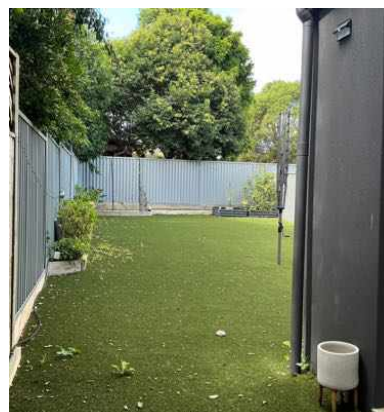
Finding 6.02

Building:	Main Building
Location:	All External Areas
Finding:	Trees within 50m
Information:	Trees within 50m of the property can be conducive to termite activity. It is recommended an invasive inspection of all trees within 50m to the property be carried out by a qualified pest control expert.

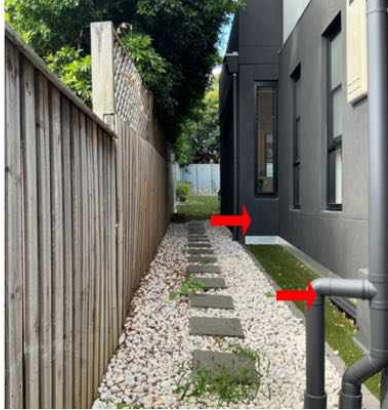
Finding 6.03

Building:	Main Building
Location:	All External Areas
Finding:	Slab Edge - Exposure
Information:	An inspection zone of at least 75mm in relation to the exposed slab edge, between the bottom brick and the perimeter pavement, is required. This inspection zone should be maintained in order to force termites into the open where they can be detected more readily during regular inspections. The slab edge should not be concealed by anything that may prevent inspection of the area, including render, landscaping, soil, turf, paving, concrete cladding or other structures.

an architect or builder may be required to consult the construction plans.

Where the slab edge cannot be properly inspected, it is highly recommended that termite or timber pest inspections be carried out every 6-12 months to aid protection of the property against infestation.

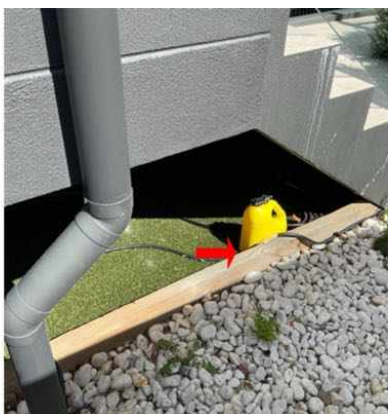
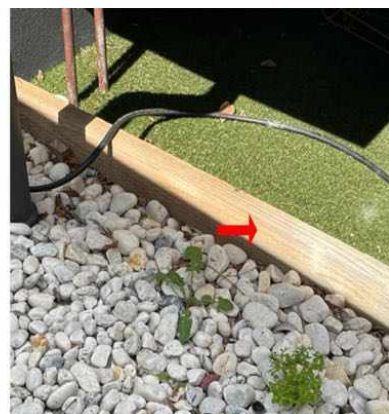
Finding 6.04

Building:	Main Building
Location:	All External Areas
Finding:	In ground contact - Timber
Information:	Any timbers in direct ground contact provide opportunity for concealed termite entry and are likely to be subject to premature rot and decay as the soil retains moisture or damp conditions against the timbers.

Remove untreated timber that is in direct contact with external grounds. Consider replacement with more durable materials i.e. treated timber or non timber elements. Frequent pest inspections are advised to readily identify any termite activity in these areas.

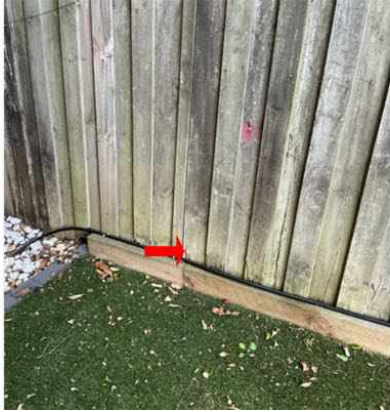
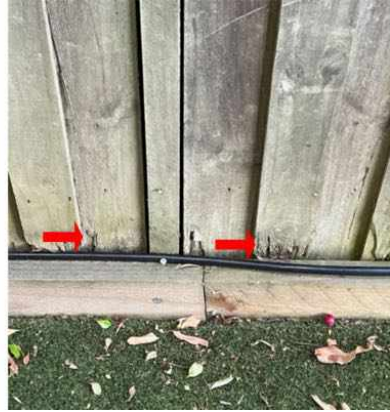
Building: Main Building
 Location: All External Areas
 Finding: Fungal decay - present
 Information: Fungal decay also known as wood decay or wood rot generally refers to the deterioration of timber elements when in contact with excessive levels of moisture for a prolonged period of time.

The development of fungal decay is accelerated by temperatures in the range of 5degreeC to 40degreeC as well as the presence of oxygen. Generally fungal decay develops on timber elements that are in use in an external environment which are exposed to rain penetration.

In this case although the affected timber element is in a decaying state the extent of

any visible damage appears to be localised to a specific area and is yet to spread to other parts of the building element or affect adjoining structures. The fungal decay is therefore likely to be of a relatively superficial nature with minimal impact on the structural integrity or tensile strength of the timber element.

A further invasive inspection by a licensed timber pest technician is highly recommended to check for concealed activity.

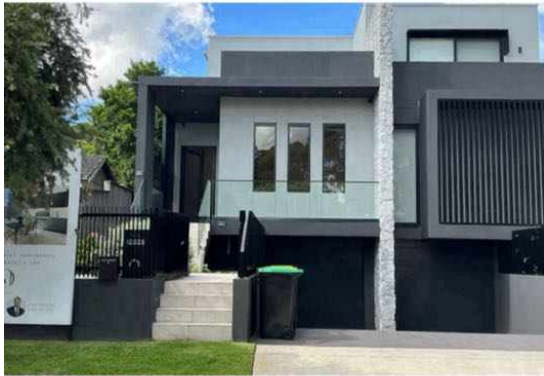
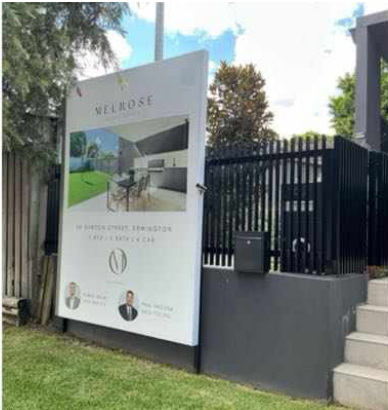
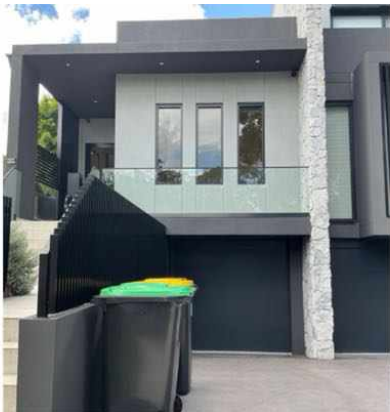
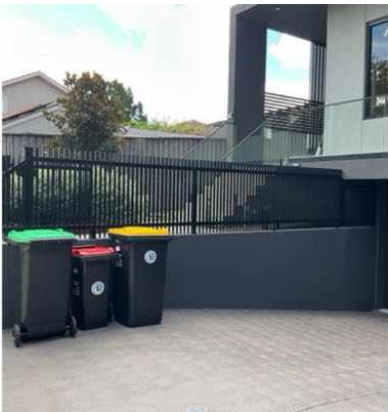
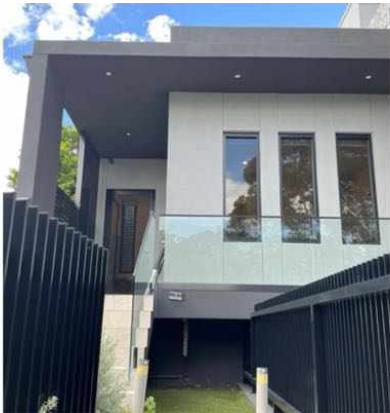
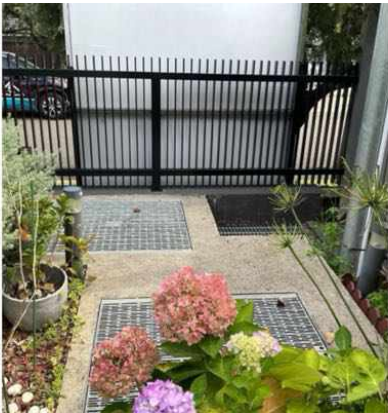
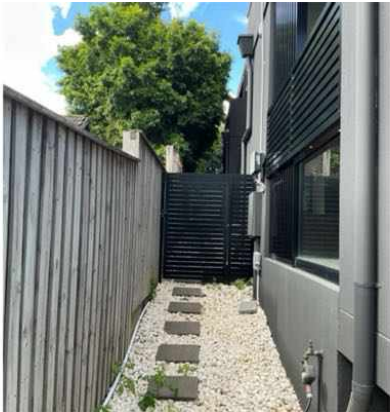
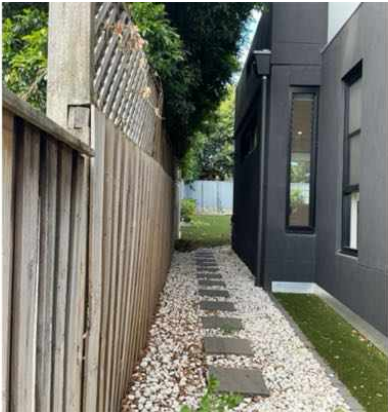
Building: Main Building
 Location: All External Areas
 Finding: Additional Photos - Obstructions and Limitations
 Information: These photographs are an indication of the obstructions and limitations which impeded full inspection of the property at the time of inspection. These obstructions can hide an array of defects and should be removed to allow full inspection to be carried out. A re-inspection is recommended once the areas are made accessible.

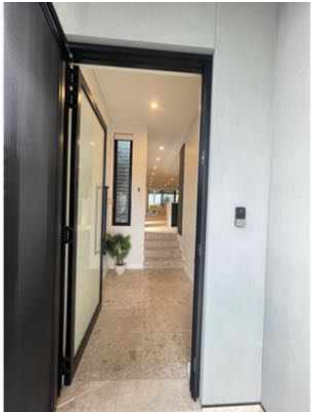
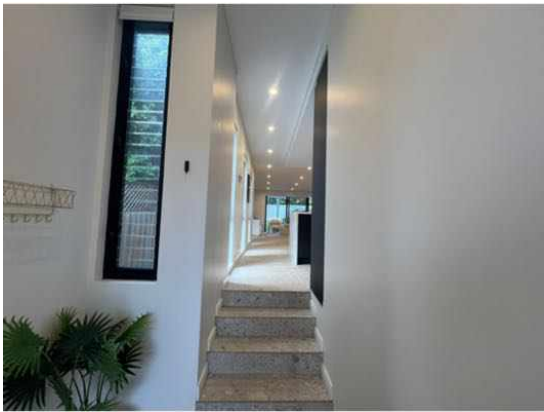
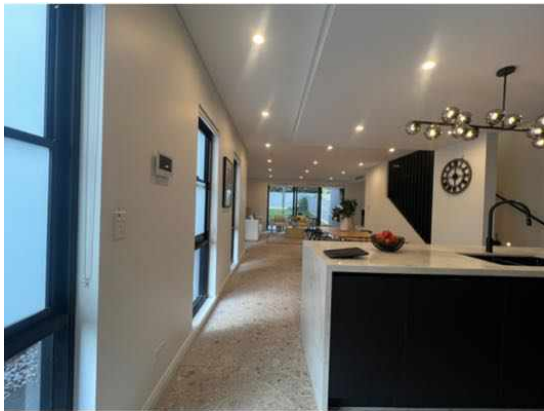
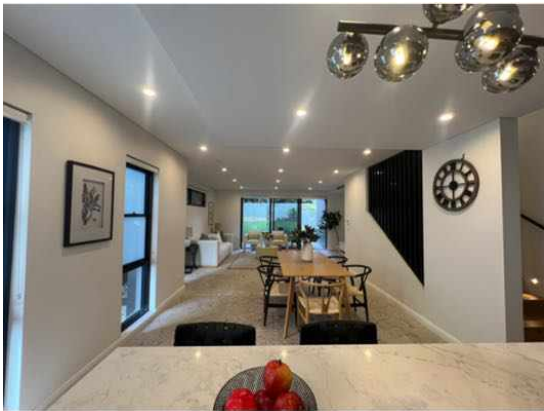
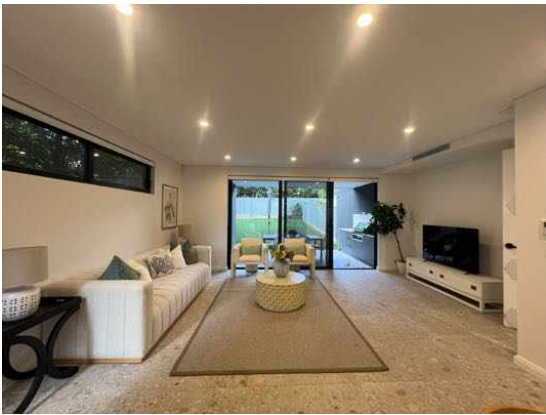
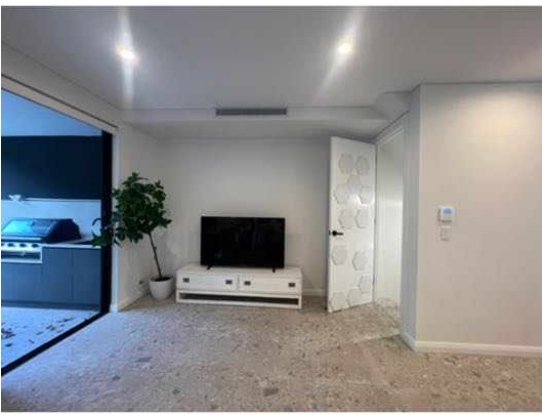
Building: Main Building
Location: All Internal Areas
Finding: Additional Photos - Obstructions and Limitations
Information: These photographs are an indication of the obstructions and limitations which impeded full inspection of the property at the time of inspection. These obstructions can hide an array of defects and should be removed to allow full inspection to be carried out. A re-inspection is recommended once the areas are made accessible.

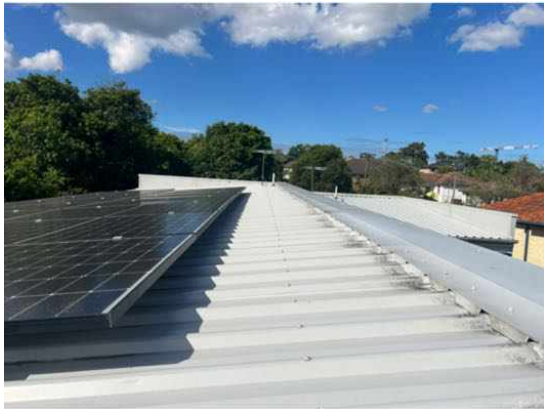
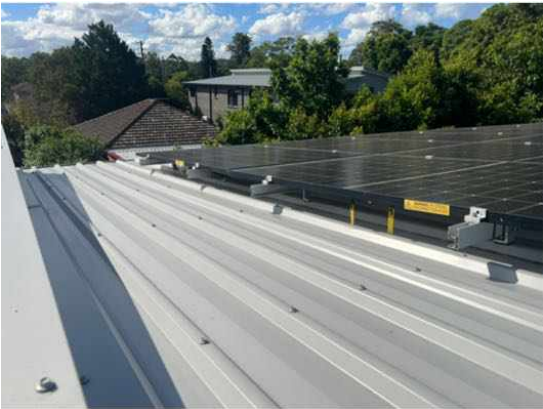
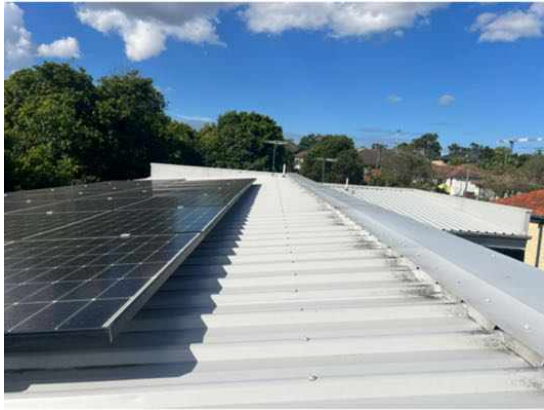
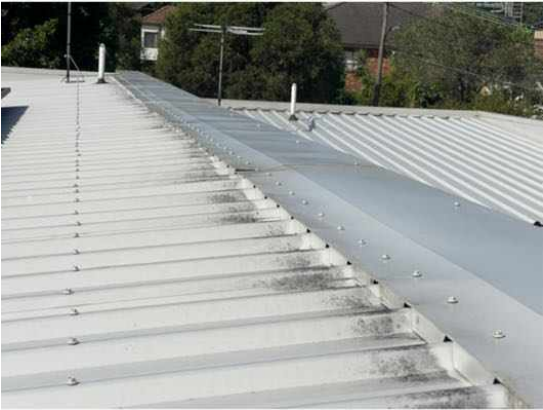
Building:	Main Building
Location:	Roof Exterior
Finding:	Additional Photos - Obstructions and Limitations
Information:	These photographs are an indication of the obstructions and limitations which impeded full inspection of the property at the time of inspection. These obstructions can hide an array of defects and should be removed to allow full inspection to be carried out. A re-inspection is recommended once the areas are made accessible.
