Building and Timber Pest Inspection Report

Inspection Date: Thu, 26 Feb 2026

Property Address: 78 Wellington St, Bondi Beach NSW 2026,
Australia

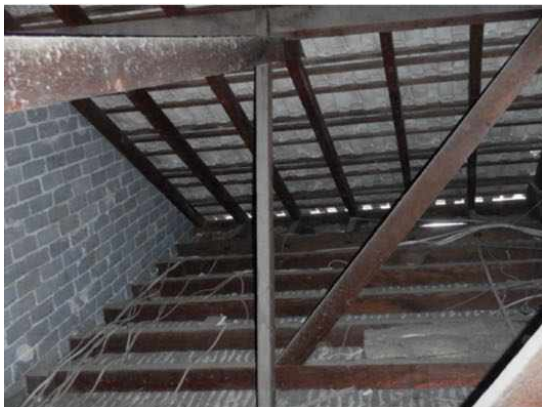
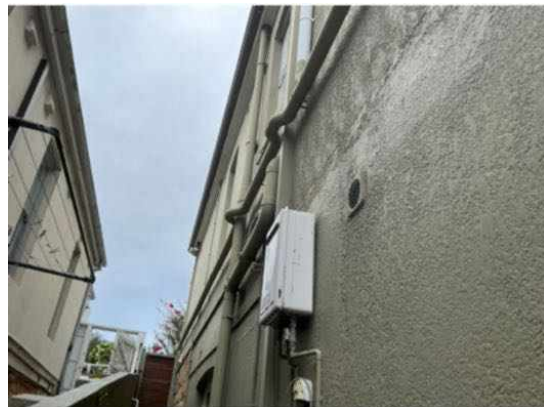
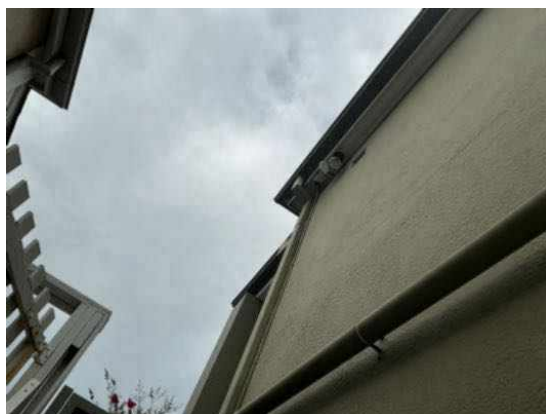
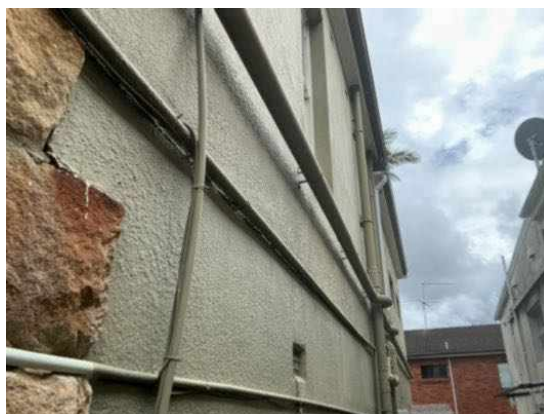
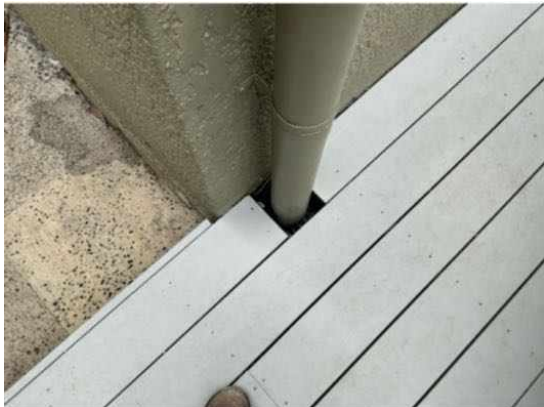
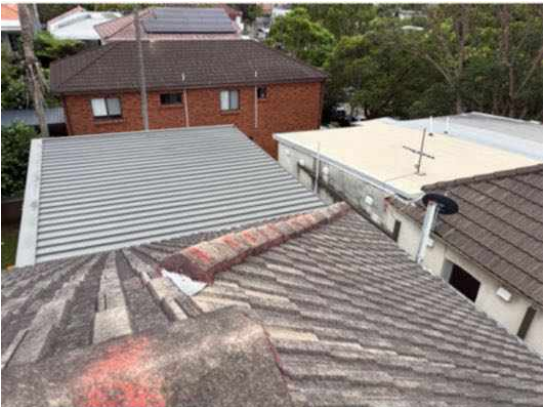
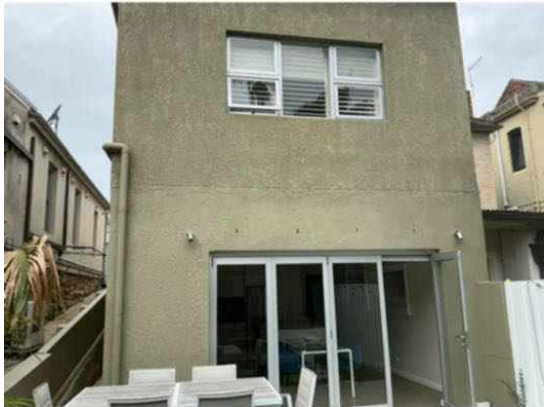
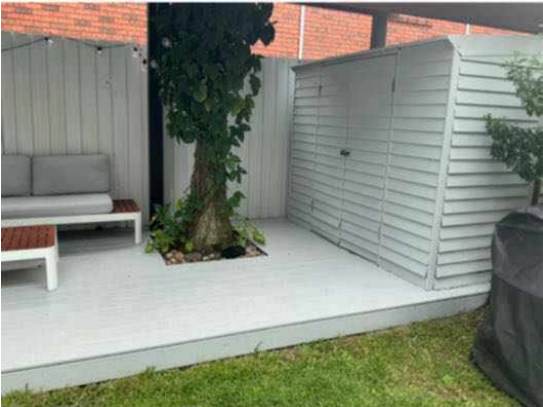
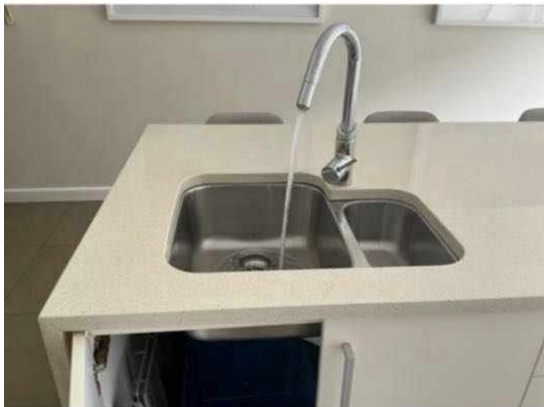
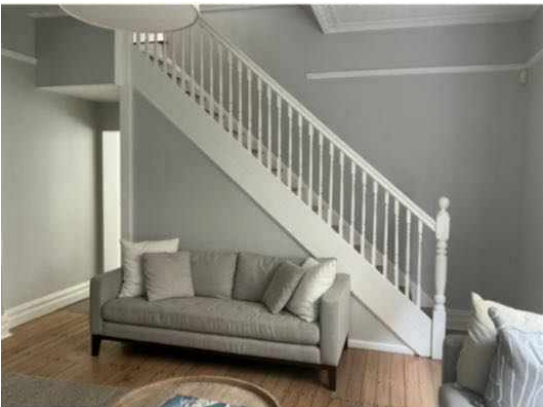
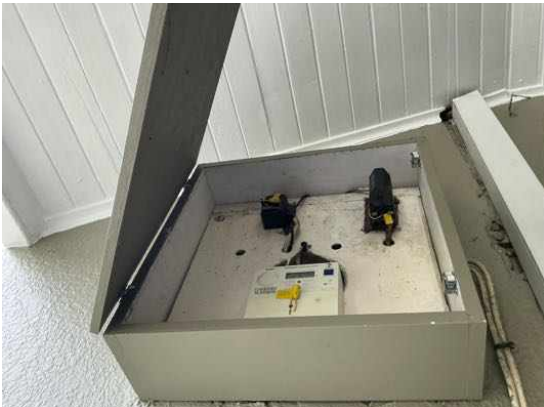
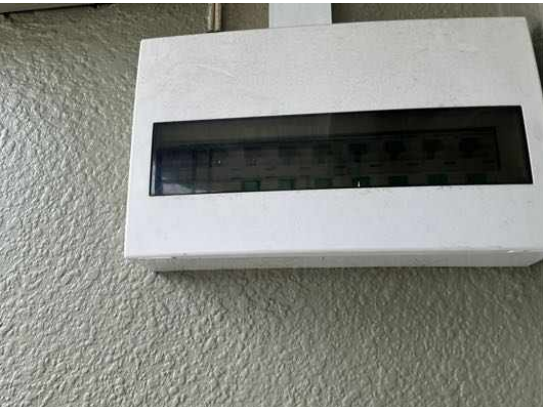
Some photos may also show obstructions and limitations which impeded full inspection of the property at the time of inspection. Additional photos also show other elements such as hot water systems and RCD switches (electrical safety switches) on power boxes.

This property has no insulation in the roof void as shown in the additional photos.
