Building and Timber Pest Inspection Report

Inspection Date: Thu, 26 Mar 2026

Property Address: 4/168 Narracan Dr, Newborough VIC 3825, Australia

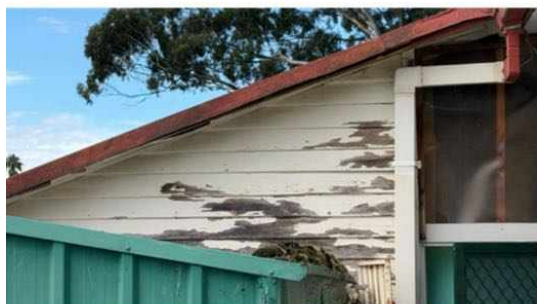
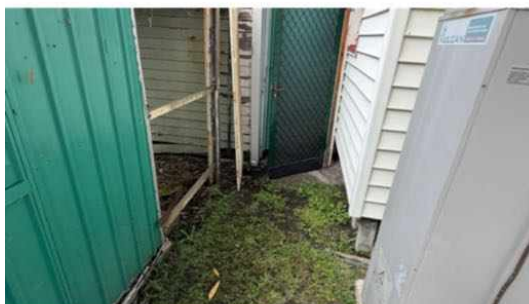
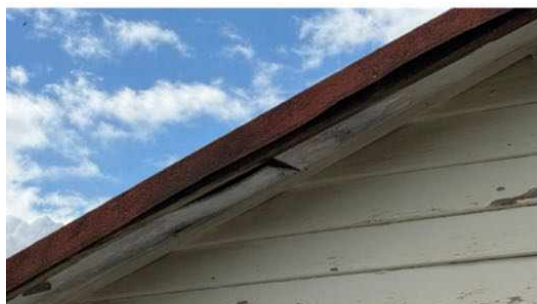
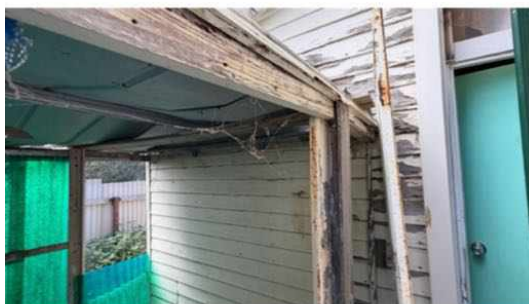
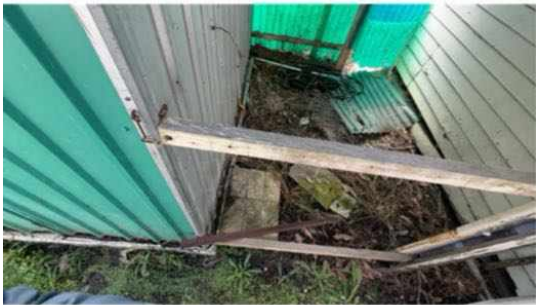
Finding 2.02

Building: Main Building
Location: Exterior walls - rear
Finding: Severely Deteriorated Rear Section
Information: The rear section of the property was observed to be in a severely deteriorated condition during the inspection. Extensive weathering of timber elements was noted, with multiple areas affected by wood rot. Damaged eaves and deteriorated roof flashings were also identified, indicating prolonged exposure to moisture and lack of maintenance.

This condition poses a risk of further structural deterioration if left unaddressed. Timber decay can compromise the integrity of affected building elements, and damaged eaves and flashings increase the likelihood of water ingress, which may lead to additional concealed damage over time.

It is strongly recommended that a registered builder and licensed roofing contractor be engaged to carry out a comprehensive assessment and undertake necessary repairs or replacement of the affected elements. Further investigation may be required to determine the full extent of damage.

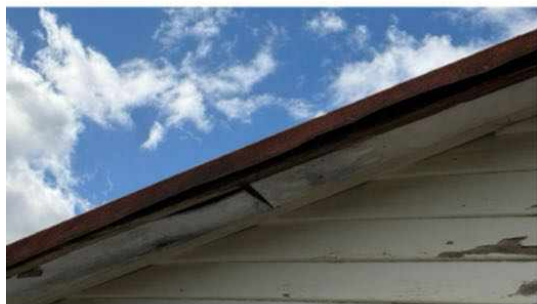
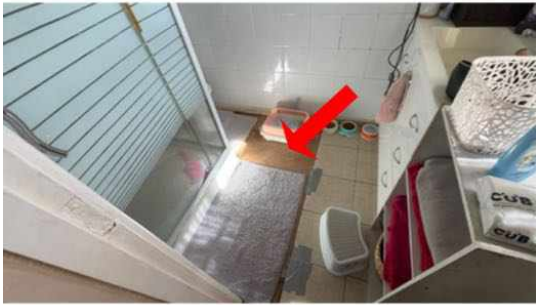
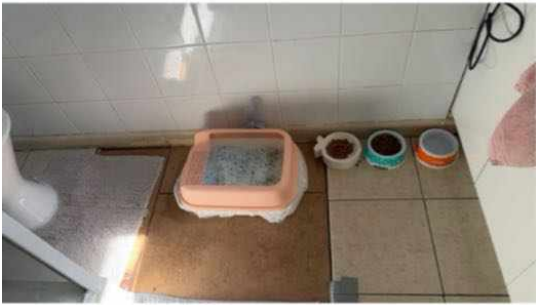
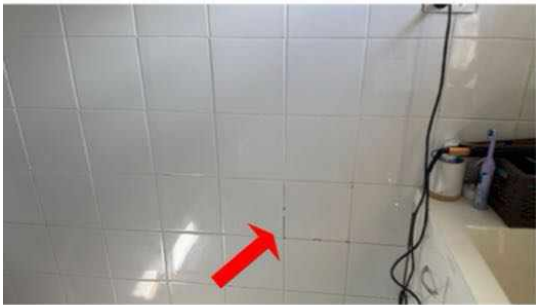
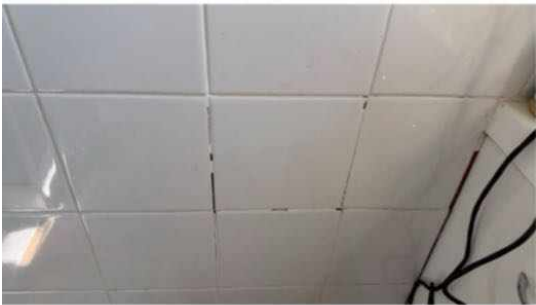
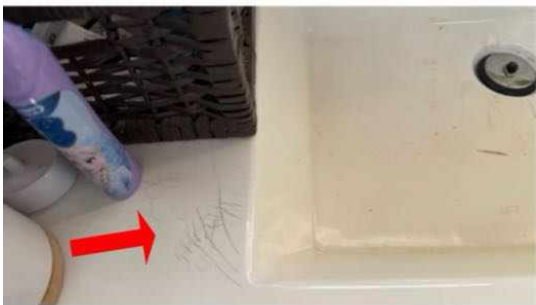
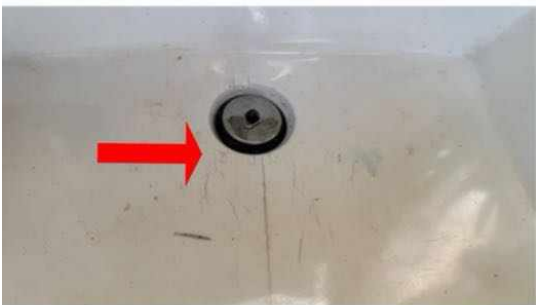
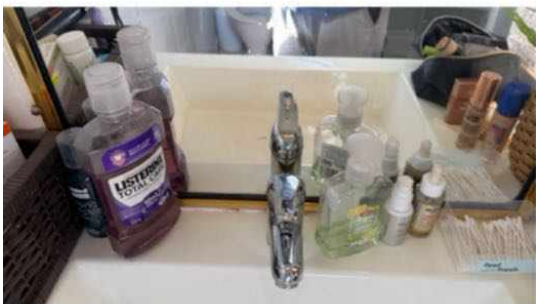
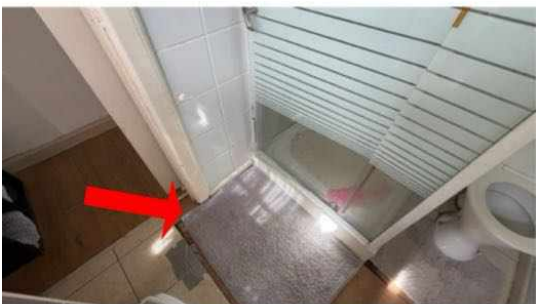
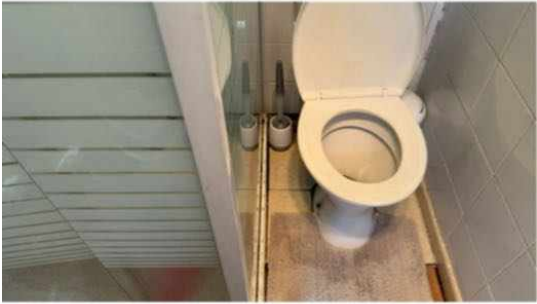
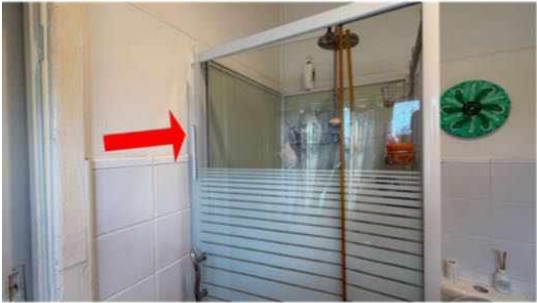
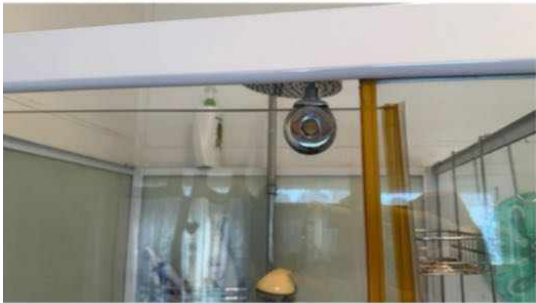
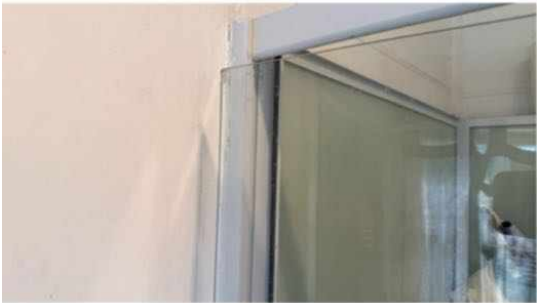
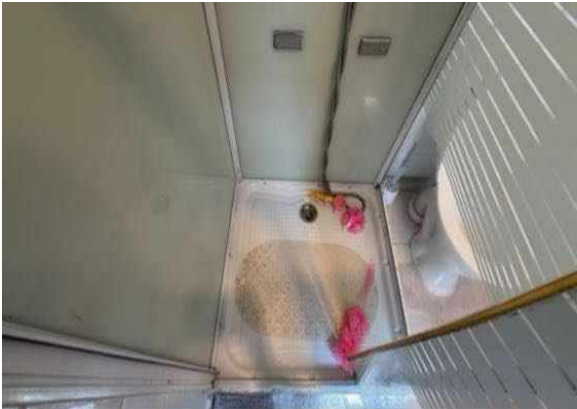
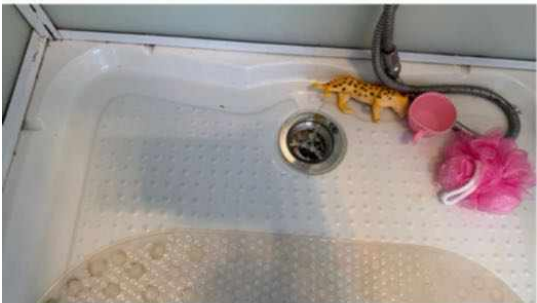
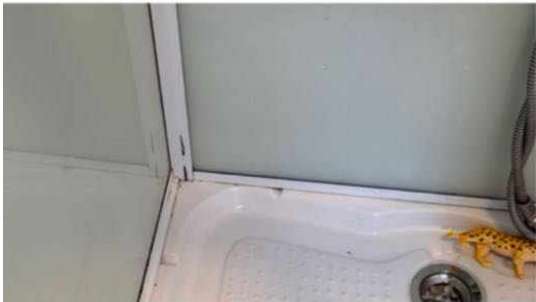
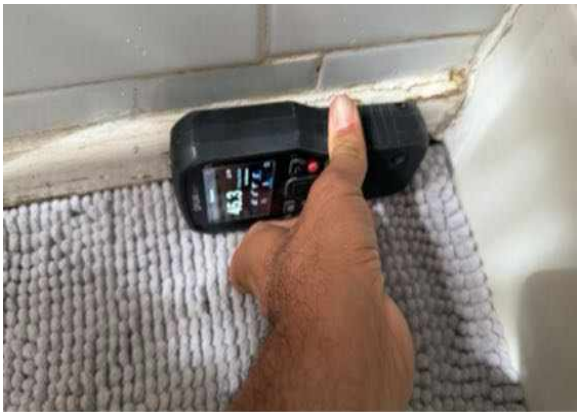
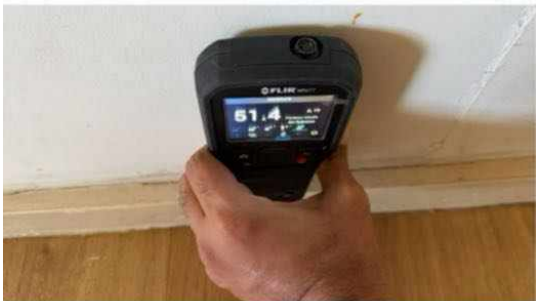
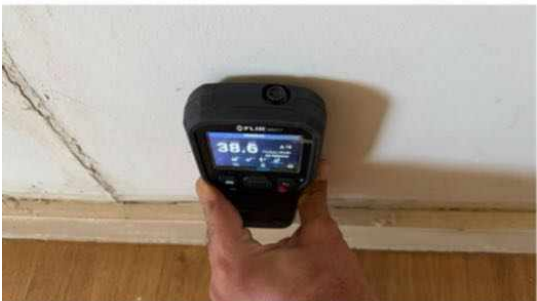
Finding 2.03

Building:	Main Building
Location:	Bathroom
Finding:	Major Bathroom Defects and Suspected Shower Leak
Information:	Significant defects were observed in the bathroom area during the inspection. Several floor tiles were missing and multiple floor tiles were cracked. Deteriorated grouts were also noted to tiled areas. The basin was found to be deteriorated, and the shower base was damaged. Shower door hardware was also faulty. Elevated moisture levels were recorded in multiple sections around the shower area, and severe wood rot was observed to timber elements near the shower and WC. These findings are consistent with a likely active and/or prolonged water leak originating from the shower area.

The extent of moisture ingress, deteriorated grouting, cracked and missing tiles, and timber decay indicates ongoing exposure to water, which may have resulted in concealed damage to adjacent structural and subfloor elements that were not visible at the time of inspection. Such conditions can compromise the integrity of affected building components and are conducive to termite infestation, increasing the risk of timber pest activity. Given the limitations of a visual, non-invasive inspection, the full extent of damage and underlying causes could not be determined.

An invasive inspection is considered essential to accurately determine the source and extent of the leak and any associated damage. It is strongly recommended that a licensed plumber be engaged to investigate and rectify the leak, and a registered builder be appointed to assess and carry out all necessary repairs and reinstatement works as soon as possible. Delay in addressing this issue may lead to further deterioration and increased repair costs.

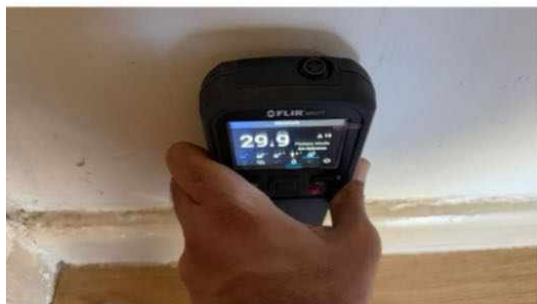
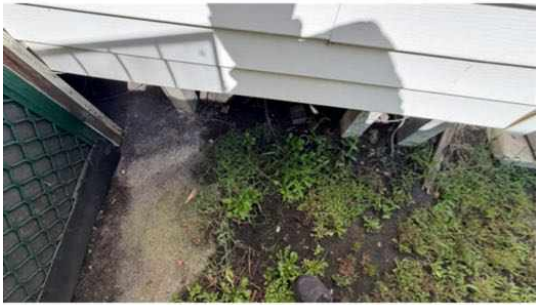
Finding 2.04

Building:	Main Building
Location:	Subfloor
Finding:	Severe Subfloor Damp Conditions
Information:	Severe damp conditions were identified in multiple sections of the subfloor, predominantly at the rear side of the property. Elevated moisture levels were noted to the subfloor environment, and supporting stumps were found to be damp at the base. This condition may be associated with a potential leak from the adjacent bathroom and/or inadequate site drainage; however, this assessment is based on a visual, non-invasive inspection only, and the exact source of moisture could not be conclusively determined.

Prolonged damp conditions within the subfloor can adversely affect the performance and durability of structural elements, including stumps, bearers, and joists. Continued exposure to moisture may lead to timber decay, weakening of structural components, and creates an environment conducive to termite infestation. It is also possible that concealed damage exists to subfloor elements that were not visible at the time of inspection.

An urgent and thorough investigation is required. It is strongly recommended that a licensed plumber be engaged to identify and rectify any plumbing leaks, and a registered builder be appointed to assess the condition of subfloor structural elements and carry out necessary remedial works. An invasive inspection may be required to determine the full extent of damage. Immediate attention is advised to mitigate further deterioration.

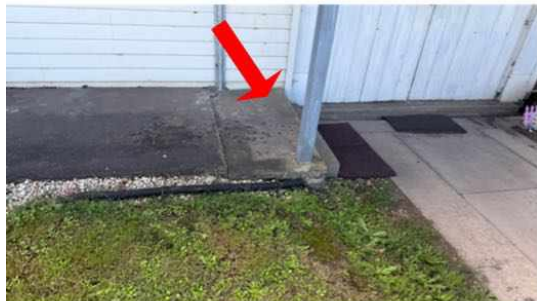
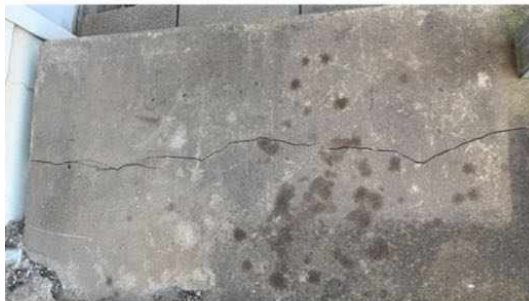
Finding 3.01

Building:	Main Building
Location:	Porch
Finding:	Cracking to Porch Concrete Paving
Information:	Cracking was observed in the concrete paving at the porch area during the inspection. This may be associated with minor ground movement, settlement of the supporting base, or inadequate site drainage contributing to soil movement beneath the slab.

While the extent of cracking appeared limited at the time of inspection, ongoing movement or poor drainage conditions may lead to further deterioration, widening of cracks, and potential unevenness of the surface, which may become a trip hazard over time.

It is recommended that the area be monitored for any progression of cracking or movement. If deterioration continues, a registered builder or concreting specialist should be engaged to assess the cause and carry out appropriate remedial works. Improving site drainage around the area may also be required to prevent further movement.

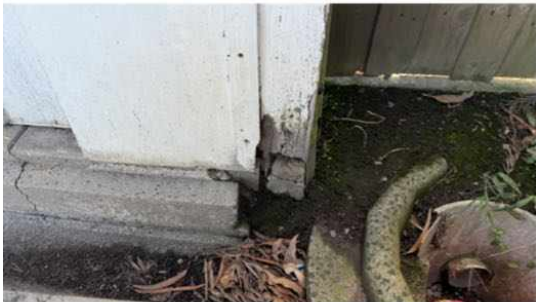
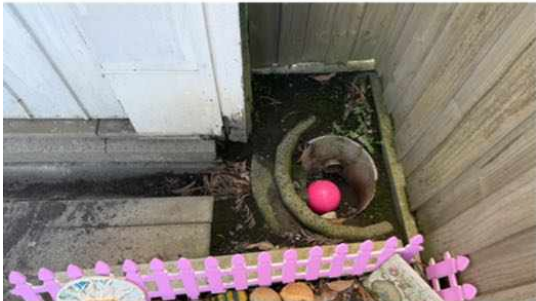
Finding 3.02

Building:	Main Building
Location:	All Areas
Finding:	Inadequate Site Drainage
Information:	The site drainage around the property was observed to be inadequate, resulting in water accumulating near the building perimeter and creating damp conditions. This may be due to poor grading, insufficient fall away from the structure, or ineffective stormwater management. Timber elements in contact with or close to the ground were also noted to have wood rot, likely as a result of prolonged moisture exposure.

Prolonged damp conditions can contribute to deterioration of building materials,

weakening of structural elements over time, and may lead to moisture ingress into the dwelling. The observed timber decay further indicates ongoing moisture issues. Additionally, such conditions are conducive to termite infestation, increasing the risk of timber pest activity.

It is recommended that a licensed plumber or drainage specialist be engaged to assess and rectify site drainage, including improving surface grading and ensuring proper connection to the stormwater system. Decayed timber elements should be repaired or replaced by a registered builder, and appropriate measures should be implemented to prevent further moisture exposure and maintain a dry perimeter around the structure.

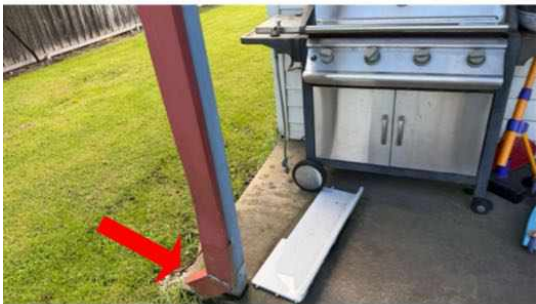
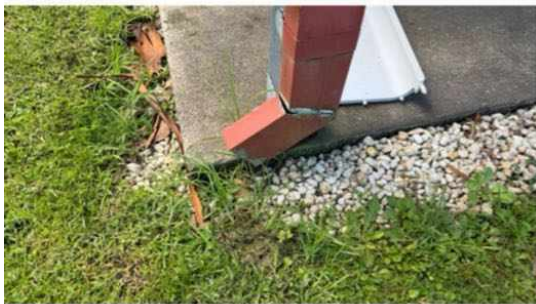
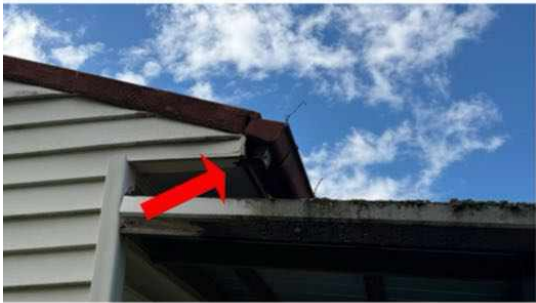
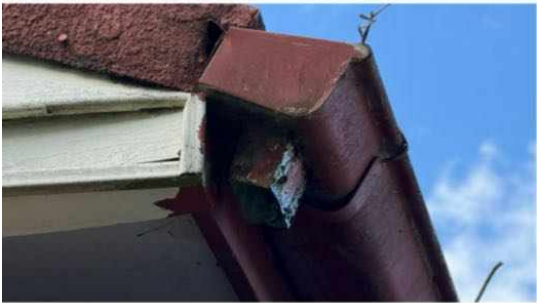
Finding 3.03

Building: Main Building
Location: All Areas
Finding: Downpipes Not Connected to Stormwater System
Information: Several downpipes were observed to be disconnected or not connected to the stormwater drainage system during the inspection. As a result, roof water is likely discharging directly at the base of the structure.

This condition can lead to localised dampness, soil saturation, and potential moisture ingress into the building. Prolonged exposure may contribute to deterioration of footings, external building elements, and create conditions conducive to termite infestation.

It is recommended that a licensed plumber be engaged to connect all downpipes to an appropriate stormwater drainage system to ensure effective discharge of roof water away from the structure.

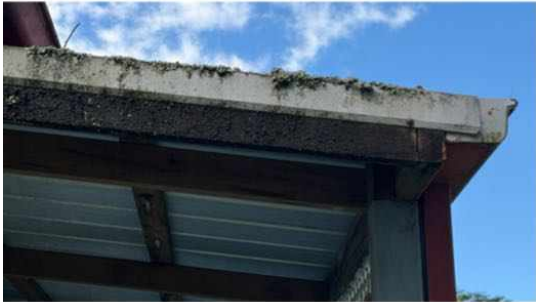
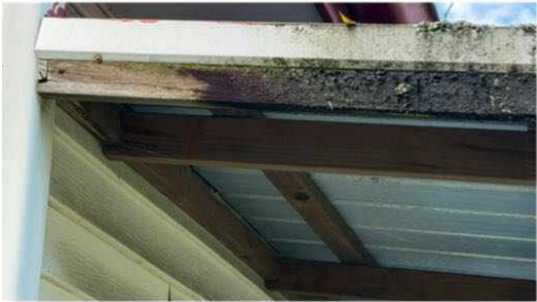
Finding 3.04

Building: Main Building
Location: Roof Exterior
Finding: Deteriorated Roof Flashings
Information: Roof flashings were observed to be severely deteriorated, with significant rusting evident to the metal components. This condition is likely due to prolonged exposure to weather and lack of maintenance over time.

Deteriorated flashings may compromise the weatherproofing of the roof, increasing the risk of water ingress into the building. If left unaddressed, this may lead to internal water damage, timber decay, and deterioration of surrounding structural elements.

It is recommended that a licensed roofing contractor be engaged to inspect, repair, or replace the affected flashings as required. Further investigation may be necessary to assess any underlying damage caused by potential water ingress.

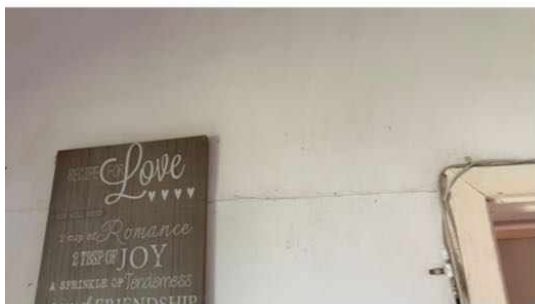
Finding 3.05

Building:	Main Building
Location:	All Areas
Finding:	Cracking to Plasterboard Walls and Ceiling
Information:	Several cracks were observed to plasterboard walls and ceiling areas during the inspection. These are likely attributed to a combination of structural movement and general wear and tear due to poor maintenance over time.

While some cracking may be cosmetic, ongoing structural movement can lead to widening of cracks and potential deterioration of internal finishes. If left unaddressed, this may affect the integrity and appearance of the affected surfaces.

It is recommended that the cracks be monitored for any progression. If movement continues or cracks widen, a registered builder should be engaged to assess the cause and carry out appropriate repairs. Rectification of finishes may also be required once the underlying cause is addressed.

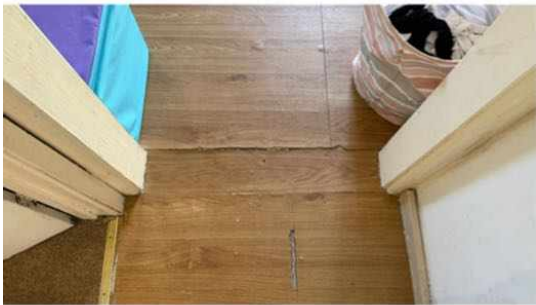
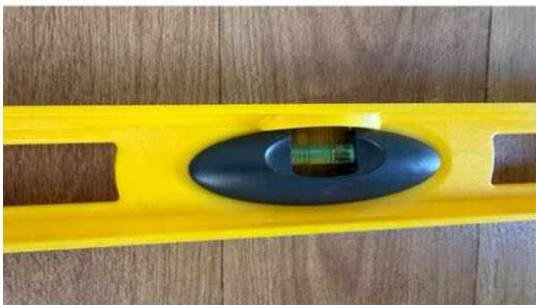
Finding 3.06

Building:	Main Building
Location:	All Areas
Finding:	Deteriorated Floating Floor
Information:	The floating floor was observed to be deteriorated and uneven, with noticeable movement underfoot during the inspection. This condition is likely associated with underlying structural movement or issues with the subfloor, resulting in loss of stability and support.

If left unaddressed, the condition may worsen over time, leading to further deterioration of the flooring system, increased unevenness, and potential safety hazards. It may also indicate underlying structural concerns that require further investigation.

It is highly recommended that a registered builder be engaged to assess the extent of the issue, identify the underlying cause, and carry out appropriate remedial works. Further investigation may be required to determine the condition of the subfloor and supporting elements.

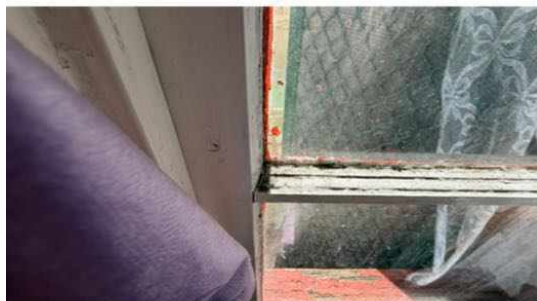
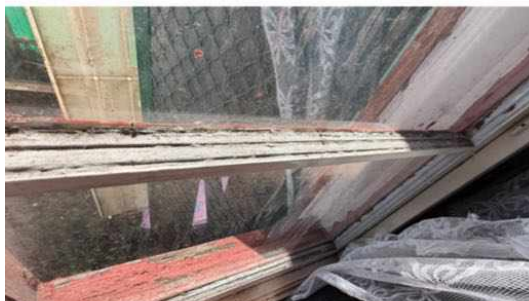
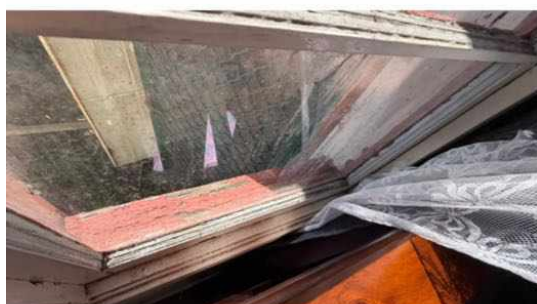
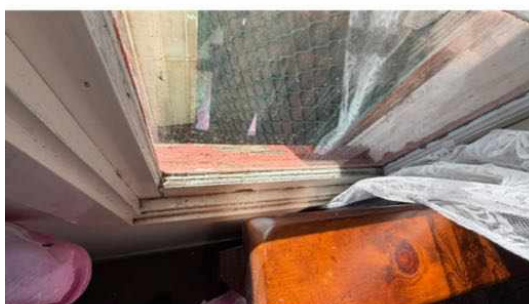
Building:	Main Building
Location:	Bedrooms
Finding:	Weathered Window Frames and Deteriorated Seals
Information:	Several window frames at the rear side of the property were observed to be weathered, with deterioration to the associated seals. This is likely due to prolonged exposure to external elements and lack of maintenance over time.

Deteriorated seals and weathered frames may compromise the weatherproofing of the windows, increasing the risk of water ingress, air leakage, and potential deterioration of surrounding building elements if left unaddressed.

It is recommended that a qualified tradesperson or window specialist be engaged to

repair or replace the affected seals and assess the condition of the frames. Ongoing maintenance or replacement may be required to ensure proper performance and durability.

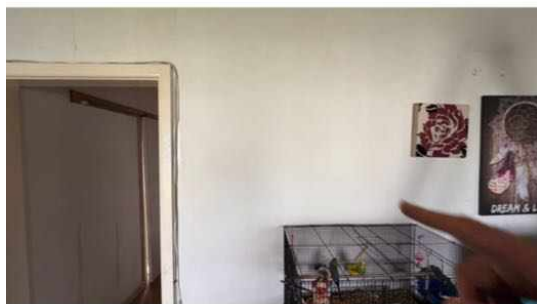
Finding 3.09

Building:	Main Building
Location:	All Areas
Finding:	Disjointed Plasterboard Walls
Information:	Sections of plasterboard walls were observed to be disjointed during the inspection. This condition is likely associated with movement within the structure, poor installation, or deterioration of fixings over time.

Disjointed plasterboard may indicate underlying movement or stress within the building and can lead to further cracking, separation of joints, and deterioration of internal finishes if left unaddressed.

It is recommended that the affected areas be monitored for any further movement. If the condition worsens, a registered builder should be engaged to assess the underlying cause and carry out appropriate repairs.

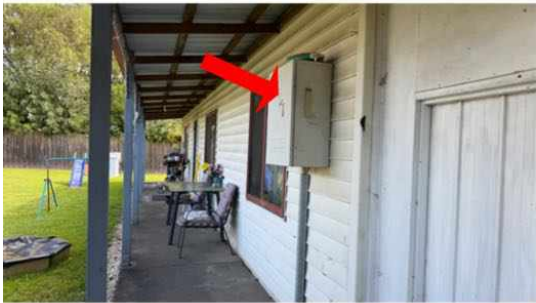
Building:	Main Building
Location:	Meter Box
Finding:	Termite Management System - no evidence of a chemical installation
Information:	The application of a post-construction chemical termite barrier is highly recommended for all properties, particularly if live termite activity has been found on the site previously. Such barriers are highly effective in preventing termite attack on any timber building elements throughout the property.

A durable notice should be placed in the switchboard unit to indicate current termite barriers. At the time of inspection, it appeared as though no termite management system has been installed, with no evidence to suggest preventative works taking place.

The client may consider gaining further advice from a pest controller as to the costs and procedures involved with this application. It is recommended that obtaining such advice be a short-term priority.

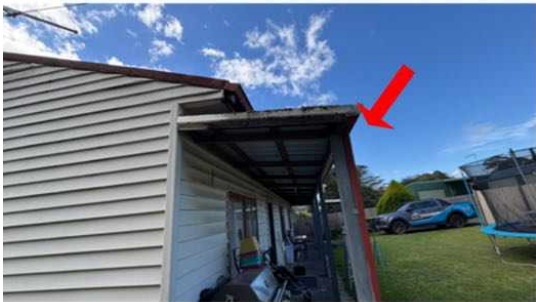
Finding 6.02

Building: Main Building
Location: All Areas
Finding: Downpipes Not Connected to Stormwater System
Information: Several downpipes were observed to be disconnected or not connected to the stormwater drainage system during the inspection. As a result, roof water is likely discharging directly at the base of the structure.

This condition can lead to localised dampness, soil saturation, and potential moisture ingress into the building. Prolonged exposure may contribute to deterioration of footings, external building elements, and create conditions conducive to termite infestation.

It is recommended that a licensed plumber be engaged to connect all downpipes to an appropriate stormwater drainage system to ensure effective discharge of roof water away from the structure.

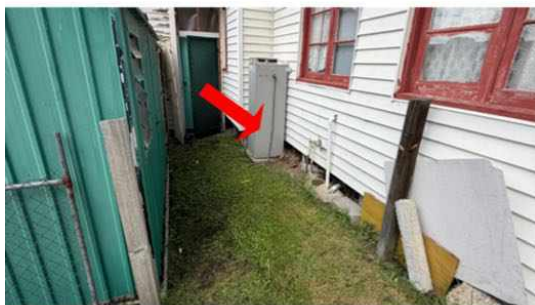
Finding 6.03

Building:	Main Building
Location:	All External Areas
Finding:	HWS Overflow - Not Connected
Information:	The Hot Water System (HWS) overflow was found to be disconnected from storm water drainage and is creating excessive moisture in the surrounding area.

These damp conditions can lead to secondary defects such as rot, rust or corrosion of associated building elements, the formation of fungal decay, or even the creation of potential slip hazards. When coupled with poor site drainage, pooling of water may also attract termite activity to this area.

It is highly recommended that a licensed plumber be appointed to connect the HWS overflow in order to prevent such an environment from being created. These minor works should be carried out as soon as possible.

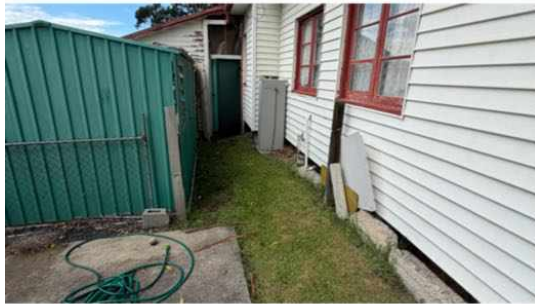
Finding 6.04

Building:	Main Building
Location:	All External Areas
Finding:	Bridging - Attachments to Buildings
Information:	Bridging occurs when items against a building provide a concealed entry point for

Where any part of an attachment to a building is not isolated and is not provided with a clear gap of not less than 25mm from the building, bridging occurs. Attachments to buildings such as hot water services, downpipes, verandahs, decks, steps, fences, service conduits are the like provide the opportunity for concealed entry.

Building attachments of this nature need to be frequently inspected for termite activity by a qualified inspector.

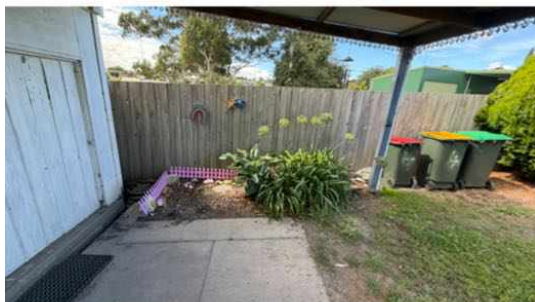
Finding 6.05

Building:	Main Building
Location:	All External Areas
Finding:	Garden Beds - Conditions Conducive to Termites
Information:	Garden beds were found to be evident in the garden area. These garden beds can include untreated timber, and with a combination of moisture from watering hosing can make conditions conducive to termite activity and termite ingress.

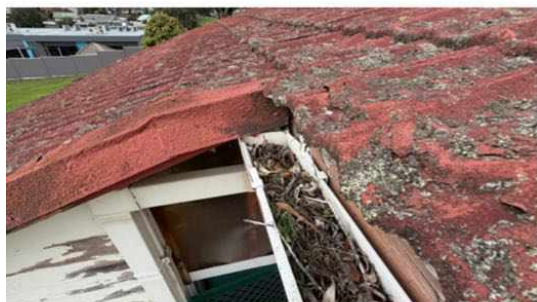
Information: During the inspection, debris accumulation was noted in the guttering and downpipes. Blocked gutters can cause water to pool and overflow, leading to excessive moisture around eaves, fascia boards, and exterior walls. Where gutter guards are installed, regular maintenance is essential to remove any debris that may settle on top or filter through. Prolonged exposure to moisture in these areas creates conditions conducive to timber decay and potential termite or timber pest activity.

Excess moisture resulting from blocked gutters can accelerate timber deterioration, increasing the risk of fungal decay and attracting timber pests such as termites. Moisture-damaged timber is highly susceptible to infestation, as pests are drawn to damp and softened wood. If left unaddressed, this issue can lead to structural weakening and costly remediation work.

It is strongly recommended that all blockages in the gutters and downpipes be cleared immediately to maintain dry conditions and reduce the risk of timber pest activity. Homeowners or a general handyperson can perform routine cleaning; however, a licensed plumber should be consulted for further assessment and any necessary

remedial work. Ongoing gutter maintenance is crucial in preventing future moisture-related timber issues.

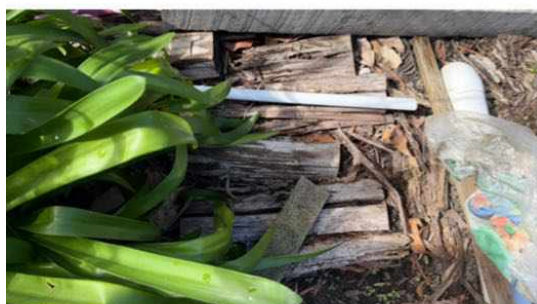
Finding 6.08

Building:	Main Building
Location:	All External Areas
Finding:	Timber debris - exterior areas & subfloor space
Information:	Timber debris were found in the exterior areas & subfloor space at the time of inspection. The storing of timbers in the subfloor space or around the external property increases the risk of termite activity being present. As they are likely to come into contact with weather conditions or excessive moisture wood rot is likely to develop on timbers that are not treated.

It is highly recommended that any stored timbers be immediately removed from areas in which they may attract any termite / timber pest attack. Minimisation of risk / prevention of termite attack is far more adequate than dealing with the presence of termite activity.

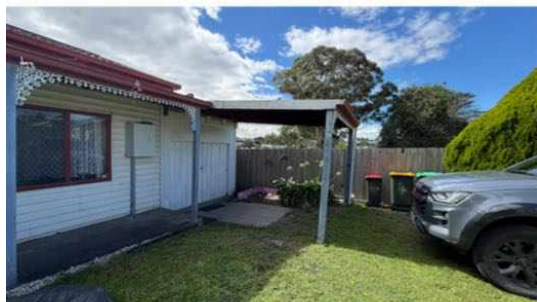
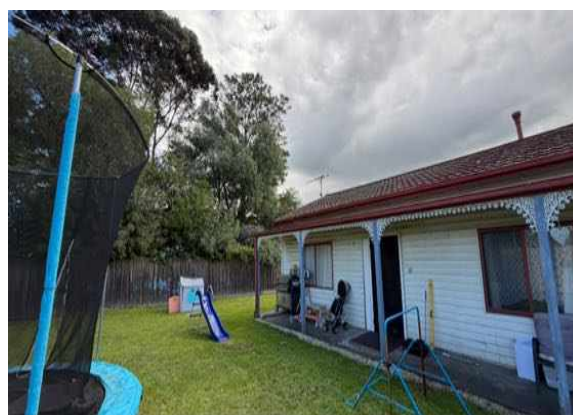
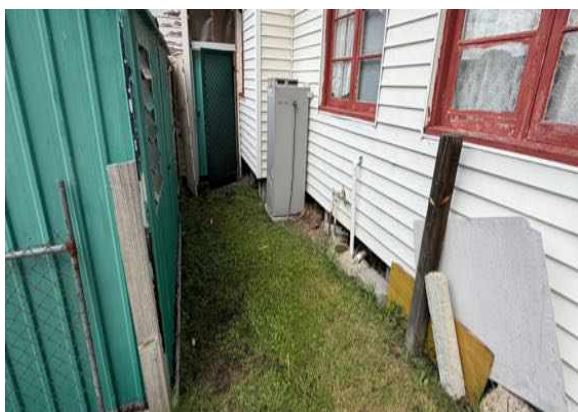
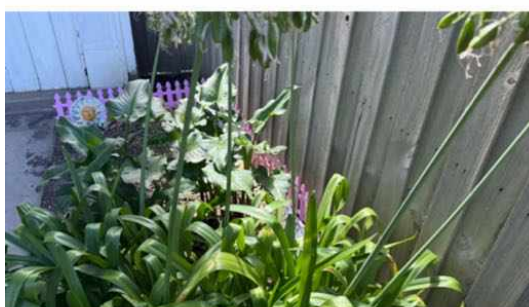
Building: Main Building
 Location: All External Areas
 Finding: Obstructions and Limitations - External areas
 Information: These photographs are an indication of the obstructions and limitations which impeded full inspection of the external areas of the property at the time of inspection. These obstructions can hide an array of defects and should be removed to allow full inspection to be carried out. A re-inspection is recommended once the areas are made accessible.

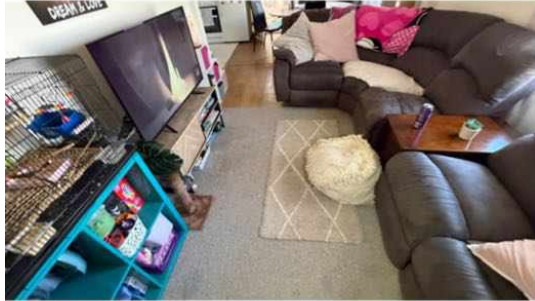
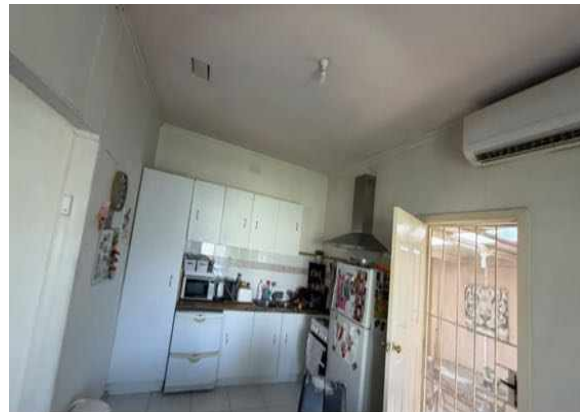
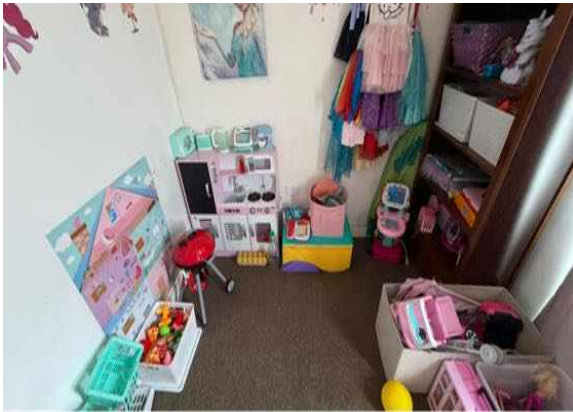
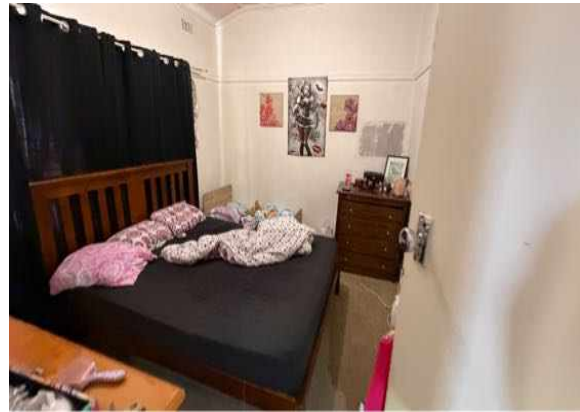
Building: Main Building
 Location: All Internal Areas
 Finding: Obstructions and Limitations - Internal areas
 Information: These photographs are an indication of the obstructions and limitations which impeded full inspection of the internal areas of the property at the time of inspection.

These obstructions can hide an array of defects and should be removed to allow full inspection to be carried out. A re-inspection is recommended once the areas are made accessible.

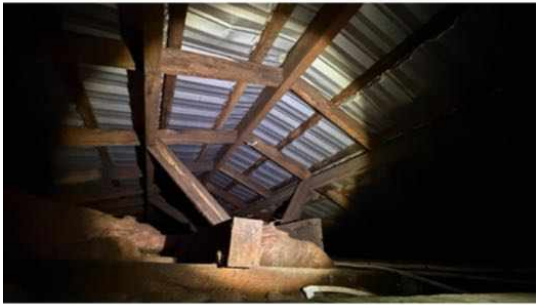
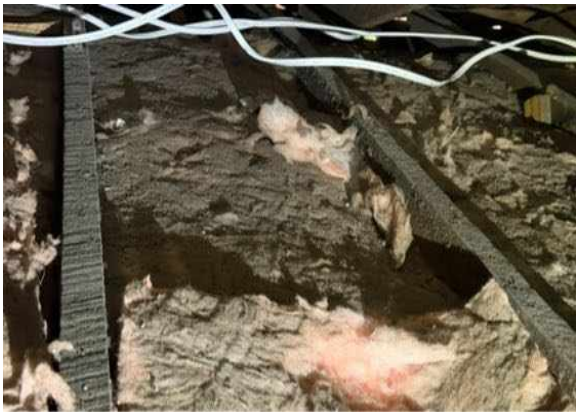
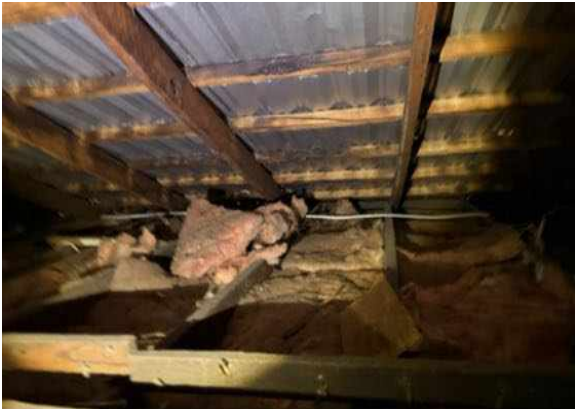
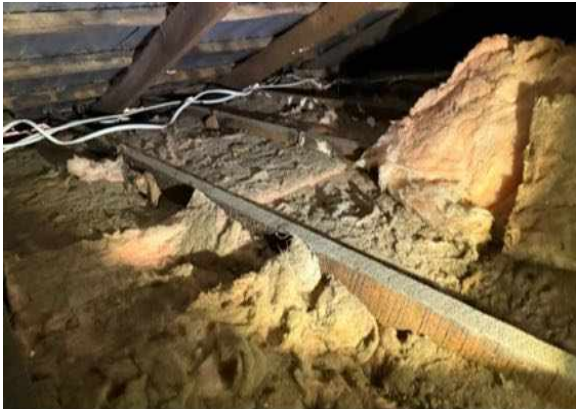
Building:	Main Building
Location:	Roof Void
Finding:	Obstructions and Limitations - Roof Cavity
Information:	These photographs are an indication of the obstructions and limitations which impeded full inspection of the roof cavity of the main building at the time of inspection. These obstructions can hide an array of defects and should be removed to allow full inspection to be carried out. A re-inspection is recommended once the areas are made accessible.

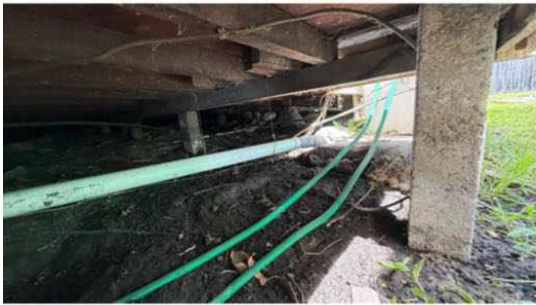
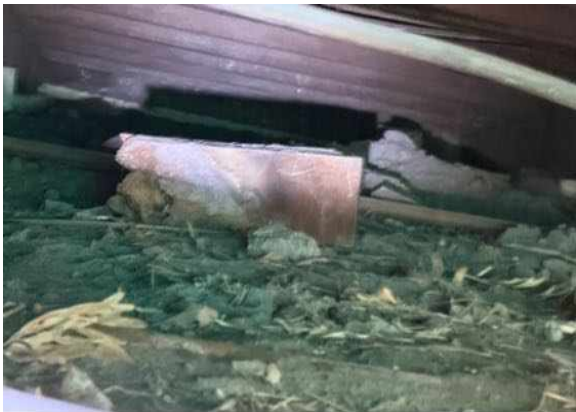
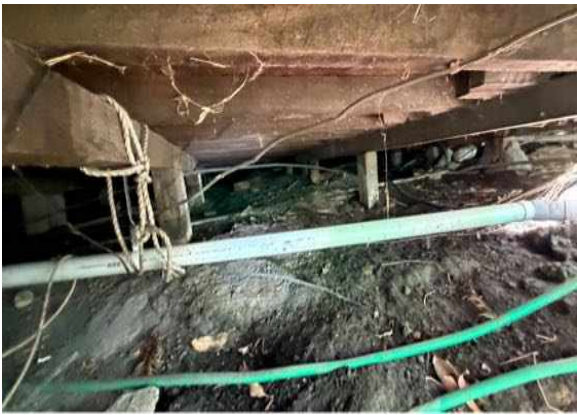
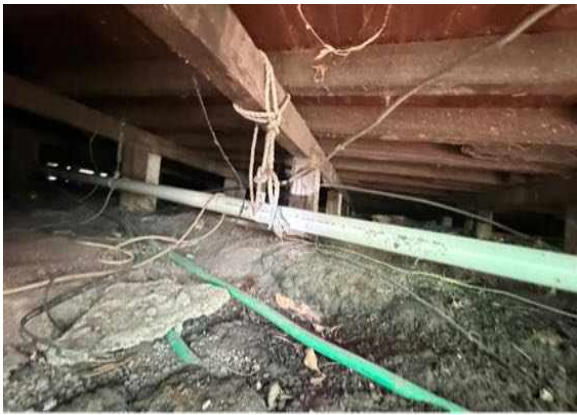
Building: Main Building
Location: Subfloor
Finding: Obstructions and Limitations - Subfloor
Information: These photographs are an indication of the obstructions and limitations which impeded full inspection of the subfloor of the main building at the time of inspection. These obstructions can hide an array of defects and should be removed to allow full inspection to be carried out. A re-inspection is recommended once the areas are made accessible.
