Building and Timber Pest Inspection Report

Inspection Date: Tue, 17 Mar 2026

Property Address: 8 Finlayson St, Wollongong NSW 2500,
Australia

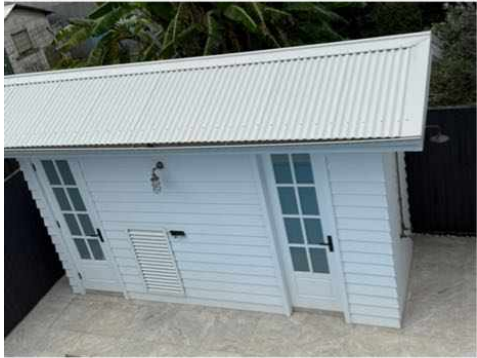
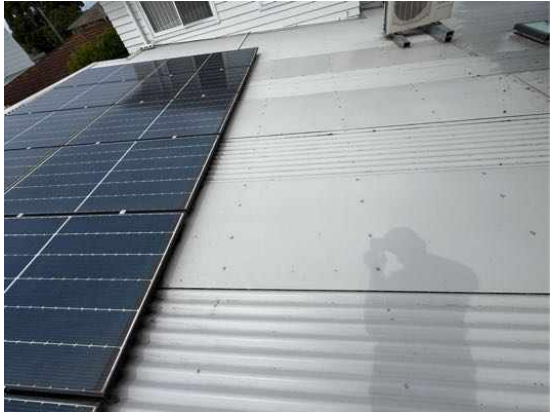
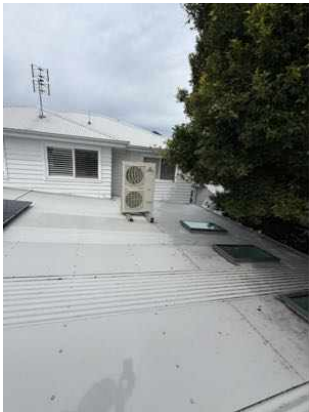
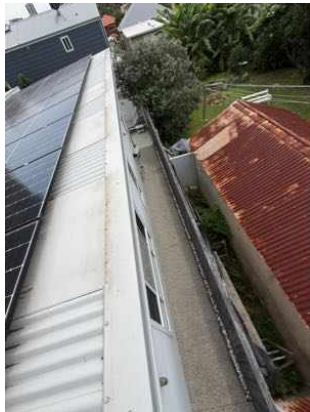
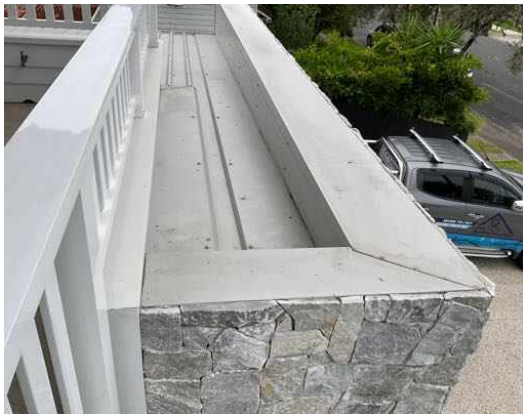
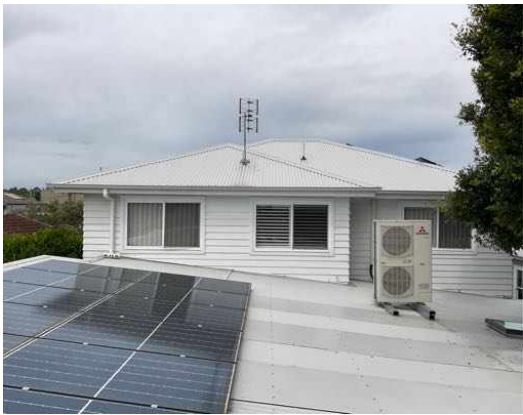
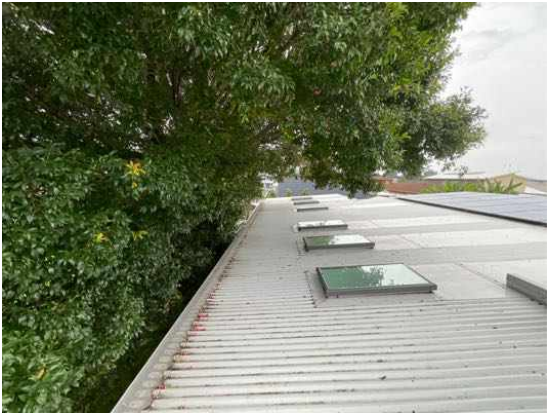
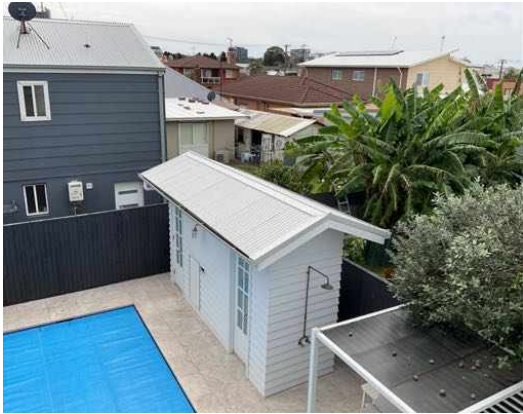
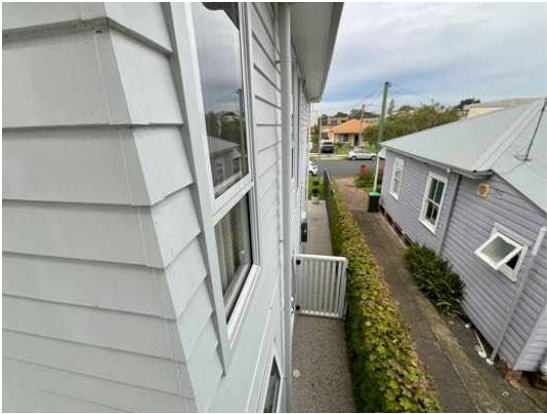
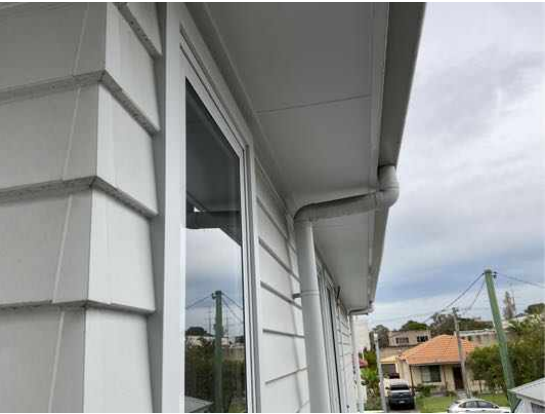
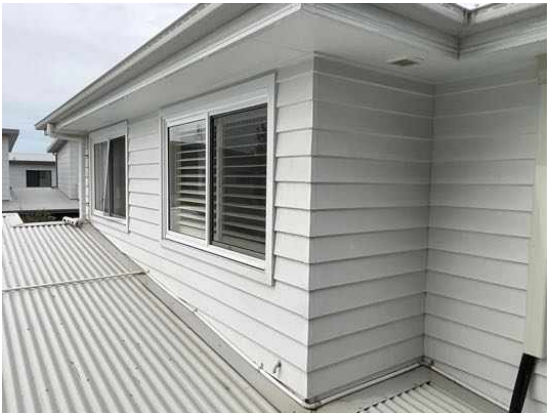
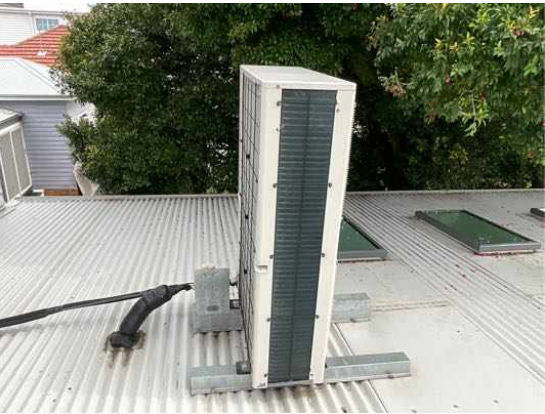
Finding 3.01

Building: Building 1
Location: Roof Exterior
Finding: Additional Photos
Information: Additional photos are provided for your general reference

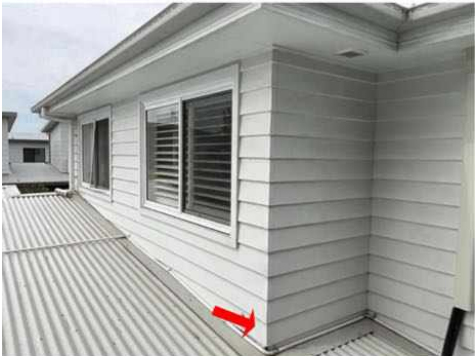
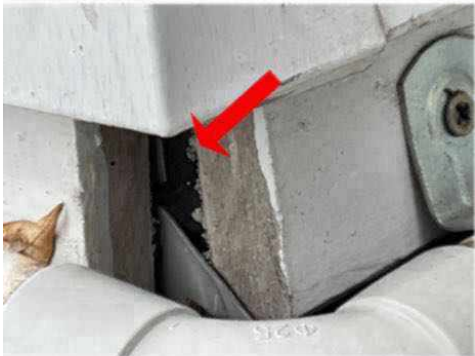
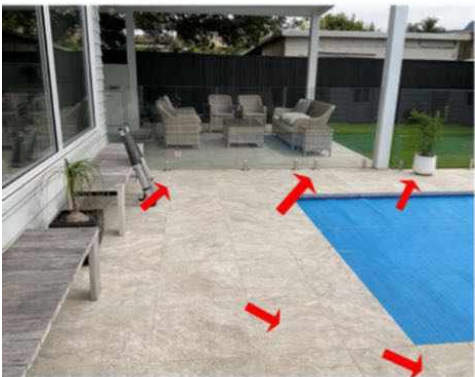
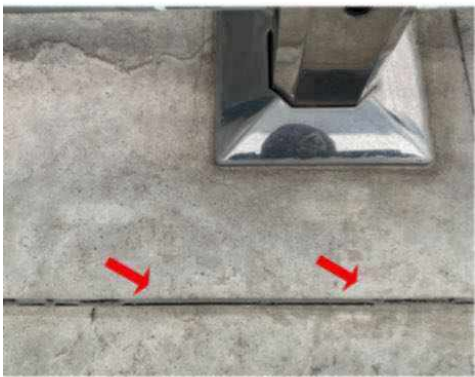
Building: Building 1
Location: Exterior walls and rear tiles
Finding: Sealant (external) - missing
Information: It was noted on inspection that areas of external sealant was missing to these pictured wall and window areas.

It is suspected if the front cladding is not sufficiently sealed, some of this cladding will detach from the front gages wall.

Flexible sealants should be applied to these affected areas to prevent any subsequent water damage that is likely to occur.

A sealant specialist or skilled handy person should be appointed to complete these works as soon as possible

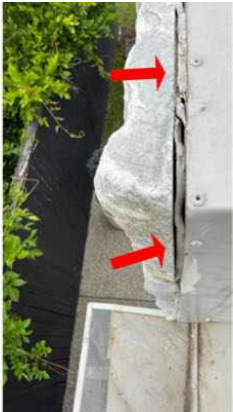
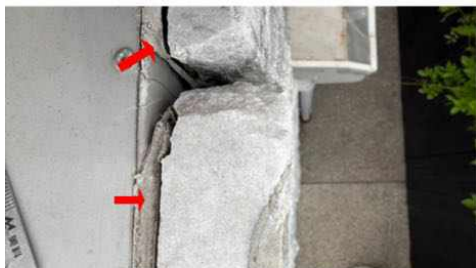
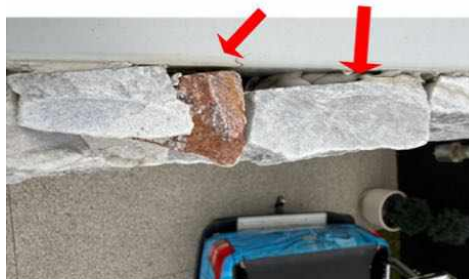
Finding 3.06

Building: Building 1
Location: Exterior front wall
Finding: Sealant to garage wall missing (continued)
Information:

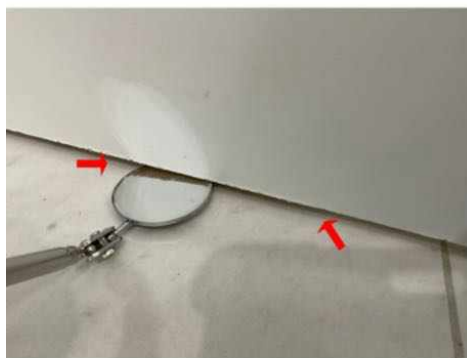
Building:	Building 1
Location:	Pictured areas
Finding:	Painting deteriorated
Information:	Some of the external and other paintwork require attention to prepare and re-paint.

Whilst incomplete or missing paint finish is generally an appearance defect, it can also lead to the development of secondary building defects over time. Incomplete areas of paint finish expose the area to moisture, potentially accelerating the deterioration of underlying building materials.

Incomplete paint finishes should be sanded back, filled, leveled and painted, as applicable. Where inadequate or missing paint protection has led to the deterioration of the associated building element, repair and/or replacement of this building element may be required.

A painting contractor should be appointed as soon as possible to perform necessary works to aid the appearance of the affected area and to ensure the area is protected against further deterioration. Alternatively, the homeowner following manufacturer instructions may perform these works.

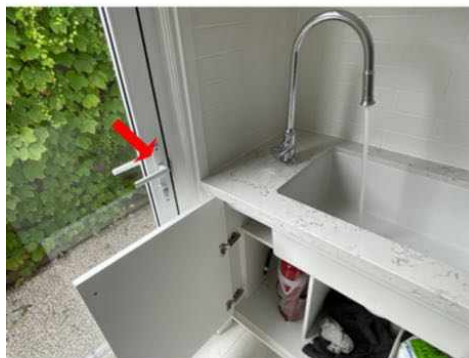
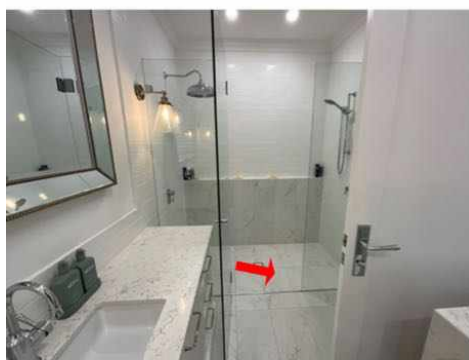
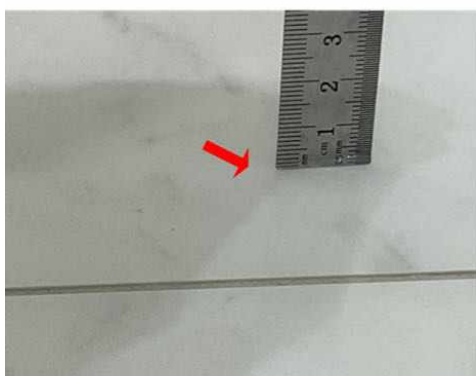
Finding 3.11

Building:	Building 1
Location:	Pictured external areas
Finding:	Building elements damaged or loose.
Information:	Evidence of minor missing or damaged areas was identified at the time of the inspection. These include -

A carpenter would be the trade responsible for rectification of these areas when convenient.

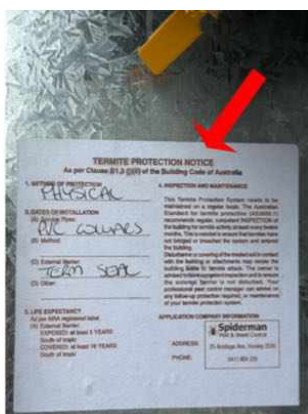
A durable notice should be placed in the switchboard unit to indicate current termite barriers. At the time of inspection, no durable notice was evident and it appeared as though no chemical termite management system has been installed, with no evidence to suggest preventative works taking place since the property was built.

The client may consider gaining further advice from a pest controller as to the costs and procedures involved with a 'chemical' application. It is recommended that obtaining such advice be a short-term priority.

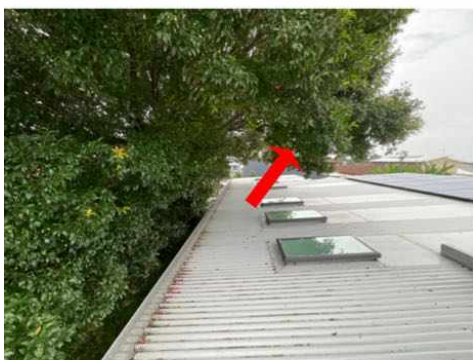
Gutters are a critical part of the building's management of storm water and rain. It is therefore important that they be kept clear to prevent secondary damage to associated building elements, including exterior and interior walls, ceiling linings and any adjoining building elements. Where gutters are blocked, pooling of rainwater is likely to occur, fast-tracking rust and corrosion of the roof plumbing elements.

It is highly advised that all overhanging tree branches be removed as soon as possible to prevent any further damage. Such works should be performed by the homeowner; however, appointment of a landscape contractor or an arborist may be required.

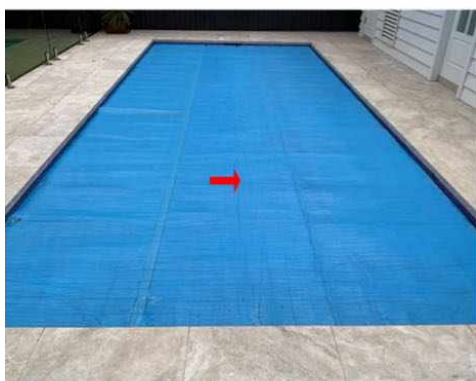
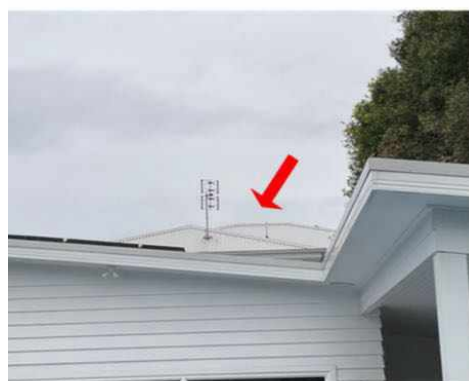
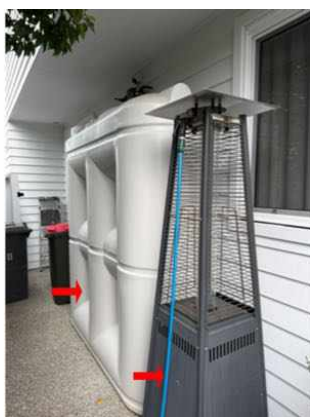
Noted Item

Building: Building 1
 Location: All External Areas
 Finding: Additional Photos - Obstructions and Limitations of EXTERNAL AREAS
 Information: These photographs are an indication of the obstructions and limitations which impeded full inspection of external areas at the time of inspection. These obstructions can hide an array of defects and should be removed to allow full inspection to be carried out. A re-inspection is recommended once the areas are made accessible.

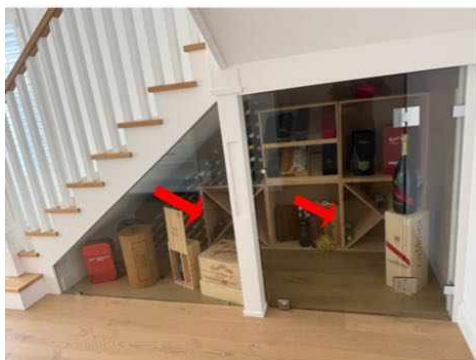
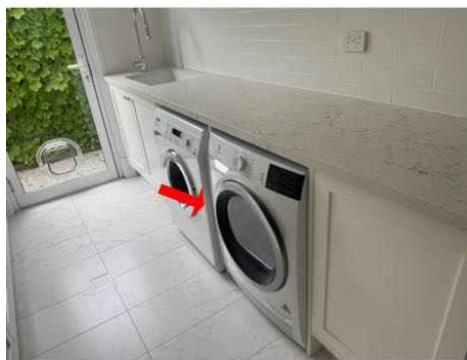
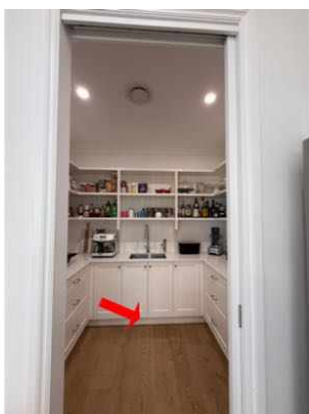
Noted Item

Building: Building 1
 Location: All Internal Areas
 Finding: Additional Photos - Obstructions and Limitations of INTERNAL AREAS
 Information: These photographs are an indication of the obstructions and limitations which impeded full inspection of Internal areas at the time of inspection. These obstructions can hide an array of defects and should be removed to allow full inspection to be

carried out. A re-inspection is recommended once the areas are made accessible.

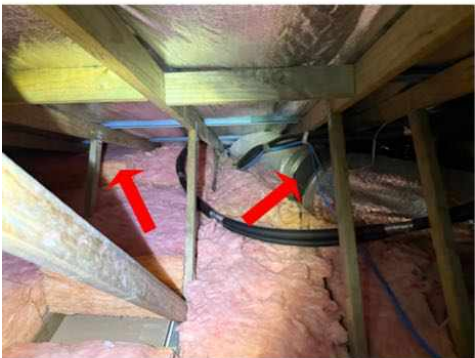
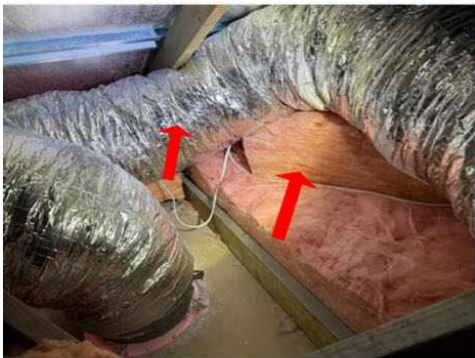
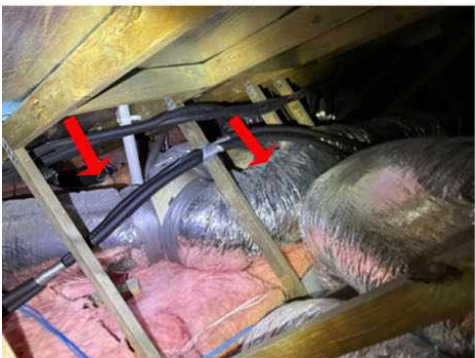
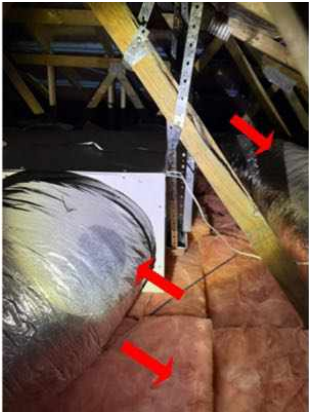
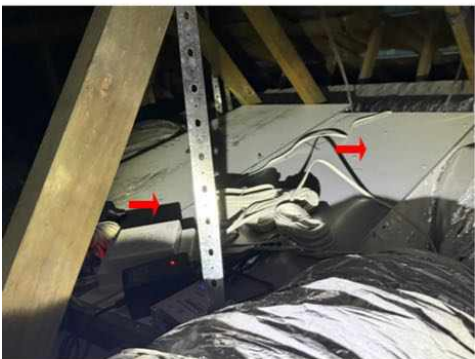
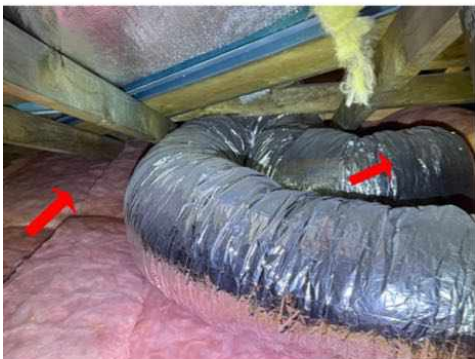
Noted Item

Building: Building 1
 Location: All Roof cavity areas
 Finding: Additional Photos - Obstructions and Limitations of the ROOF CAVITY
 Information: These photographs are an indication of the obstructions and limitations which impeded full inspection of roof cavity areas at the time of inspection. These obstructions can hide an array of defects and should be removed to allow full inspection to be carried out if applicable. A re-inspection is recommended once the areas are made accessible.

The inspection was also limited to areas with an allowable crawl space of 600mm x 600mm, in particular towards the external walls where the roof line diminishes, these areas were not accessible.

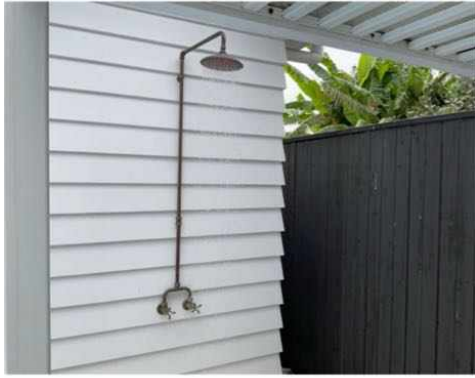
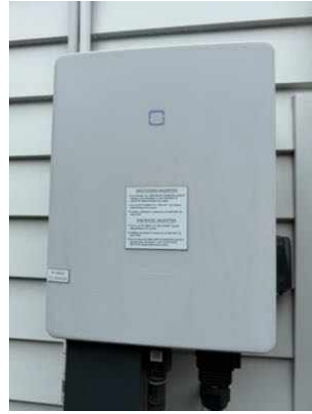
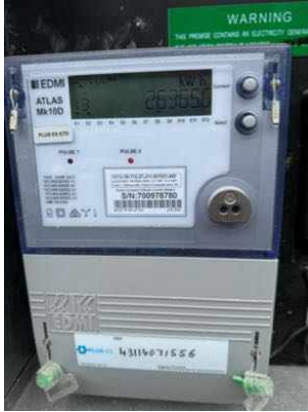
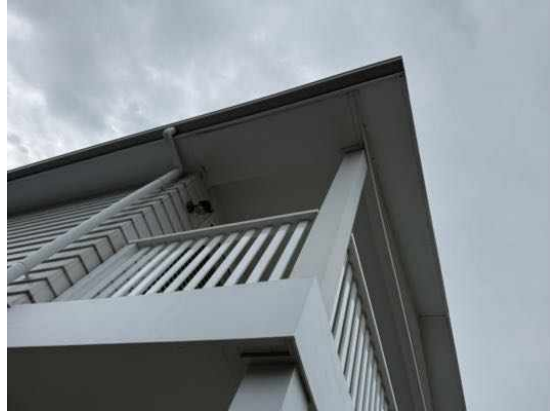
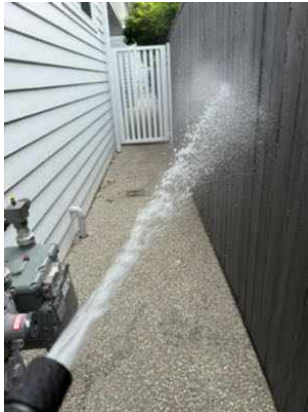
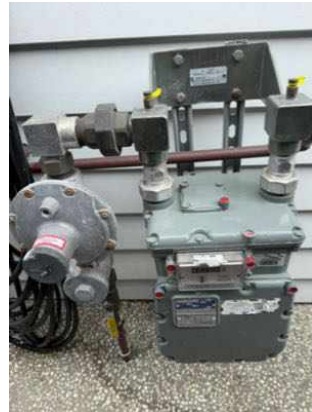
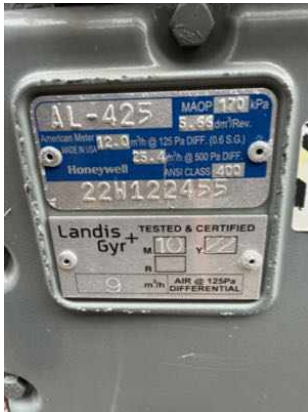
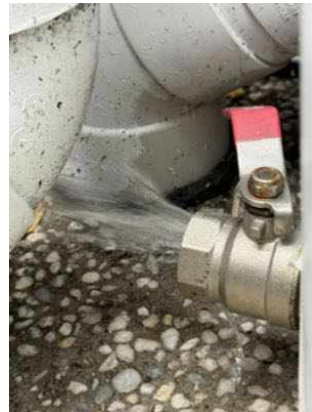
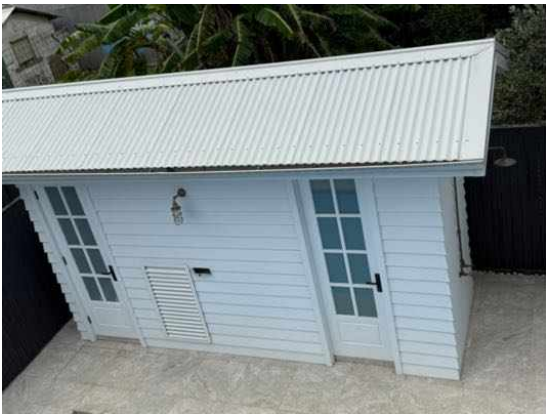
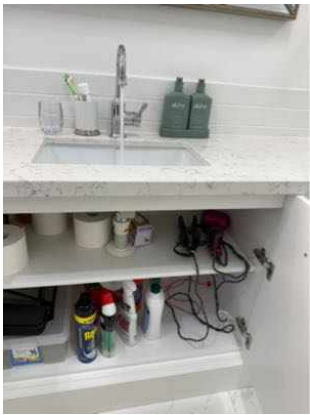
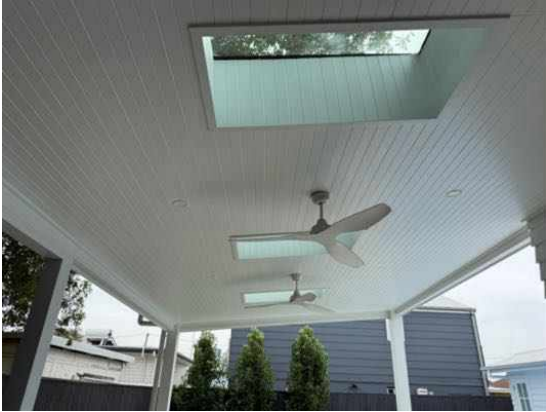
Building: Building 1
Location: All External Areas
Finding: Additional Photos
Information: Additional photos are provided for your general reference. The rear room and shower have cold water only.

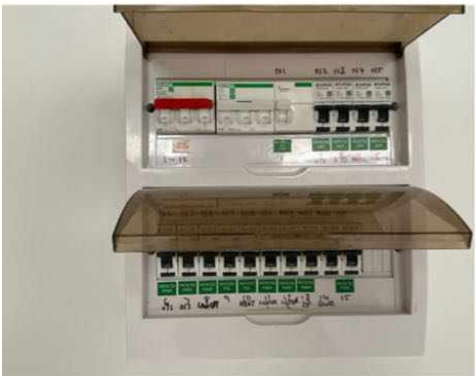
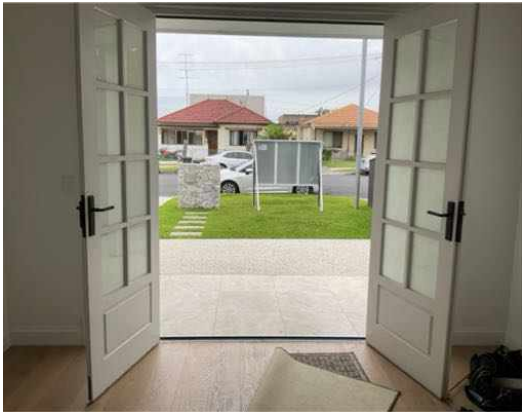
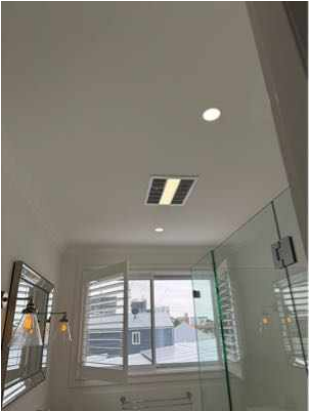
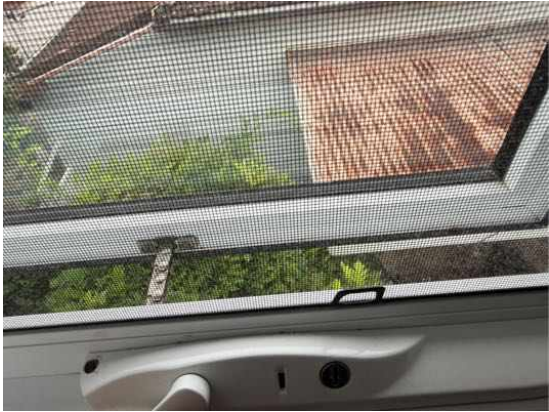
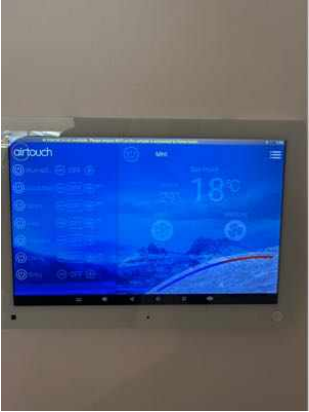
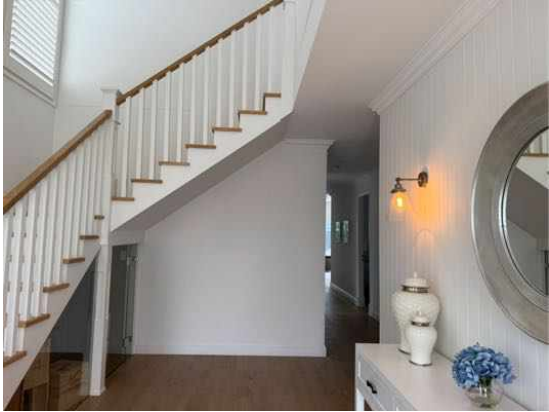
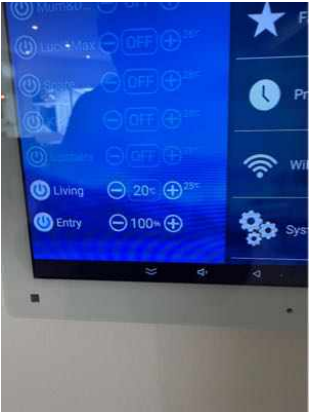
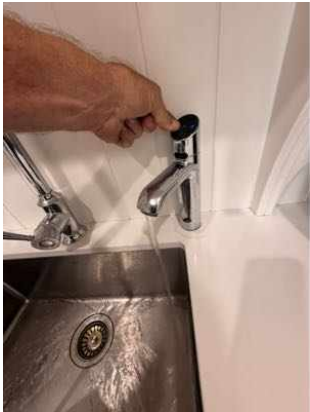
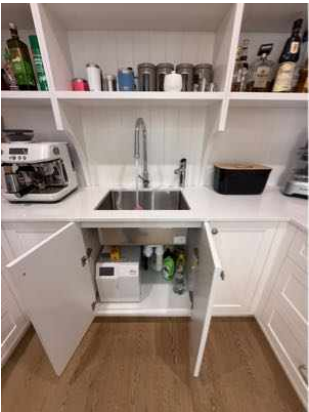
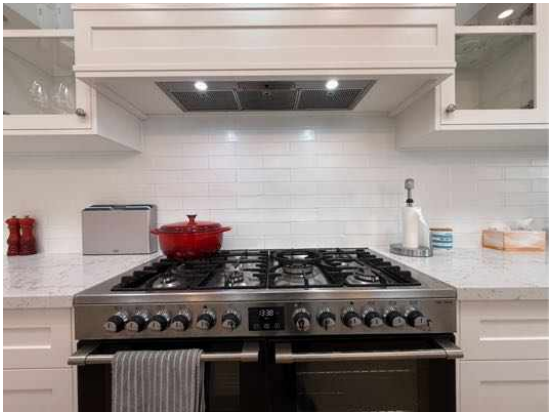
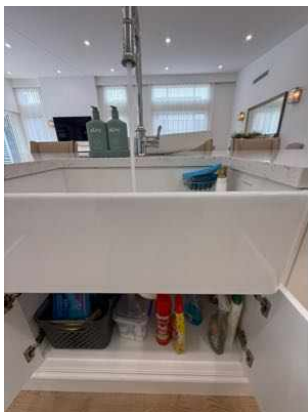
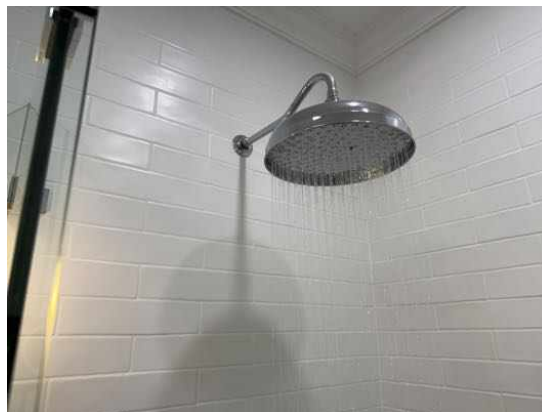
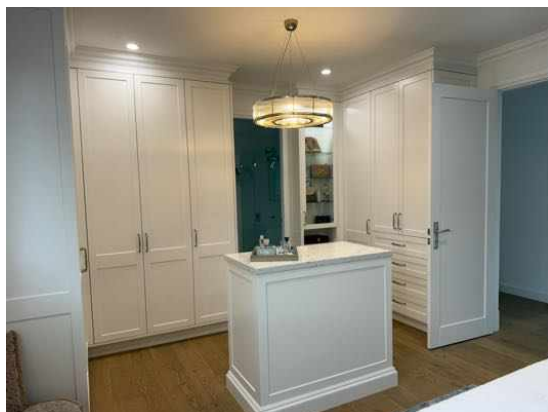
Building: Building 1
Location: All Internal Areas
Finding: Additional Photos
Information: Additional photos are provided for your general reference

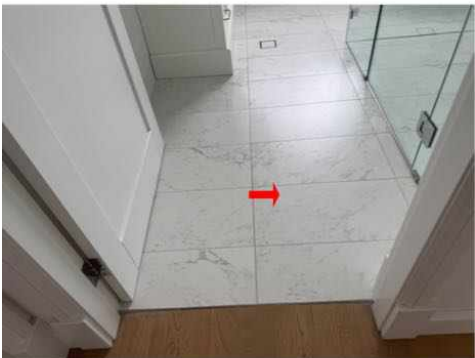
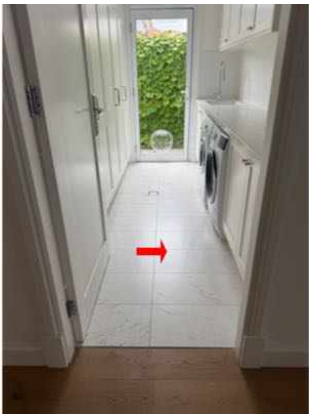
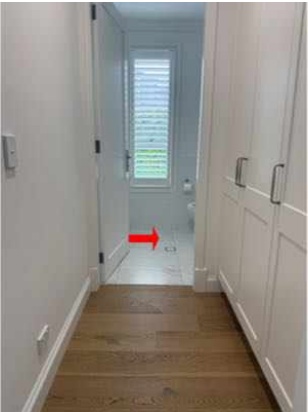
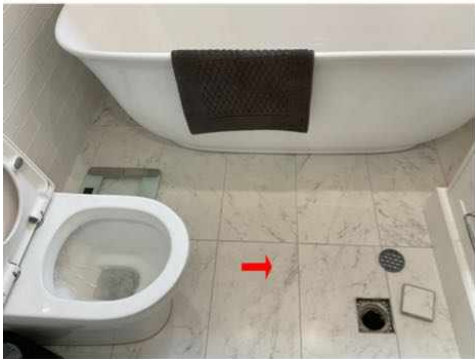
Building: Building 1
 Location: Bathrooms and laundry
 Finding: Waterproofing membranes - Information Only
 Information: Internal Water Proofing Membranes, are crucial in preventing water ingress into the property is important to know that the Membrane System used is to Australian Standards and has been installed correctly.

With older property's where this information is unavailable all wet areas should be monitored. If any leaks, water staining, peeling or bubbling of the paint become evident to any adjacent walls or ceilings below a licensed builder or waterproofing specialist is recommended to investigate further.
