Building and Timber Pest Inspection Report

Inspection Date: Mon, 30 Mar 2026

Property Address: 5 Selwyn St, Paddington NSW 2021,
Australia

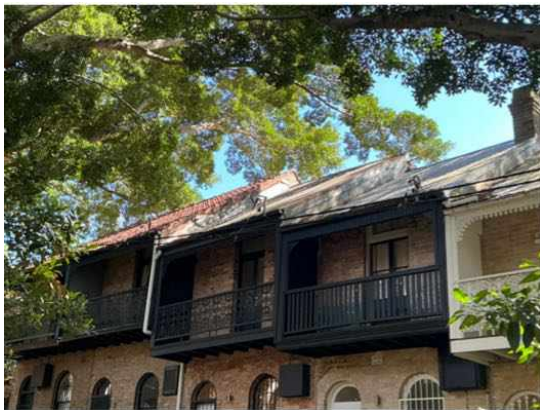
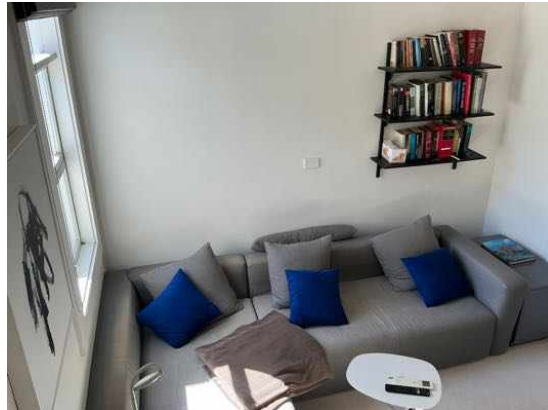
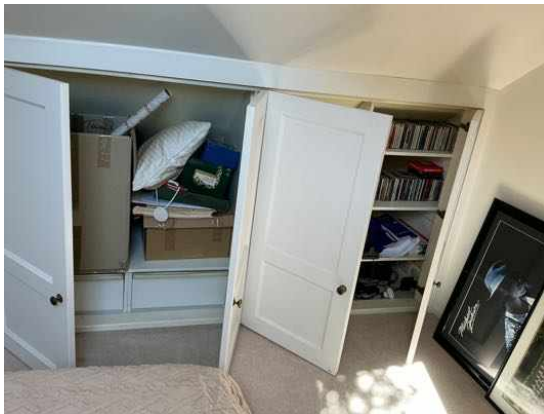
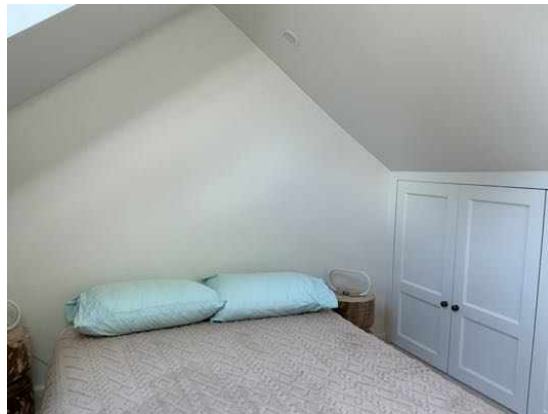
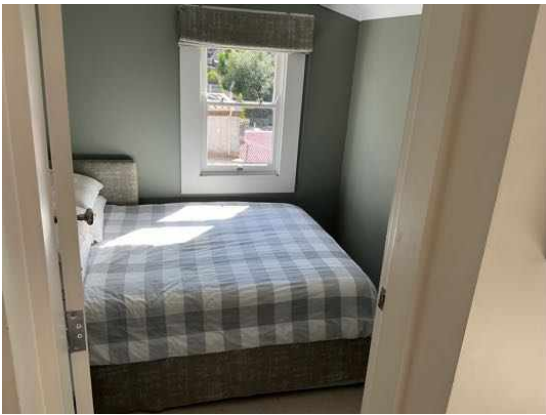
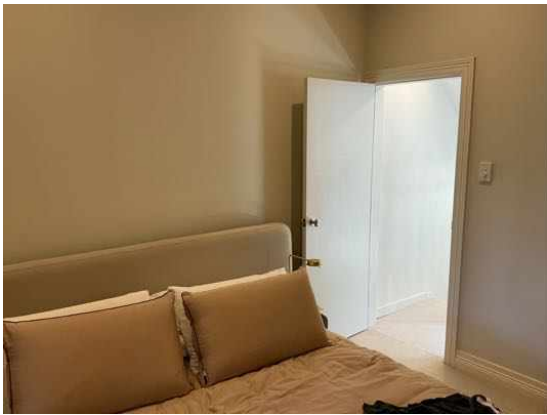
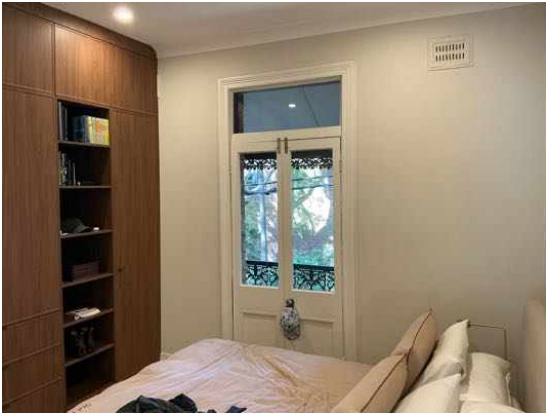
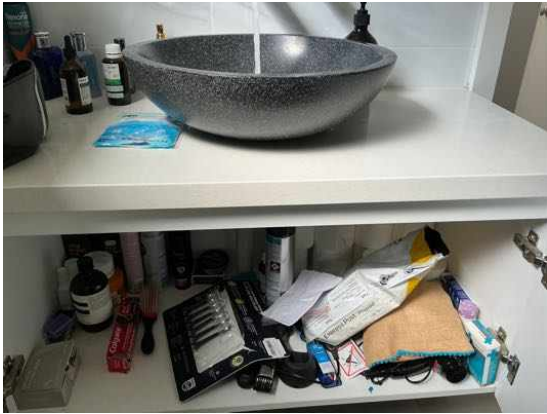
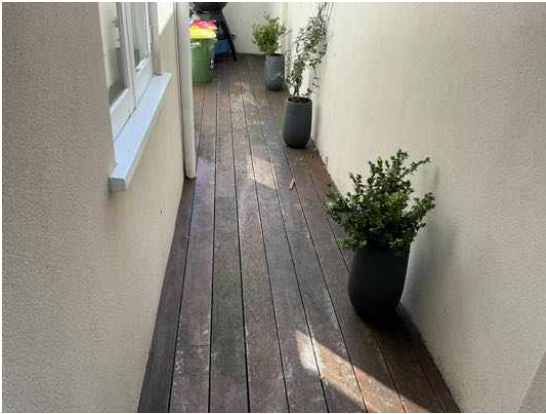
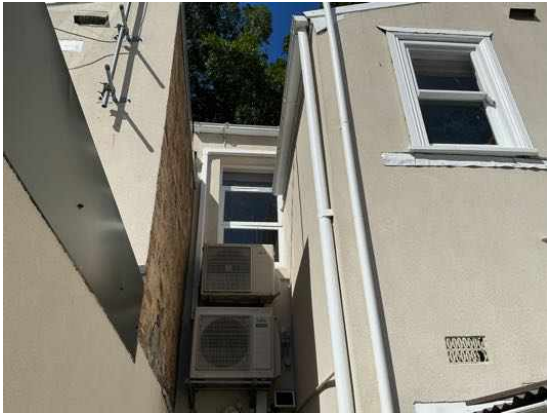
Building: Main Building
Location: All Areas
Finding: Additional Photos - Obstructions and Limitations
Information: These photographs are an indication of the obstructions and limitations which impeded full inspection of the property at the time of inspection. These obstructions can hide an array of defects and should be removed to allow full inspection to be carried out. A re-inspection is recommended once the areas are made accessible.

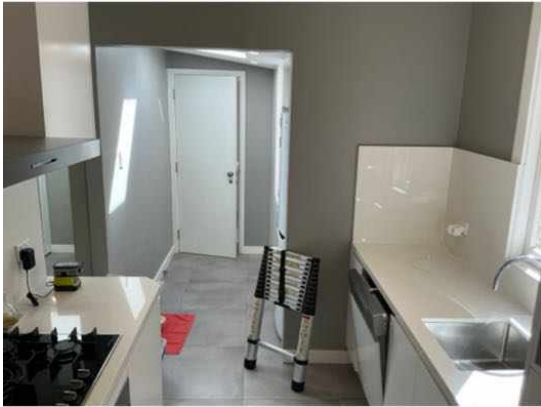
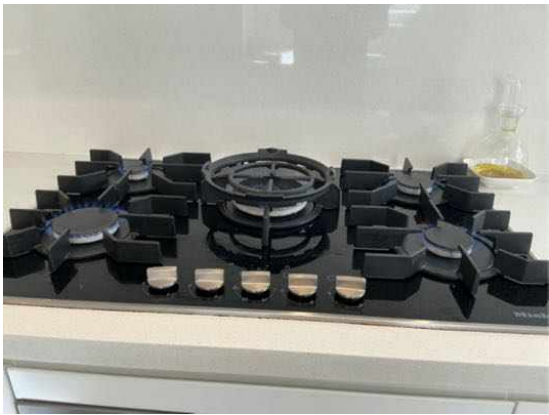
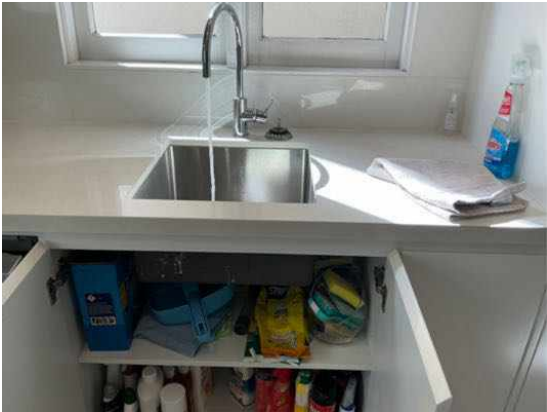
Building: Main Building
Location: Kitchen
Finding: Additional Photos
Information: Additional photos are provided for your general reference
