Building Inspection Report

Inspection Date: Thu, 12 Mar 2026

Property Address: 2602/311 Hume Hwy, Liverpool NSW 2170,
Australia

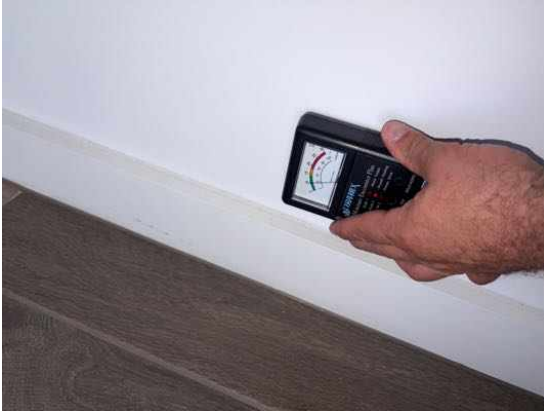
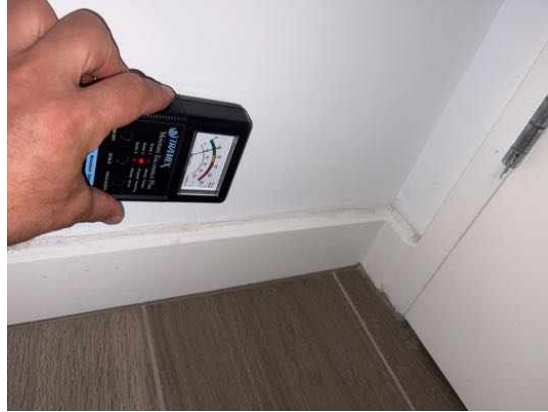
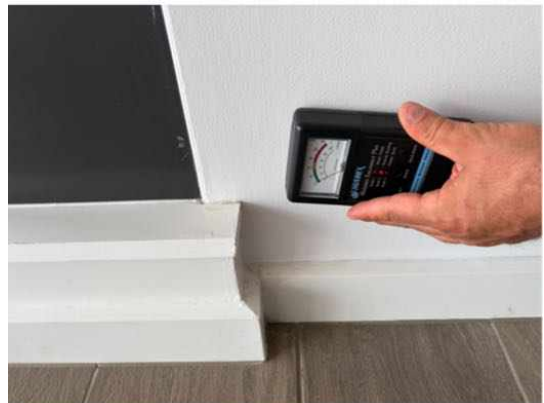
Noted Item

Building: Main Building
 Location: All Wet Areas
 Finding: Waterproofing
 Information:

Consequently, there is no conclusive evidence of any current shower recess leakage other than those which may have already been mentioned earlier in this report. It is reasonable to assume the shower waterproofing is sound. Note that if the shower is not used, or has not been used for some time, moisture readings would not vary significantly and this can lead to erroneous results. It is not possible under the visual inspection criteria (under which a prepurchase inspection is carried out) to categorically determine if there are leaks. If a more accurate assessment is required, a special purpose inspection should be requested. Alternatively, the assumption should be made that the shower may leak.

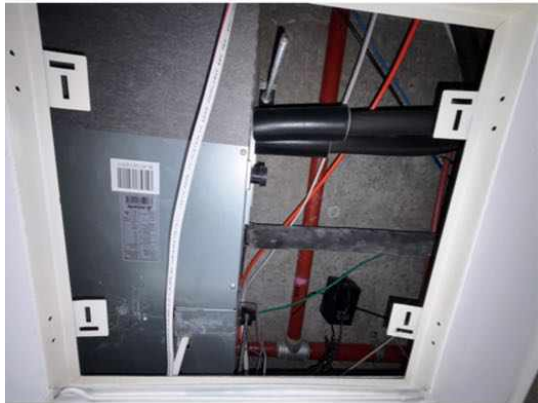
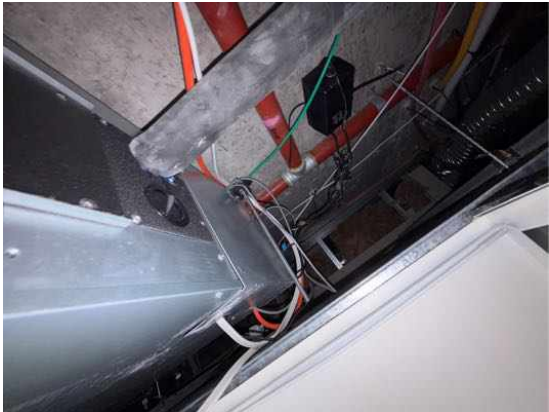
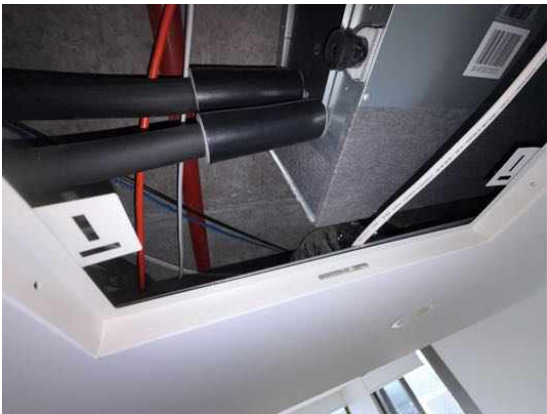
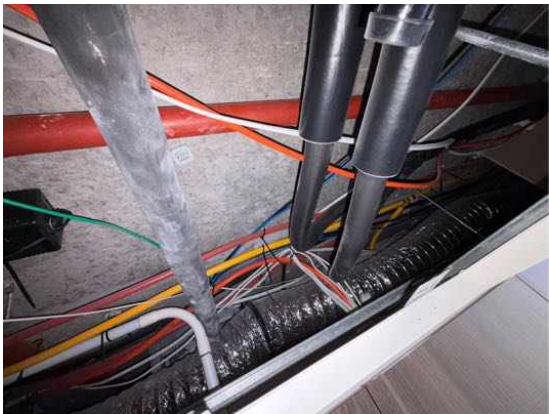
Noted Item

Building:	Main Building
Location:	Ceiling cavity
Finding:	Additional Photos- ceiling cavity
Information:	Additional photos are provided for your general reference. Arrows may have been included to highlight areas of importance. Please discuss these photos with your building consultant for clarification.

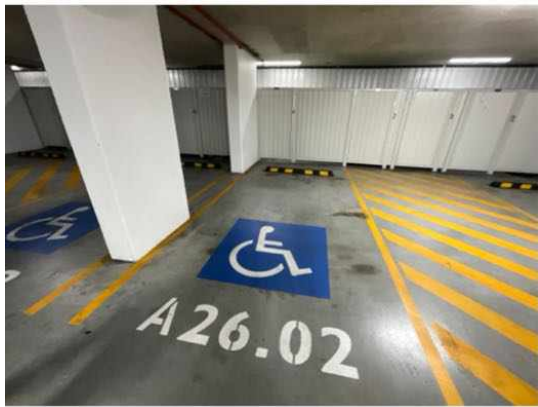
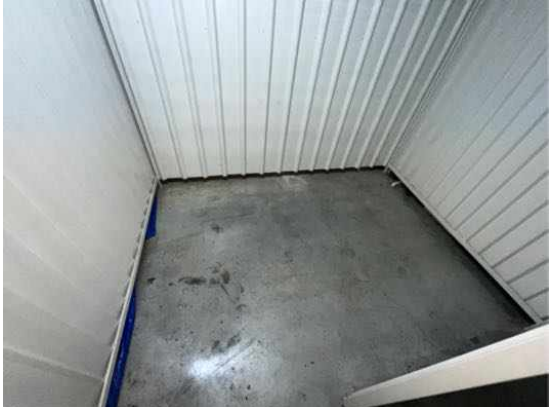
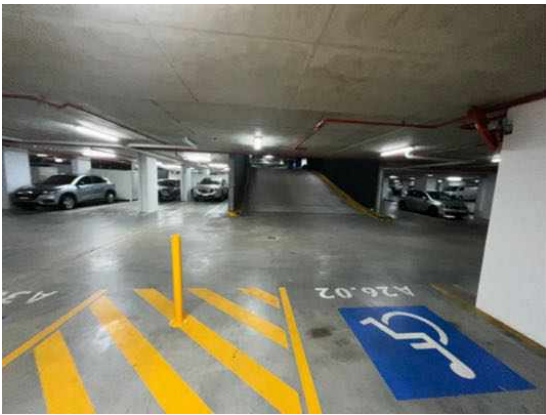
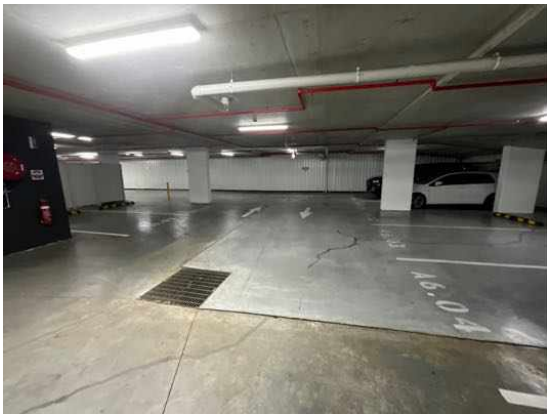
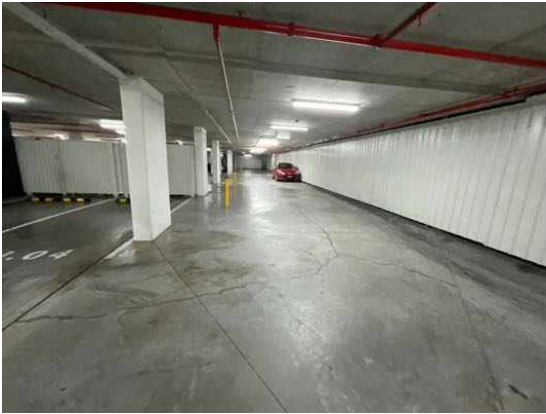
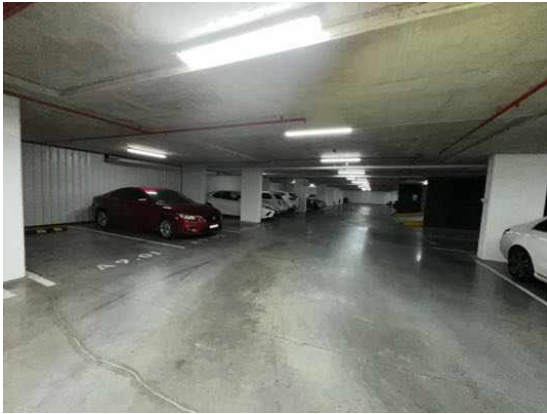
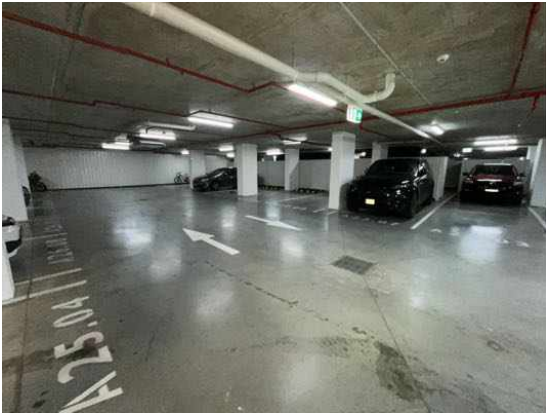
Noted Item

Building: Main Building
Location: Garage
Finding: Additional Photos- Garage
Information: Additional photos are provided for your general reference. Arrows may have been included to highlight areas of importance. Please discuss these photos with your building consultant for clarification.

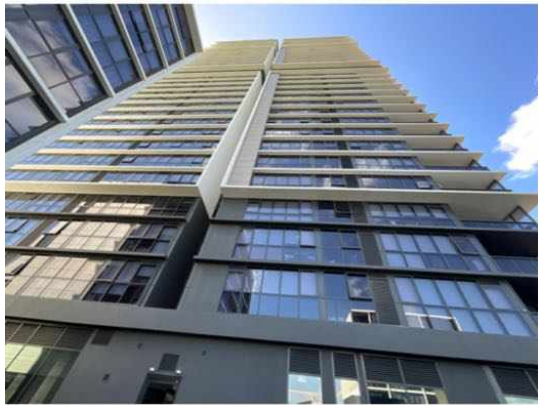
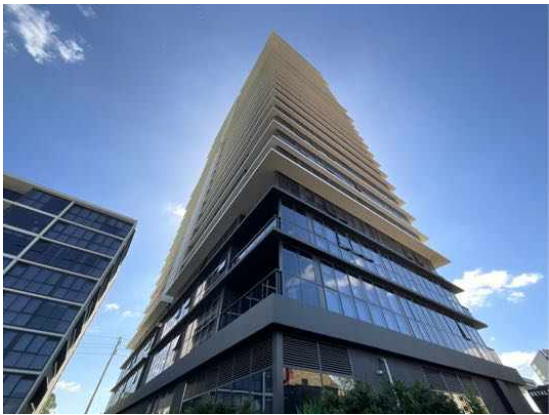
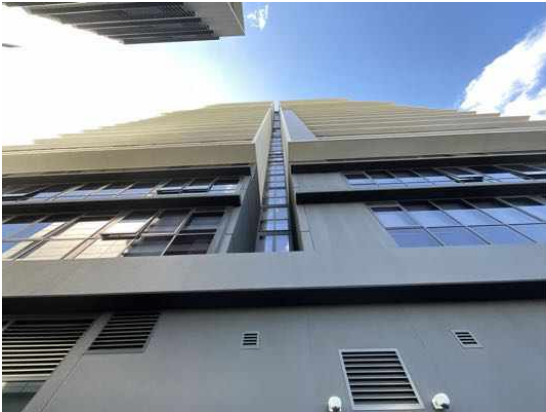
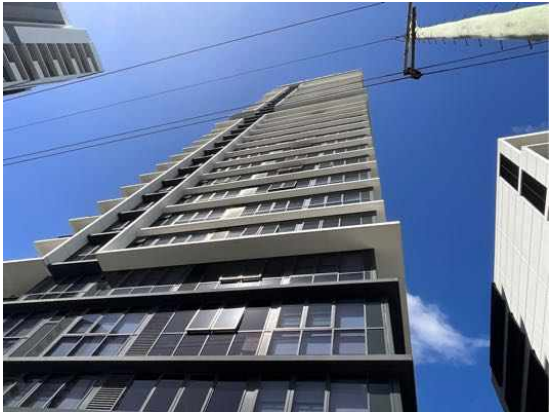
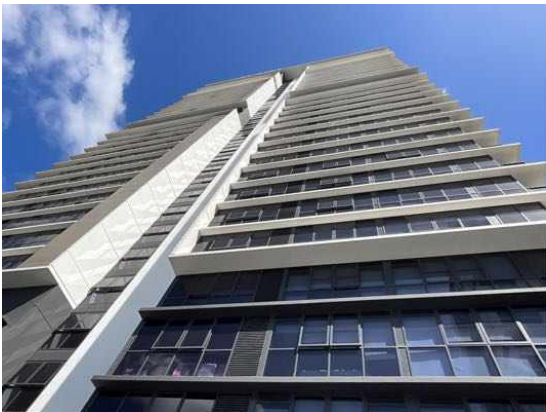
Noted Item

Building: Main Building
Location: Exterior
Finding: Additional Photos
Information:

Additional photos are provided for your general reference.

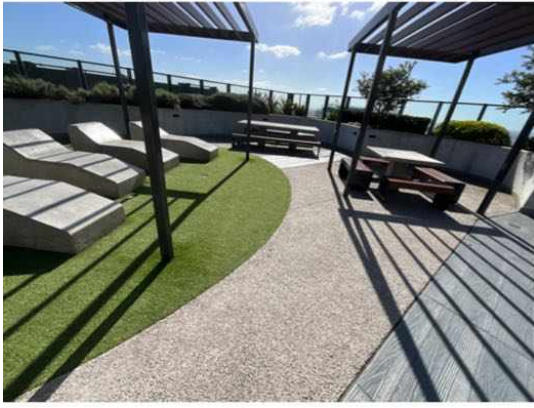
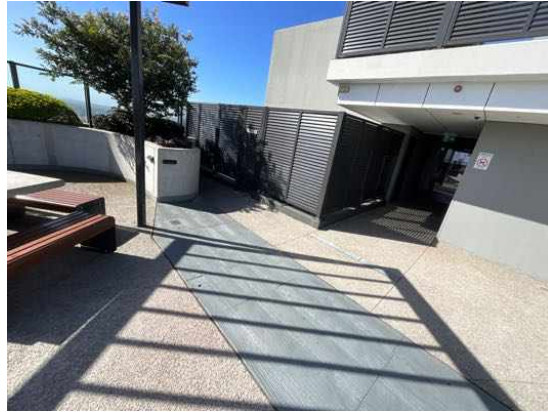
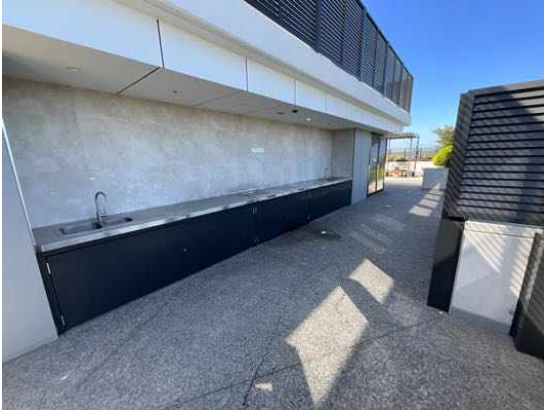
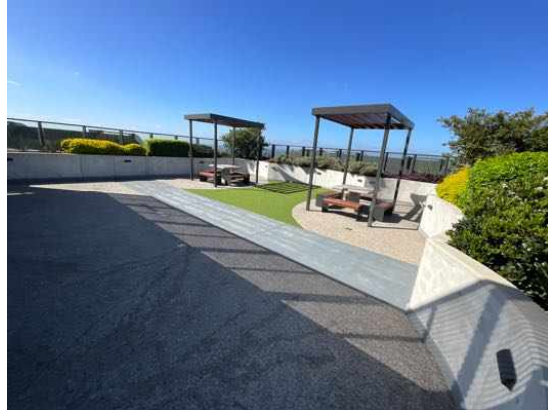
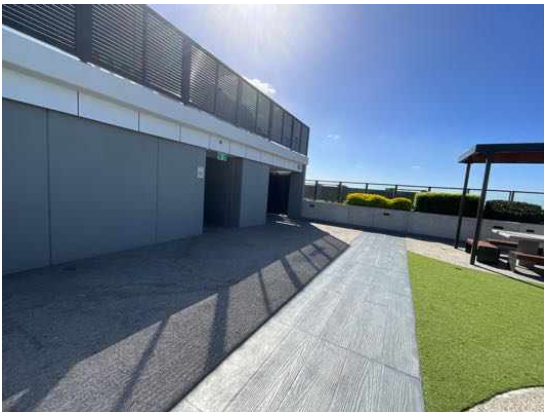
Noted Item

Building: Main Building
Location: Rooftop
Finding: Additional Photos
Information:

Additional photos are provided for your general reference.
