Building and Timber Pest Inspection Report

Inspection Date: Mon, 23 Feb 2026

Property Address: 6 Johnboy Pl, Blacktown NSW 2148,
Australia

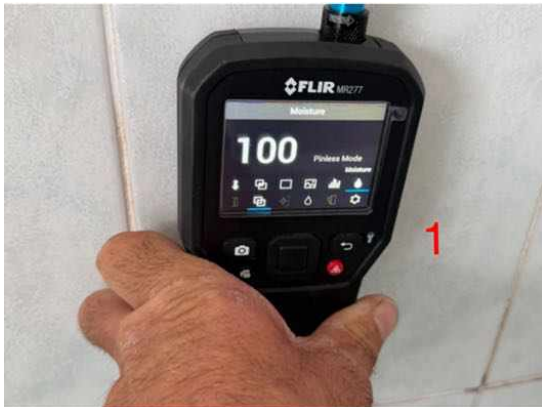
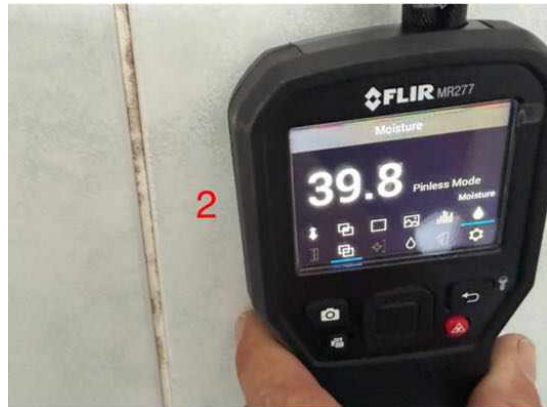
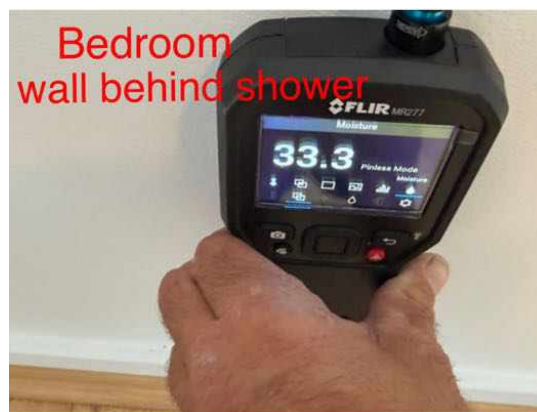
Building:	Main Building
Location:	Bathroom
Finding:	Shower seals recommended
Information:	The waterproofing to the shower recess was assessed by checking the walls in and around the shower recess for varying moisture content. A higher than normal reading was observed to one wall indicating water is penetrating behind the tiles in this area. There were no significant variations across the other tested areas. The bedroom wall

behind the high moisture reading area was tested and showed a normal reading indicating that the water is not penetrating the wall framing therefore suggesting the waterproofing to the wall is sound.

No sign of recent water damage was evident upon a visual inspection of the surrounding walls, where the visual nature of the inspection was possible. Consequently, there is no conclusive evidence of any current shower recess leakage and it is reasonable to assume the shower waterproofing is sound.

Note that if the shower is not used, or has not been used for some time, moisture readings would not vary significantly and this can lead to erroneous results. It is not possible under the visual inspection criteria (under which a pre-purchase inspection is carried out) to categorically determine if there are leaks. If a more accurate assessment is required, a special purpose inspection should be requested.

It is recommended to re-seal the shower with a new professional epoxy seal to ensure a watertight seal into the future.

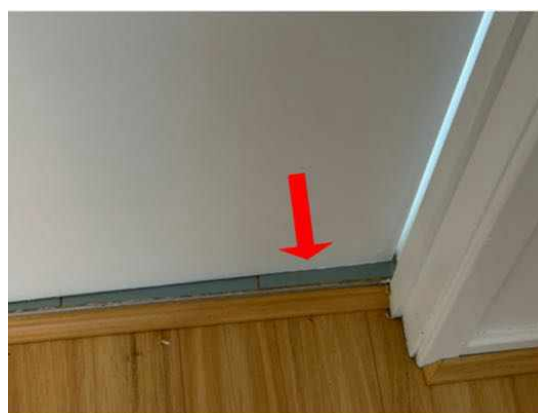
Finding 3.02

Building:	Main Building
Location:	Bathroom/Laundry/Front Entry
Finding:	Doors - Binding/Jamming
Information:	Binding and/or jamming of several doors throughout the property were evident during standard operation. This defect inhibits the functionality of affected doors as well as creating potential for secondary defects to associated building elements, such as damage to the floor covering.

A door that binds to flooring or to the associated door frame may have several causes, ranging from minor defects, such as poor installation of the door or deteriorated hinges, through to major structural issues, such as damage to subfloor structures.

Where door binding/jamming appears to indicate major structural issues, a registered builder specialising in re-stumping should be appointed to provide an estimate on the cost of rectification.

For minor causes, a qualified carpenter or general handyperson should be appointed to perform minor rectification works at client discretion.

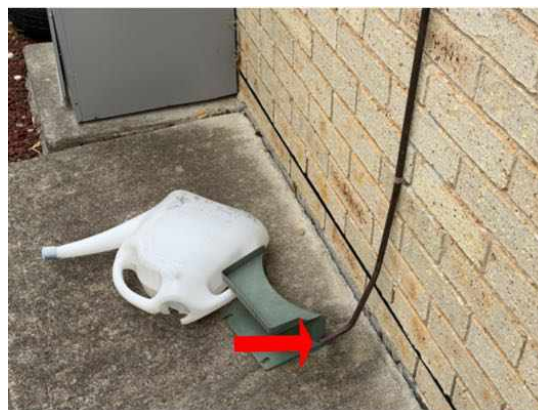
Finding 6.04

Building:	Main Building
Location:	All Areas
Finding:	Bridging or breaching of termite barriers - weep holes
Information:	Bridging is the spanning of a termite barrier or inspection zone so that subterranean termites are provided with passage over or around that barrier.

Weep holes in the exterior brickwork of the property are designed to allow condensation that may build up between the brickwork and subsequent timber framework to drain from within the wall hence preventing any deterioration of the timber building elements.

Additionally build-up of moisture is likely to occur if weep holes are covered further attracting termite activity to these areas.

It is highly recommended that weep holes are left exposed in all areas throughout the external property. Therefore if any termite activity leading into weep holes becomes easily detectable during frequent pest inspections.

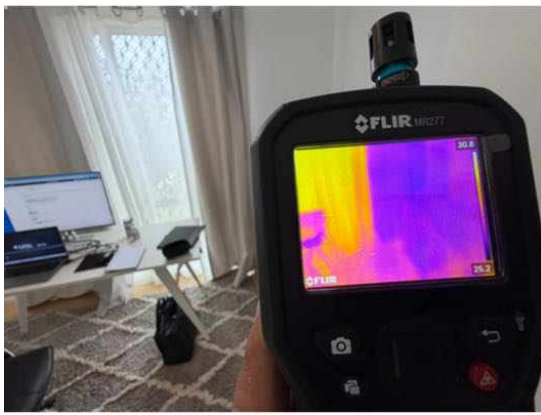
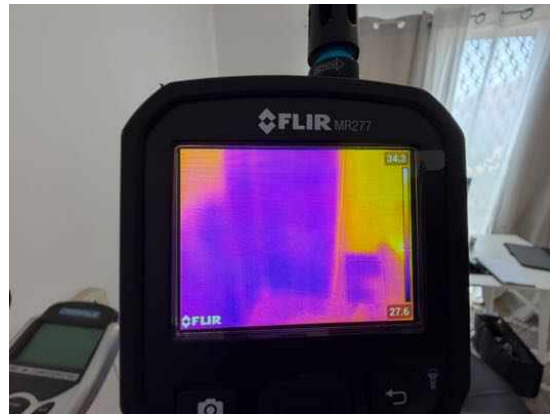
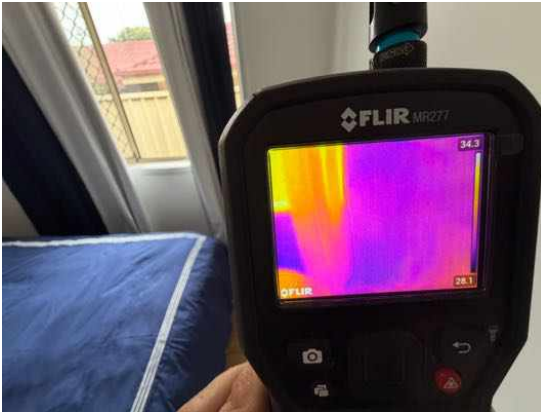
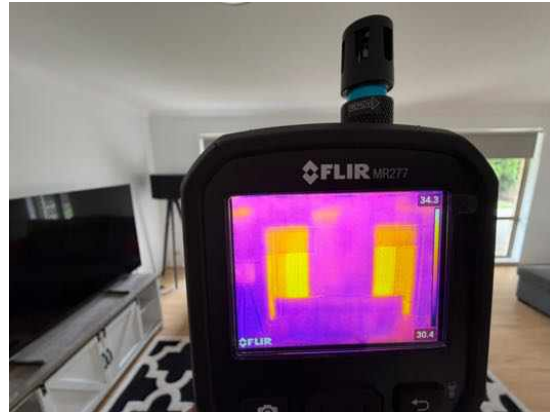
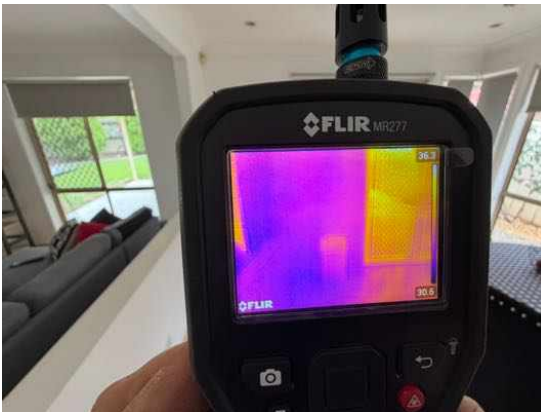
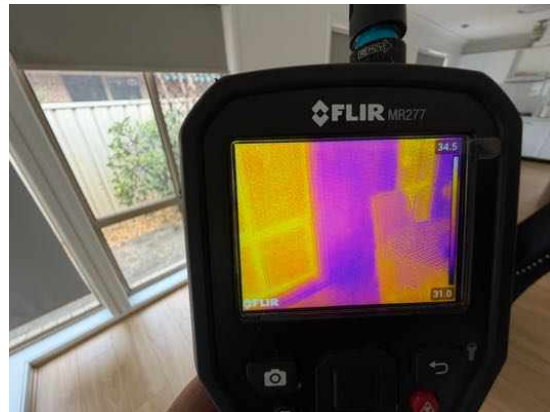
Building:	Main Building
Location:	All Internal Areas
Finding:	For your information-Thermal camera
Information:	AS 3660.2:2017 is the recommendation for the carrying out of 'Additional Tests' using specialist non-destructive tools:

A thermal imaging inspection was carried out throughout the interior of the house using a Flir MR277 thermal camera. No thermal anomalies were noted that would be consistent with any current termite activity, however various factors must be taken into effect which may hamper or impede the reading obtainable by the imager. These factors include obstructions, ambient temperature, wall material and thickness etc. If any surface is restricted visually or otherwise, a proper thermal reading is not possible and is not within the scope of this inspection. Any findings or otherwise is reported on at the time of the inspection only.

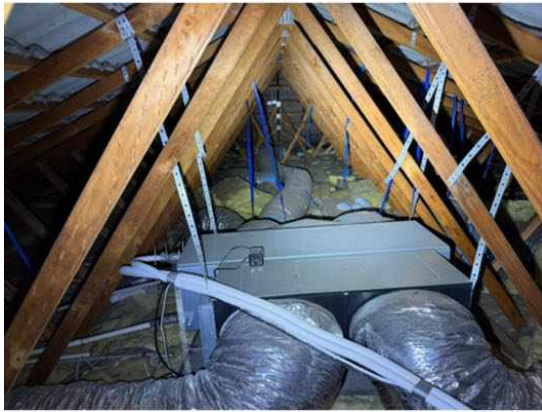
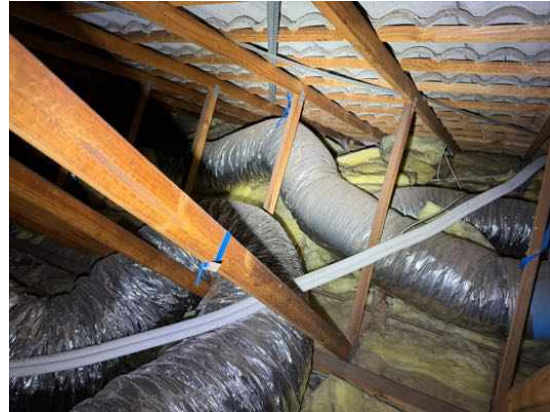
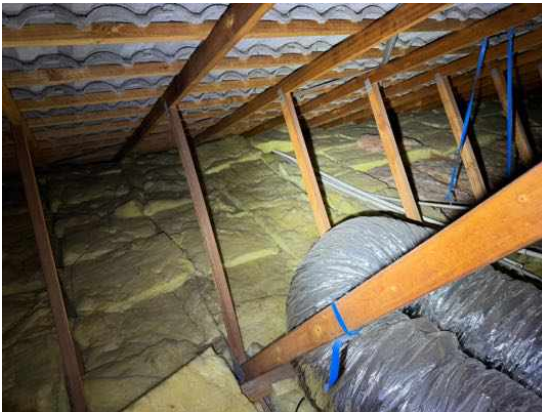
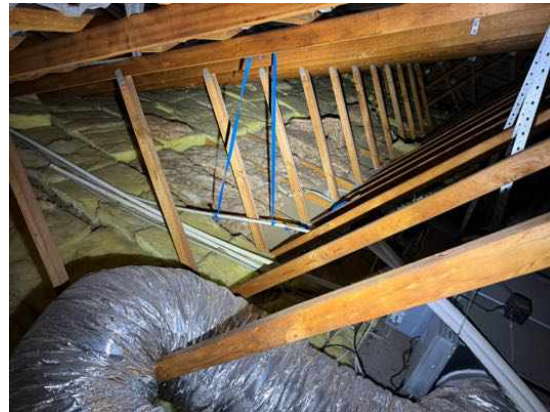
Noted Item

Building:	Main Building
Location:	Roof Void
Finding:	Obstructions and Limitations-Roof Void
Information:	These photographs are an indication of the obstructions and limitations that impeded the full inspection of the roof cavity at the time of inspection. Note that the insulation covered nearly all the ceiling joists, which are a major structural element of the ceiling; the inspection was also limited to areas with an allowable crawl space of 600mm x 600mm, in particular towards the external walls where the roof line diminishes, it was not accessible. These obstructions and limitations can hide an array of defects and should be removed to allow a full inspection to be carried out. A re-inspection is

recommended once areas are made accessible.

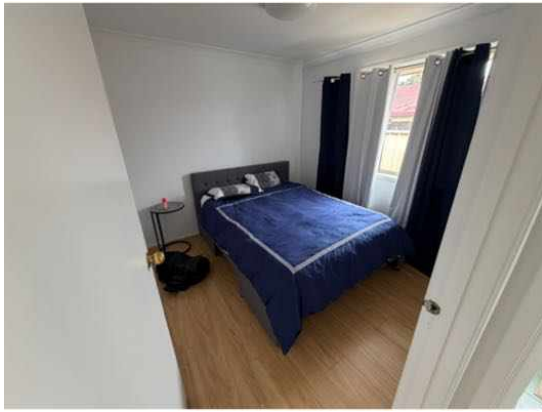
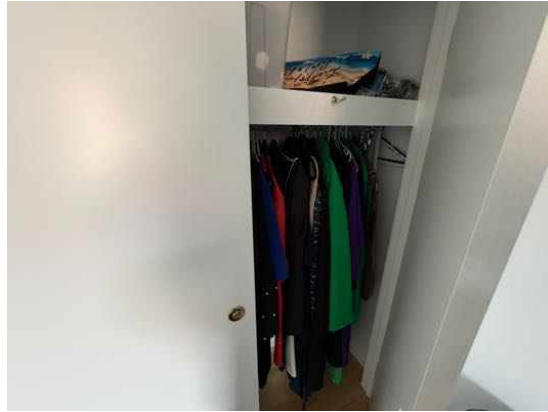
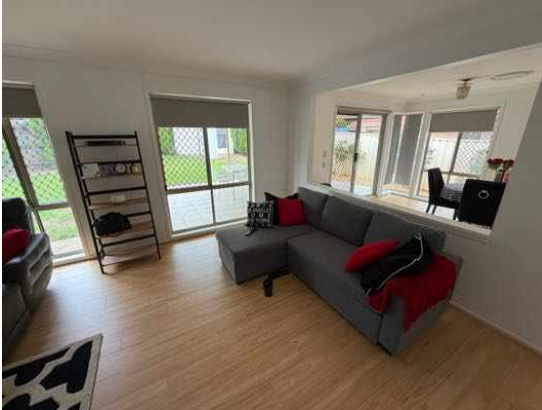
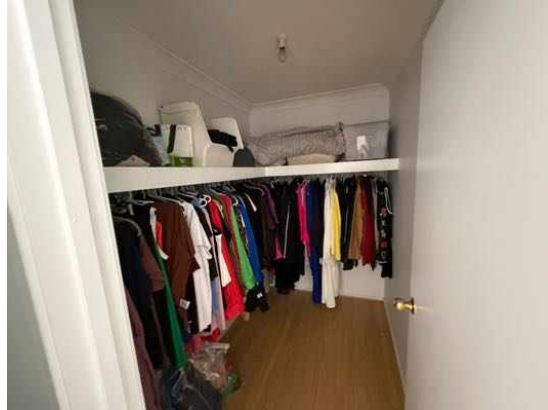
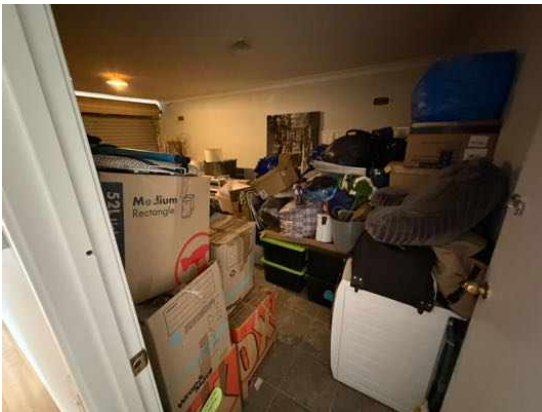
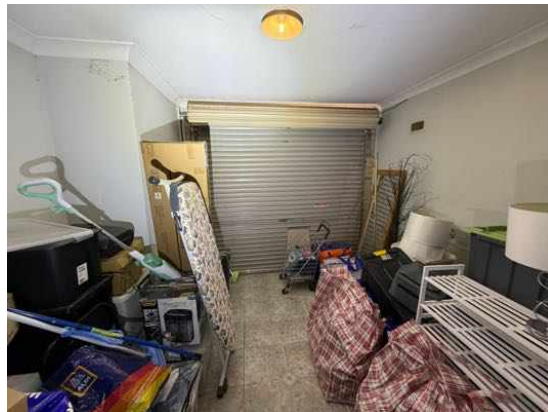
Building:	Main Building
Location:	Internal Areas
Finding:	Obstructions and Limitations-Internal areas
Information:	These photographs are an indication of the obstructions and limitations which impeded full inspection of the internal areas at the time of inspection. These obstructions can hide an array of defects and should be removed to allow a full inspection to be carried out. A re-inspection is recommended once the areas are made accessible.

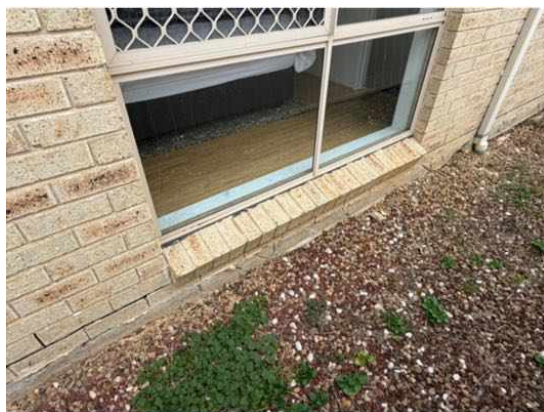
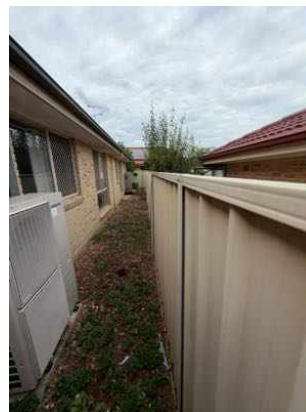
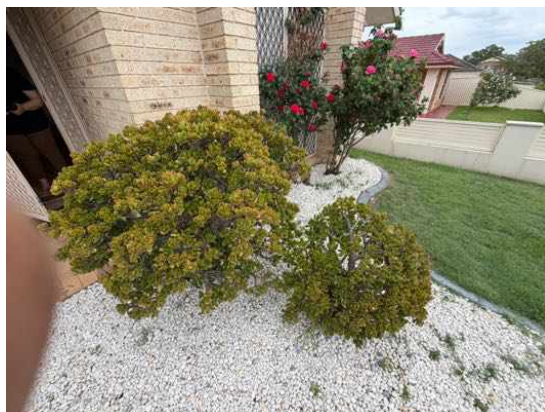
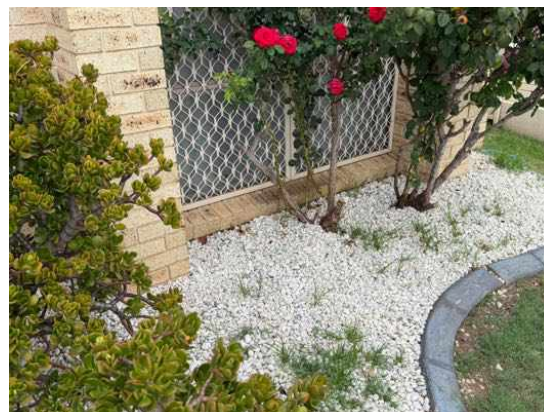
Building: Main Building
 Location: External Areas/Sub-Floor
 Finding: Obstructions and Limitations-External Areas/Sub-Floor
 Information: These photographs are an indication of the obstructions and limitations which impeded full inspection of the external areas at the time of inspection. These obstructions can hide an array of defects and should be removed to allow full inspection to be carried out. A re-inspection is recommended once the areas are made accessible.

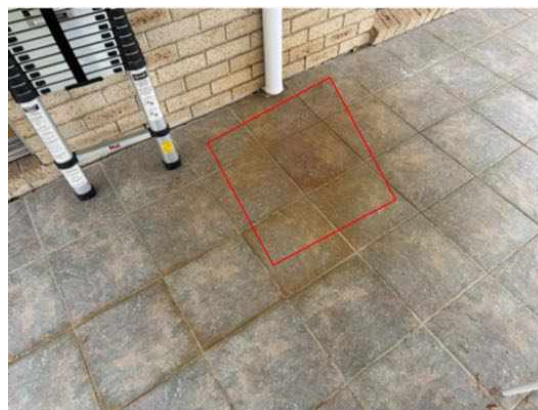
Building:	Main Building
Location:	Rear Patio
Finding:	FYI-Suspected Roof Leak (Rear Patio)
Information:	Visible water staining was noted to the tiled area beneath the rear patio roof, indicating a possible past or intermittent water leak from the roof structure above.

As weather conditions were dry at the time of inspection, it was not possible to determine whether the leak is currently active or to confirm the exact source of moisture ingress.

Water staining may result from roof covering defects, flashing issues, blocked drainage components, or previous isolated events. Further monitoring during or immediately after rainfall is recommended to determine if moisture ingress persists.

This item is provided for information only. Should staining worsen or evidence of active leaking be observed, further assessment and repair by a suitably qualified roofing contractor is recommended.

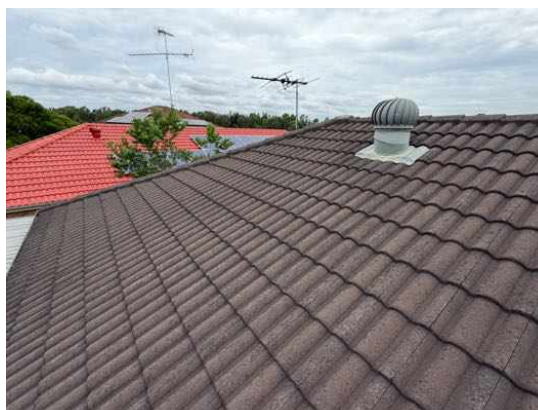
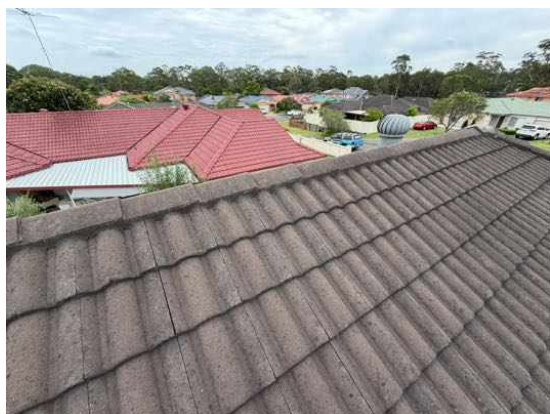
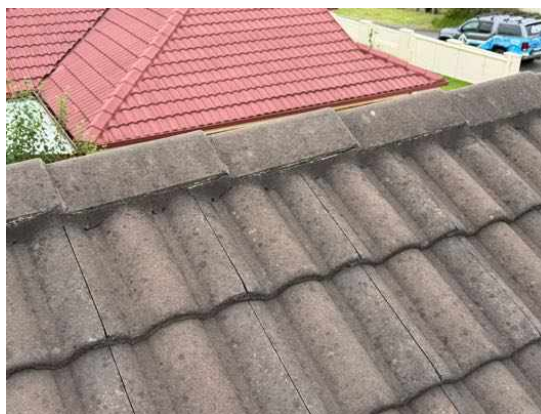
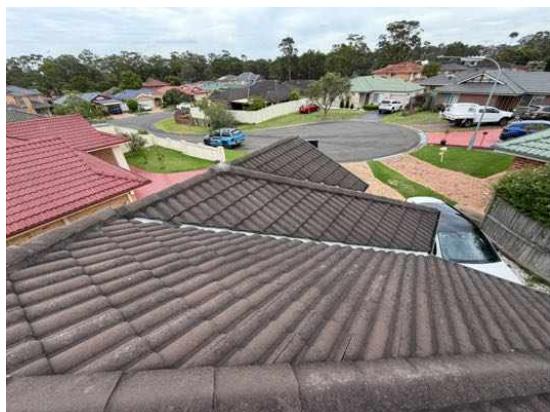
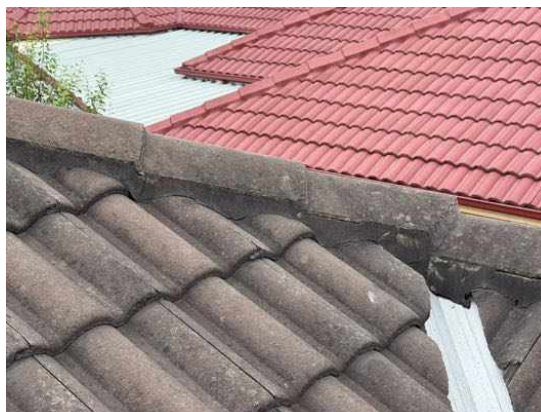
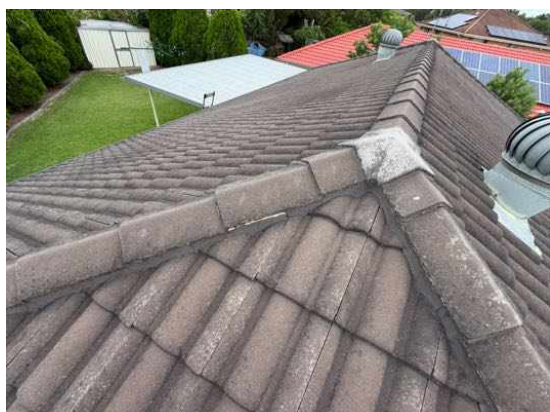
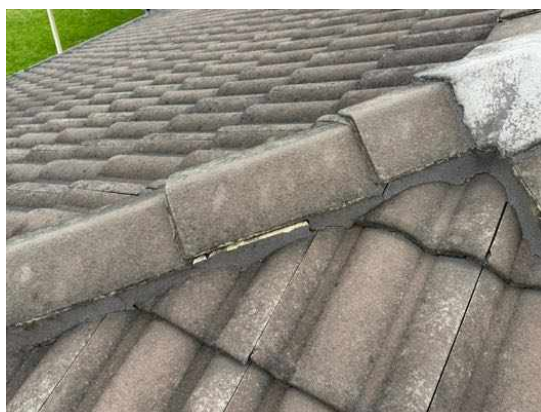
Building: Main Building
 Location: Roof Exterior
 Finding: Roof tiles - Weathered
 Information: Upon inspection of the exterior roofing, the majority of roof tiles were considered to be in a fair condition. While weathering of the tiles is consistent with the age of the property, maintenance works are required.

Isolated areas of mortar have come loose and minor cracking is also present. Repointing and re-sealing these areas may be considered as an interim solution by the client to help preserve and extend the life span of the tiles.

Where left unmanaged, deteriorating roof tiles are likely to lead to a number of secondary defects, including minor water leaks and weather exposure to internal roofing structures.

Consultation with a roofing contractor is advised to gain advice on cost of remedial works that may be required in the short to medium term. Remedial works are likely to increase the longevity of the exterior roofing structure.

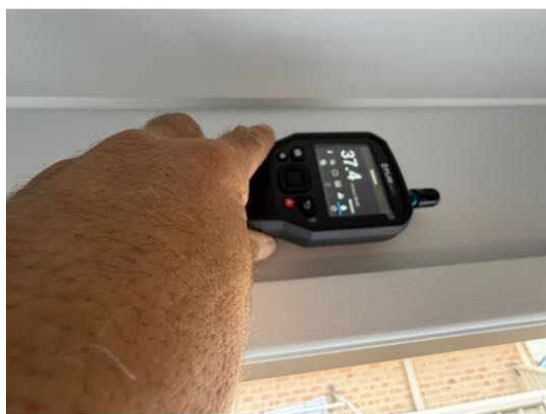
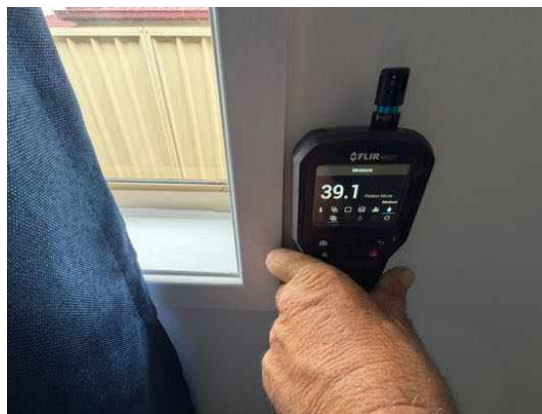
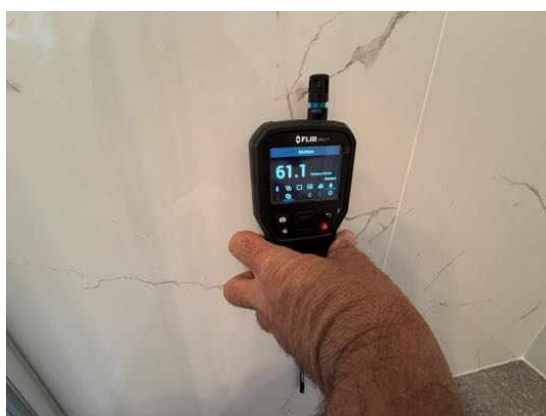
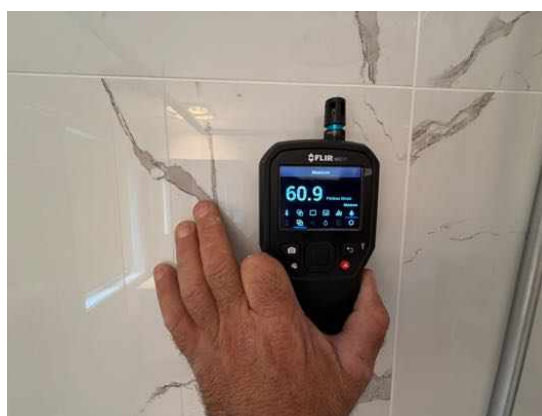
Building:	Main Building
Location:	All Areas
Finding:	FYI-Moisture Readings
Information:	Moisture readings taken during the inspection were recorded using a FLIR MR277 moisture meter, which provides numerical values rather than direct percentage readings. These values are not expressed as a percentage of moisture content but rather as relative indicators of moisture presence within building materials. Each material-such as plasterboard, timber, tile or concrete wall surfaces -has its own baseline range of ambient moisture, and the meter's readings reflect deviations from that baseline.

In short, while percentages are familiar, the meters numeric scale offers a more nuanced and material - sensitive method of identifying moisture issues. Elevated readings – especially those exceeding baseline values by around 20 points or more – are flagged for further investigation, even if no visible damage is present.

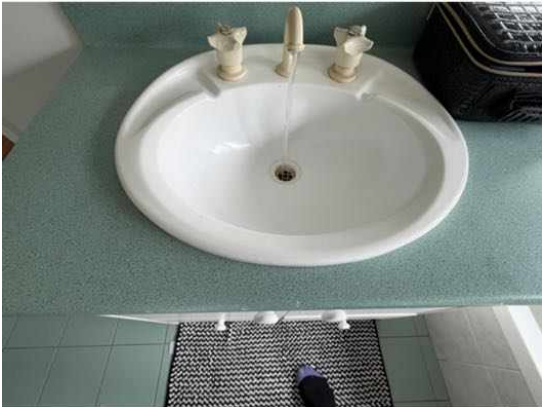
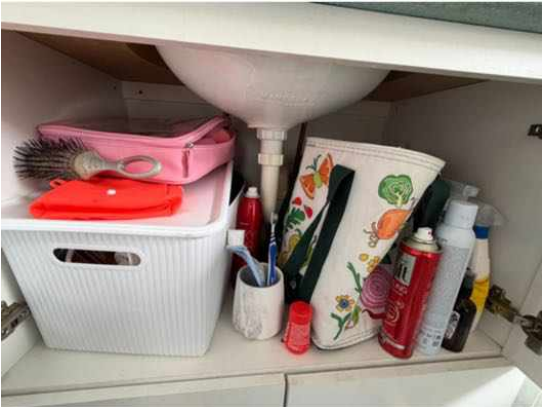
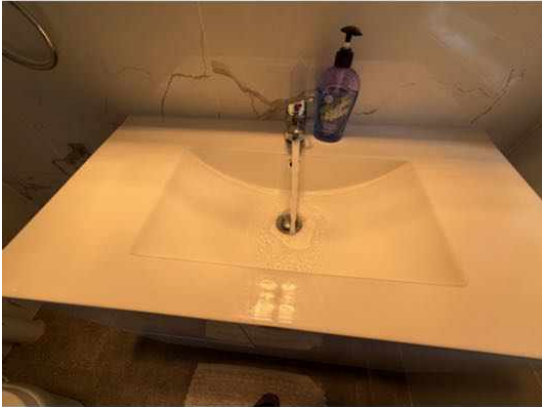
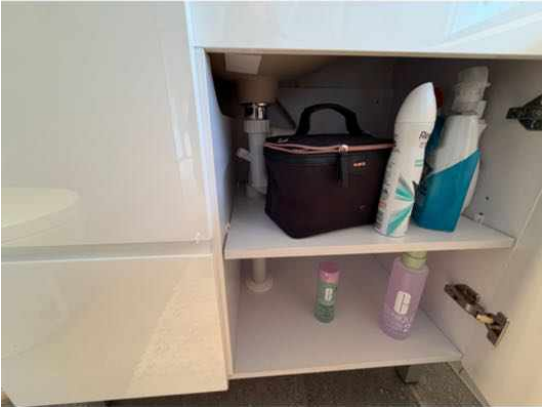
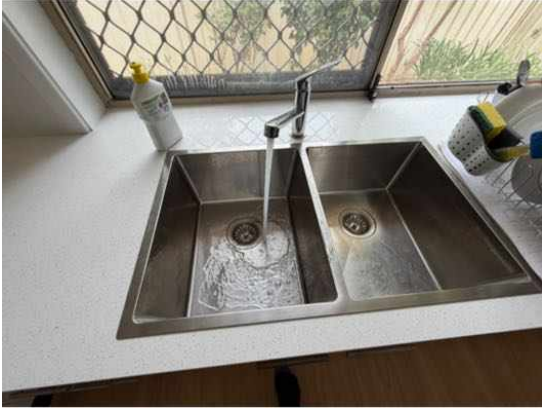
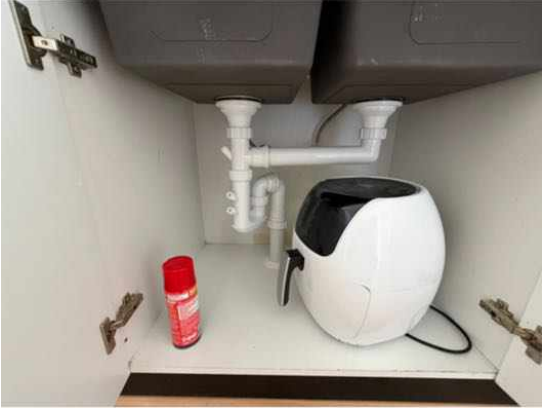
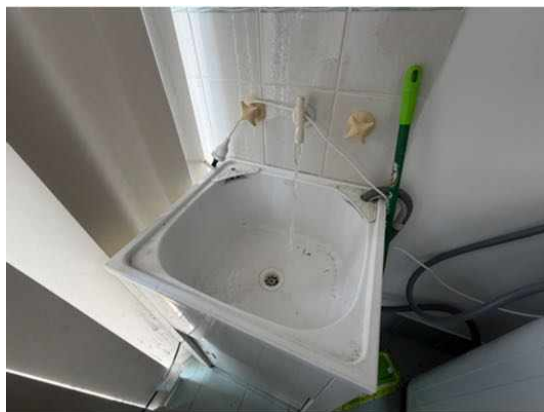
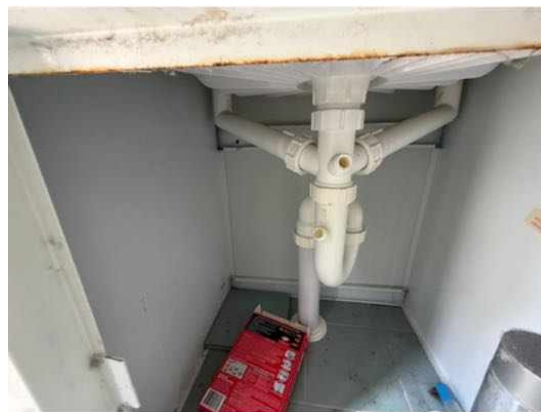
Building:	Main Building
Location:	Cabinetry Plumbing
Finding:	FYI-Cabinetry Plumbing
Information:	All cupboards where sinks and basins with drainage plumbing were inspected no

evidence of leaks were present at the time of inspection.

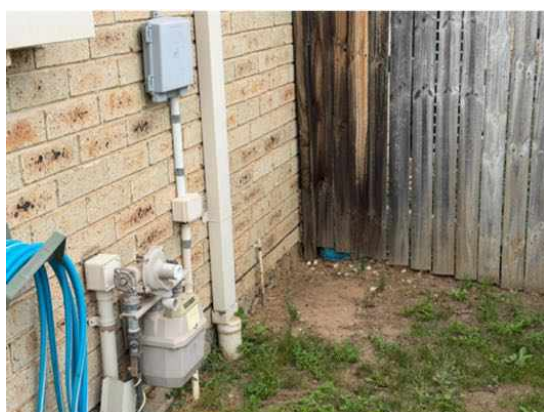
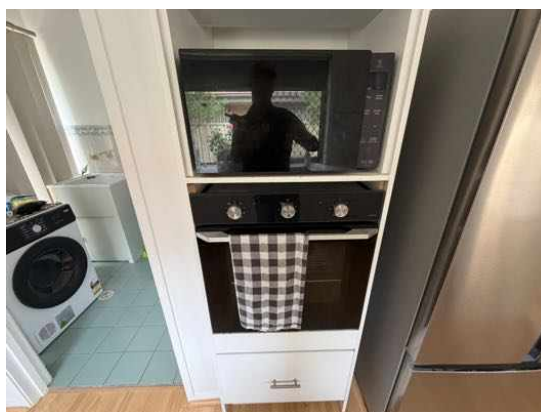
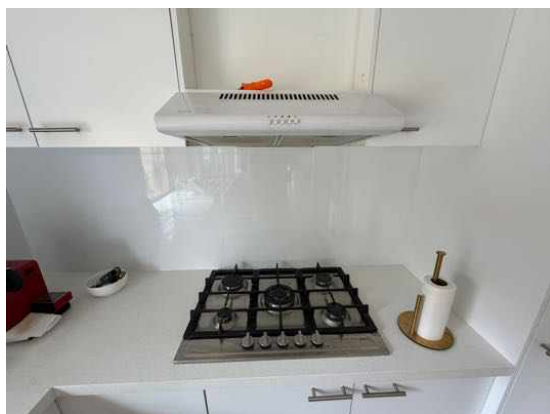
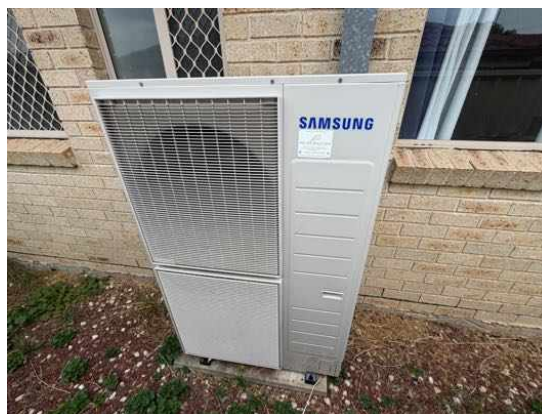
Building: Main Building
 Location: Plumbing/electrical/gas/aircon/pool equipment etc
 Finding: FYI-Plumbing and Electrical
 Information: Plumbing and Electrical inspections are outside the scope of the building inspection and must be conducted by a licensed and registered trades person.

It is highly recommended that the client makes immediate arrangements to have the gas appliances checked by a licensed gas plumber to ensure that the appliances are working safely and efficiently.

We recommend all other installations be checked also.

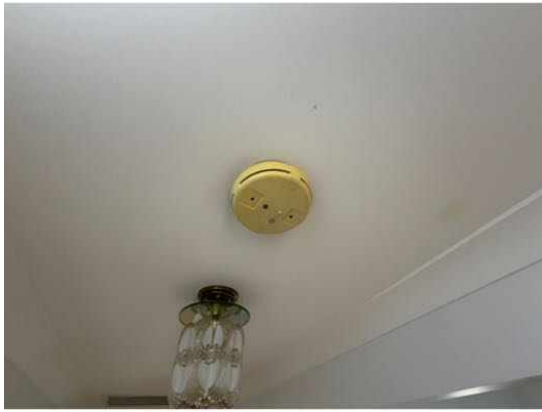
Please note that this defect is highlighted as a caution only. We suspect, based on our experience in the building industry, that the absence of smoke detectors, or their poor condition, should be addressed as a matter of urgency to improve occupant safety.

Always ensure sufficient working and suitable smoke detectors are installed prior to occupying any building. Additionally, it is advised that all smoke detectors be tested by the homeowner on a monthly basis.

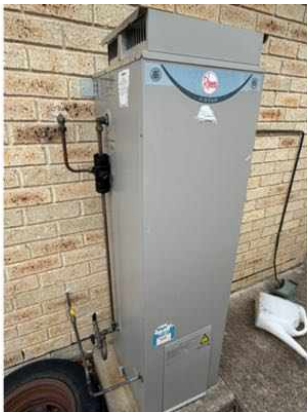
Building: Main Building
 Location: Hot Water System
 Finding: FYI-Hot Water Unit
 Information: The HWS appeared to be in good condition at the time of inspection. For the date of manufacture - (see attached photo)

Water pressure appears to be normal, however, this is not an opinion of a licensed plumber. No water hammer was noted when taps are turned off fast.

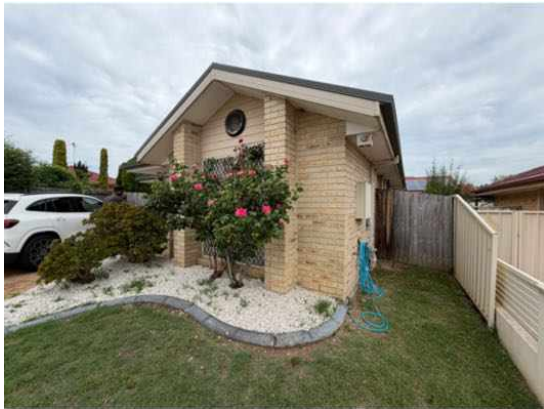
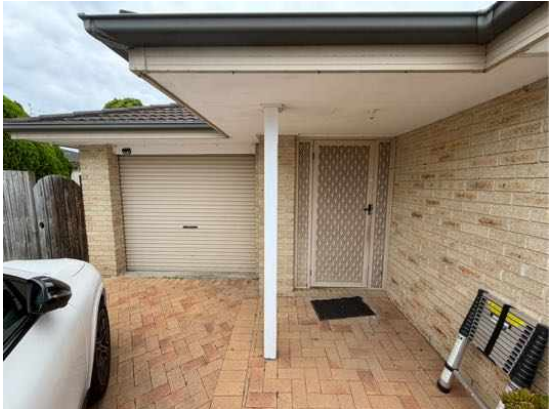
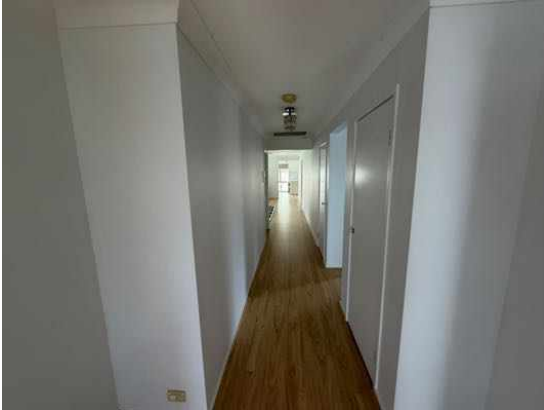
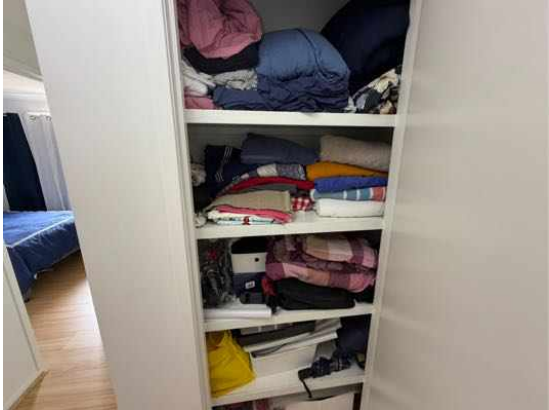
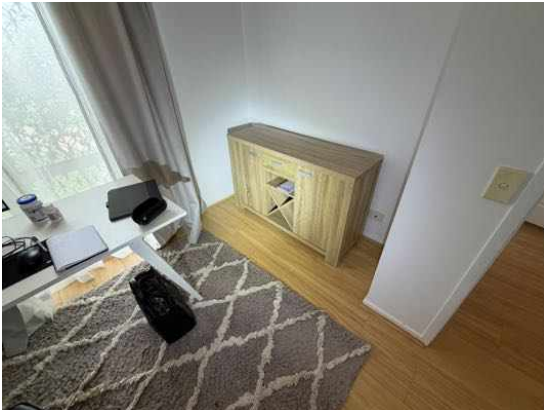
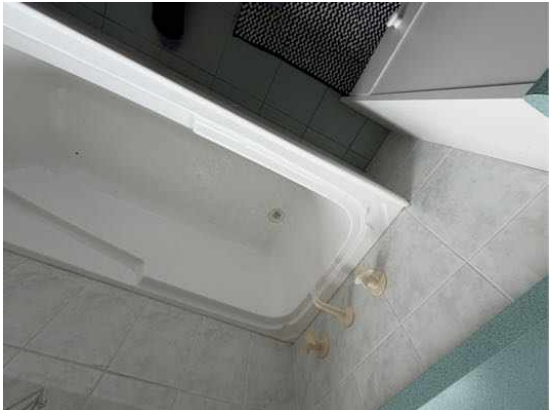
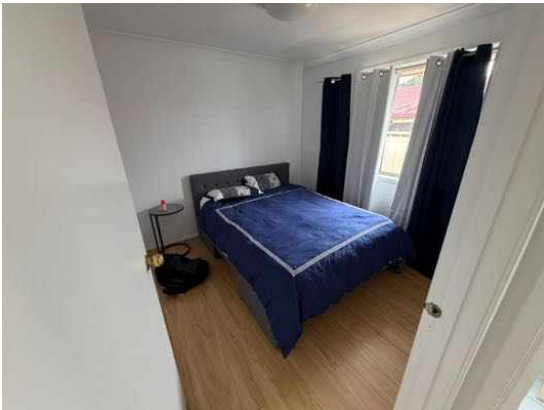
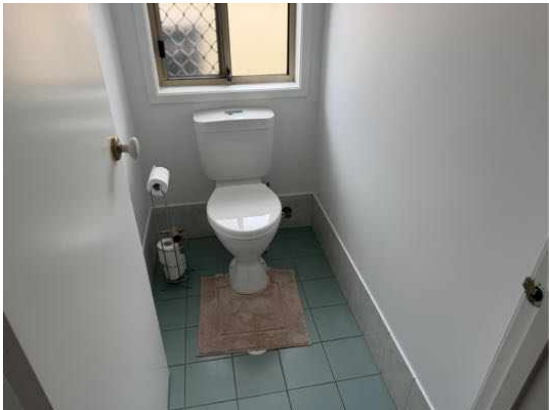
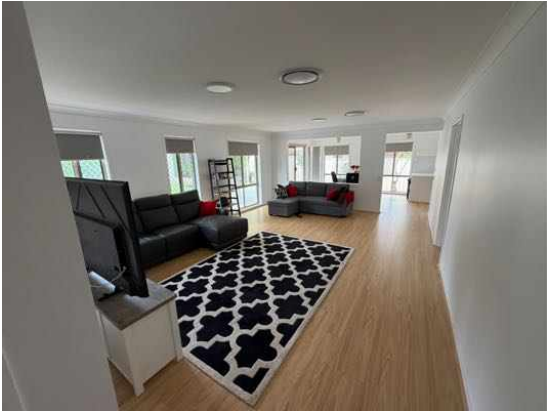
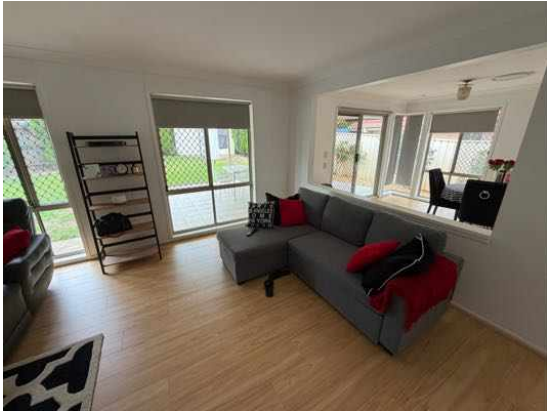
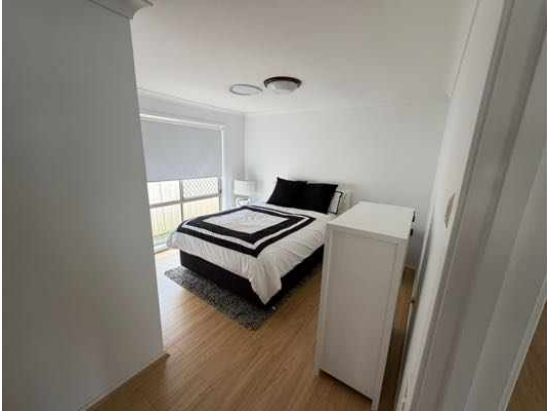
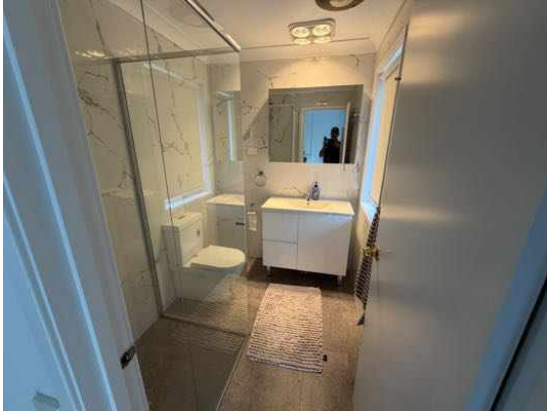
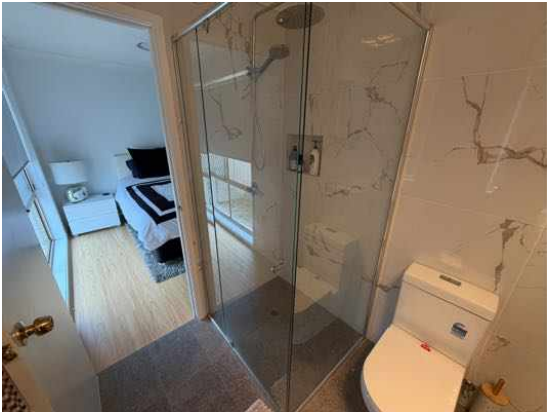
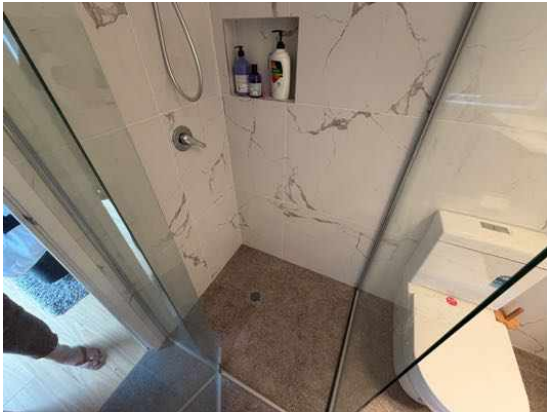
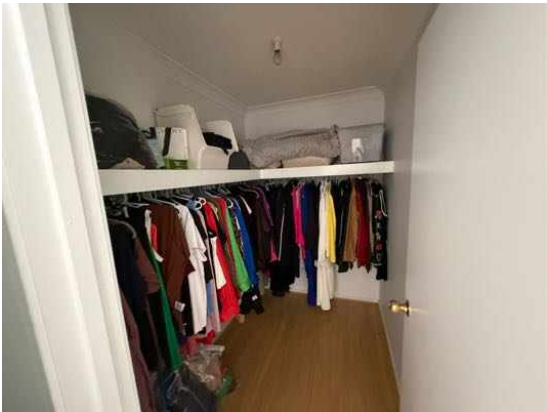
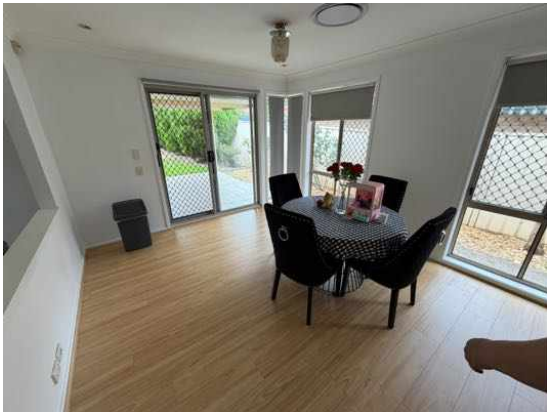
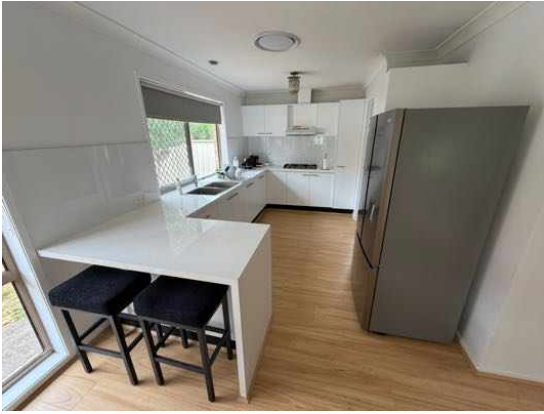
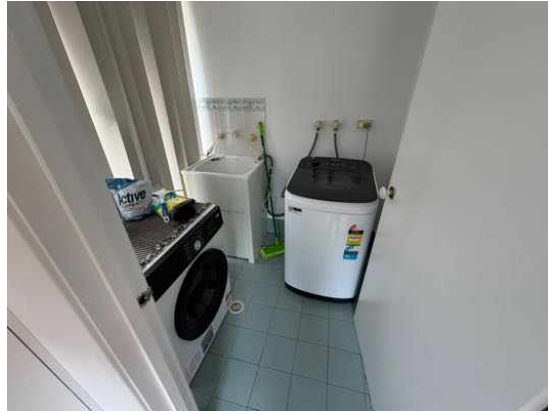
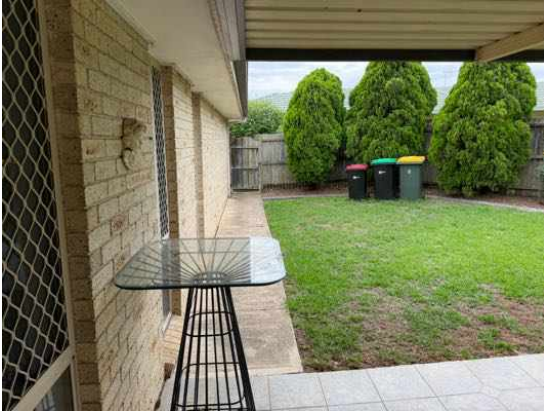
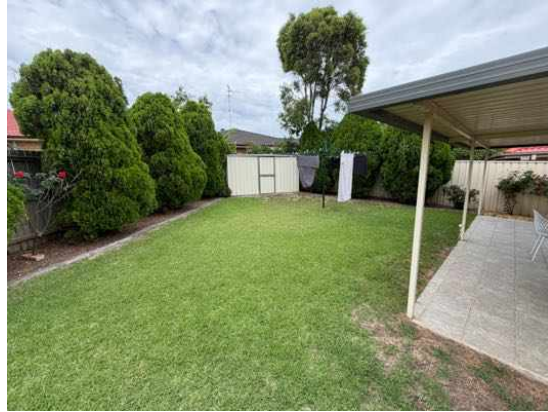
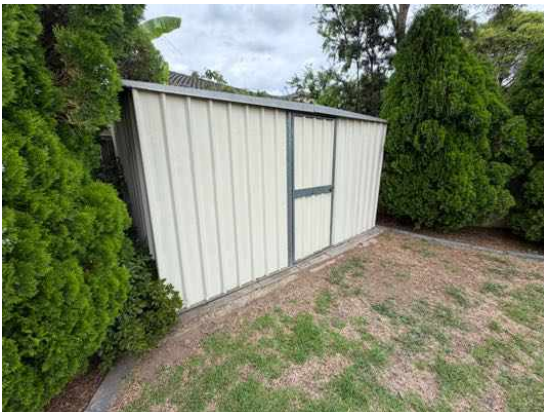
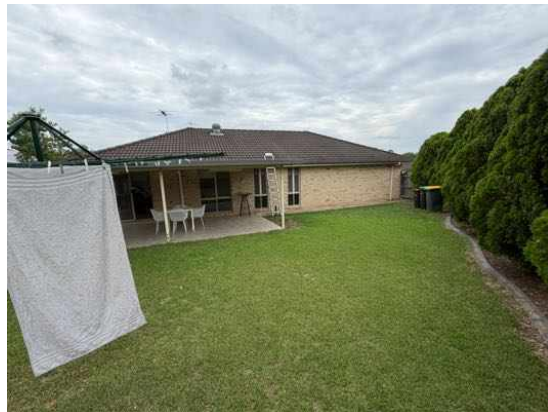
Building: Main Building
 Location: All Areas
 Finding: FYI-Additional Photos
 Information: Additional photos are provided for your general reference and may include obstructions, testing of water and windows, moisture readings or minor maintenance items.

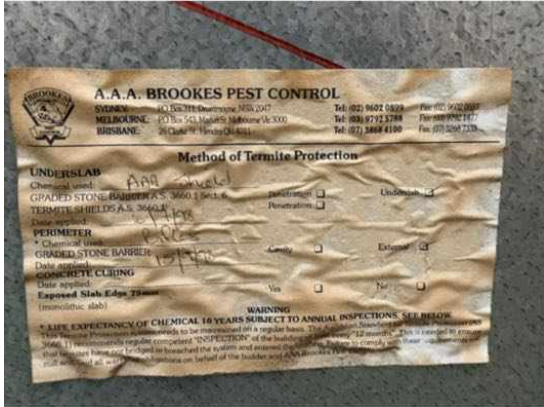
The following items were noted as - Evidence of a previous termite management program

Where a Termite Management System has been identified you should refer to the type of barrier date of installation warranty conditions and any documentation provided by a builder or past owner. Consult the company who installed the barrier to confirm whether the system is still under warranty.

Most chemical termite management systems expire and require replenishment and all physical systems are primarily designed to prevent concealed entry.
