Building and Timber Pest Inspection Report

Inspection Date: Mon, 2 Mar 2026

Property Address: 73 Alford St, Quakers Hill NSW 2763,
Australia

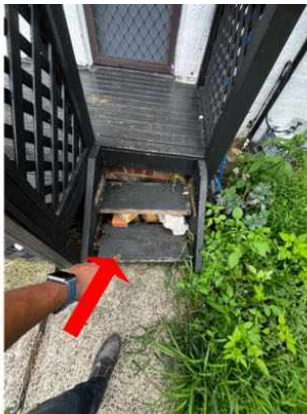
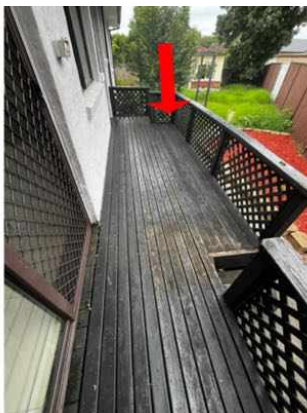
External timber structures are also constantly exposed to weather elements and can deteriorate in an accelerated manner, ongoing assessments are required.

External stairs to the decking was broken during inspection.

It is highly recommended that a Structural Engineer further assess the external timber balcony or deck to inform the client of its load capacity. Regular maintenance inspections by competent practitioners is needed.

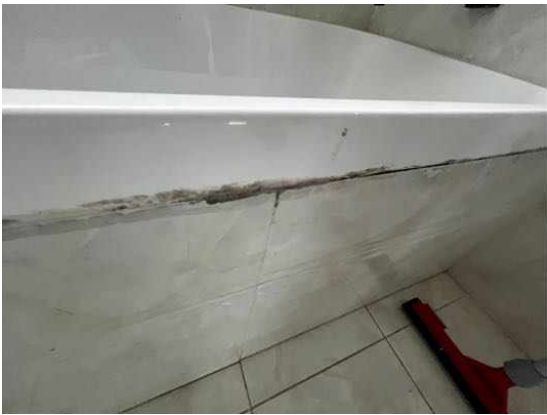
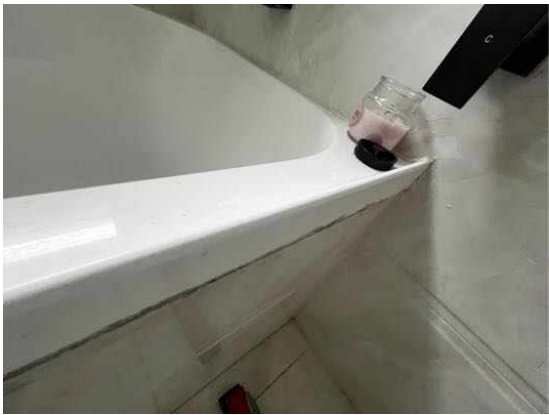
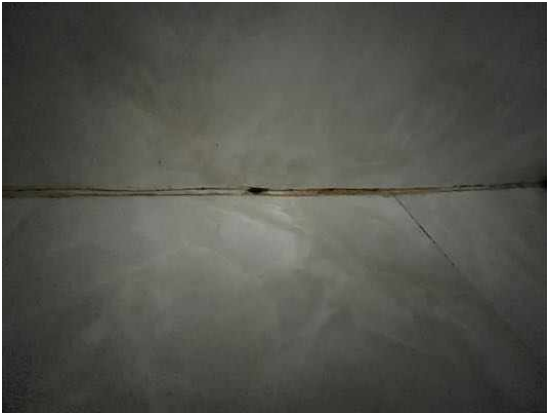
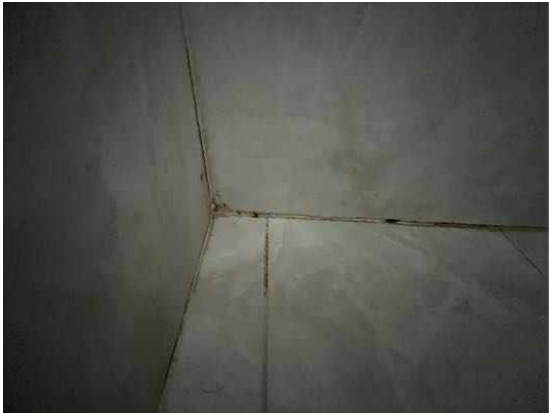
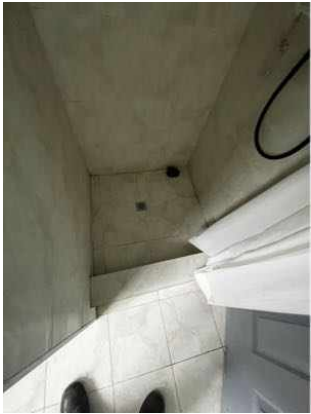
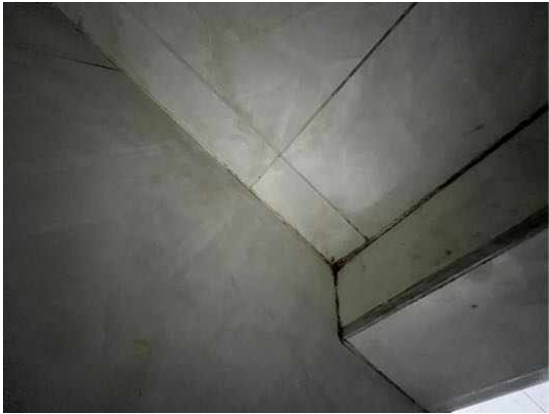
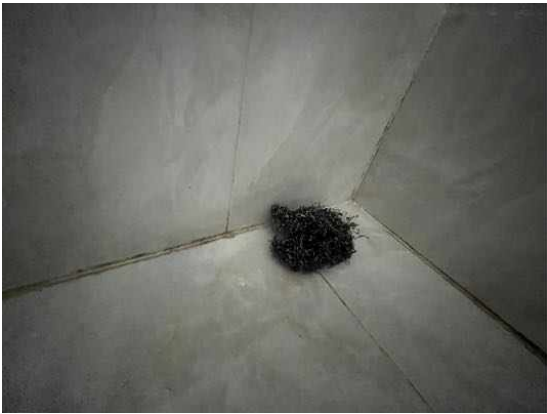
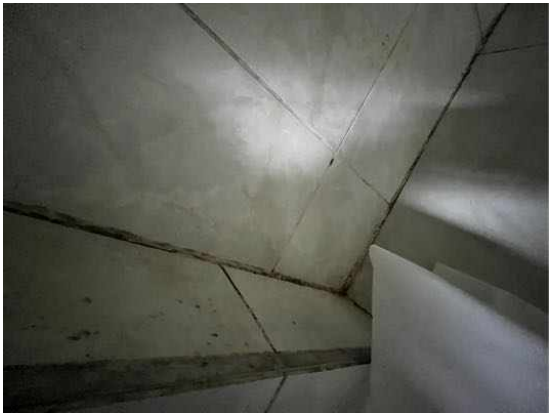
Finding 2.01

Building:	Main Building
Location:	Main Bathroom >
Finding:	Sealant and grouting - Missing or damaged -
Information:	It was noted on inspection that sealant or grout is degraded to the tiled shower alcove and or other areas of the bathroom.

Different materials and floor areas move at different rates, generally causing cracking to grout or sealant at this point. A flexible sealant is required to allow for expected expansion and contraction, while keeping the joint water tight and protective of all associated building materials.

There appears to be excessive mould to the sealant and grout which will likely require scraping out and replacement.

Flexible and mould resistant materials should be applied to affected areas to prevent any subsequent water damage that is likely to occur. Regular maintenance and replacement of damage or missing or damaged sealant and grout is highly recommended to the wet areas, as this is a regular wear and tear defect. Sealant and grouting in areas that come into regular contact with water should be maintained for the long term care of your property.

A sealant specialist or tiling contractor should be appointed to complete these works as soon as possible to prevent water ingress

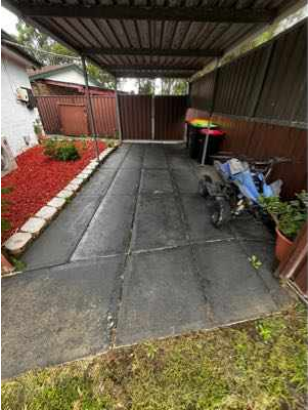
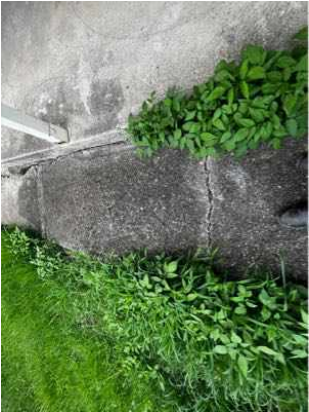
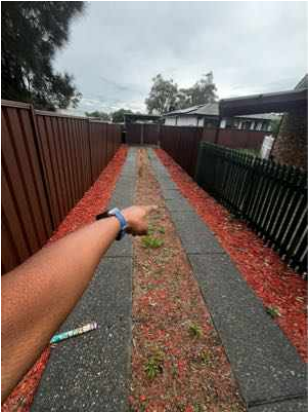
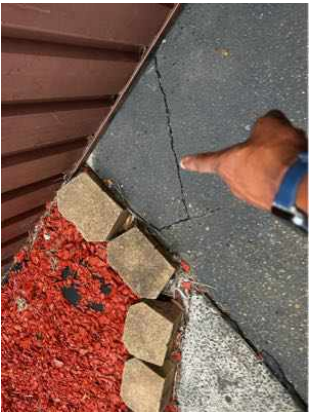
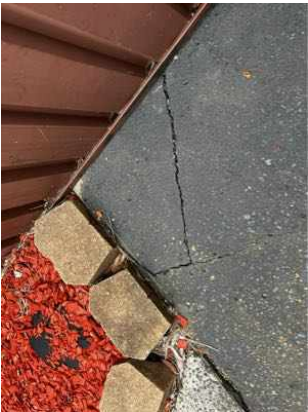
Finding 3.01

To be considered Category 2, the approximate width of the crack is less than 2.0mm, or a change in offset of less than 15mm when a 3m straight edge is placed over the defect.

Category 2 cracks to slabs should be monitored for a period of 12 months. At the end of the monitoring period, cracks rated greater than Category 2 are considered defects that require rectification.

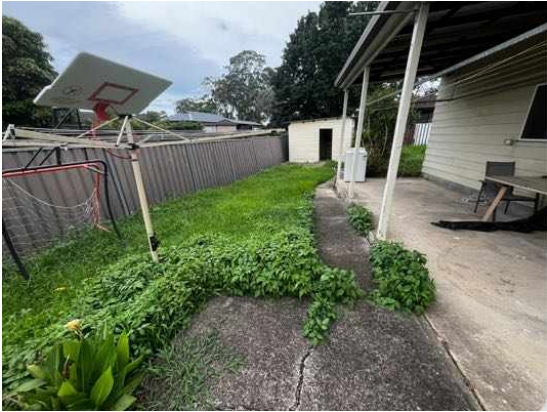
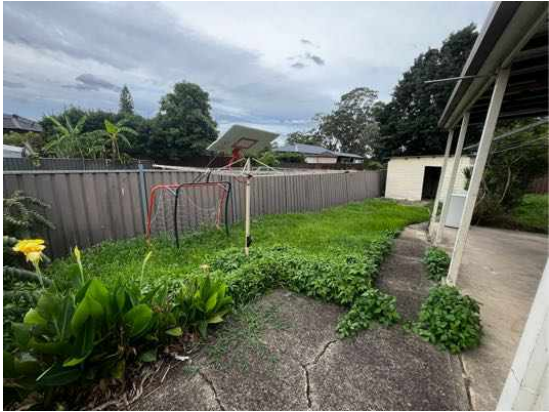
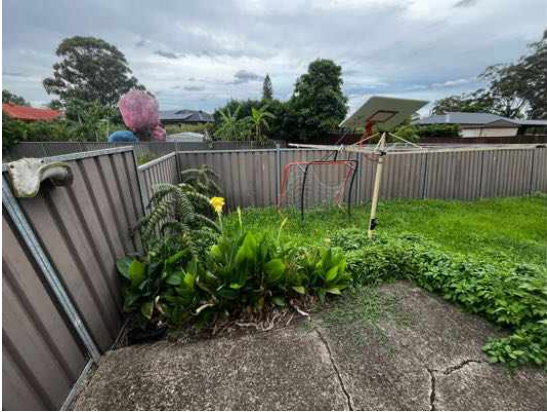
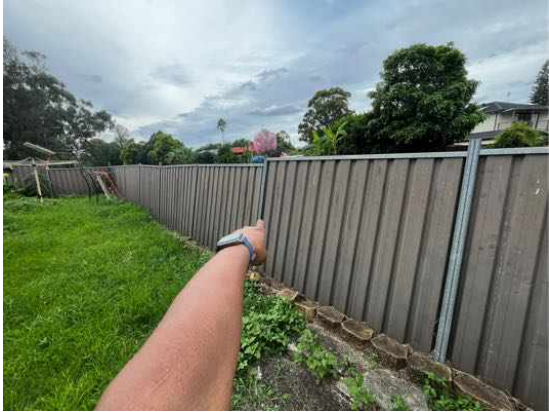
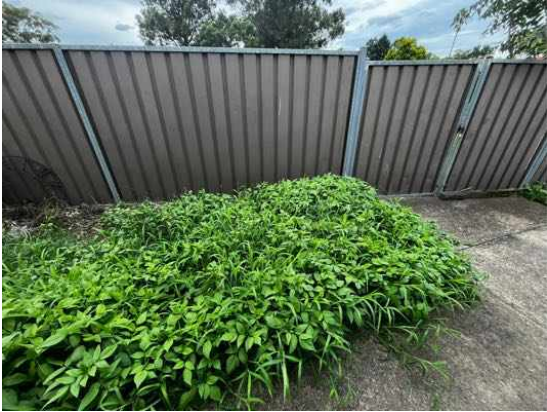
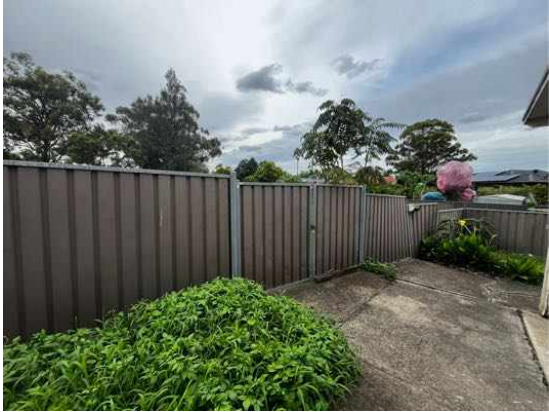
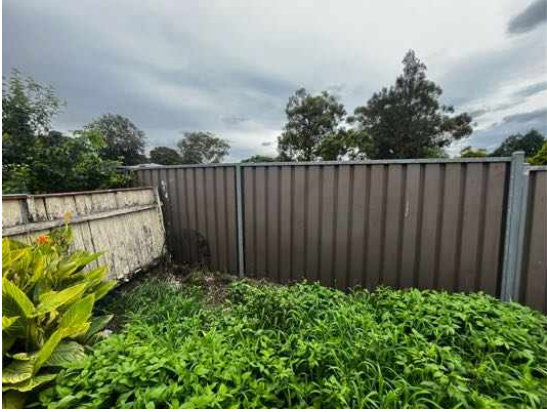
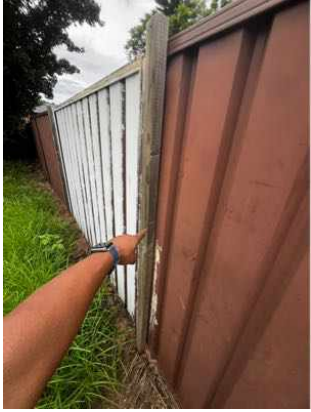
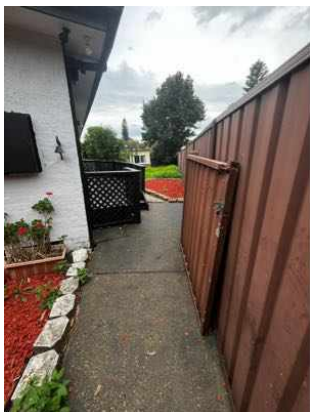
Finding: Fencing - Deteriorated

Information: It was noted at the time of inspection that sections of the fencing throughout the property have deteriorated. Typically fencing deteriorates due to age and or wear, rot and or rust which is generally expected for a structure of this age, due to prolonged exposure to weather conditions. Sometimes inadequate installation or maintenance can be to blame.

If left unattended, it is likely that further damage will occur. It is suspected that repair of several elements of the fencing may be required however replacement may be a consideration of the client also.

A licensed fencing contractor should be appointed to provide further advice and perform rectification works as necessary.

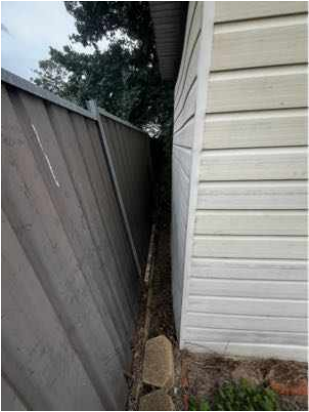
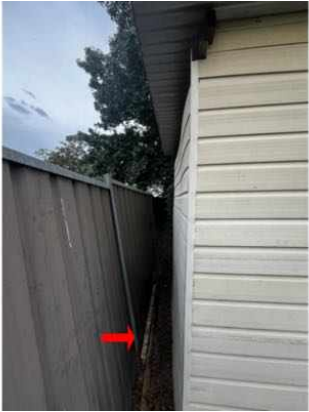
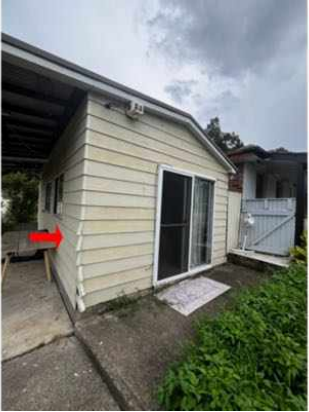
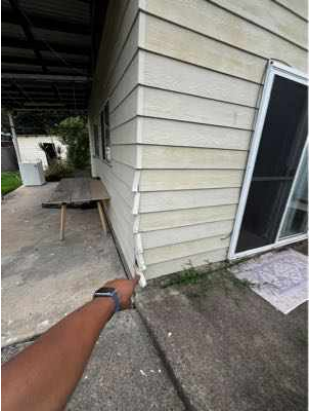
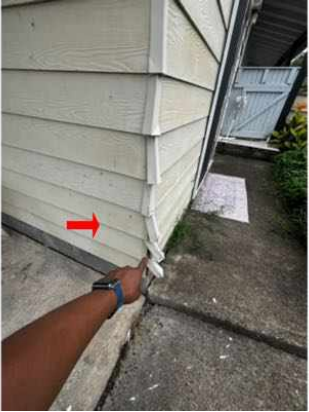
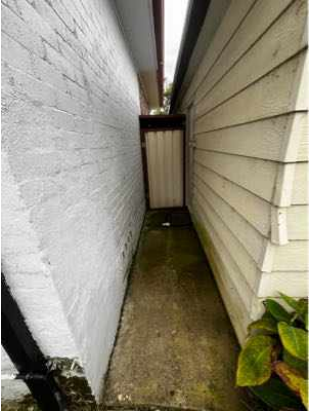
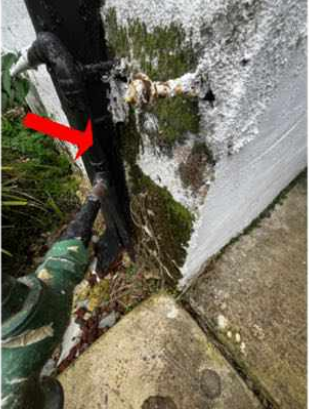
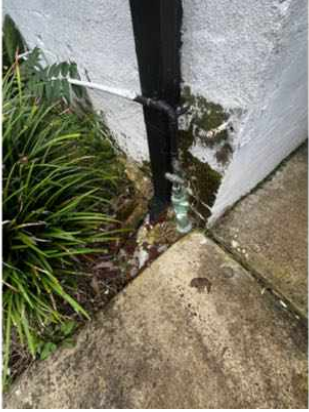
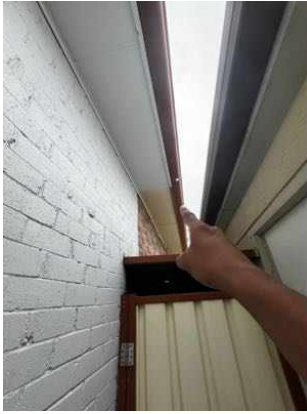
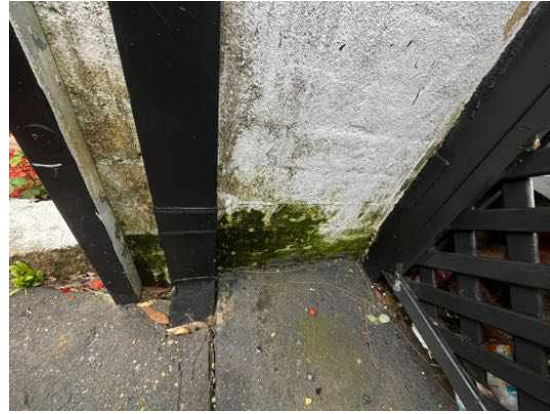
Finding 3.03

Building:	Main Building
Location:	Main House/Studio
Finding:	Weatherboards - Rotting
Information:	The external weatherboards show signs of fungal decay (wood rot) in several sections. This wood rot is suspected to have developed over a prolonged period of time due to frequent weather exposure, which is expected in a property of this age and condition

Weatherboards are sealed and protected by paint and other sealants. When these sealants deteriorate over time, they allow water penetration to the weatherboards, causing wood rot. If left unmanaged, the wood rot is likely to develop further, possibly necessitating major repair or replacement works in the long-term future.

To maintain the condition of the external wall cladding, any severely affected weatherboards should be substituted as soon as possible with pre-treated replacements. Where weatherboards have rotted due to excessive moisture other than rain penetration, the cause of the moisture should be identified immediately by a licensed plumber. A qualified carpenter should be appointed to repair and replace rotting weatherboards.

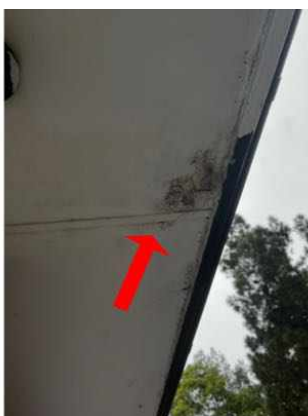
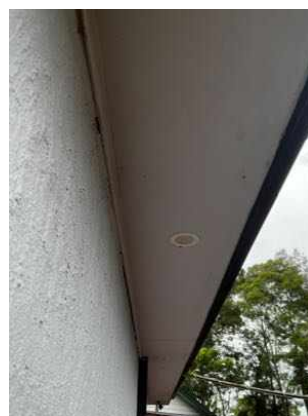
Building:	Main Building
Location:	Eves
Finding:	Ceiling - Water stained
Information:	Water staining to eves ceiling linings in this area was evident at the time of inspection. Water staining indicates that surfaces have been exposed to excessive moisture over time. The minerals and other elements in the water lead to staining, which may graduate to corrosion and deterioration if left unmanaged.

While mostly an appearance defect, water staining can be indicative of more serious defects, which may be currently concealed by interior ceilings.

Where water staining is active, a licensed plumber must be consulted to identify the cause of the staining and to provide advice on any reparation works that may be required. Replacement of any damaged structures is advised.

Conversely, where water staining is old and inactive, affected building materials may be repaired or replaced at client discretion.

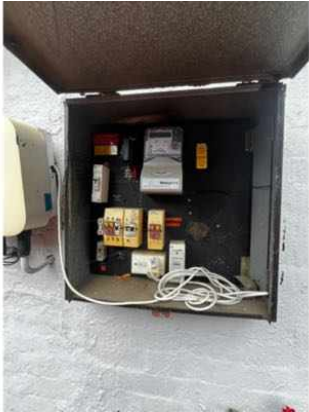
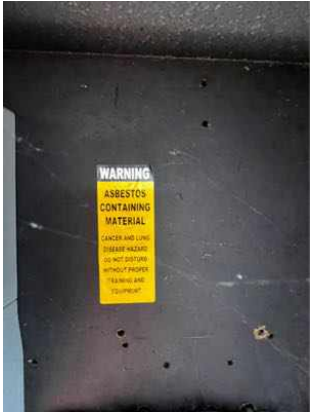
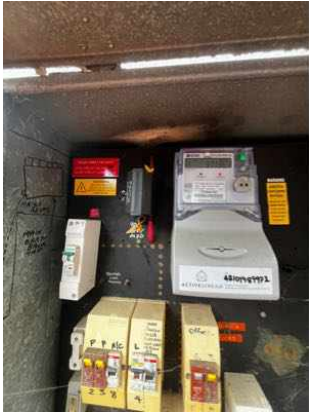
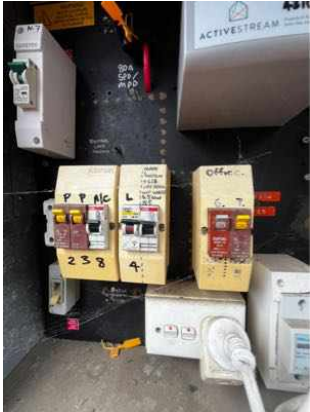
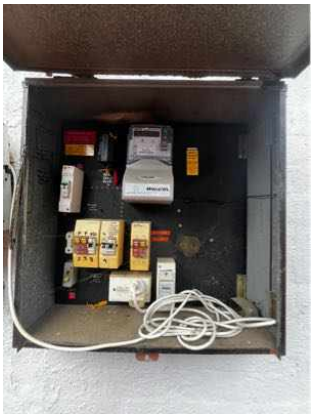
Information: Notice
The application of a post-construction chemical termite barrier is highly recommended for all properties, particularly if live termite activity has been found on the site previously. Such barriers are highly effective in preventing termite attack on any timber building elements throughout the property.

A durable notice should be placed in the switchboard unit to indicate current termite barriers. At the time of inspection, it appeared as though no termite management system has been installed, with no evidence to suggest preventative works taking place.

The client may consider gaining further advice from a pest controller as to the costs and procedures involved with this application. It is recommended that obtaining such advice be a short-term priority.

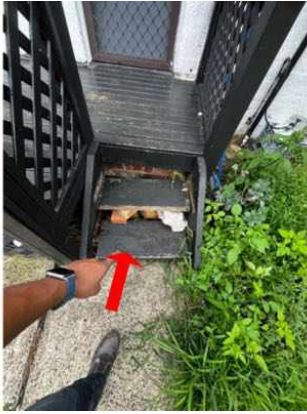
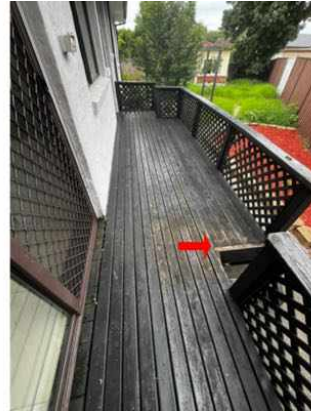
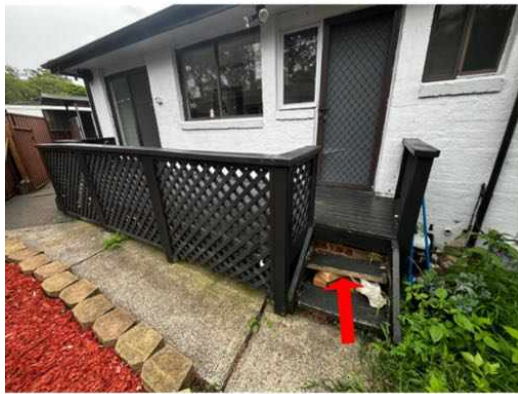
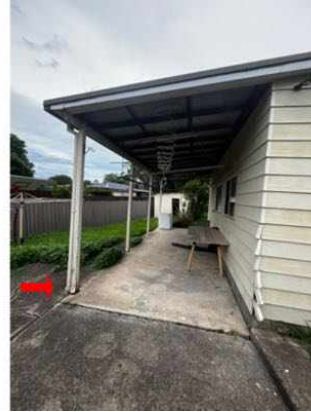
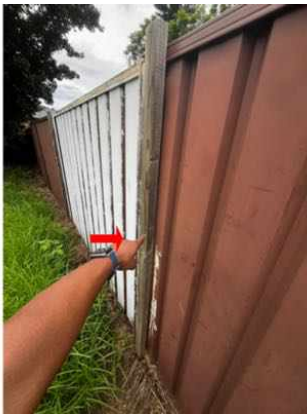
Finding 6.02

Building: Main Building
Location: All Areas
Finding: In ground contact
Information: Any timbers in direct ground contact provide opportunity for concealed termite entry and are likely to be subject to premature rot and decay as the soil retains moisture or damp conditions against the timbers.

Remove untreated timber that is in direct contact with external grounds. Consider replacement with more durable materials i.e. treated timber or non timber elements. Frequent pest inspections are advised to readily identify any termite activity in these areas.

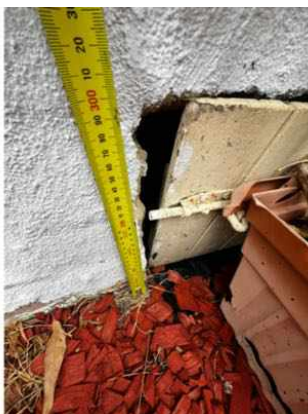
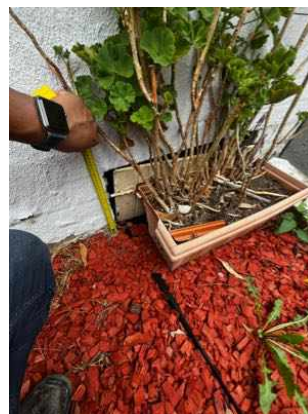
Finding 6.03

Building: Main Building

These obstructions can hide an array of defects and should be removed to allow full inspection to be carried out.

A re-inspection is recommended once the areas are made accessible.

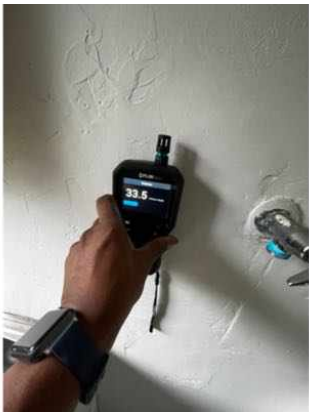
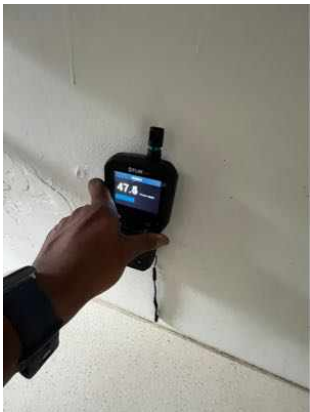
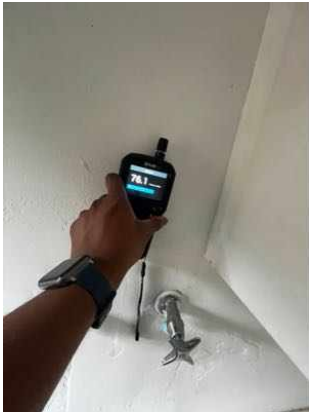
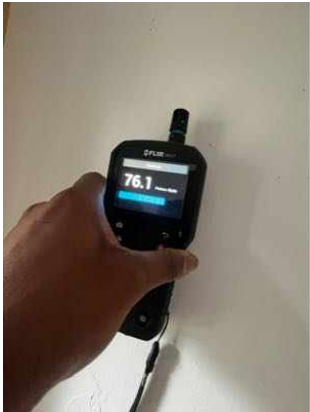
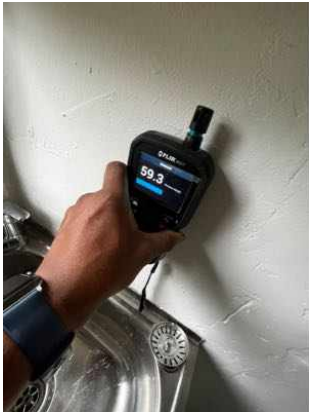
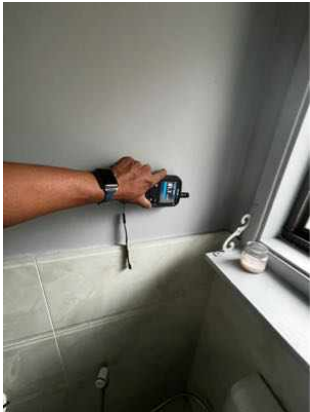
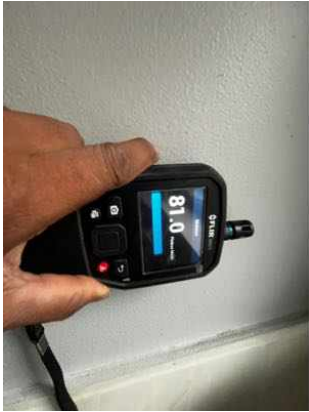
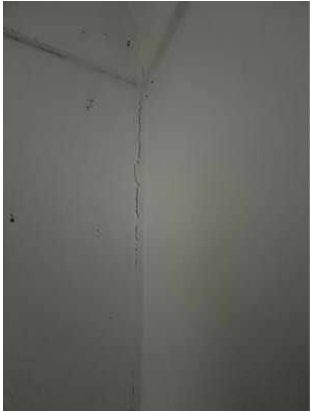
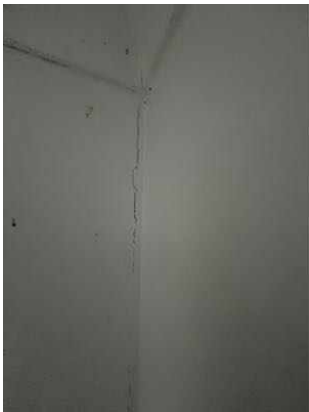
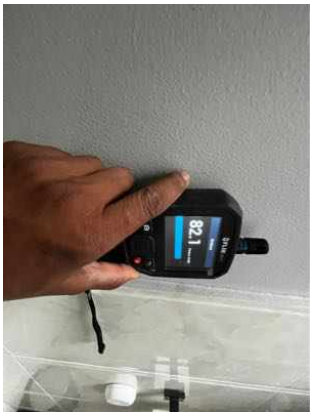
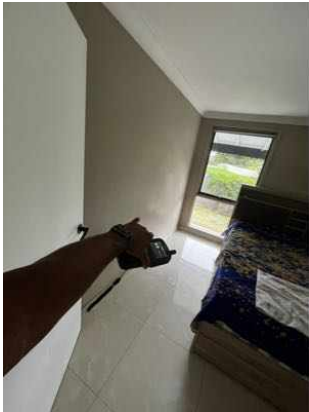
Some readings for moisture were found in the walls adjacent the showers at the time of inspection.

Wall paneling, wet paper, carpet and fixed cabinetry can obscure termite activity.

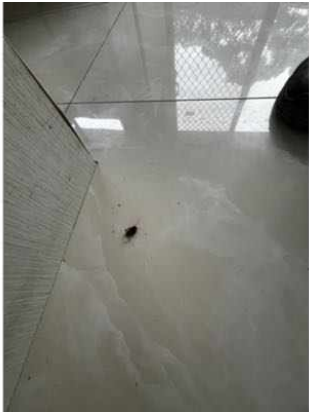
Finding 6.05

Building: Main Building
Location: All Areas
Finding: Evidence of Vermin
Information: Evidence of pests or rodents were present in the roof space at time of inspection including animal pings and odor. Rodents can cause issues ranging from smells and stains through to physical damage to wiring and other elements in the roof void. A licensed pest controller should be appointed to free the roof void of any pests and to install deterrents or seal access points to ensure that rodents can not enter the roof space as easily.

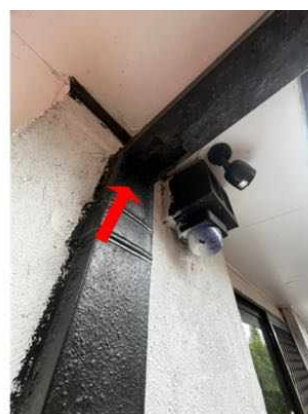
Finding 7.01

Building:	Main Building
Location:	All External Areas
Finding:	Fungal decay - present (localised)
Information:	Fungal decay also known as wood decay or wood rot generally refers to the deterioration of timber elements when in contact with excessive levels of moisture for a prolonged period of time.

The development of fungal decay is accelerated by temperatures in the range of 5degreeC to 40degreeC as well as the presence of oxygen. Generally fungal decay develops on timber elements that are in use in an external environment which are exposed to rain penetration.

In this case although the affected timber element is in a decaying state the extent of any visible damage appears to be localised to a specific area and is yet to spread to other parts of the building element or affect adjoining structures. The fungal decay is therefore likely to be of a relatively superficial nature with minimal impact on the structural integrity or tensile strength of the timber element.

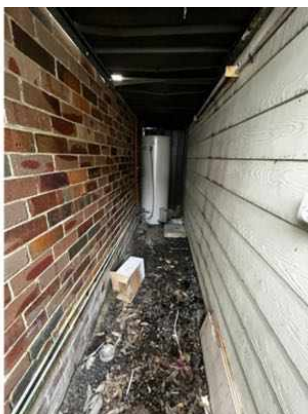
Building: Main Building
 Location: Yard - Back
 Finding: Hot Water Unit
 Information: The HWS appeared to be in good condition at the time of inspection.

Water pressure appears to be normal, however, this is not an opinion of a licensed plumber. No water hammer was noted when taps are turned off fast.

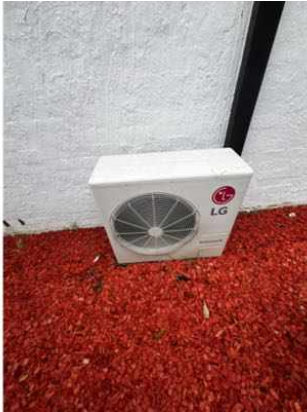
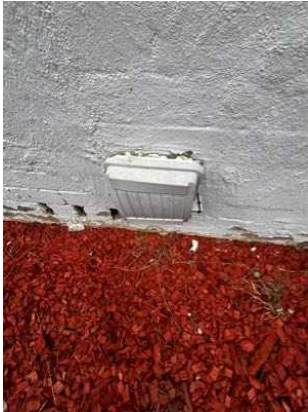
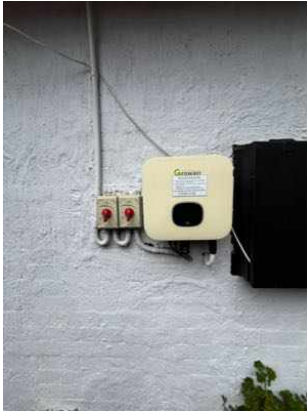
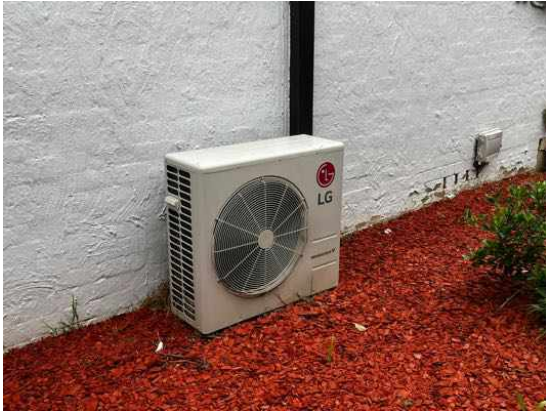
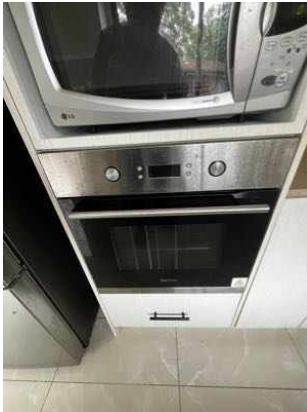
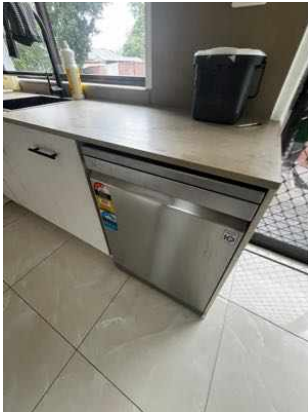
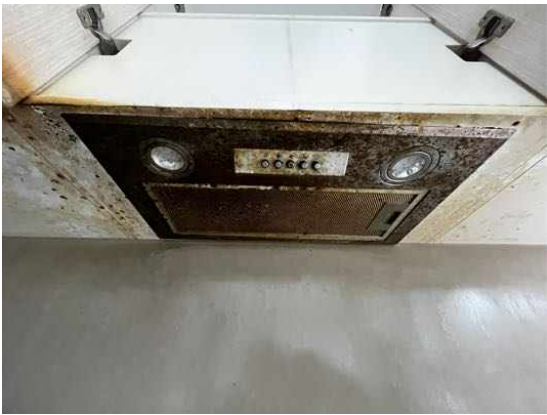
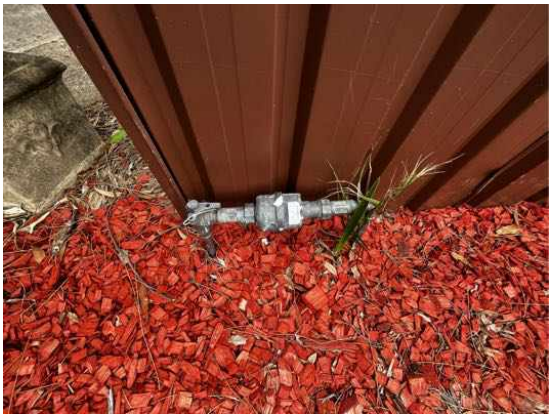
Building: Main Building
 Location: All Areas
 Finding: Plumbing/electrical/gas/aircon/appliances/pool equipment/fire safety etc
 Information: Plumbing and electrical inspections are outside the scope of the building inspection and must be conducted by a Licensed and registered Trades person.

It is highly recommended that the client makes immediate arrangements to have the gas appliances checked by a licensed gas plumber to ensure that the appliances are working safely and efficiently.

We recommend all other installations be checked also.

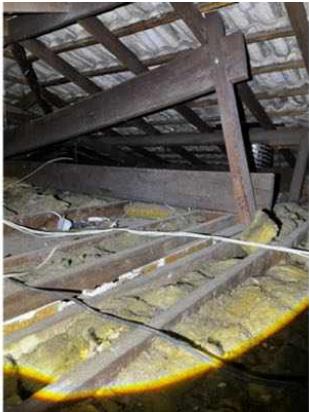
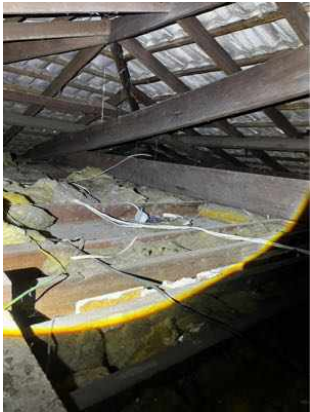
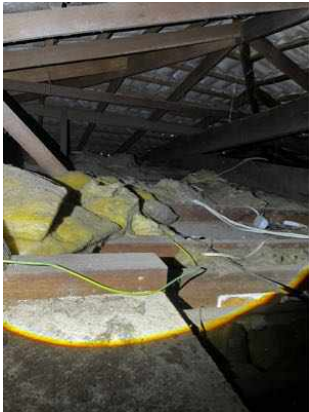
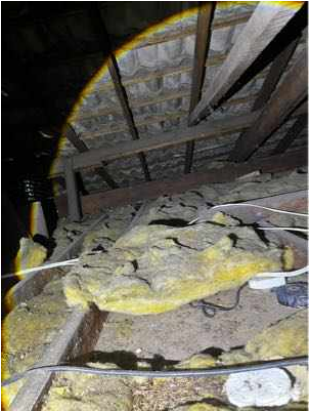
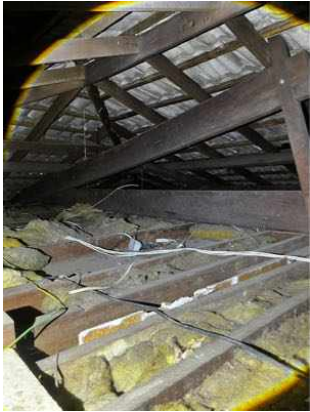
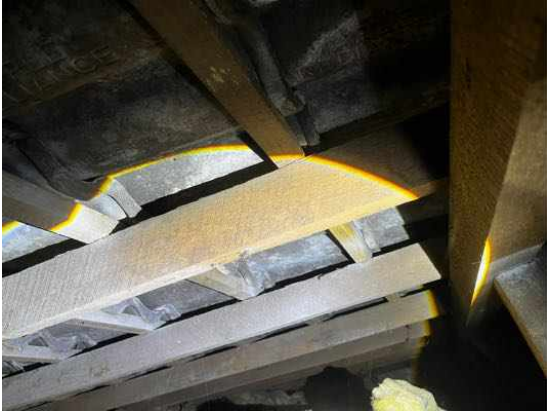
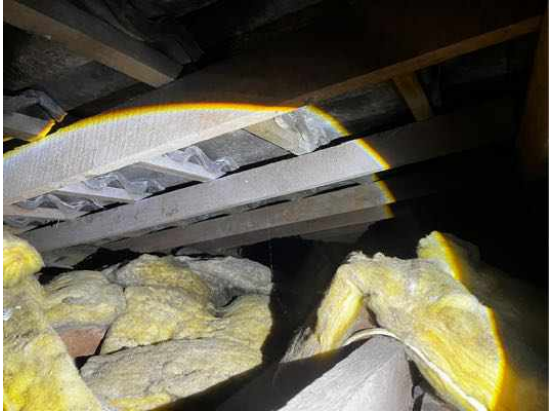
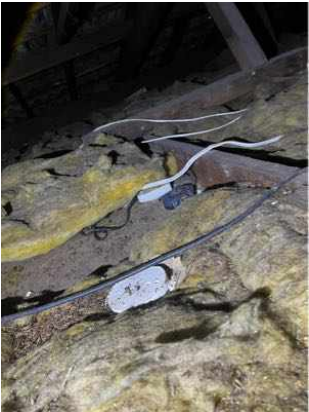
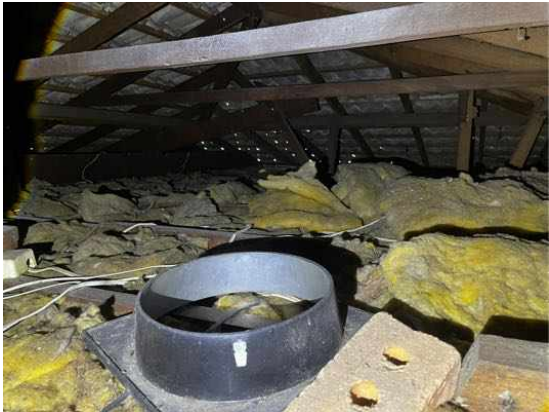
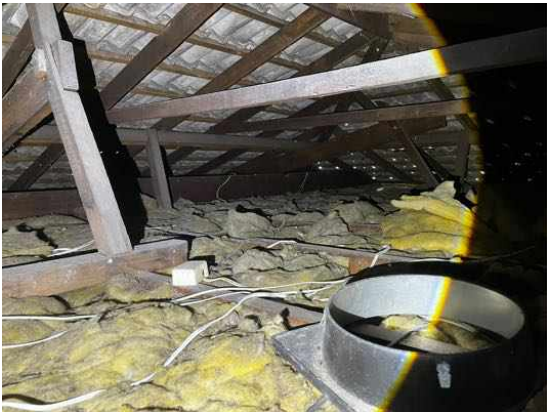
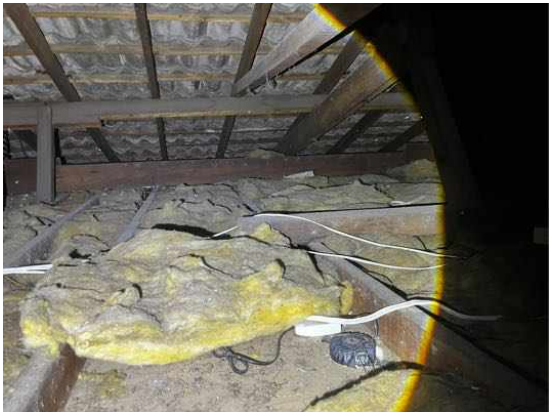
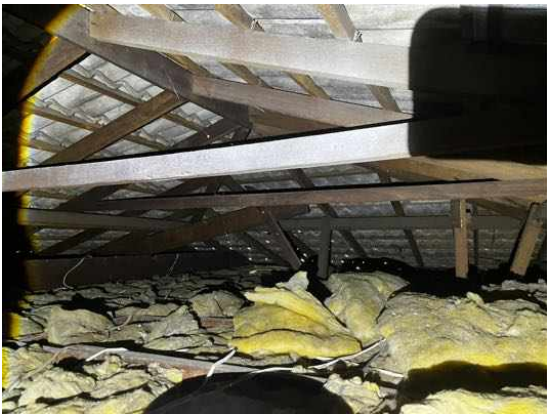
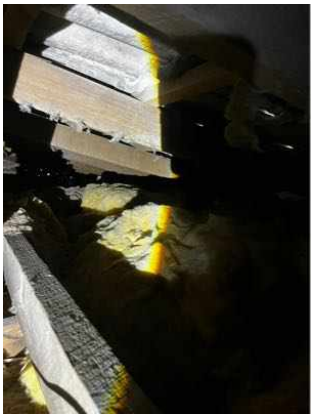
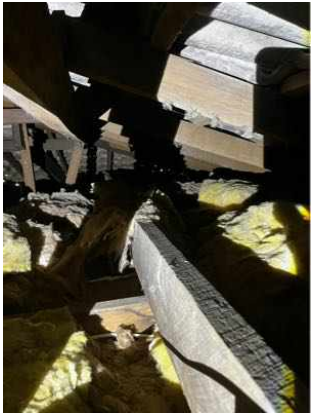
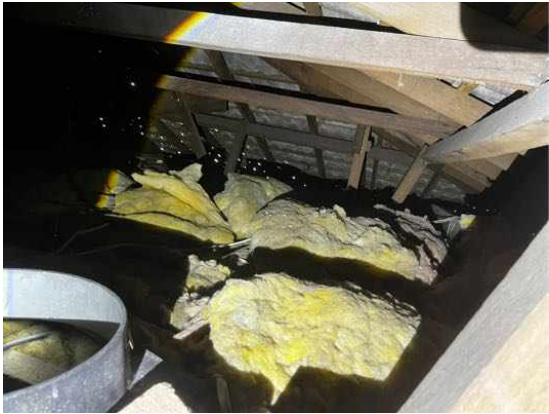
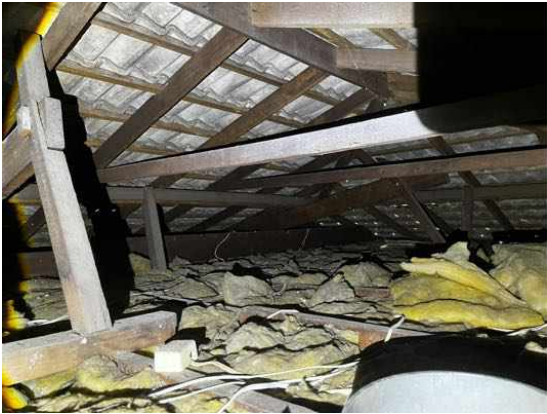
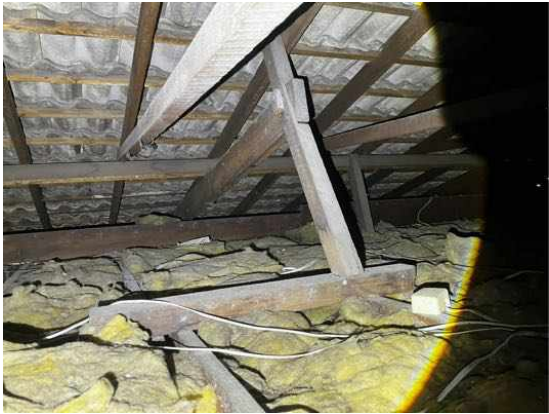
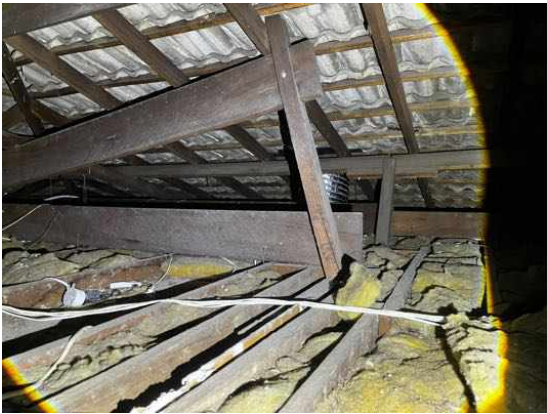
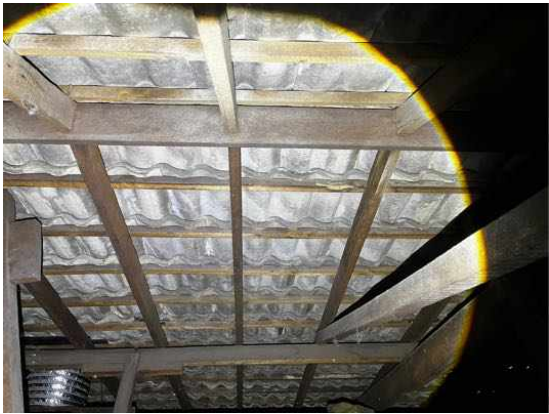
Building: Main Building
Location: Roof Void
Finding: Obstructions and Limitations - Roof space
Information: Roof space no access

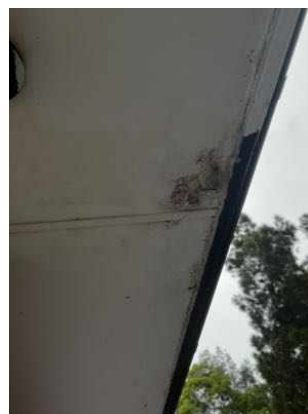
Building:	Main Building
Location:	Seperate Studio
Finding:	Additional structure - Non-compliant
Information:	The additional structure that has been affixed to this area of the dwelling does not appear to comply with contemporary building practices and current Australian Standards. While the structure does not currently appear to be unsafe, compliance with such standards ensures the structural integrity of the main dwelling and abutting addition.

As building standards have not been followed, this area provides a heightened risk of the development of building defects. The structural integrity of the area may have been compromised, which creates potential for the development or presence of major

safety issues.

It is highly recommended that any planned repair, remodeling or demolition works be carried out by registered builders. Such works may be necessary in the short-term future to ensure the safety and functionality of the area.
