## Building Inspection Report

Inspection Date: Wed, 8 Apr 2026

Property Address: 2/40 Lomman Ave, Newton SA 5074,  
Australia

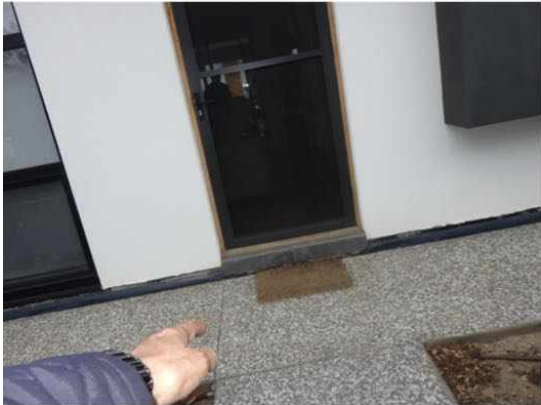
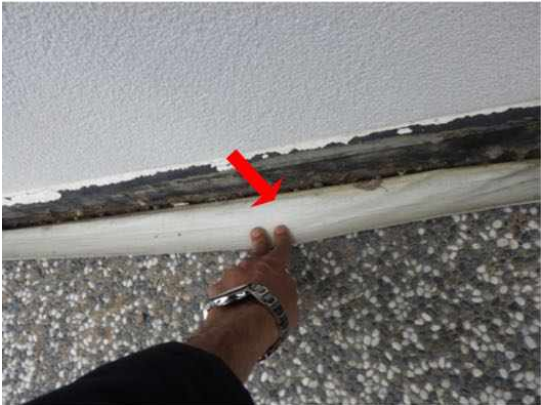
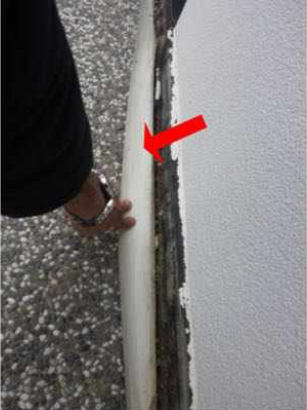
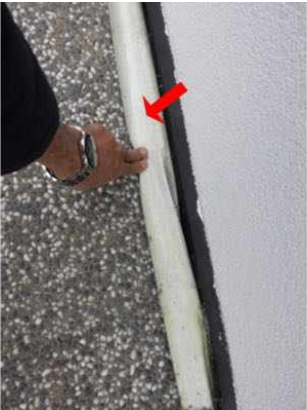
If the slab edge is not properly exposed there is a high risk of termite attack. Sometimes, in order to determine the type of slab, a suitably qualified person such as an architect or builder may be required to consult the construction plans.

Where the slab edge cannot be properly inspected, it is highly recommended that termite or timber pest inspections be carried out every 6-12 months to aid protection of the property against infestation.

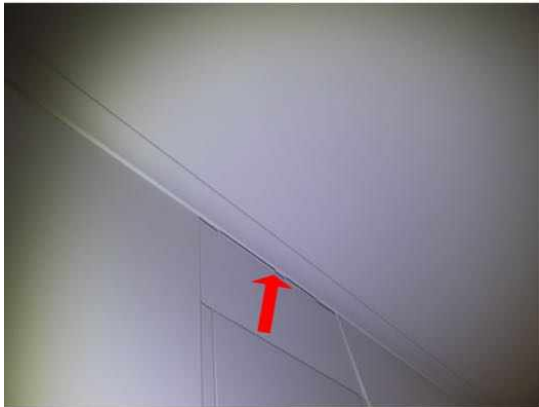
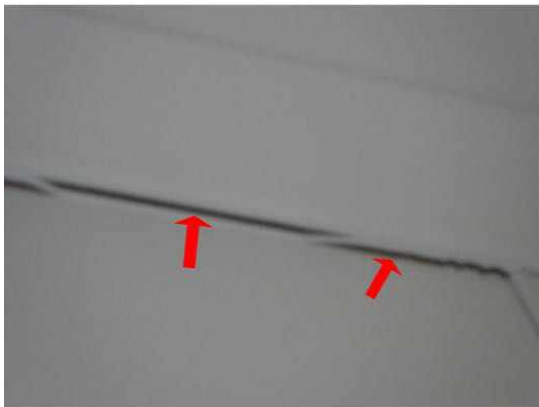
**Defects 3.04**

Building: Building 1  
Location: All Internal Areas  
Finding: Building element - Damaged  
Information: At the time of inspection it was noticed that flyscreen is damaged in this sliding door . Apart from that at the time of inspection it was also noticed that manhole cover & section of internal walls is damaged/ loose from its original fixing.

Breakage occurs generally when the building materials have either aged and decayed, or as a result of damage (accidental or deliberate).

Repair and/or replacement of broken elements is advised to ensure that additional

secondary defects do not arise as a consequence. Such works are necessary, as all building elements play a key role in the operation and function of the overall structure and its performance.

A relevant tradesperson should be appointed to repair or replace the affected building element prior to any subsequent damage being caused.

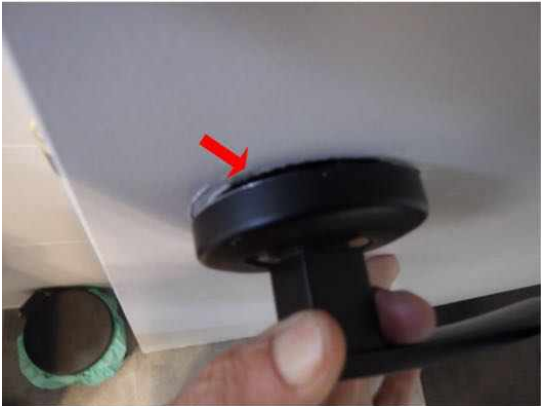
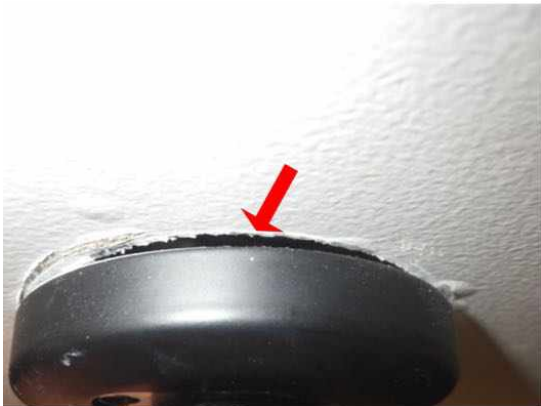
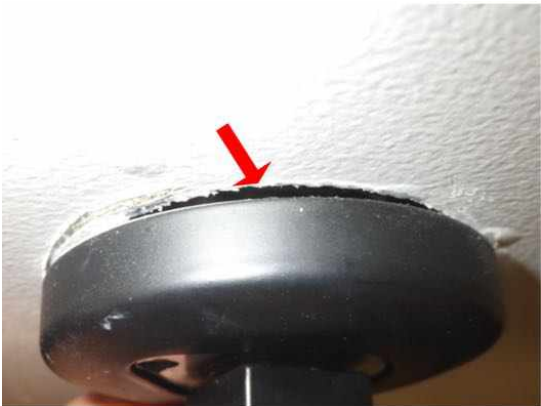
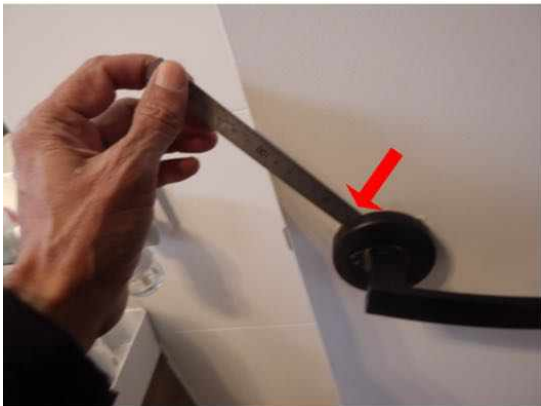
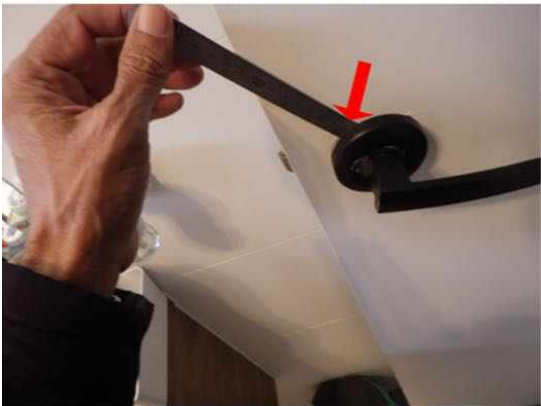
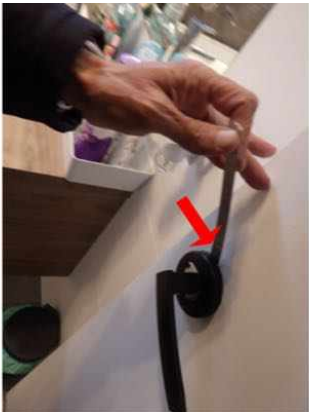
### Defects 3.05

Building: Building 1  
 Location: Bathroom 2  
 Finding: Door - Broken handle  
 Information: The door handle in this bathroom -2 area was found to be broken at the time of inspection. Breakage occurs generally when the building materials have aged and decayed, but may be indicative of impact damage (accidental or deliberate).

Repair and/or replacement of the broken door handle is advised to improve the operational state of the associated door.

A qualified carpenter or general handyman should be appointed to repair/replace the

door handle at the client's discretion.

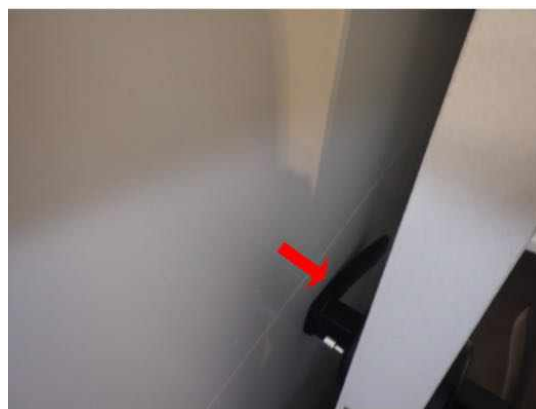
## Defects 3.06

Building:	Building 1
Location:	All Internal Areas
Finding:	Door stop - Missing
Information:	The door stop is missing or is inadequate to stop the door handle from damaging the wall. Although some building elements may seem irrelevant or unnecessary, all building elements play a key role in the operation and function of the overall structure and its performance.

Re-installation or replacement of the door stop is advised as soon as possible to prevent any subsequent damage to the door or associated structures. A general handyman may be appointed to perform these works at client discretion.

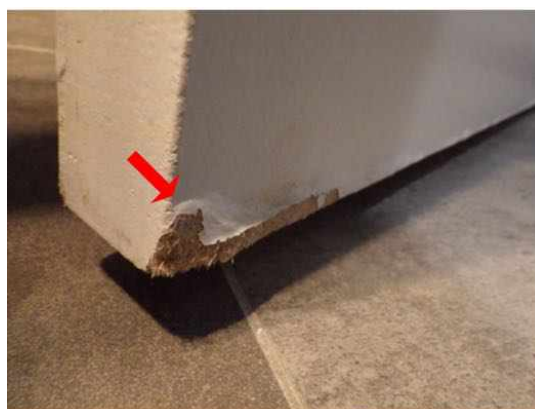
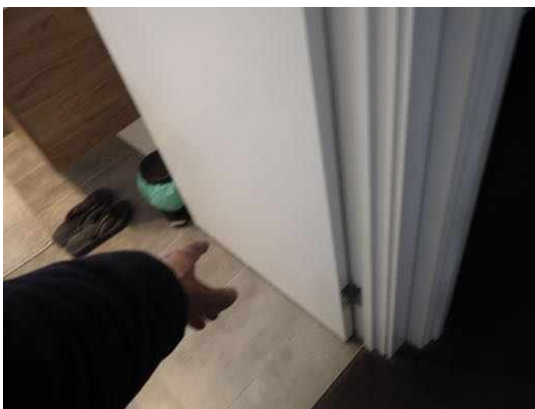
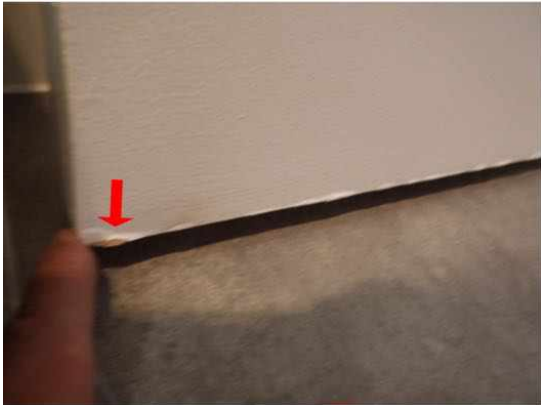
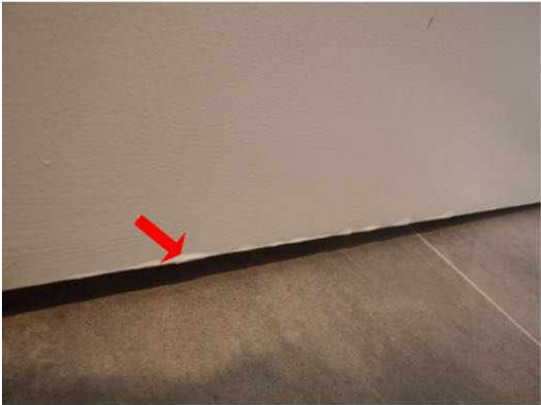
## Defects 3.07

Building:	Building 1
Location:	All Internal Areas
Finding:	Building element - Swollen
Information:	At the time of inspection it was noticed that few sections of building elements were swollen around the property.

affected by excessive moisture over a prolonged period of time, and have swollen as a result. The formation and development of mould/fungi or mildew is also a likely consequence of excessive moisture, which may pose major respiratory issues for occupants, particularly the elderly, the very young and those with existing illnesses and could be potential health safety hazards. In these cases an appropriately qualified inspector/tester should also be contacted for advice and/or technical assistance.

The structural integrity of swollen building elements can not be guaranteed, and further damage is likely to develop if left unmanaged. Excessive moisture is likely to lead to the development of secondary damage to any associated building elements, which may necessitate major reparation works if prolonged.

Rectification of the cause of the water leak should be addressed prior to any remedial works to the swollen building elements. A licensed plumber should be appointed immediately to identify the cause of the leak and provide advice on remedial works as necessary. Repair and/or replacement of swollen building elements should be conducted as a matter of urgency by a registered builder or qualified carpenter.

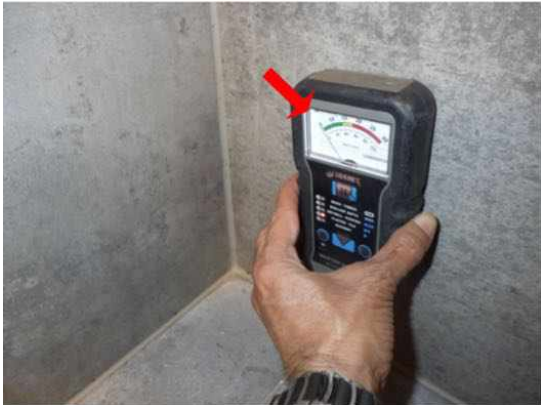
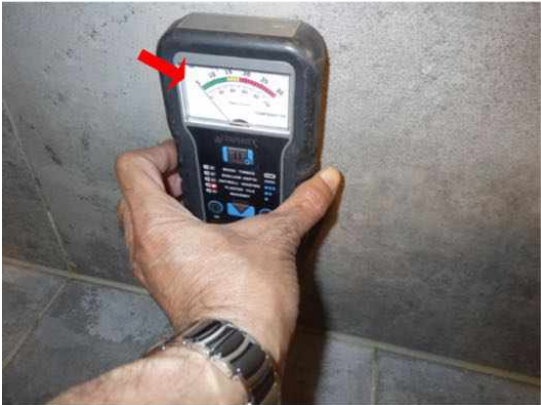
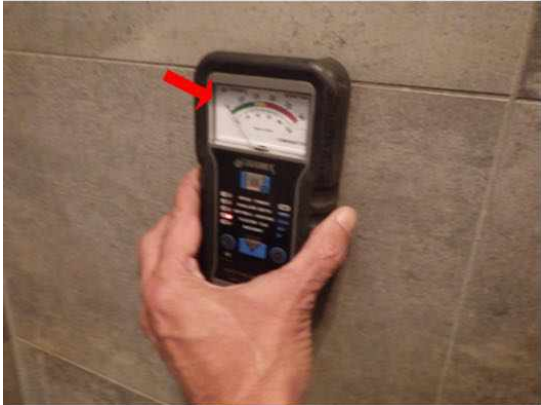
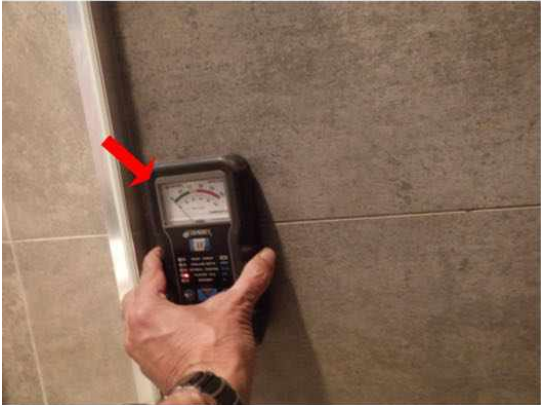
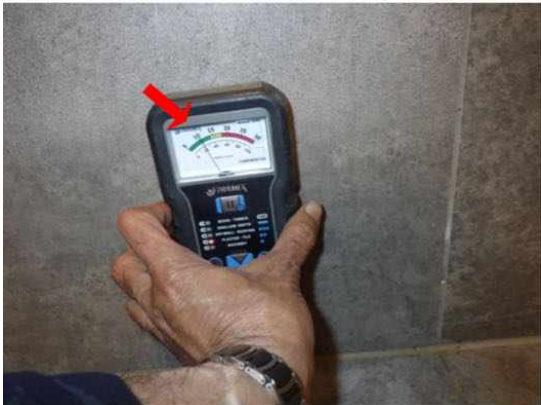
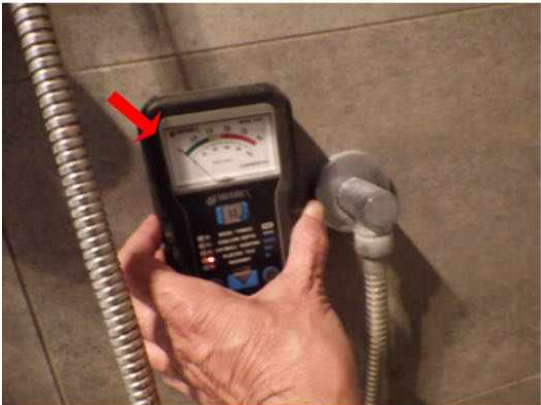
Building: Building 1  
Location: Bathroom-Ensuite  
Finding: Shower Alcove - No Damp  
Information: At the time of inspection it was noticed that damp is not evident to the shower alcove.

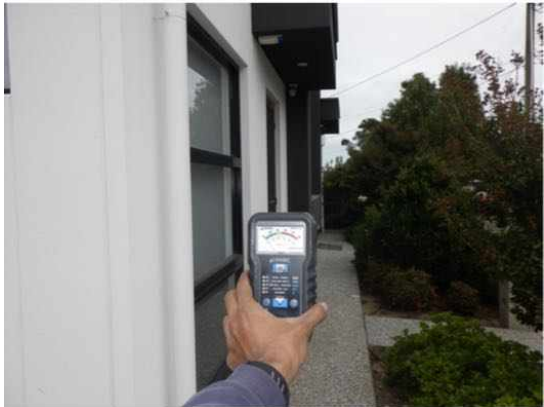
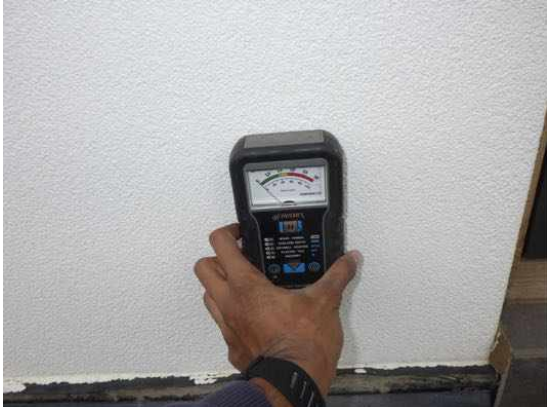
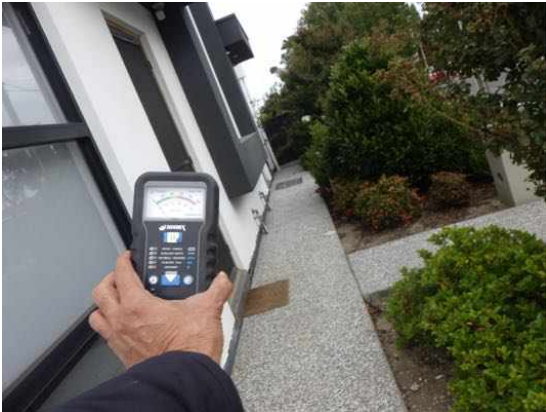
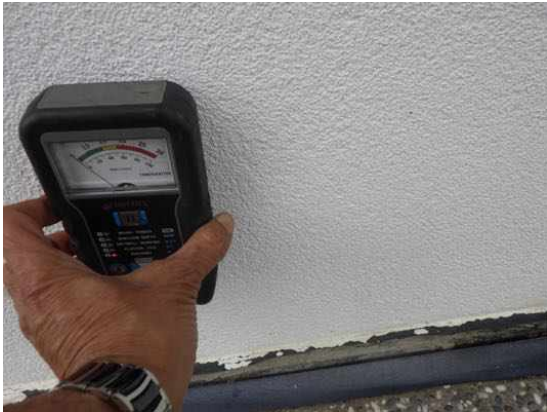
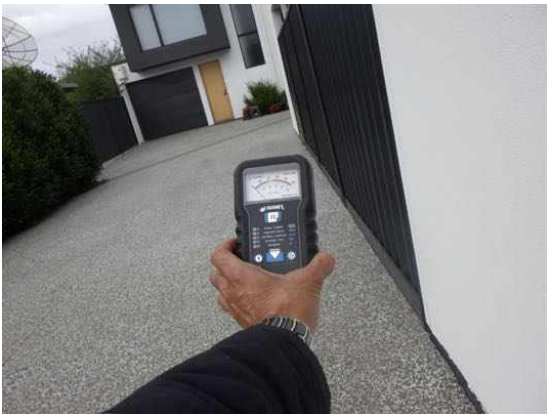
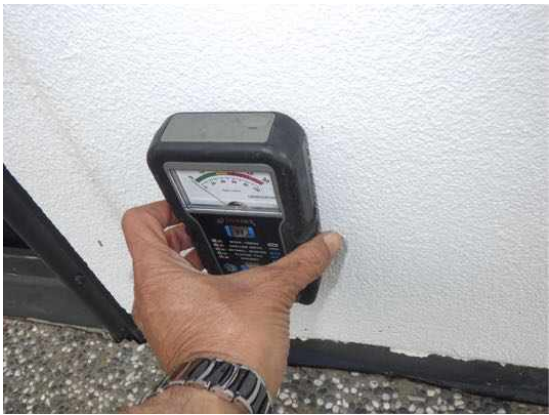
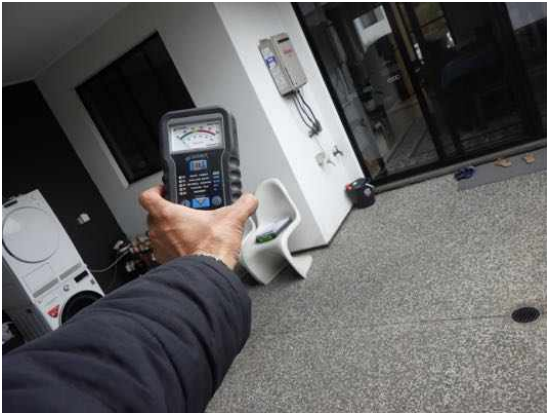
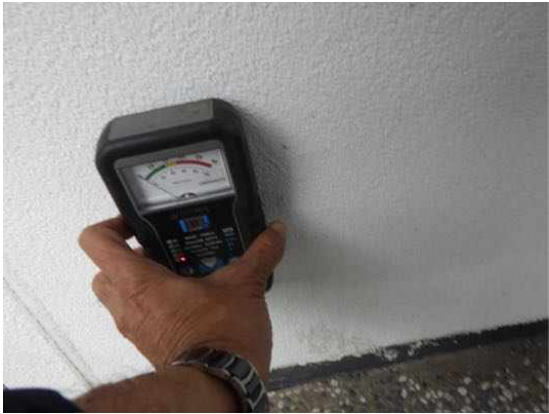
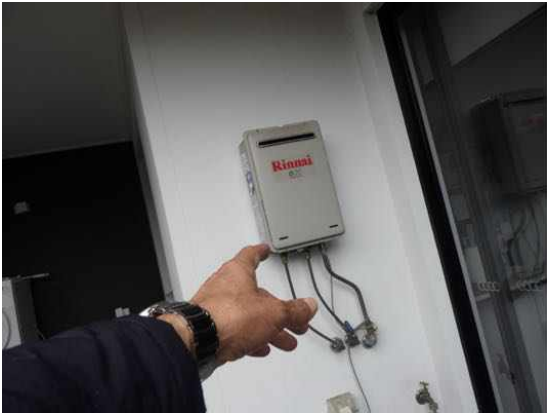
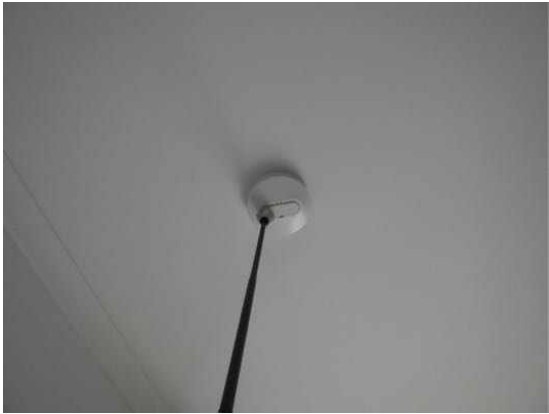
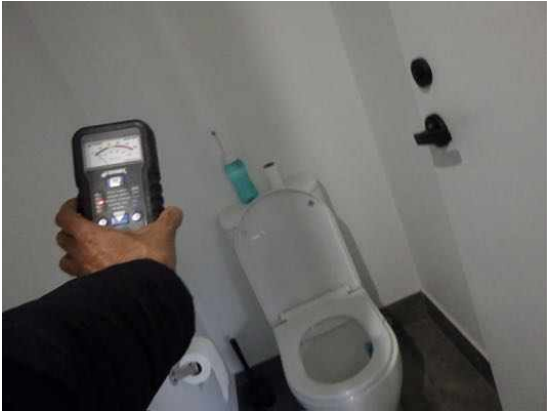
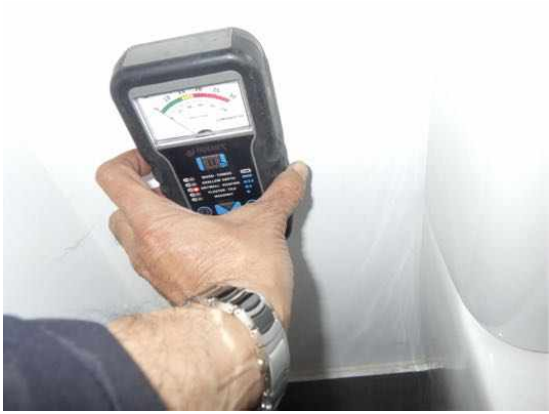
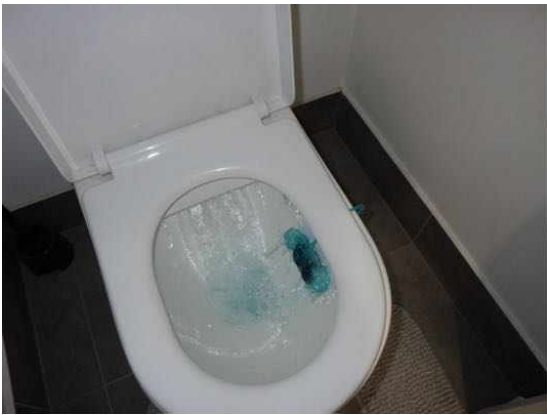
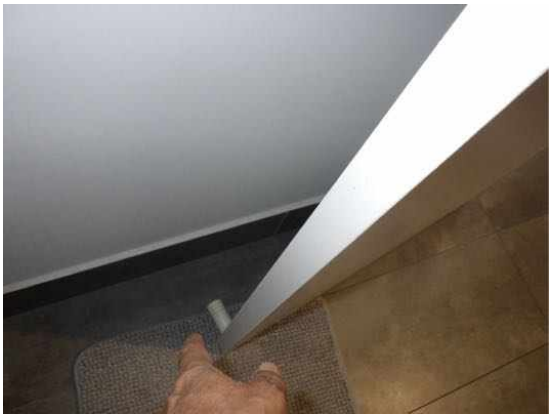
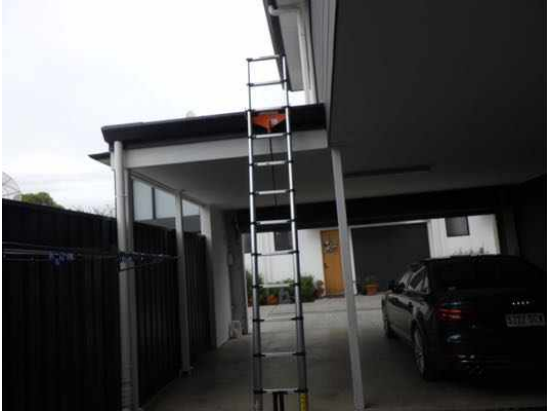
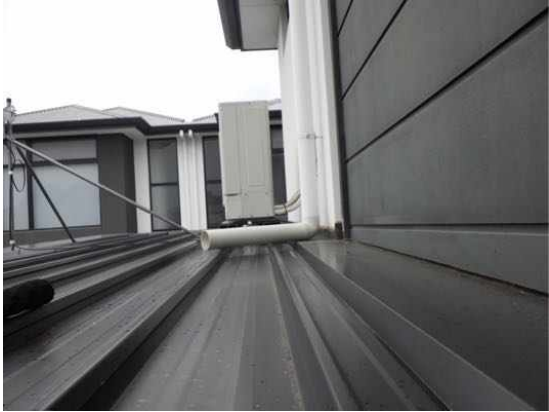
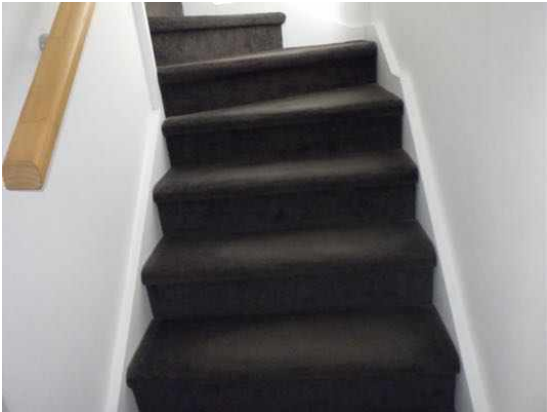
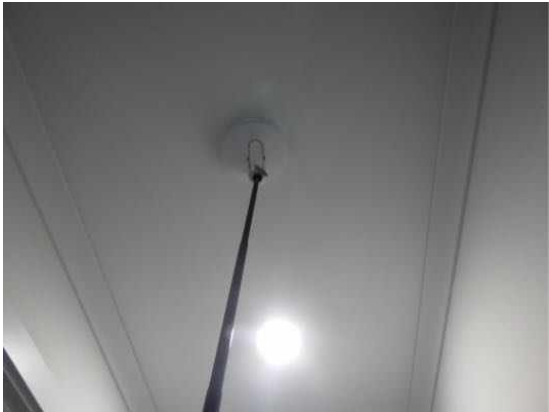
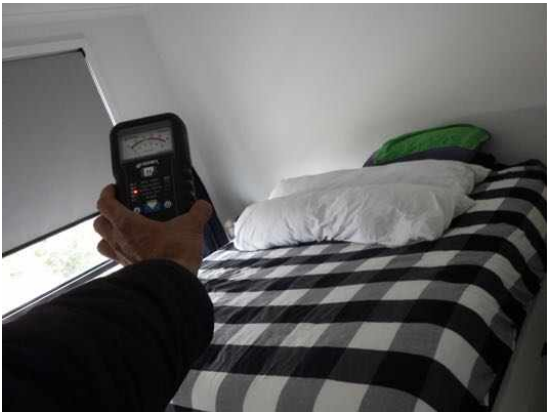
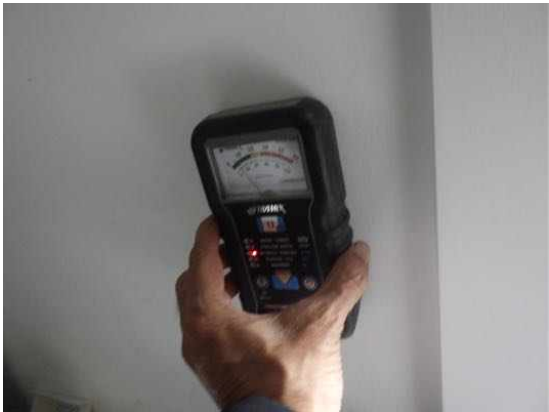
Building: Building 1  
Location: All Areas  
Finding: Additional Photos  
Information: Additional photos are provided for your general reference
