Building and Timber Pest Inspection Report

Inspection Date: Thu, 19 Feb 2026

Property Address: 80 Healy Ave, Gregory Hills NSW 2557,
Australia

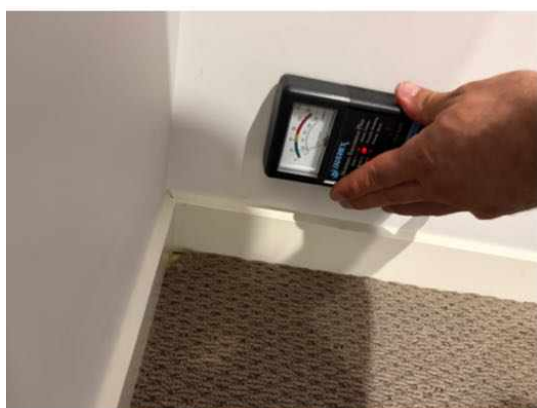
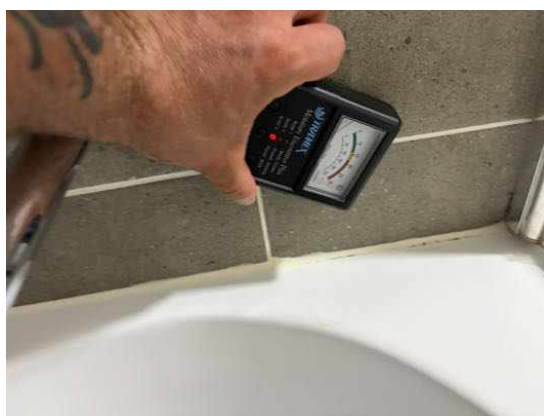
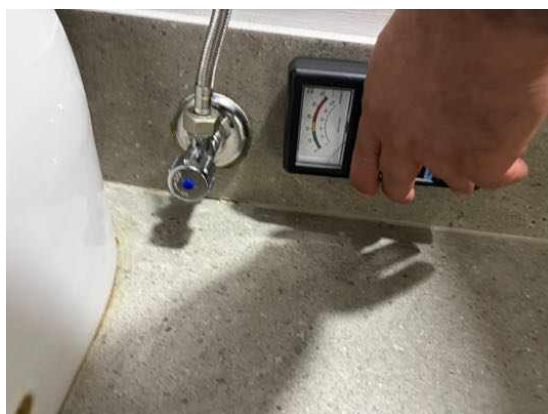
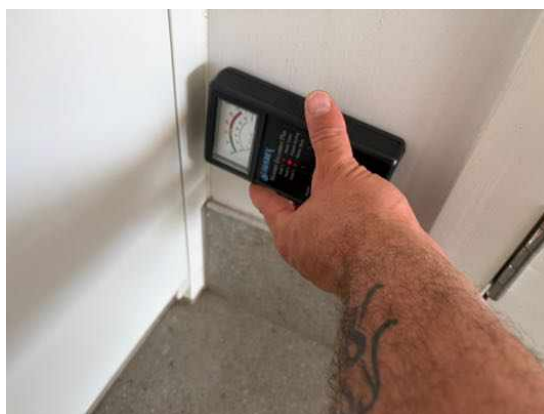
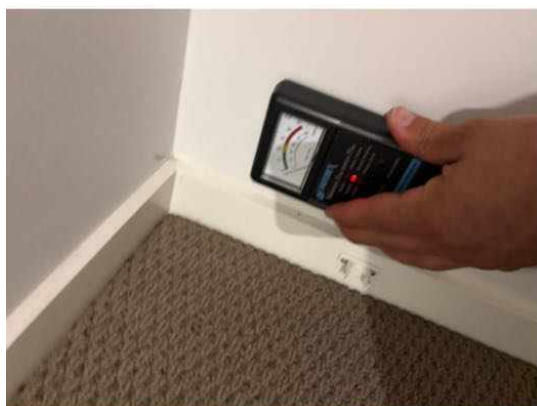
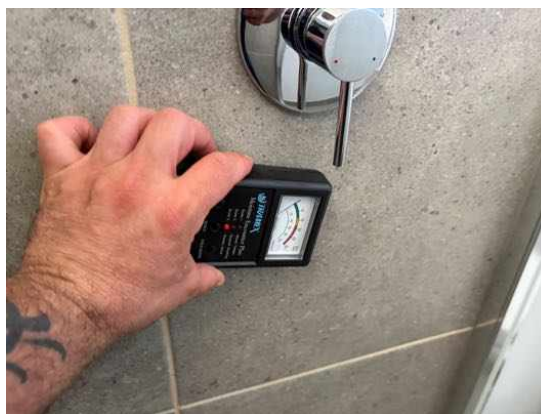
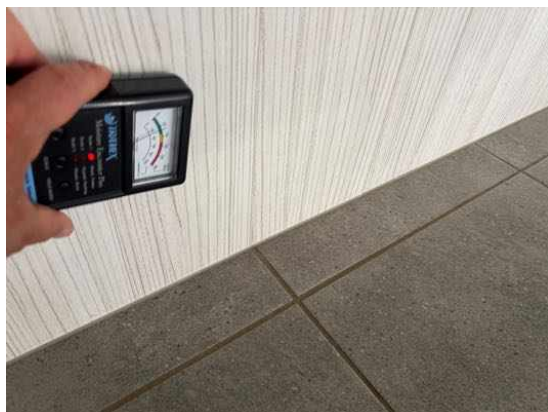
Building: Main Building
Location: All Areas
Finding: Moisture metre
Information: During the inspection the property was checked for moisture using a moisture metre.

This is for information only.

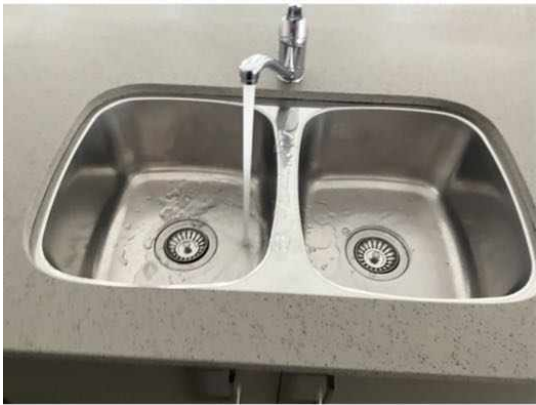
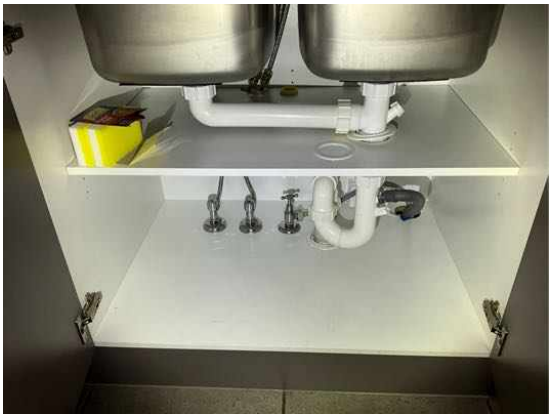
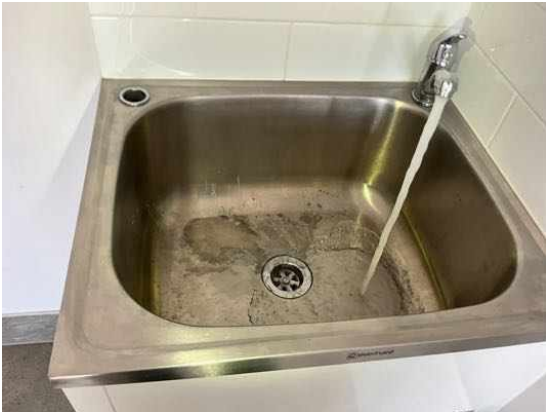
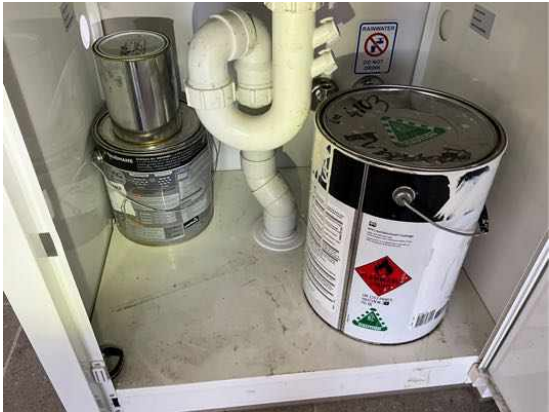
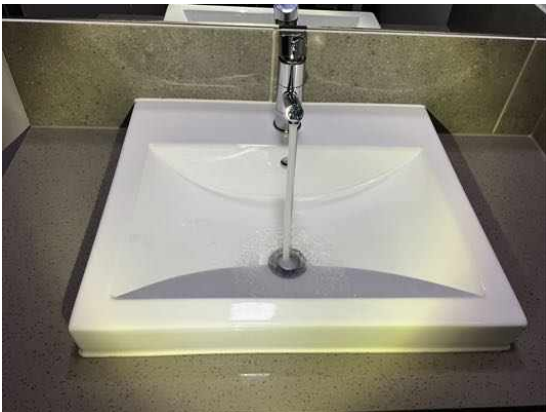
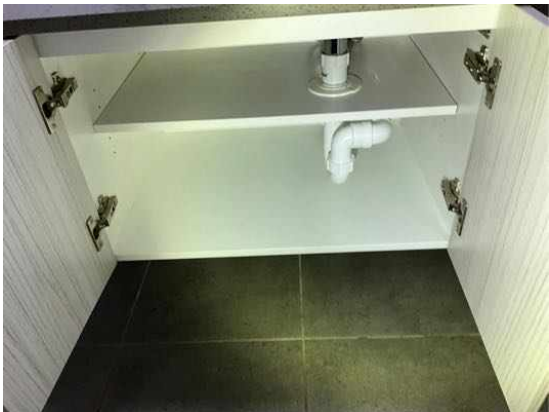
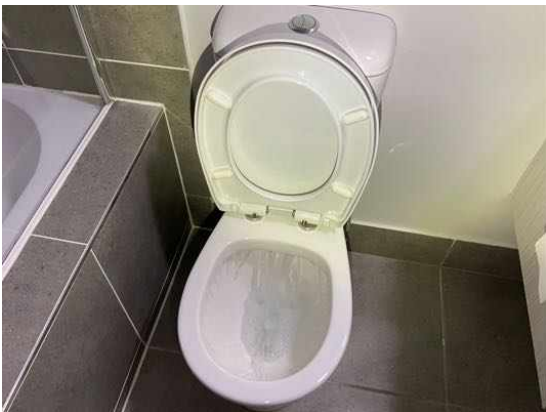
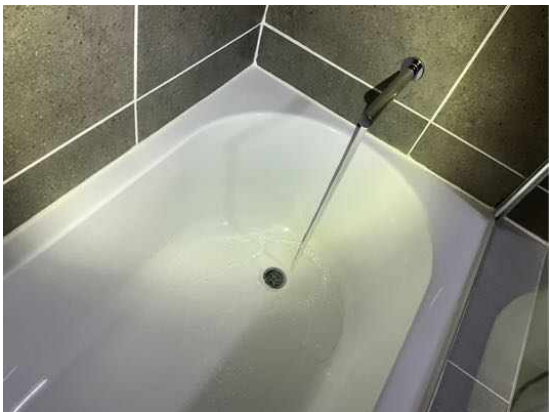
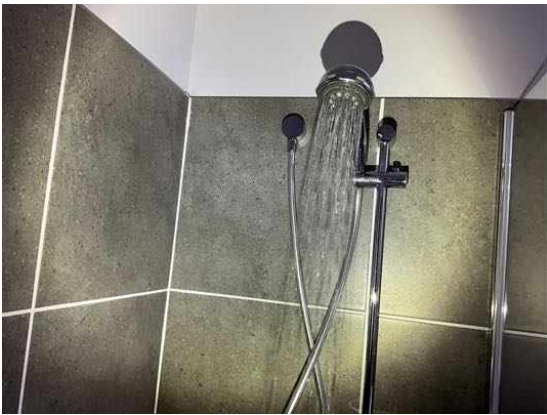
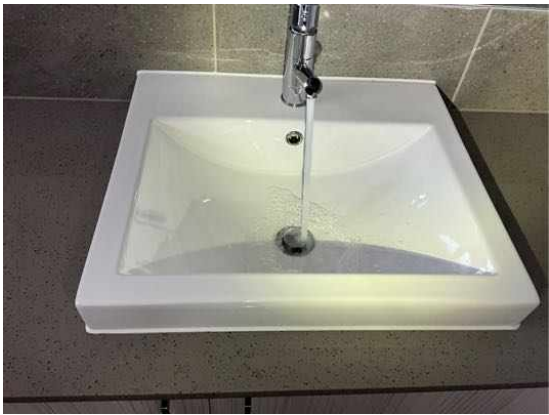
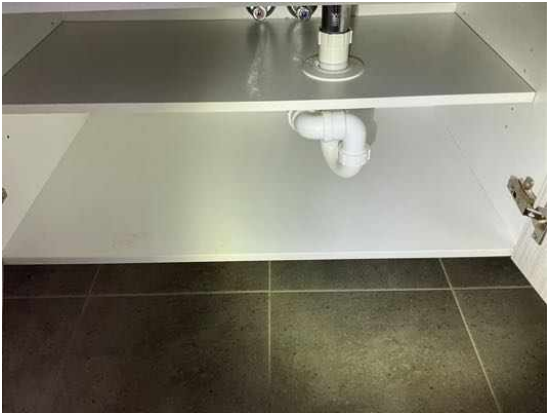
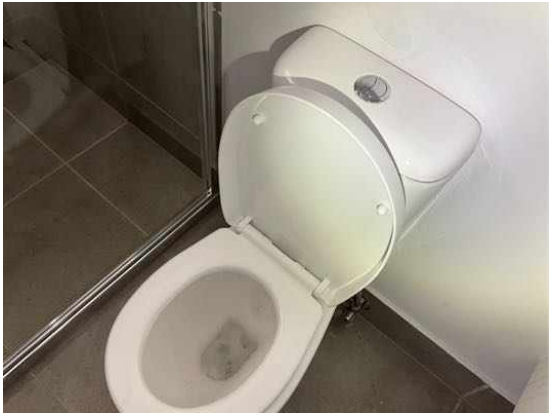
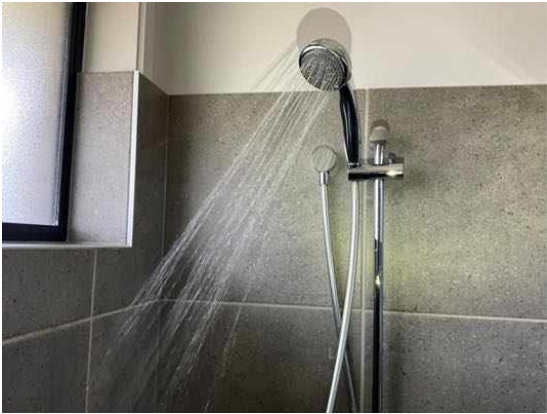
Building: Main Building
 Location: All Wet Areas
 Finding: Waterproofing
 Information:

All taps, mixers and toilets were tested for operation, except for those obstructed. The waterproofing to the shower recess was assessed by checking the walls in and around the shower recess for varying moisture content. There were no significant variations across the tested areas. No sign of recent water damage was evident upon a visual inspection of the surrounding walls, where the visual nature of the inspection was possible.

Consequently, there is no conclusive evidence of any current shower recess leakage other than those which may have already been mentioned earlier in this report. It is reasonable to assume the shower waterproofing is sound. Note that if the shower is not used, or has not been used for some time, moisture readings would not vary significantly and this can lead to erroneous results. It is not possible under the visual inspection criteria (under which a prepurchase inspection is carried out) to categorically determine if there are leaks. If a more accurate assessment is required, a special purpose inspection should be requested. Alternatively, the assumption should be made that the shower may leak.

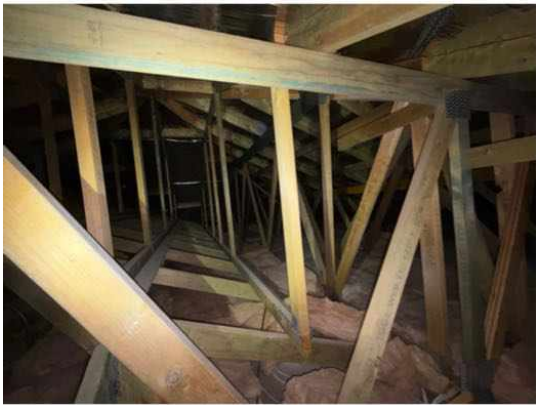
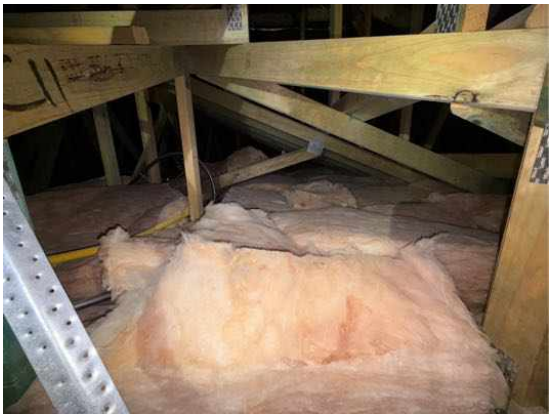
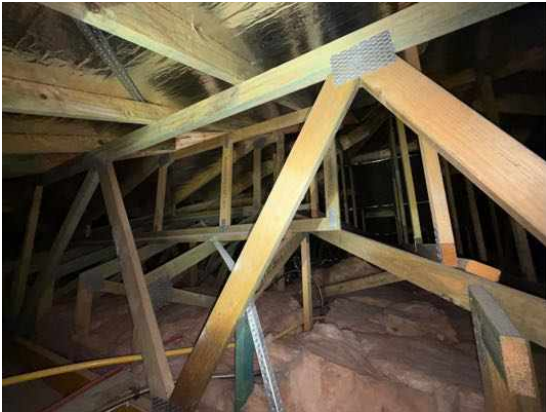
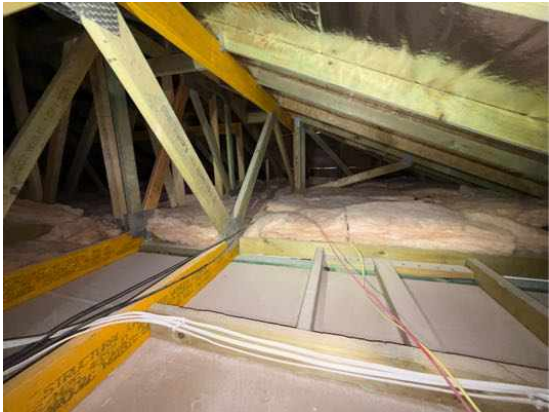
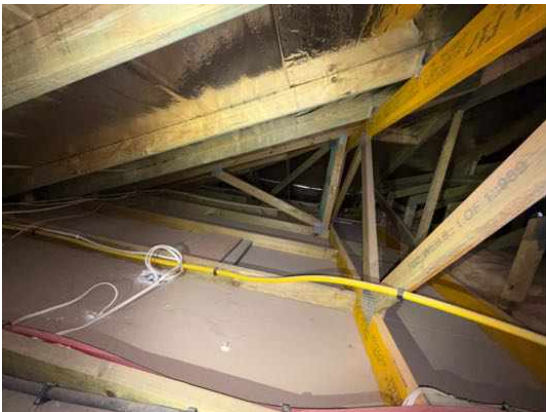
Building: Main Building
Location: Roof Void
Finding: Additional Photos
Information:

Additional photos are provided for your general reference.

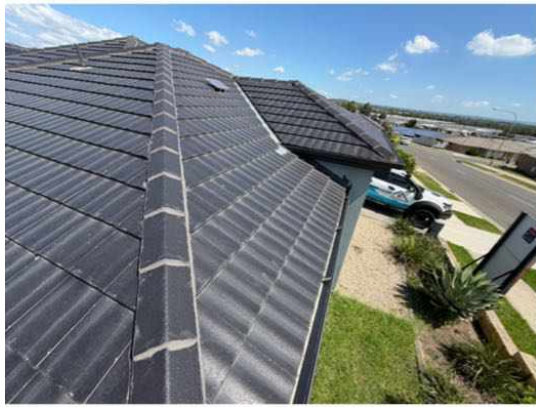
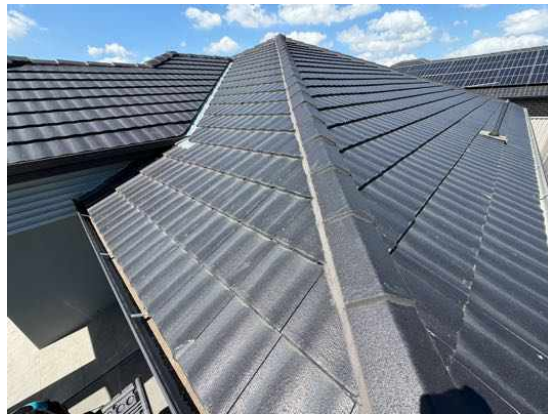
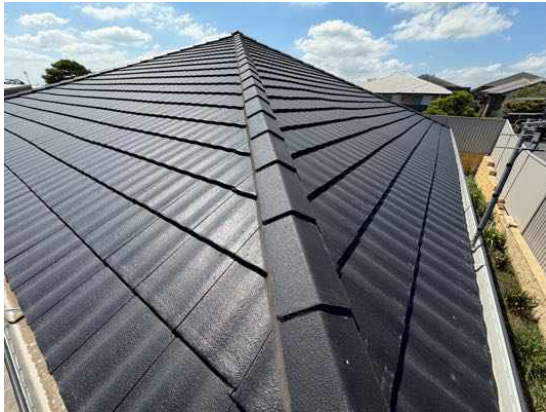
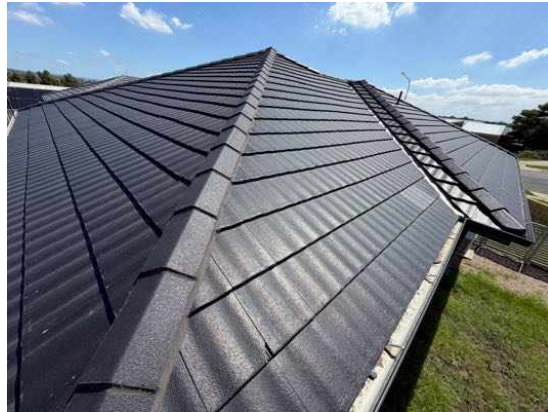
Building: Main Building
Location: Roof Exterior
Finding: Additional Photos
Information:

Additional photos are provided for your general reference.

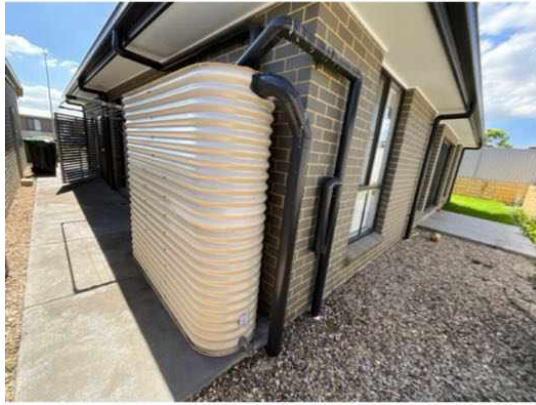
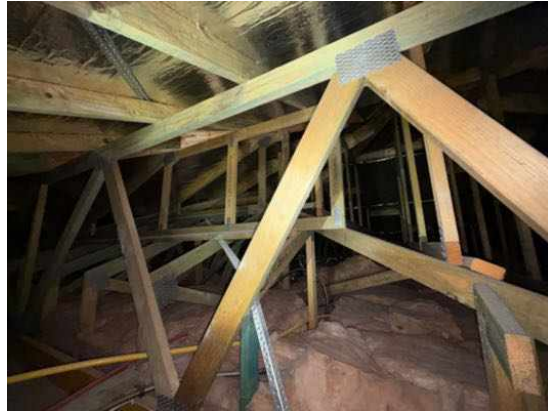
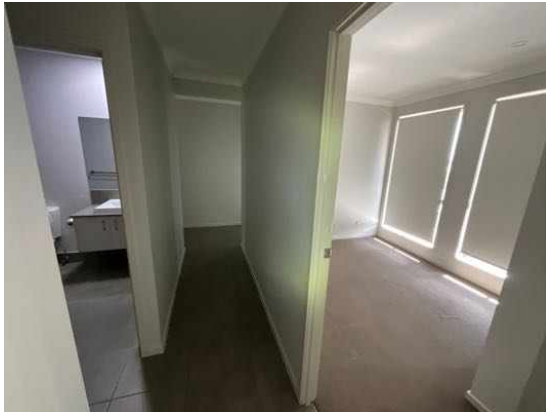
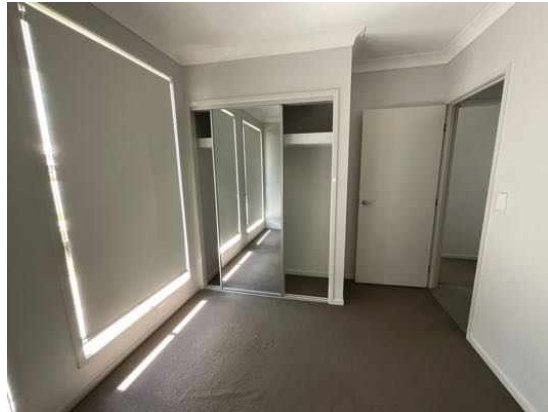
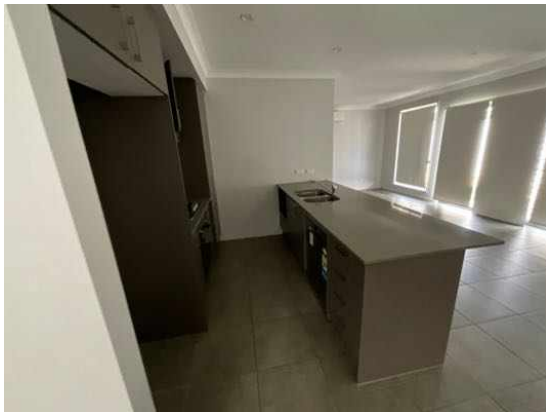
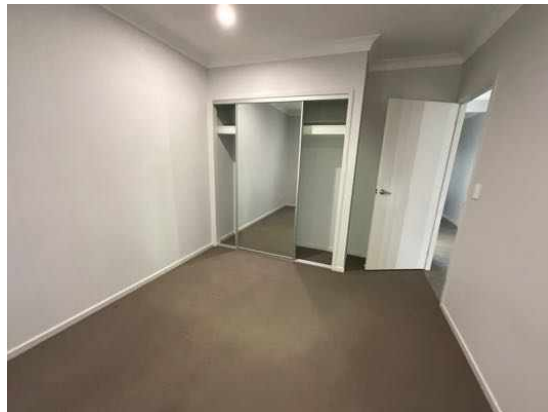
Building: Main Building
 Location: All Areas
 Finding: Additional Photos - Obstructions and Limitations
 Information:

These photographs are an indication of the obstructions and limitations which impeded full inspection of the property at the time of inspection. These obstructions can hide an array of defects and should be removed to allow full inspection to be carried out. A re-inspection is recommended once the areas are made accessible.
