Building and Timber Pest Inspection Report

Inspection Date: Thu, 19 Feb 2026

Property Address: 50 Gregson Grove, Lyndhurst VIC 3975, Australia

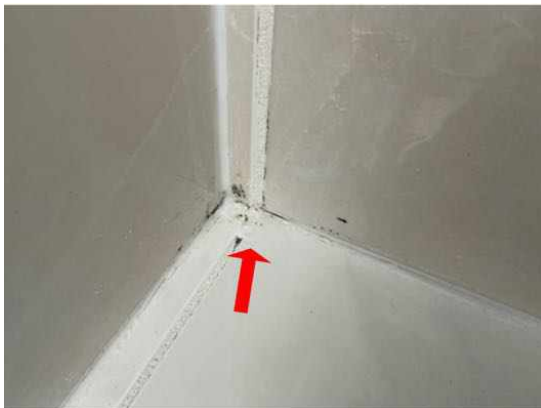
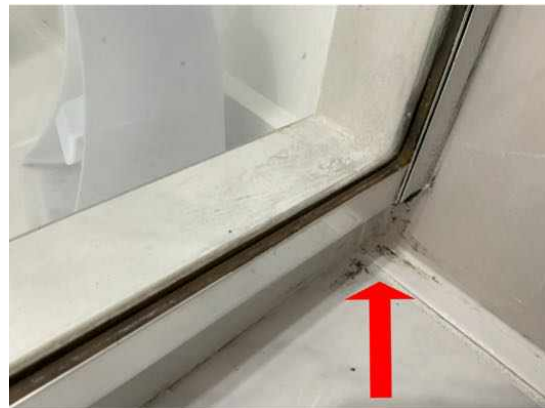
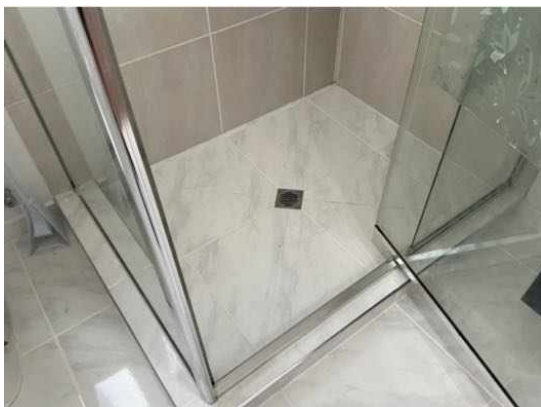
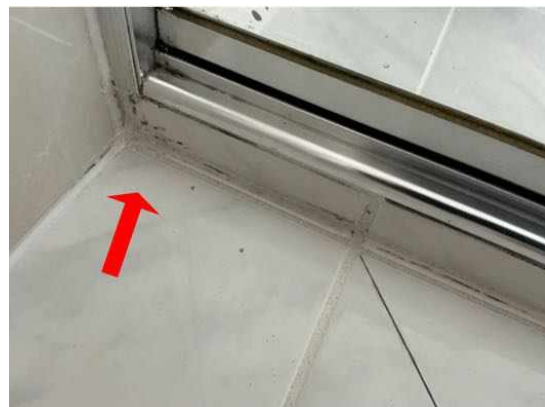
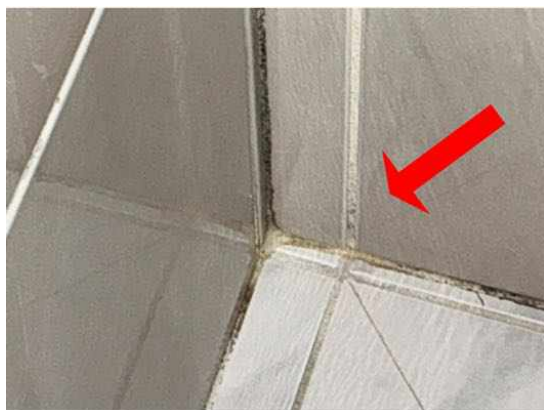
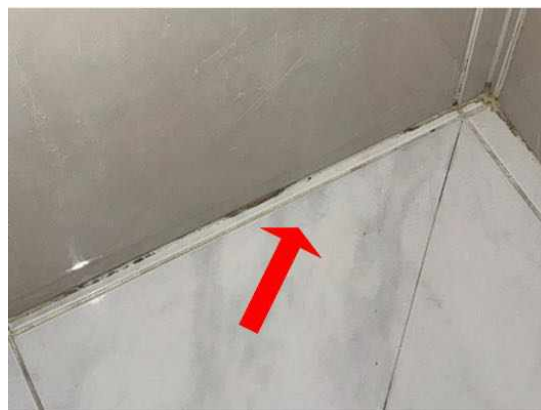
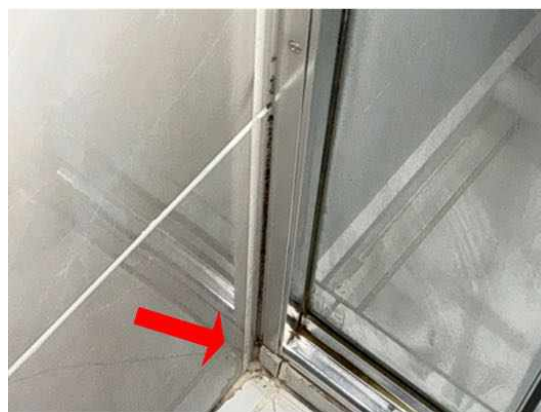
Information: Where evidence of mould growth was noted, there may be environmental, biological or health issues associated with the report. A specialist inspection by a suitably qualified environmental health inspector is warranted, where mould is extensive or where any queries regarding air quality spores or other related issues apply.

Generally, the client is advised to ensure that the general environment is free of moisture and humidity to aid in the prevention of mould formation and development. Any mould found during the inspection should be cleaned immediately by a cleaning contractor or the homeowner as applicable.

Please note that severely affected building elements may require replacement by a registered builder or qualified carpenter.

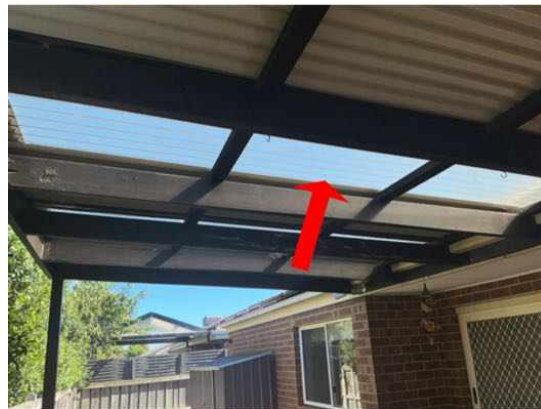
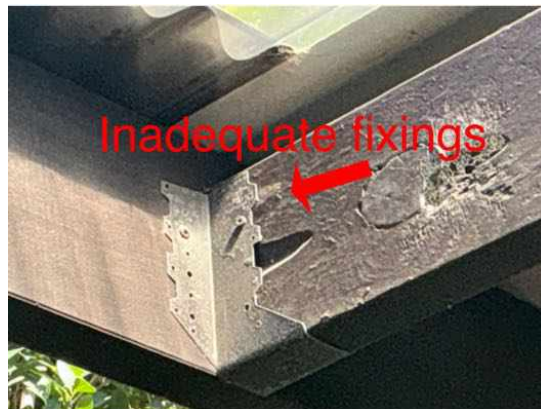
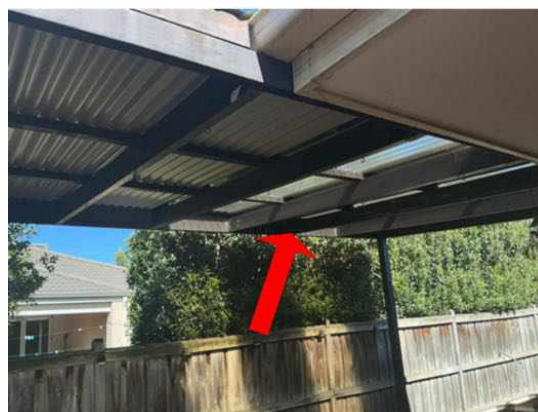
Finding 1.02

Building:	Main Building
Location:	Alfresco
Finding:	Additional structure built without a permit (Suspected)
Information:	The pergola structure on the rear of the house is suspected to have been constructed without a building permit. A building permit would be required for the structure.

It is highly advised to request that the current owner provide a Defect report (Owner Builder/Section 137b) for this structure. This would involve a structural engineer or a licenced building surveyor conducting an inspection of the structure and advising of any defects and/or areas of non-compliance in accordance with the current building codes. The current owner should then attend to any issues on this report prior to settlement.

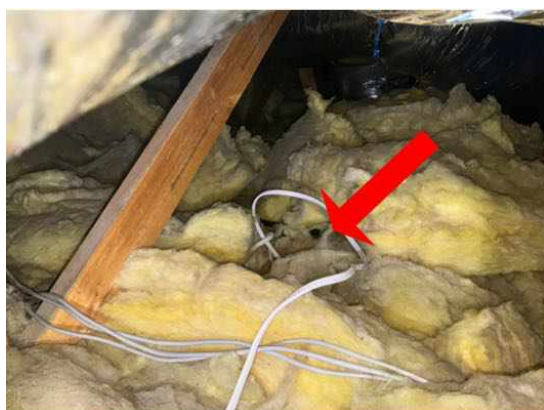
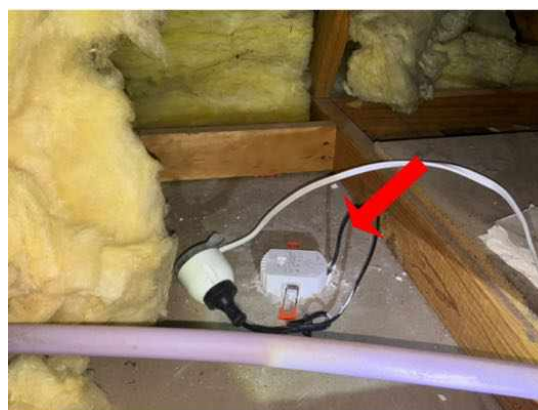
Finding 1.03

Building:	Main Building
Location:	Roof Void
Finding:	Down lights - Unprotected or uncovered
Information:	The down light holdings within the ceiling void were found to be missing protective covering during inspection.

As this is a potential safety hazard, it is highly advised that these works be conducted as a matter of urgency.

In accordance with Australian Standards, fire-resistant protection covers are required on all down lights. A qualified electrician should be appointed to install appropriate covers immediately to increase fire safety within the roof void. Alternatively, protective covers can be purchased from hardware stores and offer installation instructions for the homeowner.

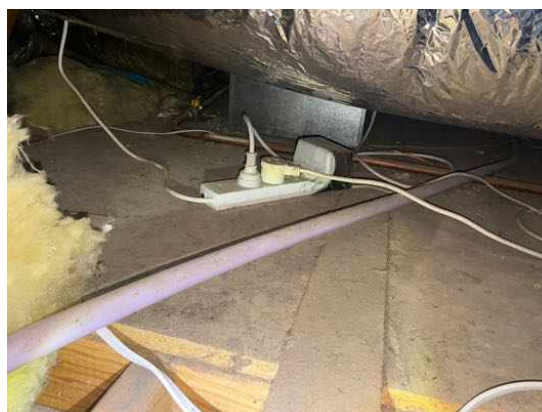
Finding 1.04

This installation is non-compliant to AS 3000 domestic electrical installations.

The client should exercise care when coming into the immediate vicinity of the substandard works. Rectification works are advised immediately by a licensed electrician

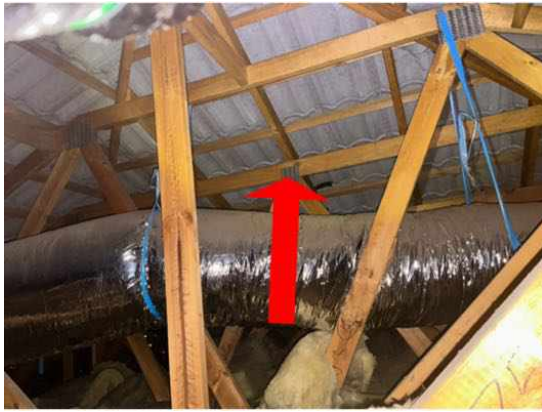
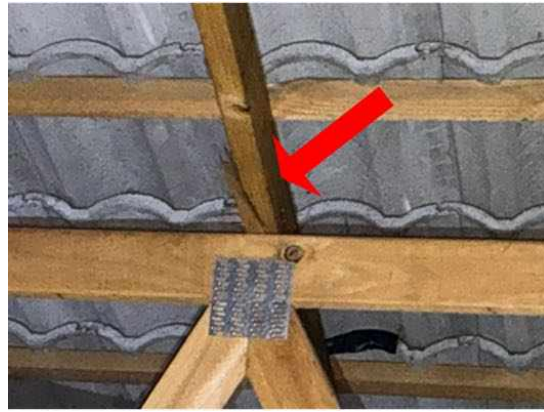
Finding 2.01

Building: Main Building
 Location: Roof Void
 Finding: Broken/damaged roof truss
 Information: It was observed at the time of the inspection that a jacktruss to the rear of the building was split and damaged. It appears that the roof truss was damaged during construction.

Roof trusses to buildings are engineered design designed and no allowance is made for trusses to be damaged. Roof trusses demonstrating damage components can cause instability or structural failure.

A registered builder or qualified carpenter should be engaged to review immediately

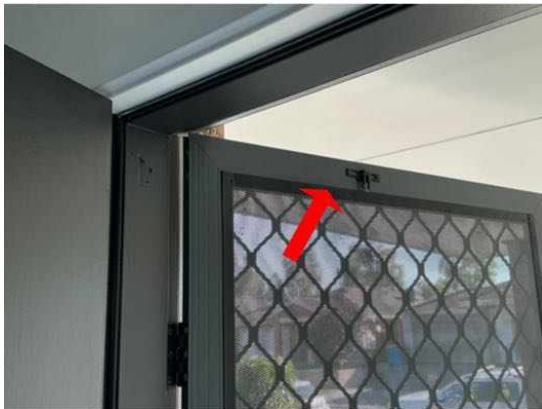
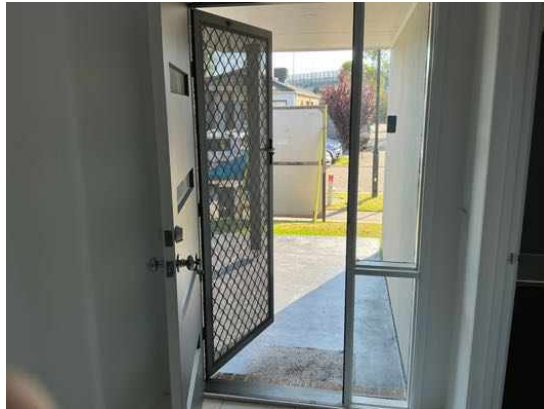
Finding 3.01

Finding: Door closure missing/damaged

Information: It was observed at the time of the inspection that the door closure to the front security door was missing.

A general handyman should be engaged to review at the clients discretion

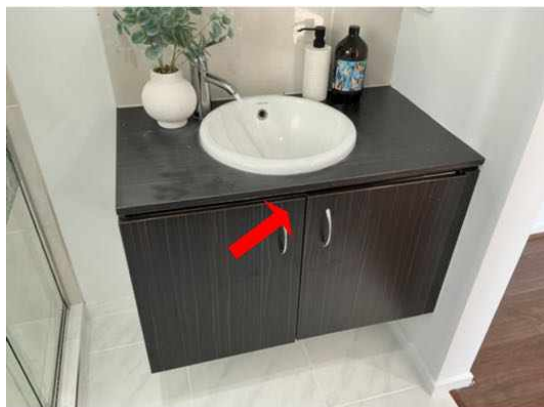
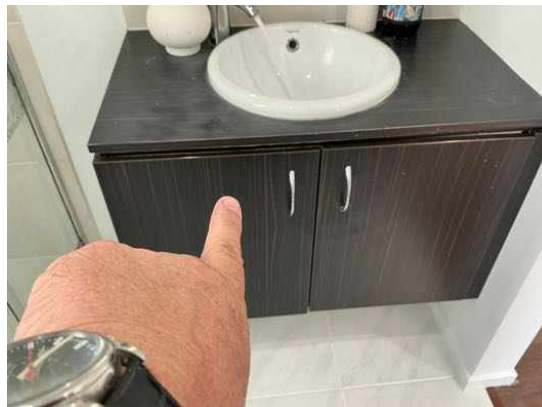
Finding 3.02

Information: It was noted that the ensuite vanity cabinet doors had become loose overtime and has caused the doors to bind and become difficult to open.

Doors which catch and bind can damage laminated surfaces and allow water ingress into cabinetry elements. This can cause swelling of the chipboard substrate and premature deterioration of the structure of the cabinet.

A qualified cabinet maker should review at the owners discretion.

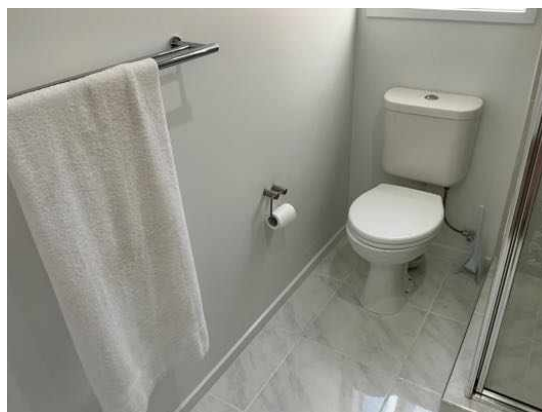
Finding 3.03

Building: Main Building
 Location: Ensuite
 Finding: Toilet roll holder - Loose
 Information: The toilet roll holder was found to be loose at the time of inspection. While not a major operational defect, function can deteriorate if the problem is left unmanaged.

It is advised that the homeowner performs remedial works to re-attach the toilet roll holder to its original fixing. A general handyperson may be required to perform these works.

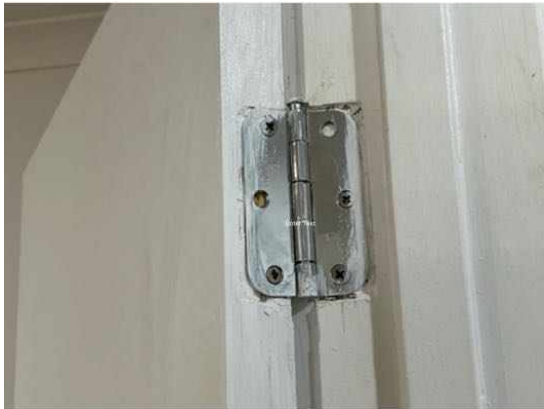
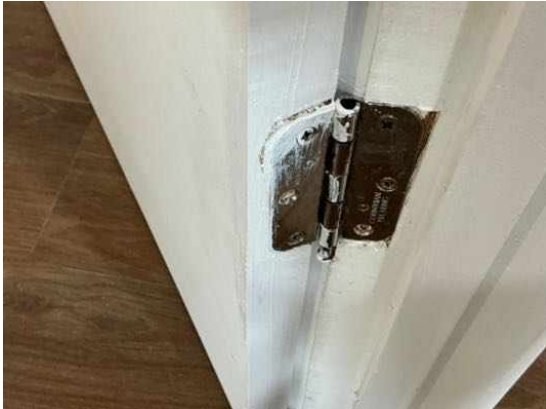
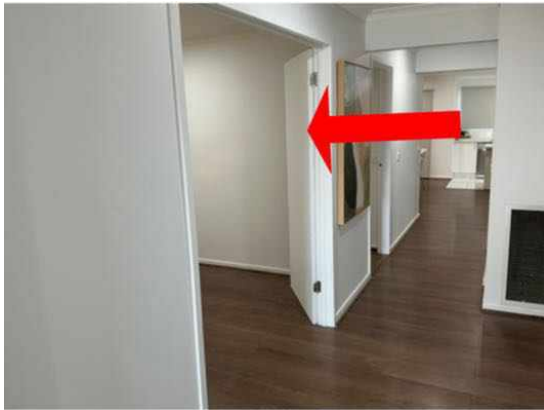
Finding 3.04

Building: Main Building
 Location: Bedroom 2
 Finding: Incomplete or substandard works

Works that have not been completed to a satisfactory level create potential for the development of building defects and may impede on the safety and integrity of the overall structure.

It is highly recommended that a qualified carpenter and painter be appointed to complete these works and ensure the longevity of all associated building elements.

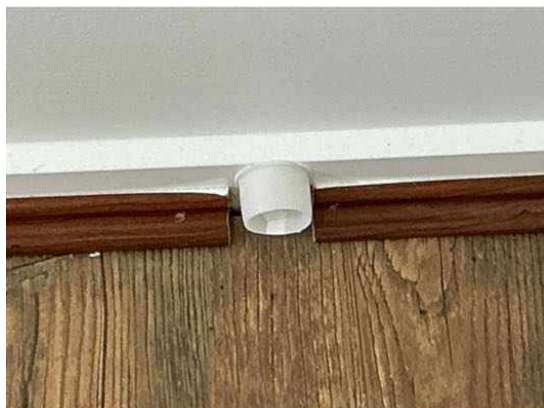
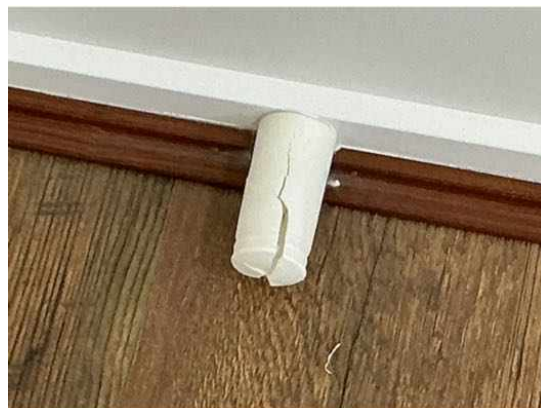
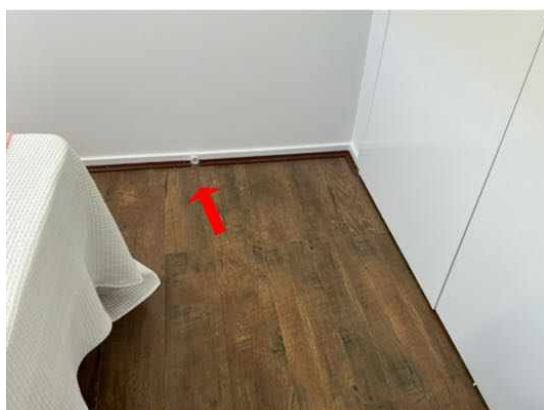
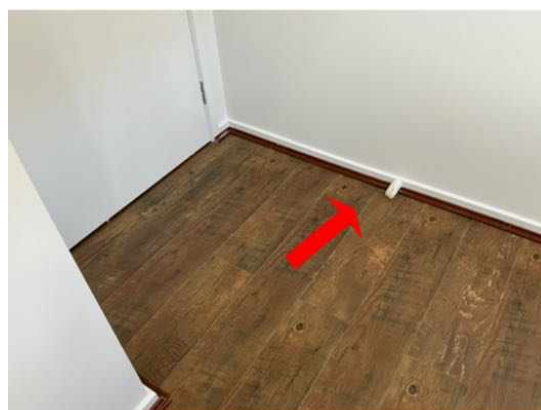
Finding 3.05

Location: All Internal Areas
 Finding: Door cushion missing/ damaged
 Information: It was observed that many door cushions to the building were missing or damaged.

Missing door cushions allow the door handle to strike the wall when the door is opened. This can cause damage to the plaster walls.

A handyman should be engaged to provide a new door cushion at the owners convenience .

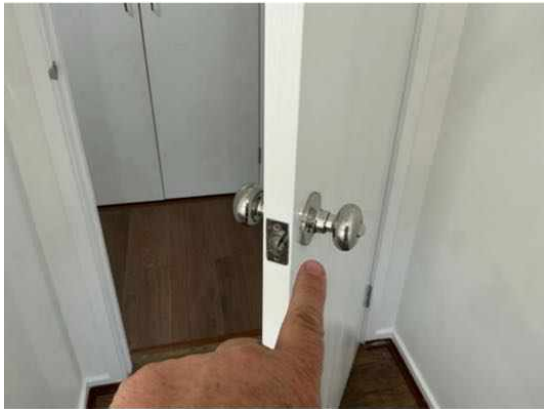
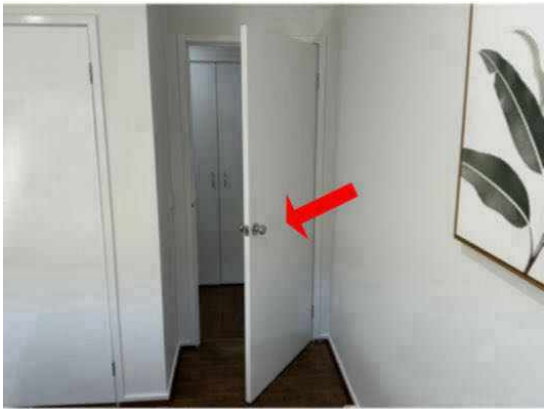
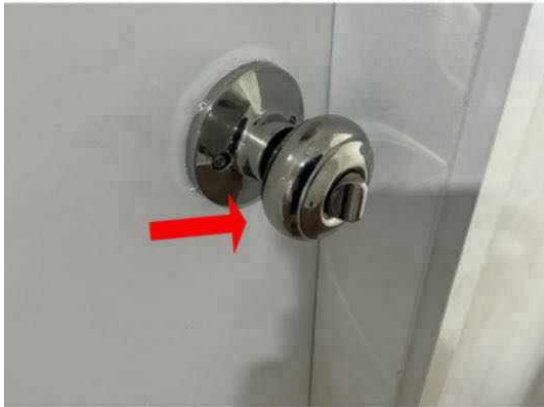
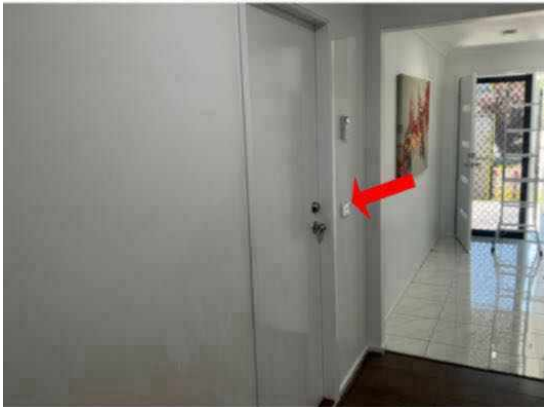
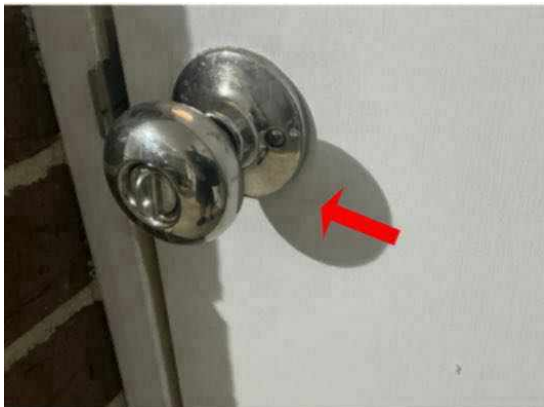
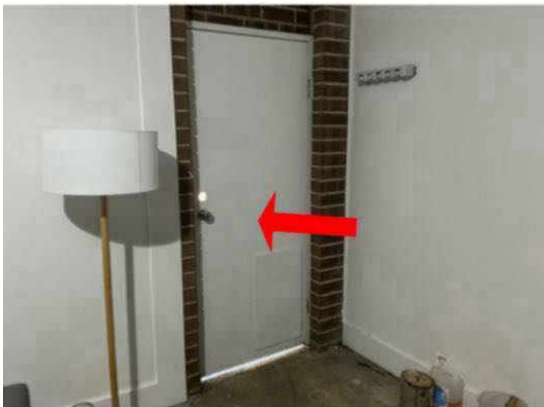
Finding 3.06

Building: Main Building
 Location: All Internal Areas
 Finding: Door lock not operating as intended
 Information: It was noted at the time of the inspection that several door locks internal and external to the building have been fitted poorly and are loose.

Poorly fitted door furniture of this nature can cause accidental lockout and reduce the overall security of the building

A qualified carpenter should be engaged to review the oldest description

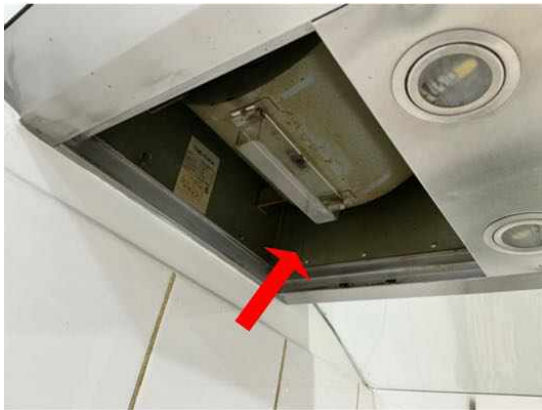
Finding 3.07

Building: Main Building
 Location: Kitchen
 Finding: Rangehood filters missing
 Information: It was noted at the time of the inspection that the mesh filters to the Rangehood were missing.

The Rangehood filters enable cooking smells and fat deposits to be filtered prior to entering the ventilation ducts of the rangehood. This could cause malfunction or in extreme cases may cause fire.

Licensed electrician should be engaged to review at the owners discretion

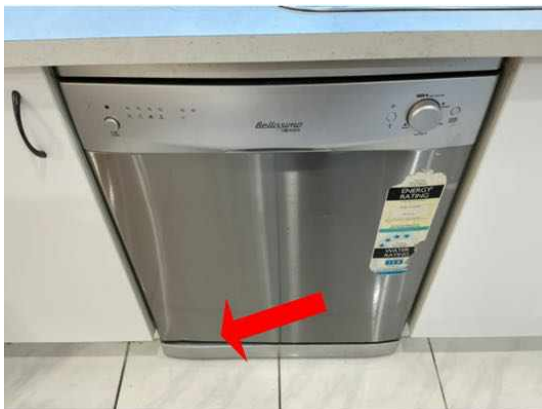
Finding 3.08

Building: Main Building
 Location: Kitchen
 Finding: Dishwasher door damaged
 Information: It was noted that the dishwasher door was damaged and dented

This is an aesthetic defect, however it detracts from the overall appearance of the building.

A licensed plumber should be appointed to review at the owners discretion.

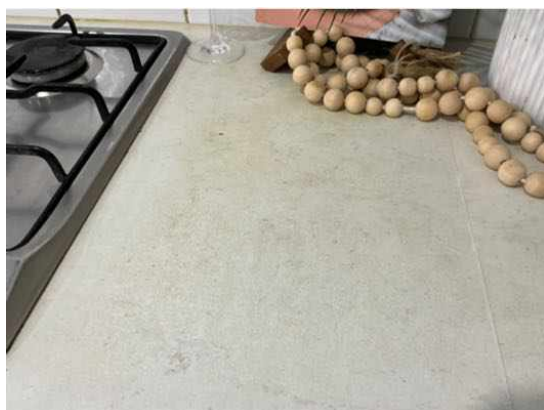
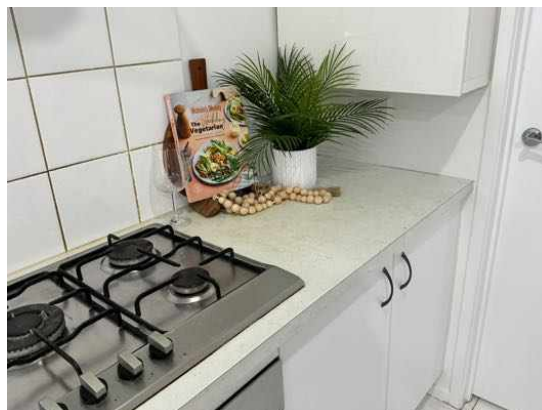
Finding 3.09

Building:	Main Building
Location:	Kitchen
Finding:	Kitchen benchtop damaged
Information:	It was observed at the time of the inspection that the kitchen benchtop was damaged. There was impact damage and there was some excessive heat related damage.
	Damage to the bench to can cause premature deterioration of the building and provide a unhygienic food preparation area
	A qualified cabinet maker should be engaged to review at the owners discretion

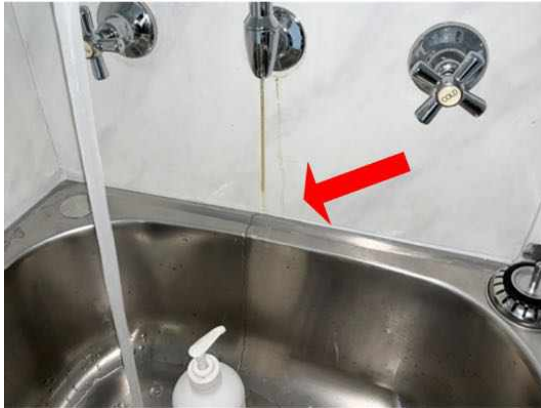
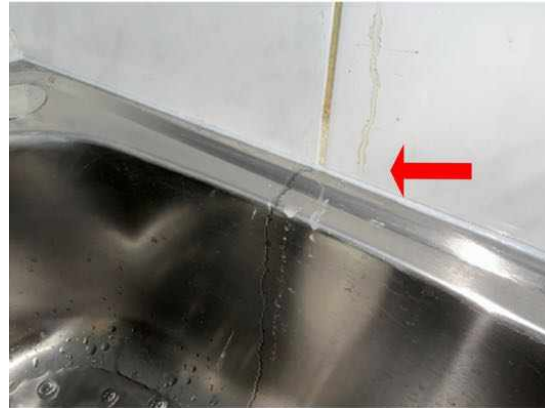
Finding 3.10

Building:	Main Building
Location:	Laundry
Finding:	Tap spout - Leaking
Information:	The laundry tap spout was found to be leaking at the time of inspection. This is a common defect that is consistent with general ageing of the building element. However, it may be indicative of substandard plumbing workmanship if the fitting is relatively new.

While this defect only seems minor, if left unmanaged, it is likely to result in the development of rust, water damage and/or extensive water usage.

It is advised that a handyman or licensed plumber be appointed to perform remedial works on the affected tap. Such works should be performed prior to the development of secondary defects to ensure adequate functionality of all associated building elements.

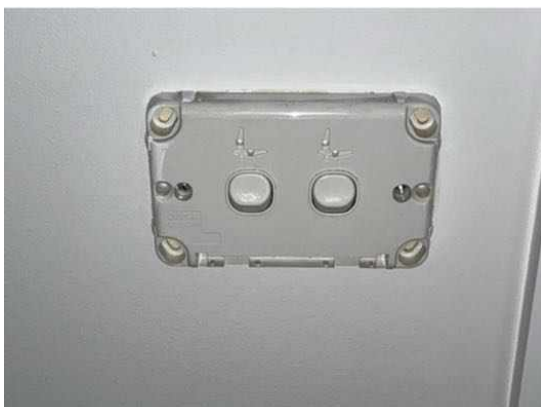
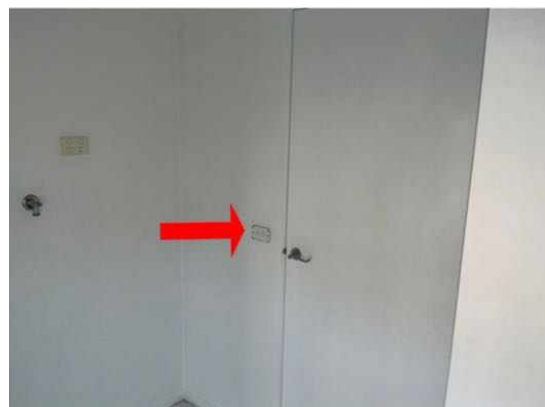
Finding 3.11

Building:	Main Building
Location:	Laundry
Finding:	Cover plate missing
Information:	Was observed at the time of the inspection that the cover flight to the laundry light switch was missing.

Although this is an aesthetic, it detracts from the overall appearance of the building.

A general handyman should be engaged to review at their own discretion

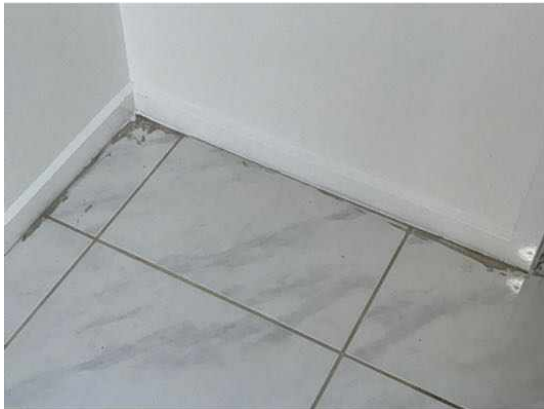
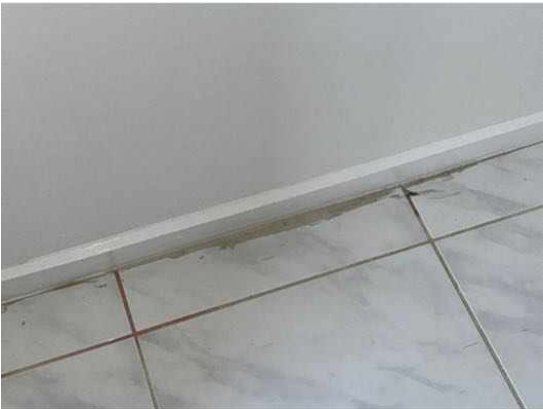
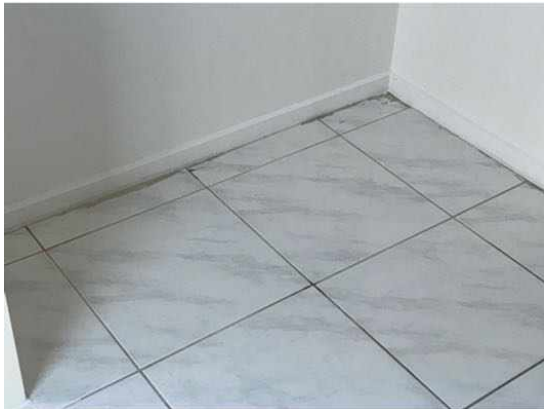
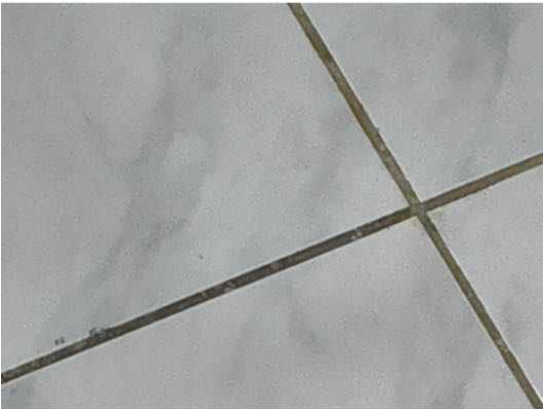
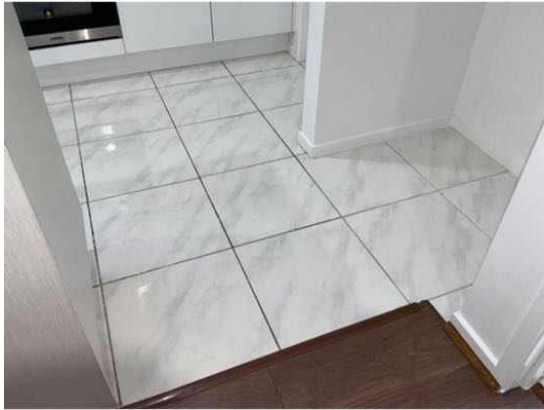
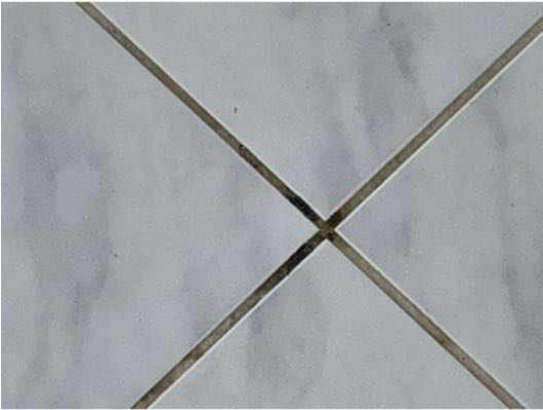
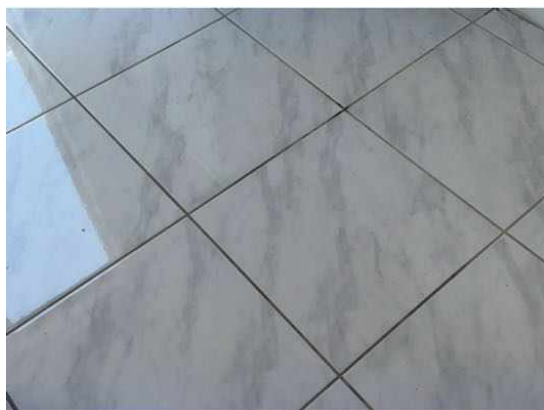
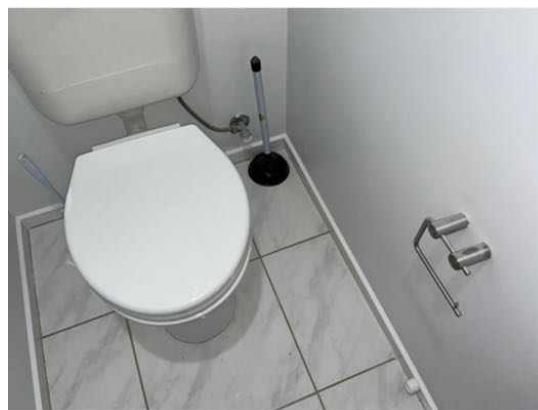
Finding 3.12

Location: All Internal Areas
Finding: Floor tile grout, dirty and grease stained
Information: It was noted at the time of the inspection that the floor tile grout to several areas appear to be grease stained and dirty. The tiles appear to have never been sealed.

Although this is an aesthetic default, it detracts from the overall appearance of the building.

A tile cleaning and sealing contractor should be engaged to review at the owners discretion, or the owner may wish to clean the tiles and seal themselves.

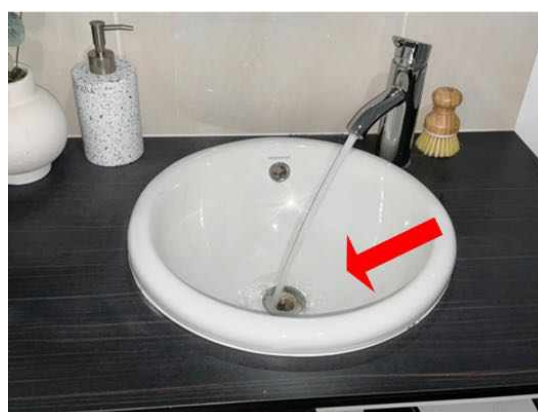
Finding 3.13

Building:	Main Building
Location:	Bathroom
Finding:	Basin waste damaged
Information:	It was observed at the time of the inspection that the basin waste was damaged.

The damage to the waste could allow for debris such as, hair to enter the draining system which could cause a blockage.

A licensed plumber should be engaged to review at their owners discretion

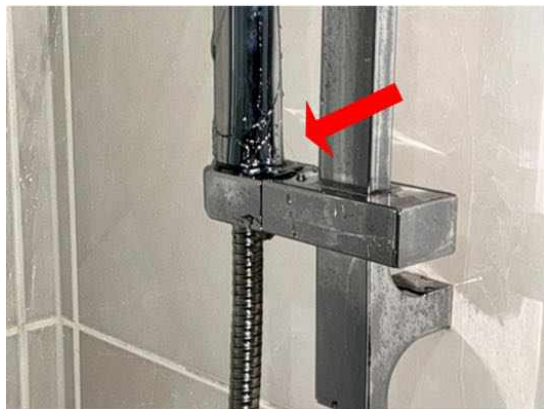
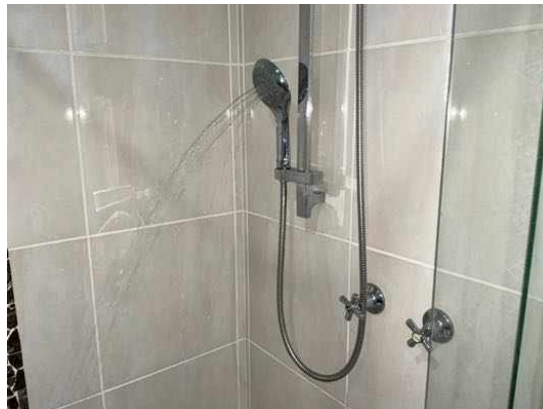
Finding 3.14

Building:	Main Building
Location:	Bathroom
Finding:	Handheld shower rose leaking
Information:	It was noted at the time of the inspection that the handheld shower rose/spray was leaking.

The leaking showers prevent the fitting to be used to its full potential and given time would permanently deteriorate until the leak became excessive.

A licensed plumber should be engaged to review at their owners discretion

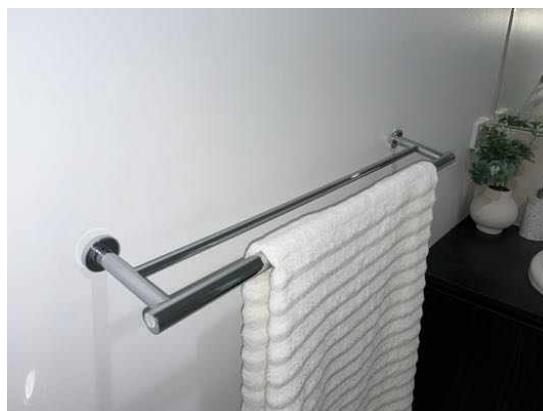
Finding 3.15

Finding: Towel rail - Loose

Information: The towel rails were found to be loose at the time of inspection. While not a major operational defect, function can deteriorate if the problem is left unmanaged.

It is advised that the homeowner performs remedial works to re-attach the towel rail to its original fixing. A general handyman may be required to perform these works.

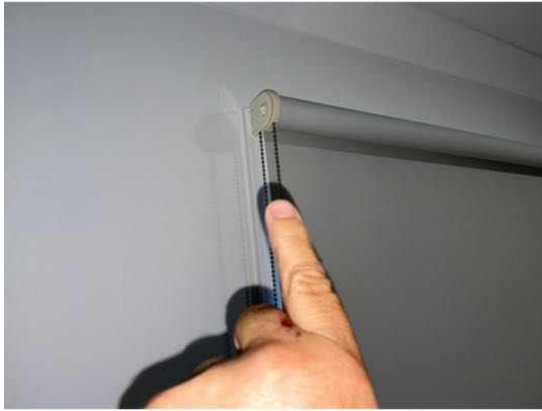
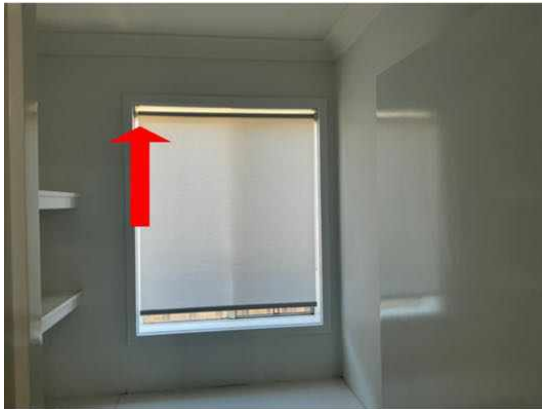
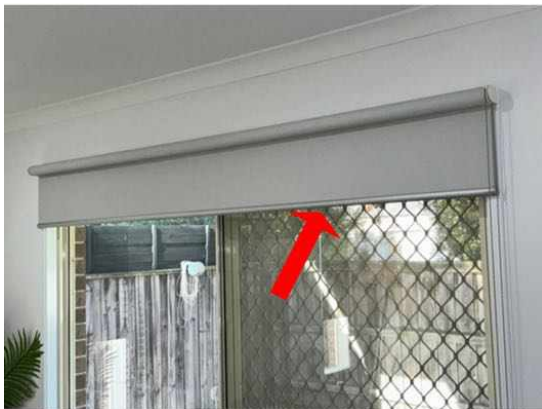
Finding 3.16

Information: It was noted at the time of the inspection that several window blinds throughout the building were stiff to operate and difficult to open and close. It appears that the roller mechanism is worn and may require replacement.

A blind repair contractor should be engaged to review as their owners discretions

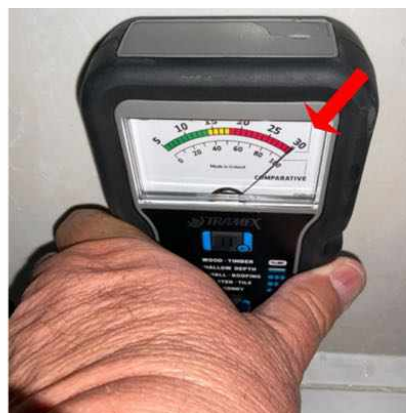
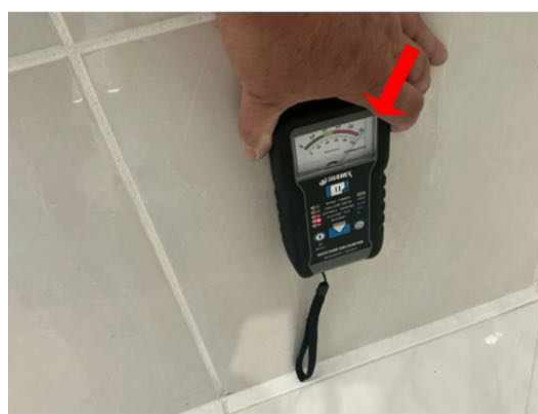
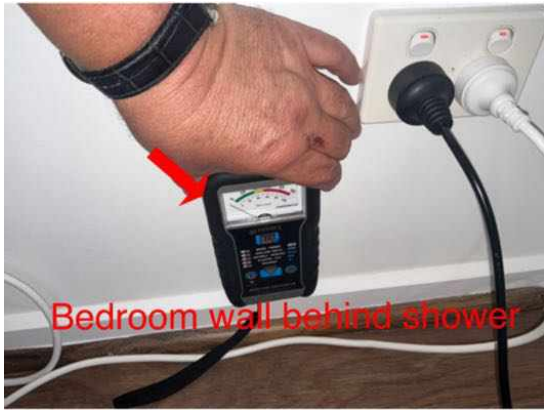
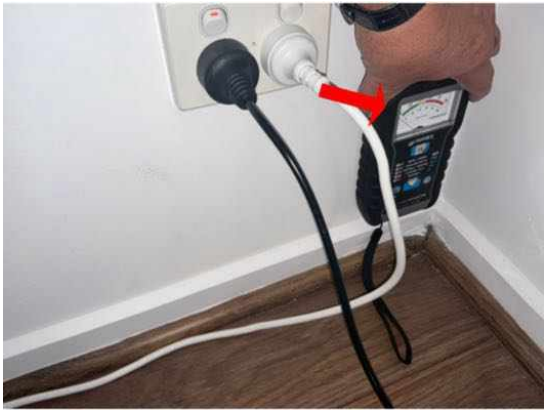
Finding 3.17

Building: Main Building
 Location: Ensuite
 Finding: Shower damp - Monitor
 Information: Damp is evident to the lower 400mm of wall to the shower alcove. There is also a high reading around the taps. There are no high readings transferring to the other side of the wall. Sealant appears to have been repaired recently and both sealant and grout appear in acceptable condition at present.

This defect is quite common, and is suspected to have been caused by moisture permeating or leaching through the grouting and perhaps gaps in the sealant prior to

repair.

Unmanaged damp in the shower recess is likely to facilitate the formation and development of mould and fungi growth, decaying associated building materials and compromising their structural integrity. It is important to address damp conditions, as the World Health Organisation notes that excess moisture leads - on almost all indoor materials - to growth of microbes such as moulds, fungi and bacteria, which subsequently emit spores and other matter into the indoor air. Exposure to these contaminants is associated with a wide range of respiratory and other health-related problems.

Monitoring the area is advised and if any visual signs of excessive moisture appear (peeling paint, mould) then consultation with a qualified plumber or bathroom specialist would be advised to identify the cause of damp and to perform remedial works as required.

Always ensure that sealant and grout is in good condition to prevent any moisture issues occurring in the future.

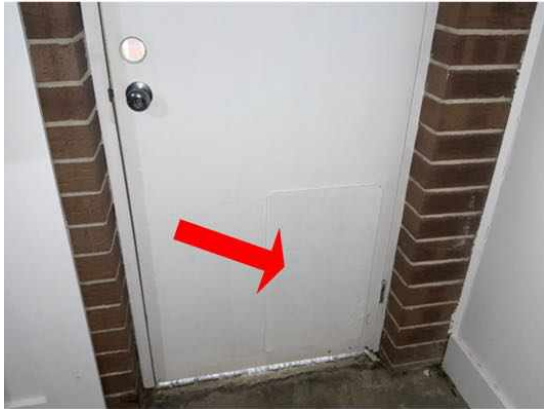
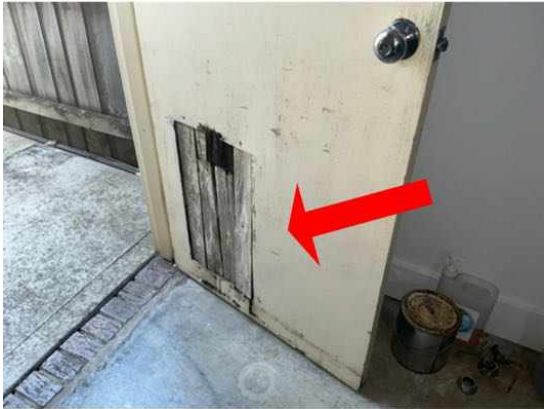
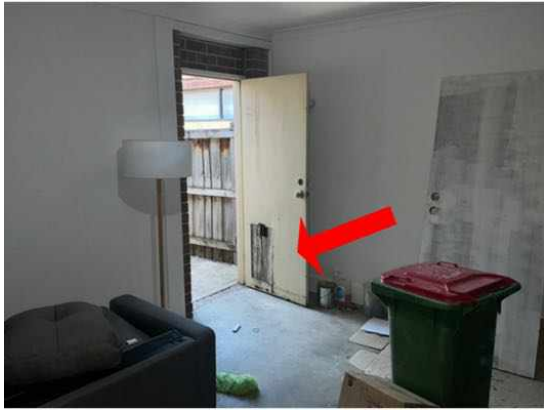
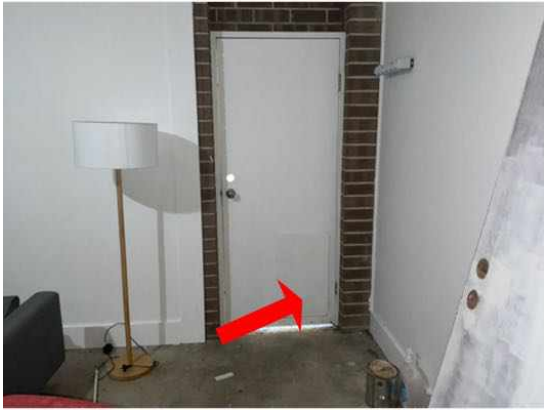
Finding 3.18

Building: Main Building
 Location: Garage
 Finding: Garage pedestrian door damaged
 Information: It was noted at the time of the inspection that the pedestrian door to the garage has been damaged and a poor attempt at repair has been made.

The door provides security to the garage and prevents the ingress of weather elements

A qualified carpenter and painter should be engaged to review as soon as possible

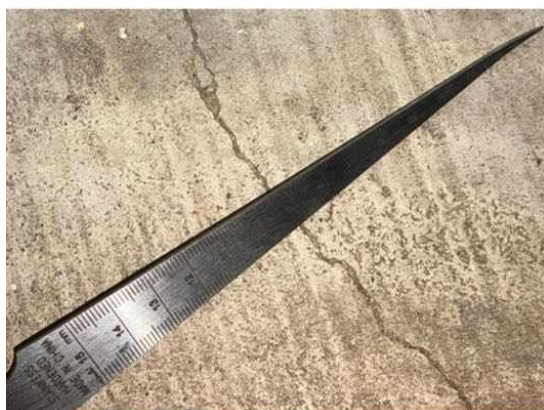
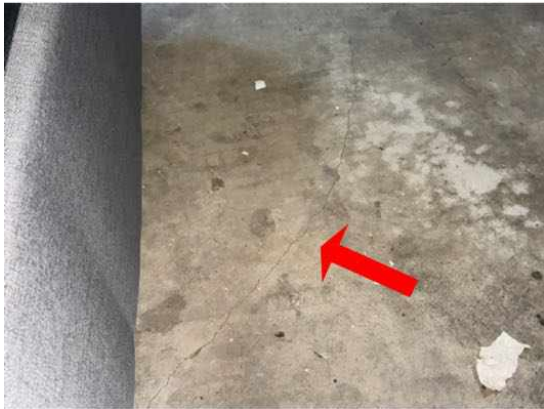
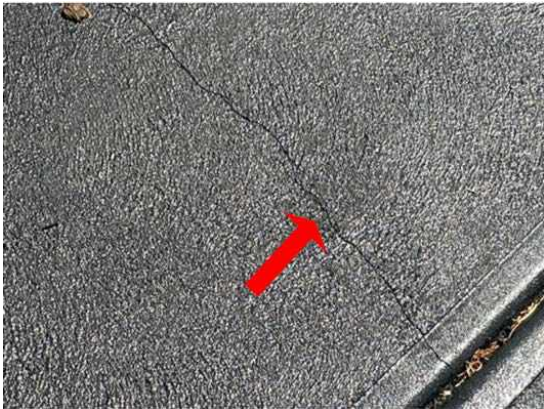
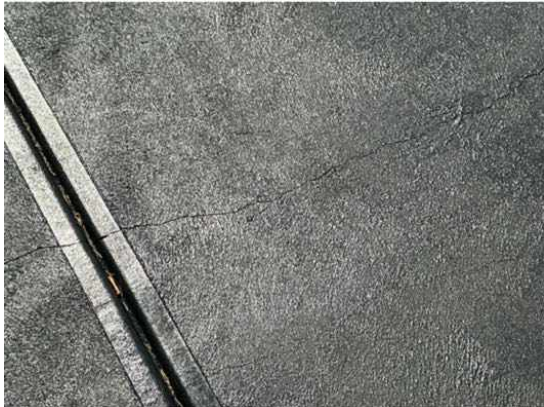
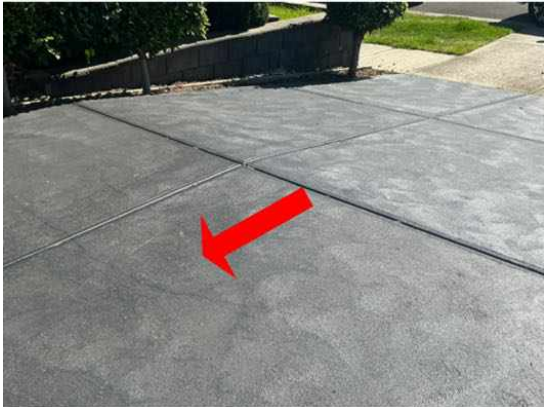
Finding 3.19

Building: Main Building
Location: Garage and driveway
Finding: Crack in concrete slab - Category 1
Information: A crack coded as Category 1 was identified in the slab. A Category 1 crack is described as a fine but noticeable crack, with the slab at an otherwise reasonable level.

To be considered Category 1, the approximate width of the crack is less than 1.0mm, or a less than 10mm change in offset when a 3m straight edge is placed over the defect.

Category 1 cracks should be monitored for a period of 12 months. At the end of the monitoring period, identified cracks that are rated greater than Category 2 are considered defects, and require rectification.

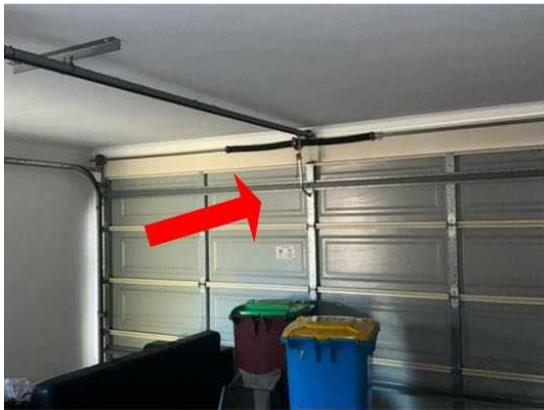
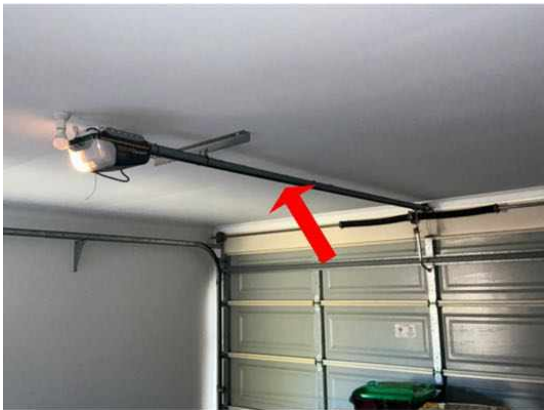
Finding 3.20

Building: Main Building
 Location: Garage
 Finding: Garage door inoperable
 Information: It was observed at the time of the inspection that the garage door closer motor was inoperable door with the garage door unable to be opened and closed except by manual operation. This may be due to the garage motor/mechanism becoming worn and faulty.

A garage door specialist should be engaged by the owners to review as soon as possible

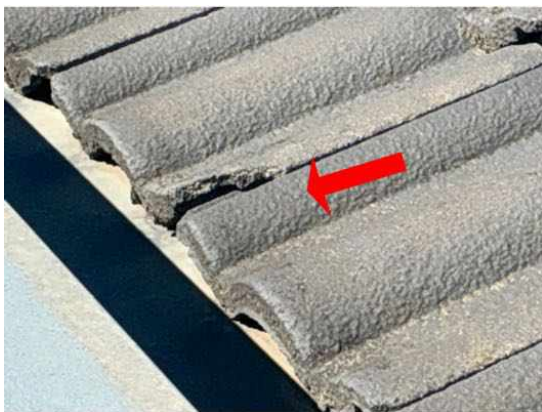
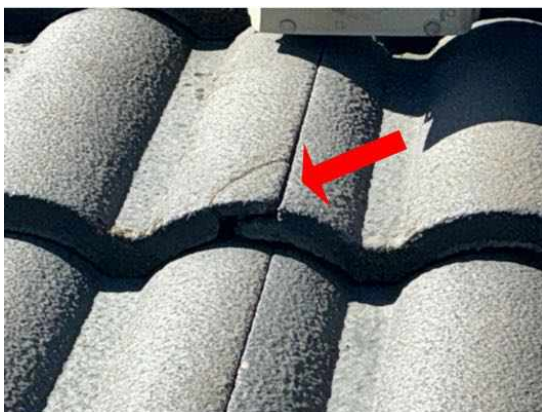
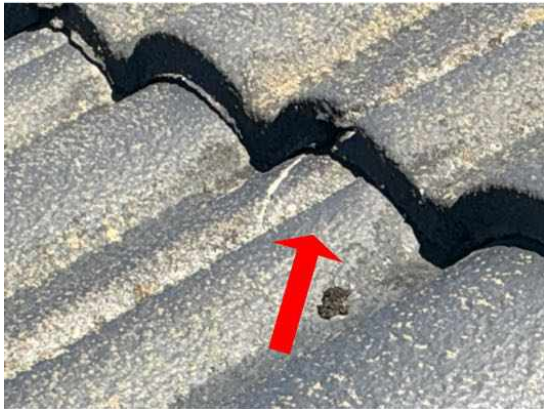
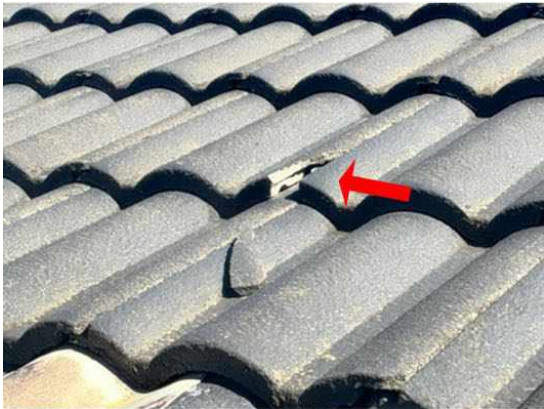
Finding 3.21

Finding: Roof tiles - Broken

Information: Upon inspection of the exterior roof covering, broken roofing tiles were identified. Broken and friable roof tiles are generally the result of ageing and weathering of what is essentially a porous material.

If left to further deteriorate, broken and brittle roof tiles are likely to lead to water penetration via the roof into the ceiling space, causing secondary damage to ceiling linings, insulation and roof structures. Broken roof tiles are also likely to detract from the effectiveness of the roof drainage system, creating potential for secondary damage to the exterior roof covering and roof plumbing.

Replacement of broken tiles is required and should be performed by a roofing contractor as soon as possible.

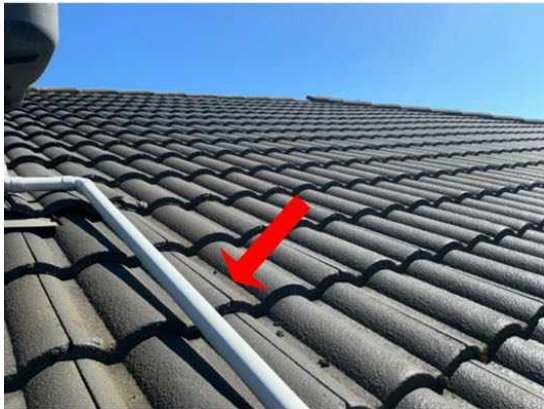
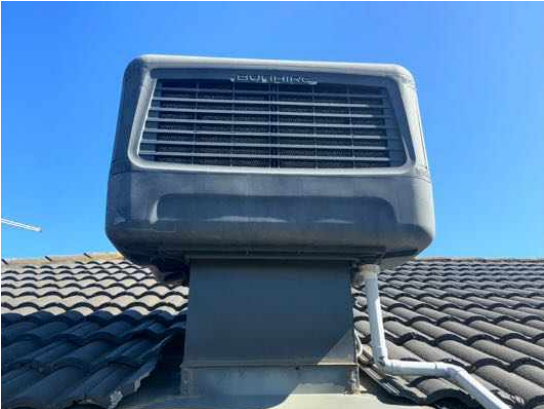
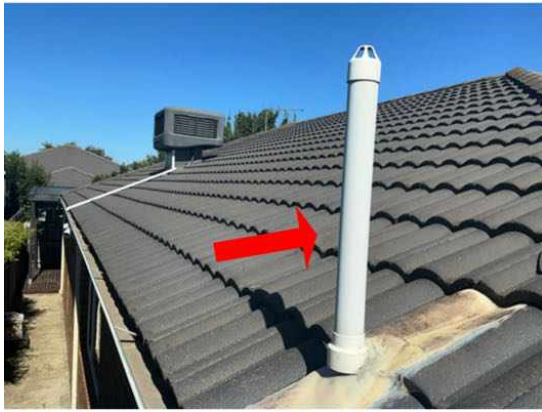
Building: Main Building
Location: Roof Exterior
Finding: PVC plumbing pipes not protected from UV
Information: It was observed that there were several PVC plumbing pipes on the roof exterior. These pipes have not been treated or coated to prevent deterioration from UV radiation.

UV radiation causes PVC pipes to go brittle and prematurely deteriorate.

A general handyman should be engaged to provide a UV protective coating to these PVC plumbing pipes at the owners discretion

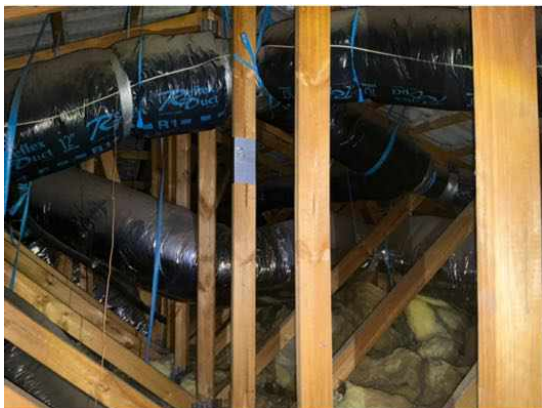
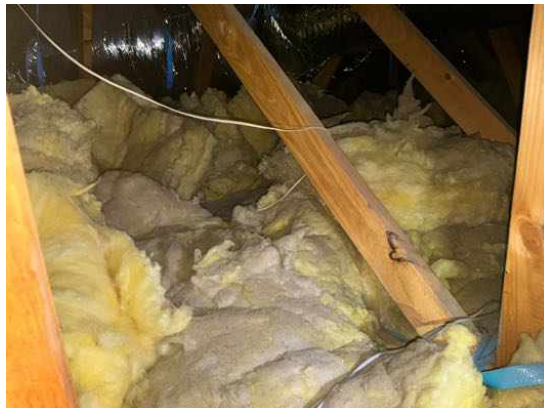
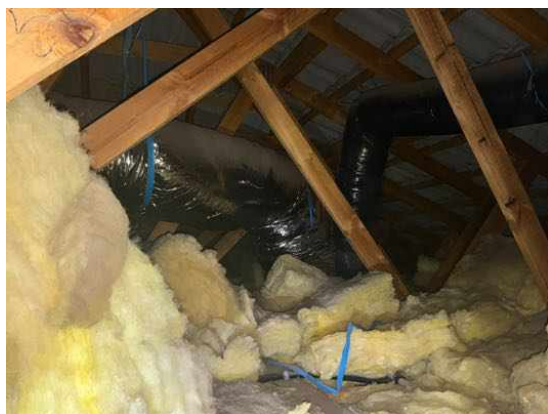
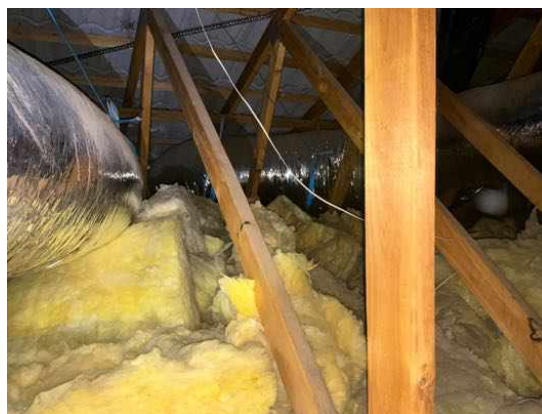
Finding 3.23

Building:	Main Building
Location:	Roof Void
Finding:	Insulation - Missing-disturbed
Information:	Upon inspection of the roof void it was noted that insulation is not present or disturbed.

Insufficient insulation will result in a comparatively higher cost to heat and cool a property as there is a lack of Insulation (or uneven coverage of insulation) which works as a barrier to heat transfer. This helps to keep out unwanted heat in summer and preserves warmth inside your home in winter. It can also help soundproof your home from unwanted airborne noise transfer.

Where insulation is absent, the area does not meet current Australian Standards. Installation of adequate insulation is required and should be conducted as soon as possible.

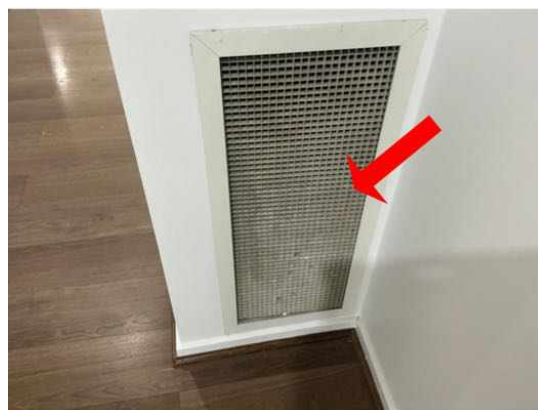
Finding: Return air grill dirty and damaged
 Information: It was noted at the time of the inspection that the grill to the heating return air was demonstrating some minor damage.

Although the damage is minor and the defect is mostly cosmetic, however it tracks from the overall appearance of the building.

A licensed plumber or General handyman should review at the clients discretion.
