Building and Timber Pest Inspection Report

Inspection Date: Thu, 19 Feb 2026

Property Address: 50 Gregson Grove, Lyndhurst VIC 3975, Australia

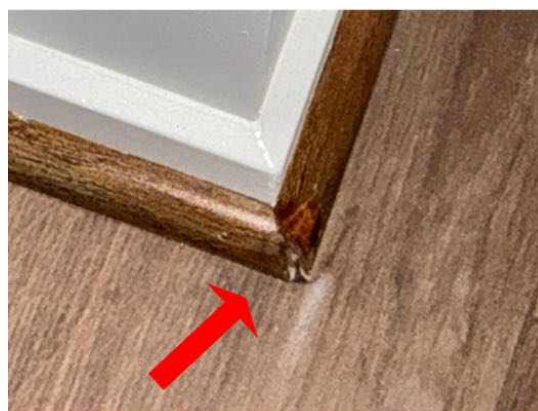
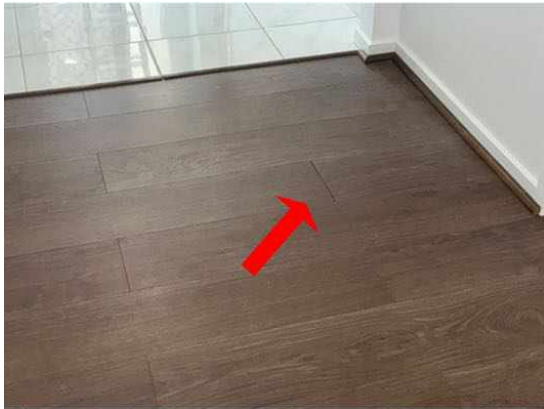
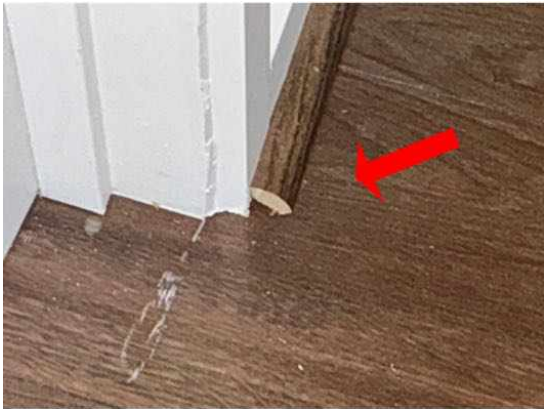
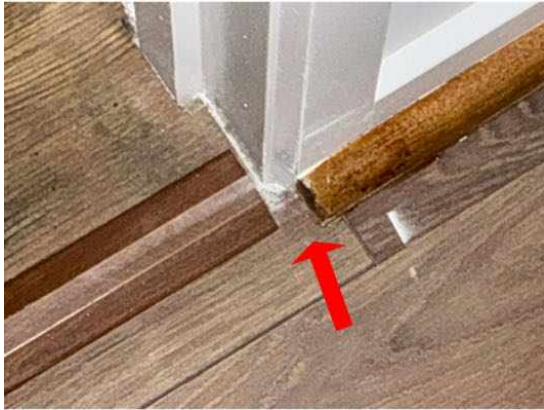
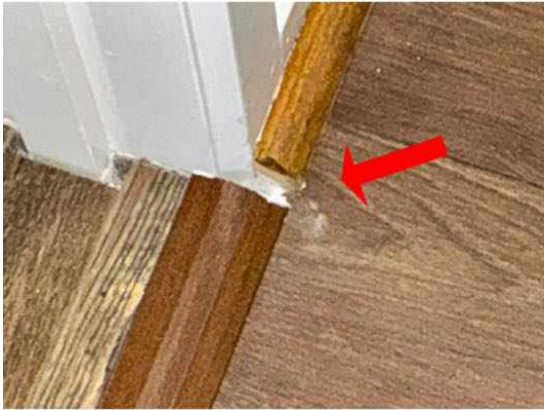
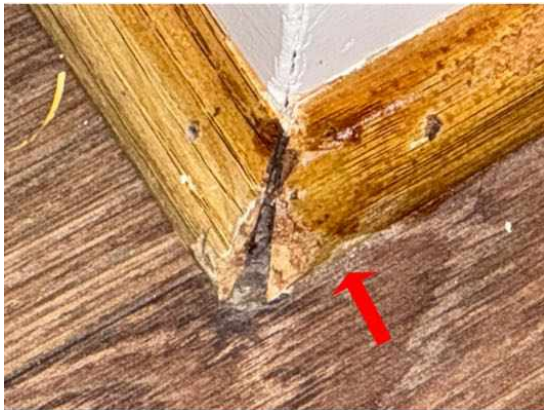
Finding 3.26

Building: Main Building
 Location: All Internal Areas
 Finding: Poor installation/floating floor
 Information: It was observed at the time of the inspection that the floating floor was demonstrating signs of poor and handyman workmanship.

The poor workmanship is mostly an aesthetic defect however this poor workmanship could contribute to the premature deterioration of the floating floor elements.

A specialist flooring contractor should be engaged to review at the owners discretion

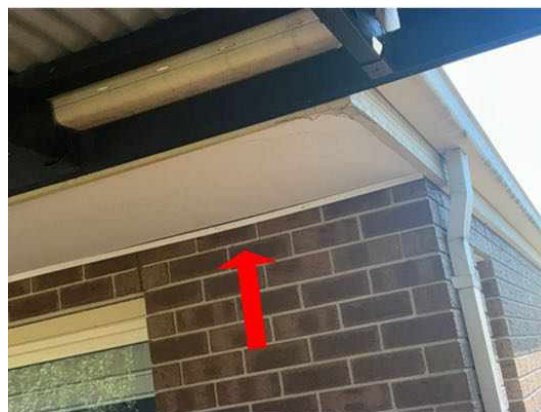
Building: Main Building
 Location: Rear Elevation
 Finding: Eaves - Sagging
 Information: Sagging to the eaves was evident in this area at the time of inspection. This type of defect is generally consistent with older properties, where the eave sheeting has worn over time.

Sagging eaves are susceptible to the attraction of excessive moisture, and are therefore considered non-functional. This defect also detracts from the overall appearance and condition of the roofing structure and any associated structures.

A roofing plumber or general handyman is recommended to perform rectification works as soon as possible. Subsequent water damage is likely to result over time if left unattended.

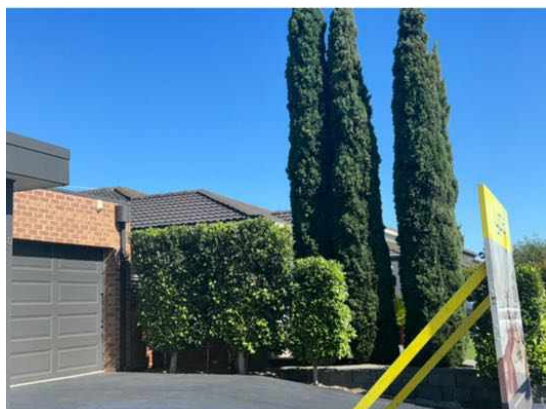
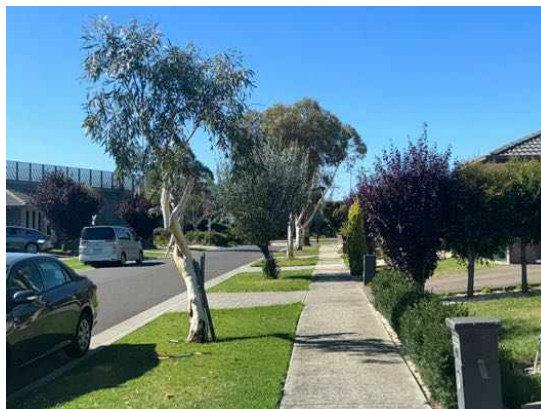
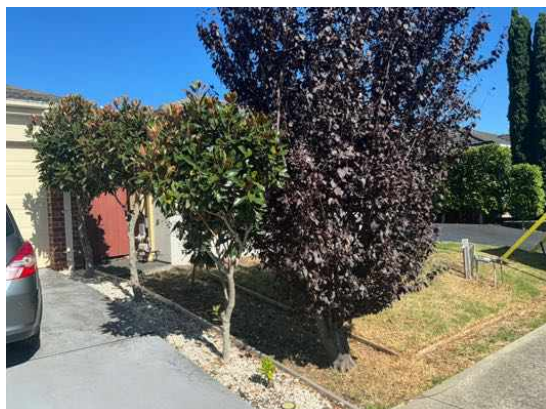
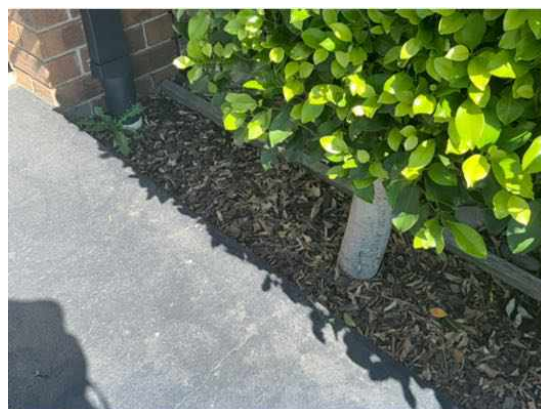
Finding 6.08

Building:	Main Building
Location:	All External Areas
Finding:	Trees/large/termite
Information:	It was observed that there were several large trees next to or nearby the building.

The trees have the potential to provide conducive conditions for termite infestation

It is recommended that periodic 12 monthly inspections by a registered pest control contractor be undertaken and further reinstatement of outdated termite barriers as soon as possible.

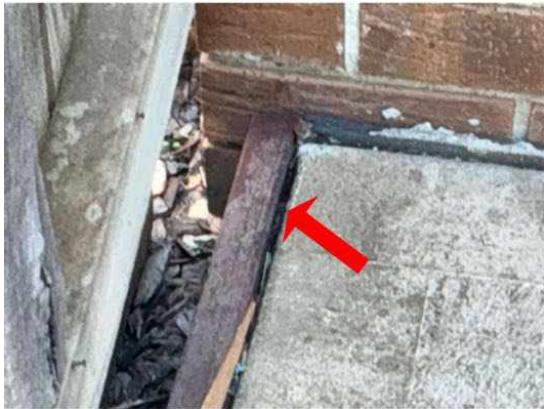
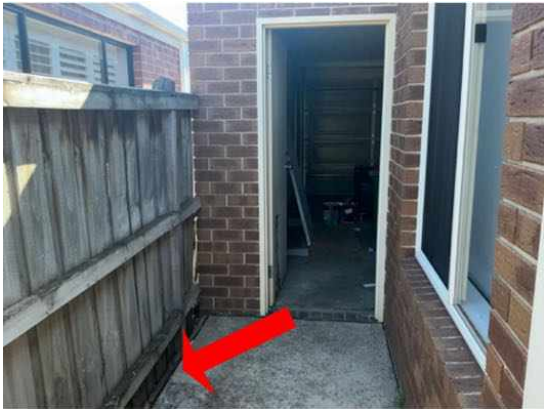
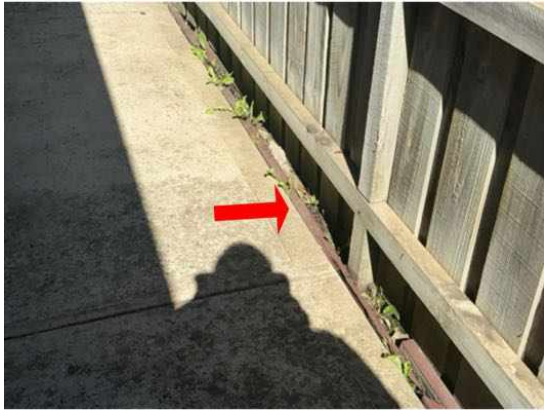
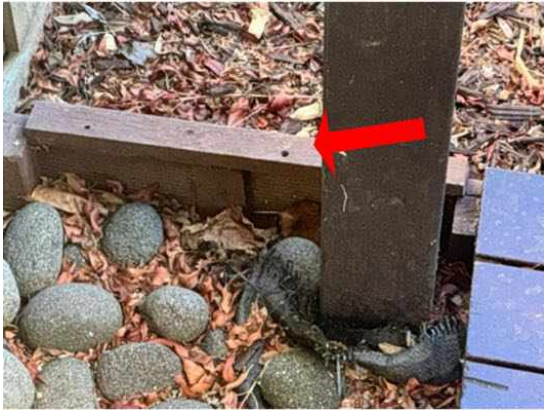
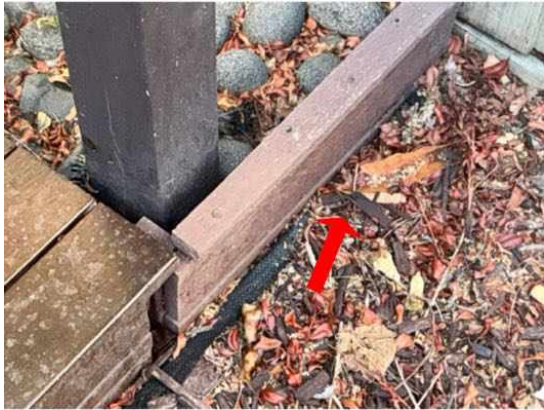
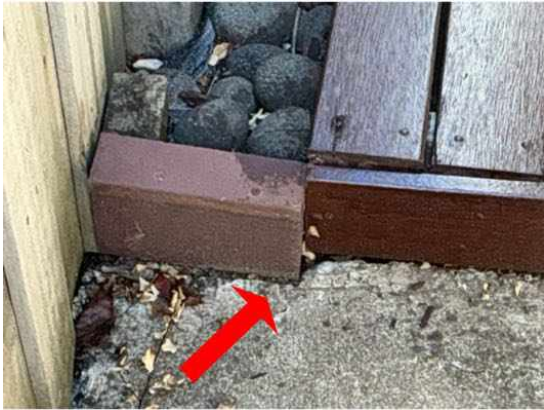
Finding 6.09

Building:	Main Building
Location:	All External Areas
Finding:	Untreated or non-durable timbers in a hazardous environment
Information:	To reduce the risk of timber pest attack it is essential that timber used in a hazardous environment (e.g. in direct contact with the ground or frequently exposed to damp conditions) is of sufficient durability and/or is adequately preservative treated.

Untreated timbers in direct contact with the ground are likely to develop severe wood rot and/or fungal decay if left unattended creating attraction for subterranean termites to infest the timbers from surrounding areas.

If untreated or non-durable timbers are found to be in a hazardous environment it is highly advised that replacement of these building elements be performed as soon as possible to aid the protection of the property against termite / timber pest attack.

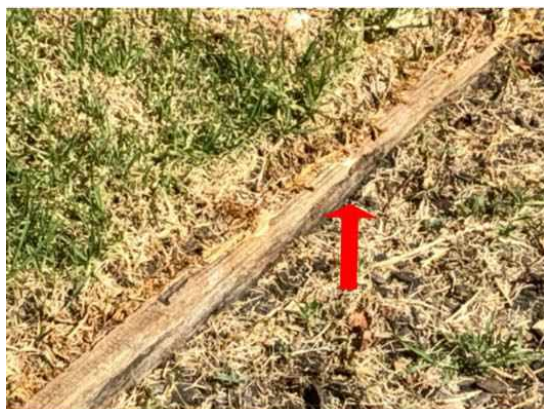
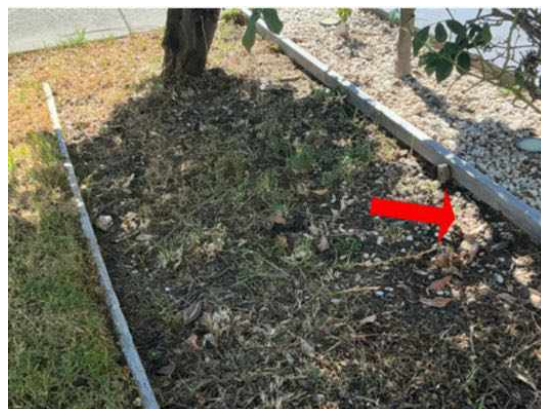
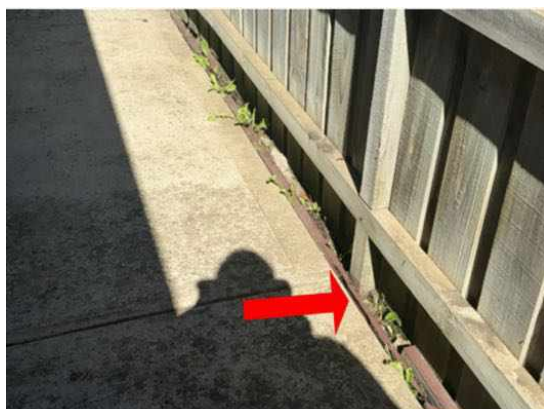
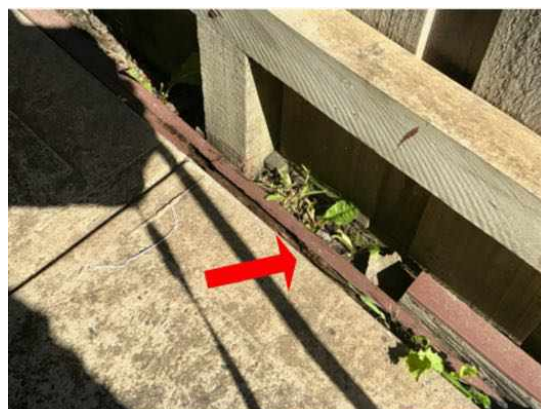
Finding 7.01

Building: Main Building
Location: All External Areas
Finding: Fungal decay - present (localised)
Information: Fungal decay also known as wood decay or wood rot generally refers to the deterioration of timber elements when in contact with excessive levels of moisture for a prolonged period of time.

The development of fungal decay is accelerated by temperatures in the range of 5degreeC to 40degreeC as well as the presence of oxygen. Generally fungal decay develops on timber elements that are in use in an external environment which are exposed to rain penetration.

In this case although the affected timber element is in a decaying state the extent of any visible damage appears to be localised to a specific area and is yet to spread to other parts of the building element or affect adjoining structures. The fungal decay is therefore likely to be of a relatively superficial nature with minimal impact on the structural integrity or tensile strength of the timber element.

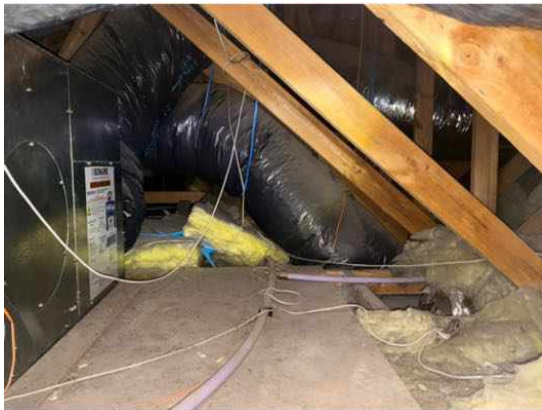
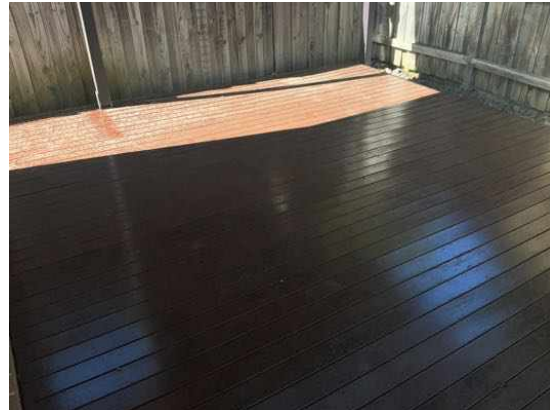
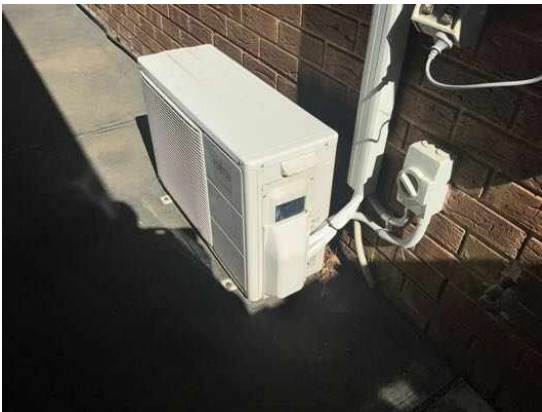
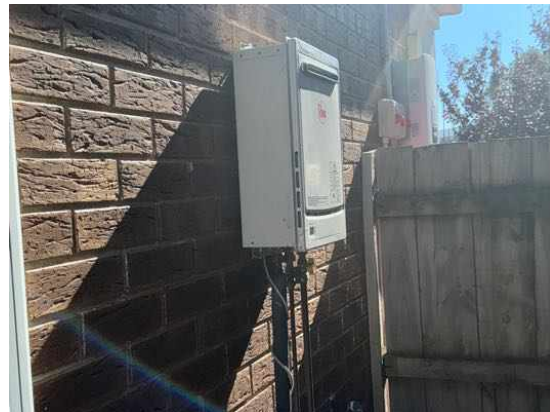
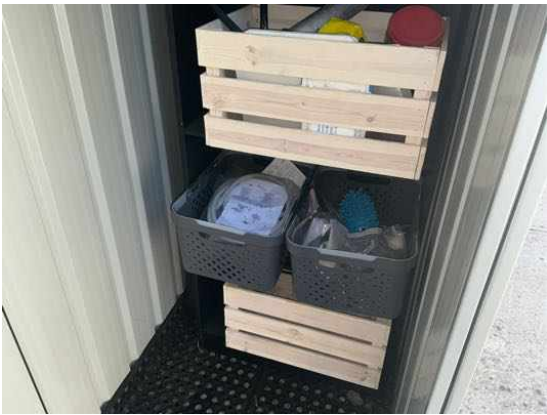
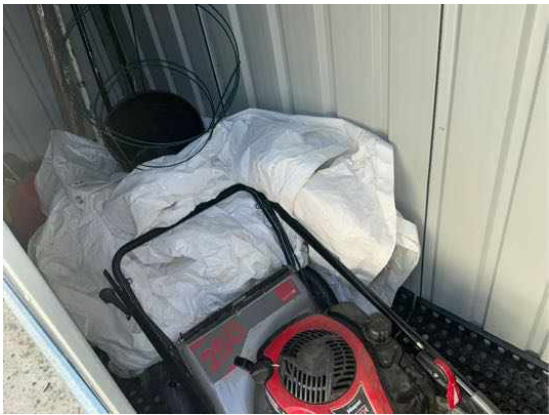
Building: Main Building
Location: All Areas
Finding: Additional Photos - Obstructions and Limitations
Information: These photographs are an indication of the obstructions and limitations which impeded full inspection of the property at the time of inspection. These obstructions can hide an array of defects and should be removed to allow full inspection to be carried out. A re-inspection is recommended once the areas are made accessible.
