# Building and Timber Pest Inspection Report

Inspection Date: Fri, 30 Jan 2026

Property Address: 6 Tortola Pl, Parrearra QLD 4575, Australia

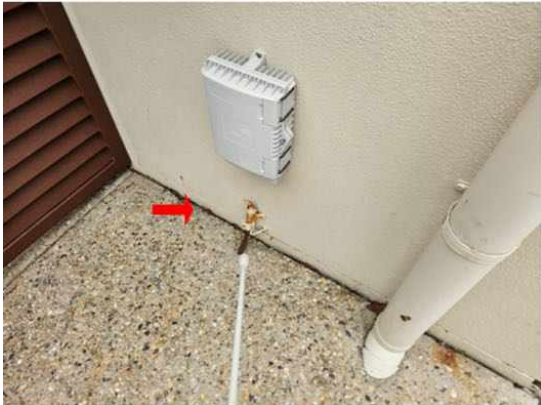
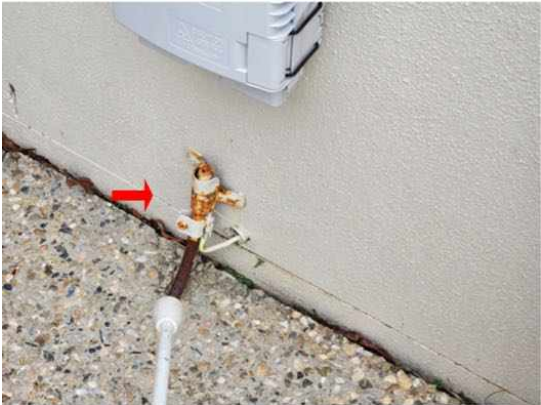
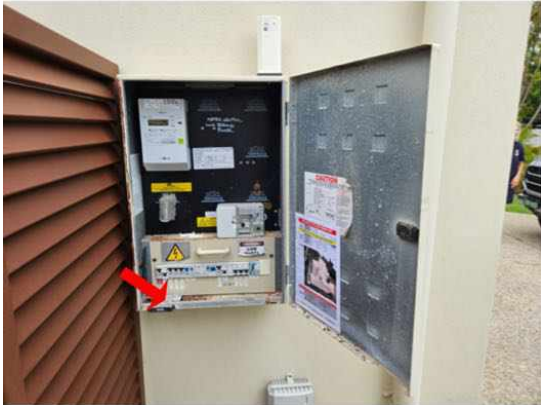
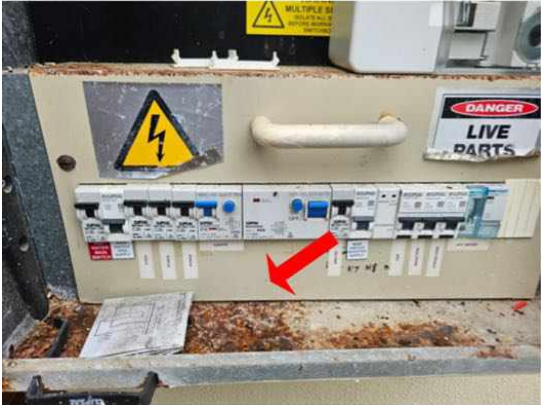
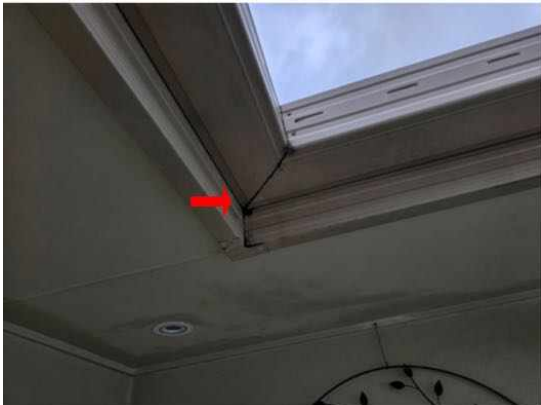
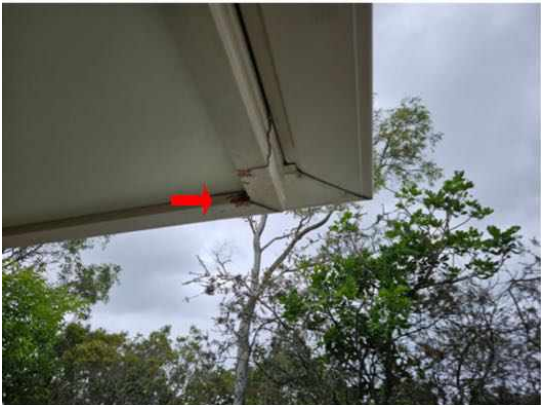
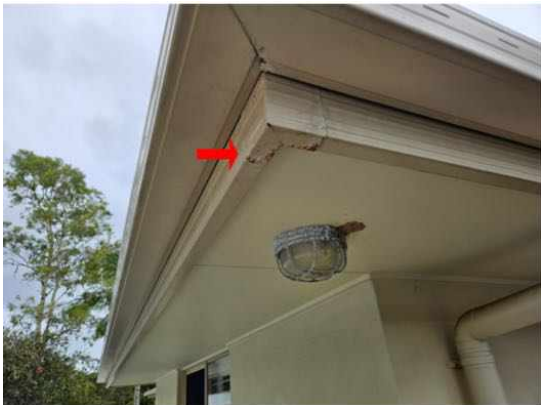
Building: Main Building  
Location: As shown  
Finding: Miscellaneous minor defects  
Information: Below are listed the miscellaneous minor defects identified on the day of inspection.

1. Chip to render at front left corner.
2. Rust to the earth stake and clip.
3. Minor surface to meter box.
4. Minor surface to fascia and gutter.

These minor defects should be attended to in the short term to prevent further deterioration.

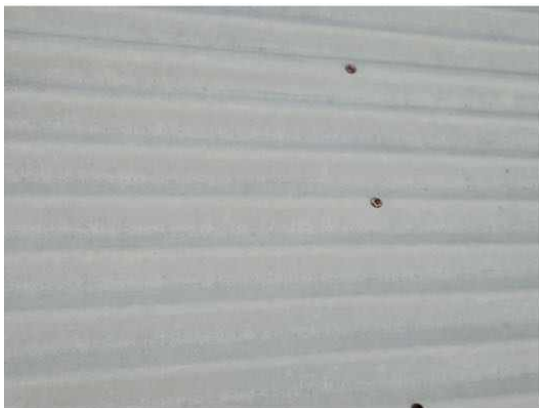
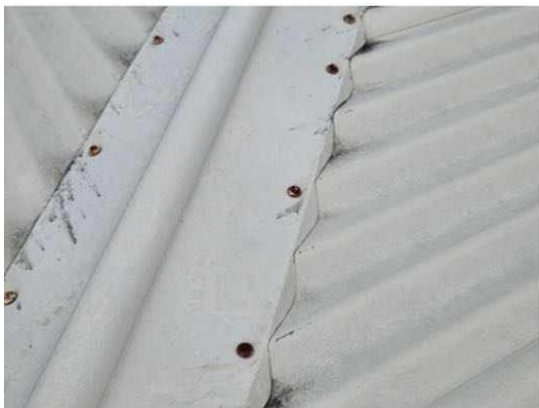
Finding 3.02

Building: Main Building  
Location: All External Areas  
Finding: Roof screws - rusting  
Information: It was noted during inspection, that throughout the roof surface the majority of roof screws are showing signs of rust at varying degrees ranging from minor to moderate.

This should be monitored over time, and should the condition worsen, consider replacement of the screws. As roof screws deteriorate they can have an effect on the adjoining roof materials.

A roofing plumber could be appointed at the clients discretion to replace the screws in question.

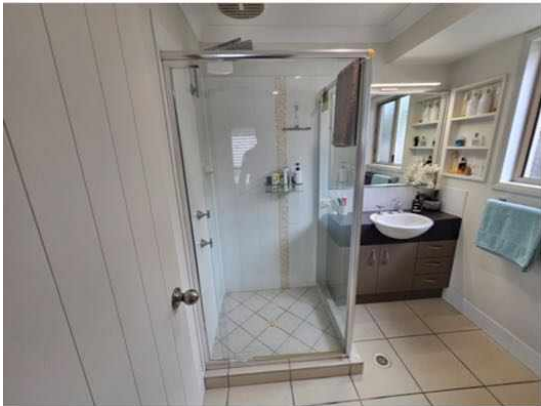
**Finding 3.03**

Building: Main Building  
Location: Bathroom  
Finding: No moisture detected in bathroom / ensuite  
Information: On the day of inspection the showers in the bathroom/s and ensuite are measure for moisture using a "Tramex" moisture meter. During this inspection no moisture was detected in these areas and the tiled / sheeted surfaces appear to be in good order.

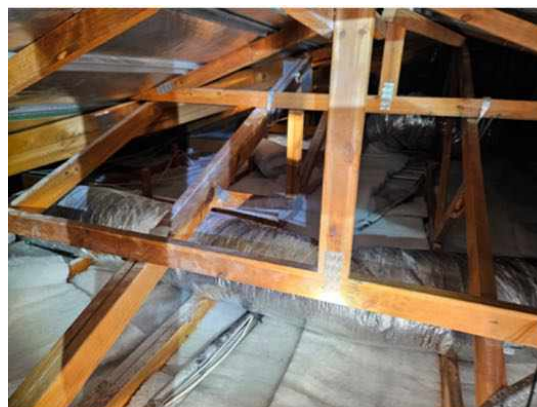
Building: Main Building  
 Location: Garage  
 Finding: Roof cavity / ceiling space - inaccessible  
 Information: On the day of inspection, the ceiling space / roof cavity was considered unsafe to fully inspect due to the congested / restrictive nature of the roof framing. This combined with the congested nature of the entry to the main roof area, made it a WH&S issue and ;therefore not inspected fully.

Should a full inspection be requested, an alternative position for an additional roof access hatch is advised.

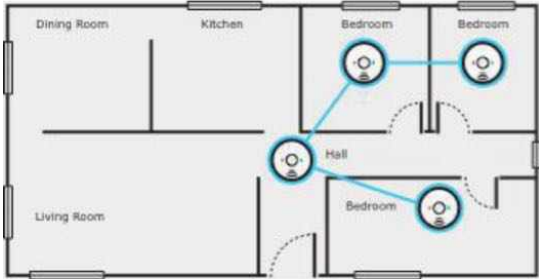
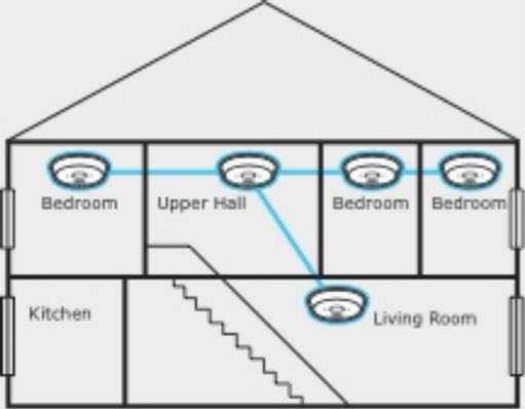
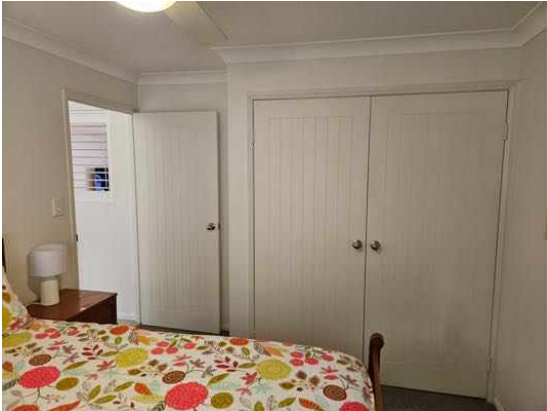
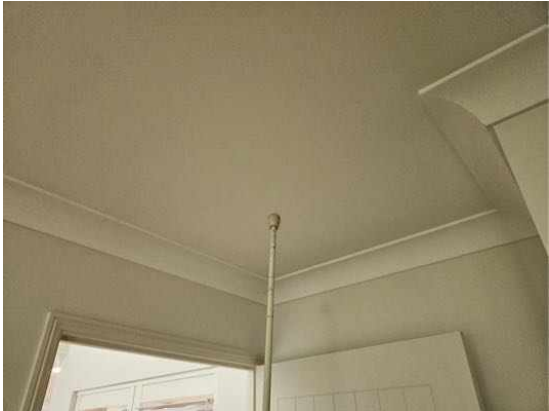
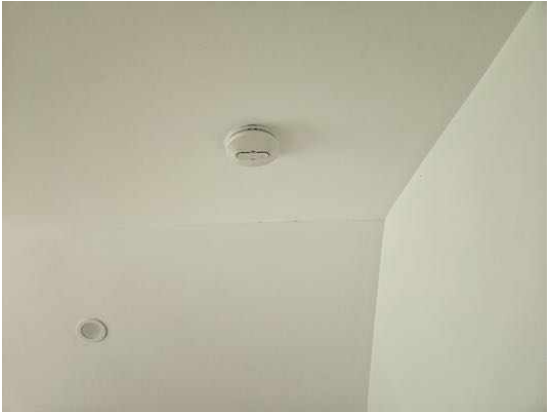
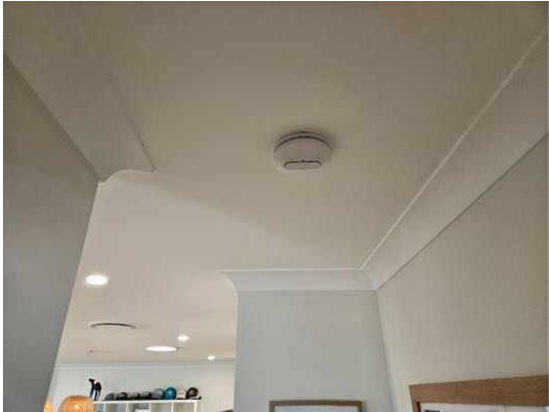
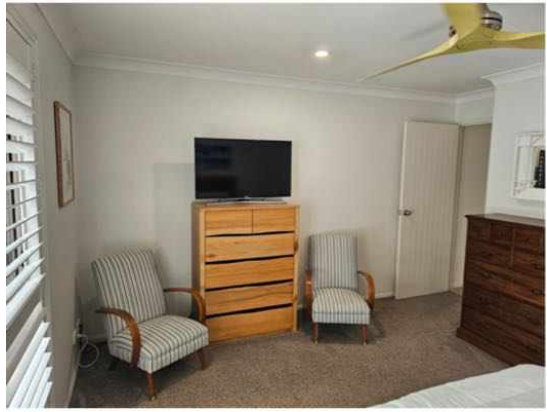
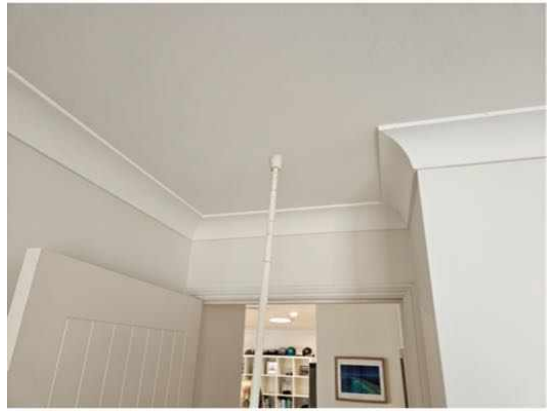
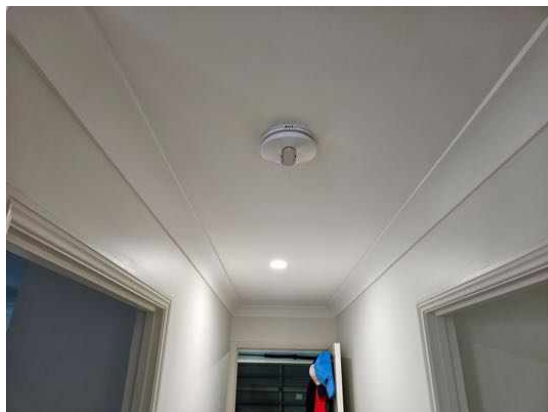
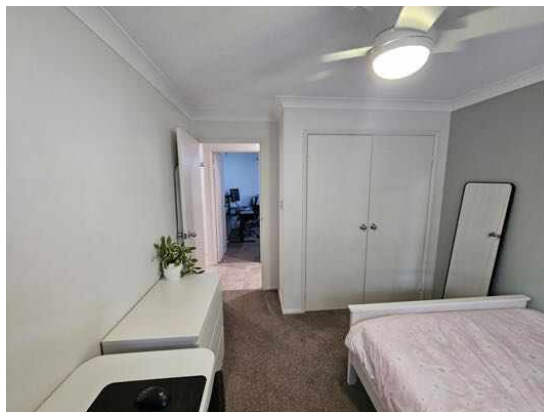
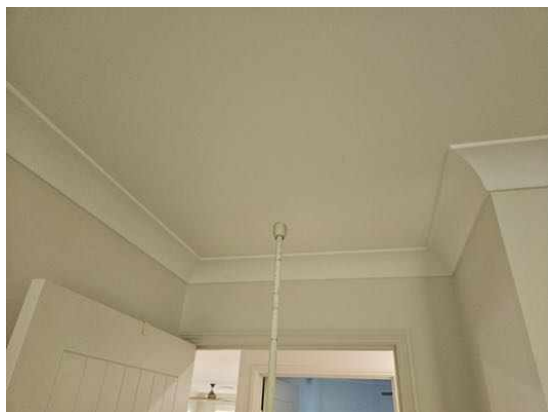
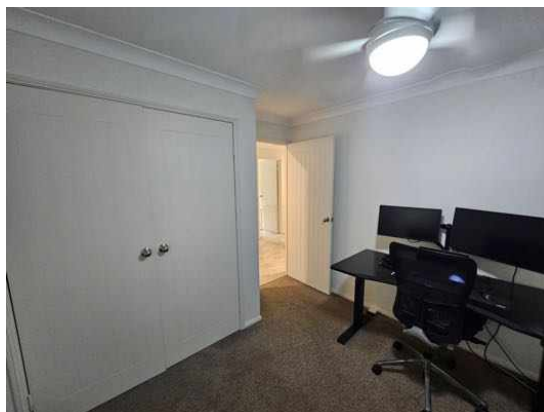
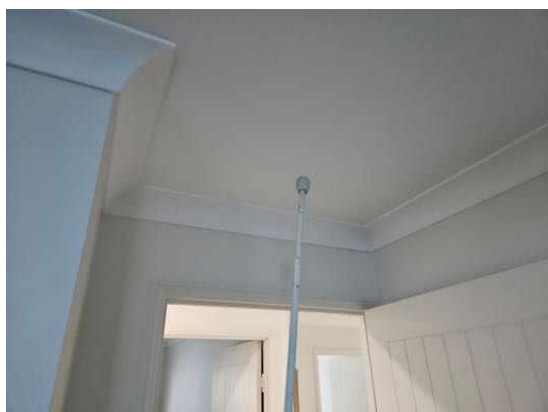
Building: Main Building  
 Location: All Internal Areas  
 Finding: Smoke Detectors and Alarms. AS 3786:2014  
 Information: Reporting on Smoke Detectors or Alarms, including hard wired smoke detection

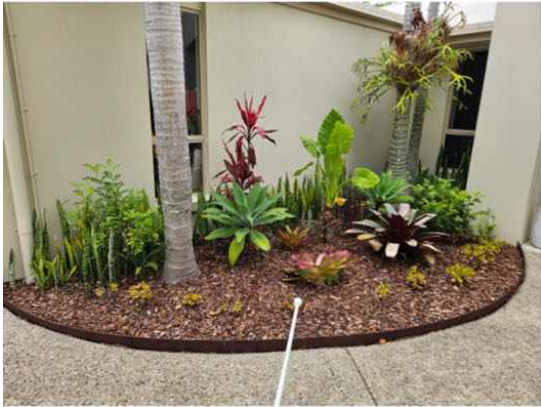
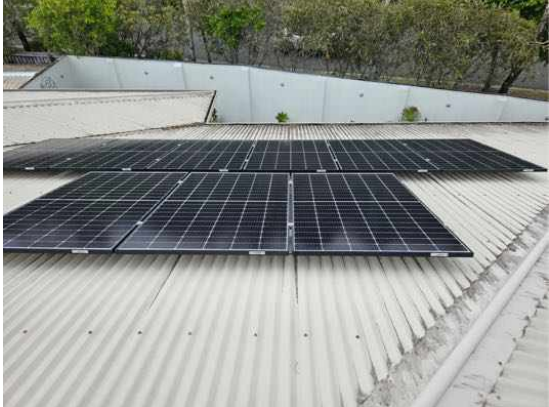
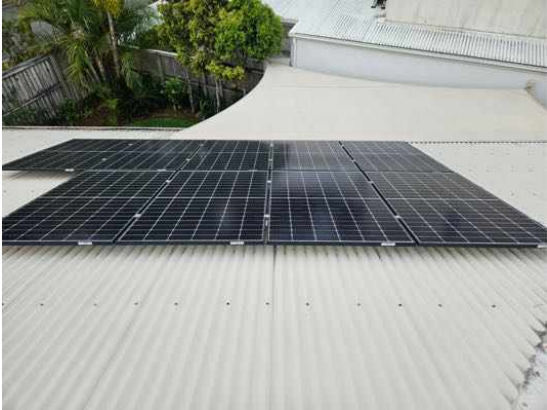
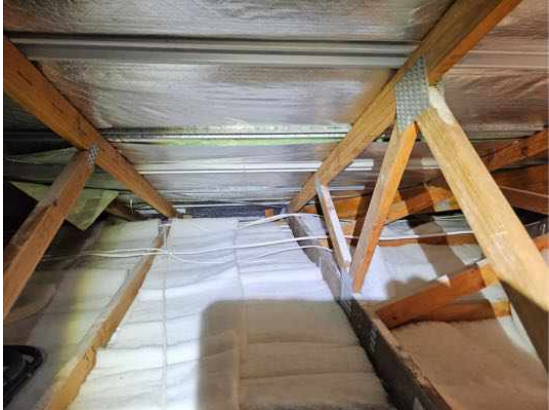
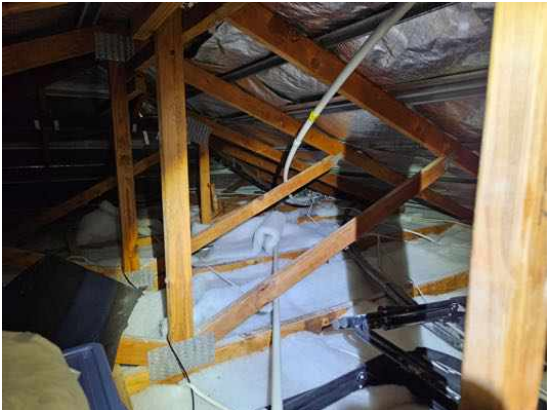
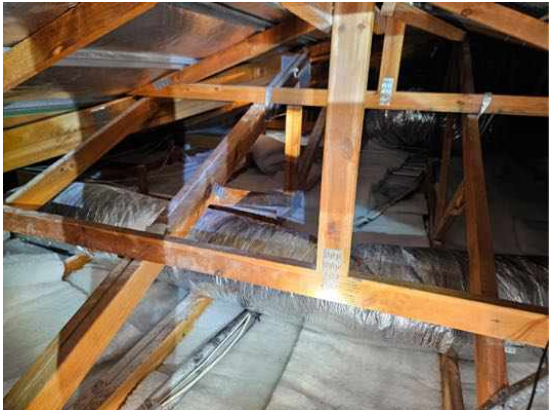
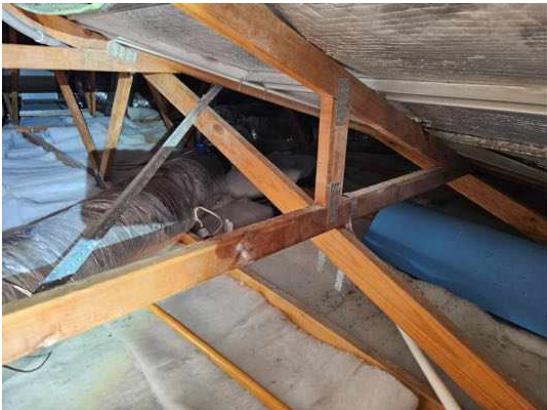
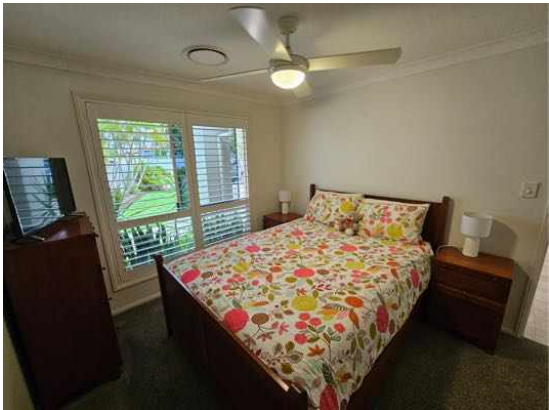
Building: Main Building  
Location: All Areas  
Finding: Additional Photos - Obstructions and Limitations  
Information: These photographs are an indication of the obstructions and limitations which impeded full inspection of the property at the time of inspection. These obstructions can prevent full inspections of the areas shown.

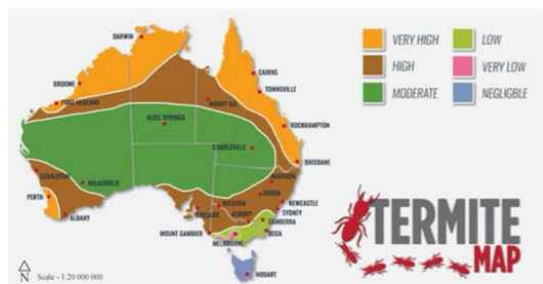
Building:	Main Building
Location:	Meter box, kitchen cupboard
Finding:	Durable pest inspection notice - not assessable
Information:	On the day of inspection it was noted that the durable timber pest inspection / treatment notice was missing, not visible or out of date. These notices / stickers are to verify the timber pest inspection dates, the inspector, the currency and type of timber pest system / barrier in place or being used in and around the property.

Annual, or more regular, inspections are crucial in maintaining and managing the properties timber pest risk profile. By not having regular inspections of the property raises the properties risk of undetected defects and damage. Without regular inspection at intervals of not greater than annually the buildings risk profile will categorised as high. Properties with trees within 50m and with gardens close to the building are at greater risk and will have a high risk profile.

It is recommend that a licensed timber pest controller be contacted to assess the properties needs and provide costings for an annual inspection programme.
