Building and Timber Pest Inspection Report

Inspection Date: Thu, 5 Mar 2026

Property Address: 579 Homer St, Earlwood NSW 2206,
Australia

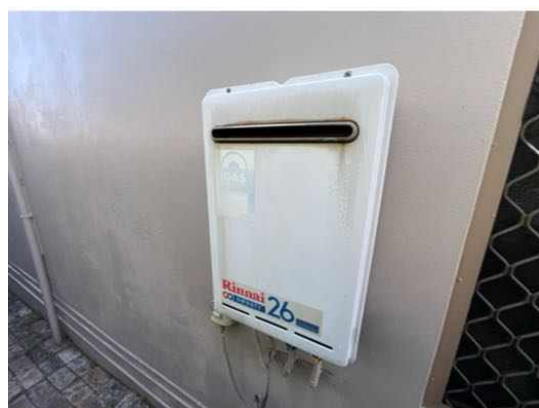
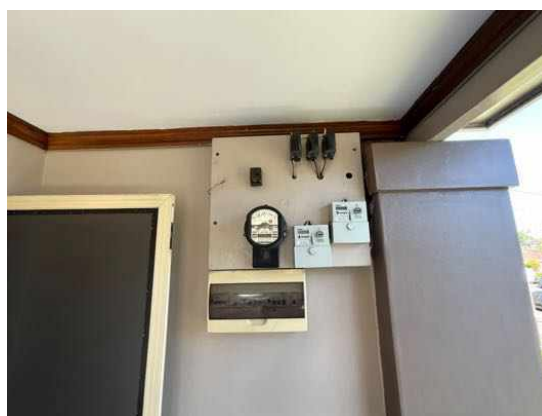
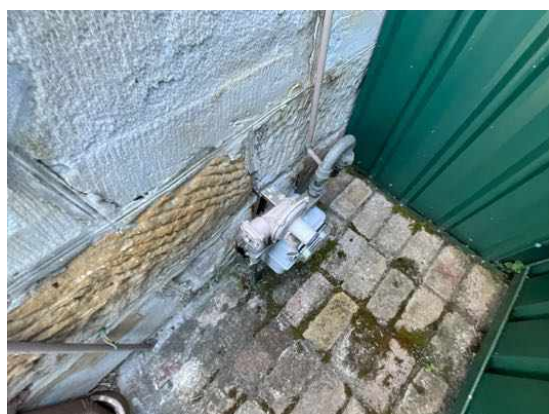
Building:	Main Building
Location:	All Areas
Finding:	Photos Added
Information:	Additional photos are provided for your general reference.

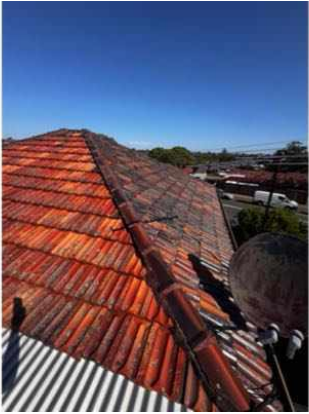
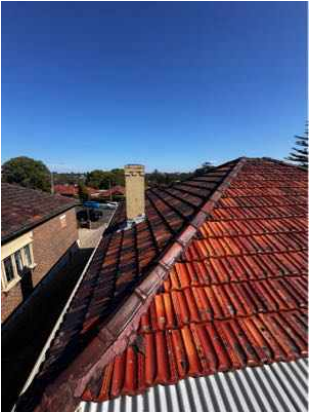
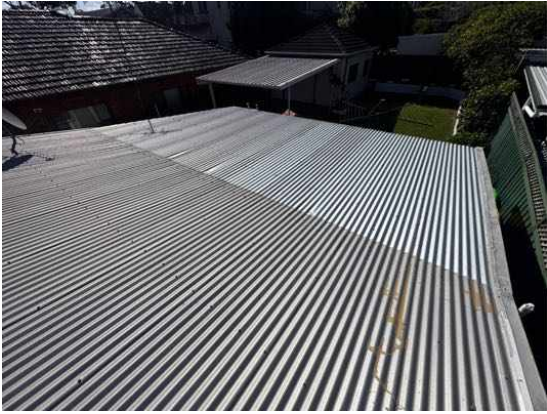
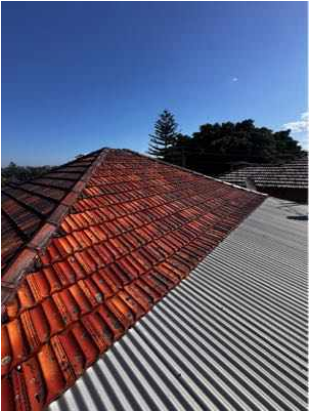
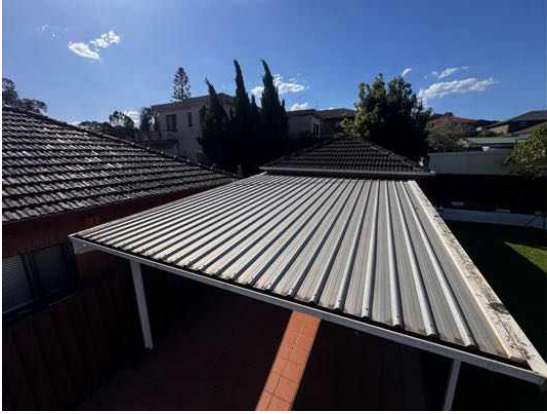
Building: Main Building
 Location: Roof Exterior
 Finding: Photos Added
 Information: Additional photos are provided for your general reference.
