Building and Timber Pest Inspection Report

Inspection Date: Fri, 30 Jan 2026

Property Address: 38 & 38A Glenfern Cres, Bossley Park NSW
2176, Australia

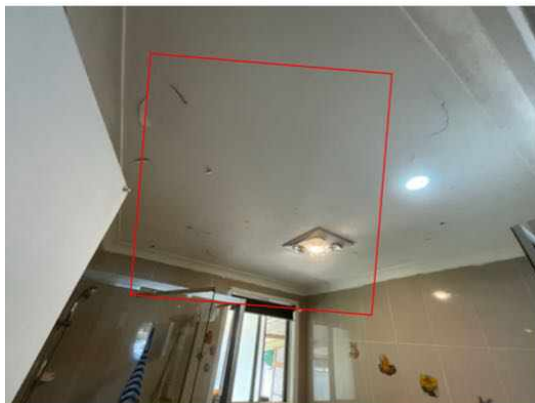
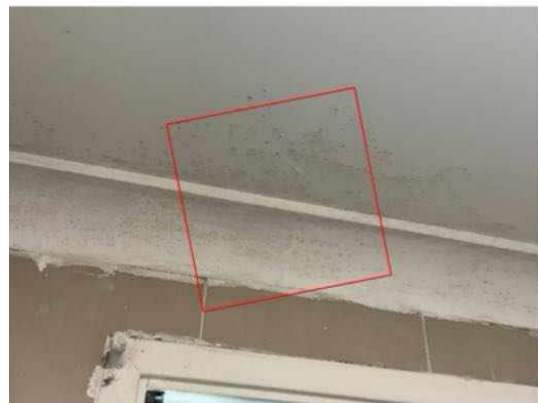
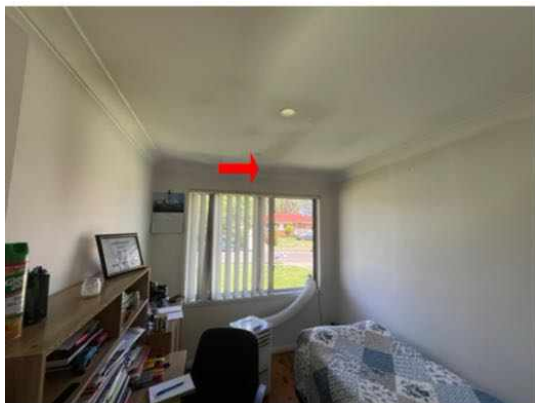
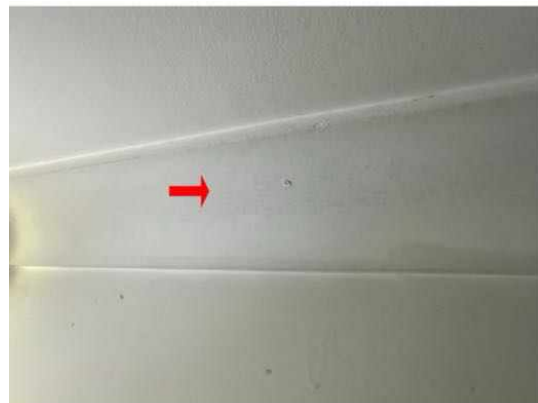
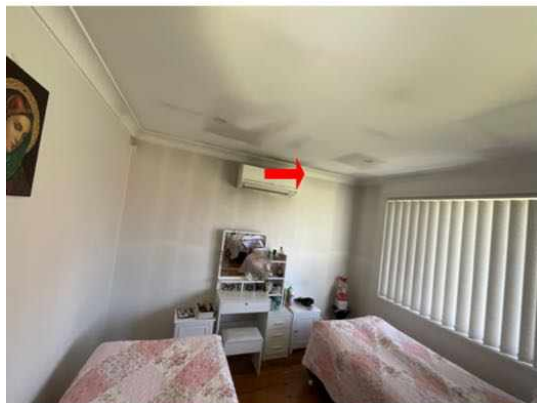
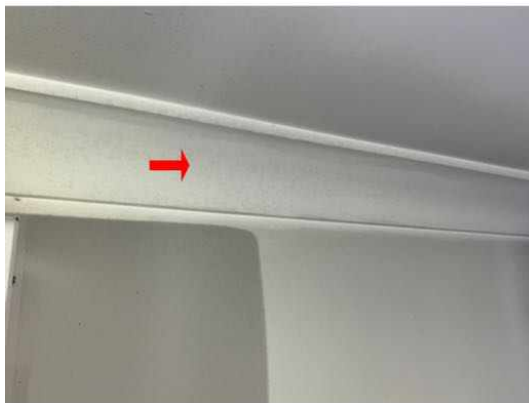
Building: Main Building
Location: Bathroom, bedrooms
Finding: Mould - Present
Information: Evidence of mould growth was noted, which is believed to have grown due to lack of ventilation to the area. Where evidence of mould growth was noted, there may be environmental, biological or health issues associated with the report. A specialist inspection by a suitably qualified environmental health inspector is warranted, where mould is extensive or where any queries regarding air quality spores or other related issues apply.

Generally, the client is advised to ensure that the general environment is free of moisture and humidity to aid in the prevention of mould formation and development. Any mould found during the inspection should be cleaned immediately by a cleaning contractor or the homeowner as applicable.

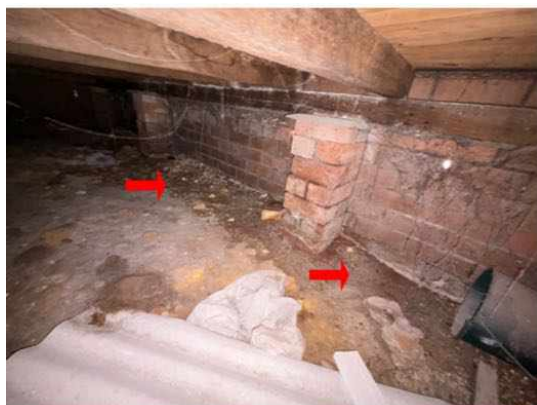
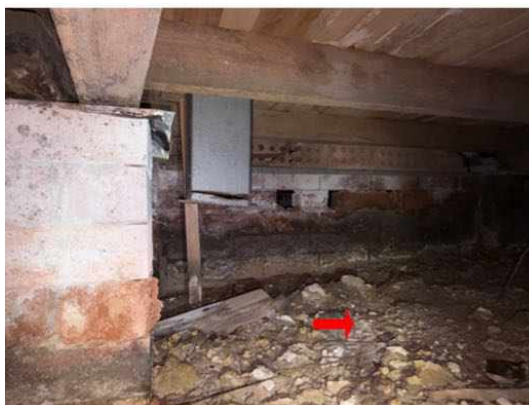
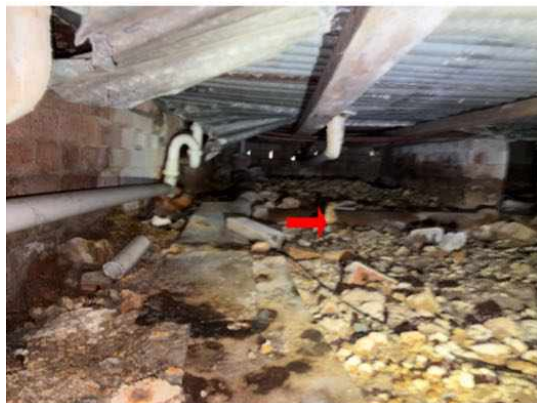
Finding 2.01

Building:	Main Building
Location:	Subfloor
Finding:	Subfloor - Dampness
Information:	Dampness to several sections of the subfloor area was identified. It is suspected that this dampness may be exacerbated by poor site drainage and inadequate subfloor ventilation however may also be due to leaking pipes. Dampness in this area is likely to lead to wood decay and general deterioration of structures within the subfloor space. Excessive moisture also creates an environment which is conducive to termite and pest infestation. A licensed plumber should be engaged immediately to assess where the moisture is coming from and rectify this as a matter of urgency to ensure a dry sub floor.

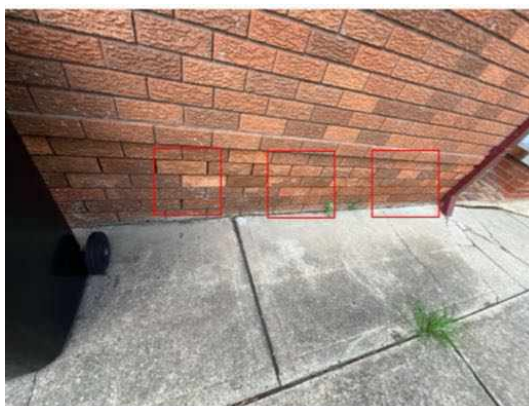
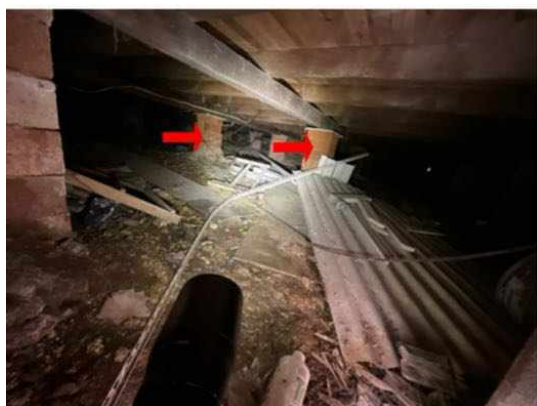
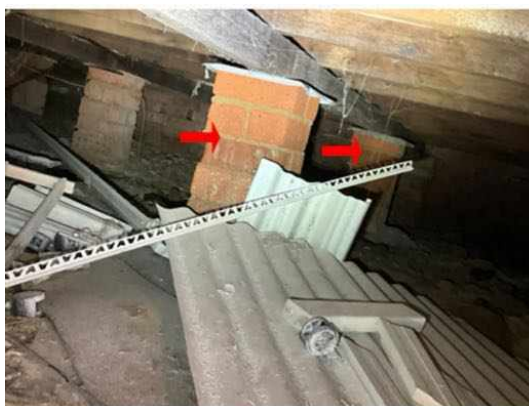
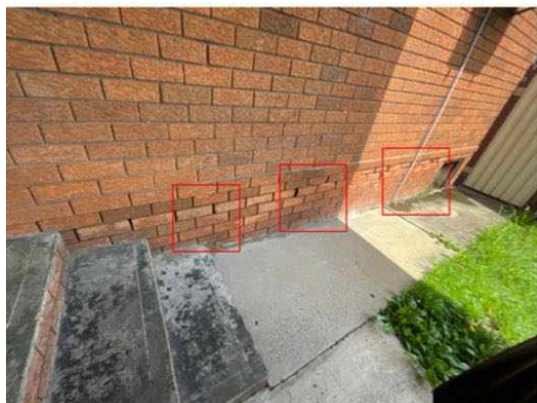
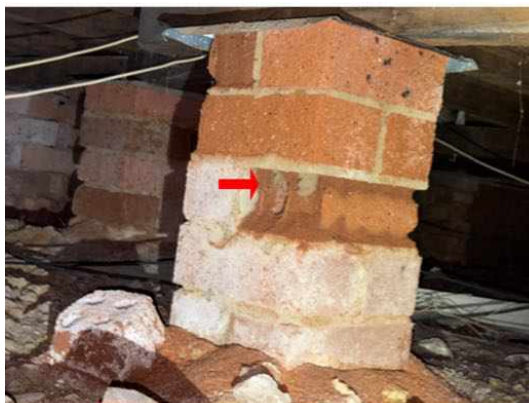
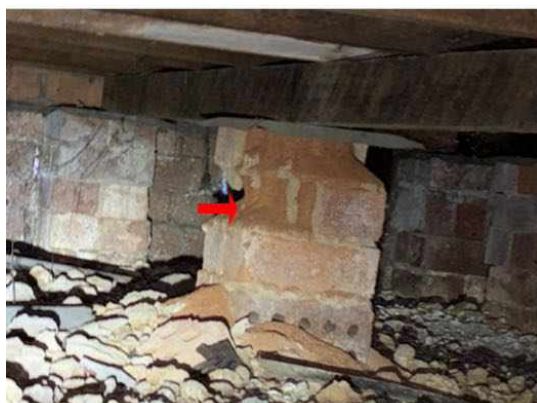
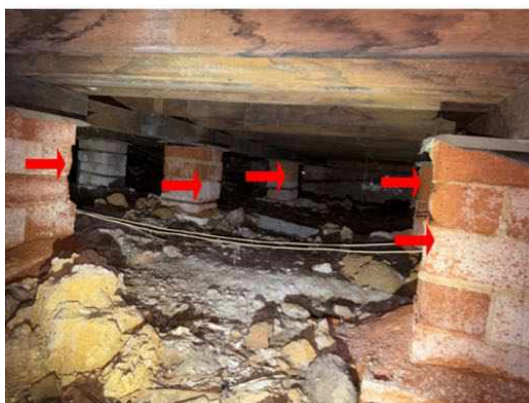
Finding 2.02

Building:	Main Building
Location:	Multiple areas
Finding:	Brickwork and Mortar - Deteriorated (Erosion)
Information:	This section of walls and piers were found to be deteriorated. Mortar, or `bedding`, is the material which fills joints and intersections between bricks in masonry walls and structures.

Commonly referred to as corrosion or erosion, the bricks and mortar are aged and likely to have been affected by a variety of factors, including moisture, salt-based deterioration, and more.

Mortar and brickwork should be replaced to ensure the structure remains in their intended location and to prevent gaps, which would allow water or moisture ingress and secondary damage as a result.

This can be addressed by a licensed bricklayer where areas of deterioration are localised and easily accessible. Otherwise engagement of a licensed builder is required.

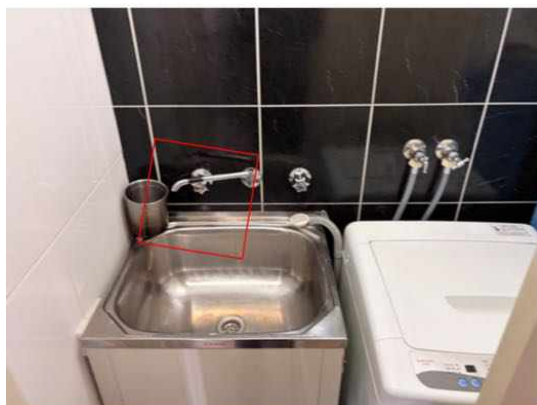
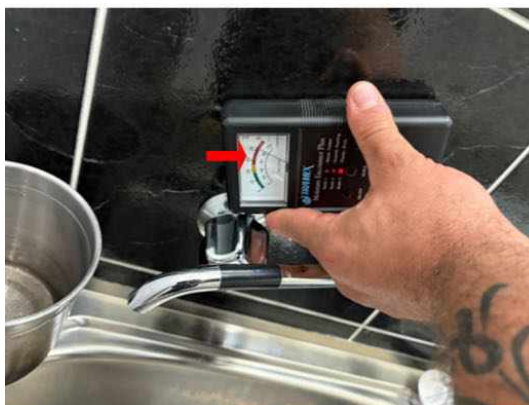
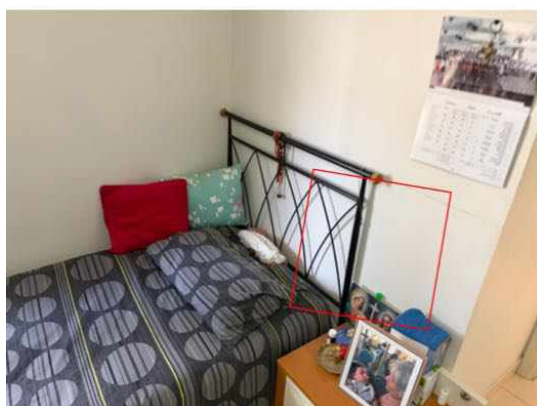
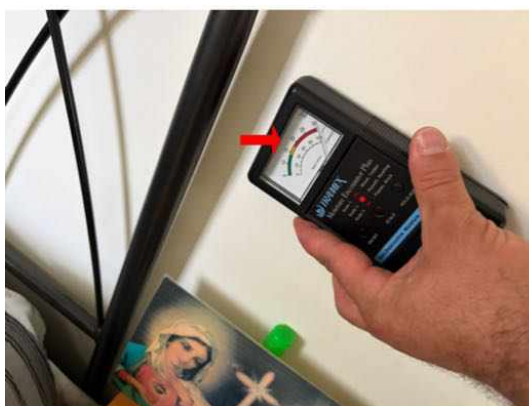
Finding 2.03

Building:	Main Building
Location:	Granny flat laundry
Finding:	Evidence of excessive moisture was present at the time of inspection
Information:	Excessive moisture can attract termites and produce conditions that promote termite attack, fungal growth and wood decay. Excessive moisture is generally caused by deteriorated, inadequate or missing roof drainage, leaking plumbing pipes or fixtures, poorly plumbed HWS overflows or condenser units and poor site drainage. It is highly recommended that all plumbing and drainage fixtures and fittings be maintained regularly in order to prevent excessive moisture being present in the external / internal property.

A licensed plumber must be appointed urgently for assessment and any required repairs.

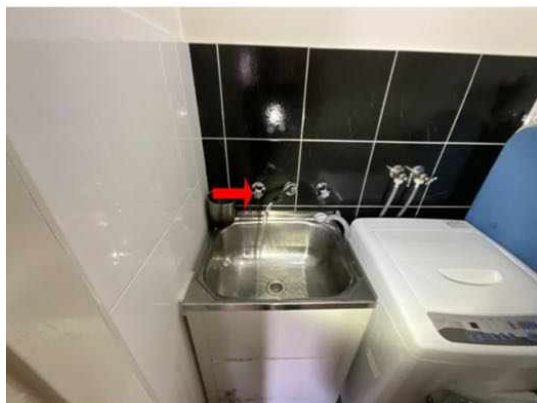
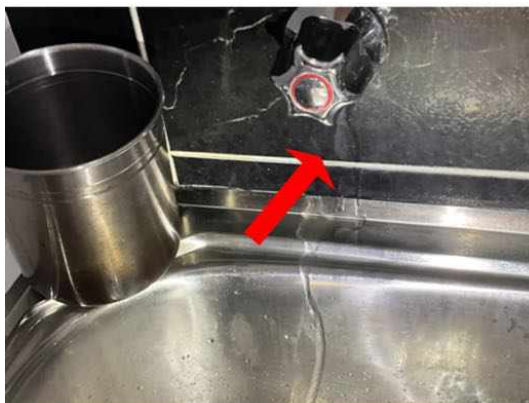
Finding 3.01

Building:	Main Building
Location:	Granny flat laundry
Finding:	Tap - Leaking
Information:	The tap in this area was found to be leaking at the time of inspection. This is a common defect that is consistent with general ageing of the building element. However, it may be indicative of substandard plumbing workmanship if the tap is relatively new.

While this defect only seems minor, if left unmanaged, it is likely to result in the development of rust, water damage and/or extensive water usage.

It is advised that a handyman or licensed plumber be appointed to perform remedial works on the affected tap. Such works should be performed prior to the development of secondary defects to ensure adequate functionality of all associated building elements.

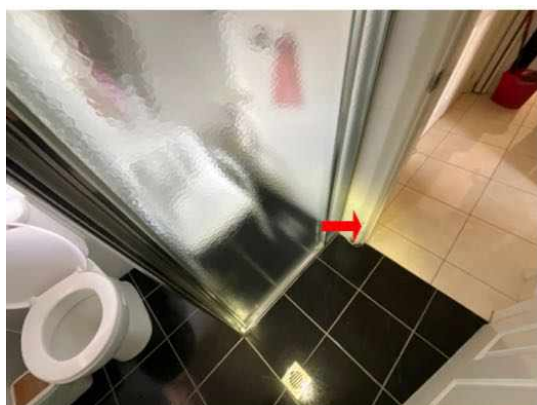
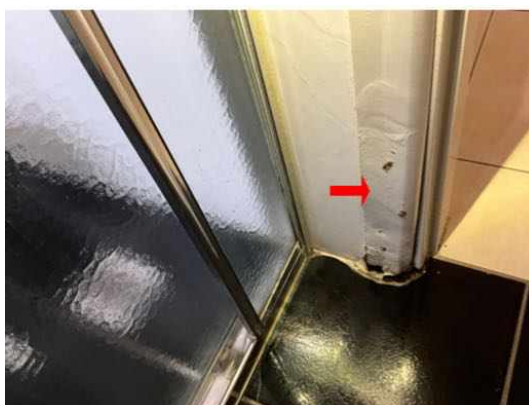
Finding 3.02

Building:	Main Building
Location:	Granny flat bathroom
Finding:	Water Damage
Information:	Water damage is generally an indication of excessive moisture being present, usually via a leak. In this case it is suspected that water leaks outside the shower, being the underlying cause.

Left unmanaged, further deterioration is possible.

A sealant specialist must be appointed to ensure all sealant and grouting is in serviceable condition. A carpenter and a painter should also be appointed for cosmetic repairs.

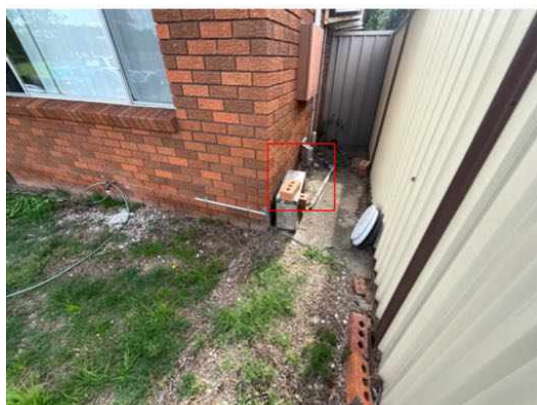
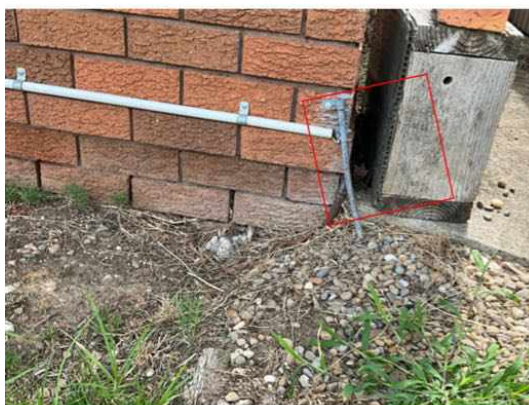
Finding 3.03

Building:	Main Building
Location:	Exterior walls - left side
Finding:	Air vents - Blocked or inadequate
Information:	It was noted at the time of inspection that the subfloor area lacks adequate ventilation. The cause of this inadequate ventilation is the state of the air vents to the subfloor

A well ventilated subfloor aids in maintaining dry conditions, preventing secondary damage such as wood rot and pest activity, as well as preventing the development of mould/fungi and mildew (which can lead to major respiratory issues or safety hazards for occupants, particularly the elderly, the very young and those with existing illnesses).

All air vents should be cleared of blockages to promote adequate air flow to the area. Where ventilation is still insufficient, retrospective installation of air vents may be required. Appointment of a licensed builder may be required to perform these works as necessary.

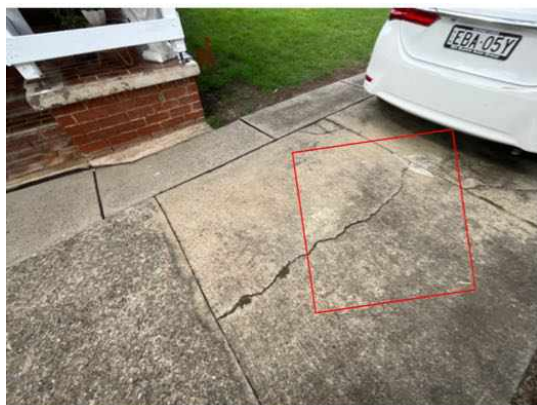
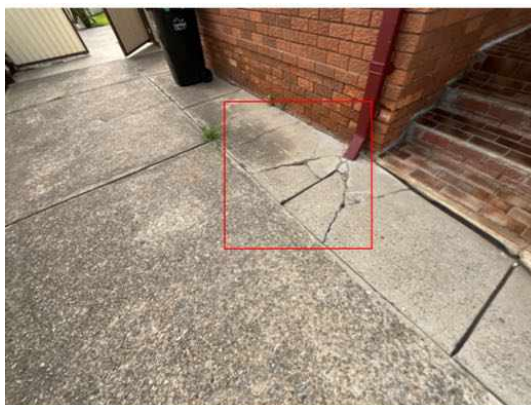
Finding 3.04

Building:	Main Building
Location:	Driveway
Finding:	Cracking - External Concrete Paving Damage Category 4 - Gaps in Slab (4mm - 10mm +)
Information:	Gaps in the slab were identified in external concrete paving. Gaps in the slab are significant and are likely to lead to the development of safety hazards and secondary defects if left unmanaged, such as the creation of a trip hazard.

General age and expected deterioration of the paved areas is a common cause of this type of cracking. However, expansion and contraction of the slab may also have occurred due to environmental factors. Such factors include variable moisture and weather conditions, the presence of trees and their roots having a settling or lifting affect on the soil, or the effect of load bearing, e.g. heavy vehicles over a sustained period of time.

Cracking to this degree may also be due to poor original installation of the concrete. Factors such as poor compaction of the sub surface and/or inadequate reinforcing of the slab may create cracking and other secondary defects. Gaps in the concrete paving may also have a more significant structural cause, such as subsidence of soils.

Where gaps in the concrete paving are adjacent to structural elements of the building, the advice of a Structural Engineer is advisable before undertaking repairs.

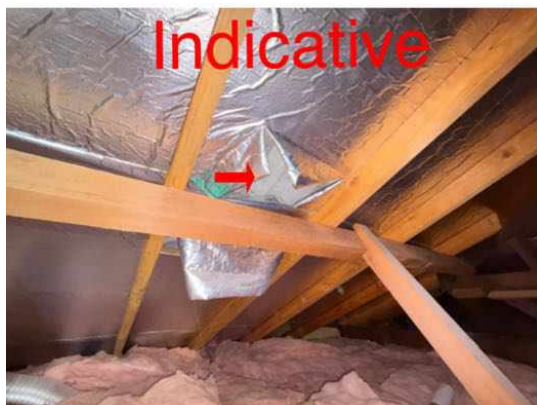
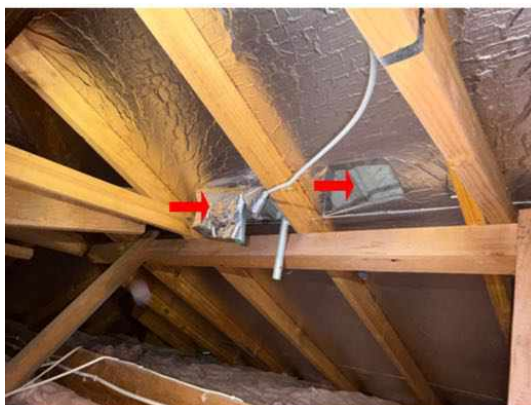
Finding 3.05

Building:	Main Building
Location:	Multiple areas
Finding:	Sarking - Damaged
Information:	Sarking, a laminated aluminium foil applied to the interior of the roof covering, assists in insulating the property and acting as a vapour-barrier to the roof void and, subsequently, to the household.

Where sarking is damaged, both insulation and moisture protection of the property are inhibited. This creates a loss of energy and thus negatively impacts the energy efficiency of the property, allowing potential for moisture ingress from condensation or leaking roof tiles.

It is important to repair any holes or damaged sections of sarking to ensure that the building material is fully functional. A registered builder or qualified carpenter should be consulted to provide further advice on this defect and to perform rectification works at client discretion.

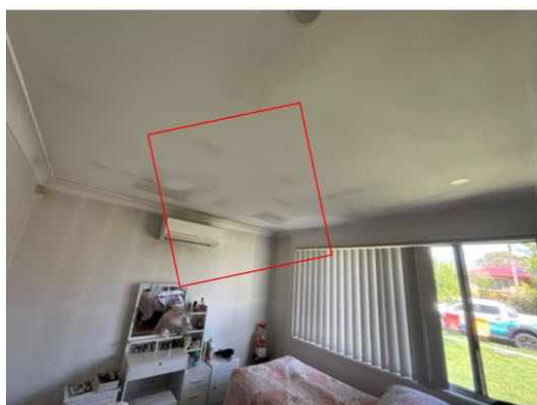
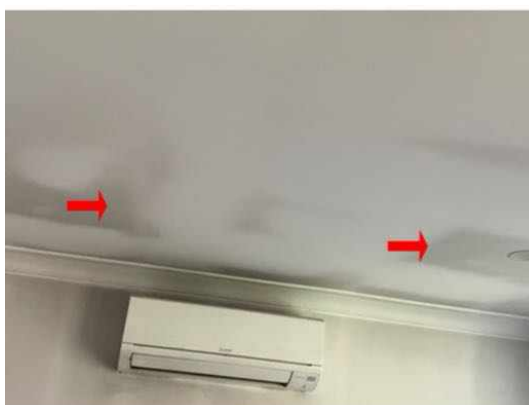
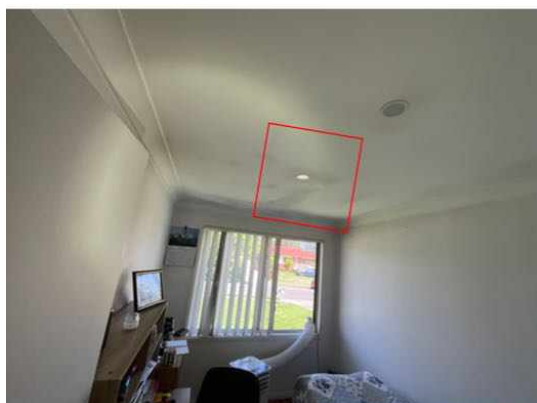
Finding 3.06

Building:	Main Building
Location:	Bedroom 2, 3
Finding:	Insulation - Inadequate
Information:	Cold refrigerant lines sweating in hot/ humid weather indicates inadequate or missing insulation above this area.

The level of insulation in the property does not meet current Australian Standards. Installation of adequate insulation is required and should be conducted as soon as possible.

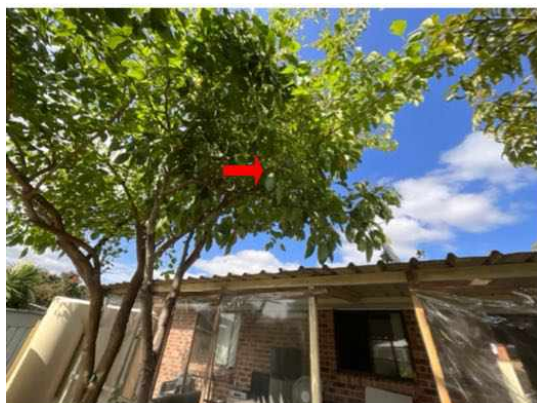
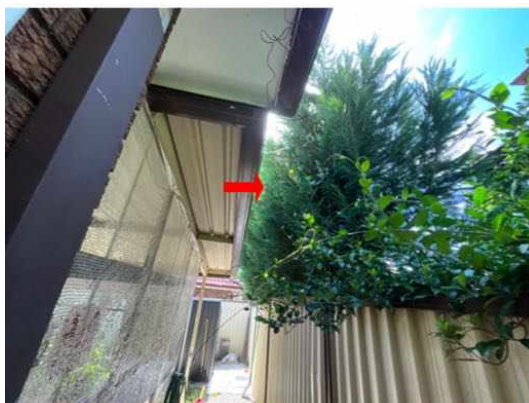
Finding 3.07

Building:	Main Building
Location:	Roof Exterior
Finding:	Trees - Overhanging and filling gutters
Information:	Overhanging trees often result in excessive amounts of leaf debris accumulating in gutters.

Gutters are a critical part of the building's management of storm water and rain. It is therefore important that they be kept clear to prevent secondary damage to associated building elements, including exterior and interior walls, ceiling linings and any adjoining building elements. Where gutters are blocked, pooling of rainwater is likely to occur, fast-tracking rust and corrosion of the roof plumbing elements.

It is highly advised that all overhanging tree branches be removed as soon as possible to prevent any further damage. Repair and/or replacement of sections of damaged guttering may also be required where the extent of the damage necessitates.

Such works should be performed by the homeowner; however, appointment of a landscape contractor or an arborist may be required. Consultation with a licensed roof plumber is required where guttering has been damaged.

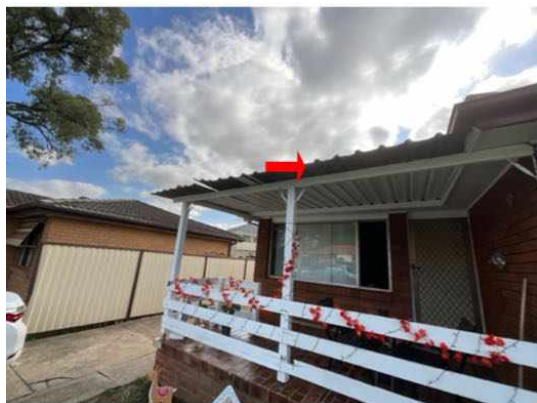
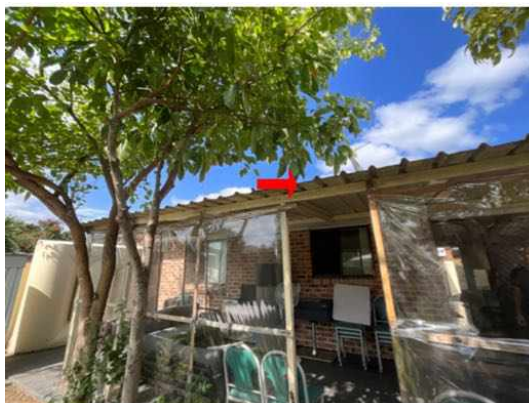
Finding 3.08

Building:	Main Building
Location:	Porch, alfresco
Finding:	Roof plumbing - Missing
Information:	Some sections of the roof are not adequately drained via gutters and downpipes. Gutters and downpipes that are not installed adequately are likely to result in excessively damp conditions against the exterior surfaces and around the base perimeter of the building.

Excessive moisture creates an environment which accelerates the deterioration of building elements in the area, as well as being conducive to termite and pest

infestation. Such an environment is likely to necessitate repair and/or replacement of building elements, which are prone to sustaining wood rot, rust or corrosion.

A roofing plumber should be appointed as soon as possible to install relevant roof plumbing materials. Depending on the extent of the damage, repair and/or replacement of damaged building elements may be required.

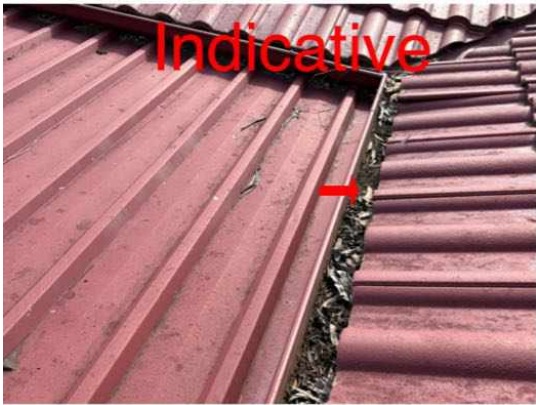
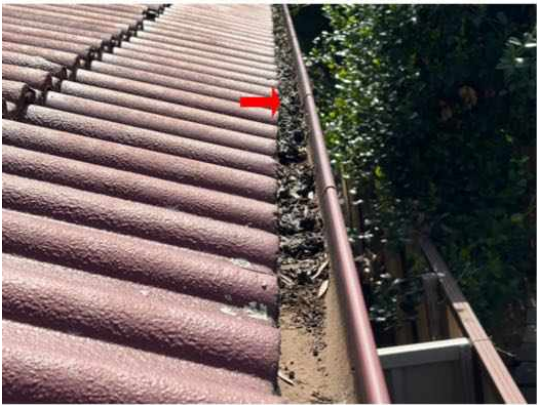
Blocked gutters are likely to lead to high levels of moisture in the affected areas. Such moisture will not only cause rust and decay of the associated building materials, but can also provide conditions that are conducive to termite and timber pest activity. Blockages in gutters should therefore be removed immediately to ensure dry conditions are maintained.

Consult a Licensed Plumber for further specific advice on remedial works that may be required. In the interim, it is highly advised that blocked gutters be removed by the homeowner or a general handyperson as a matter of urgency.

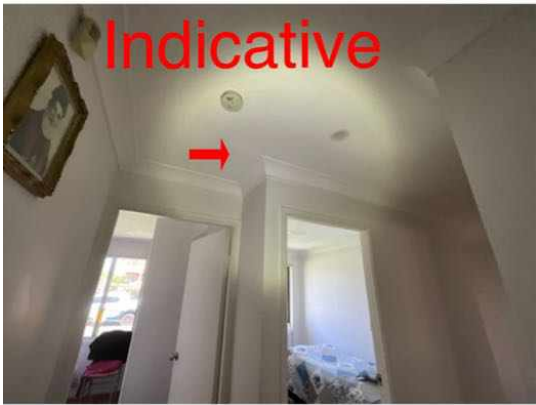
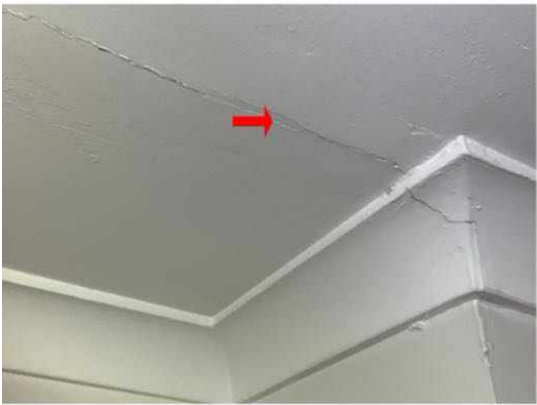
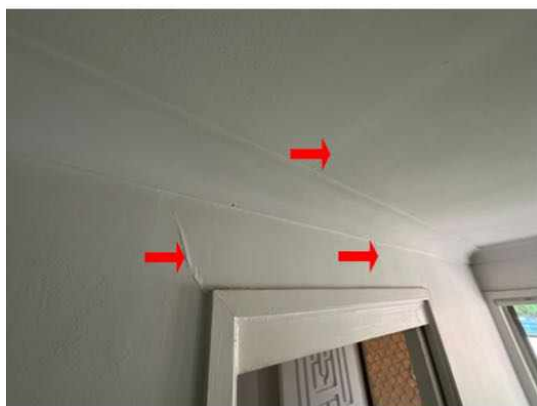
Finding 3.10

Building: Main Building
Location: Multiple areas
Finding: Cracking - Damage Category 1 - Fine (up to 1mm)
Information: Although fine cracks are quite noticeable, they are often only considered to be an appearance defect, and usually do not indicate any structural damage. Generally, the cause of a fine crack is indicative of a separation between building materials and finishes (e.g. paint, plaster, etc.) along joins.

Cracking of this nature can generally be repaired with minor sanding, filling and/or repainting. Such works should be performed by a qualified painter or a general handyman.

Monitoring of all cracking should be conducted frequently. Always contact a building inspector should cracks widen, lengthen, or become more numerous.

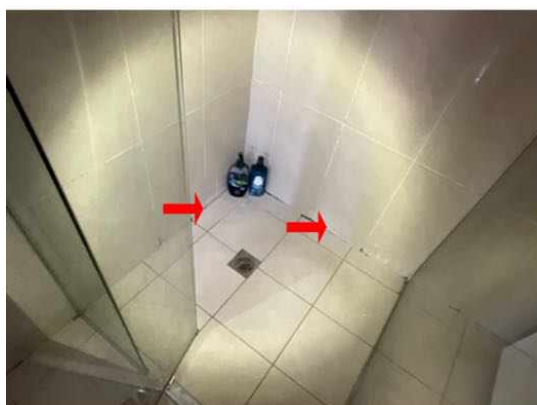
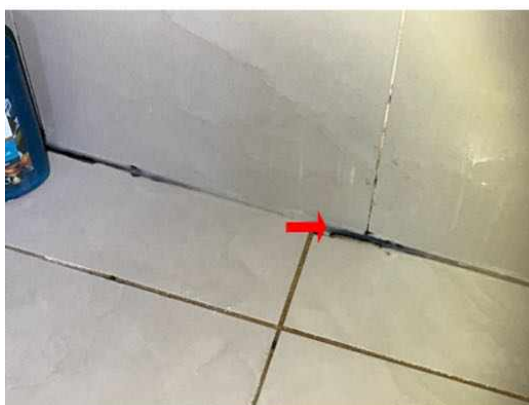
Finding 3.11

Building: Main Building
 Location: All Wet Areas
 Finding: Sealant and grouting - Missing or damaged
 Information:

It was noted on inspection that sealant or grout is degraded to this area.

Different materials and floor areas move at different rates, generally causing cracking to grout or sealant at this point. A flexible sealant is required to allow for expected expansion and contraction, while keeping the joint water tight and protective of all associated building materials.

Flexible and mould resistant materials should be applied to affected areas to prevent any subsequent water damage that is likely to occur. Regular maintenance and replacement of damage or missing or damaged sealant and grout is highly recommended to the wet areas, as this is a regular wear and tear defect. Sealant and grouting in areas that come into regular contact with water should be maintained for the long term care of your property.

A sealant specialist should be appointed to complete these works as soon as possible.

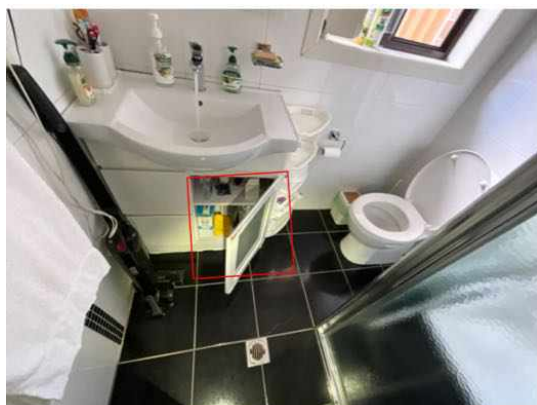
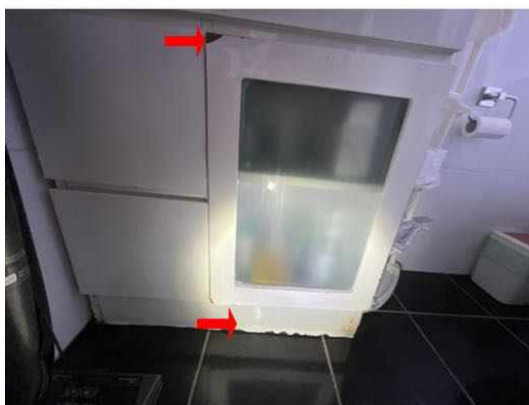
Finding 3.12

Building:	Main Building
Location:	Granny flat bathroom
Finding:	Cupboard/vanity - Swollen/Water Damaged
Information:	Water damage was identified inside the vanity/cupboards in this area and it was also found to be swollen. Water damaged/swollen building elements generally indicate that the building materials have been affected by excessive moisture over a prolonged period of time, and have swollen as a result. A licensed plumber should be engaged to assess where the moisture is coming from and carry out any rectification as soon as possible. Replacement of the vanity/cupboards is also advised by a licensed cabinetmaker.

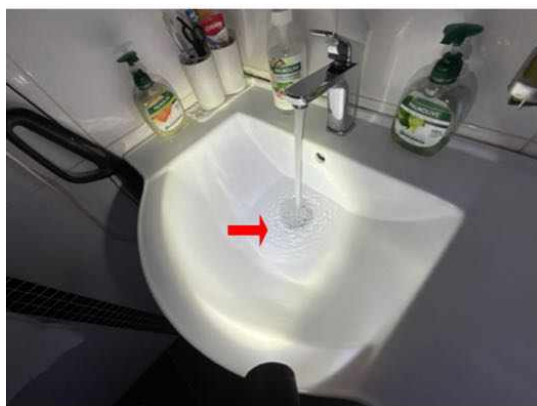
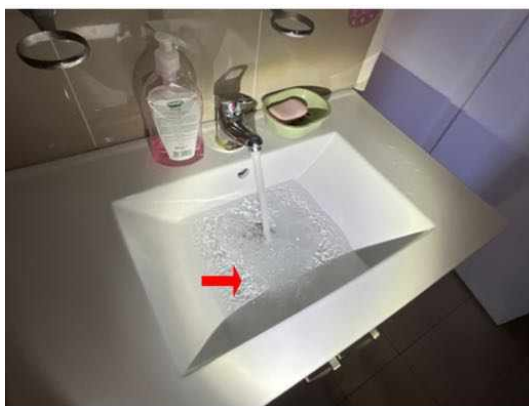
Finding 3.13

Building:	Main Building
Location:	Both bathrooms
Finding:	Sink/basin - slow draining
Information:

The sink/basin drain appeared to be partially blocked at the time of inspection. Blockages here are usually caused by hair and other debris. If left unmanaged, a lack of general maintenance may lead to the development of more significant defects, such as water damage to surrounding building materials.

A licensed plumber should be appointed to remove the blockage at the client discretion.

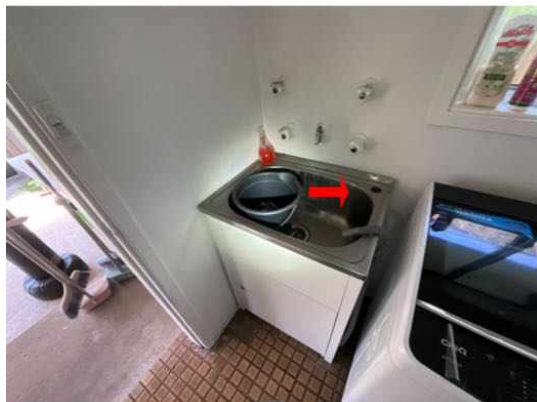
Finding 3.14

Building: Main Building
 Location: Laundry
 Finding: Fitting or fixture - Loose sink
 Information:

The laundry sink in this area is loose and can be moved with minimal force applied by hand. The sink should be fixed firmly to the wall and/or floor.

If left unmanaged, the sink may move and cause damage to pipes, fitting and finishes.

A licensed plumber should be appointed to perform these rectification works.

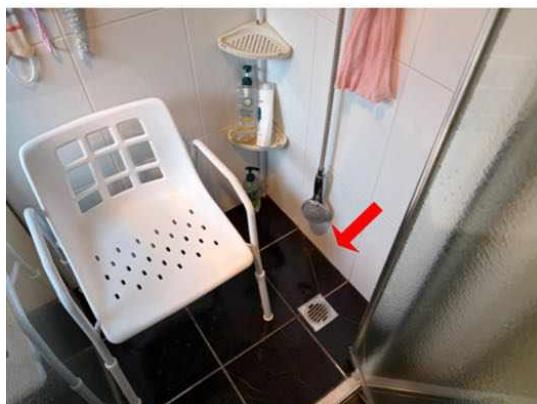
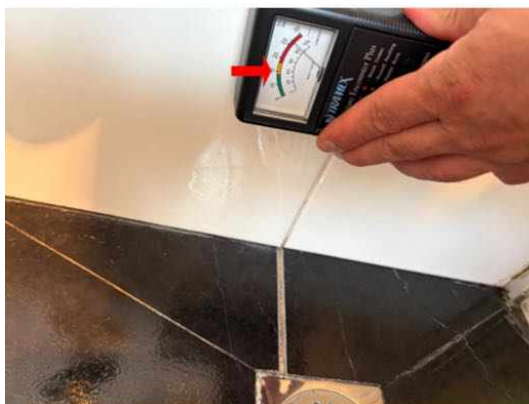
Building:	Main Building
Location:	Granny flat bathroom
Finding:	Shower damp - Monitor
Information:	Damp is evident to the lower 400mm of wall to the shower alcove. There is no high reading around the taps nor are there high readings transferring to the other side of the wall. Sealant appears to have been repaired recently and both sealant and grout appear in acceptable condition at present.

This defect is quite common, and is suspected to have been caused by moisture permeating or leaching through the grouting and perhaps gaps in the sealant prior to repair.

Monitoring the area is advised and if any visual signs of excessive moisture appear (peeling paint, mould) then consultation with a qualified plumber or bathroom specialist would be advised to identify the cause of damp and to perform remedial works as

required.

Always ensure that sealant and grout is in good condition to prevent any moisture issues occurring in the future.

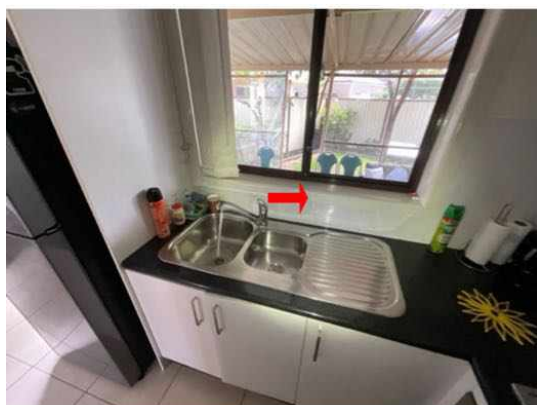
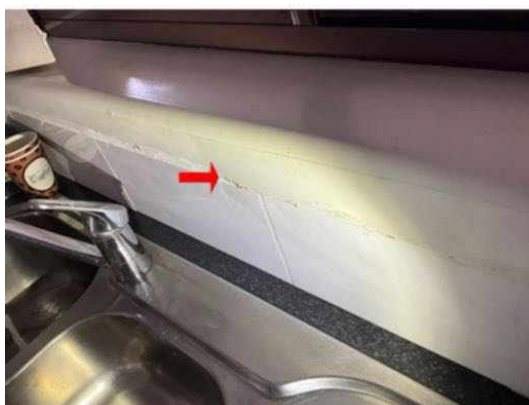
Finding 3.17

Building:	Main Building
Location:	Granny flat kitchen
Finding:	Building element - Swollen
Information:	Swollen building elements generally indicate that the building materials have been affected by excessive moisture over a prolonged period of time, and have swollen as a result. Excessive moisture is likely to lead to the development of secondary damage to any associated building elements, which may necessitate major repair works if prolonged.

Repair and/or replacement of swollen building elements should be conducted by a general handyman.

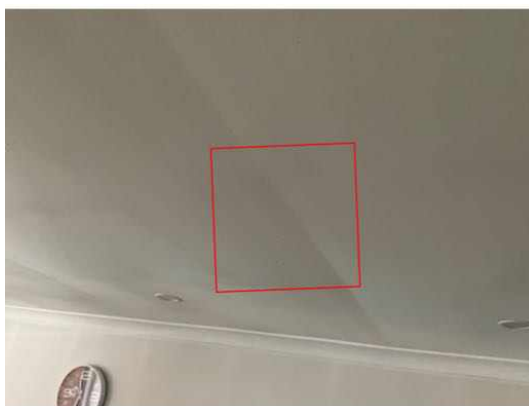
Finding 3.18

Building:	Main Building
Location:	Loungeroom

Finding: Ceiling - Sagging
Information: Sections of the ceiling were found to be sagging at the time of inspection. Sagging to the fixed ceiling structure generally indicates that the building materials have swollen, due to contact with water, or that fixings (e.g. nails or glue) have become loose and require reattachment.

Where minor sagging is evident, comparatively minor works, such as re-gluing of ceiling sheets, may be required. Such works may be performed by relevant tradespeople, such as plasterers and painters. Where excessive moisture has caused the roofing structure to swell and sag, the source of the water leak should primarily be identified prior to any remedial works being performed.

The appropriate action should be taken by the client as soon as possible to ensure that any potential further damage is limited.

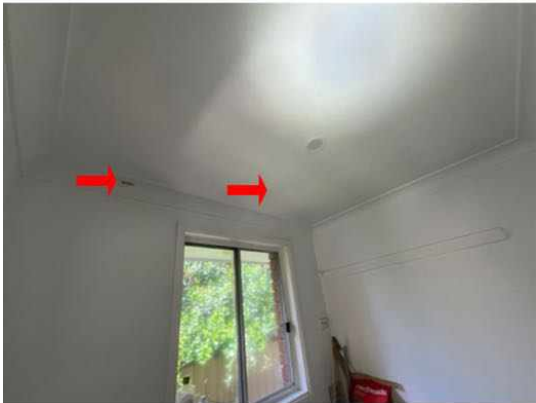
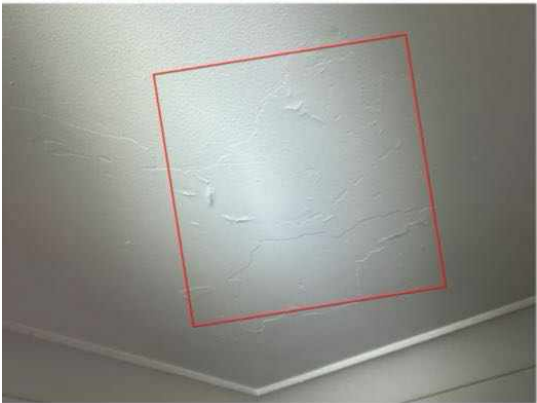
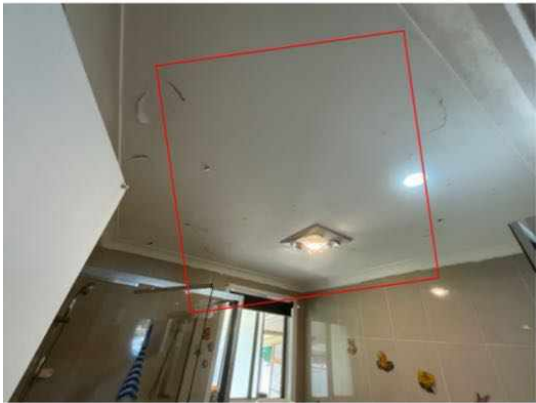
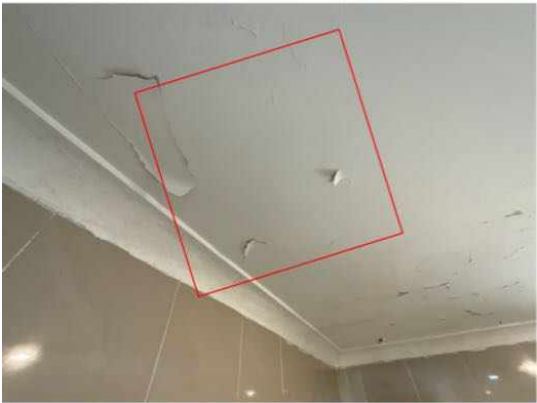
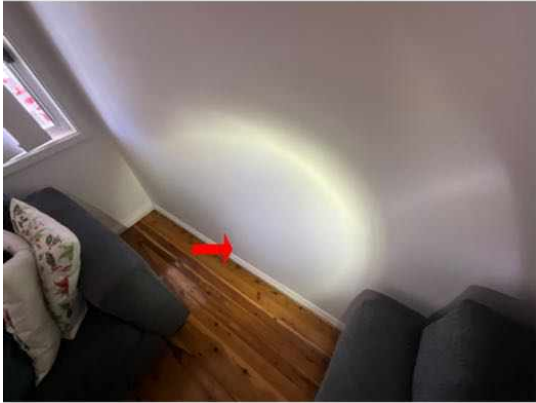
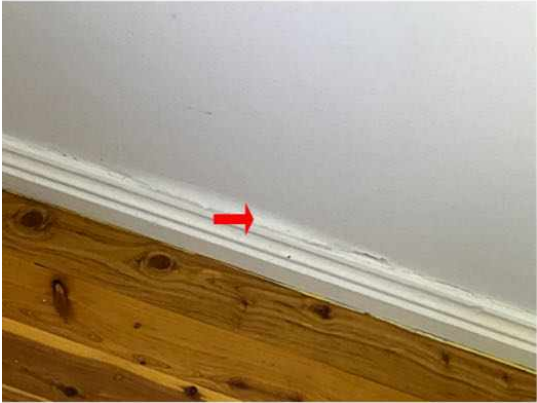
Finding 3.19

Building: Main Building
Location: Multiple areas
Finding: Paint cracking and peeling
Information: Cracking and ultimately flaking of paint can occur for a variety of reasons. Often these failures are due to the fact that the paint has inadequate adhesion and flexibility, both common problems with lower quality exterior flat paints.

When timber is involved, moisture intrusion results in swelling of the wood surface followed by contraction as the wood dries. The expansion and contraction cycles, can result in cracking and subsequent paint failure by flaking and peeling.

Cracking and flaking can also result when paint is applied too thinly due to overspreading (higher-than-recommended spread rate) or excessive thinning. These practices tend to diminish the paint's final film thickness, so that it is more vulnerable to cracking and flaking.

Inadequate surface preparation can also cause these failures, especially when paint is applied to bare wood or a very porous surface without first applying a primer.

A qualified painter should be appointed to rectify the problem.

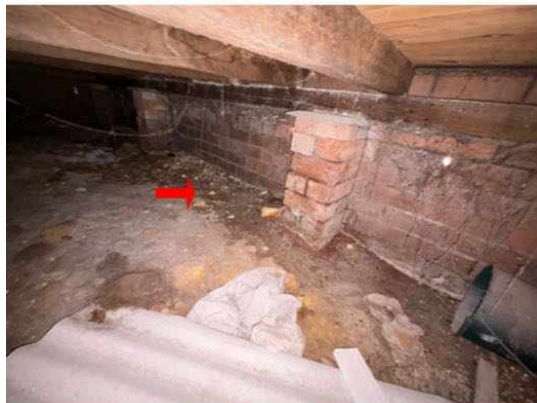
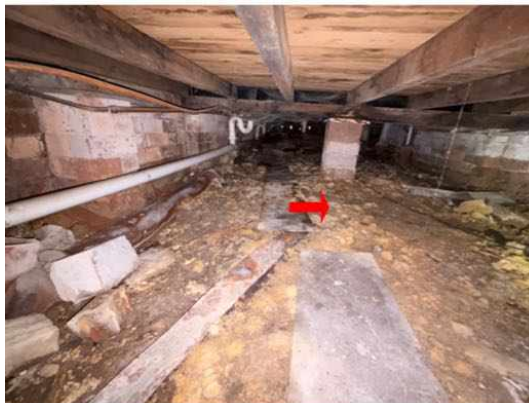
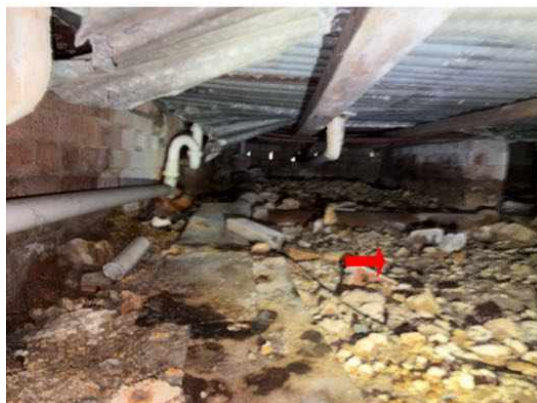
Building:	Main Building
Location:	Subfloor
Finding:	Subfloor - Dampness
Information:	Dampness to several sections of the subfloor area was identified. It is suspected that this dampness may be exacerbated by poor site drainage and inadequate subfloor ventilation however may also be due to leaking pipes. Dampness in this area is likely

to lead to wood decay and general deterioration of structures within the subfloor space. Excessive moisture also creates an environment which is conducive to termite and pest infestation. A licensed plumber should be engaged immediately to assess where the moisture is coming from and rectify this as a matter of urgency to ensure a dry sub floor.

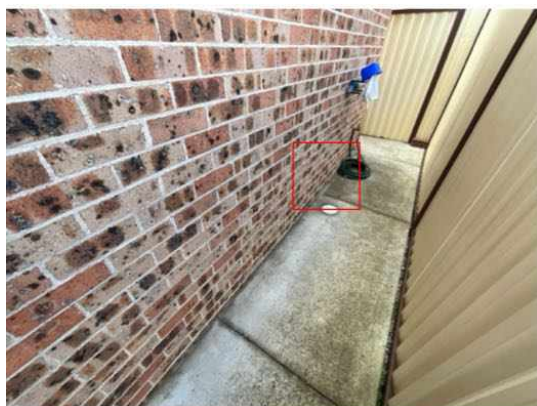
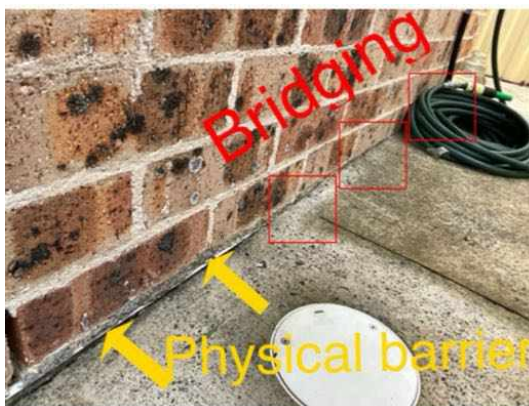
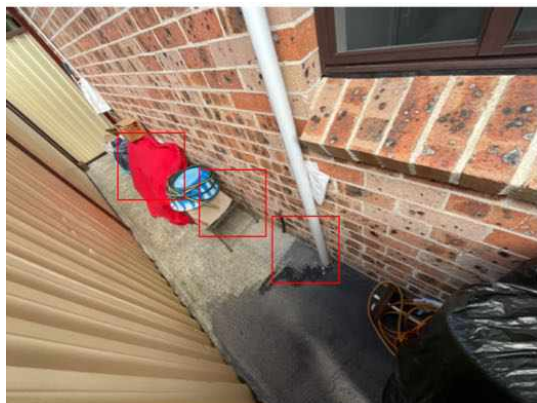
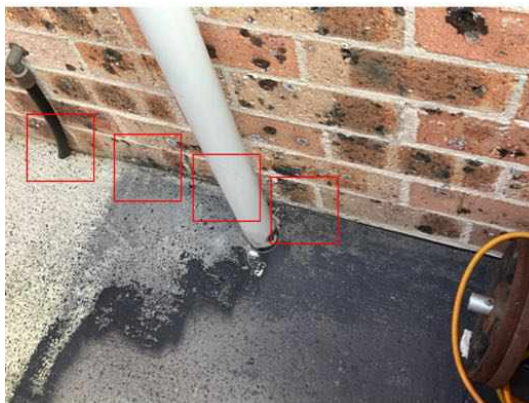
Finding 6.02

Building:	Main Building
Location:	Granny flat
Finding:	Bridging of termite barrier
Information:	Bridging of termite barriers occurs when termites bridge (usually by building a mud tunnel) a termite barrier or inspection zone or where termites have a passage allowing them to bridge the barrier.

Generally this takes the form of finished ground levels external paving or concrete being retrospectively installed above the damp course level the adjacent internal floor level or weep and ventilation holes.

Where bridging has occurred full inspection is prevented and termites may enter a property in a concealed or undetectable manner.

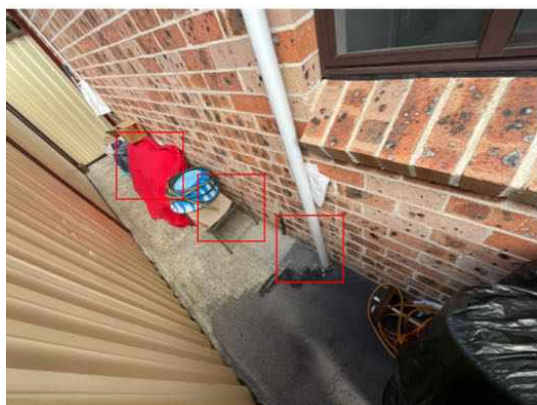
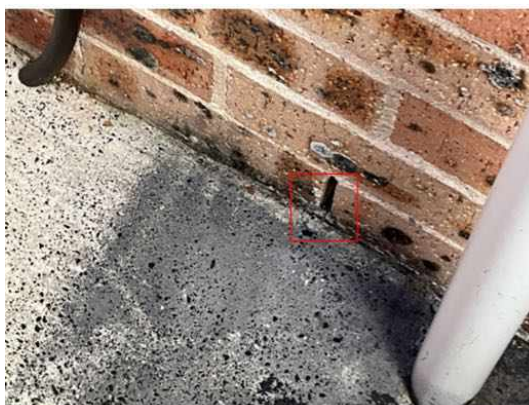
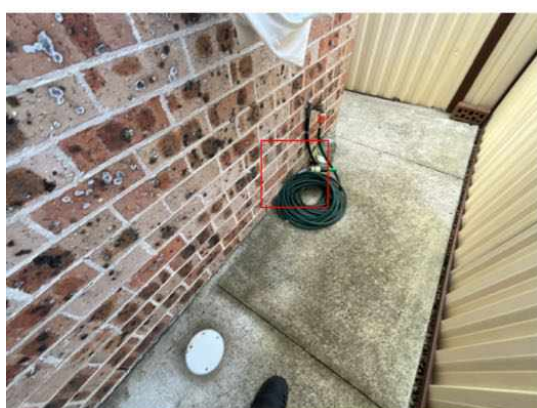
Finding 6.03

Building:	Main Building
Location:	Granny flat
Finding:	Bridging or breaching of termite barriers - weep holes
Information:	Bridging is the spanning of a termite barrier or inspection zone so that subterranean termites are provided with passage over or around that barrier.

Weep holes in the exterior brickwork of the property are designed to allow condensation that may build up between the brickwork and subsequent timber framework to drain from within the wall hence preventing any deterioration of the timber building elements.

Additionally build-up of moisture is likely to occur if weep holes are covered further attracting termite activity to these areas.

It is highly recommended that weep holes are left exposed in all areas throughout the

external property. Therefore if any termite activity leading into weep holes becomes easily detectable during frequent pest inspections.

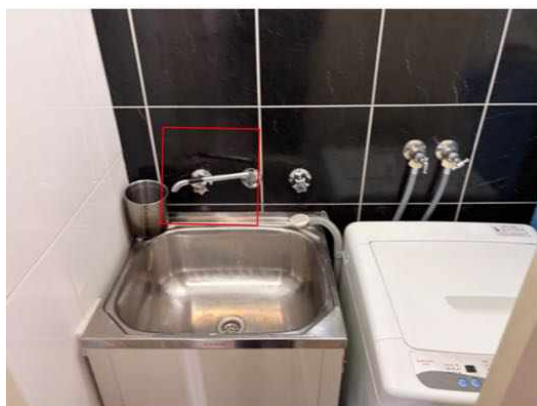
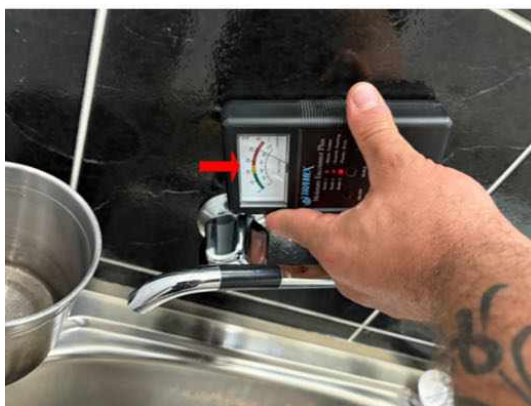
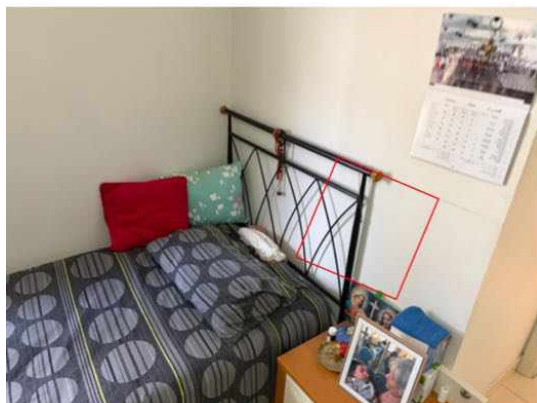
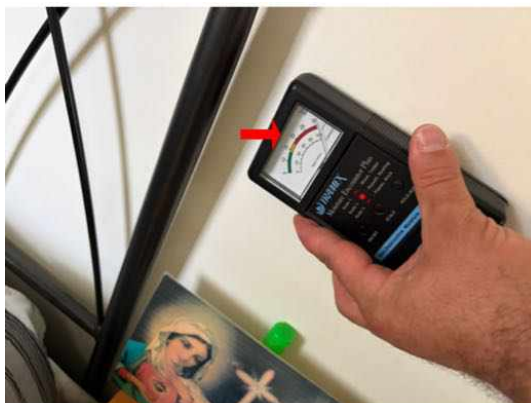
Finding 6.04

Building:	Main Building
Location:	Granny flat laundry
Finding:	Evidence of excessive moisture was present at the time of inspection
Information:	Excessive moisture can attract termites and produce conditions that promote termite attack, fungal growth and wood decay. Excessive moisture is generally caused by deteriorated, inadequate or missing roof drainage, leaking plumbing pipes or fixtures, poorly plumbed HWS overflows or condenser units and poor site drainage. It is highly recommended that all plumbing and drainage fixtures and fittings be maintained regularly in order to prevent excessive moisture being present in the external / internal property.

A licensed plumber must be appointed urgently for assessment and any required repairs.

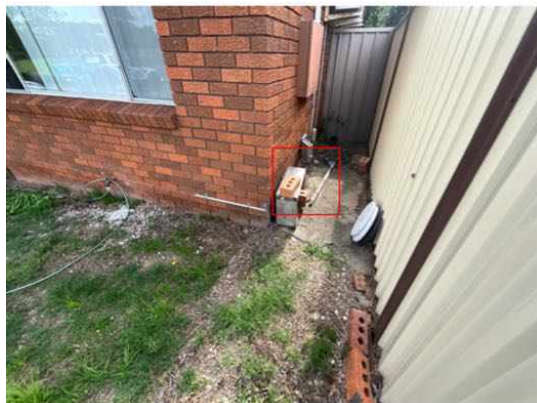
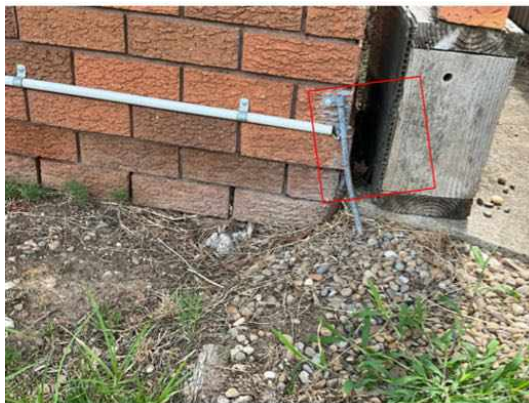
Building: Main Building
 Location: Exterior walls - left side
 Finding: Air vents - Blocked or inadequate
 Information: It was noted at the time of inspection that the subfloor area lacks adequate ventilation. The cause of this inadequate ventilation is the state of the air vents to the subfloor area. Where air vents are insufficient in number or are blocked, either fully or partially, subfloor ventilation is decreased.

A well ventilated subfloor aids in maintaining dry conditions, preventing secondary damage such as wood rot and pest activity, as well as preventing the development of mould/fungi and mildew (which can lead to major respiratory issues or safety hazards for occupants, particularly the elderly, the very young and those with existing illnesses).

All air vents should be cleared of blockages to promote adequate air flow to the area. Where ventilation is still insufficient, retrospective installation of air vents may be required. Appointment of a licensed builder may be required to perform these works as necessary.
