Building and Timber Pest Inspection Report

Inspection Date: Fri, 30 Jan 2026

Property Address: 38 & 38A Glenfern Cres, Bossley Park NSW
2176, Australia

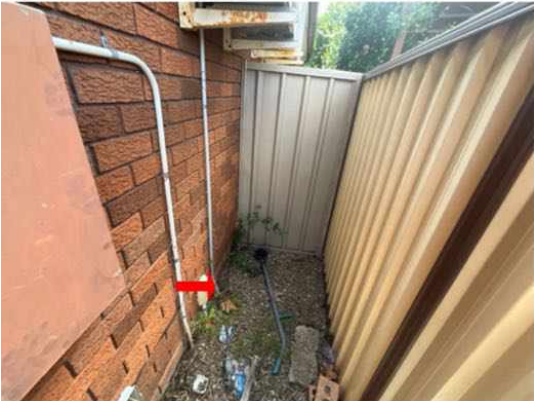
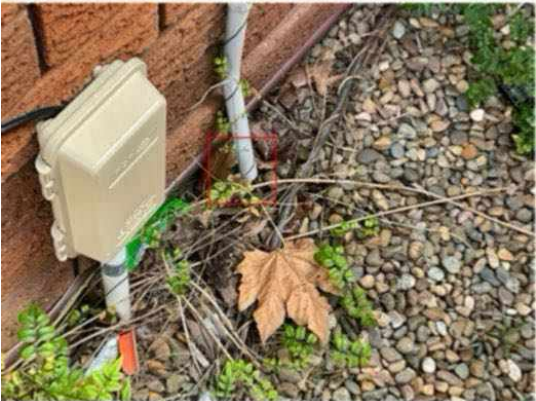
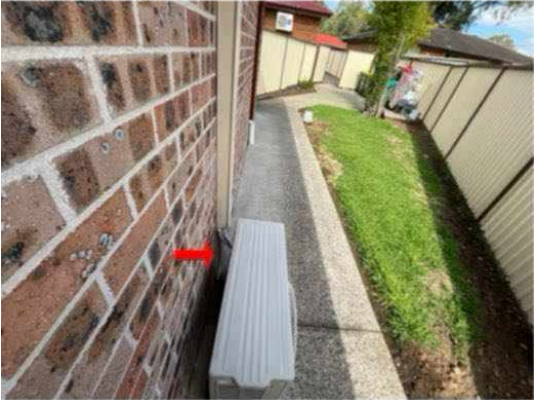
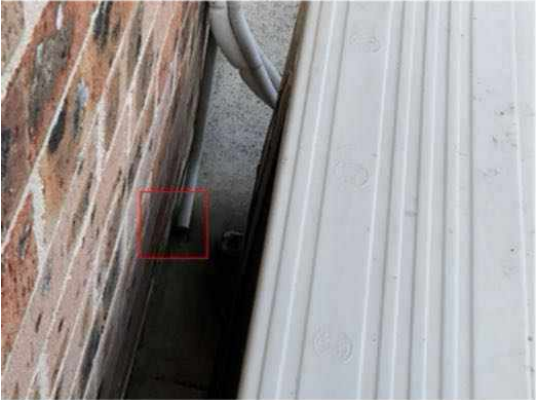
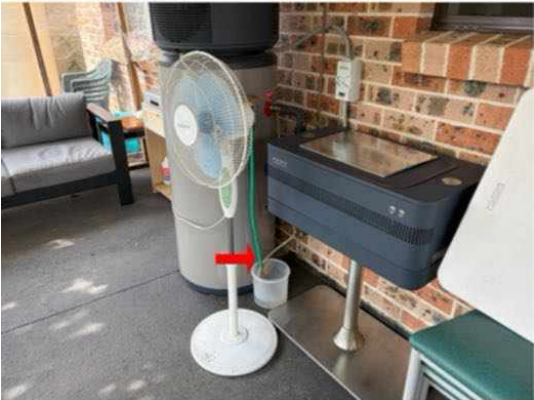
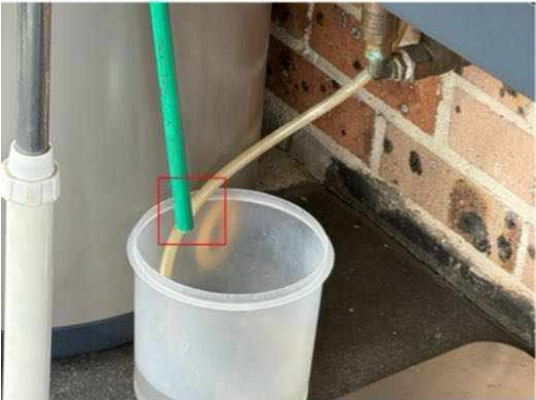
These damp conditions can lead to secondary defects such as rot, rust or corrosion of associated building elements, the formation of fungal decay, or even the creation of potential slip hazards. When coupled with poor site drainage, pooling of water may also attract termite activity to this area.

It is highly recommended that a licensed plumber be appointed to install adequate drainage to the overflow. These works will ensure that the area remains dry and free of any secondary defects.

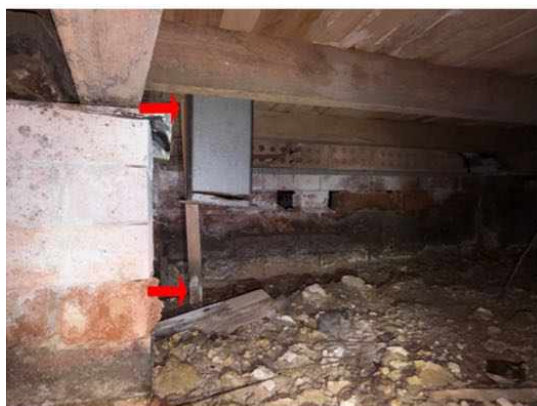
Finding 6.08

Building:	Main Building
Location:	Subfloor
Finding:	Bridging of termite barrier
Information:	Bridging of termite barriers occurs when termites bridge (usually by building a mud tunnel) a termite barrier or inspection zone or where termites have a passage allowing them to bridge the barrier.

Generally this takes the form of finished ground levels external paving or concrete being retrospectively installed above the damp course level the adjacent internal floor level or weep and ventilation holes.

Where bridging has occurred full inspection is prevented and termites may enter a property in a concealed or undetectable manner.

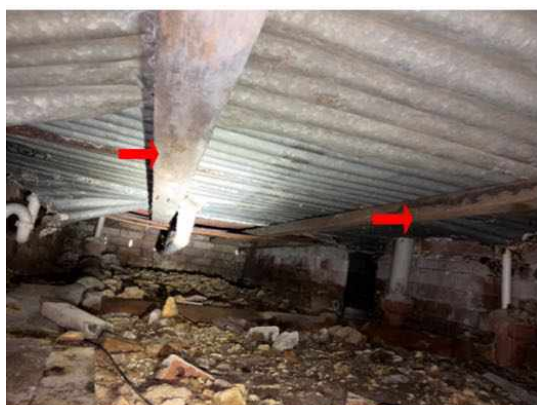
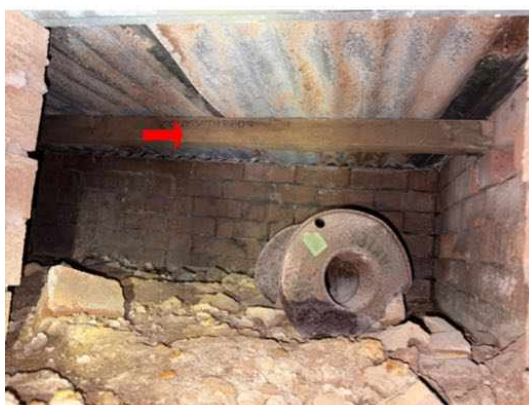
Finding 6.09

Building:	Main Building
Location:	Bathroom, porch
Finding:	Formwork timbers - left in situ
Information:	Formwork timber appears to have been left on site and in situ after concrete construction. Formwork timber is used to support and shape the concrete while pouring during the construction process. Leaving formwork timbers in the subfloor space or around the exterior of the property increases the risk of termite activity being present. As they are likely to come into contact with weather conditions or excessive moisture wood rot is likely to develop on timbers that are not treated. It is highly recommended that any formwork timbers be immediately removed from areas in which they may attract any termite/timber pest attack. Minimisation of risk/prevention of termite attack is far more adequate than dealing with the presence of termite activity.

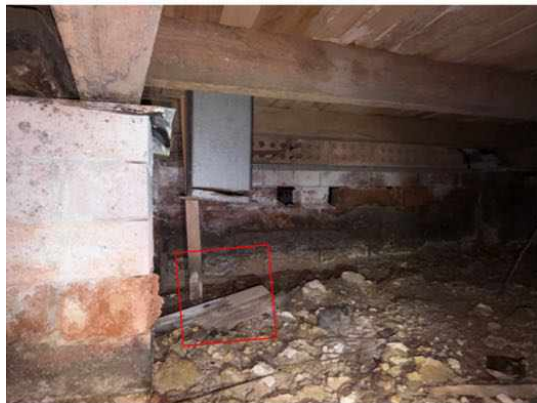
Finding 6.10

Building:	Main Building
Location:	Subfloor
Finding:	Stored timbers - subfloor space or external area
Information:	The storing of timbers in the subfloor space or around the external property increases the risk of termite activity being present. As they are likely to come into contact with

weather conditions or excessive moisture wood rot is likely to develop on timbers that are not treated.

It is highly recommended that any stored timbers be immediately removed from areas in which they may attract any termite / timber pest attack. Minimisation of risk / prevention of termite attack is far more adequate than dealing with the presence of termite activity.

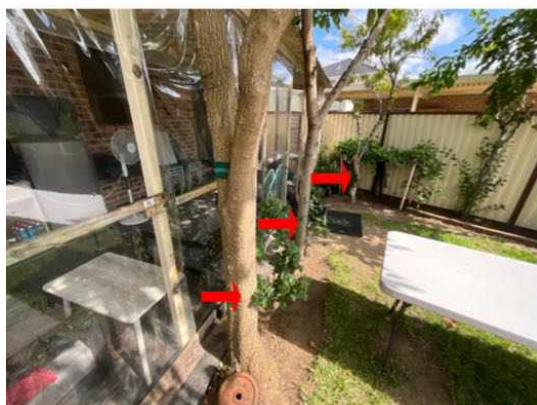
Finding 6.11

Building:	Main Building
Location:	Vegetation
Finding:	Vegetation - Abutting property
Information:	Vegetation against external wall may have an invasive root system. If there are weak points in the brick work or concrete slab, it is possible for the roots to gain entry into these areas. Once the roots have gained entry, it is possible for termites to gain concealed entry via these roots. It is recommended to remove the vegetation and root system where possible.

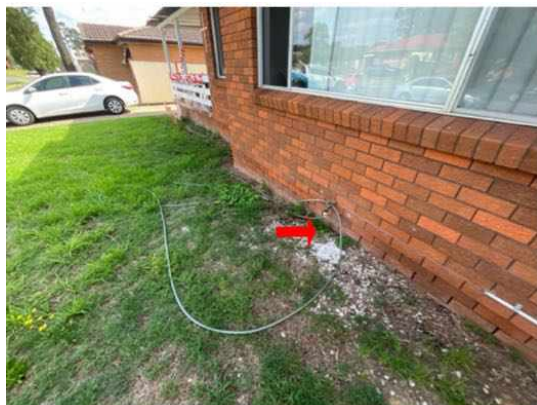
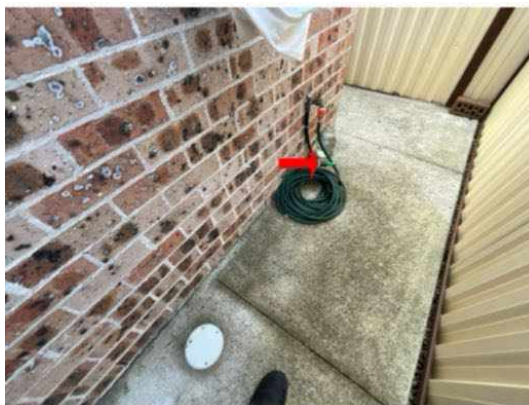
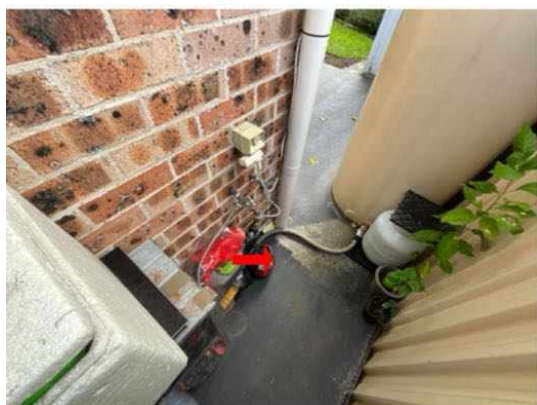
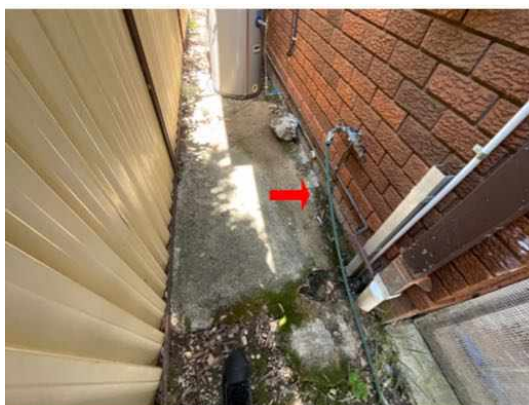
Finding 6.12

Building:	Main Building
Location:	External tap

Finding: Tap - No drain
 Information: The external tap in this area was noted to have no drain at the time of inspection.

This keeps the surrounding surfaces damp while using the tap, which becomes conducive to termite activity.

A licensed plumber must be appointed to ensure an appropriate drain is installed.

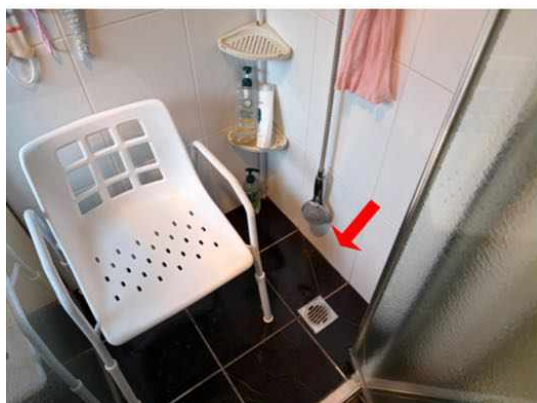
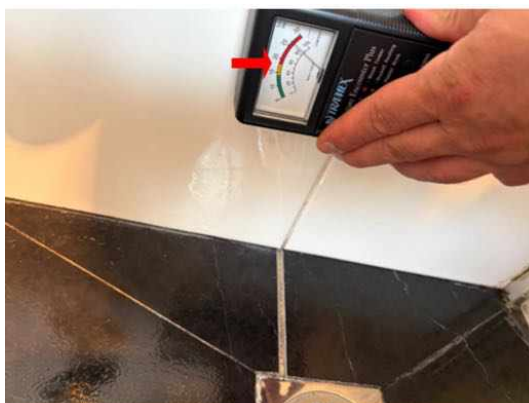
Finding 6.13

Building: Main Building
 Location: Granny flat bathroom
 Finding: Shower damp - Monitor
 Information: Damp is evident to the lower 400mm of wall to the shower alcove. There is no high reading around the taps nor are there high readings transferring to the other side of the wall. Sealant appears to have been repaired recently and both sealant and grout appear in acceptable condition at present.

This defect is quite common, and is suspected to have been caused by moisture permeating or leaching through the grouting and perhaps gaps in the sealant prior to repair.

Monitoring the area is advised and if any visual signs of excessive moisture appear (peeling paint, mould) then consultation with a qualified plumber or bathroom specialist would be advised to identify the cause of damp and to perform remedial works as required.

Always ensure that sealant and grout is in good condition to prevent any moisture issues occurring in the future.

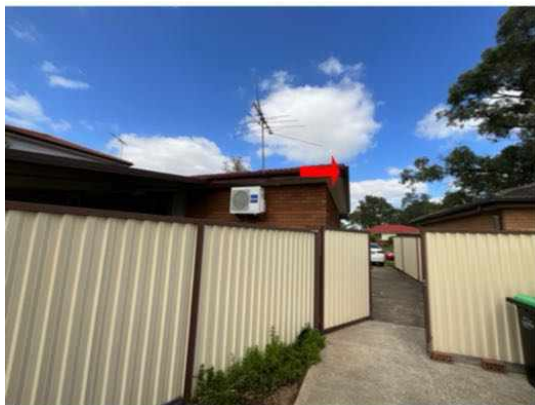
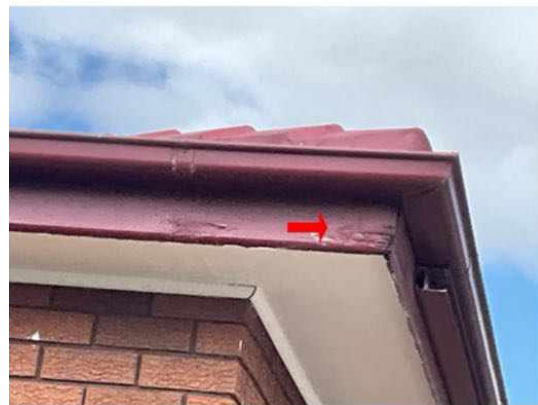
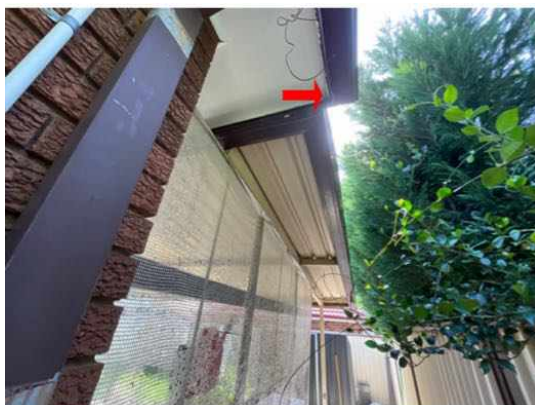
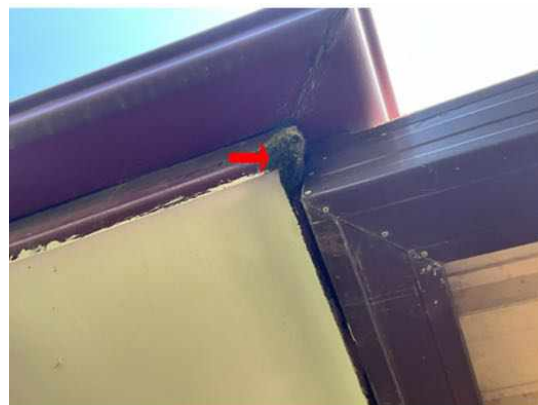
Building:	Main Building
Location:	Fascias
Finding:	Fascias - Wood rot/decay
Information:	Wood rot was found to be affecting fascias and barges in this area, evidenced by the presence of mould on the surface in some areas. Wood rot, also known as Fungal Decay, occurs when timbers and other cellulose building materials are exposed to damp conditions on an ongoing basis.

It is likely that this wood rot has developed as a result of faults in the roof plumbing, creating excessive moisture in this areas. Otherwise frequent exposure to rain and other weather conditions also make fascias and barges susceptible to accelerated deterioration.

It is advised that a roof plumber be appointed to inspect all roof plumbing and subsequently identify the cause of the wood rot. Replacement of affected fascias and

barges may then be a necessary step in protecting surrounding building elements from such deterioration.

A licensed plumber may be appointed to assess the cause of excessive moisture and to provide advice on any remedial works as required. A licensed carpenter may also be required to replace affected building materials.

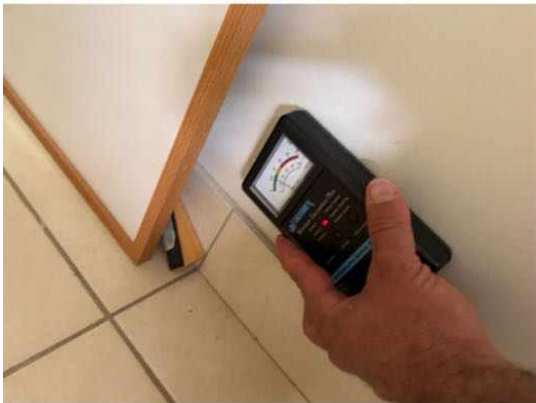
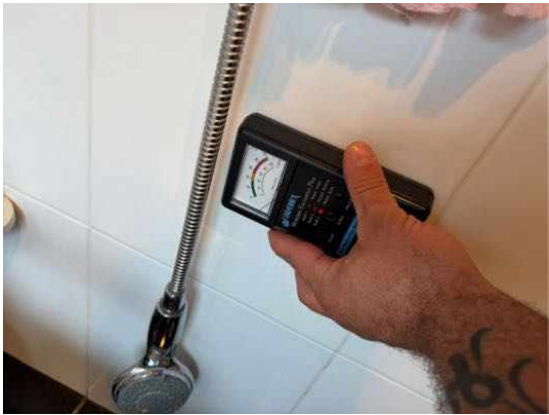
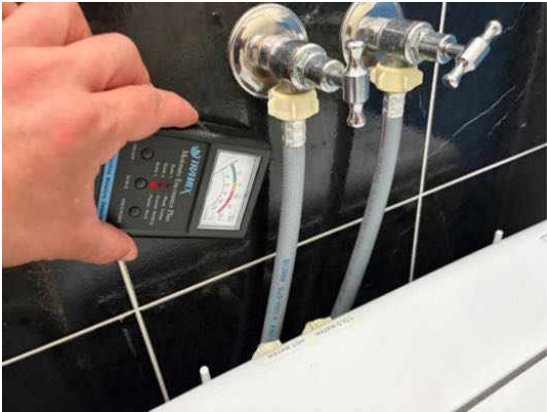
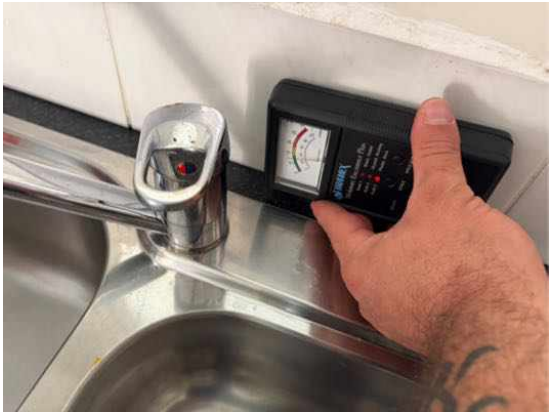
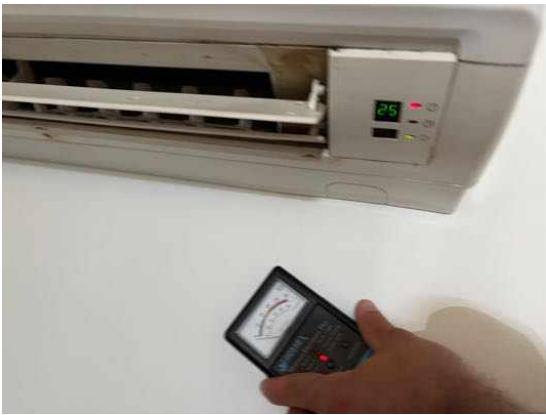
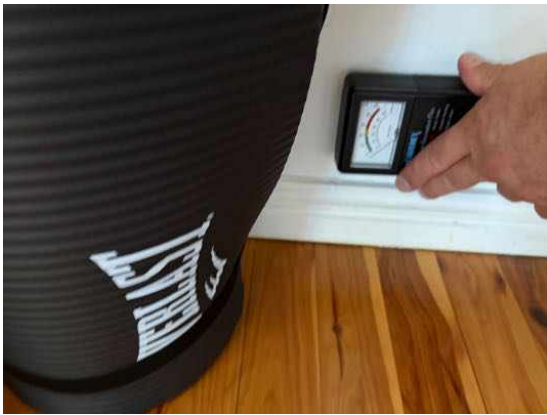
Building: Main Building
Location: All Areas
Finding: Moisture metre
Information: During the inspection the property was checked for moisture using a moisture metre.

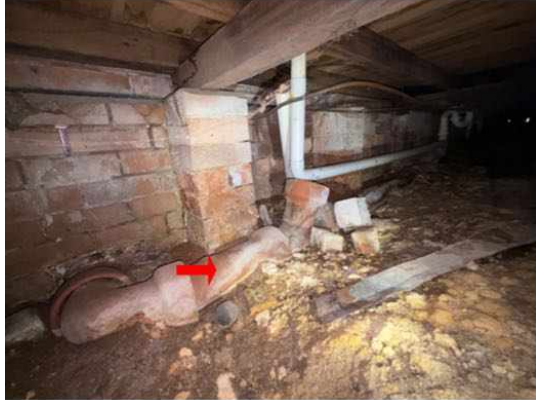
Building: Main Building
 Location:
 Finding: Pipework - Old urban wear pipes
 Information: Old urban wear pipes were identified at the time of inspection.

Consultation with a licensed plumber is advised. CCTV inspection on pipes may be required.

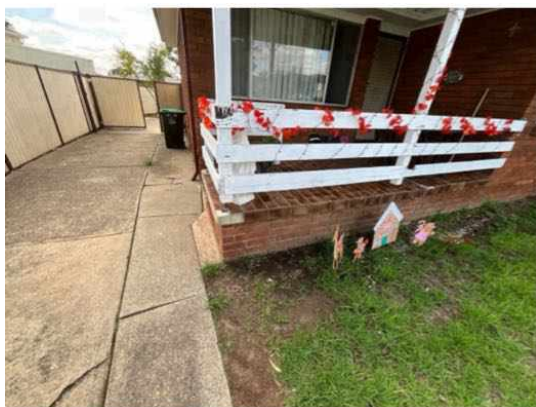
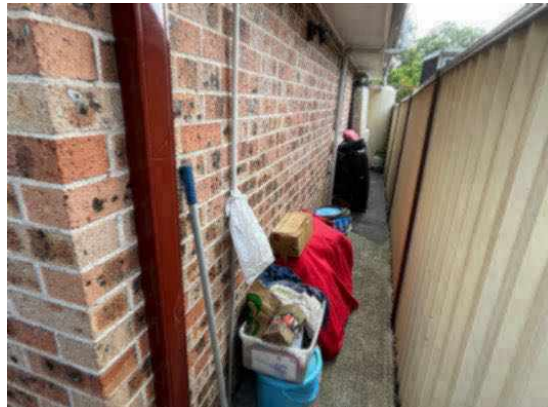
Building: Main Building
 Location: All Areas
 Finding: Additional Photos - Obstructions and Limitations
 Information:

These photographs are an indication of the obstructions and limitations which impeded full inspection of the property at the time of inspection. These obstructions can hide an array of defects and should be removed to allow full inspection to be carried out. A re-inspection is recommended once the areas are made accessible.

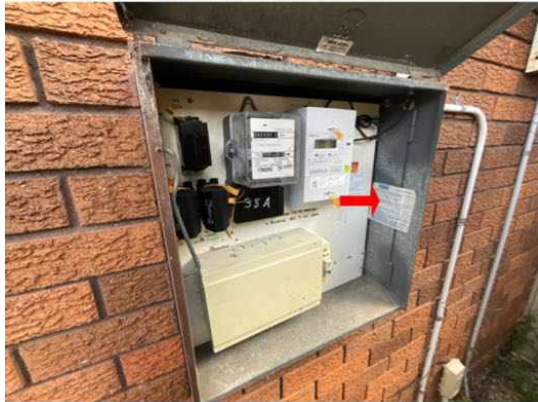
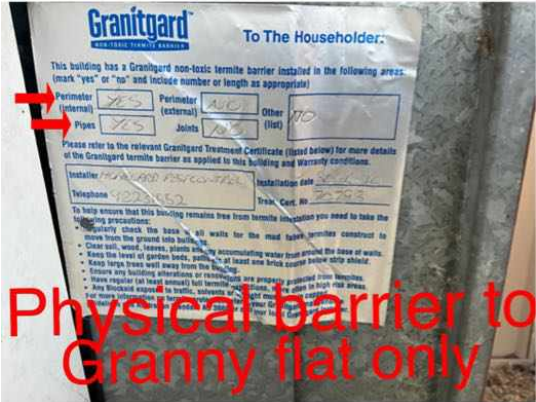
The following items were noted as - Evidence of a previous termite management program

Where a Termite Management System has been identified you should refer to the type of barrier date of installation warranty conditions and any documentation provided by a builder or past owner. Consult the company who installed the barrier to confirm whether the system is still under warranty.

Most chemical termite management systems expire and require replenishment and all physical systems are primarily designed to prevent concealed entry.
