Building and Timber Pest Inspection Report

Inspection Date: Wed, 4 Mar 2026

Property Address: 13/13 Churchill Ave, Chadstone VIC 3148,
Australia

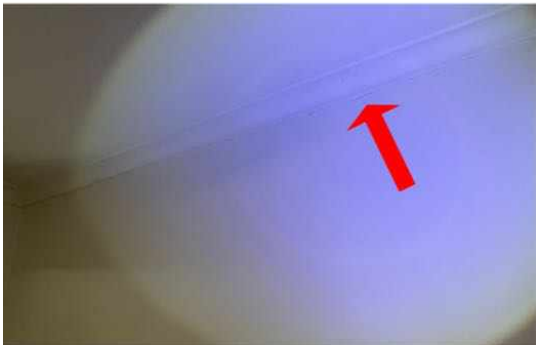
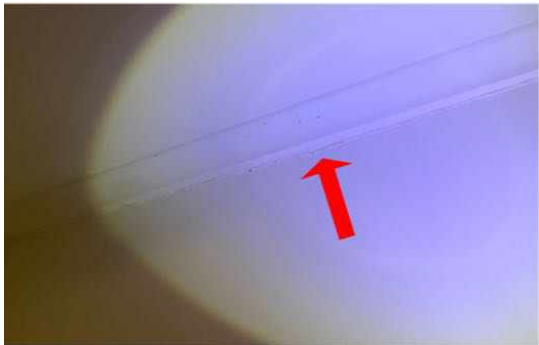
Finding: Cracking - fine

Information: Some fine cracking was noted throughout the property.

Although fine cracks are quite noticeable, they are often only considered to be an appearance defect, and usually do not indicate any structural damage. Generally, the cause of a fine crack is indicative of a separation between building materials and finishes (e.g. paint, plaster, etc.) along joins.

Cracking of this nature can generally be repaired with minor sanding, filling and/or repainting. Such works should be performed by a qualified painter or a general handyman.

Monitoring of all cracking should be conducted frequently. Always contact a building inspector should cracks widen, lengthen, or become more numerous.

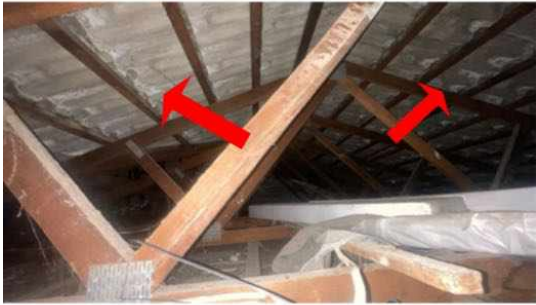
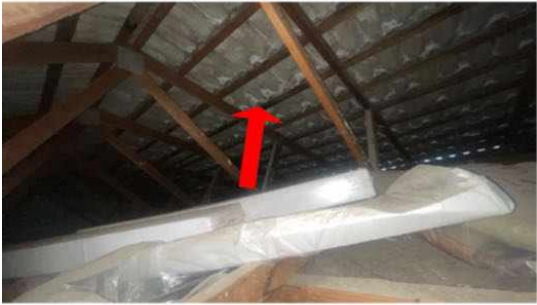
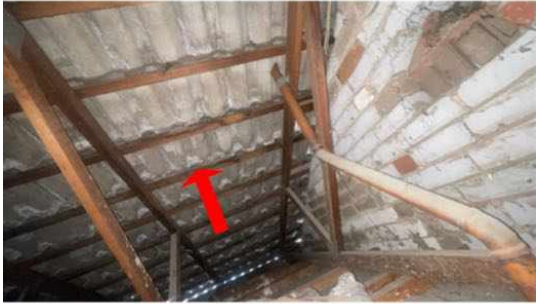
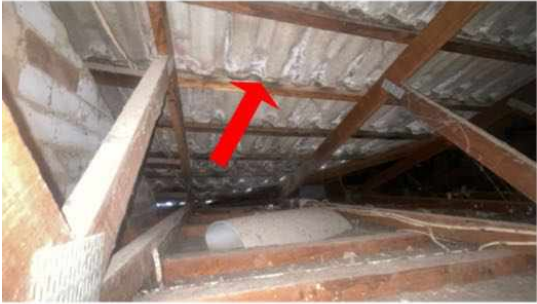
Please note. It is suspected this would be a owners corporation issue. Your own enquiries should be made to determine whether this is the case.

A cleaning contractor or general handyperson may be appointed to perform these works at the discretion of the client.

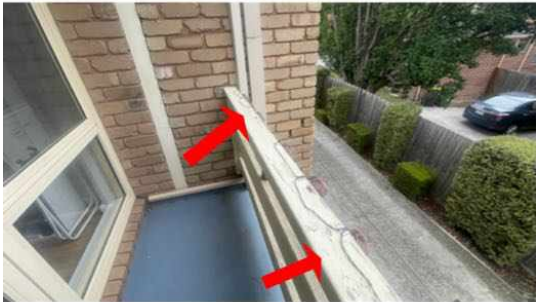
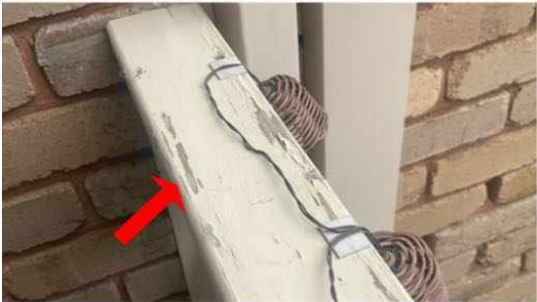
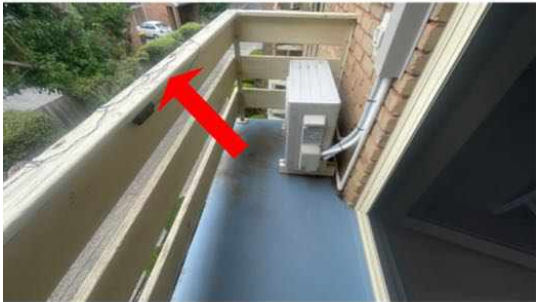
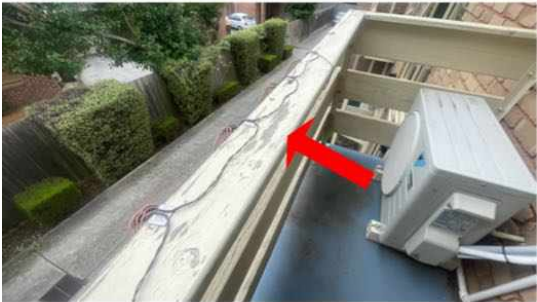
Please note as these are external timbers it is suspected they would be covered by the owners corporation. Your own enquiry should be made to determine whether this is the case.

Adequate treatment of these timbers is required as soon as possible by a painting contractor or general handyman.

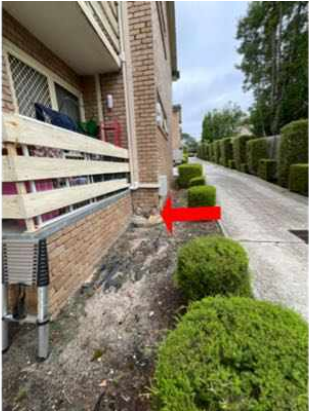
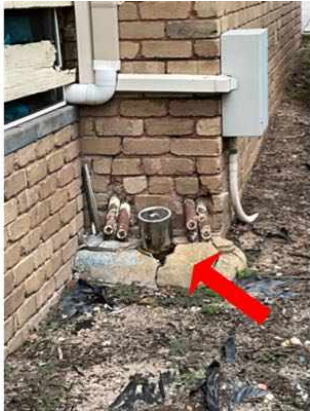
Building:
Location: Exterior walls - left side
Finding: Additional Photos - for your information (common areas - suspected owners corporation issue)
Information: Additional photos are provided for your general reference.

It is suspected these items would be covered by the owners corporation. Your own enquiries should be made to determine whether this is the case.

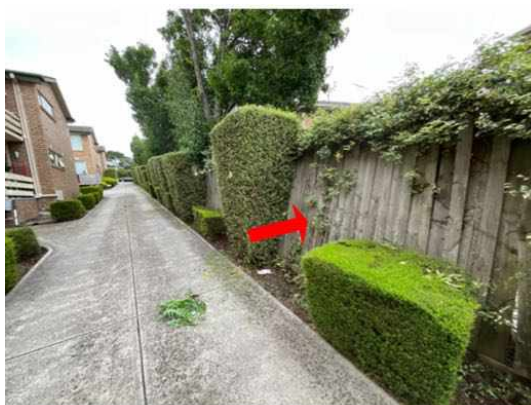
Please note: it is suspected this item would be covered by the owners corporation. Your own enquiry should be made to determine whether this is the case.

A licensed fencing contractor should be appointed to provide further advice and perform rectification works as necessary.
